NC DEPARTMENT OF TRANSPORTATION  
DIVISION OF HIGHWAYS  
STRUCTURE MANAGEMENT UNIT

## Structure Safety Report

### Routine Element Inspection - Contract

COUNTY: CALDWELL STRUCTURE NUMBER: 130262 FREQUENCY: 24 MONTHS

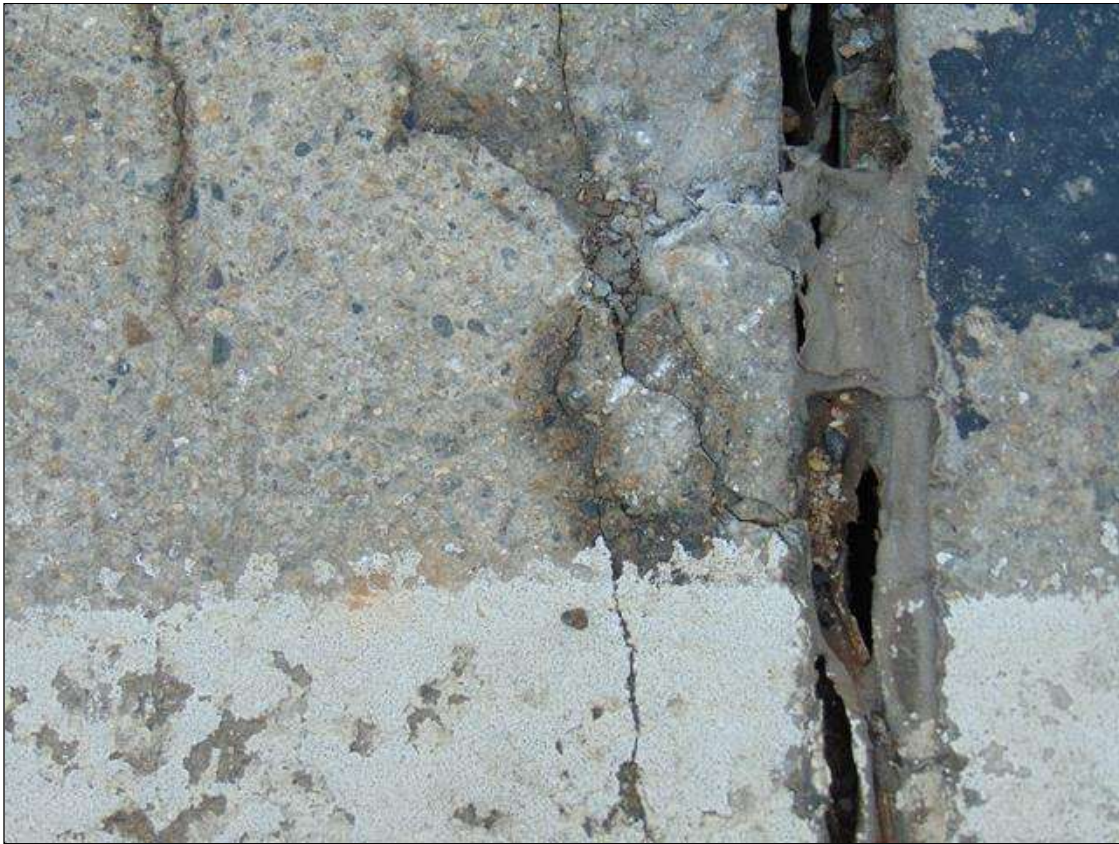
Span 8 Deck: (2) up to 4" x 5" x 1" deep spall in Eastbound lane at Bent 9

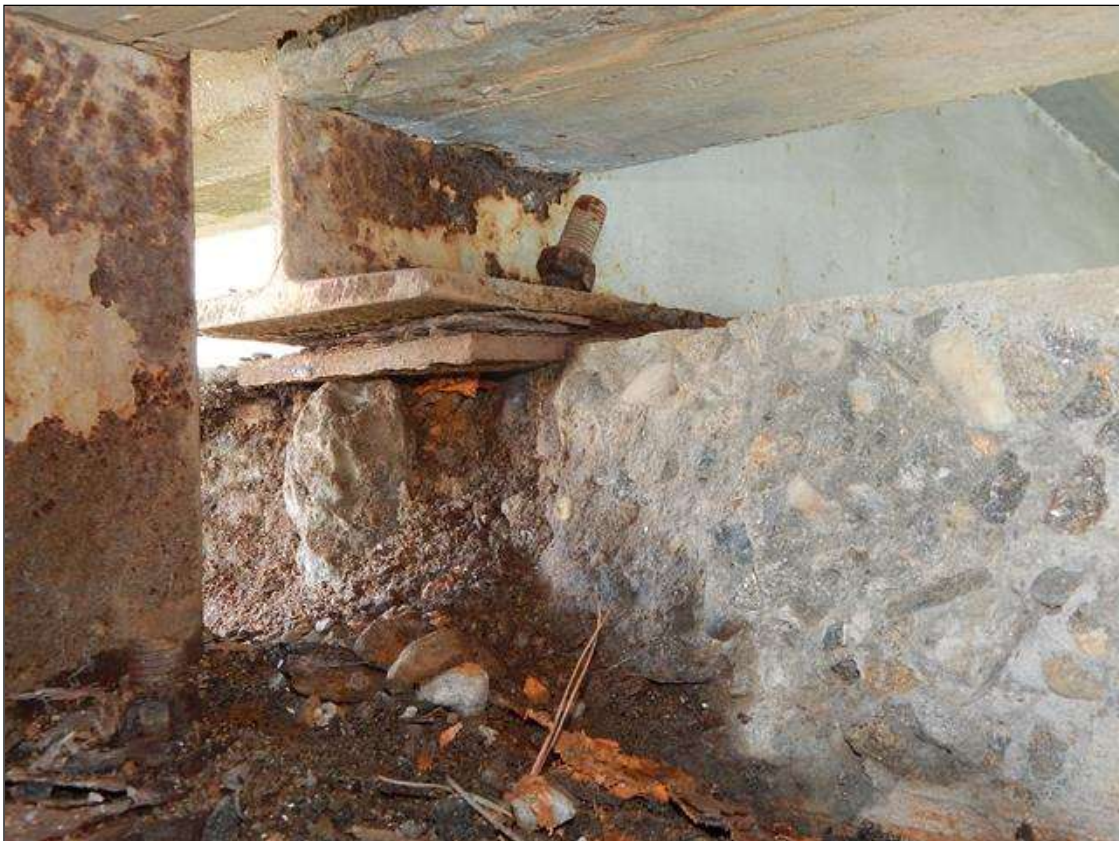
Bent 8 Cap : 31" x 7" x 5" deep spall with 7" x 3" loss of bearing on top of cap under Beam 1 on Span 8 face

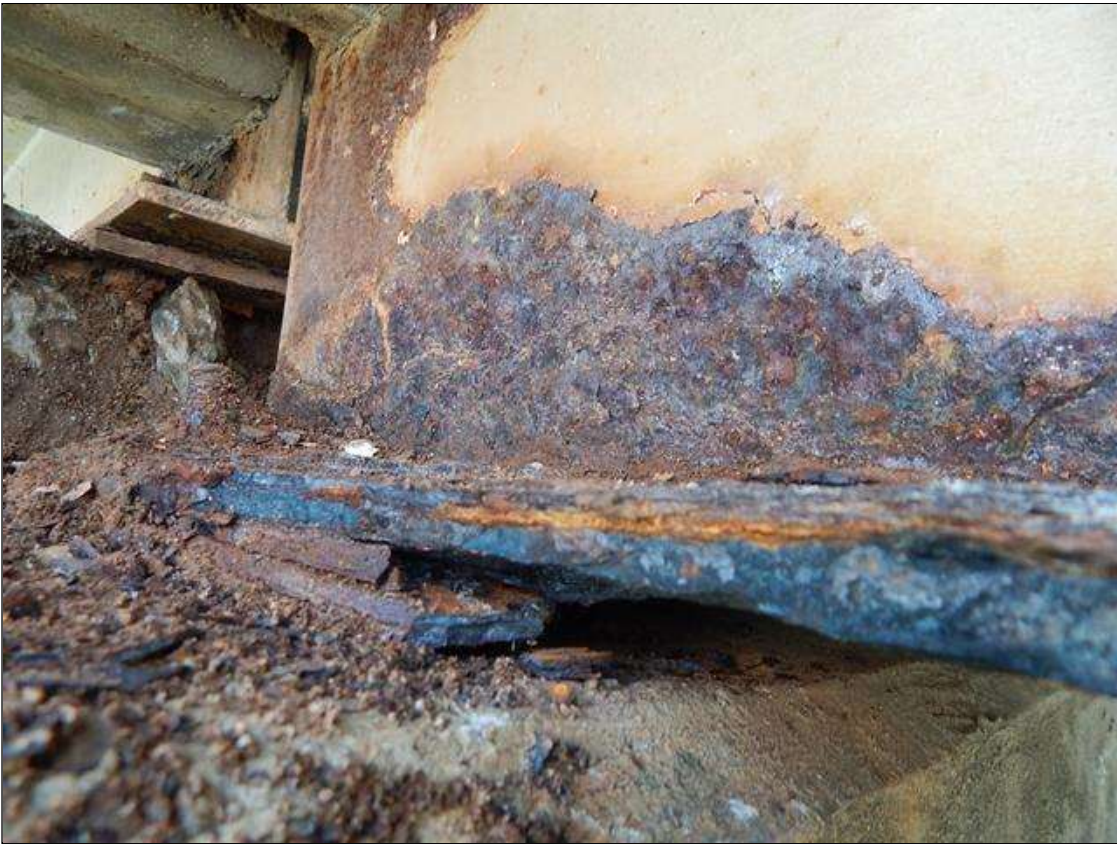
Span 8 Beam 1: 12" x 4" area of 1/4" section loss (1/2" remaining) with 1/4" loss of width on left side of bottom flange at Bent 8

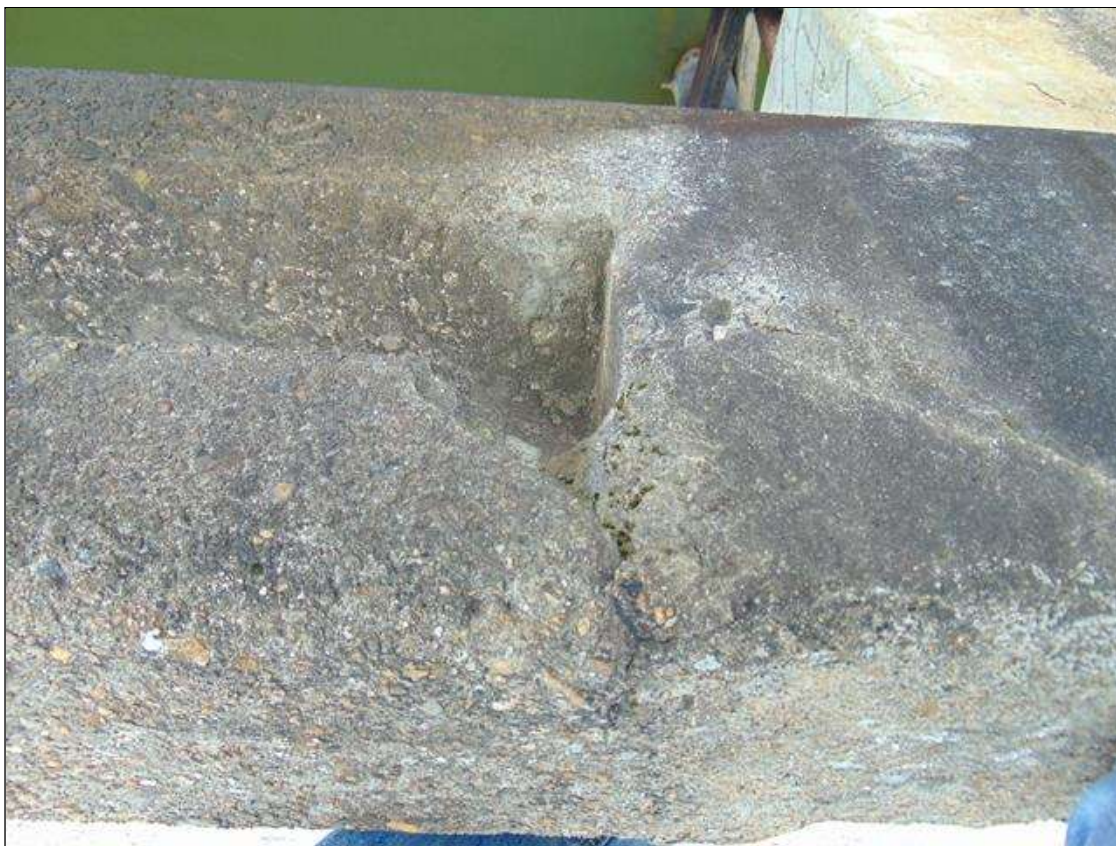
Span 7 Left Bridge Rail: (2) up to 3" x 3" x 1/2" deep spall in curb near Bent 7

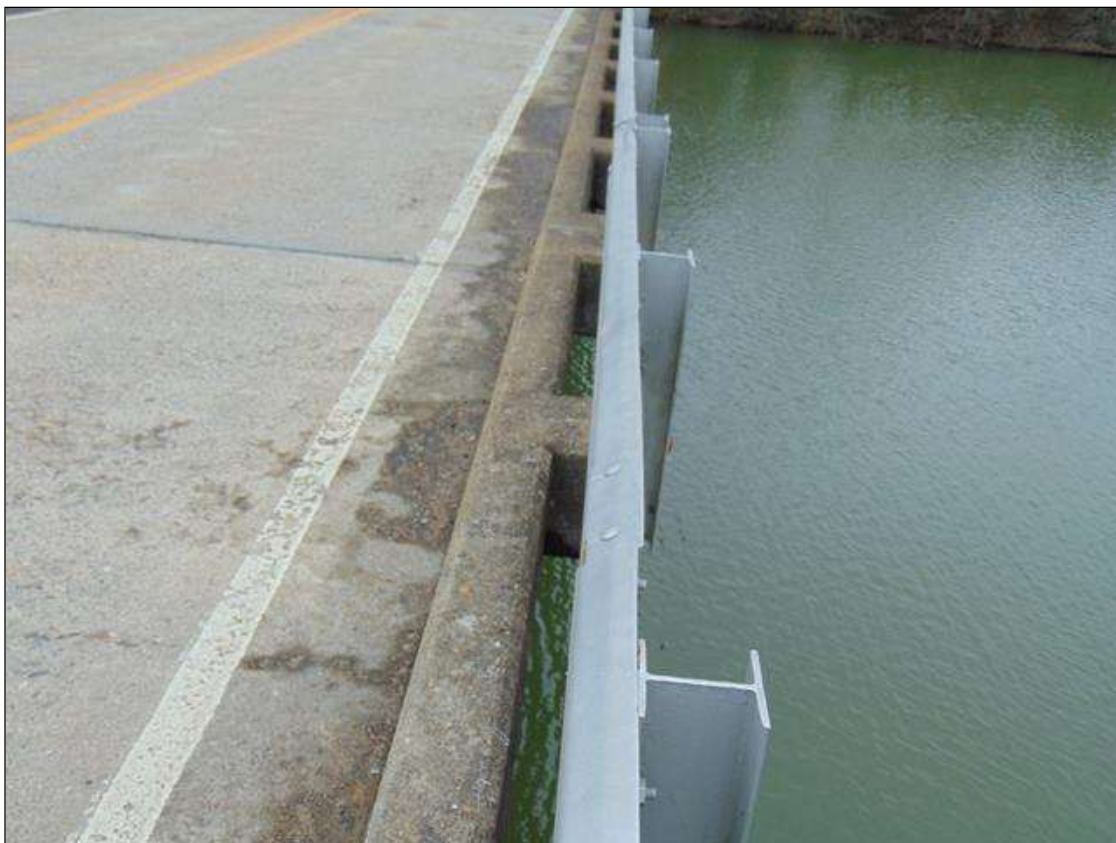
Span 7 Left Bridge Rail: 12' impact damage

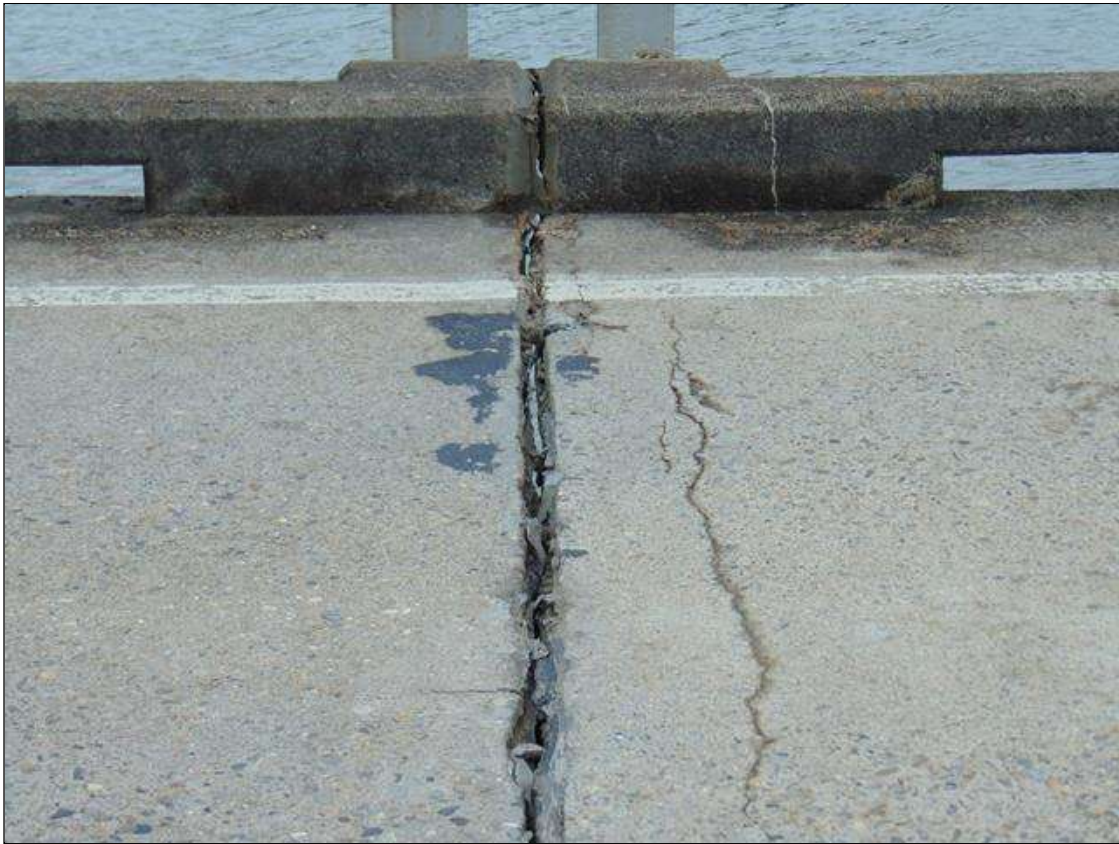
Expansion Joint 8 : 8' missing joint material

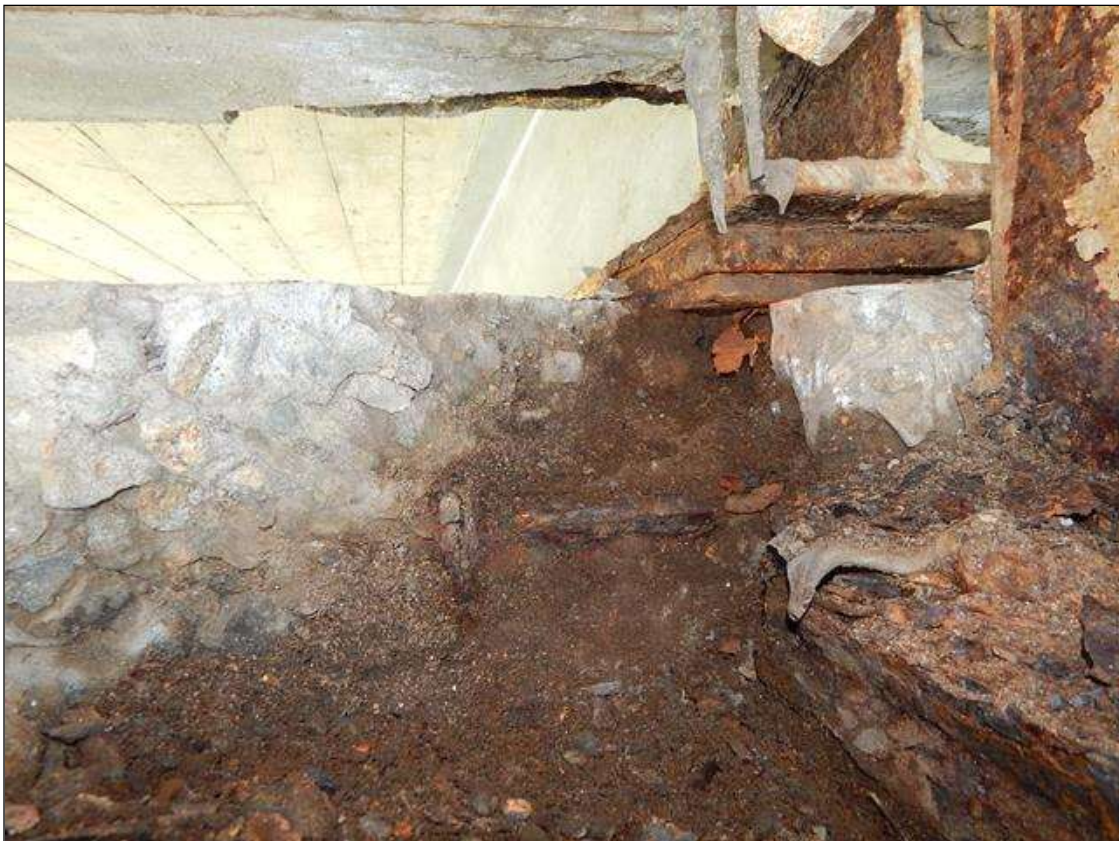
Bent 8 Cap : 14" x 8" x 6" deep spall with exposed rebar and 2" x 2" loss of bearing on top of cap under Beam 2 on Span 8 face at left side (Right side similar)

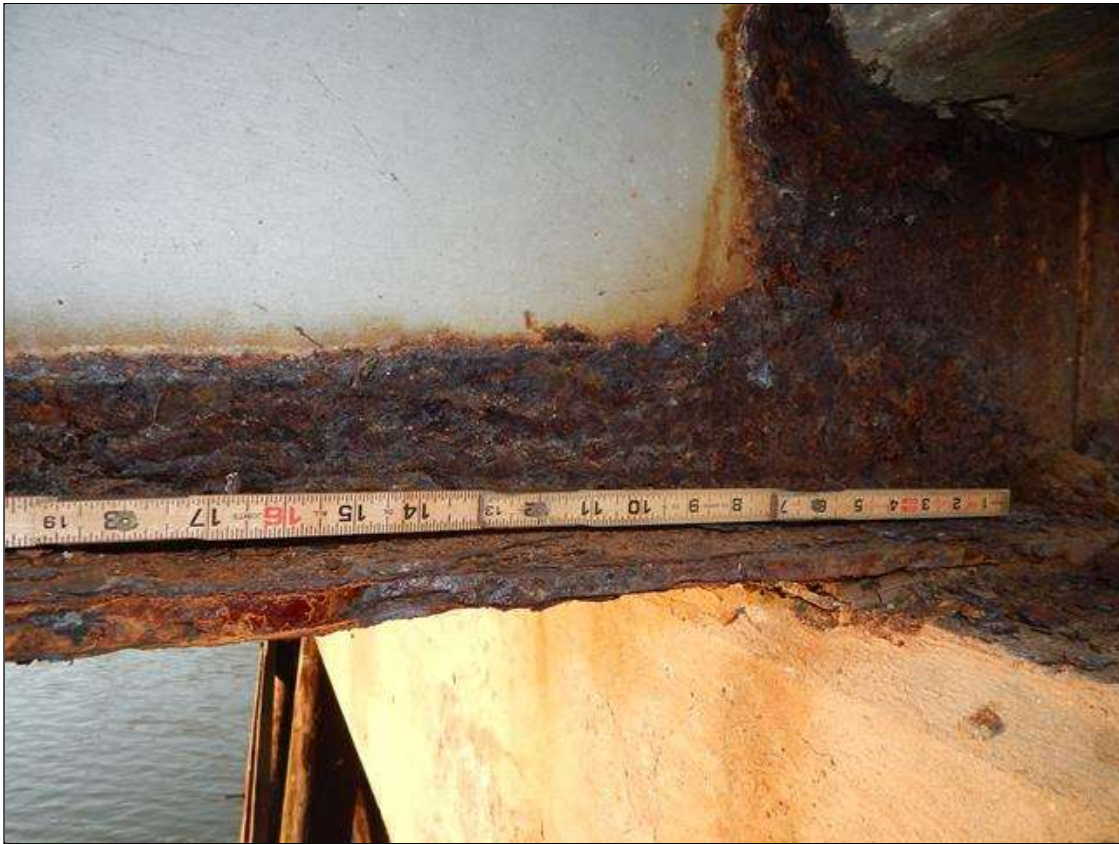
Span 11 Beam 4: 20" x 4" area of 5/16" section loss (7/16" remaining) on the right side of bottom flange at Bent 11

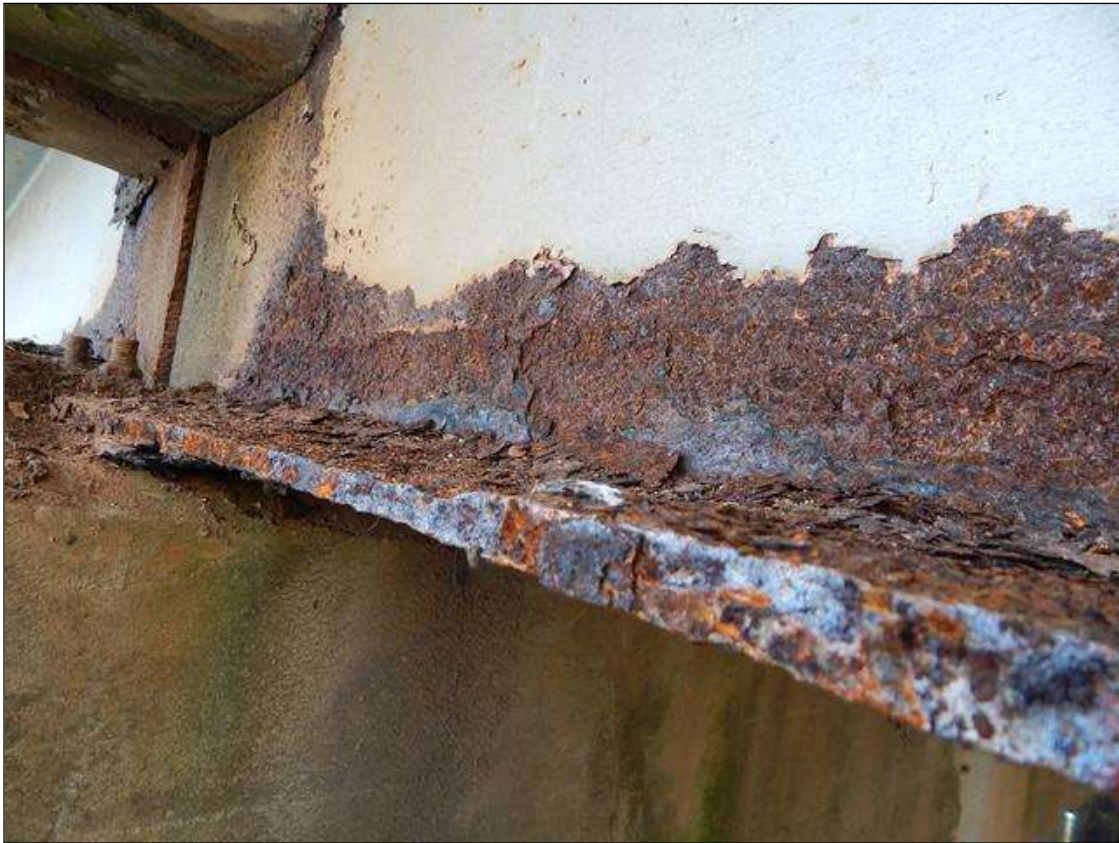
SPAN 1 BEAM 1: 26" X 4" AREA OF 3/8" SECTION LOSS (3/8" REMAINING) ON BOTH SIDES OF BOTTOM FLANGE AT BENT 1

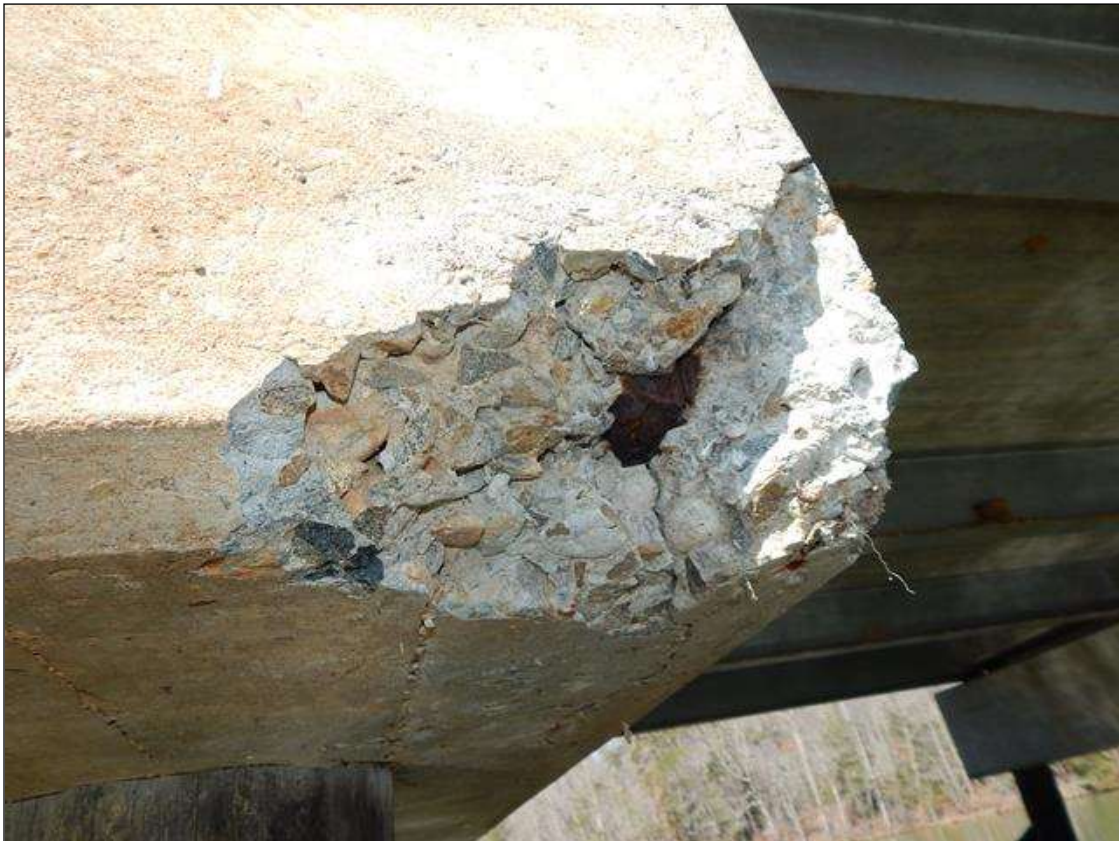
BENT 4 CAP : 11" X 6" X 4" DEEP SPALL WITH EXPOSED REBAR ON SOUTH FACE

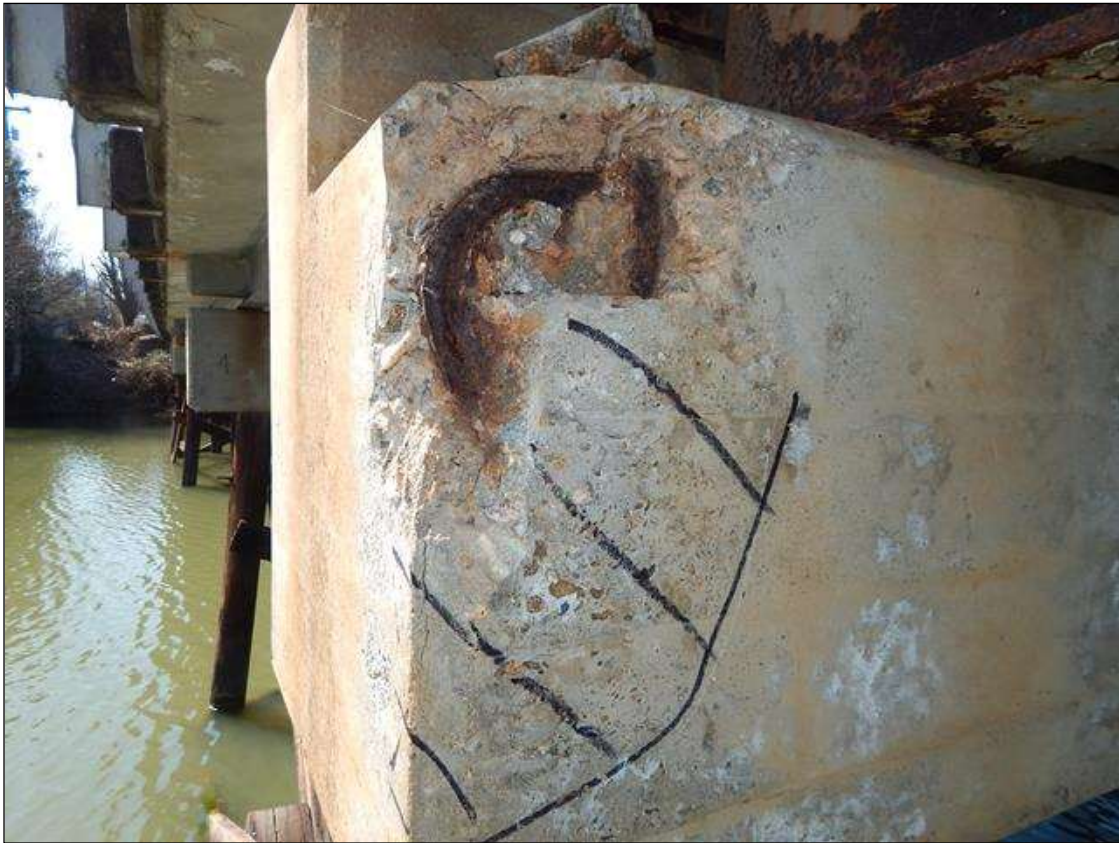
BENT 5 CAP : 11" X 18" X 3" DEEP SPALL WITH EXPOSED REBAR AND AREA OF DELAMINATION AT SOUTHEAST CORNER

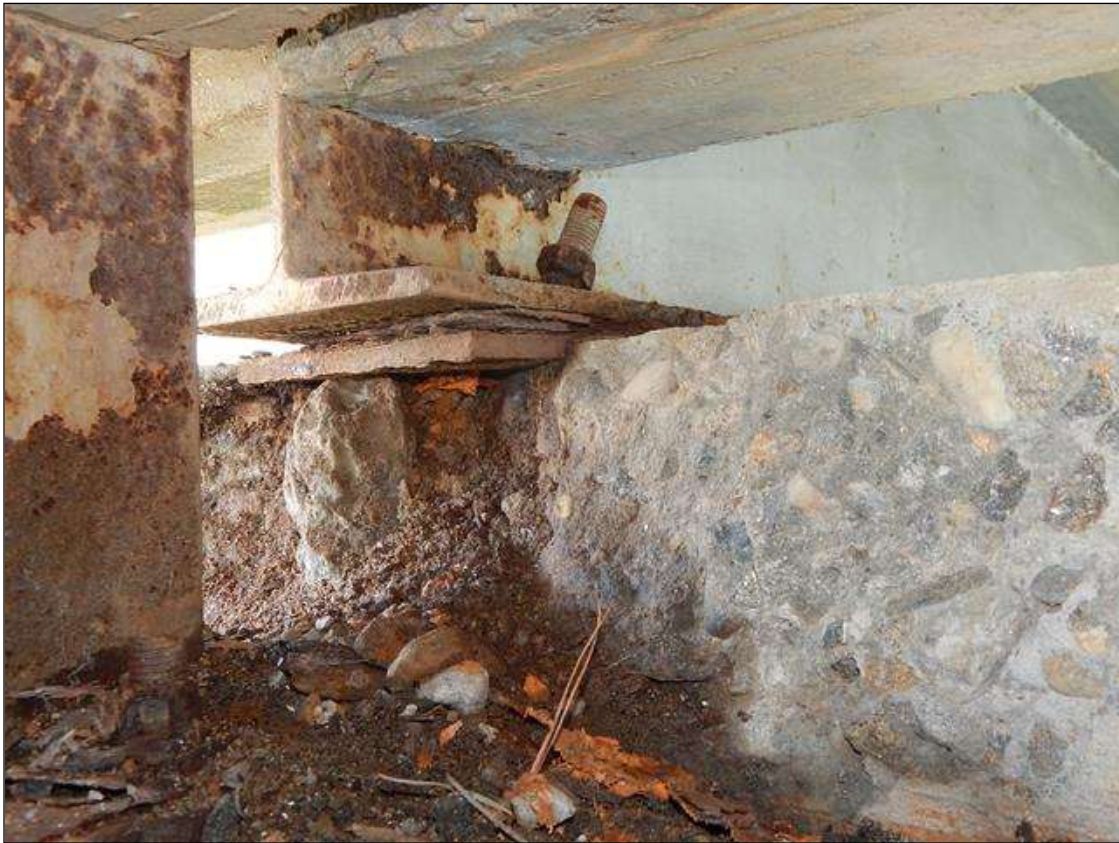
BENT 8 CAP : 31" X 7" X 5" DEEP SPALL WITH 7" X 3" LOSS OF BEARING ON TOP OF CAP UNDER BEAM 1 ON SPAN 8 FACE

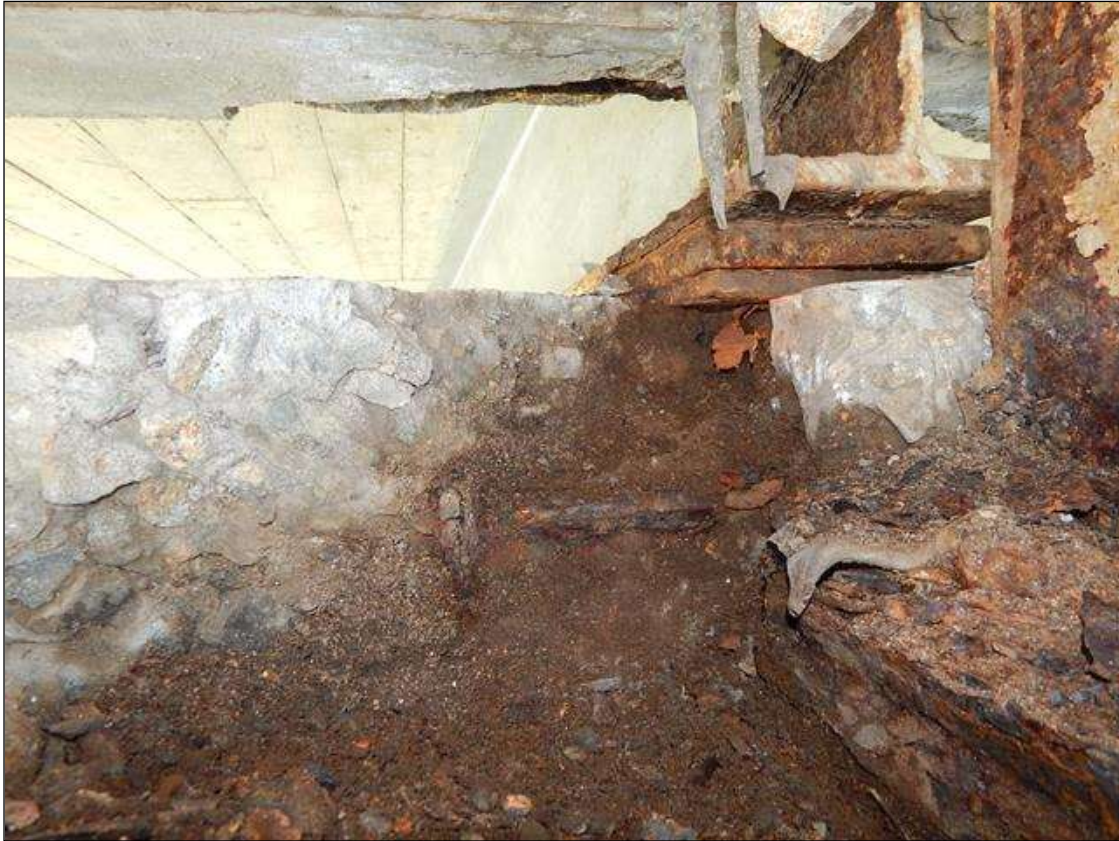
BENT 8 CAP : 14" X 8" X 6" DEEP SPALL WITH EXPOSED REBAR AND 2" X 2" LOSS OF BEARING ON TOP OF CAP UNDER BEAM 2 ON SPAN 8 FACE AT LEFT SIDE

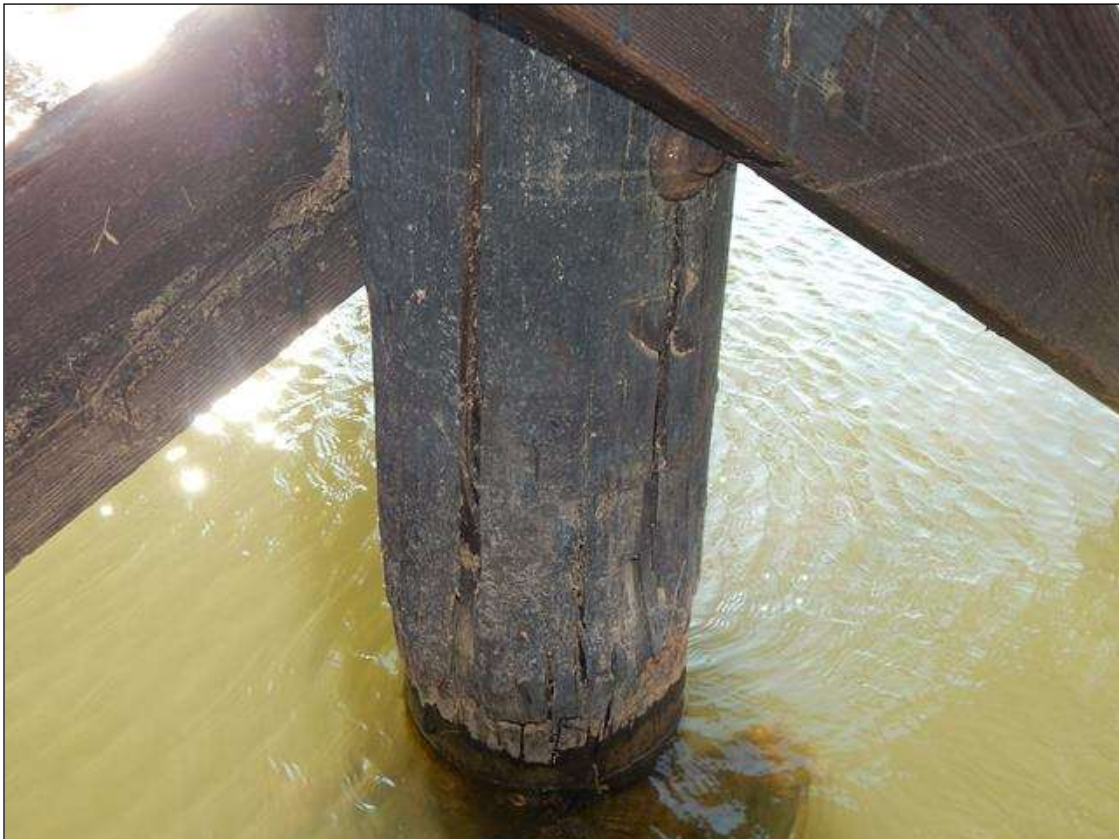
BENT 9 PILE 2: 28" LONG PILE MUSHROOMING

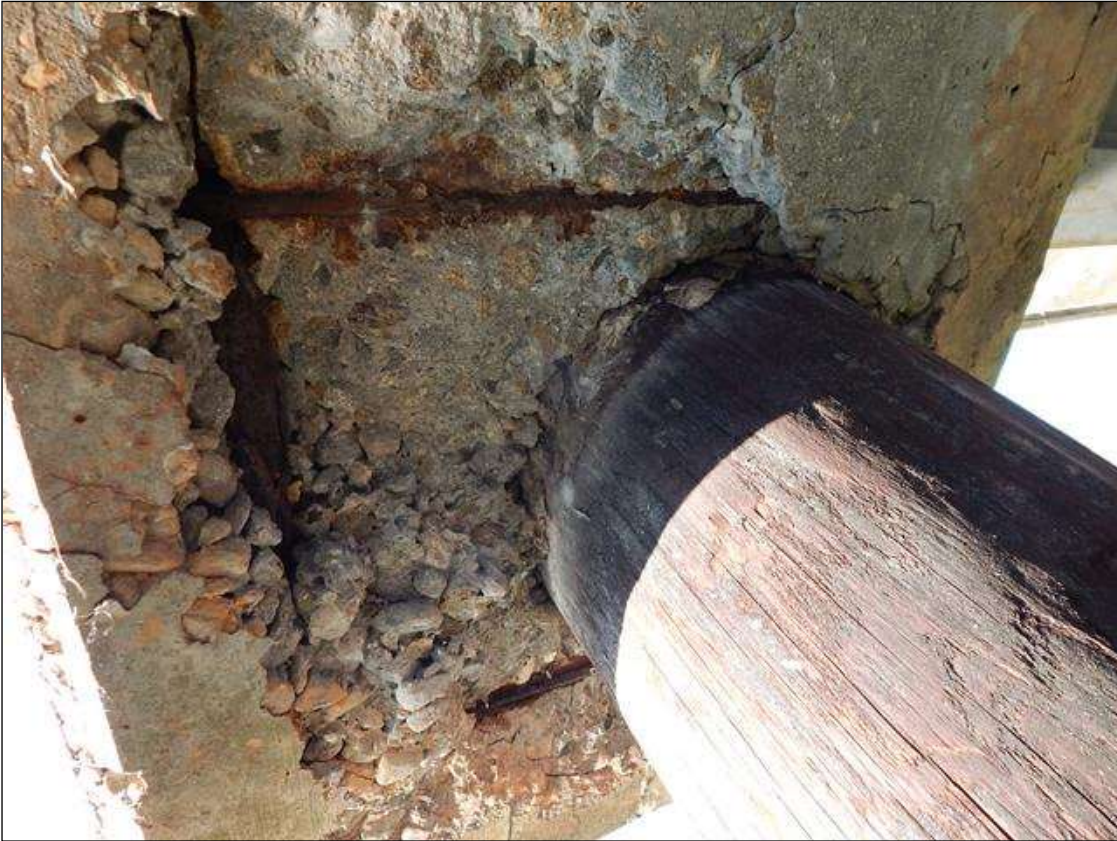
BENT 10 CAP: 44" X 22" X 3" DEEP SPALL WITH EXPOSED REBAR ON BOTTOM OF CAP AT PILE 1

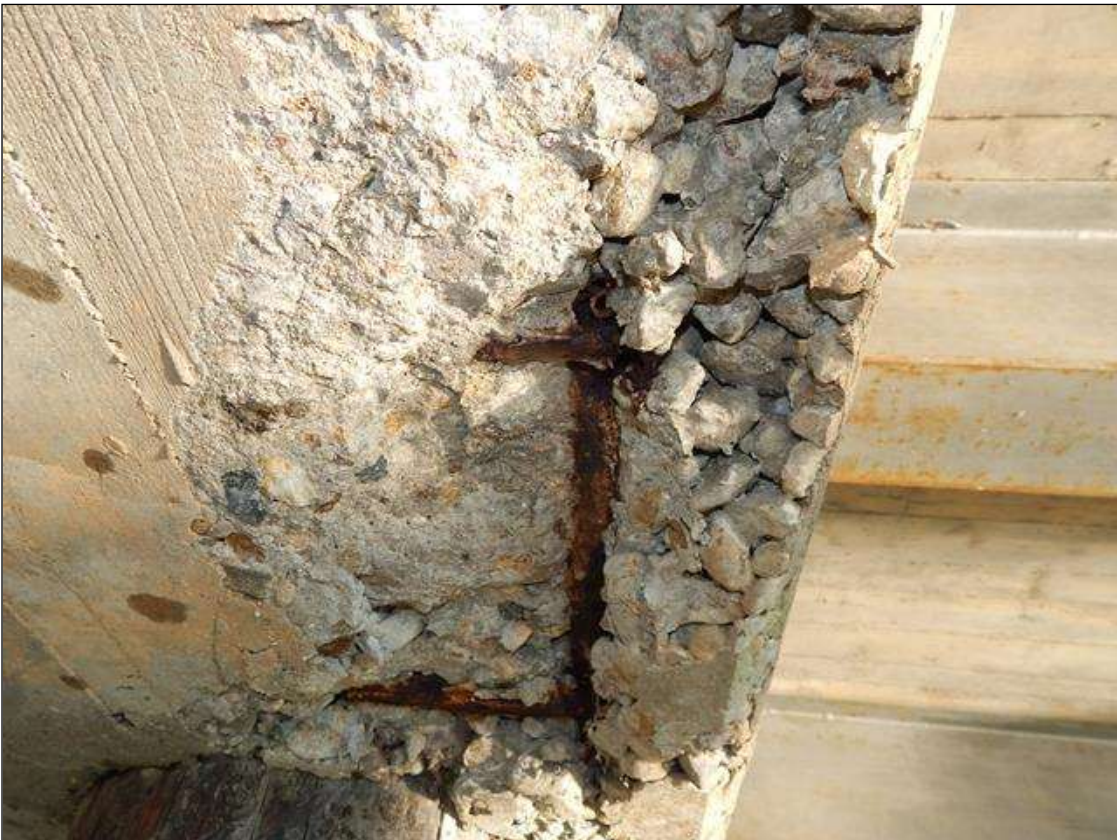
BENT 10 CAP : 24" X 11" X 2" DEEP SPALL WITH EXPOSED REBAR AT BOTTOM OF CAP BETWEEN PILES 2 AND 3

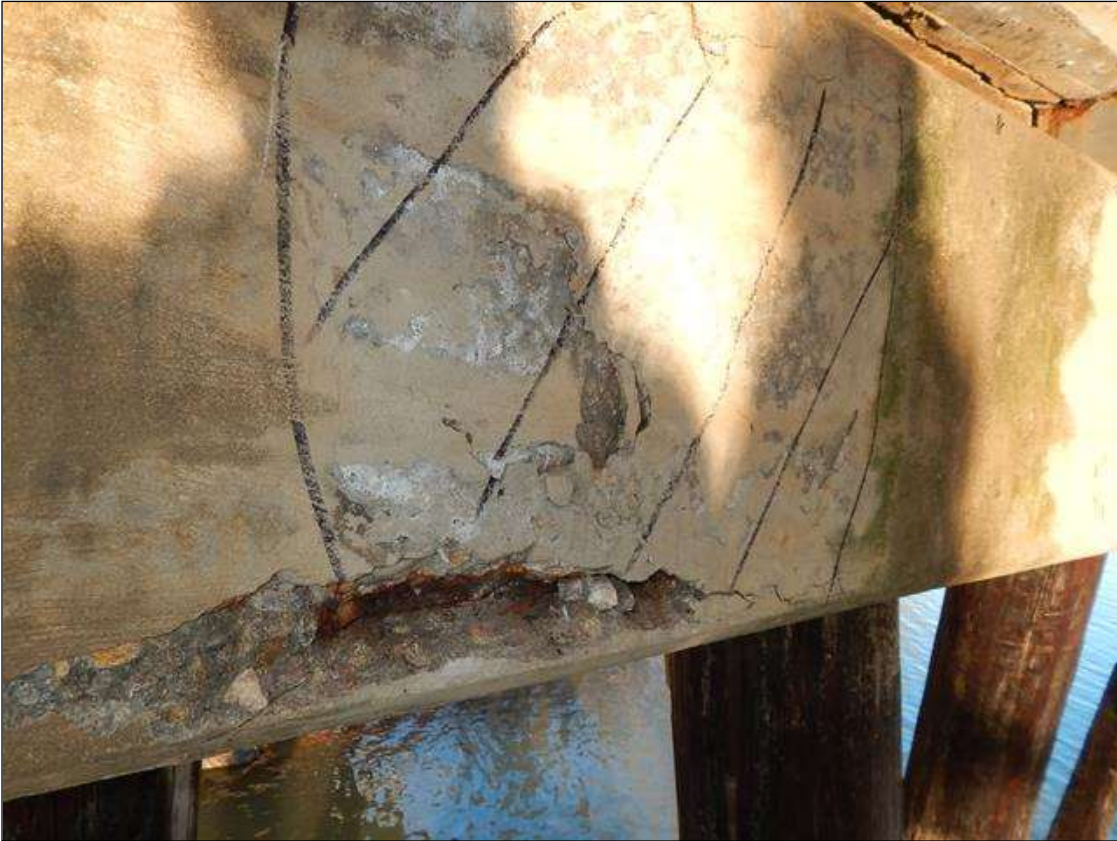
BENT 11 CAP : 18" X 3" X 1 1/2" DEEP SPALL WITH EXPOSED REBAR ON SPAN 11 FACE UNDER BAY 2

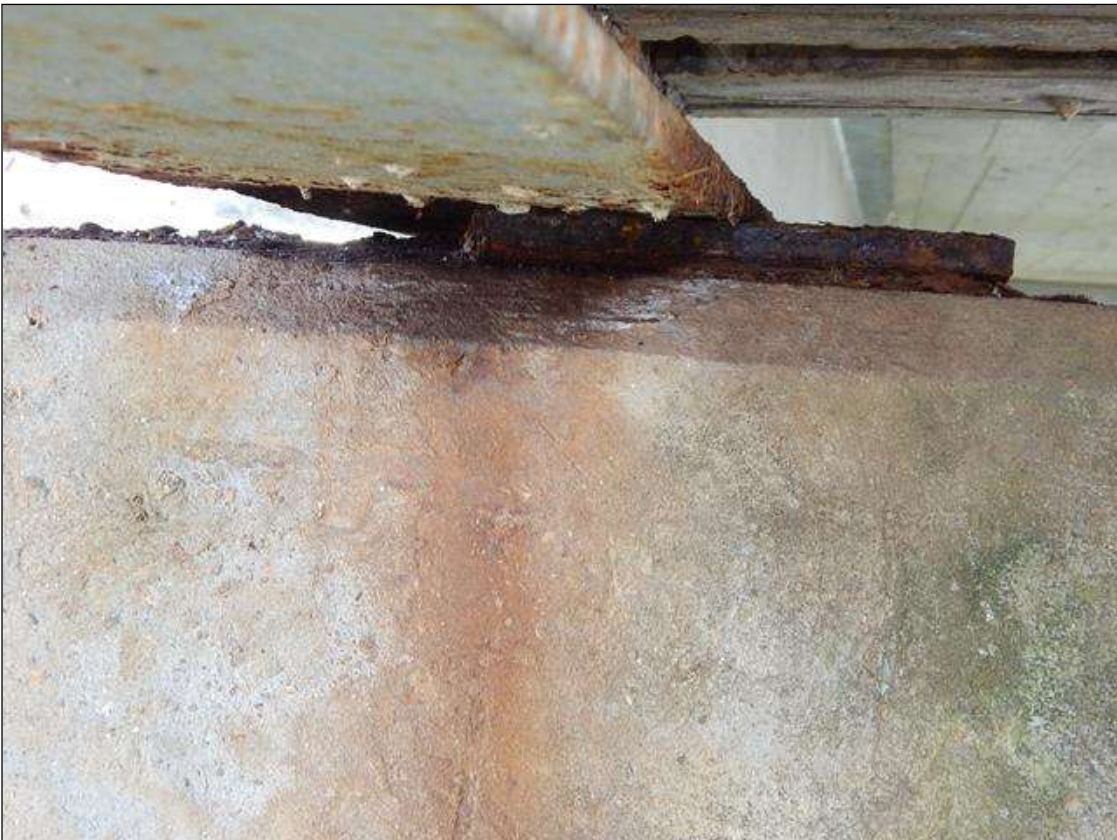
SPAN 9 BEAM 4 NEAR BEARING : UP TO 3 1/2" X 7" LOSS OF BEARING AREA

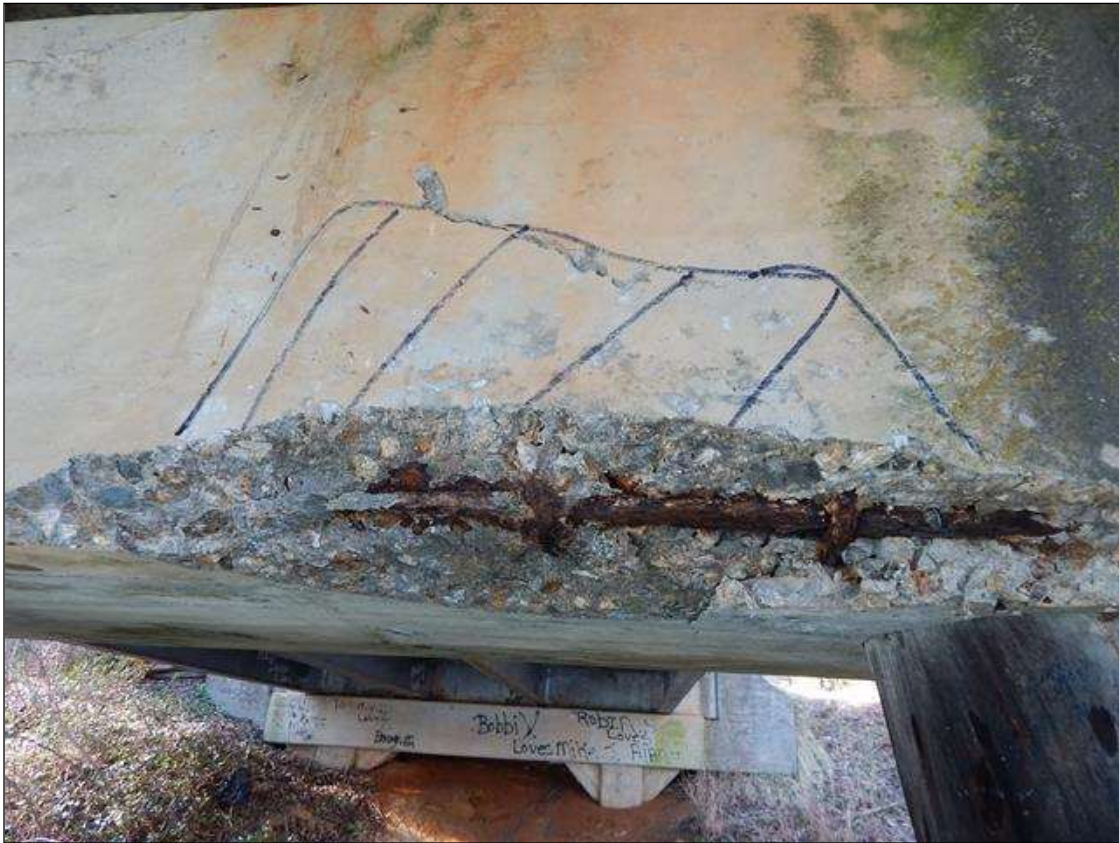
BENT 1 CAP : 43" X 12" X 9" DEEP SPALL WITH EXPOSED REBAR AND AREA OF DELAMINATION ON BOTTOM OF CAP BETWEEN PILES 1 AND 2 (OTHER LOCATIONS SIMILAR)

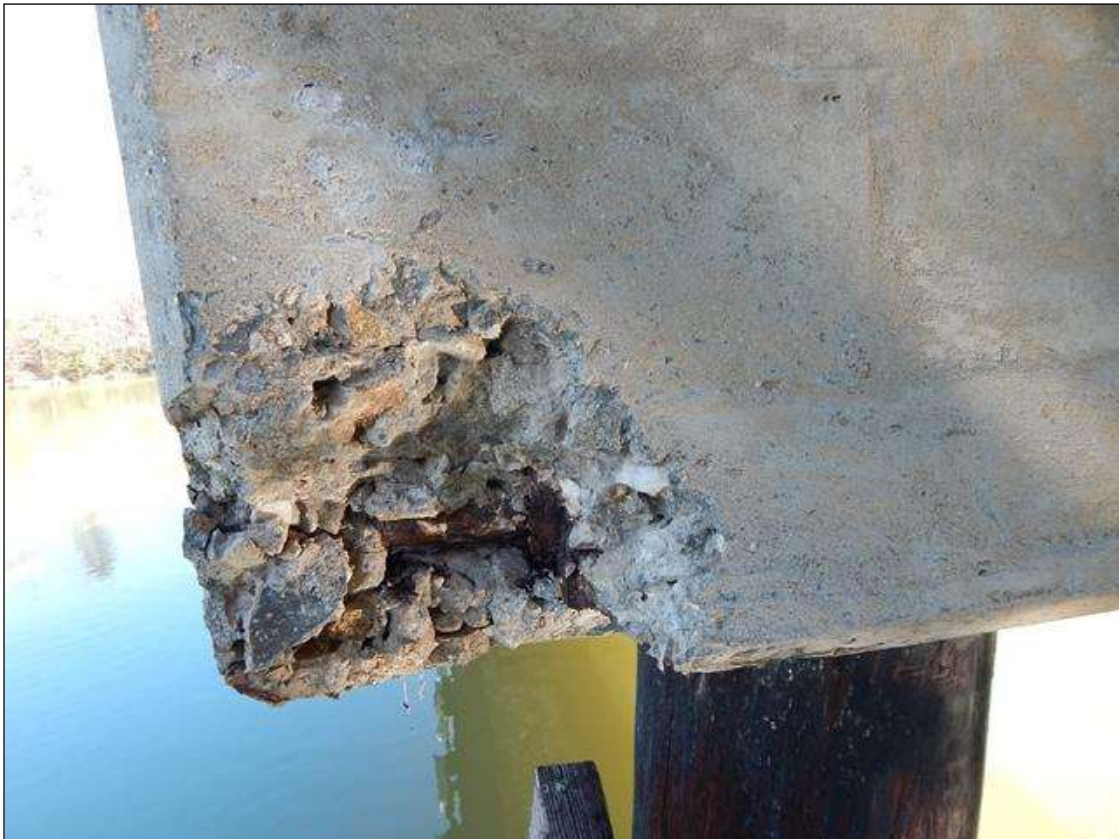
BENT 3 CAP : 9" X 8" X 3" DEEP SPALL WITH EXPOSED REBAR ON SPAN 3 FACE AT NORTH END
