NC DEPARTMENT OF TRANSPORTATION  
DIVISION OF HIGHWAYS  
STRUCTURE MANAGEMENT UNIT

# Structure Safety Report

## Municipal Routine Element Inspection - Contract

DIVISION: 6 COUNTY: CUMBERLAND STRUCTURE NUMBER: 250211 FREQUENCY: 24 MONTHS

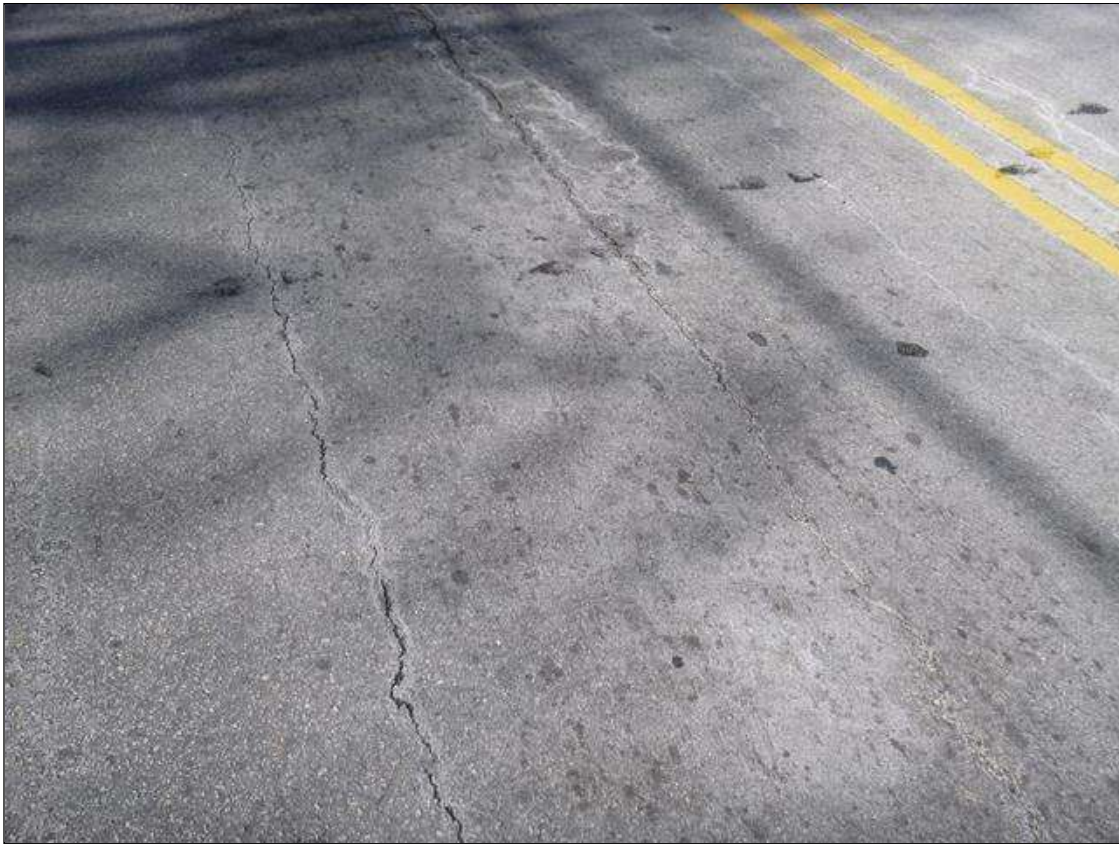
| Element Number | Defect Type | Defect Description | CS | CS Qty | Maint Qty | |
|---|---|---|---|---|---|---|
| 510 | Crack (Wearing Surface) | (8) 31' REFLECTIVE LONGITUDINAL CRACKS UP TO 1/8", THROUGHOUT TRAVEL LANES. | 3 | 248 | 248 | Square Feet |

Span 1 Wearing Surface: (8) 31' REFLECTIVE LONGITUDINAL CRACKS UP TO 1/8", THROUGHOUT TRAVEL LANES.

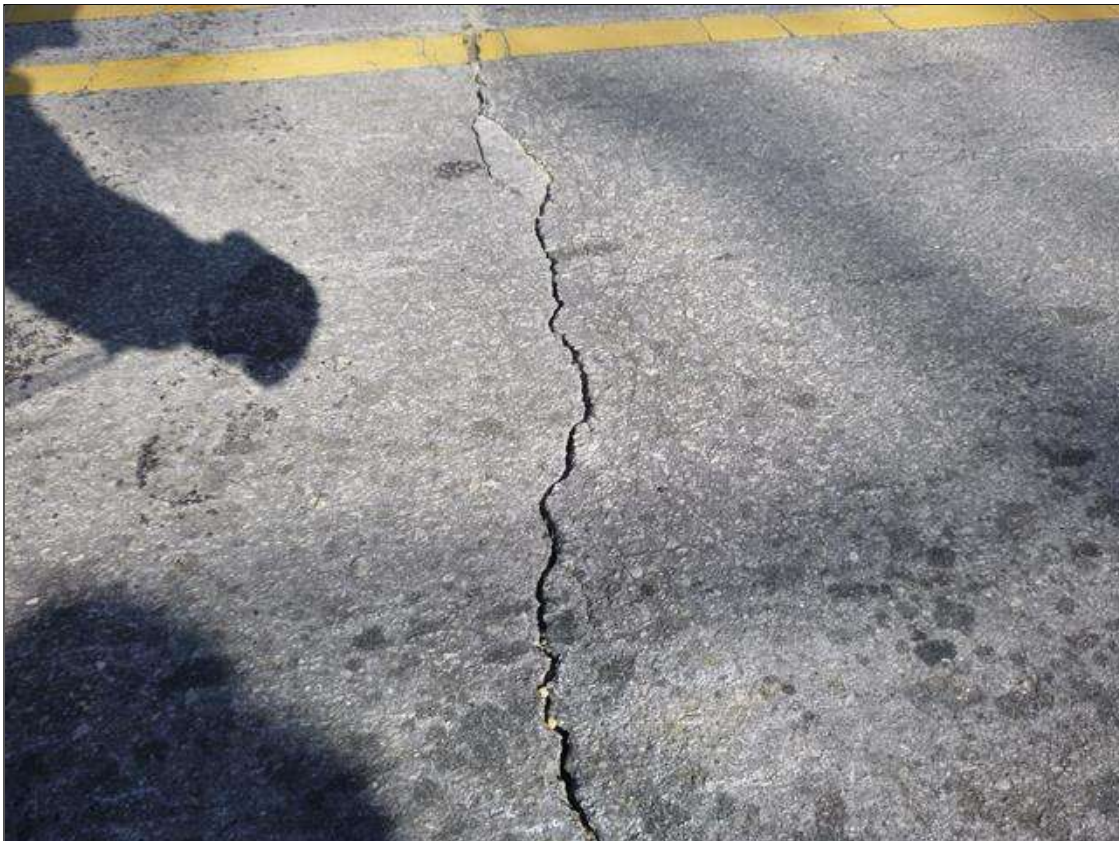
| Element Number | Defect Type | Defect Description | CS | CS Qty | Maint Qty | |
|---|---|---|---|---|---|---|
| 510 | Crack (Wearing Surface) | 30' TRANSVERSE CRACK UP TO 1/4", OVER END BENT 1. | 3 | 30 | 30 | Square Feet |

Span 1 Wearing Surface: 30' TRANSVERSE CRACK UP TO 1/4", OVER END BENT 1.

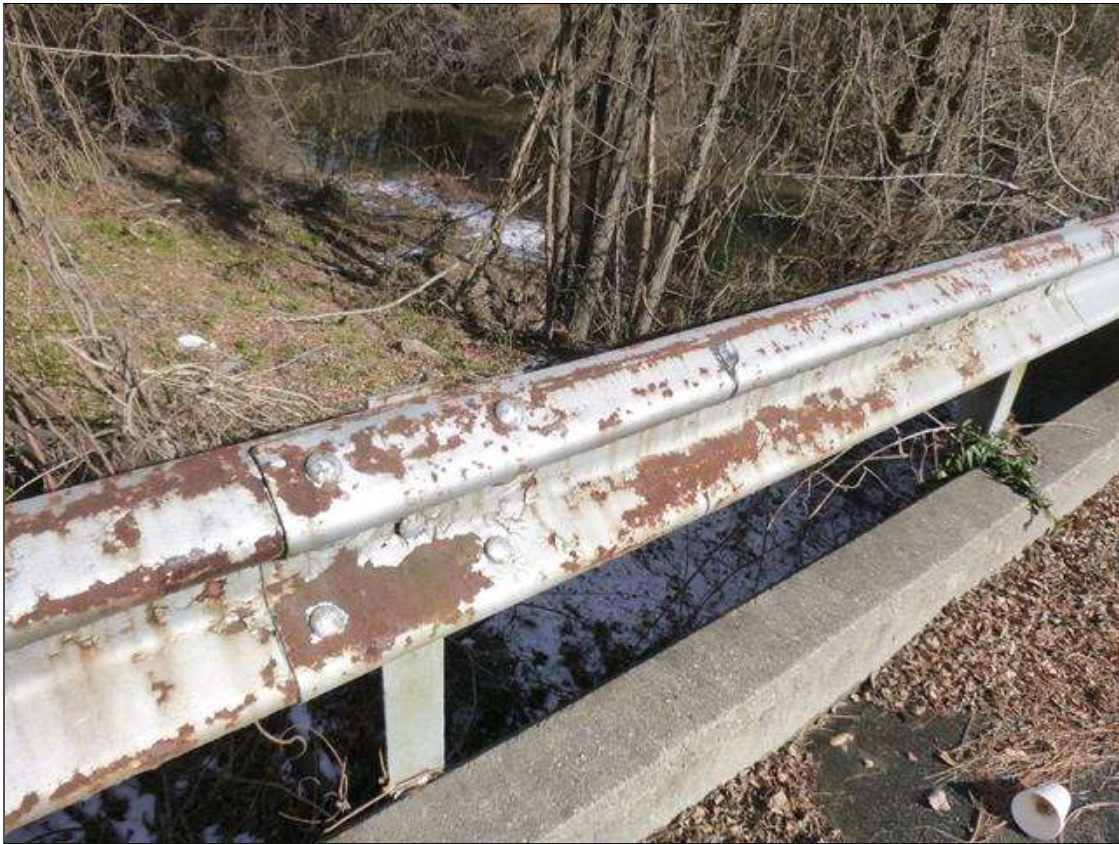
| Element Number | Defect Type | Defect Description | CS | CS Qty | Maint Qty | |
|---|---|---|---|---|---|---|
| 330 | Corrosion | 31' OF SURFACE RUST ALONG RAIL. | 2 | 31 | | Square Feet |

Span 1 Left Bridge Rail: 31' OF SURFACE RUST ALONG RAIL.

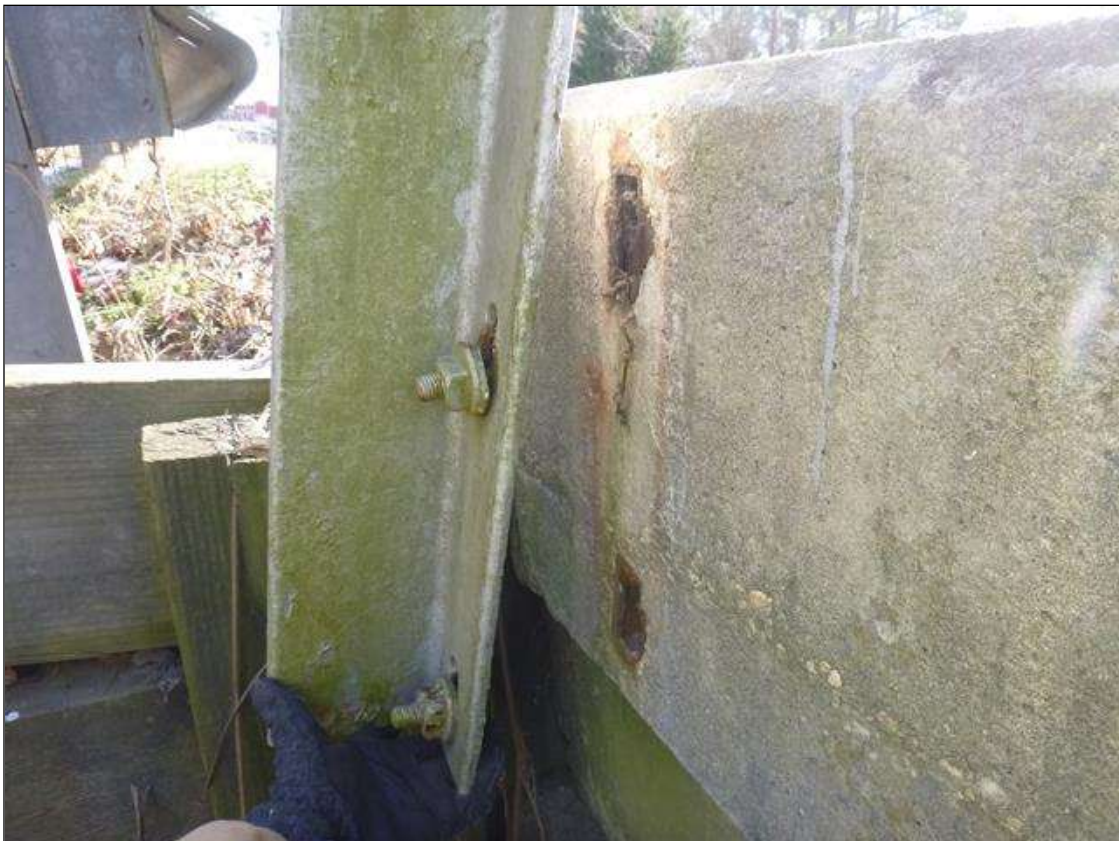
Span 3 Left Bridge Rail: 10' OF RAIL IS NOT SUPPORTED DUE TO LAST 2 RAIL POST NOT BEING ATTACHED TO STRUCTURE. (PM)

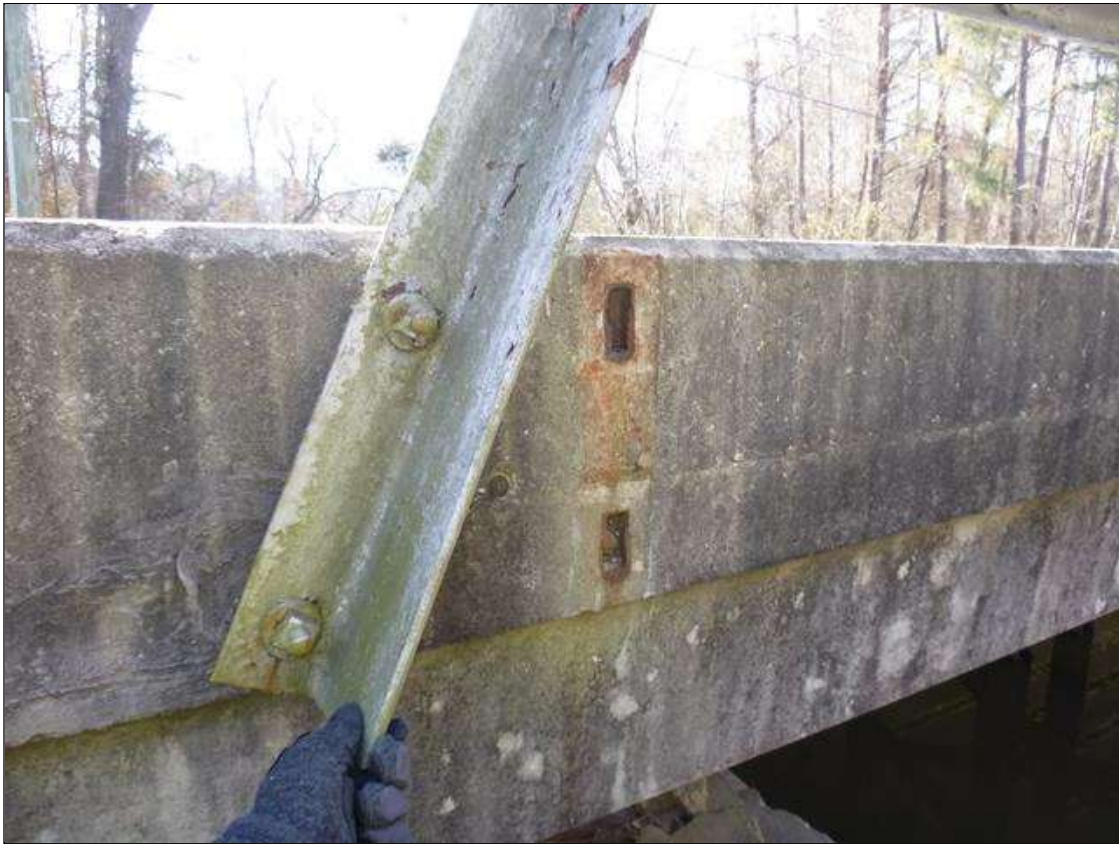
Span 3 Left Bridge Rail: 10' OF RAIL IS NOT SUPPORTED DUE TO LAST 2 RAIL POST NOT BEING ATTACHED TO STRUCTURE. (PM)

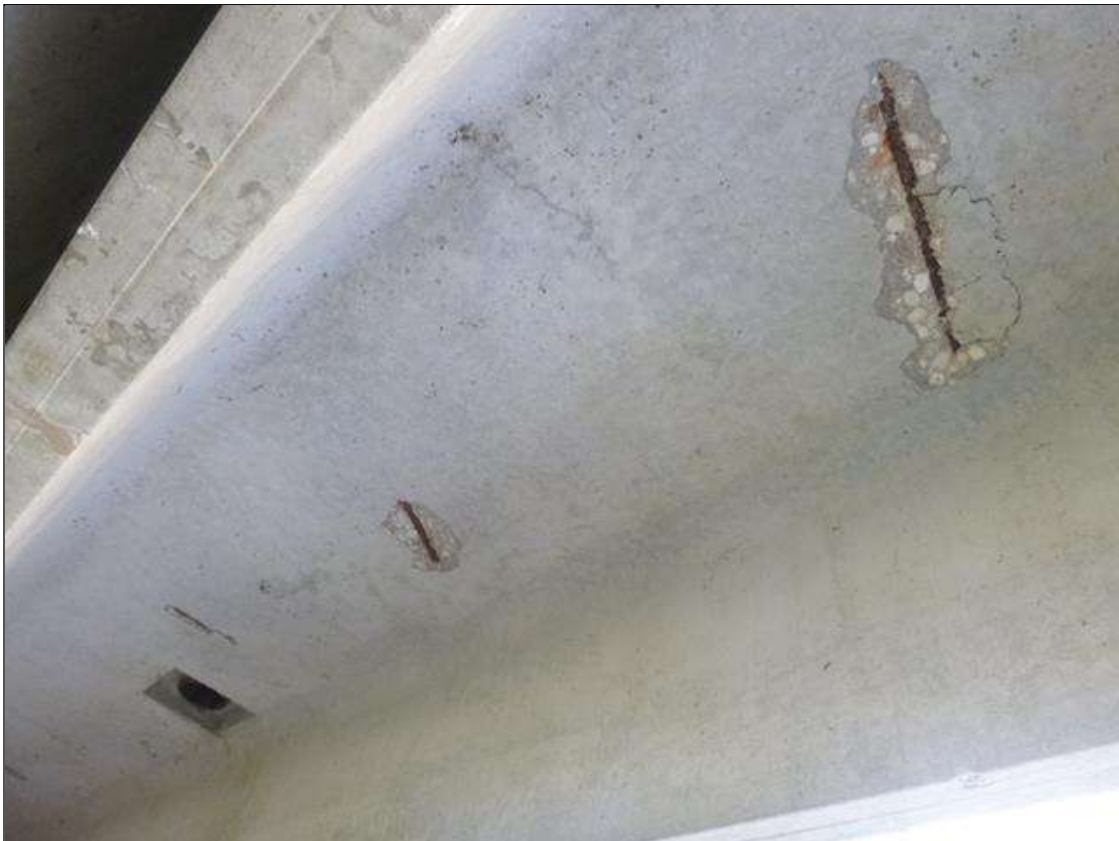
| Element Number | Defect Type | Defect Description | CS | CS Qty | Maint Qty | |
|---|---|---|---|---|---|---|
| 109 | Delamination/Spall | (9) 2" X UP TO 10" X 1/4" SPALLS WITH EXPOSED REINFORCING, AT RANDOM ALONG UNDERSIDE OF TOP SLAB. | 2 | 9 | 9 | Feet |

Span 1 Slab 1: (9) 2" X UP TO 10" X 1/4" SPALLS WITH EXPOSED REINFORCING, AT RANDOM ALONG UNDERSIDE OF TOP SLAB.

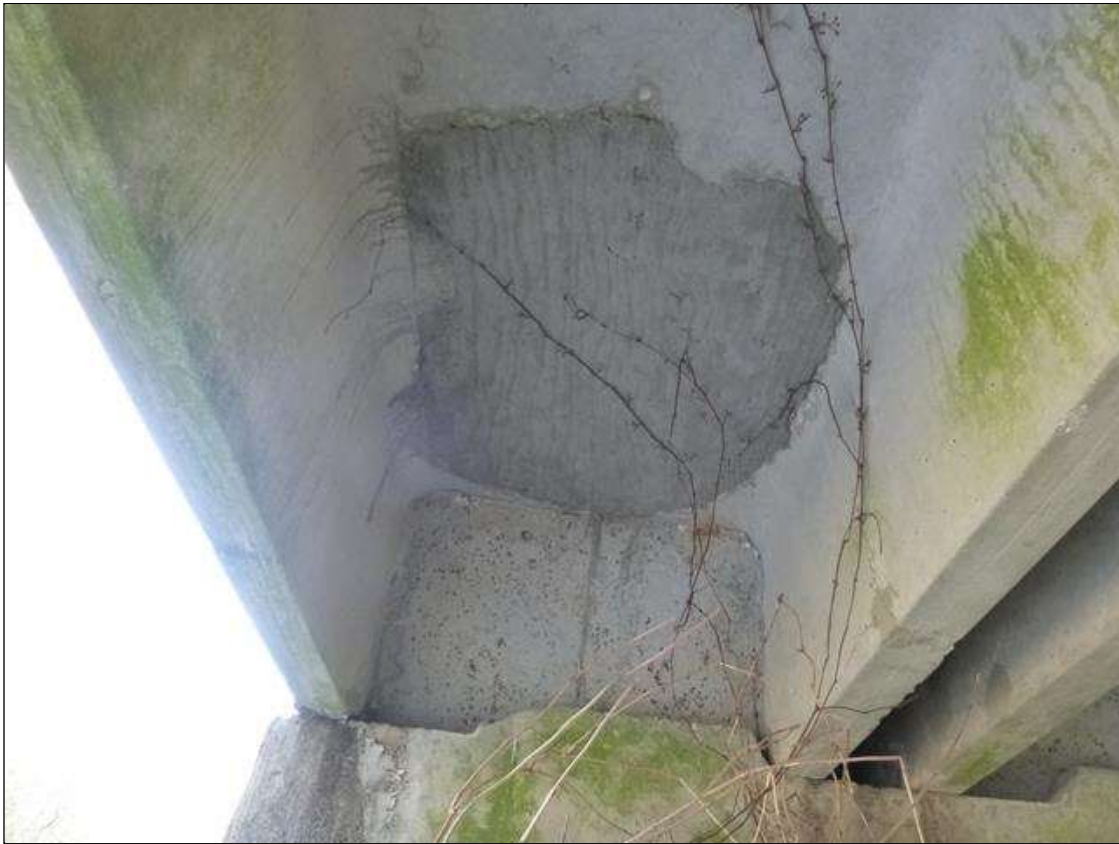
Span 1 Slab 1: 2' PATCHED AREA, UNDERSIDE OF TOP SLAB FOR CRUTCH BENT PILE, AT BENT 1.

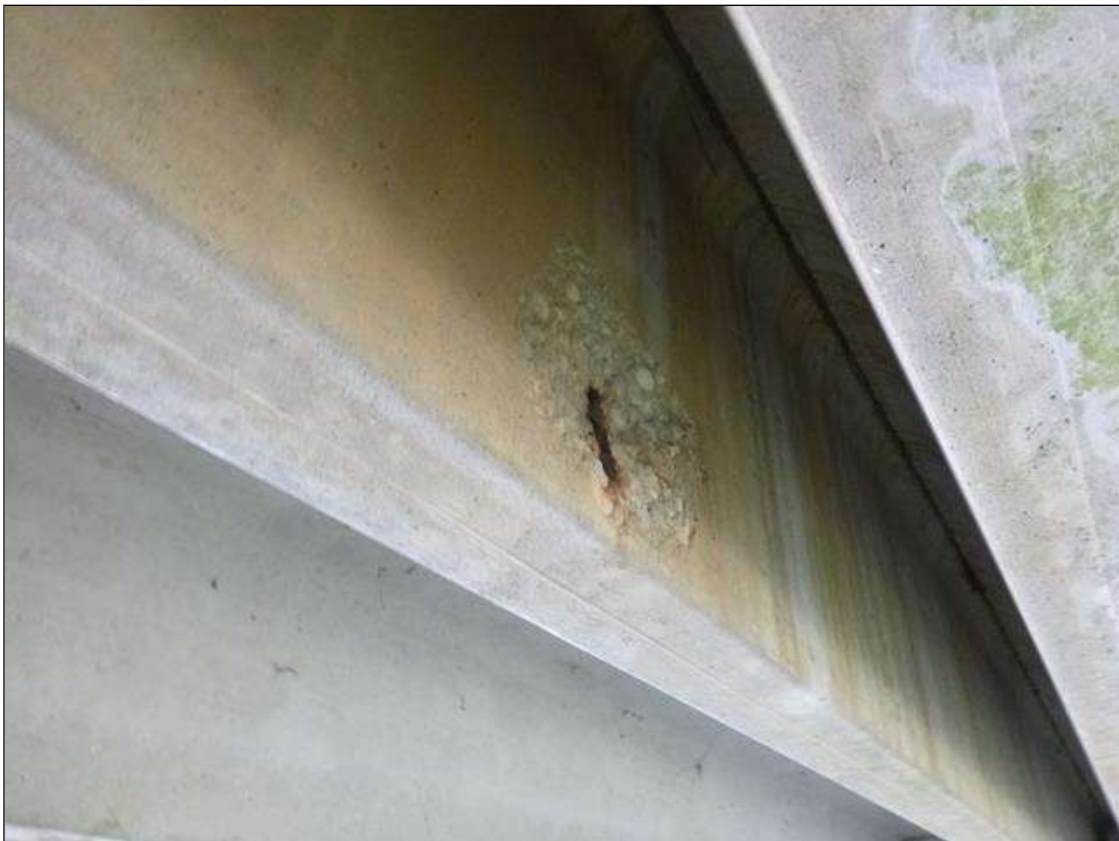
| <b>109</b> | Delamination/Spall | 6" DIAMETER X 1/2" SPALL, OUTSIDE FACE OF LEG 2, 10' FROM BENT 1. | 2 | 1 | 1 Feet |

Span 1 Slab 2: 6" DIAMETER X 1/2" SPALL, OUTSIDE FACE OF LEG 2, 10' FROM BENT 1.

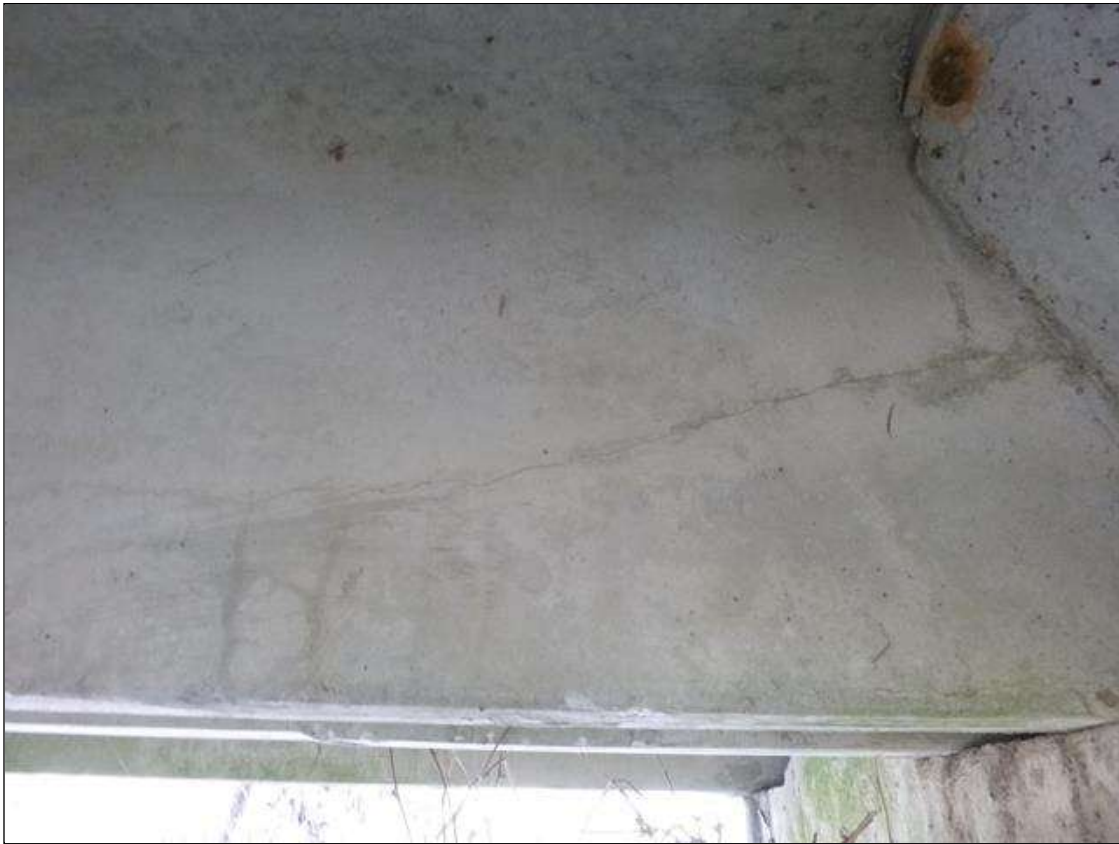
| <b>109</b> | Cracking (PSC) | 20" HORIZONTAL CRACK UP TO .002", INSIDE FACE OF LEG 1, AT BENT 1. | 3 | 2 | 2 Feet |

Span 1 Slab 2: 20" HORIZONTAL CRACK UP TO .002", INSIDE FACE OF LEG 1, AT BENT 1.

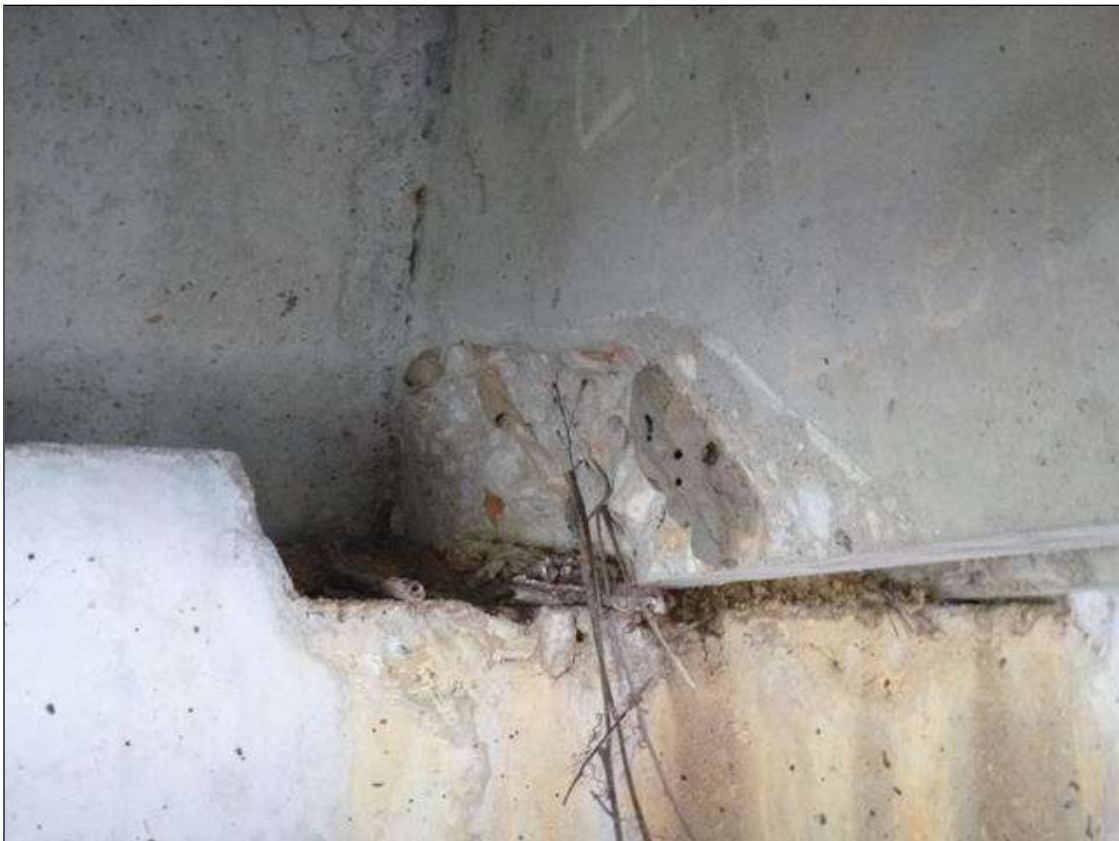
| Element Number | Defect Type | Defect Description | CS | CS Qty | Maint Qty |
|---|---|---|---|---|---|
| <b>109</b> | Delamination/Spall | 14" X 4" X 2" SPALL, INSIDE FACE OF LEG 1, AT END BENT 1. | 3 | 1 | 1 Feet |

Span 1 Slab 3: 14" X 4" X 2" SPALL, INSIDE FACE OF LEG 1, AT END BENT 1.

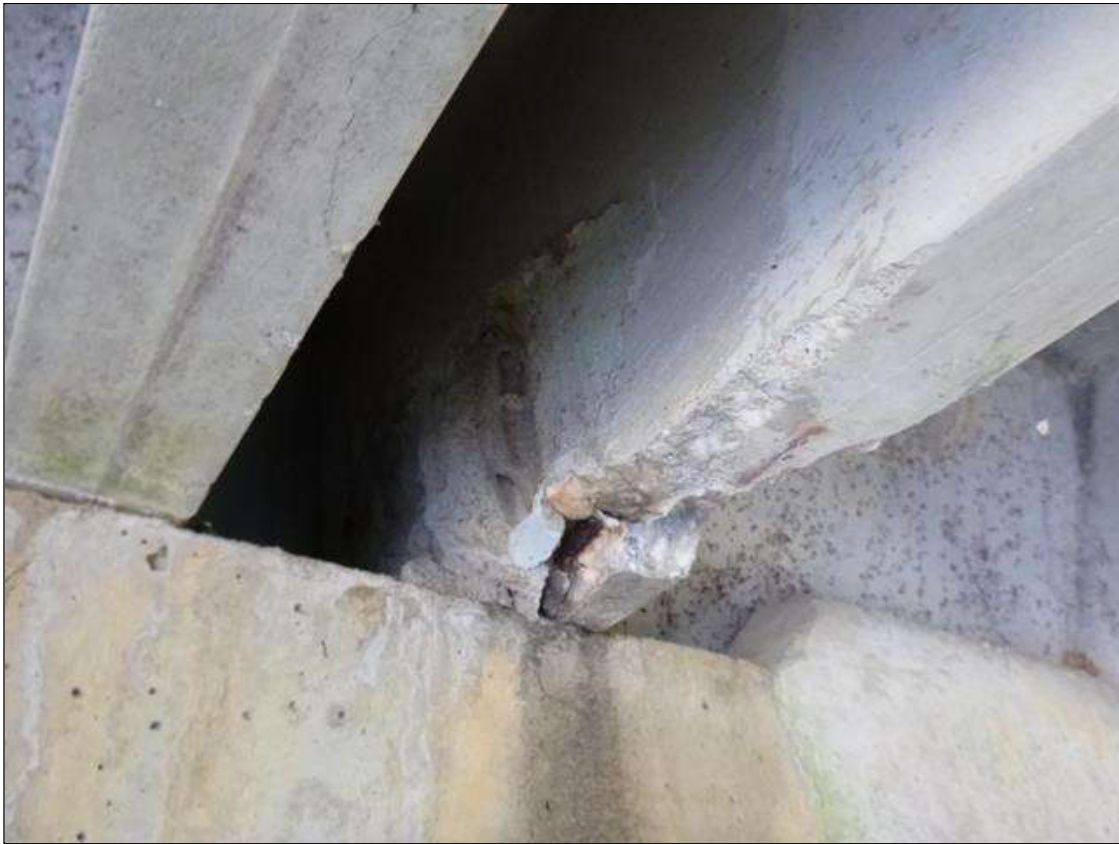
| Element Number | Defect Type | Defect Description | CS | CS Qty | Maint Qty |
|---|---|---|---|---|---|
| <b>109</b> | Delamination/Spall | 10" X 1" X 2" SPALLED PATCHED AREA, OUTSIDE FACE OF LEG 1, AT BENT 1. | 3 | 1 | 1 Feet |

Span 1 Slab 3: 10" X 1" X 2" SPALLED PATCHED AREA, OUTSIDE FACE OF LEG 1, AT BENT 1.

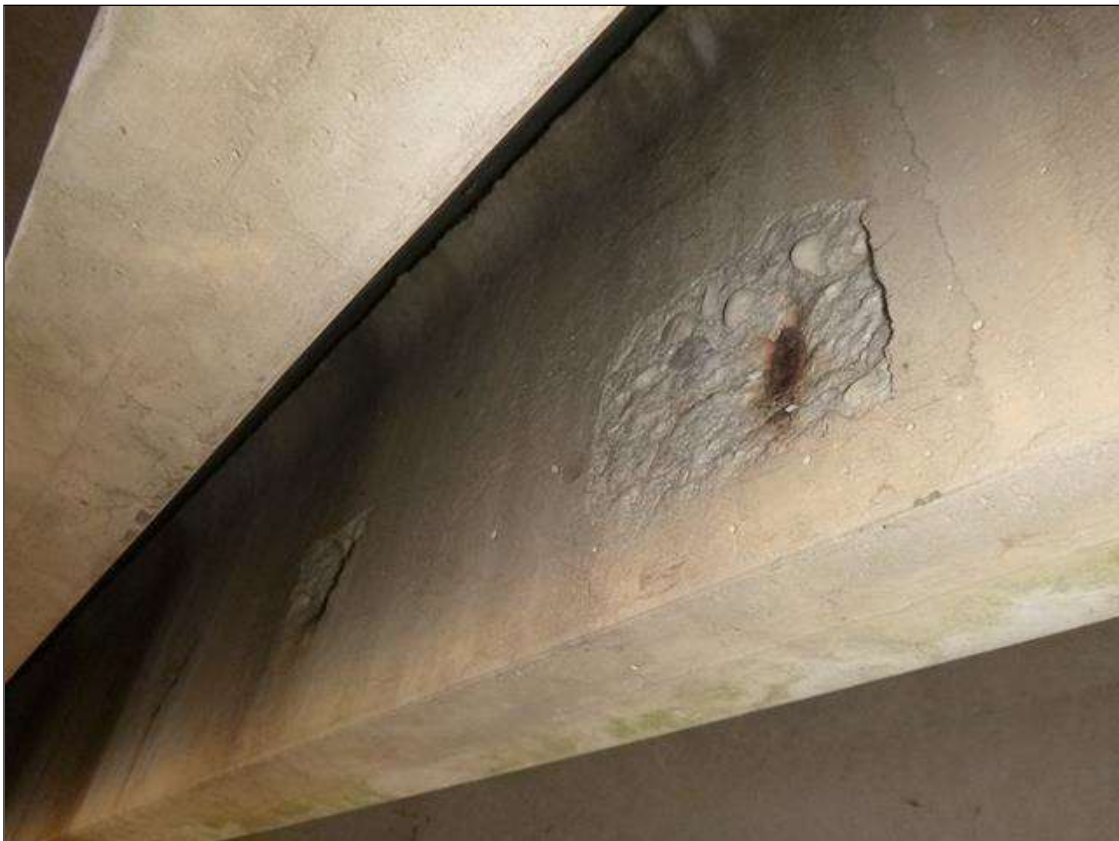
| Element Number | Defect Type | Defect Description | CS | CS Qty | Maint Qty |
|---|---|---|---|---|---|
| <b>109</b> | Delamination/Spall | (3) 4" DIAMETER X 1/2" SPALLS WITH EXPOSED REINFORCING, OUTSIDE FACE OF LEG 1, 9' FROM BENT 1. | 2 | 3 | 3 Feet |

Span 1 Slab 4: (3) 4" DIAMETER X 1/2" SPALLS WITH EXPOSED REINFORCING, OUTSIDE FACE OF LEG 1, 9' FROM BENT 1.

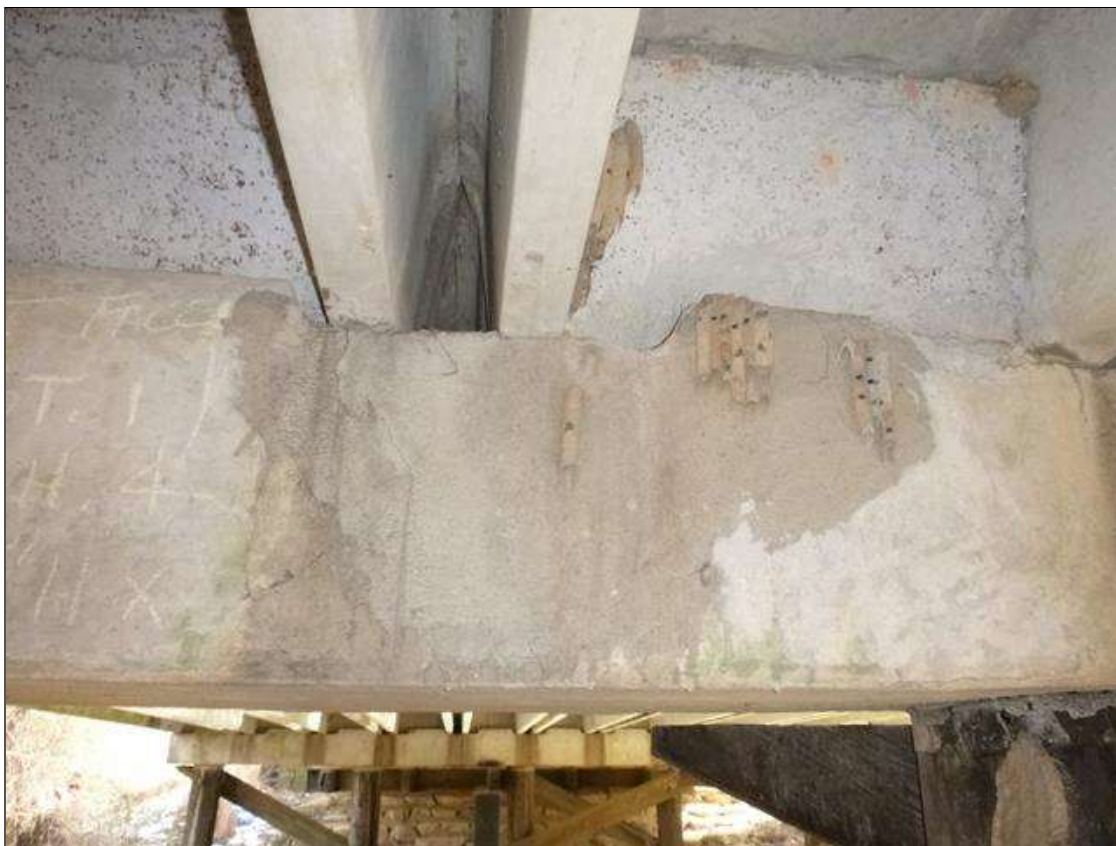
Bent 1 Cap 1: 2' X 11" PATCHED AREA, WEST FACE, BELOW SLABS 4 AND 5.

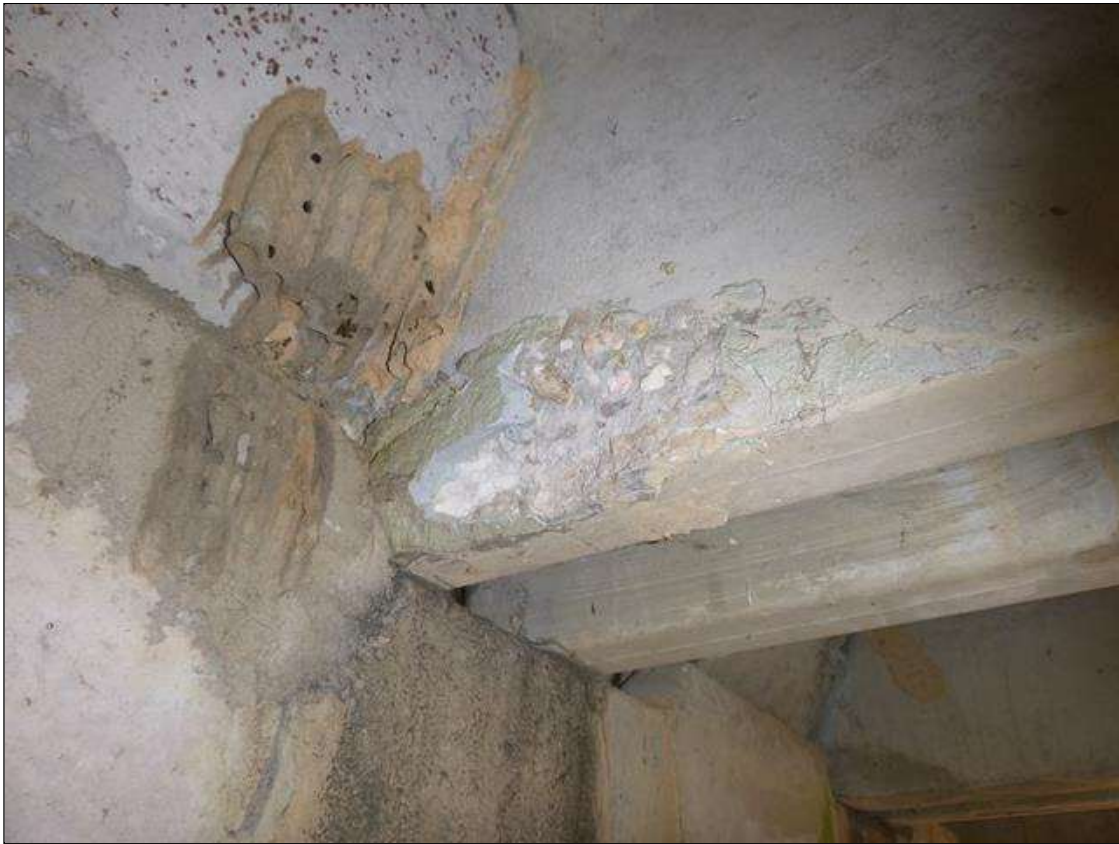
| Element Number | Defect Type | Defect Description | CS | CS Qty | Maint Qty |
|---|---|---|---|---|---|
| <b>109</b> | Delamination/Spall | 8" X 3" X 1" SPALL, INSIDE FACE OF LEG 2, AT BENT 1. | 2 | 1 | 1 Feet |

Span 1 Slab 7: 8" X 3" X 1" SPALL, INSIDE FACE OF LEG 2, AT BENT 1.

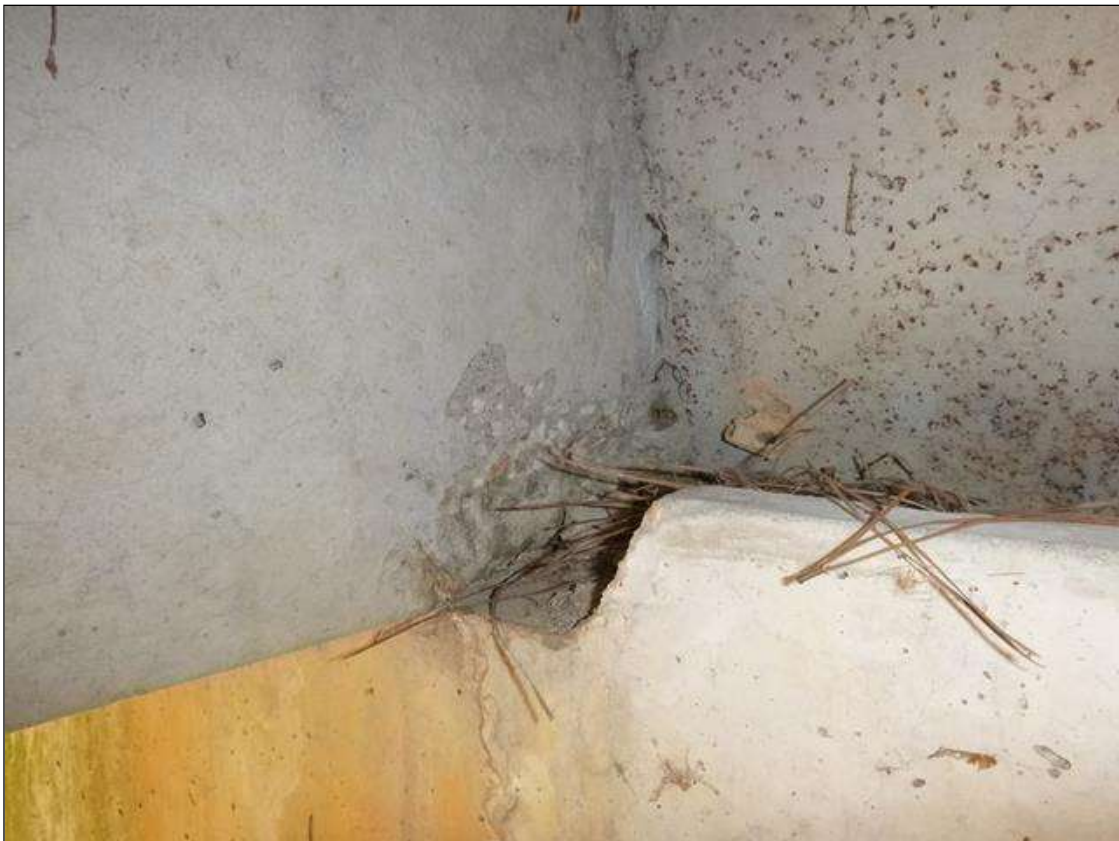
| Element Number | Defect Type | Defect Description | CS | CS Qty | Maint Qty | |
|---|---|---|---|---|---|---|
| 109 | Delamination/Spall | 7" X 3" X 1" SPALL, INSIDE FACE OF LEG 2, AT END BENT 1. | 2 | 1 | 1 | Feet |

Span 1 Slab 10: 7" X 3" X 1" SPALL, INSIDE FACE OF LEG 2, AT END BENT 1.

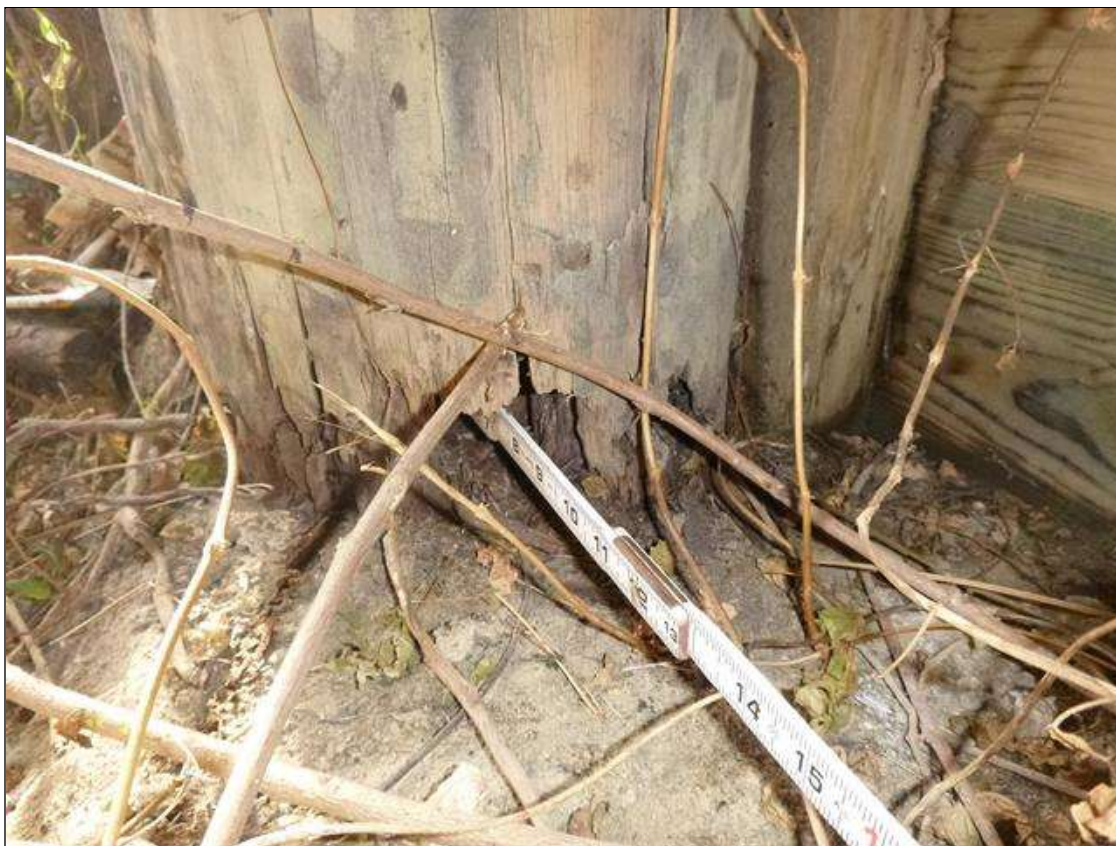
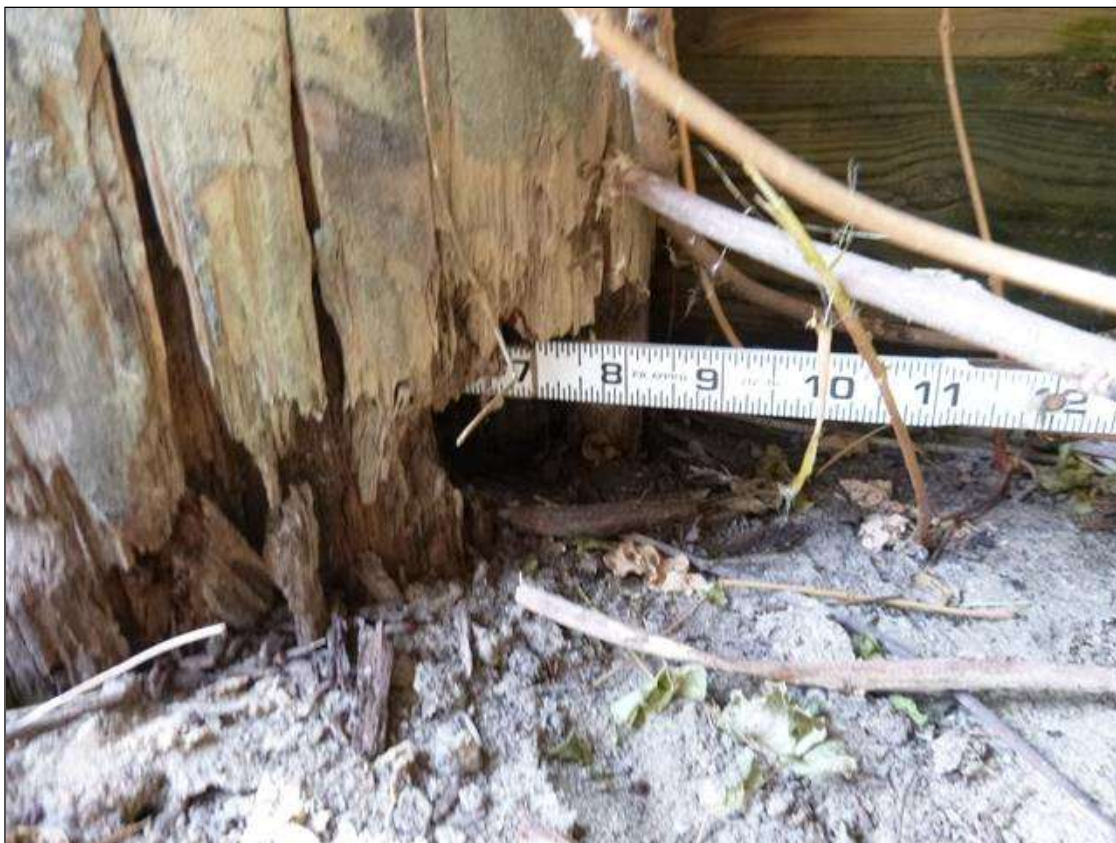
| Element Number | Element Name | Total Qty | CS1 Qty | CS2 Qty | CS3 Qty | CS4 Qty | |
|---|---|---|---|---|---|---|---|
| 228 | Decay/Section Loss | 8" DEEP DECAY ALONG BASE OF PILE. (PM) | 4 | 1 | 2 | | Each |

End Bent 1 Pile 6: 8" DEEP DECAY ALONG BASE OF PILE. (PM)

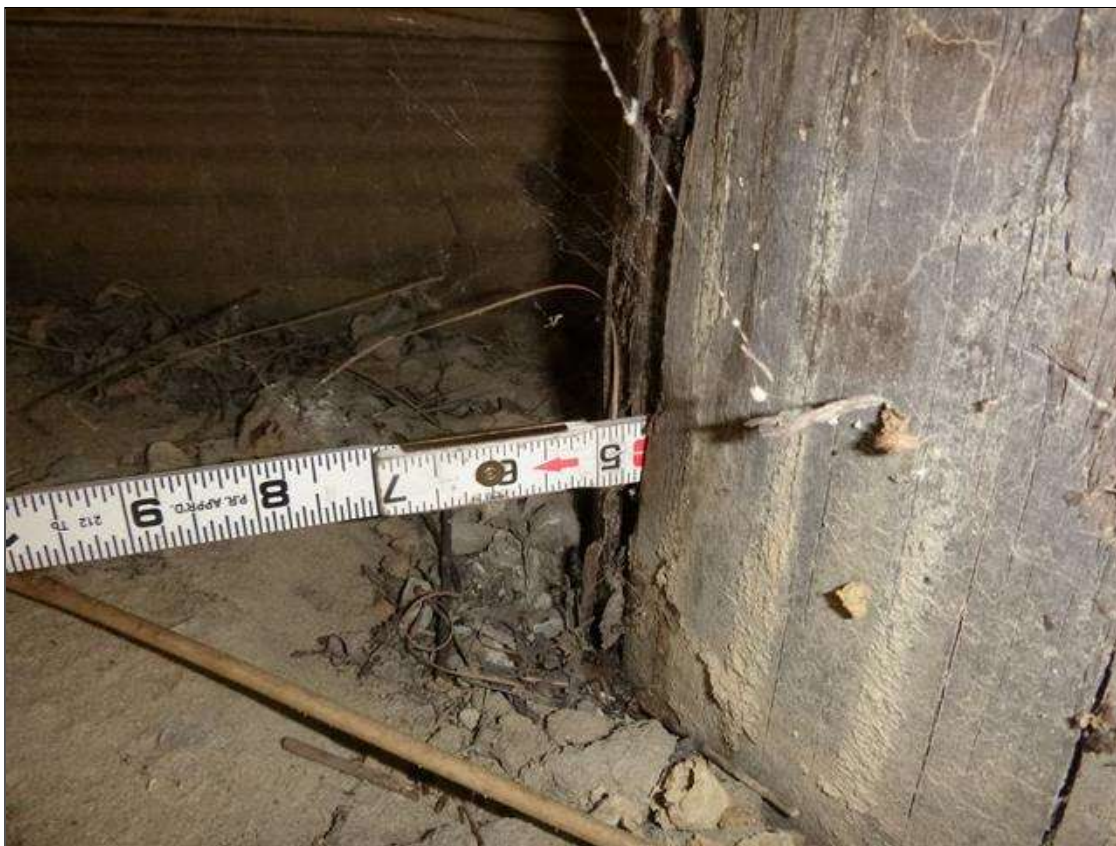
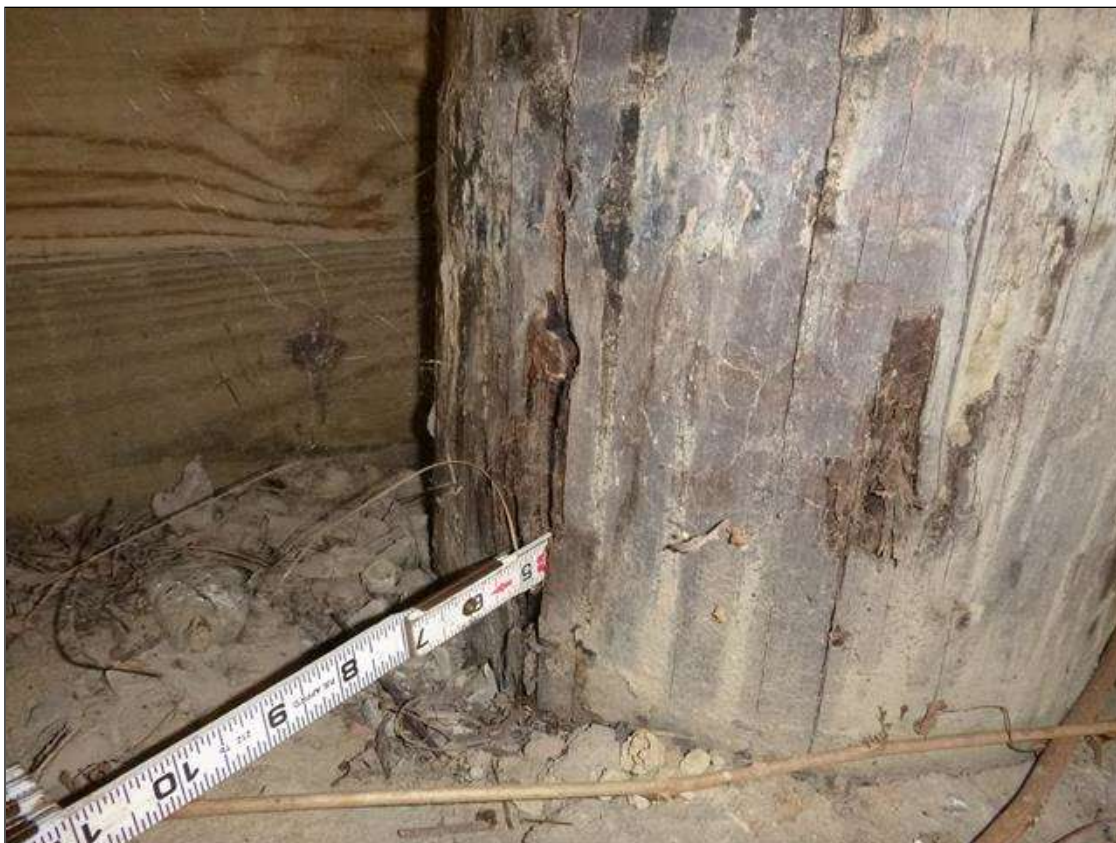
| Element Number | Defect Type | Defect Description | CS | CS Qty | Maint Qty |
|---|---|---|---|---|---|
| 228 | Decay/Section Loss | 5" DEEP AREA OF DECAY, SOUTH SIDE OF PILE, BEGINNING AT GROUND. (PM) | 4 | 1 | 1 Each |

End Bent 1 Pile 3: 5" DEEP AREA OF DECAY, SOUTH SIDE OF PILE, BEGINNING AT GROUND. (PM)

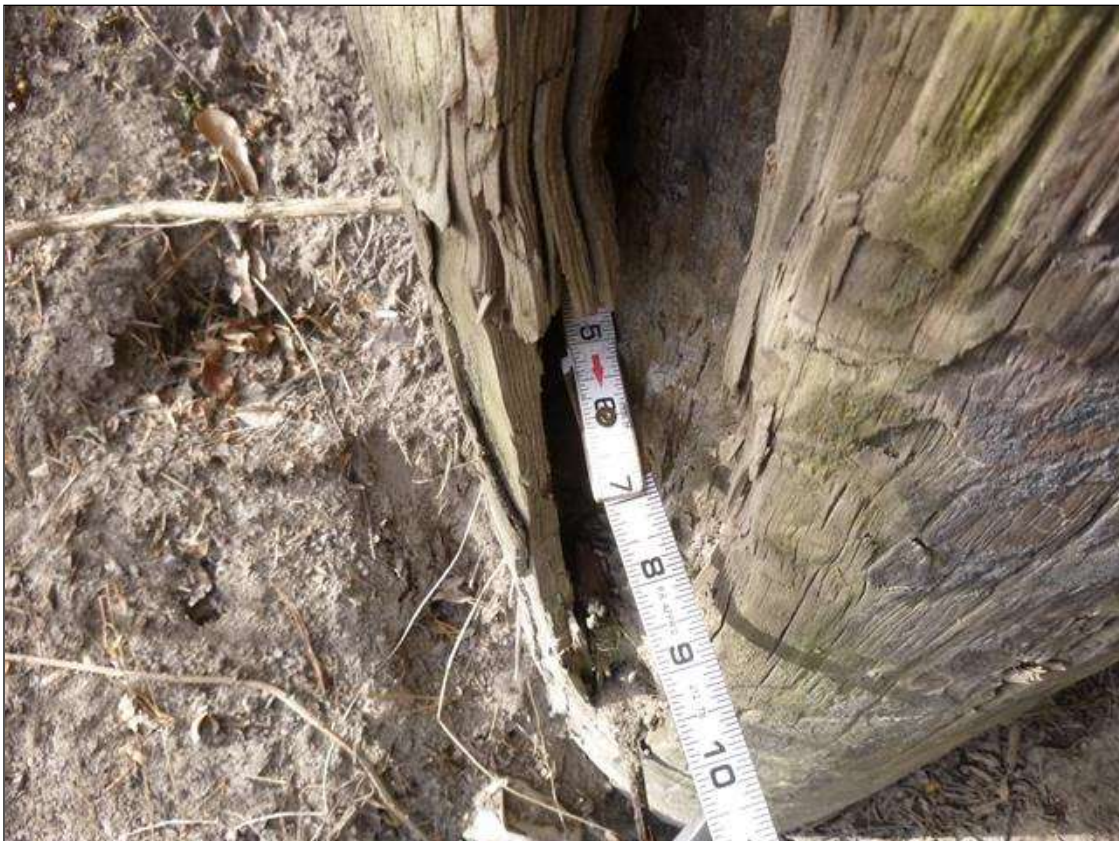
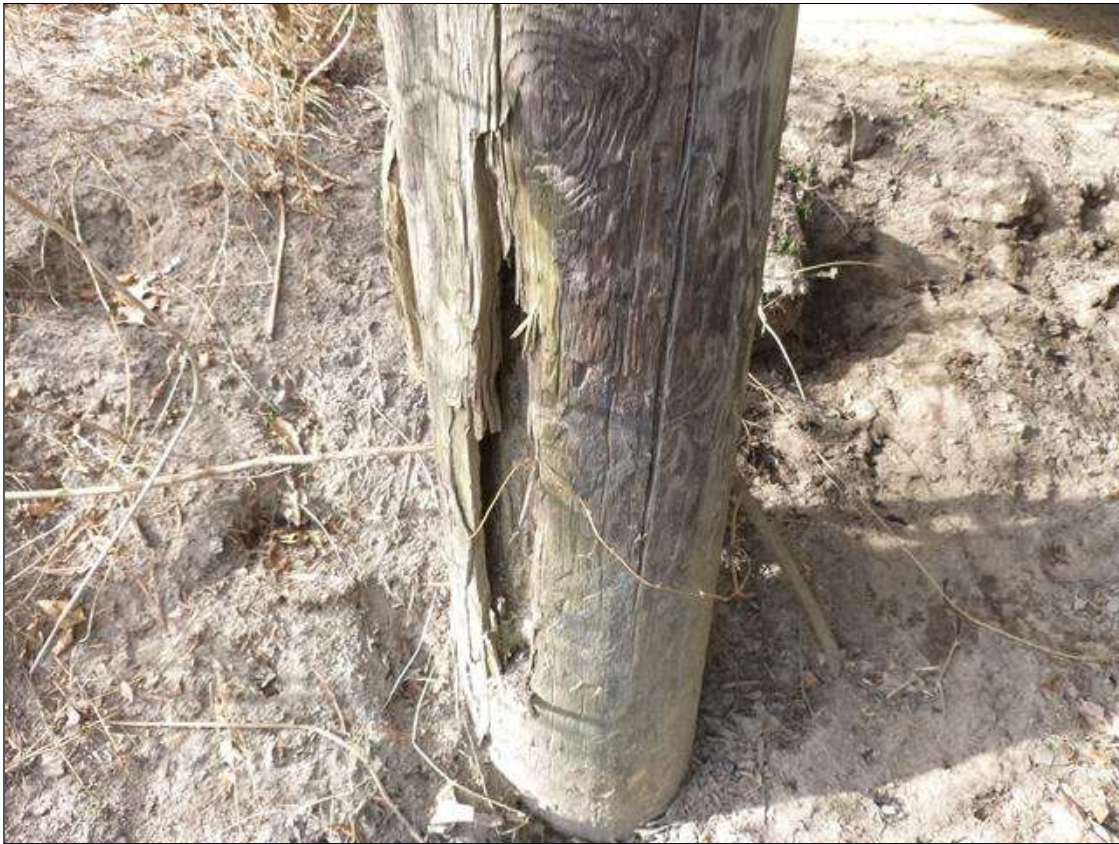
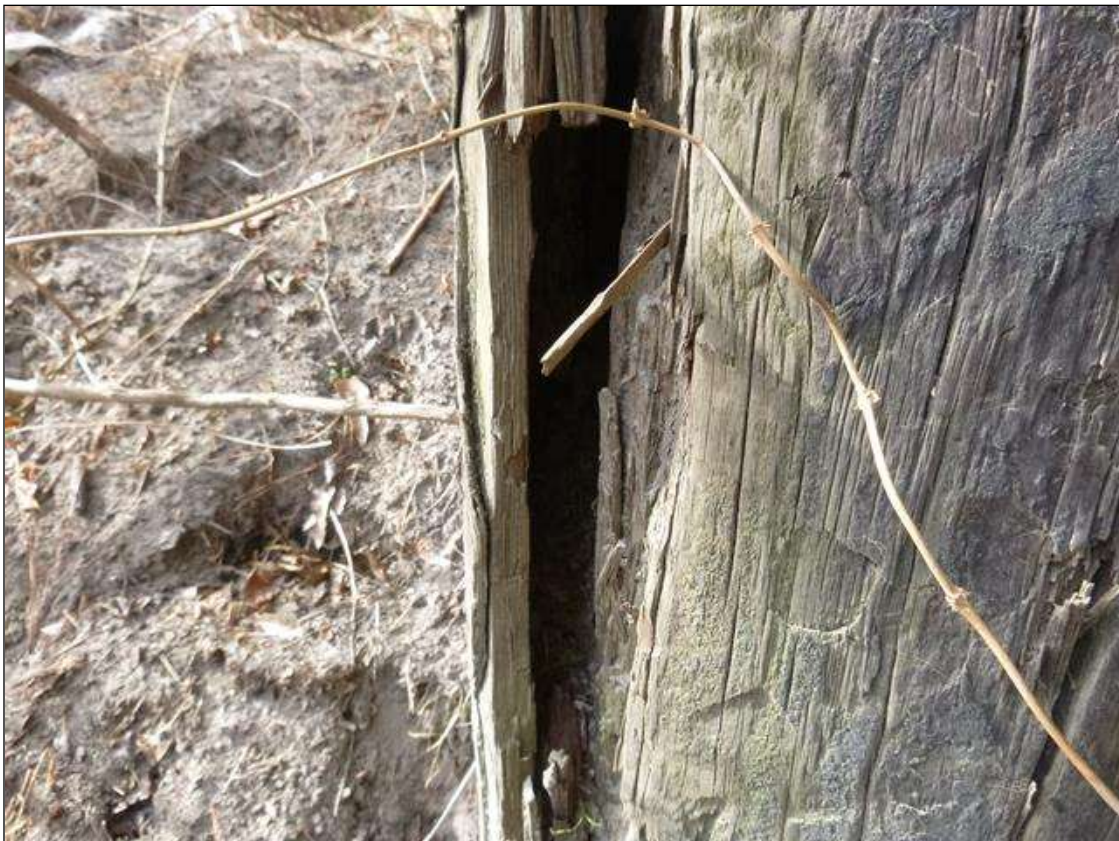
| Element Number | Defect Type | Defect Description | CS | CS Qty | Maint Qty | |
|---|---|---|---|---|---|---|
| 228 | Decay/Section Loss | 5' OF DECAY WITH 2' X 3" HOLE, SOUTHEAST FACE OF PILE WITH 1" SHELL REMAINING. (PM) | 4 | 1 | 5 | Each |

Bent 1 Pile 6: 5' OF DECAY WITH 2' X 3" HOLE, SOUTHEAST FACE OF PILE WITH 1" SHELL REMAINING. (PM)
