NC DEPARTMENT OF TRANSPORTATION  
DIVISION OF HIGHWAYS  
STRUCTURE MANAGEMENT UNIT

# Structure Safety Report

## Municipal Routine Element Inspection - Contract

DIVISION: 6 COUNTY: CUMBERLAND STRUCTURE NUMBER: 250211 FREQUENCY: 24 MONTHS

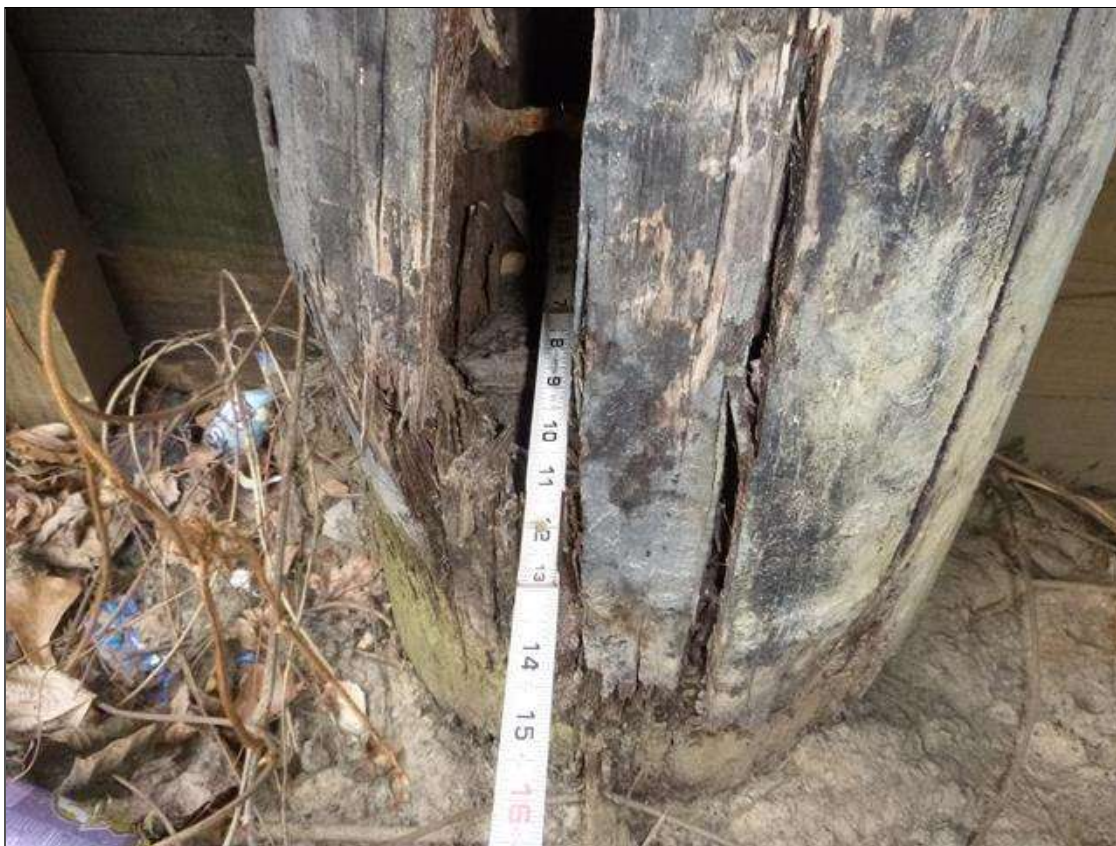
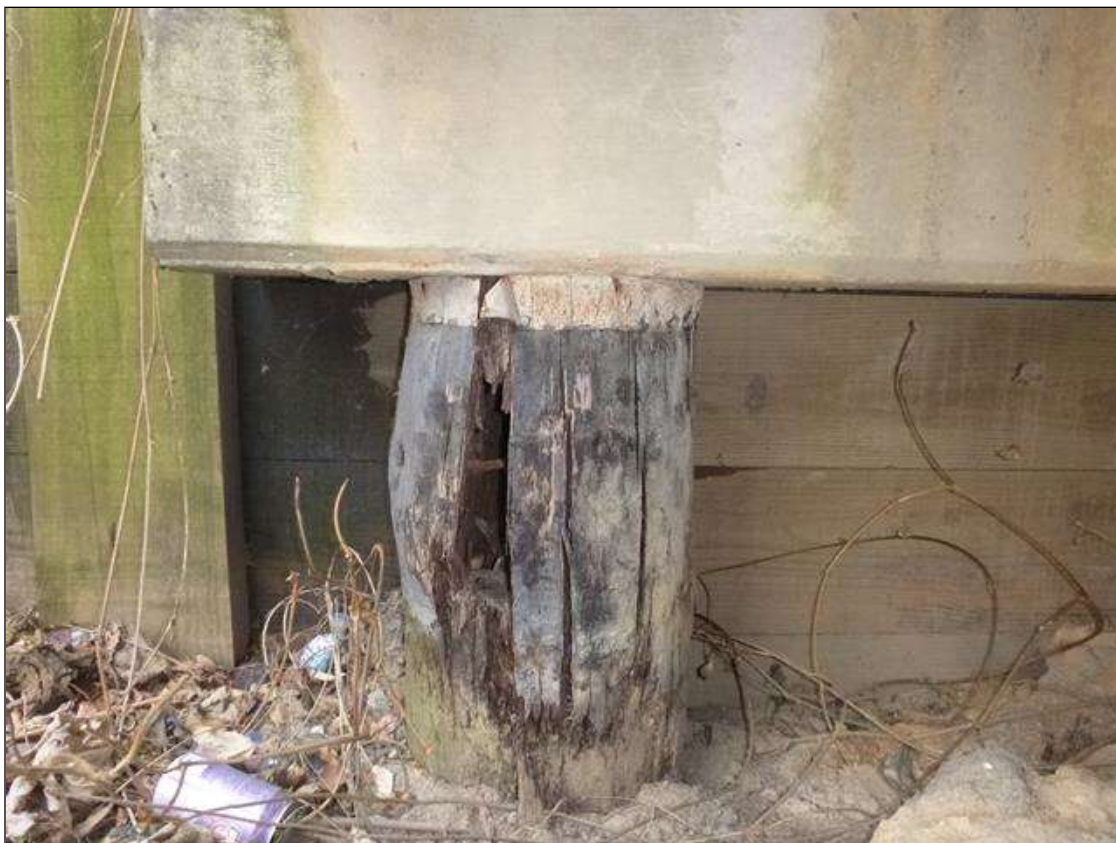
| Element Number | Defect Type | Defect Description | CS | CS Qty | Maint Qty | |
|---|---|---|---|---|---|---|
| 228 | Decay/Section Loss | 30" OF COMPLETE DECAY OF PILE WITH BULGING. (PM) | 4 | 1 | 3 | Each |

End Bent 2 Pile 1: 30" OF COMPLETE DECAY OF PILE WITH BULGING. (PM)

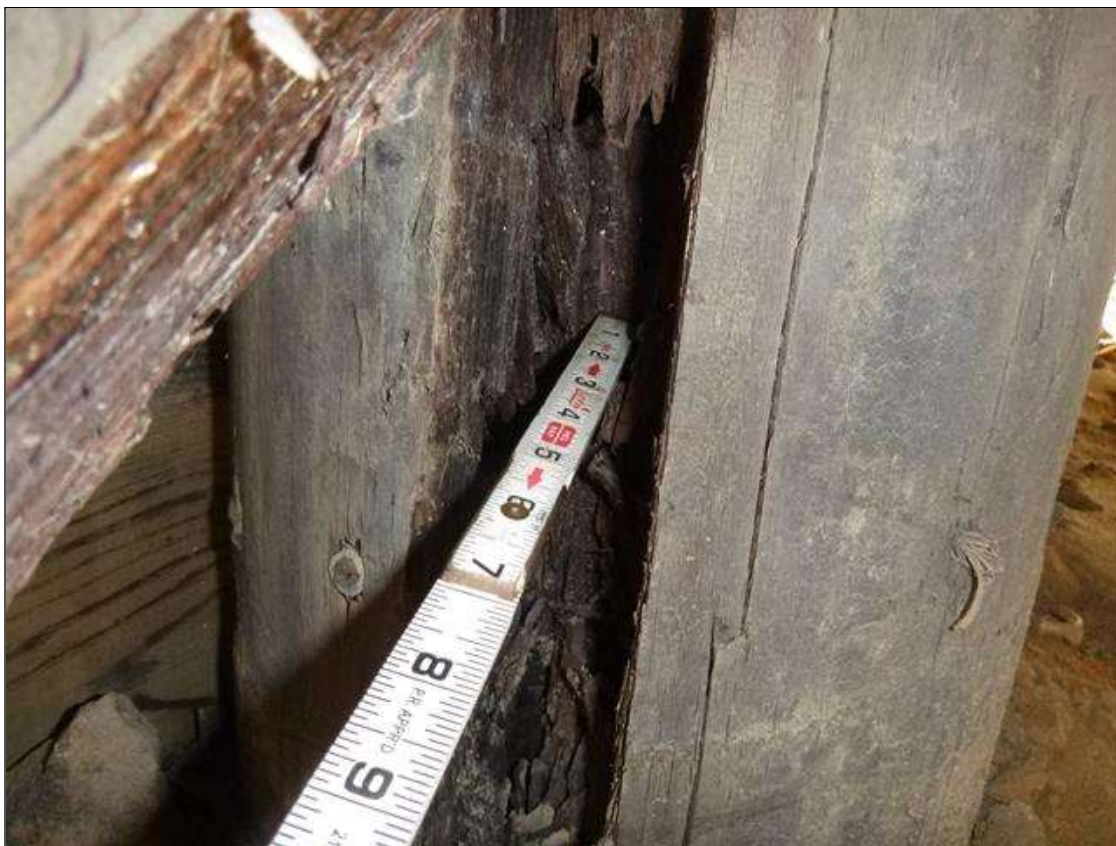
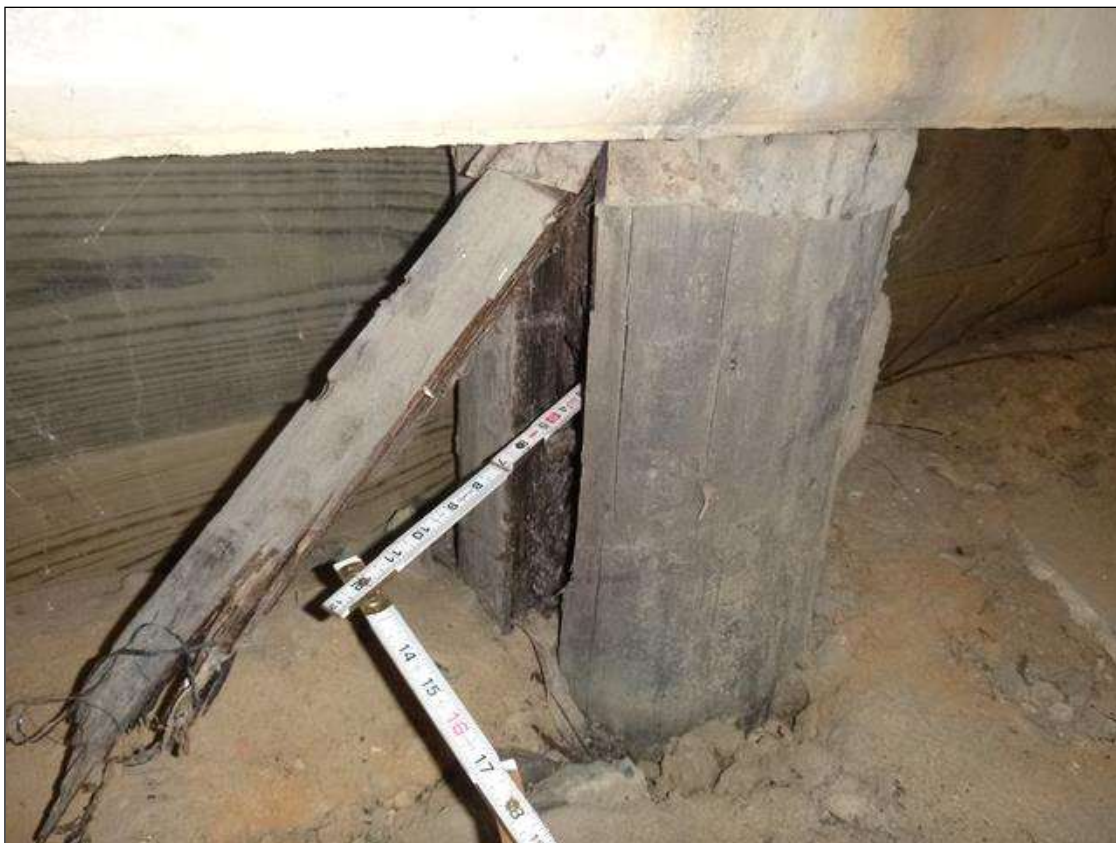
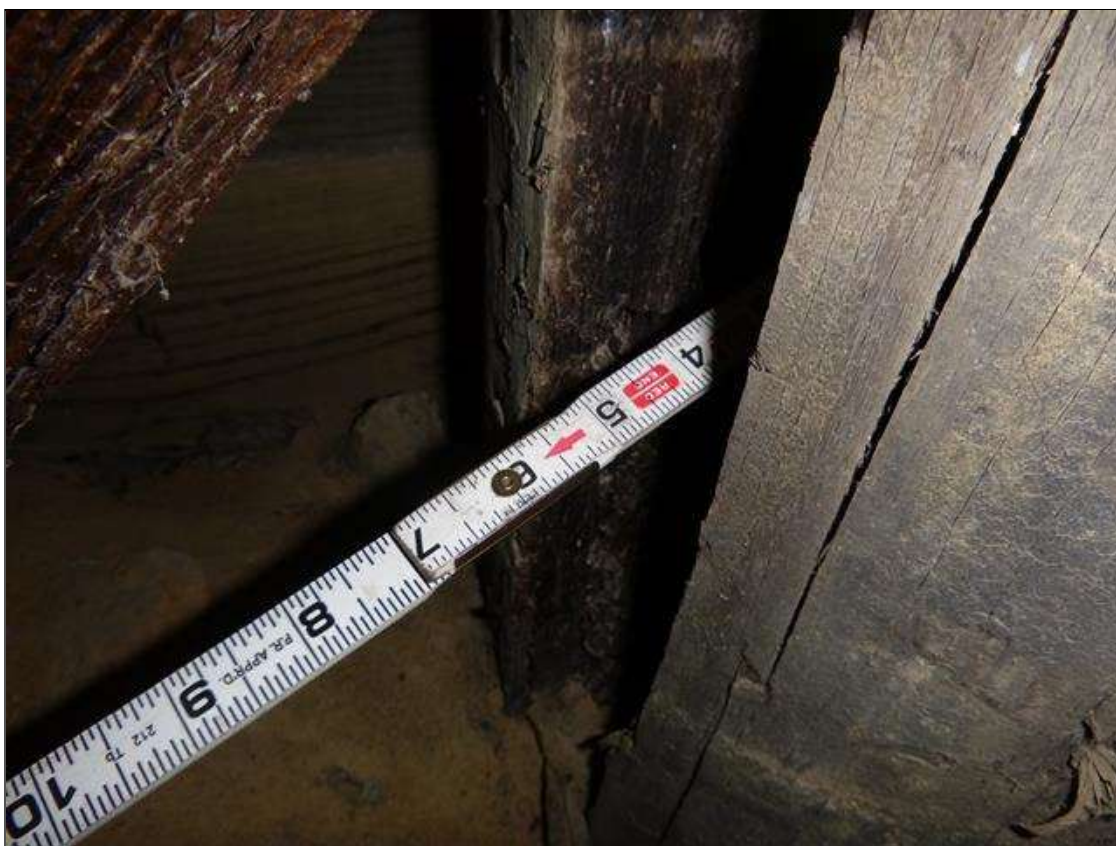
| Element Number | Element Name | Total Qty | CS1 Qty | CS2 Qty | CS3 Qty | CS4 Qty | |
|---|---|---|---|---|---|---|---|
| 228 | Decay/Section Loss | 2' OF DECAY, 3" WIDE X 5" DEEP, ALONG NORTH FACE. (PM) | 4 | 1 | 2 | | Each |

End Bent 2 Pile 4: 2' OF DECAY, 3" WIDE X 5" DEEP, ALONG NORTH FACE. (PM)

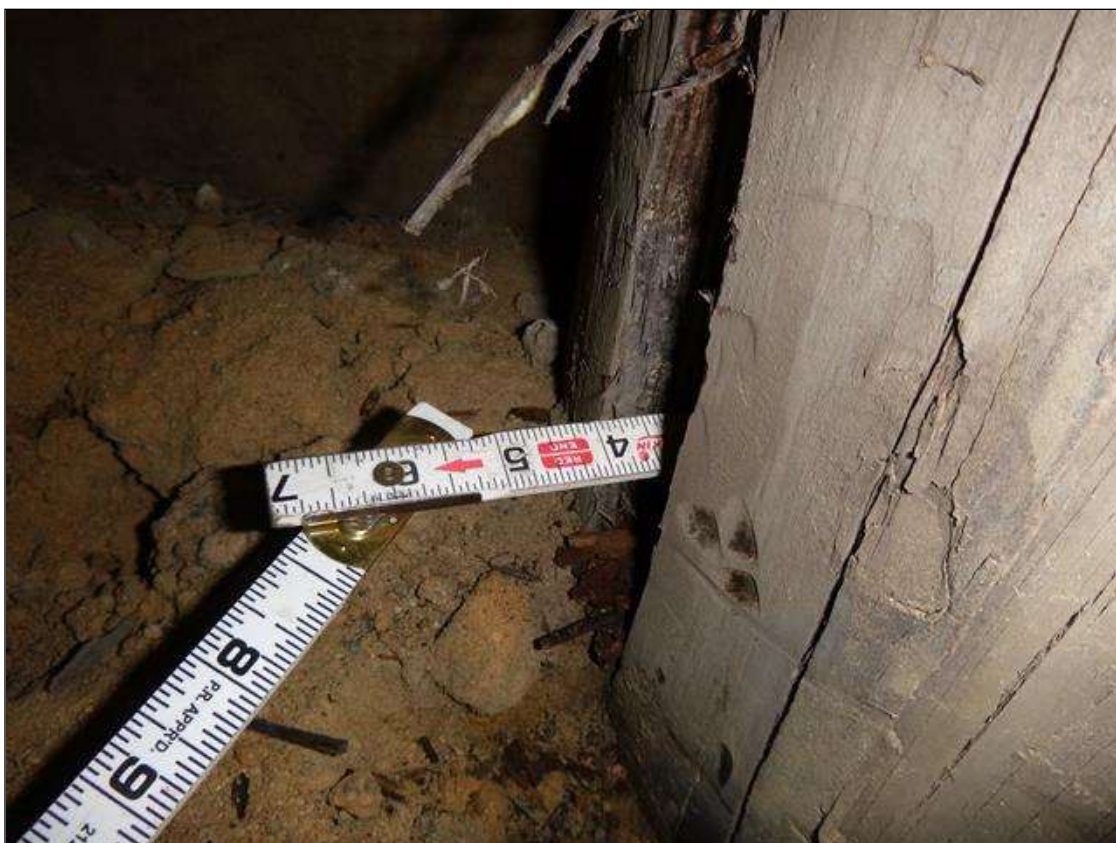
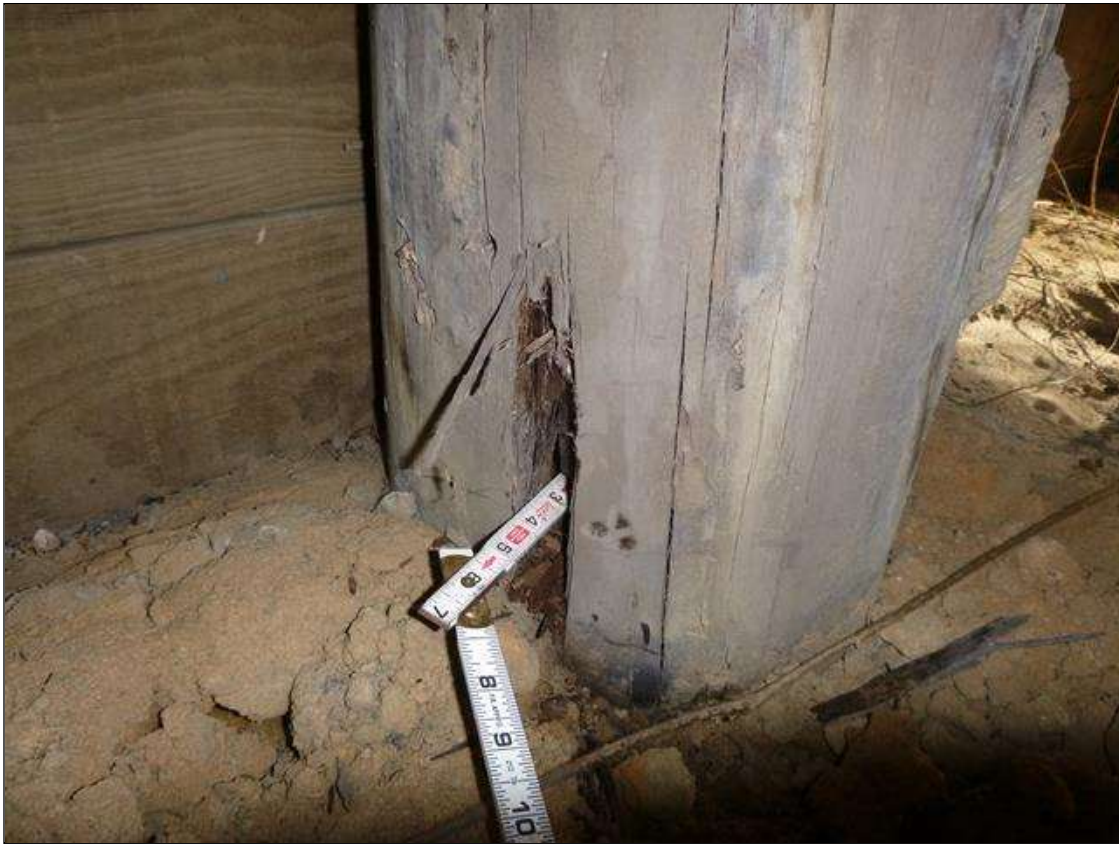
| Element Number | Element Name | Total Qty | CS1 Qty | CS2 Qty | CS3 Qty | CS4 Qty | |
|---|---|---|---|---|---|---|---|
| 228 | Decay/Section Loss | 1' OF DECAY, 2" WIDE X 4" DEEP, ALONG NORTH FACE. (PM) | 4 | 1 | 2 | | Each |

End Bent 2 Pile 5: 1' OF DECAY, 2" WIDE X 4" DEEP, ALONG NORTH FACE. (PM)

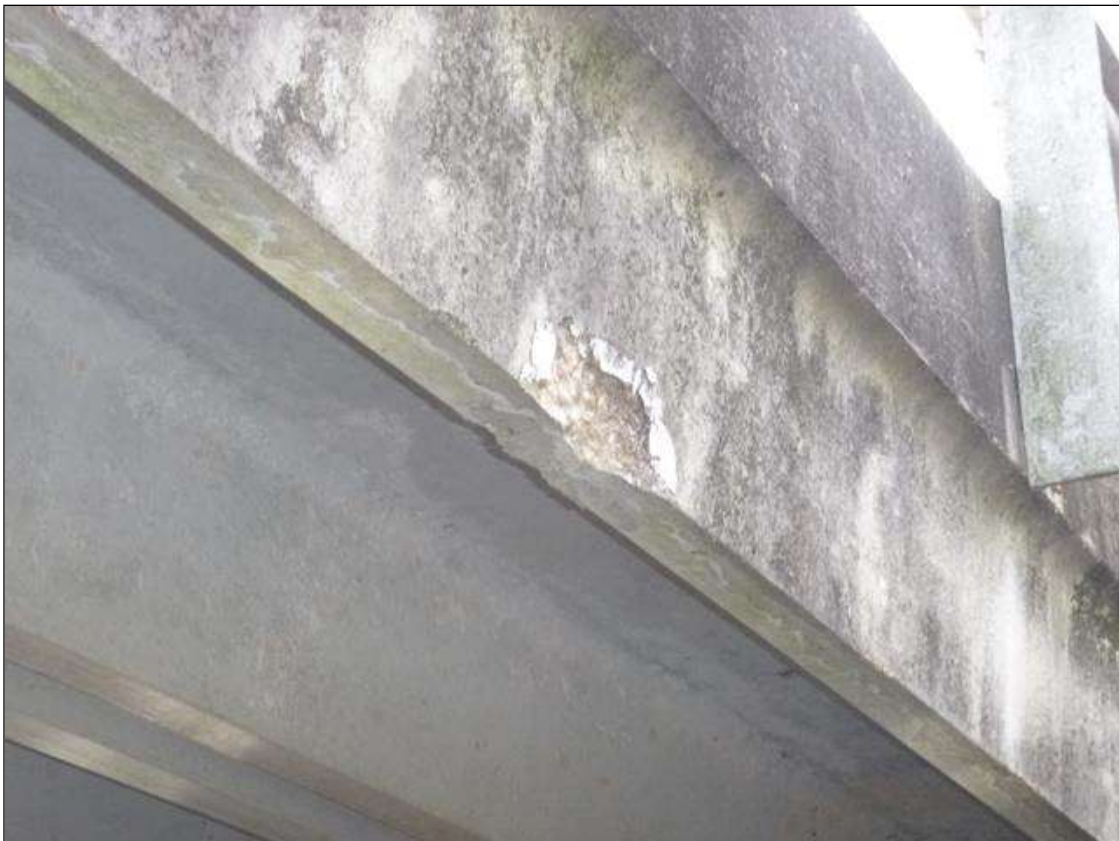
| Element Number | Defect Type | Defect Description | CS | CS Qty | Maint Qty | |
|---|---|---|---|---|---|---|
| 109 | Delamination/Spall | 7" X 4" X 1" SPALL, OUTSIDE FACE OF LEG 1, 10' FROM BENT 2. | 2 | 1 | 1 | Feet |

Span 3 Slab 1: 7" X 4" X 1" SPALL, OUTSIDE FACE OF LEG 1, 10' FROM BENT 2.

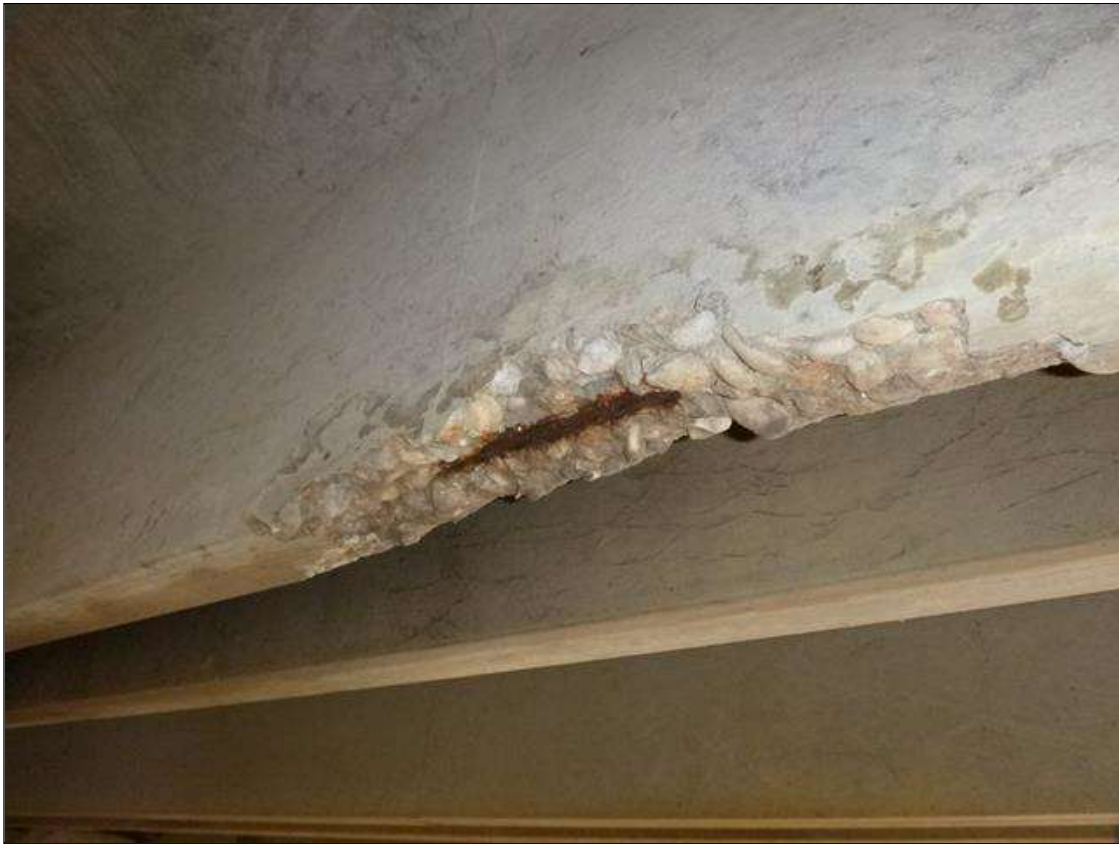
| Element Number | Defect Type | Defect Description | CS | CS Qty | Maint Qty | |
|---|---|---|---|---|---|---|
| 109 | Delamination/Spall | 14" X 2" X 2-1/2" SPALL WITH EXPOSED REINFORCING, BOTTOM OF LEG 2, 10' FROM END BENT 2. (PM) | 4 | 2 | 2 | Feet |

Span 3 Slab 7: 14" X 2" X 2-1/2" SPALL WITH EXPOSED REINFORCING, BOTTOM OF LEG 2, 10' FROM END BENT 2. (PM)

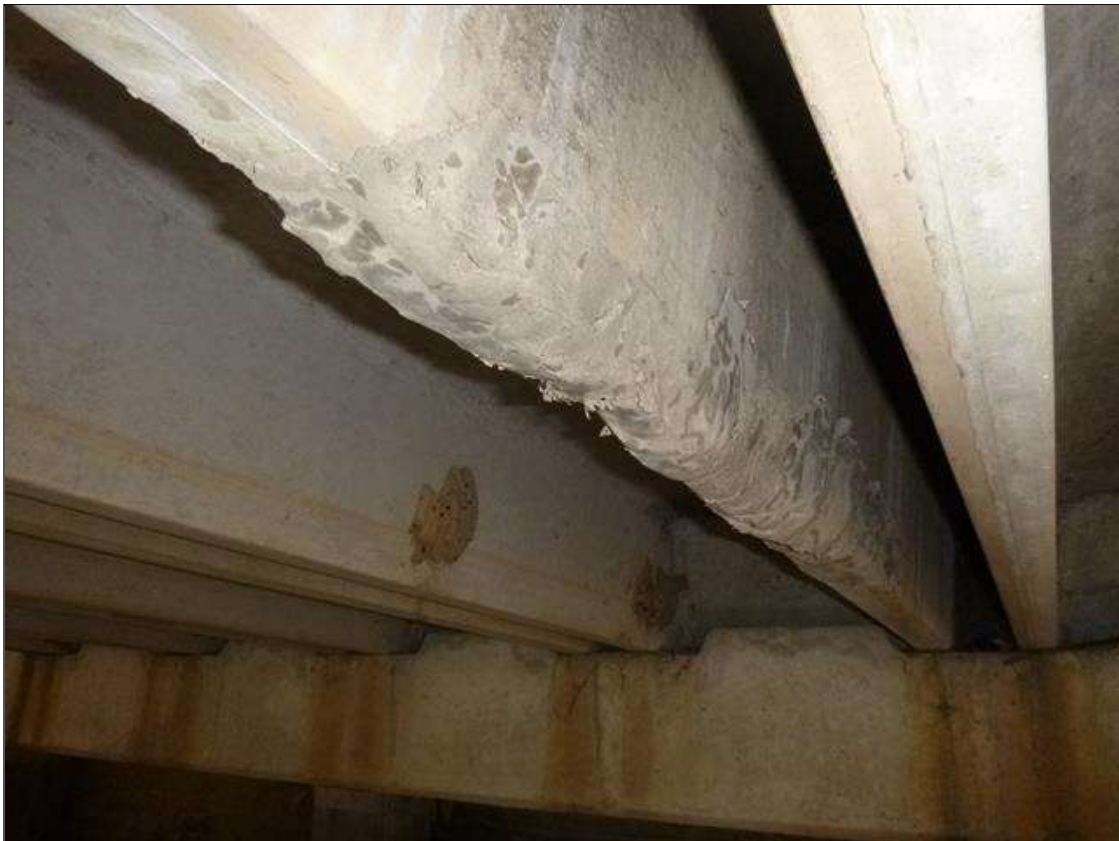
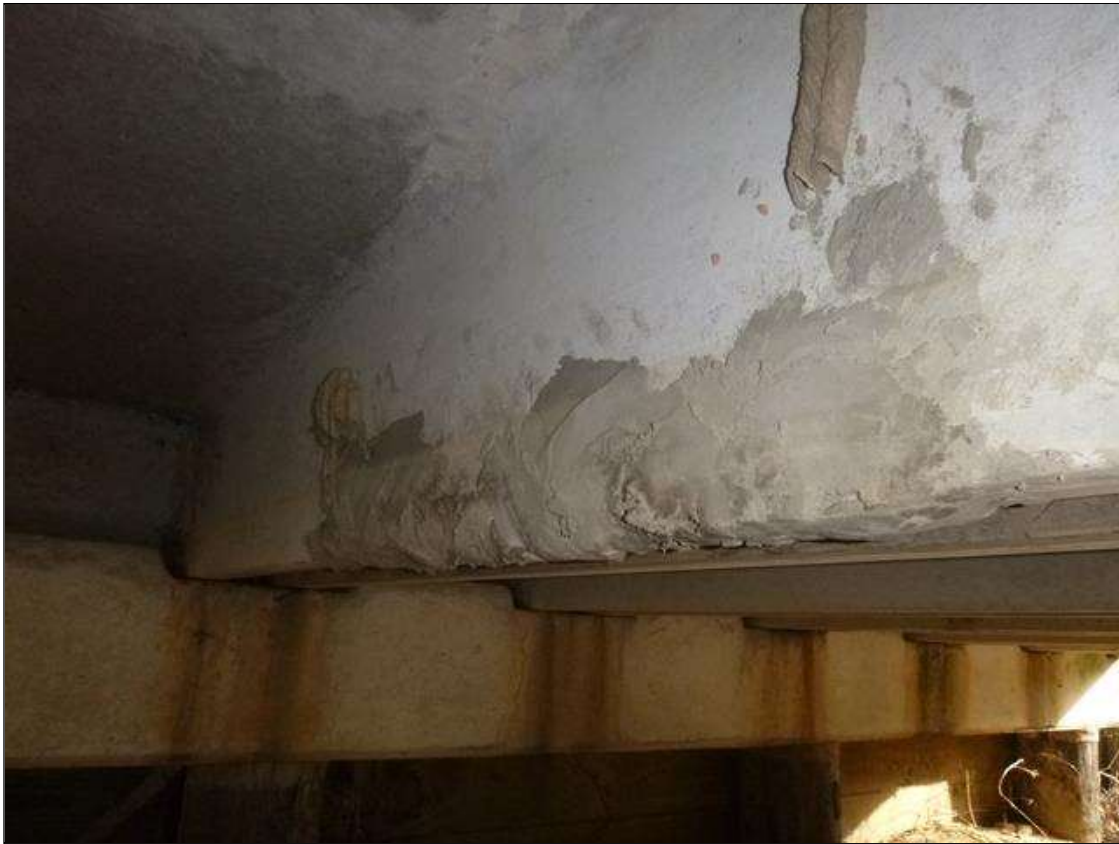
Span 3 Slab 7: 32" PATCHED AREA, BOTTOM OF LEG 2, 5' FROM END BENT 2.

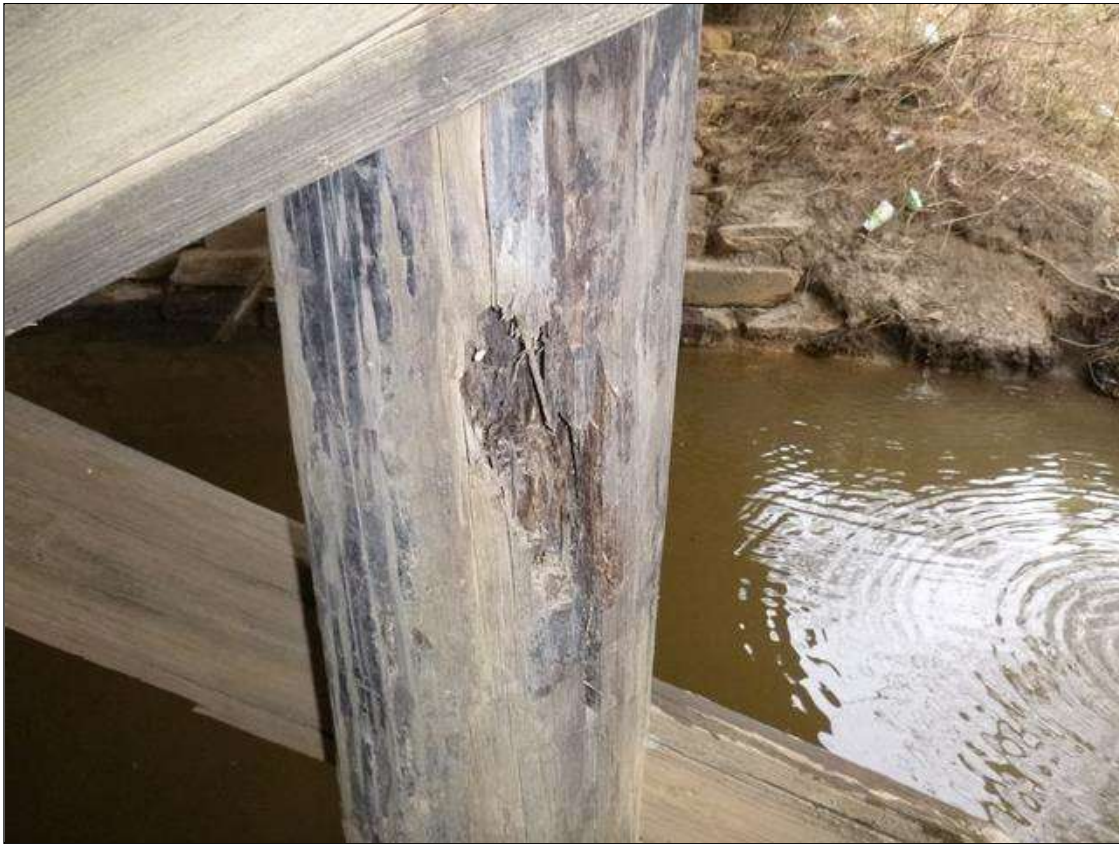
| Element Number | Defect Type | Defect Description | CS | CS Qty | Maint Qty | |
|---|---|---|---|---|---|---|
| 228 | Decay/Section Loss | 12" X 3" X 2" AREA OF DECAY, WEST FACE, 4' BELOW CAP. (PM) | 4 | 1 | 1 | Each |

Bent 2 Pile 6: 12" X 3" X 2" AREA OF DECAY, WEST FACE, 4' BELOW CAP. (PM)

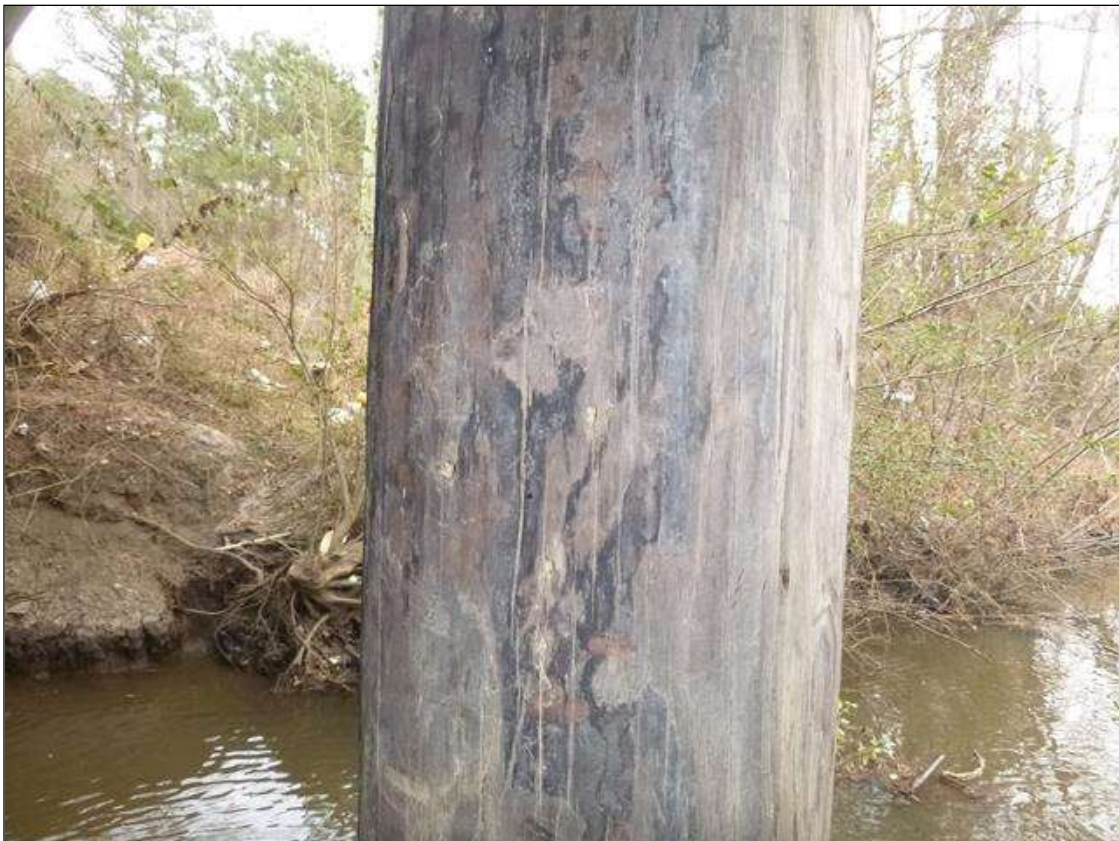
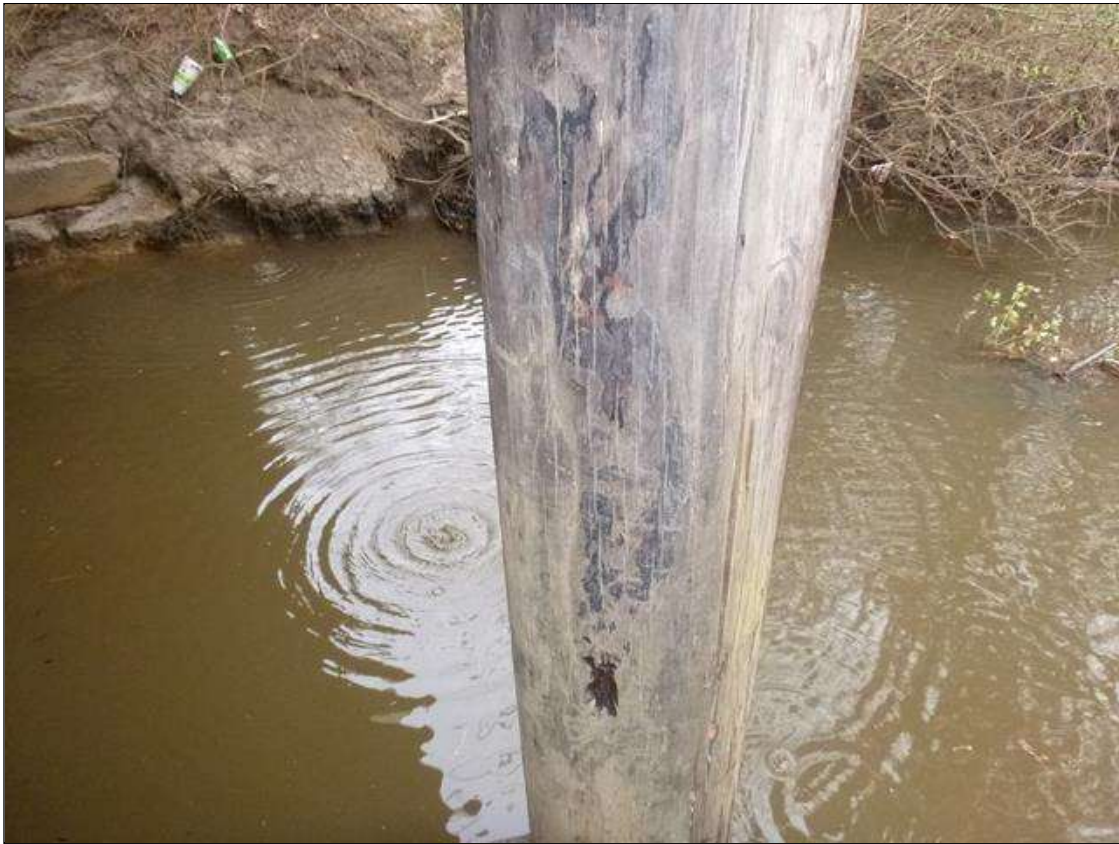
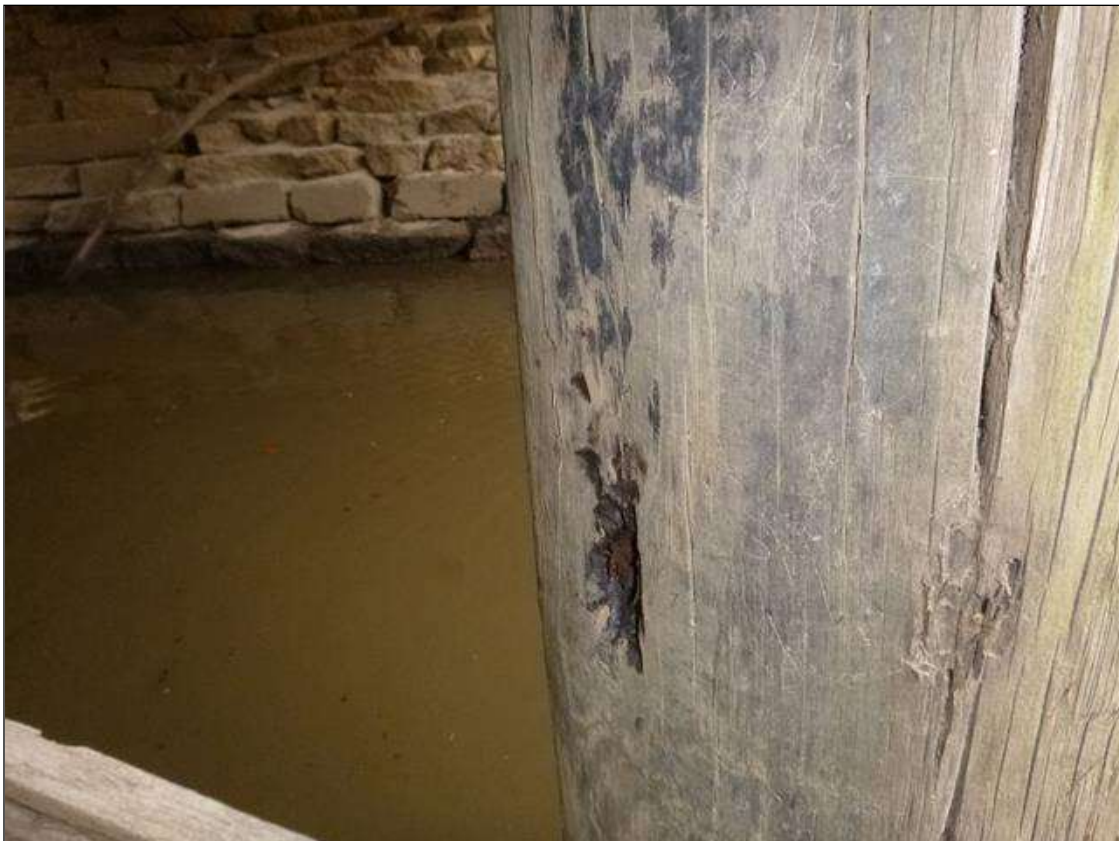
| Element Number | Defect Type | Defect Description | CS | CS Qty | Maint Qty | |
|---|---|---|---|---|---|---|
| 228 | Decay/Section Loss | 5' OF DECAY AND HOLLOW SOUNDING ALONG NORTH FACE, BEGINNING 2' BELOW CAP. (PM) | 4 | 1 | 5 | Each |

Bent 2 Pile 7: 5' OF DECAY AND HOLLOW SOUNDING ALONG NORTH FACE, BEGINNING 2' BELOW CAP. (PM)

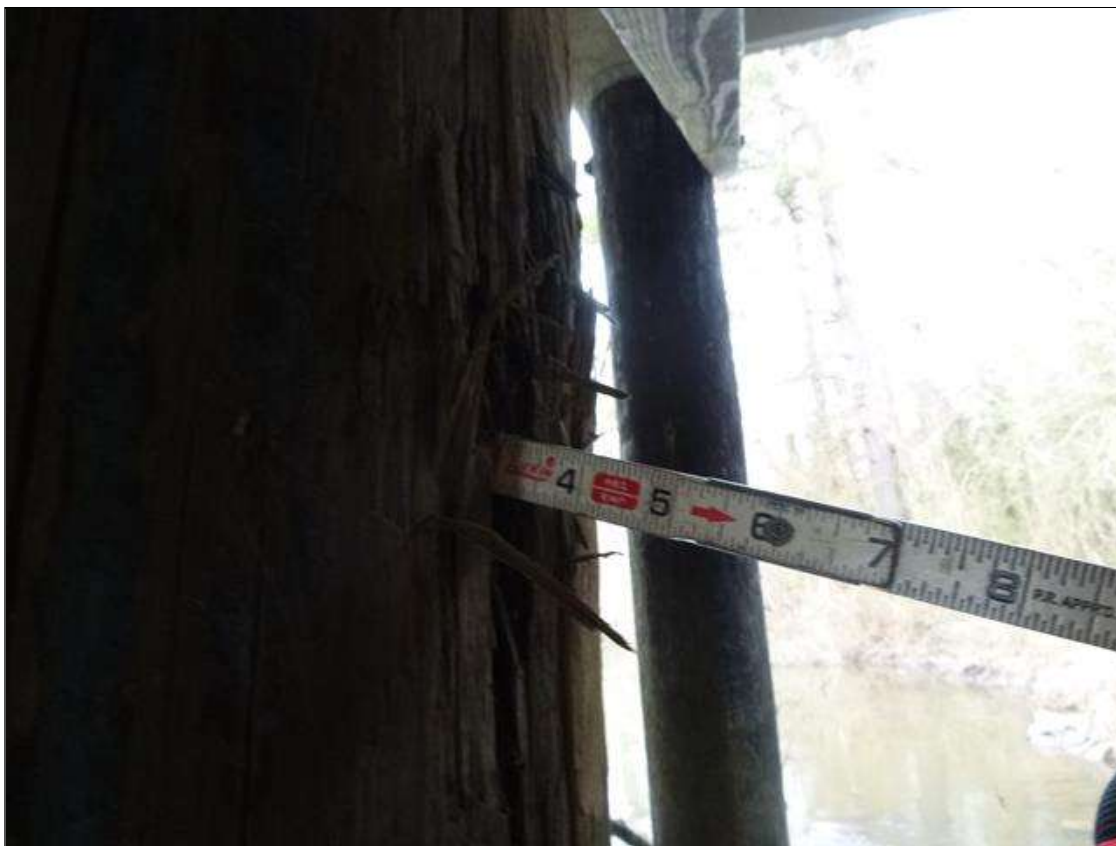
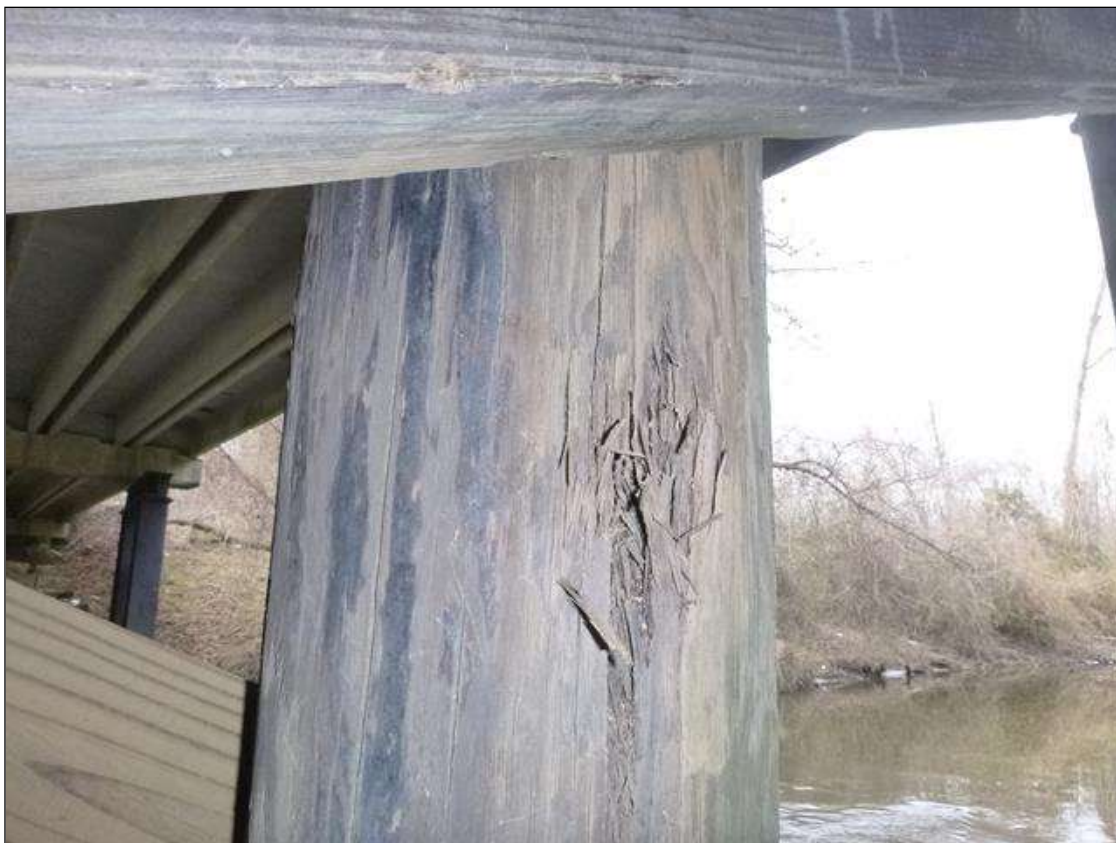
| Element Number | Defect Type | Defect Description | CS | CS Qty | Maint Qty | |
|---|---|---|---|---|---|---|
| 228 | Decay/Section Loss | 12" X 5" X 4" AREA OF DECAY BELOW CROSS BRACE, BEGINNING 4' BELOW CAP. (PM) | 3 | 1 | 1 | Each |

Bent 2 Pile 2: 12" X 5" X 4" AREA OF DECAY BELOW CROSS BRACE, BEGINNING 4' BELOW CAP. (PM)

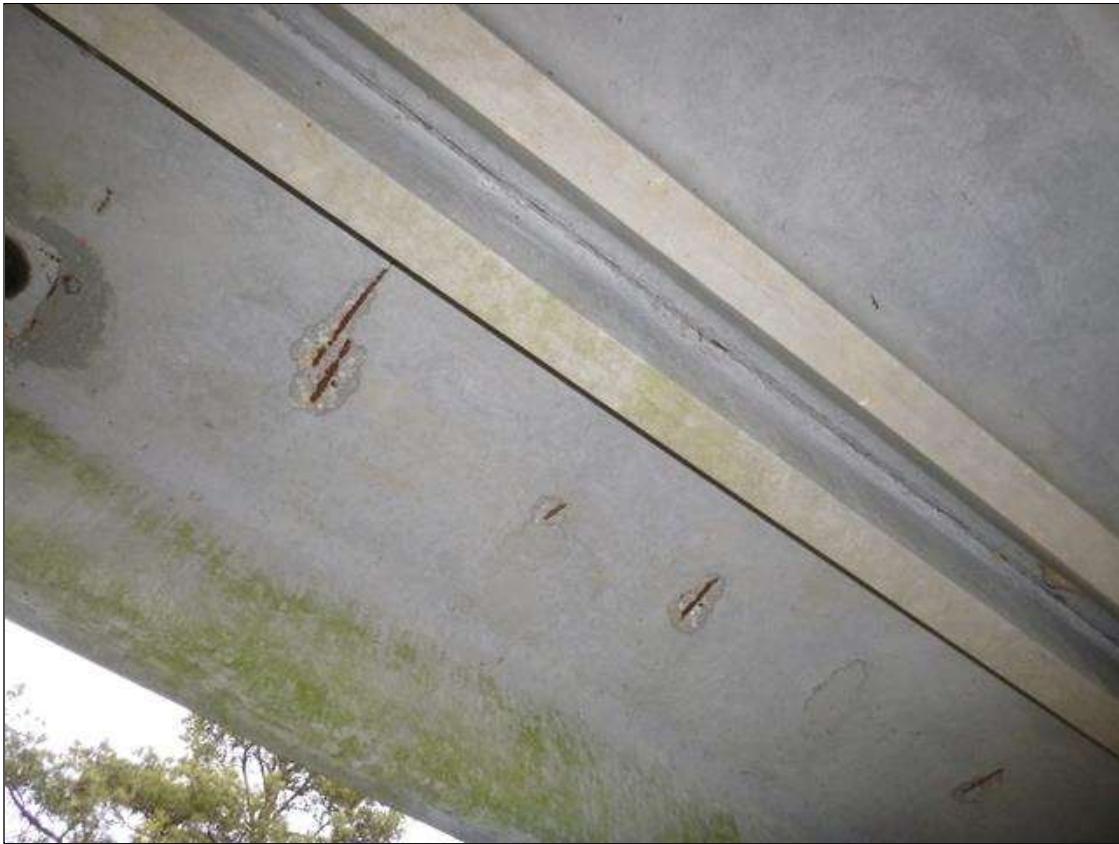
| Element Number | Defect Type | Defect Description | CS | CS Qty | Maint Qty | |
|---|---|---|---|---|---|---|
| 109 | Delamination/Spall | (11) 2" X UP TO 10" X 1/4" SPALLS WITH EXPOSED REINFORCING, AT RANDOM ALONG UNDERSIDE OF TOP SLAB. | 2 | 11 | 11 | Feet |

Span 2 Slab 1: (11) 2" X UP TO 10" X 1/4" SPALLS WITH EXPOSED REINFORCING, AT RANDOM ALONG UNDERSIDE OF TOP SLAB.

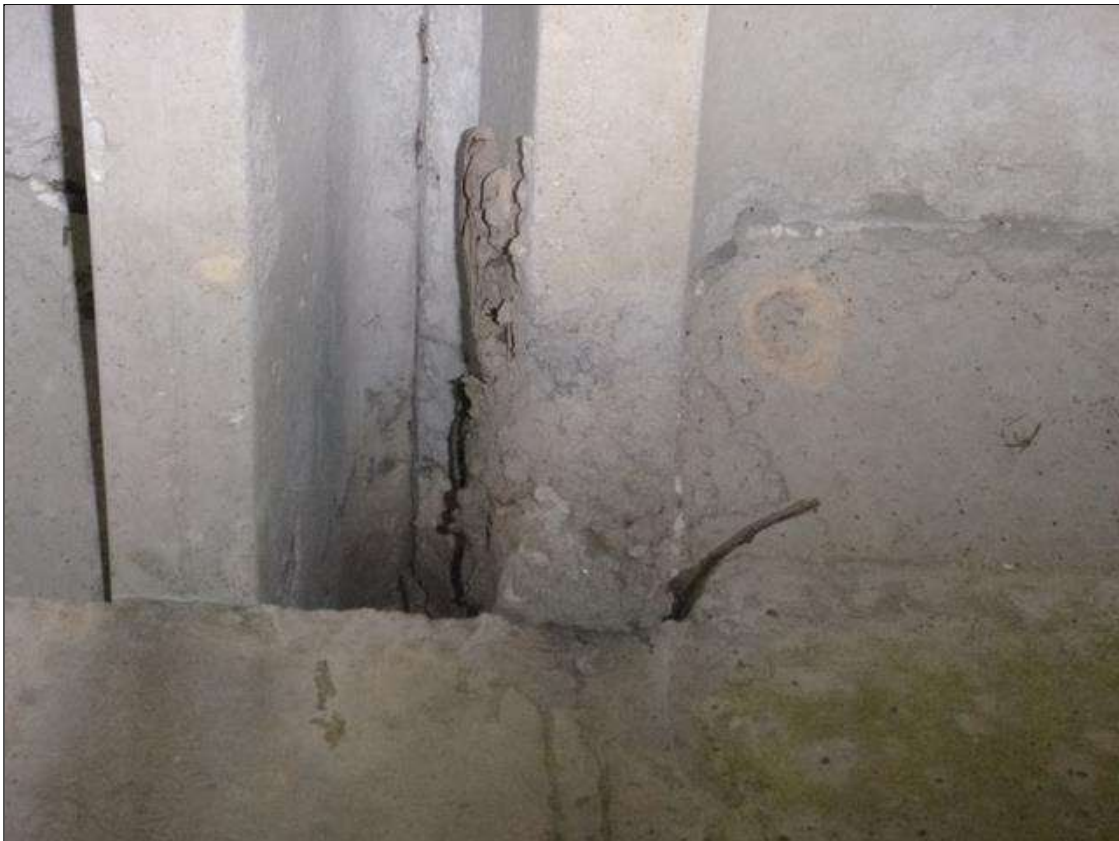
Span 2 Slab 2: 8" X 4" X 2" PATCHED AREA, BOTTOM OF LEG 2, AT BENT 1.

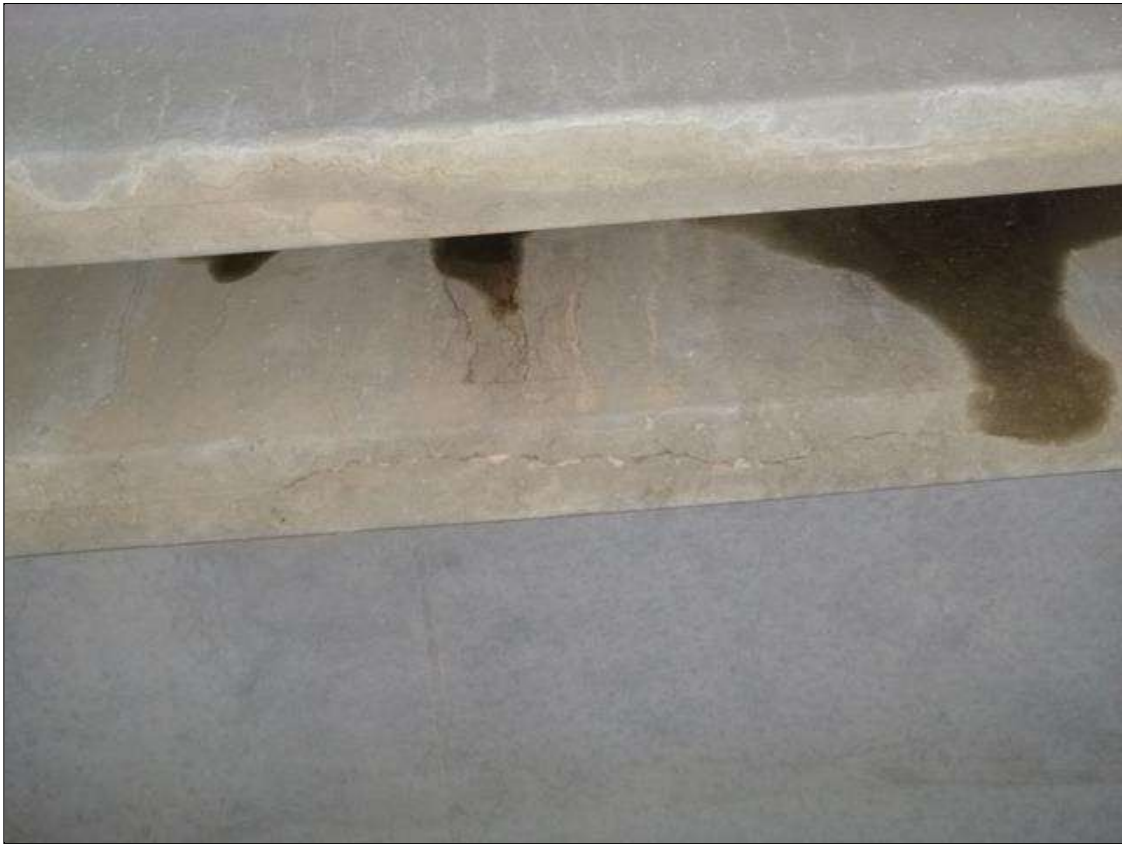
| Element Number | Defect Type | Defect Description | CS | CS Qty | Maint Qty | |
|---|---|---|---|---|---|---|
| 109 | Cracking (PSC) | 18" HORIZONTAL CRACK UP TO 1/16", UNDERSIDE OF LEG 2, 5' FROM BENT 1. | 3 | 2 | 2 | Feet |

Span 2 Slab 3: 18" HORIZONTAL CRACK UP TO 1/16", UNDERSIDE OF LEG 2, 5' FROM BENT 1.

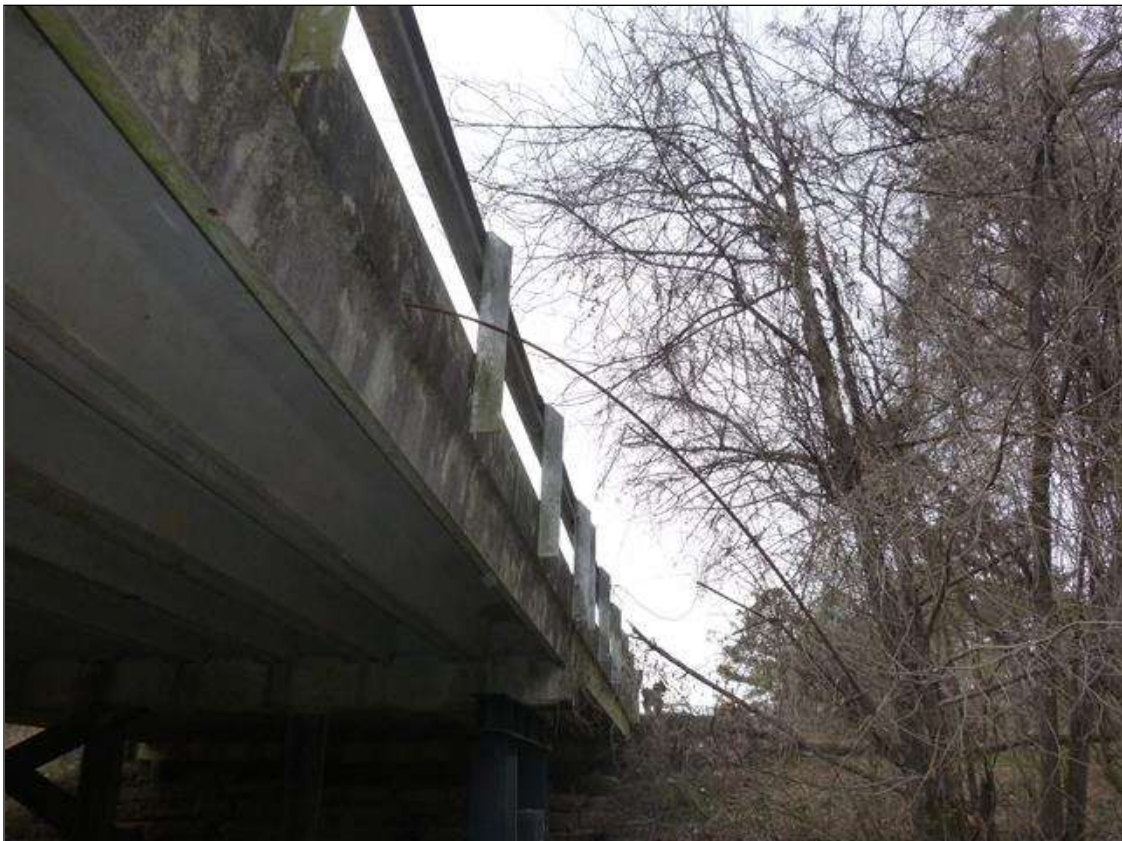
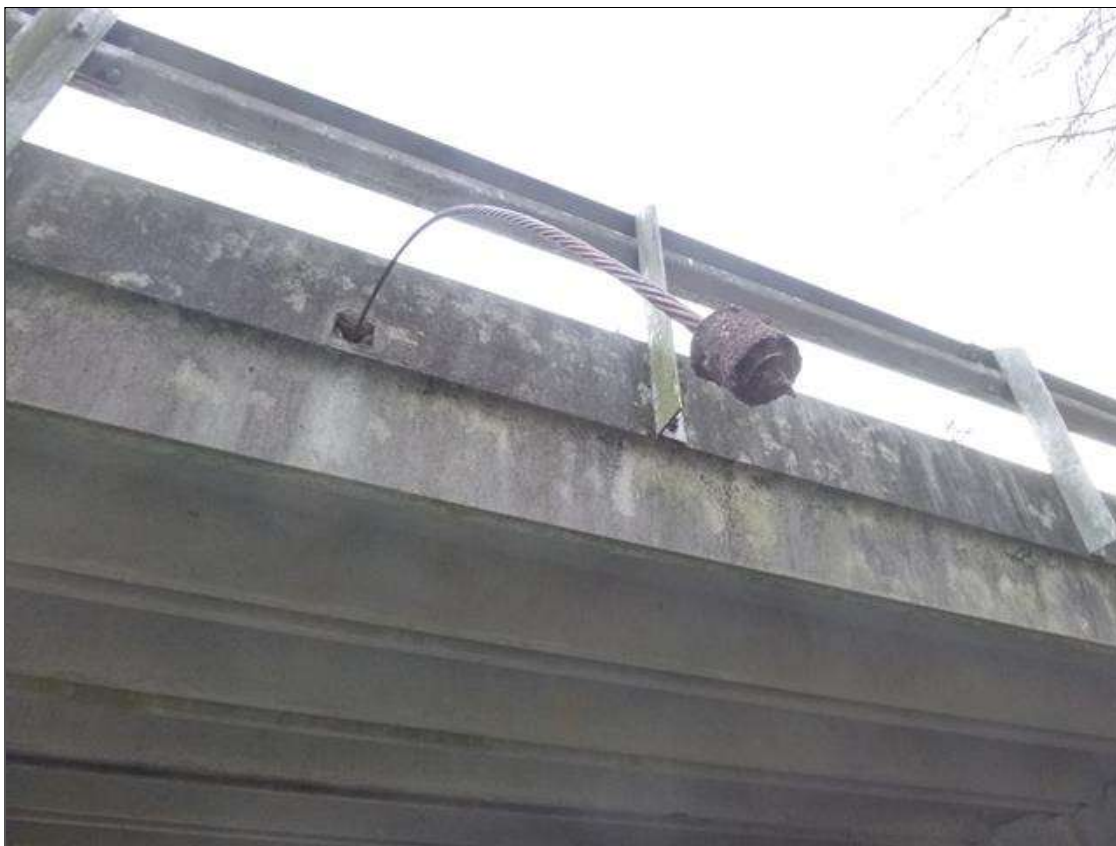
Superstructure: POST TENSIONING CABLE SHOT OUT NORTH SIDE, CENTER OF SPAN 2. (PM)
