NC DEPARTMENT OF TRANSPORTATION  
DIVISION OF HIGHWAYS  
STRUCTURE MANAGEMENT UNIT

# Structure Safety Report

## Municipal Routine Element Inspection - Contract

DIVISION: 6 COUNTY: CUMBERLAND STRUCTURE NUMBER: 250211 FREQUENCY: 24 MONTHS

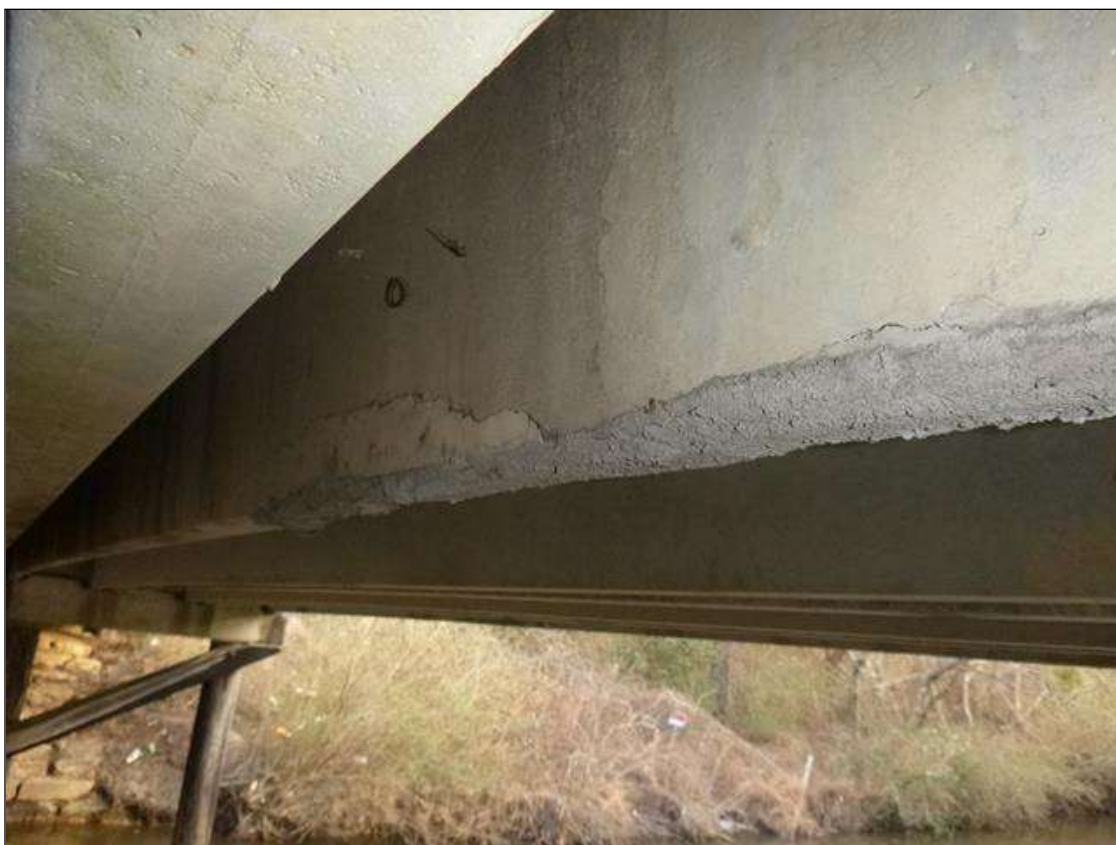
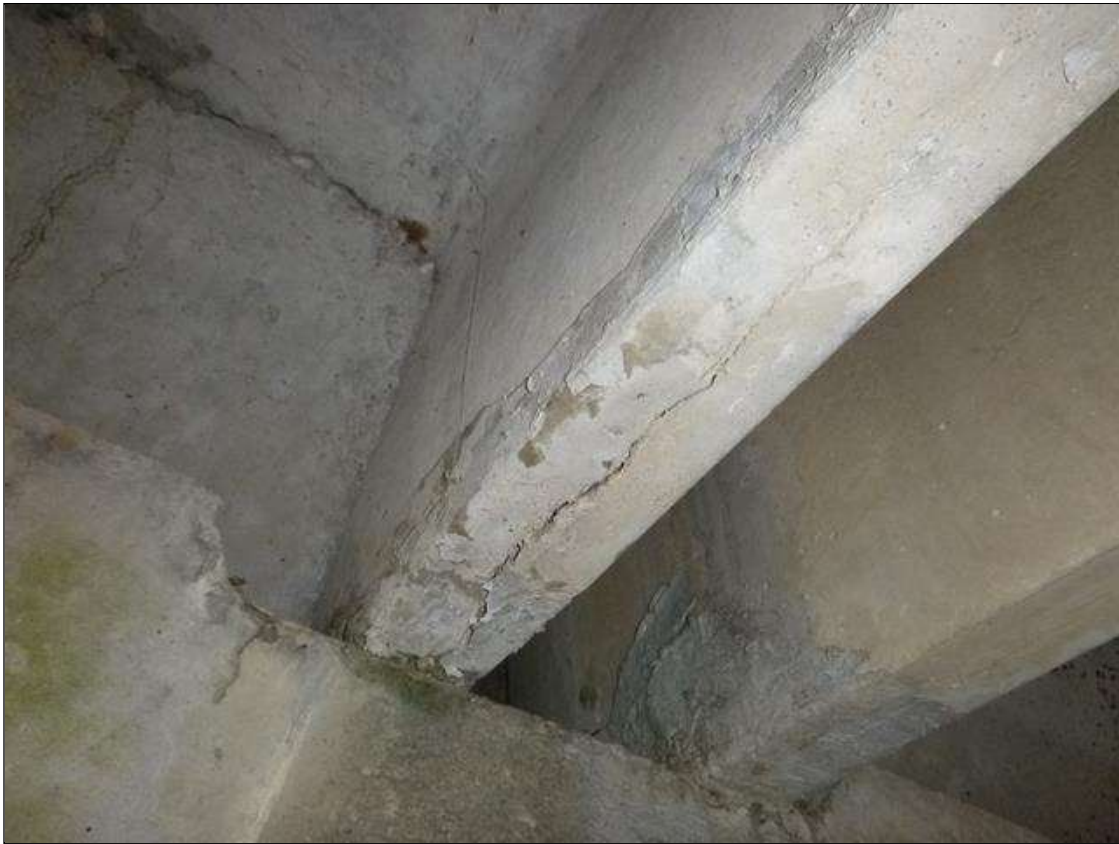
| Element Number | Defect Type | Defect Description | CS | CS Qty | Maint Qty | |
|---|---|---|---|---|---|---|
| 109 | Cracking (PSC) | 4' HORIZONTAL CRACK UP TO 1/8", UNDERSIDE OF LEG 1, BEGINNING AT BENT 1. | 3 | 4 | 4 | Feet |

Span 2 Slab 10: 4' HORIZONTAL CRACK UP TO 1/8", UNDERSIDE OF LEG 1, BEGINNING AT BENT 1.

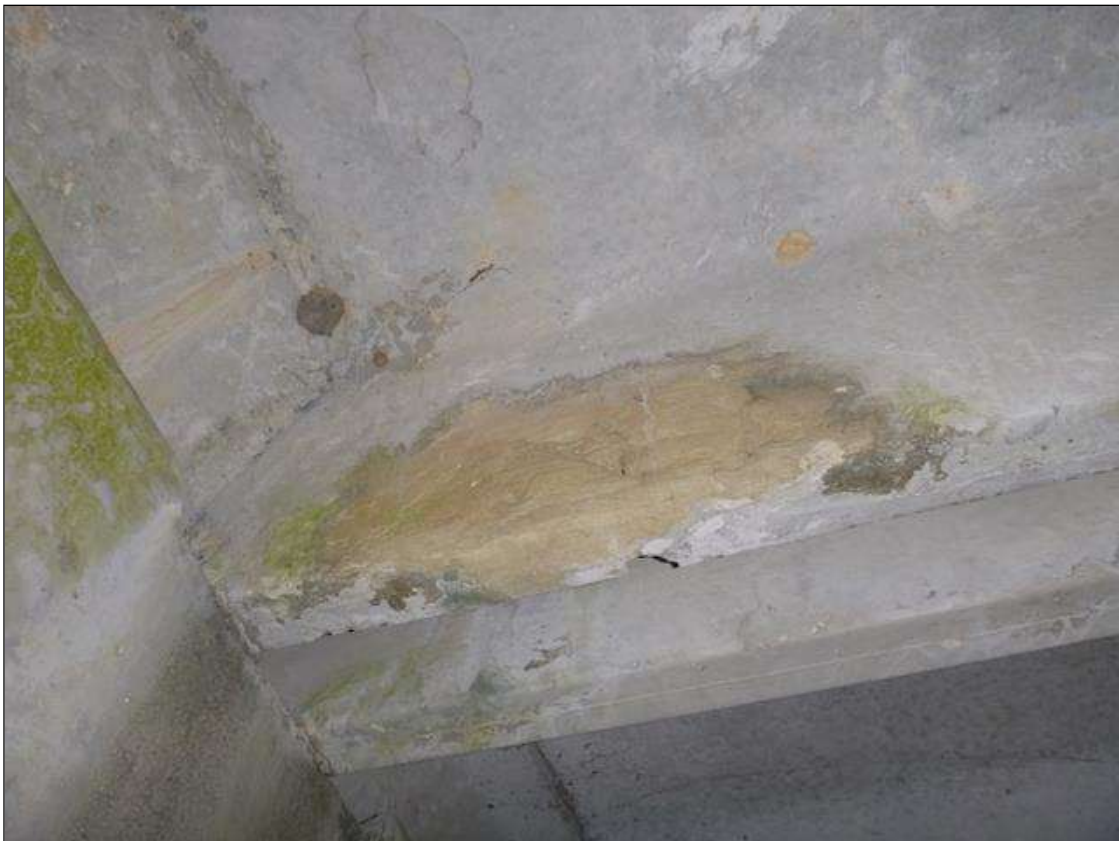
Span 2 Slab 12: 16" X 8" PATCHED AREA, INSIDE FACE OF LEG 1, AT BENT 1.

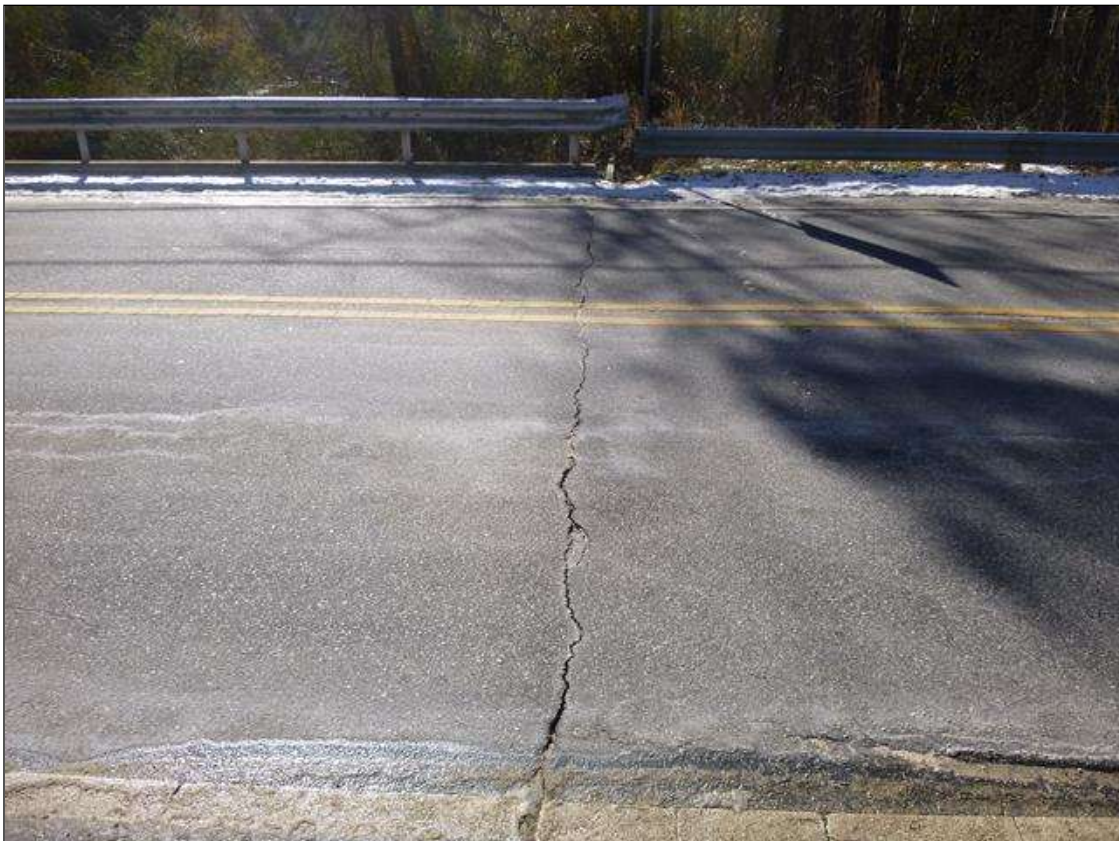
CRACK IN ASPHALT WEARING SURFACE OVER END BENT 1, LOOKING SOUTH

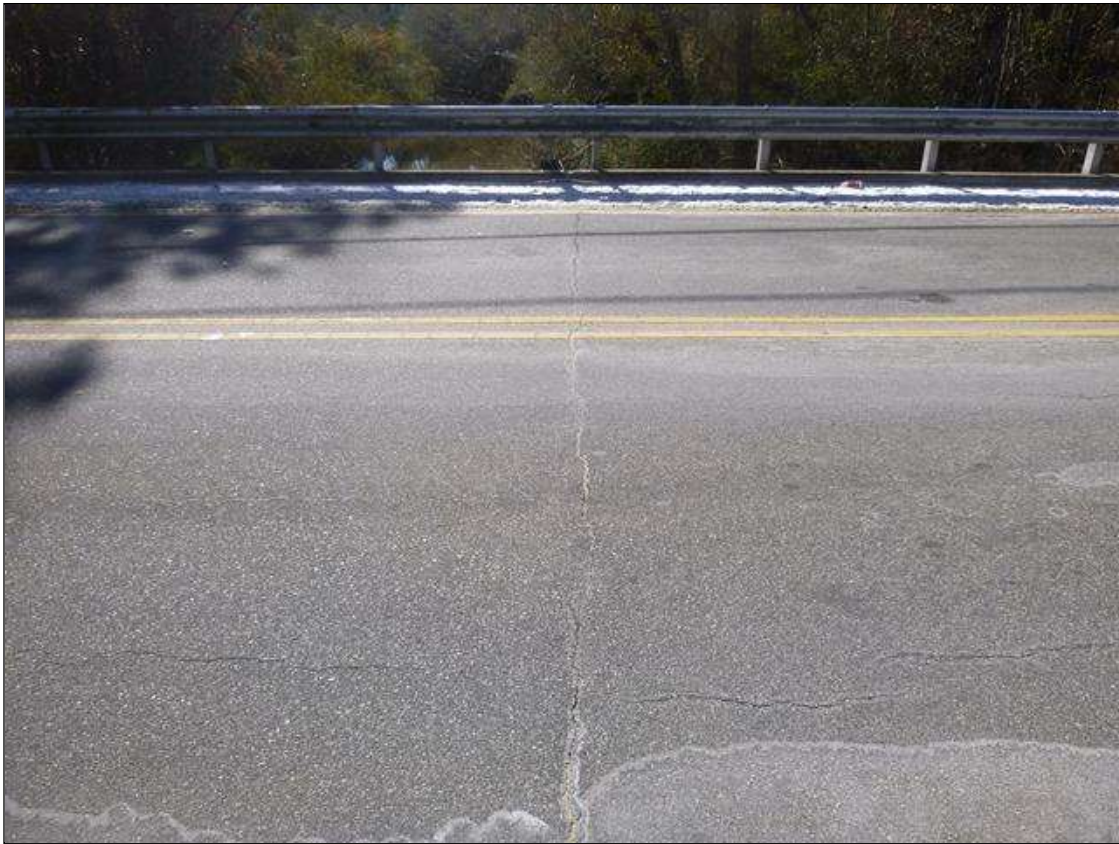
CRACK IN ASPHALT WEARING SURFACE OVER BENT 1, LOOKING SOUTH

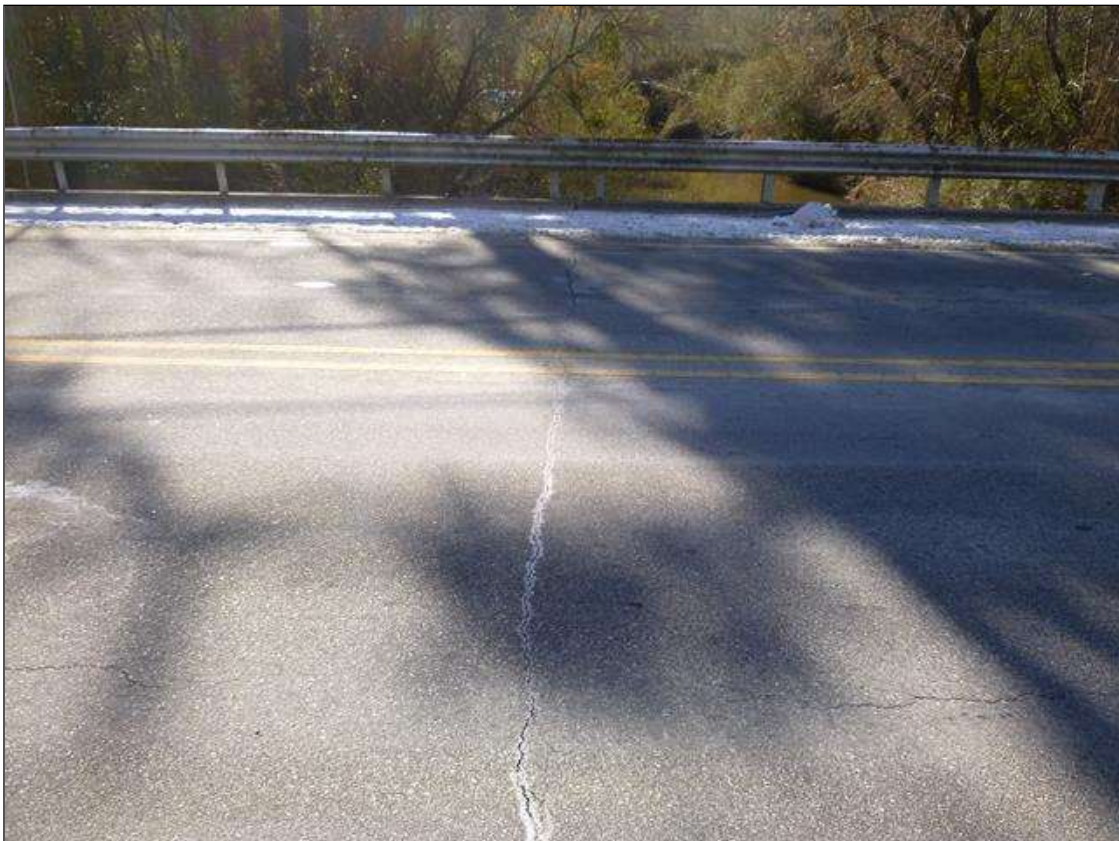
CRACK IN ASPHALT WEARING SURFACE OVER BENT 2, LOOKING SOUTH

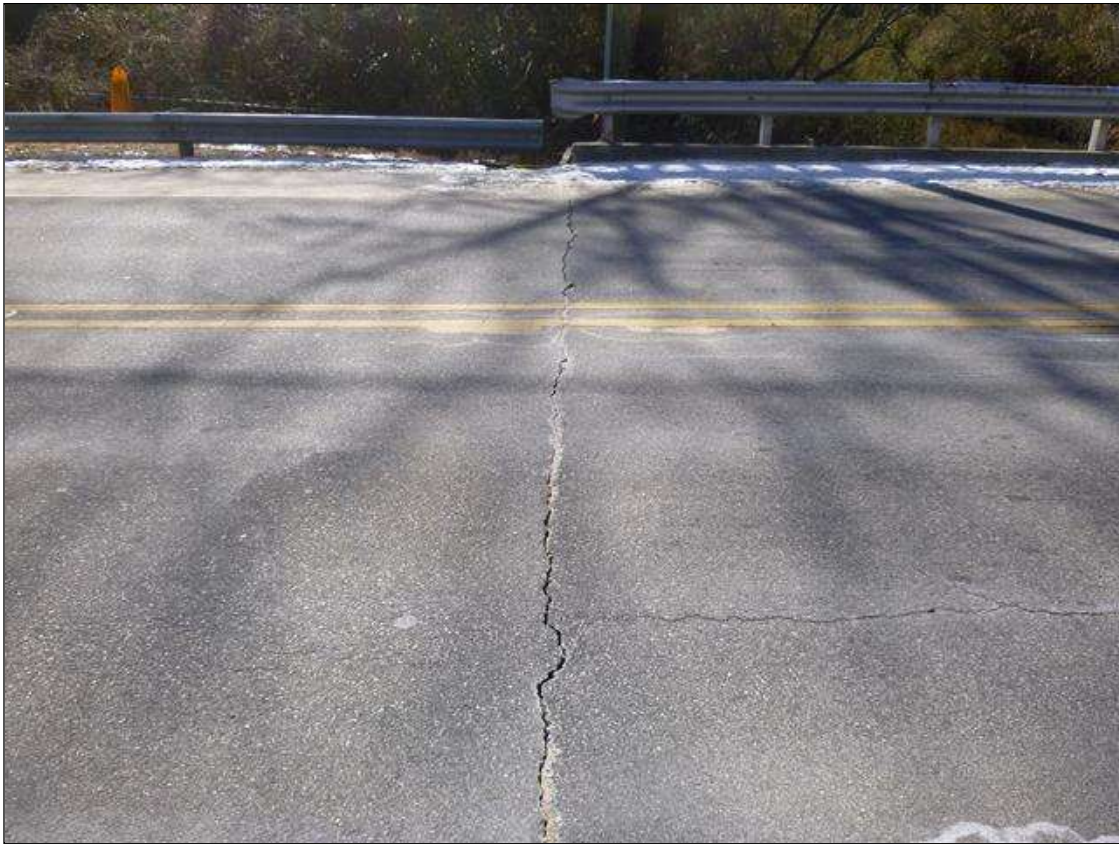
CRACK IN ASPHALT WEARING SURFACE OVER END BENT 2, LOOKING SOUTH
