NC DEPARTMENT OF TRANSPORTATION  
DIVISION OF HIGHWAYS  
STRUCTURE MANAGEMENT UNIT

## Structure Safety Report

### Routine Element Inspection - Contract

COUNTY: YADKIN STRUCTURE NUMBER: 980010 FREQUENCY: 24 MONTHS

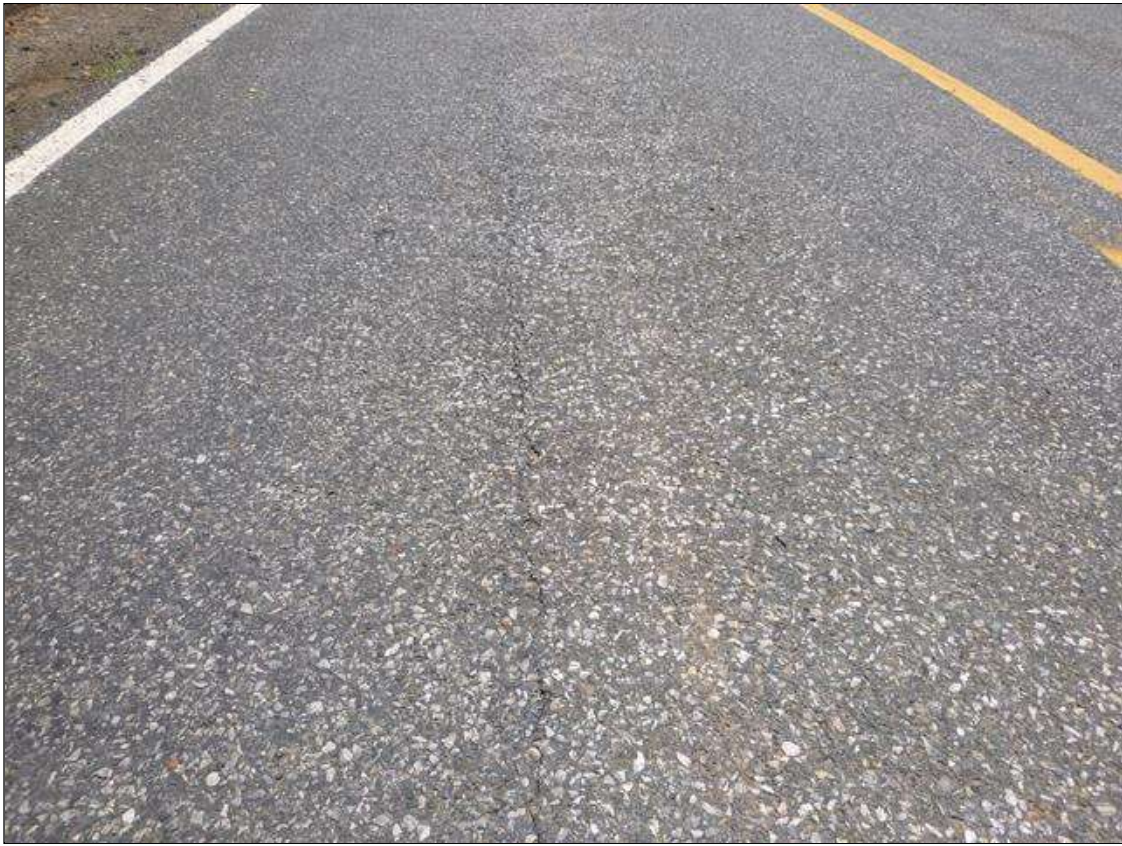
30 Square Feet of Crack (Wearing Surface): Width 0.012-0.05 in. or spacing of 1.0-3.0 ft. Longitudinal crack 7' from right rail and another at centerline of roadway at midspan.

Span 2 Wearing Surface : Longitudinal crack 7' from right rail and another at centerline of roadway at midspan.

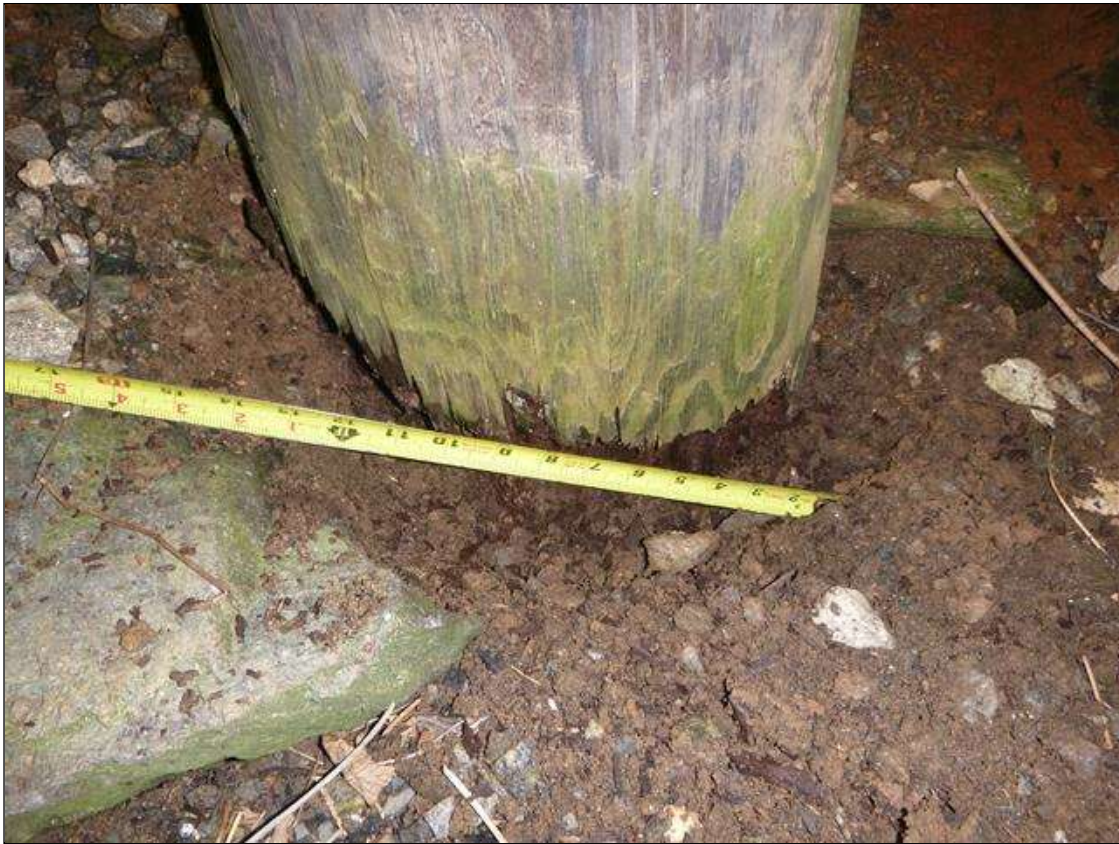
End Bent 1 Pile 5: 1 Each of Decay/Section Loss: Affects less than 10% of the member section. Surface decay 4" long 18" high on NORTH side.

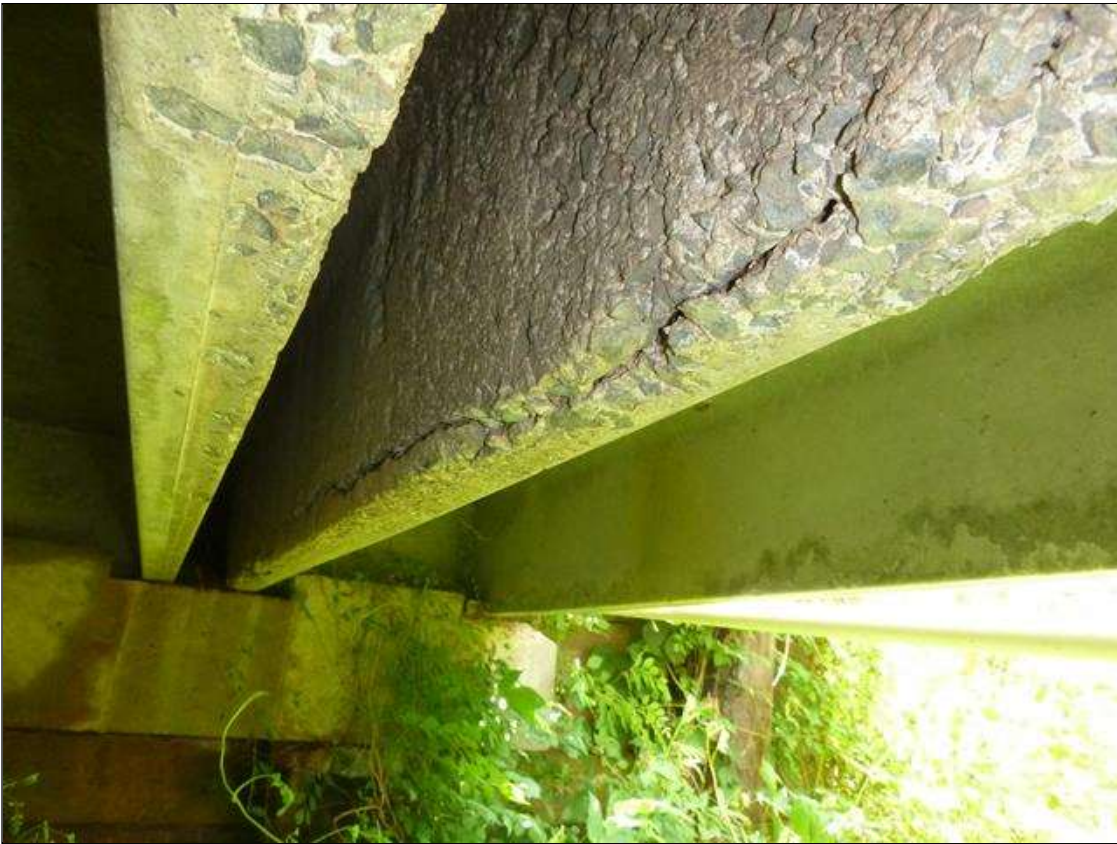
7 Feet of Cracking (PSC): The condition warrants a structural review to determine the effect on strength or serviceability of the element or bridge; OR a structural review has been completed and the defects impact strength or serviceability of the element or bridge. 1/4" longitudinal crack 2" from bottom of right leg at end bent 1.

Span 1 Channel/Slab 1: 7 Feet of Cracking (PSC): The condition warrants a structural review to determine the effect on strength or serviceability of the element or bridge; OR a structural review has been completed and the defects impact strength or serviceability of the element or bridge. 1/4" longitudinal crack 2" from bottom of right leg at end bent 1.

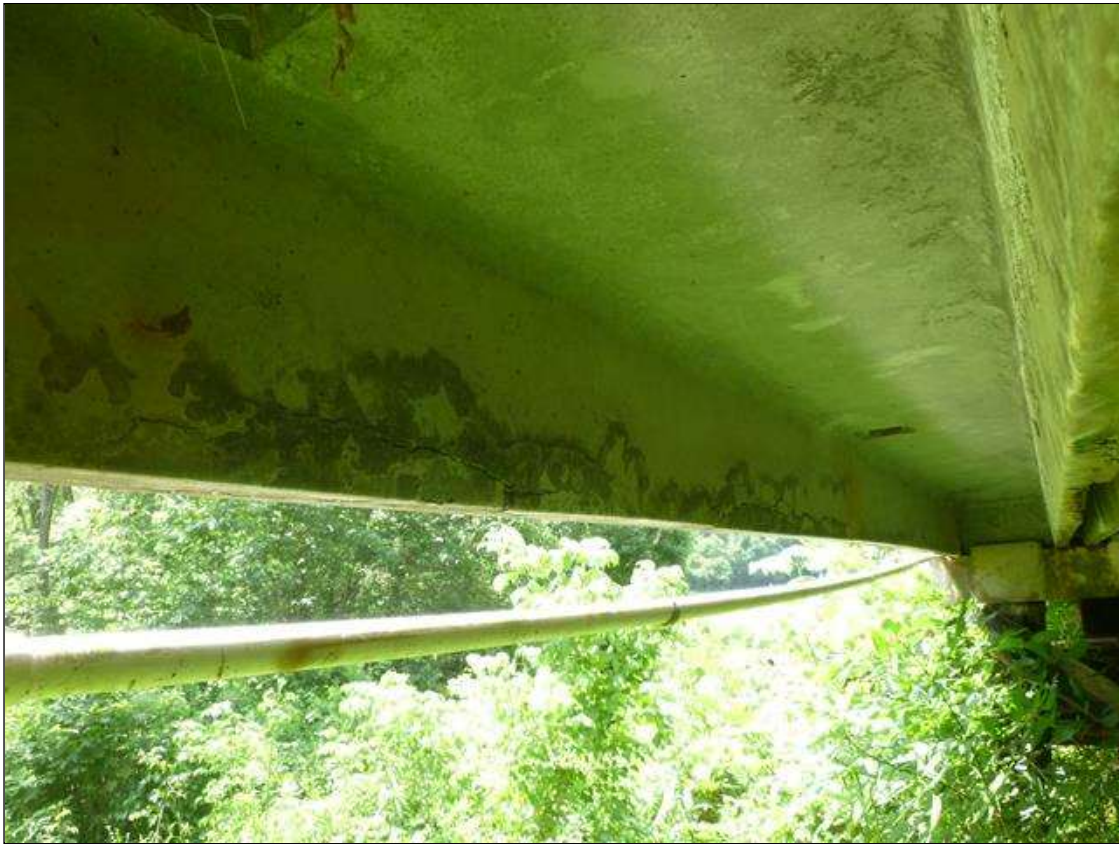
8 Feet of Cracking (PSC): Width greater than 0.009 in. or spacing less than 1 ft. 1/8" longitudinal crack 2" from bottom of left leg with delam at midspan.

Span 1 Channel/Slab 1: 8 Feet of Cracking (PSC): Width greater than 0.009 in. or spacing less than 1 ft. 1/8" longitudinal crack 2" from bottom of left leg with delam at midspan.

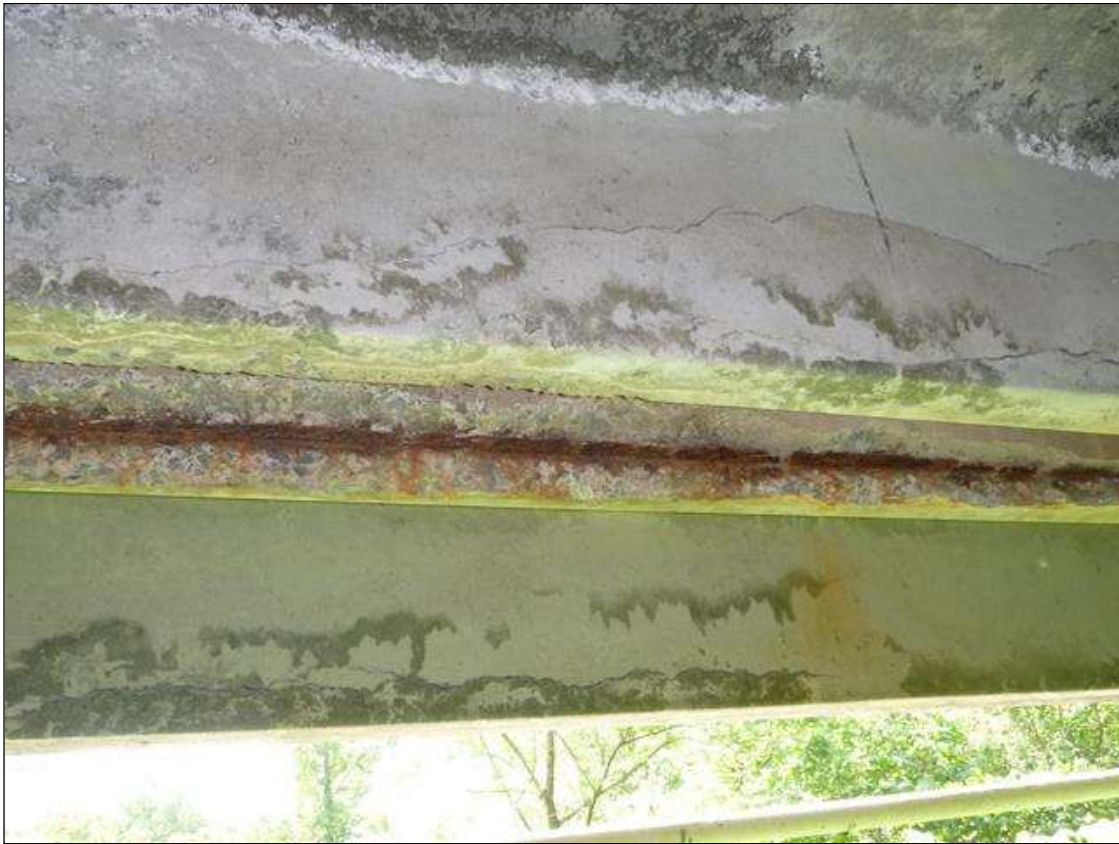
5 Feet of Exposed Prestressing: The condition warrants a structural review to determine the effect on strength or serviceability of the element or bridge; OR a structural review has been completed and the defects impact strength or serviceability of the element or bridge. 3" x 1.5" x 5' spall on bottom of right leg of channel near midspan.

Span 1 Channel/Slab 1: 5 Feet of Exposed Prestressing: The condition warrants a structural review to determine the effect on strength or serviceability of the element or bridge; OR a structural review has been completed and the defects impact strength or serviceability of the element or bridge. 3" x 1.5" deep x 5' spall on bottom of right leg of channel near midspan with exposed cable.

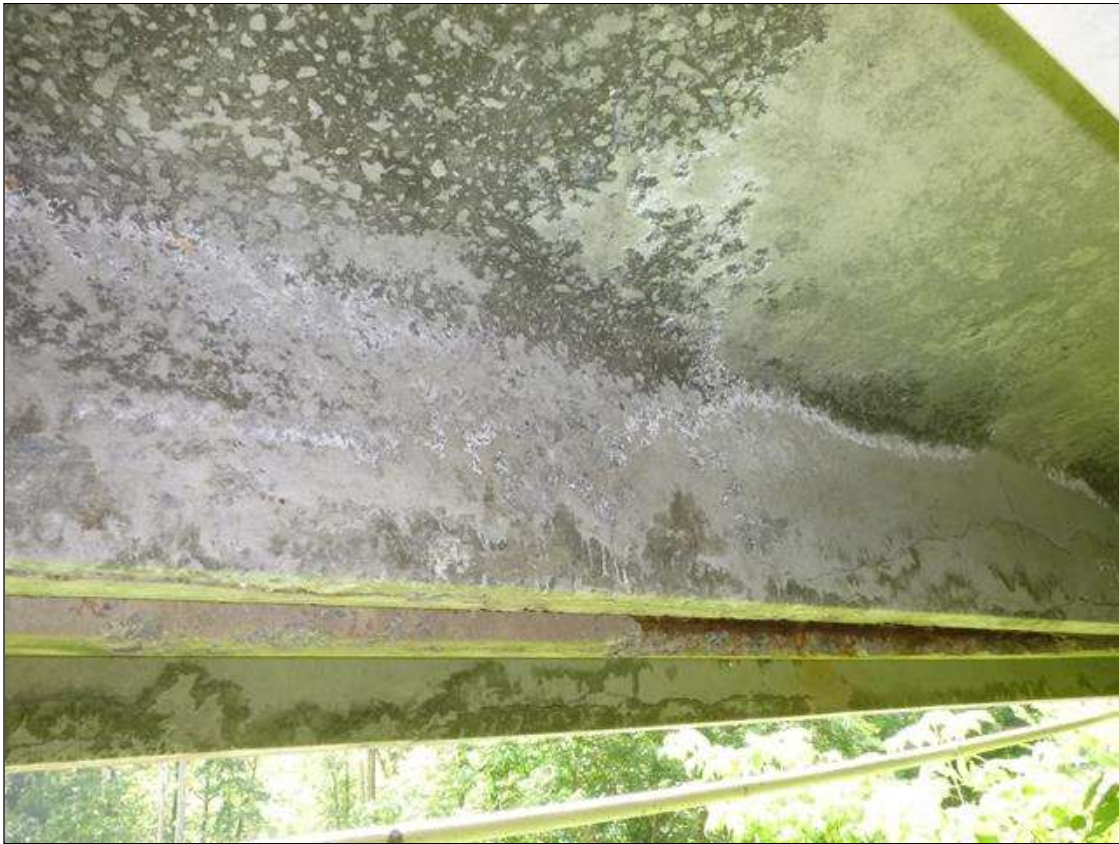
7 Feet of Cracking (PSC): The condition warrants a structural review to determine the effect on strength or serviceability of the element or bridge; OR a structural review has been completed and the defects impact strength or serviceability of the element or bridge. Multiple longitudinal cracks from hairline up to 1/4" with delam on bottom of left leg near midspan.

Span 1 Channel/Slab 2: 7 Feet of Cracking (PSC): The condition warrants a structural review to determine the effect on strength or serviceability of the element or bridge; OR a structural review has been completed and the defects impact strength or serviceability of the element or bridge. Multiple longitudinal cracks from hairline up to 1/4" with delam on bottom of left leg near midspan.

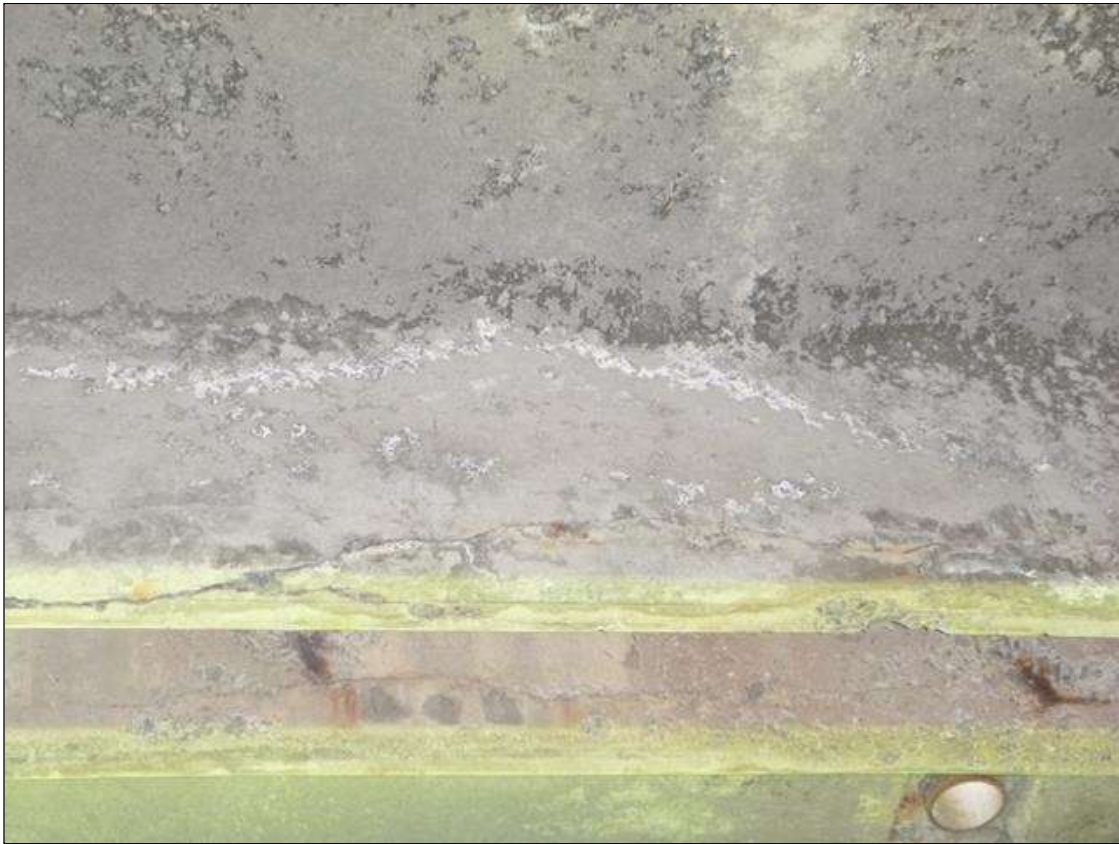
5 Feet of Cracking (PSC): The condition warrants a structural review to determine the effect on strength or serviceability of the element or bridge; OR a structural review has been completed and the defects impact strength or serviceability of the element or bridge. Multiple longitudinal cracks from hairline up to 1/4" with delam on bottom of left leg near bent 1.

Span 1 Channel/Slab 2: 5 Feet of Cracking (PSC): The condition warrants a structural review to determine the effect on strength or serviceability of the element or bridge; OR a structural review has been completed and the defects impact strength or serviceability of the element or bridge. Multiple longitudinal cracks from hairline up to 1/4" with delam on bottom of left leg near bent 1.

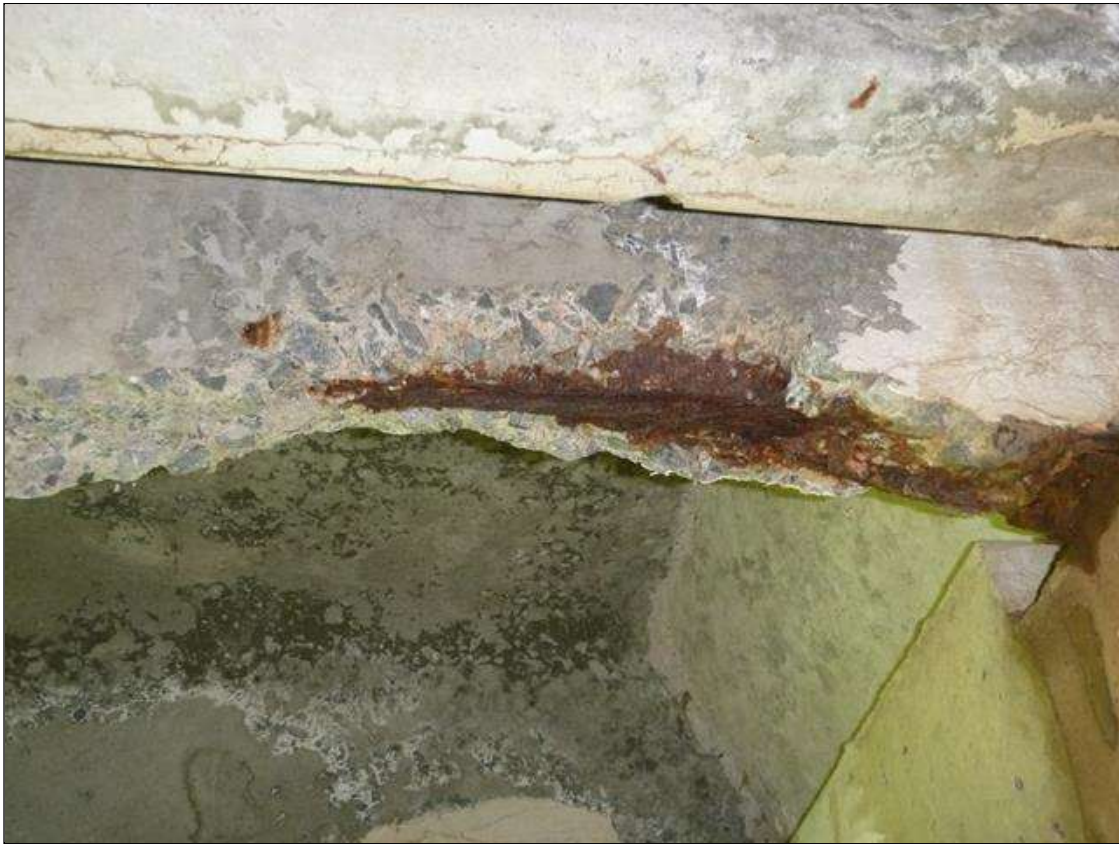
1 Feet of Exposed Prestressing: The condition warrants a structural review to determine the effect on strength or serviceability of the element or bridge; OR a structural review has been completed and the defects impact strength or serviceability of the element or bridge. 16" x 3" x 2" deep spall on bottom of right leg at bent 1.

Span 1 Channel/Slab 2: 1 Feet of Exposed Prestressing: The condition warrants a structural review to determine the effect on strength or serviceability of the element or bridge; OR a structural review has been completed and the defects impact strength or serviceability of the element or bridge. 16" x 3" x 2" deep spall on bottom of right leg at bent 1 with exposed cable.

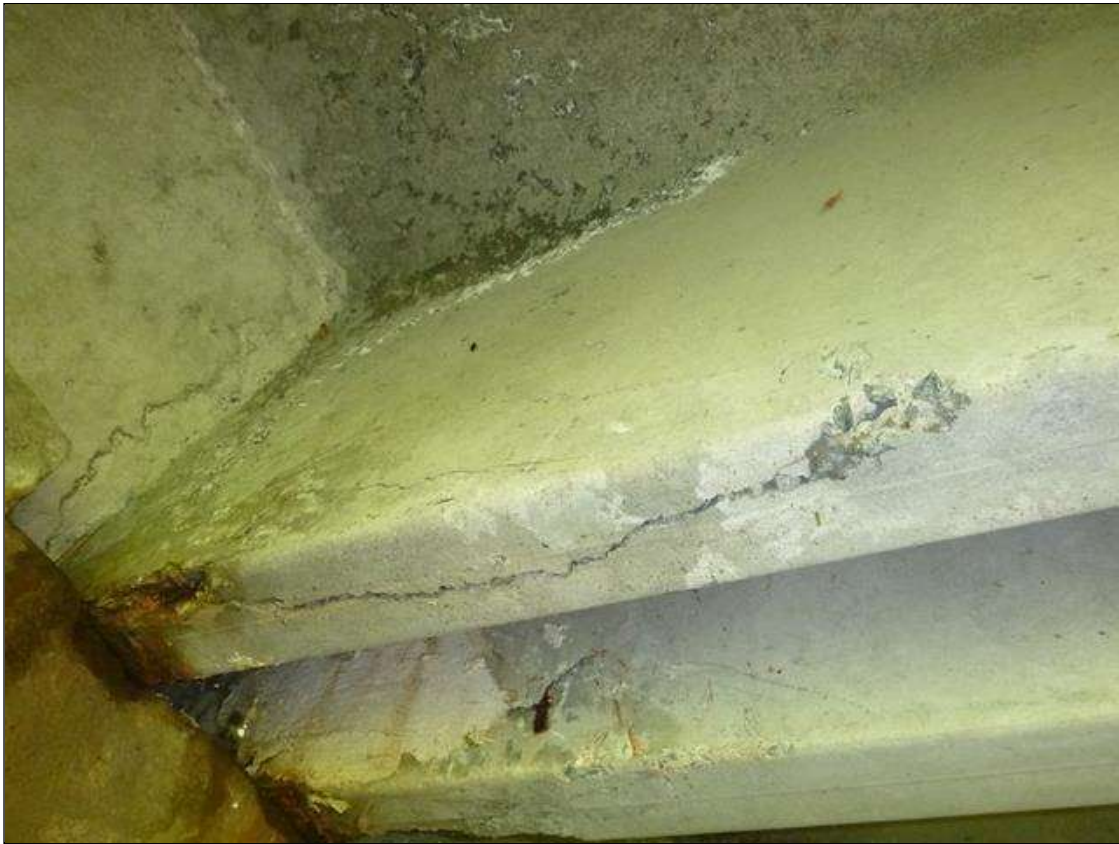
2 Feet of Cracking (PSC): The condition warrants a structural review to determine the effect on strength or serviceability of the element or bridge; OR a structural review has been completed and the defects impact strength or serviceability of the element or bridge. 1/8" crack with delam on bottom of right leg at bent 1.

Span 1 Channel/Slab 3: 2 Feet of Cracking (PSC): The condition warrants a structural review to determine the effect on strength or serviceability of the element or bridge; OR a structural review has been completed and the defects impact strength or serviceability of the element or bridge. 1/8" crack with delam on bottom of right leg at bent 1.

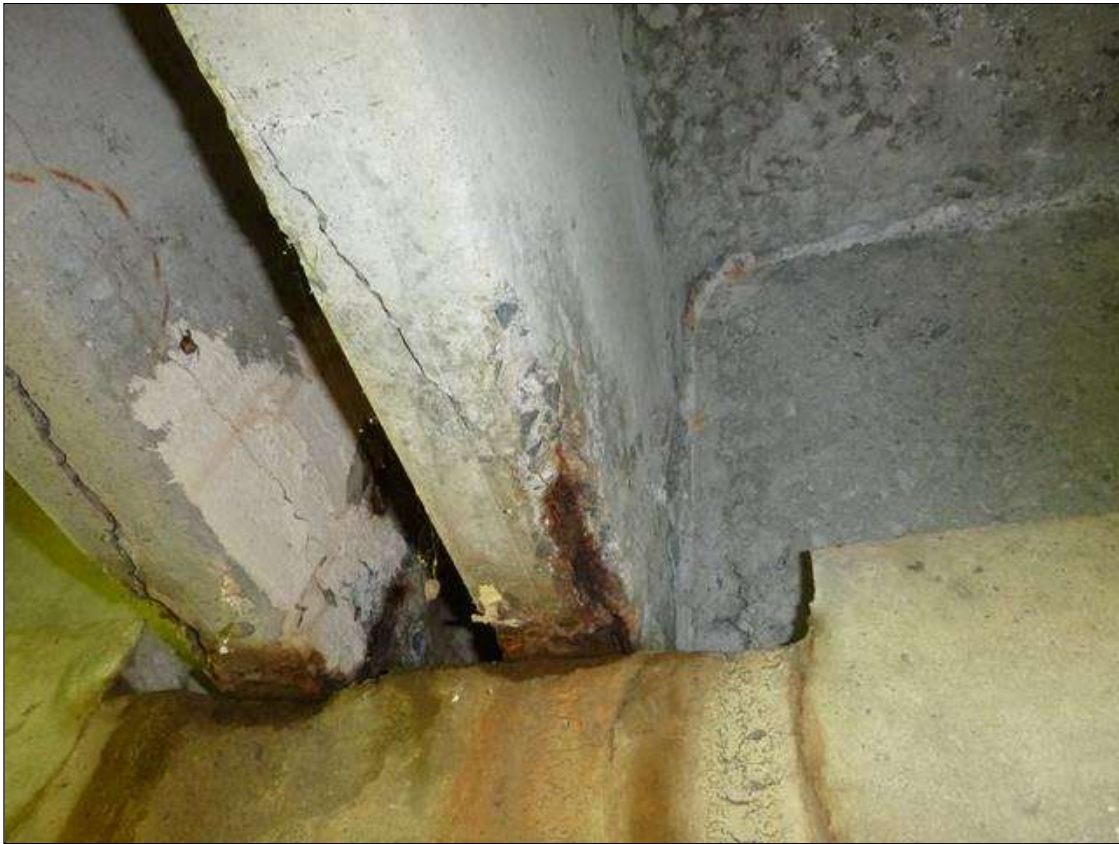
1 Feet of Cracking (PSC): Width greater than 0.009 in. or spacing less than 1 ft. Longitudinal crack with 6" x 1" x 1/2" deep spall in bottom of left leg at bent 1.

Span 1 Channel/Slab 4: 1 Feet of Cracking (PSC): Width greater than 0.009 in. or spacing less than 1 ft. Longitudinal crack with 6" x 1" x 1/2" deep spall in bottom of left leg at bent 1.

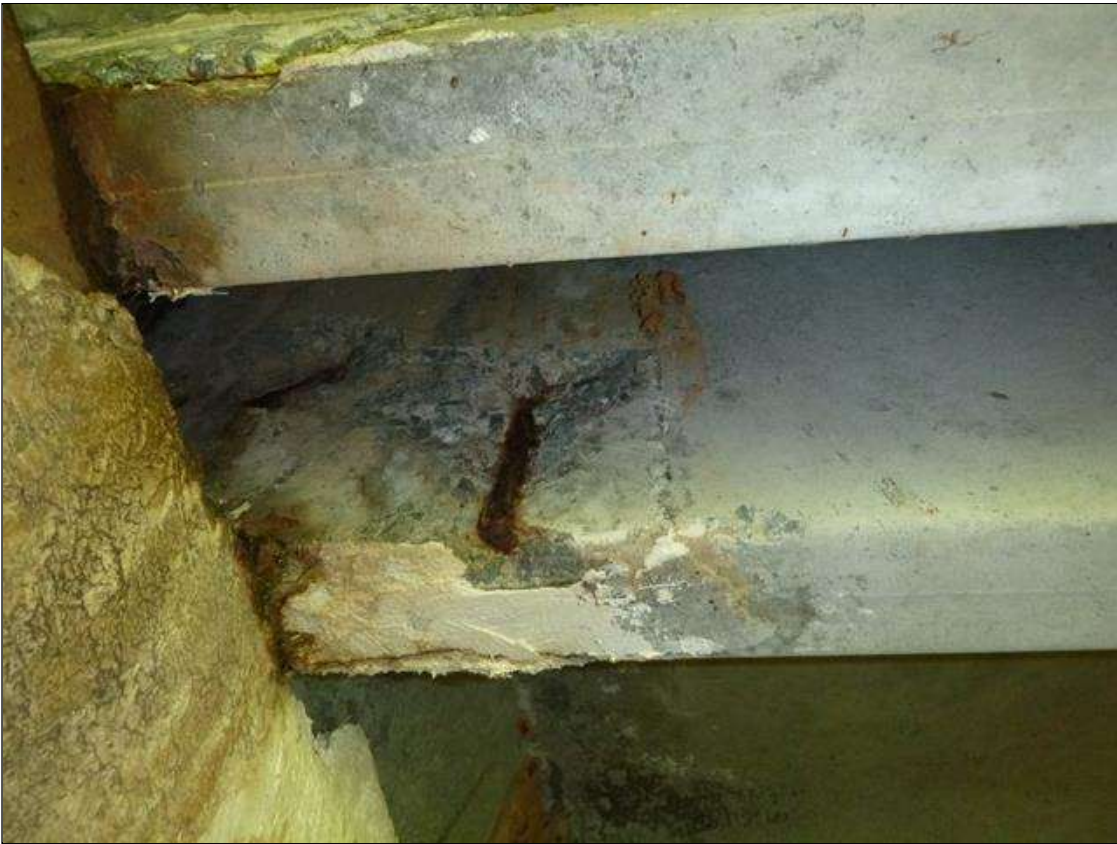
1 Feet of Delamination/Spall/Patched Area: Delaminated. Spall 1 in. or less deep or 6 in. or less in diameter. Up to 4" x 4" x 1/2" deep with exposed rebar in bottom of left and right leg at bent 1.

Span 1 Channel/Slab 5: 1 Feet of Delamination/Spall/Patched Area: Delaminated. Spall 1 in. or less deep or 6 in. or less in diameter. Up to 4" x 4" x 1/2" deep with exposed rebar in bottom of left and right leg at bent 1.

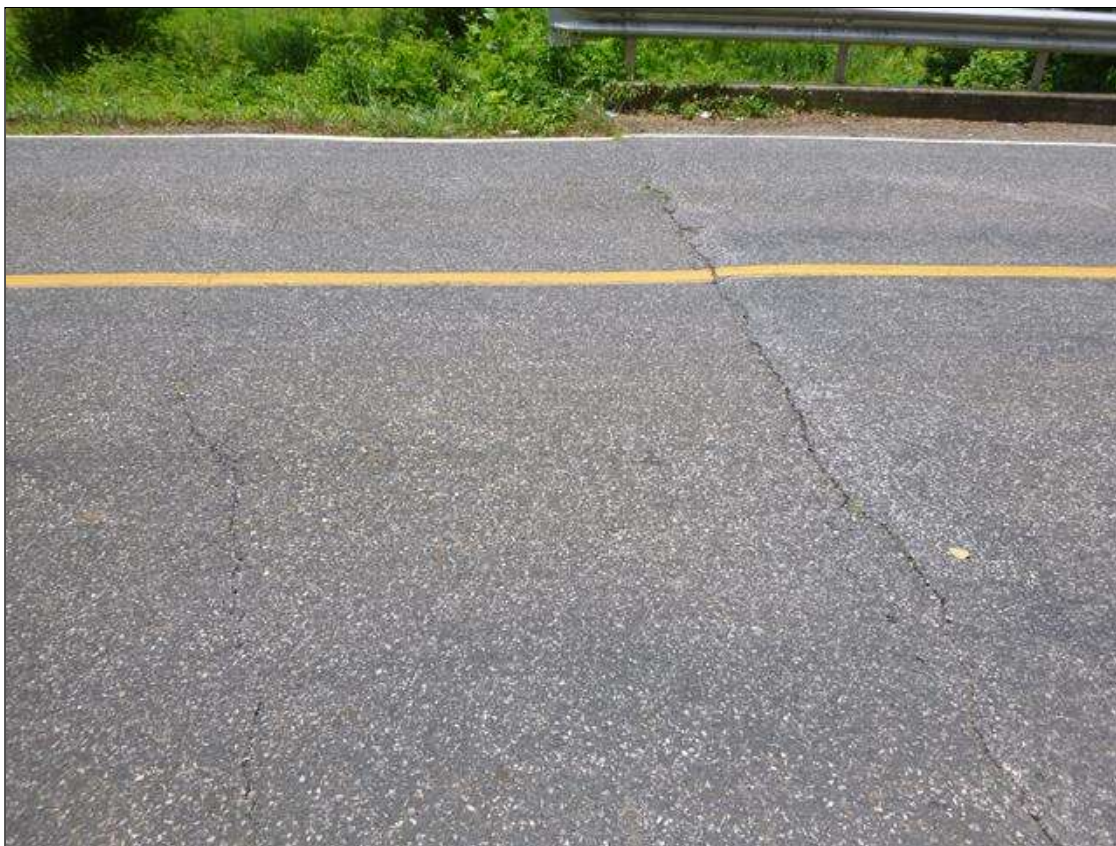
ASPHALT WEARING SURFACE WITH TRANSVERSE CRACK AND SETTLED 1" AT SOUTH APPROACH

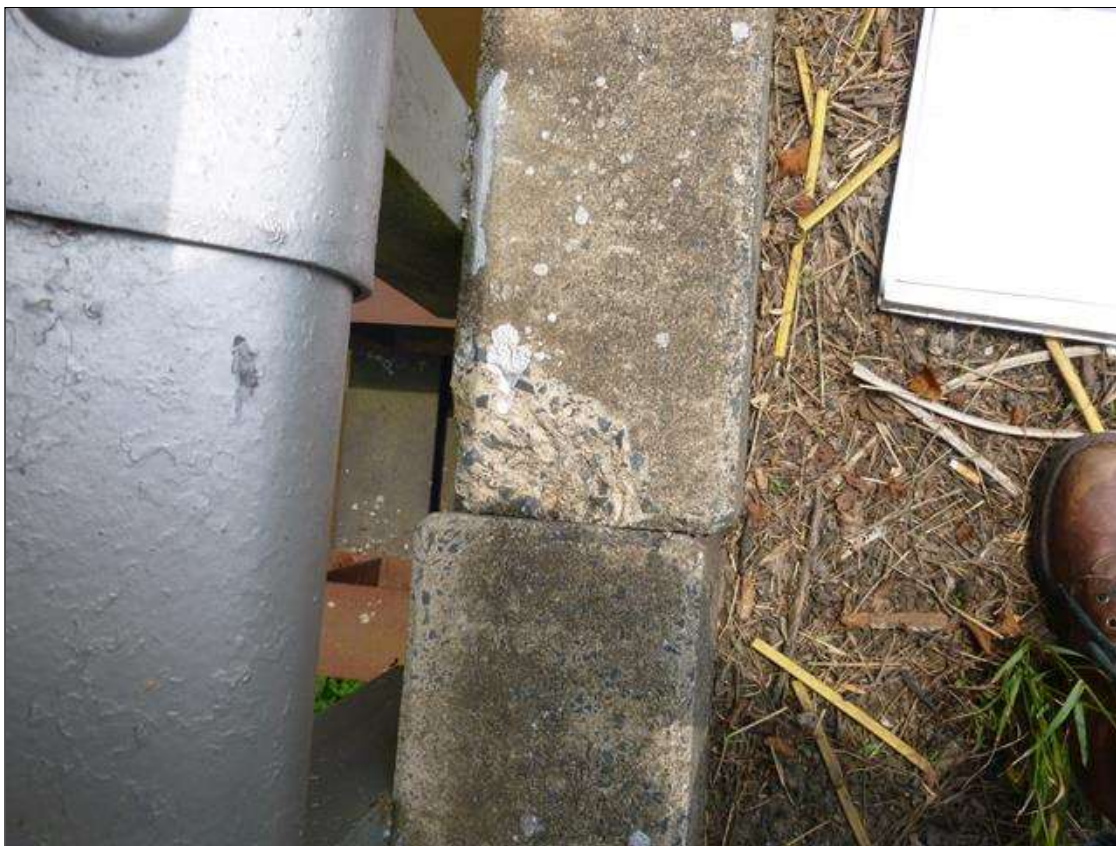
Span 3 : 4" x 5" x 1" deep spall on right curb at bent 3

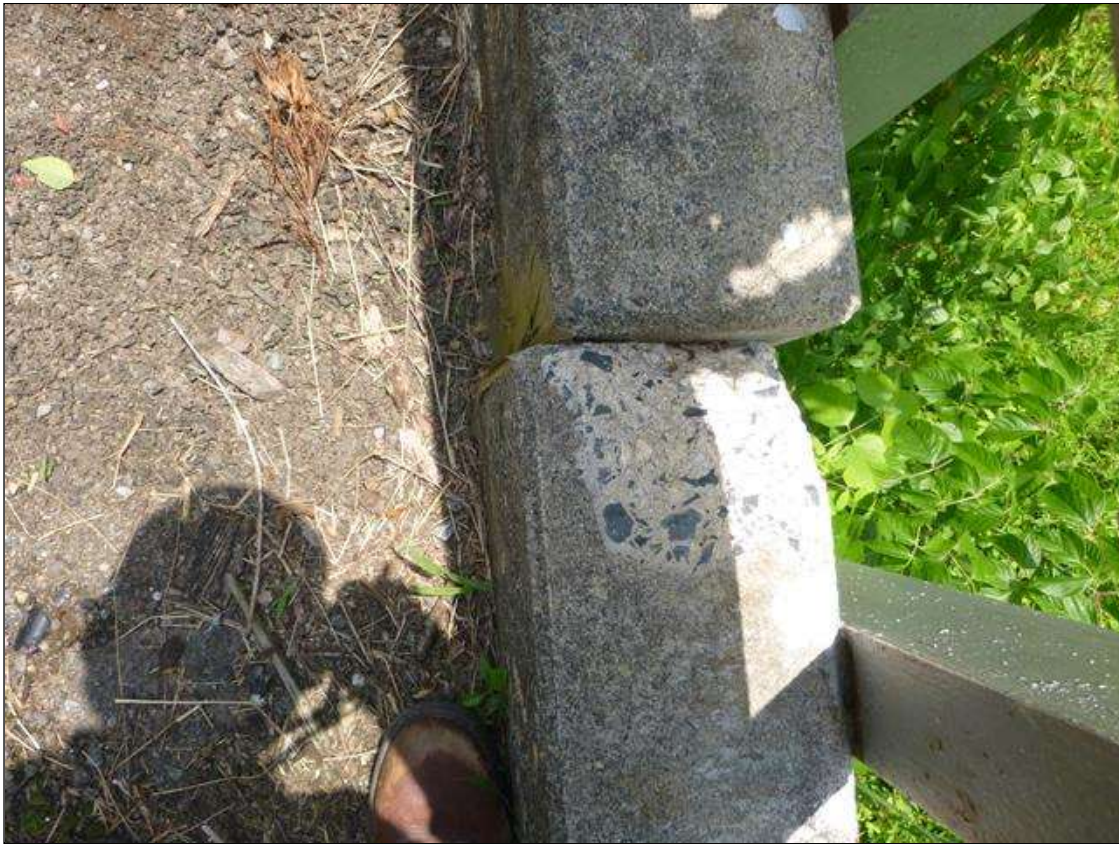
Span 5 : 6" x 6" x 2" deep spall on left curb at bent 4

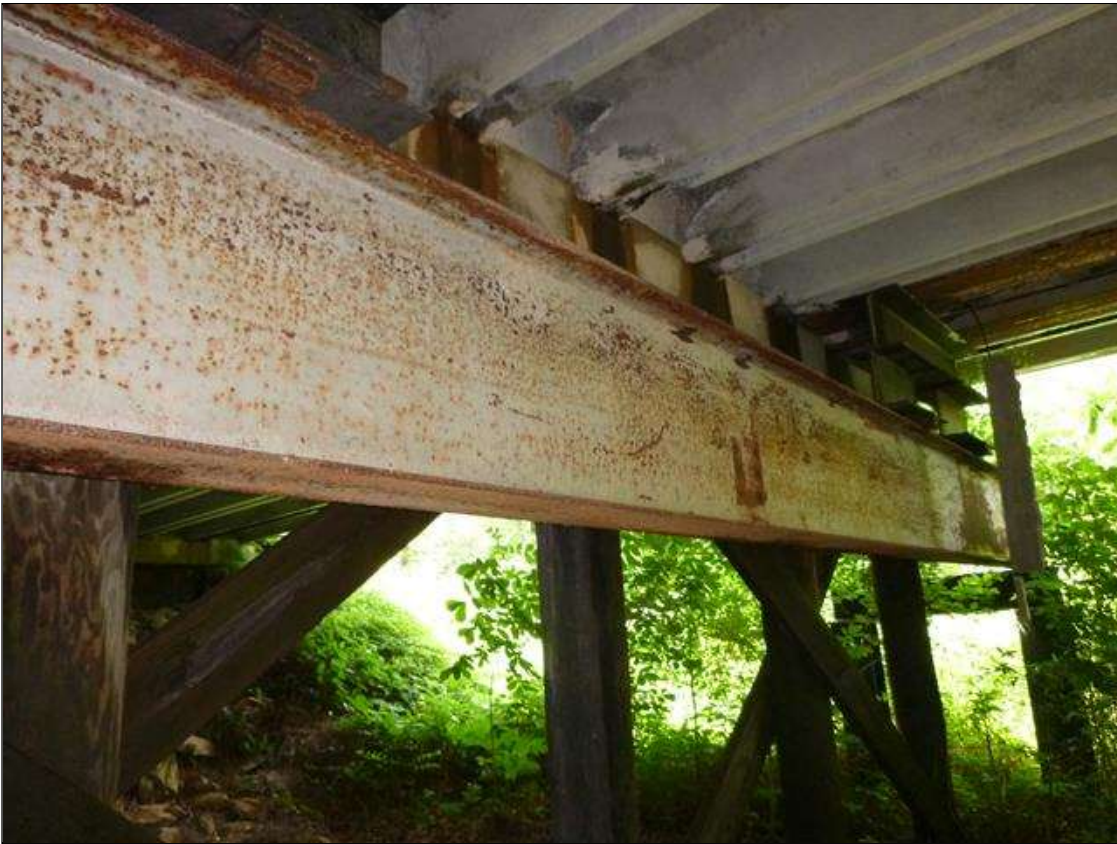
Bent 1 Cap : 22 Feet of Corrosion: Freckled Rust. Corrosion of the steel has initiated. Random surface rust on flanges and web.

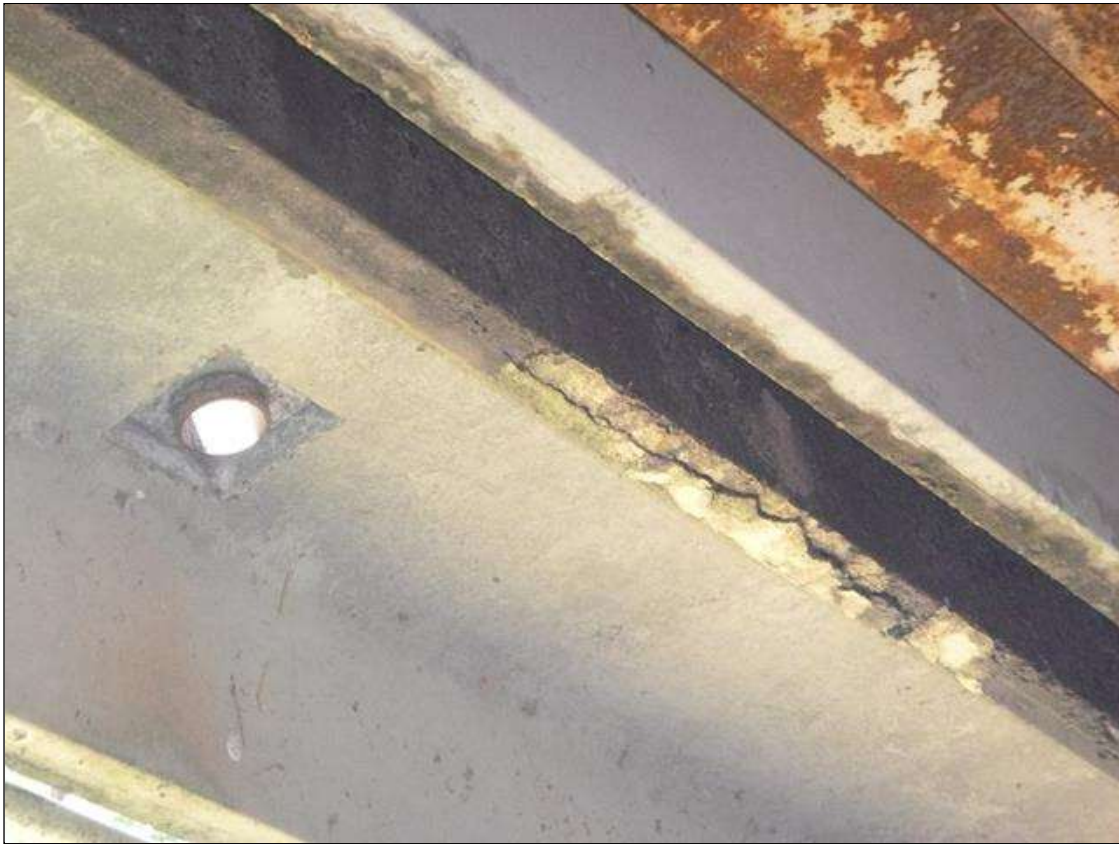
3 Feet of Cracking (PSC): Width greater than 0.009 in. or spacing less than 1 ft. Hairline to 1/4" crack on bottom of right leg 10' from bent 2.

Span 2 Channel/Slab 1: 3 Feet of Cracking (PSC): Width greater than 0.009 in. or spacing less than 1 ft. Hairline to 1/4" crack on bottom of right leg 10' from bent 2.

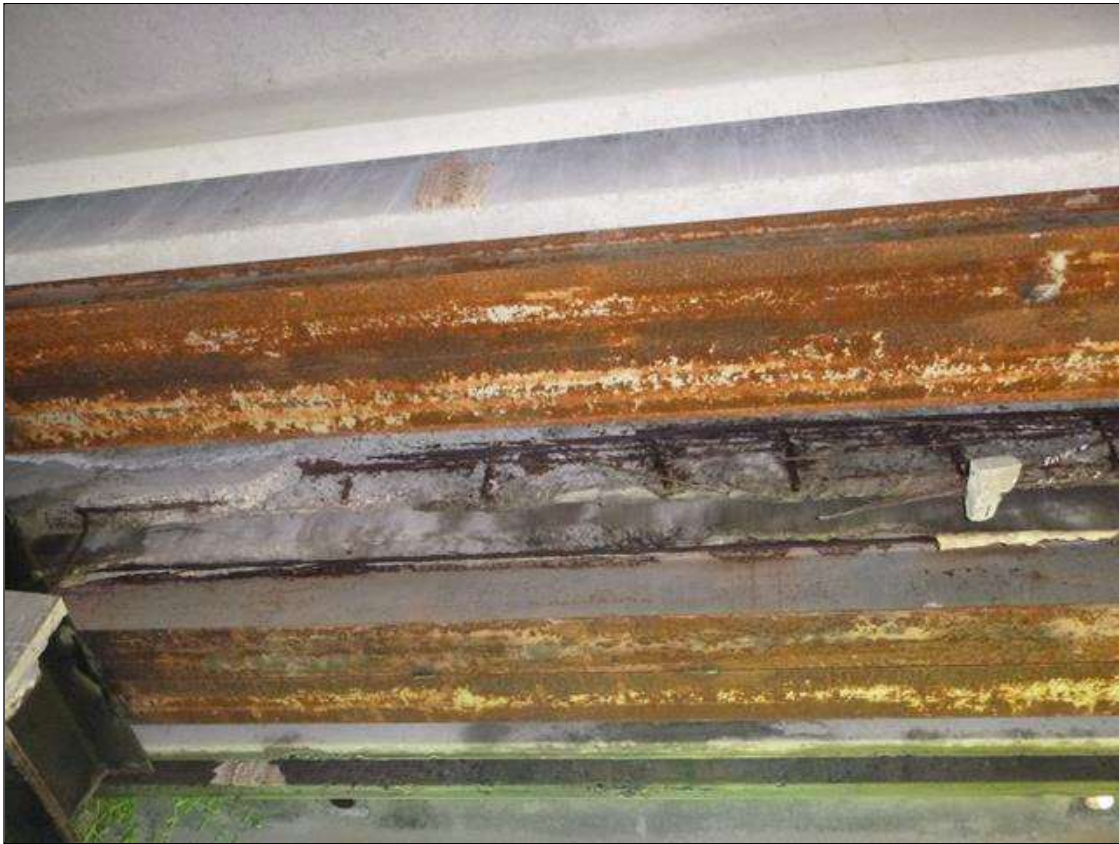
10 Feet of Exposed Prestressing: The condition warrants a structural review to determine the effect on strength or serviceability of the element or bridge; OR a structural review has been completed and the defects impact strength or serviceability of the element or bridge. Extensive spalling with exposed broken strands in left leg near bent 1.

Span 2 Channel/Slab 3: 10 Feet of Exposed Prestressing: The condition warrants a structural review to determine the effect on strength or serviceability of the element or bridge; OR a structural review has been completed and the defects impact strength or serviceability of the element or bridge. Extensive spalling with exposed broken strands in left leg near bent 1.

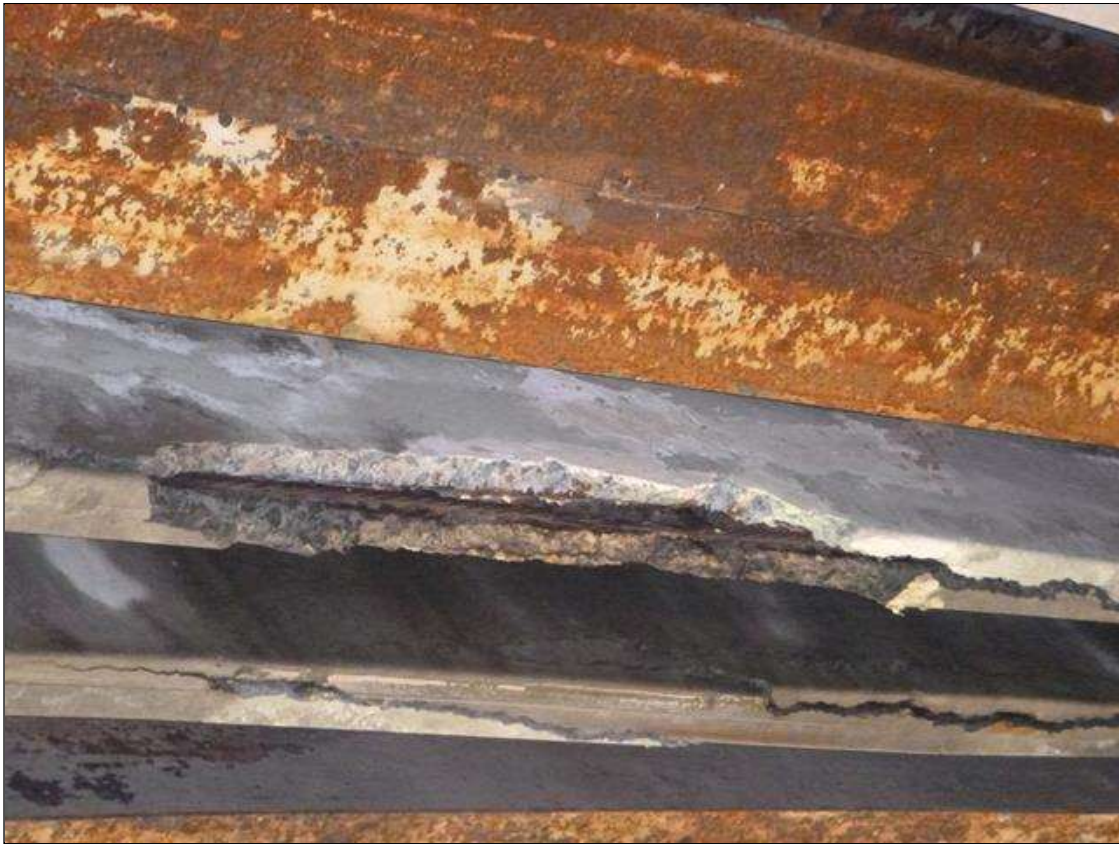
6 Feet of Exposed Prestressing: The condition warrants a structural review to determine the effect on strength or serviceability of the element or bridge; OR a structural review has been completed and the defects impact strength or serviceability of the element or bridge. Spall and crack with exposed strands in left leg 8' from bent 2.

Span 2 Channel/Slab 3: 6 Feet of Exposed Prestressing: The condition warrants a structural review to determine the effect on strength or serviceability of the element or bridge; OR a structural review has been completed and the defects impact strength or serviceability of the element or bridge. Spall and crack with exposed strands in left leg 8' from bent 2.

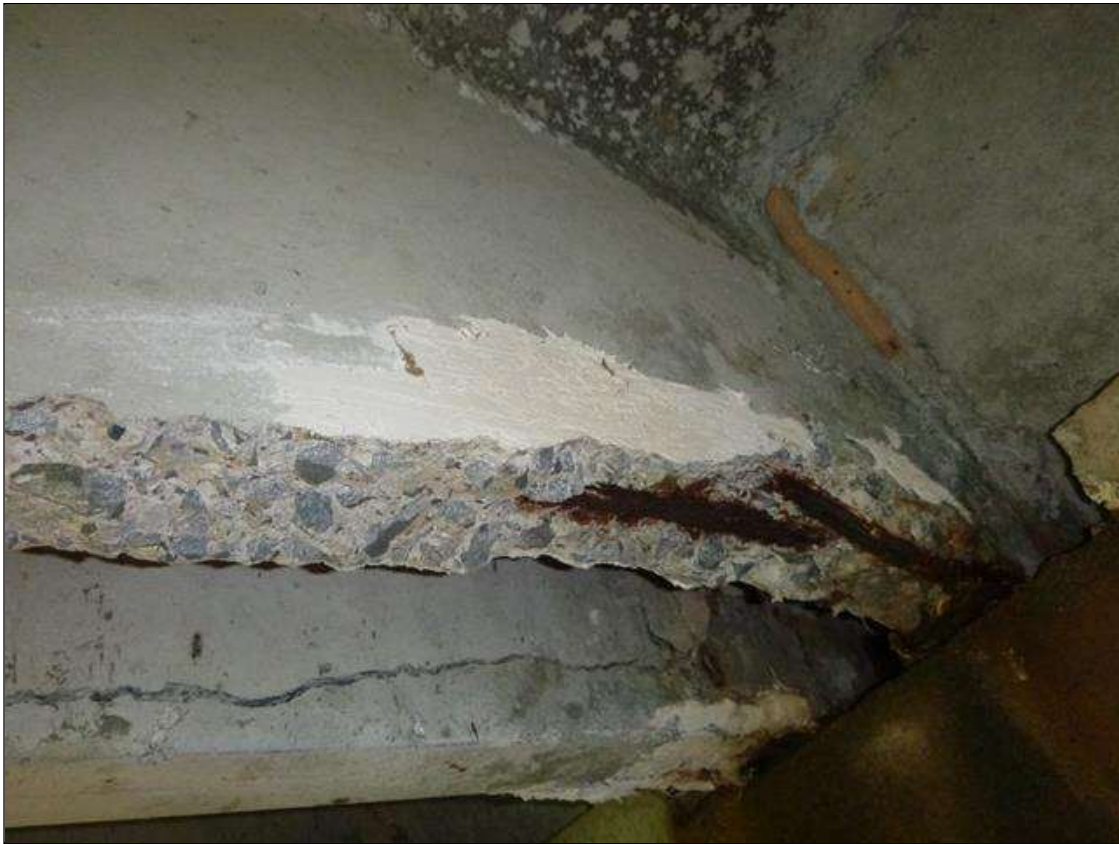
Span 2 Channel/Slab 5: 2 Feet of Exposed Prestressing: The condition warrants a structural review to determine the effect on strength or serviceability of the element or bridge; OR a structural review has been completed and the defects impact strength or serviceability of the element or bridge. 21" spall with exposed strands in bottom of left leg at bent 2.

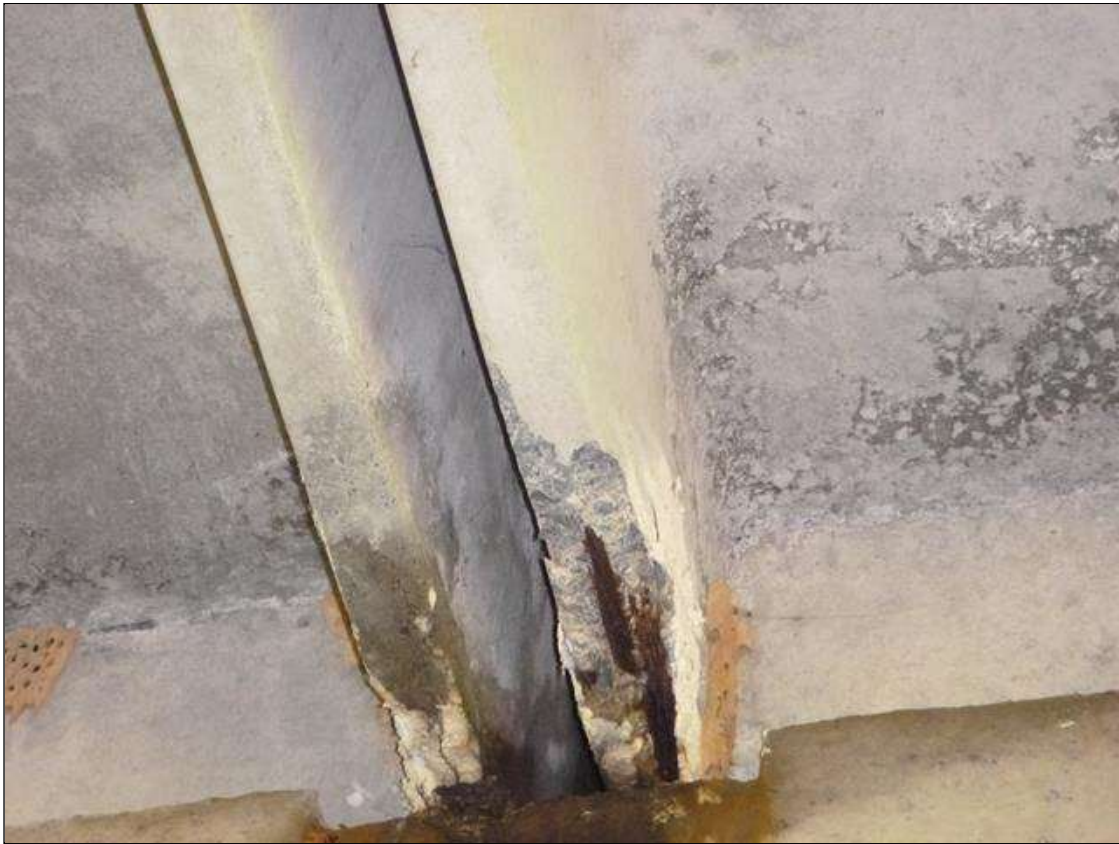
Span 2 Channel/Slab 5: 2 Feet of Exposed Prestressing: The condition warrants a structural review to determine the effect on strength or serviceability of the element or bridge; OR a structural review has been completed and the defects impact strength or serviceability of the element or bridge. 15" spall with exposed strands on right leg at bent 1.

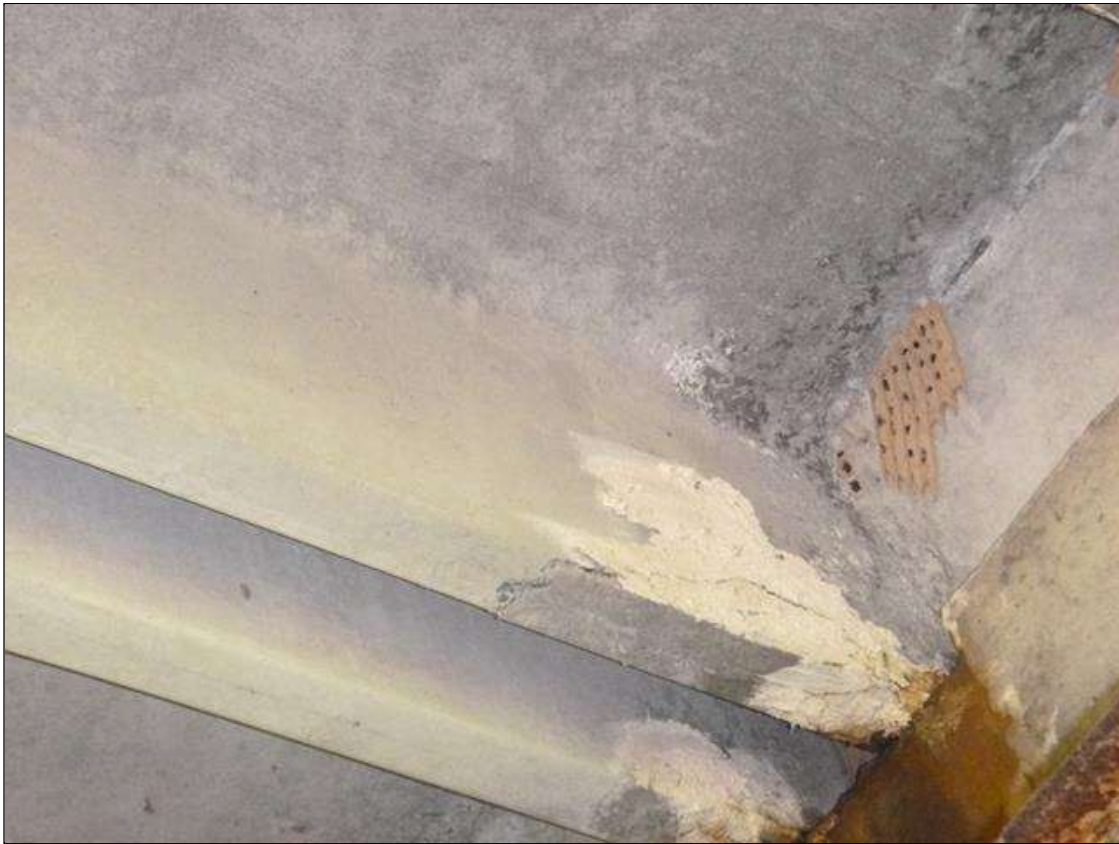
Span 2 Channel/Slab 6: 2 Feet of Delamination/Spall/Patched Area: Spall greater than 1 in. deep or greater than 6 in. diameter. Patched area that is unsound or showing distress. Does not warrant structural review. 13" spall with delam in right leg and 12" patch in left leg at bent 1.
