NC DEPARTMENT OF TRANSPORTATION  
DIVISION OF HIGHWAYS  
STRUCTURE MANAGEMENT UNIT

## Structure Safety Report

### Routine Element Inspection - Contract

COUNTY: YADKIN STRUCTURE NUMBER: 980010 FREQUENCY: 24 MONTHS

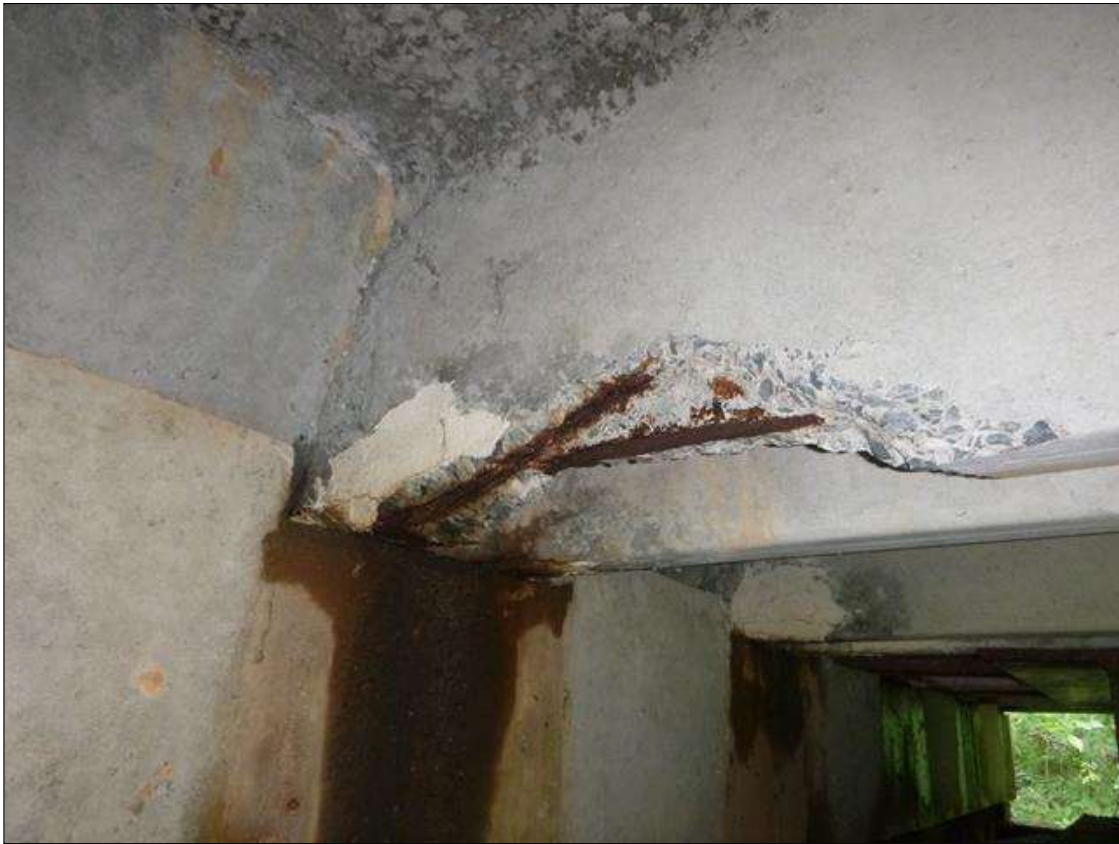
Span 2 Channel/Slab 6: 2 Feet of Exposed Prestressing: The condition warrants a structural review to determine the effect on strength or serviceability of the element or bridge; OR a structural review has been completed and the defects impact strength or serviceability of the element or bridge. 18" spall with exposed strands in bottom of right leg at bent 2.

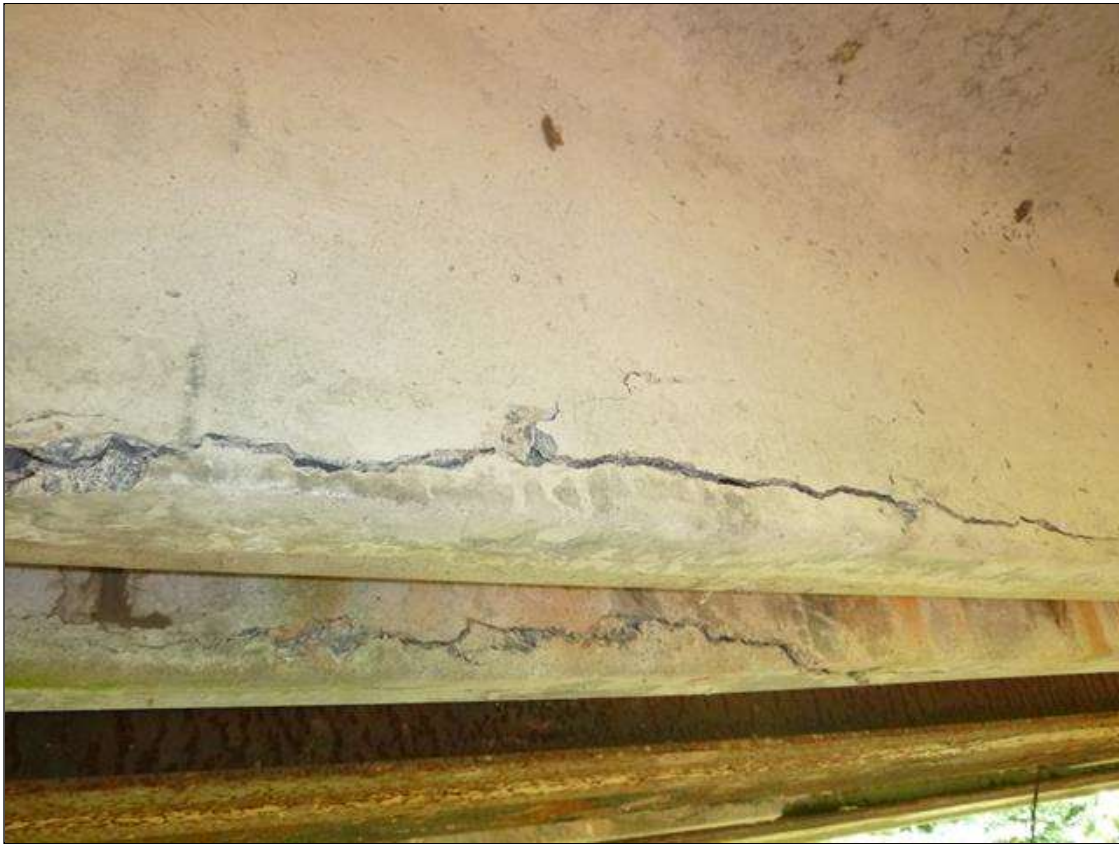
Span 2 Channel/Slab 7: 2 Feet of Delamination/Spall/Patched Area: Spall greater than 1 in. deep or greater than 6 in. diameter. Patched area that is unsound or showing distress. Does not warrant structural review. Delam in bottom of right leg 3' from bent 2.

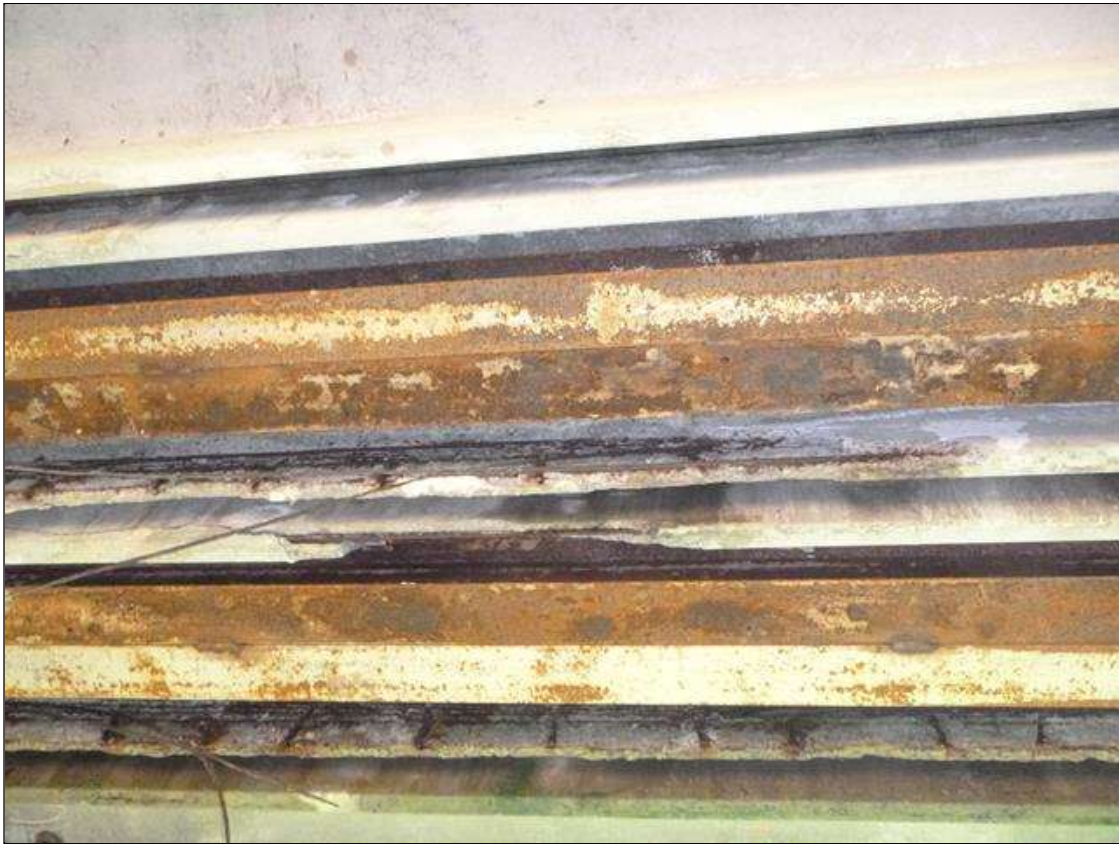
Span 2 Channel/Slab 8: 14 Feet of Exposed Prestressing: The condition warrants a structural review to determine the effect on strength or serviceability of the element or bridge; OR a structural review has been completed and the defects impact strength or serviceability of the element or bridge. Extensive spall with broken strands in right leg at bent 2.

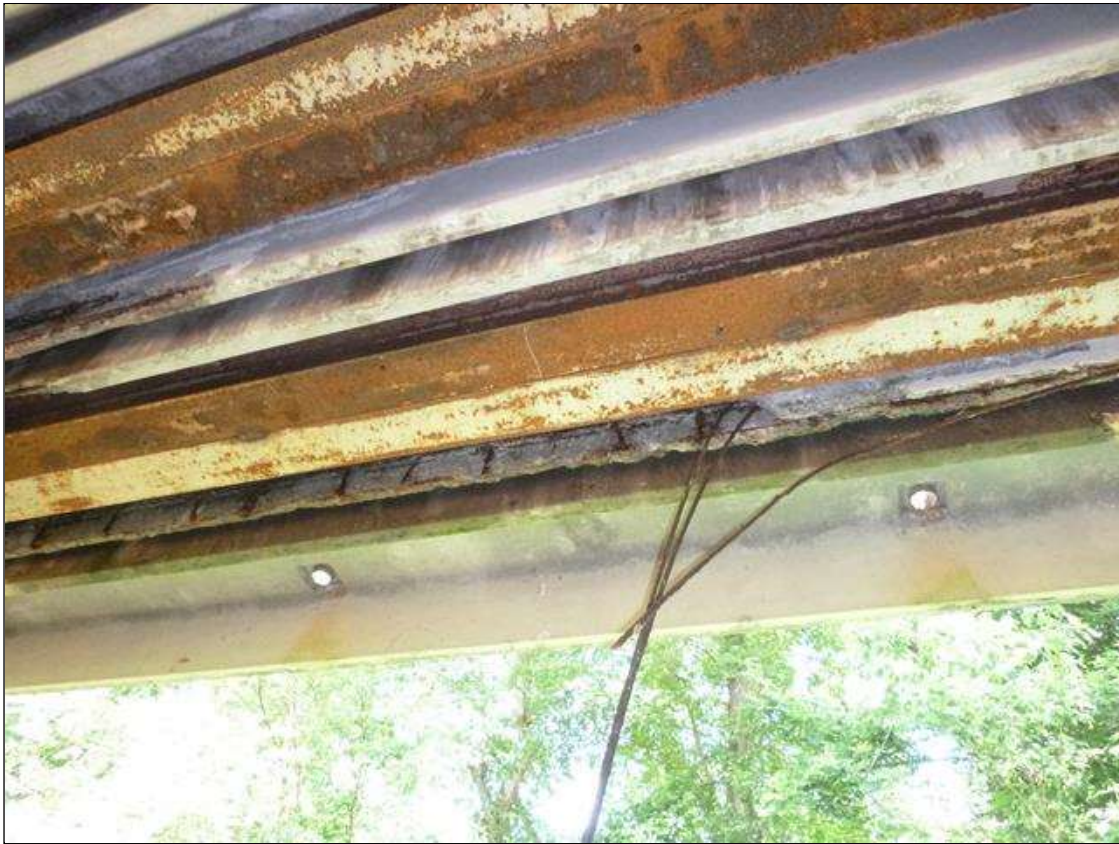
Span 2 Channel/Slab 9: 25 Feet of Exposed Prestressing: The condition warrants a structural review to determine the effect on strength or serviceability of the element or bridge; OR a structural review has been completed and the defects impact strength or serviceability of the element or bridge. Extensive spalling with exposed strands in right leg along nearly the entire length. Left leg shows some cracking and delam for approximately 6'.

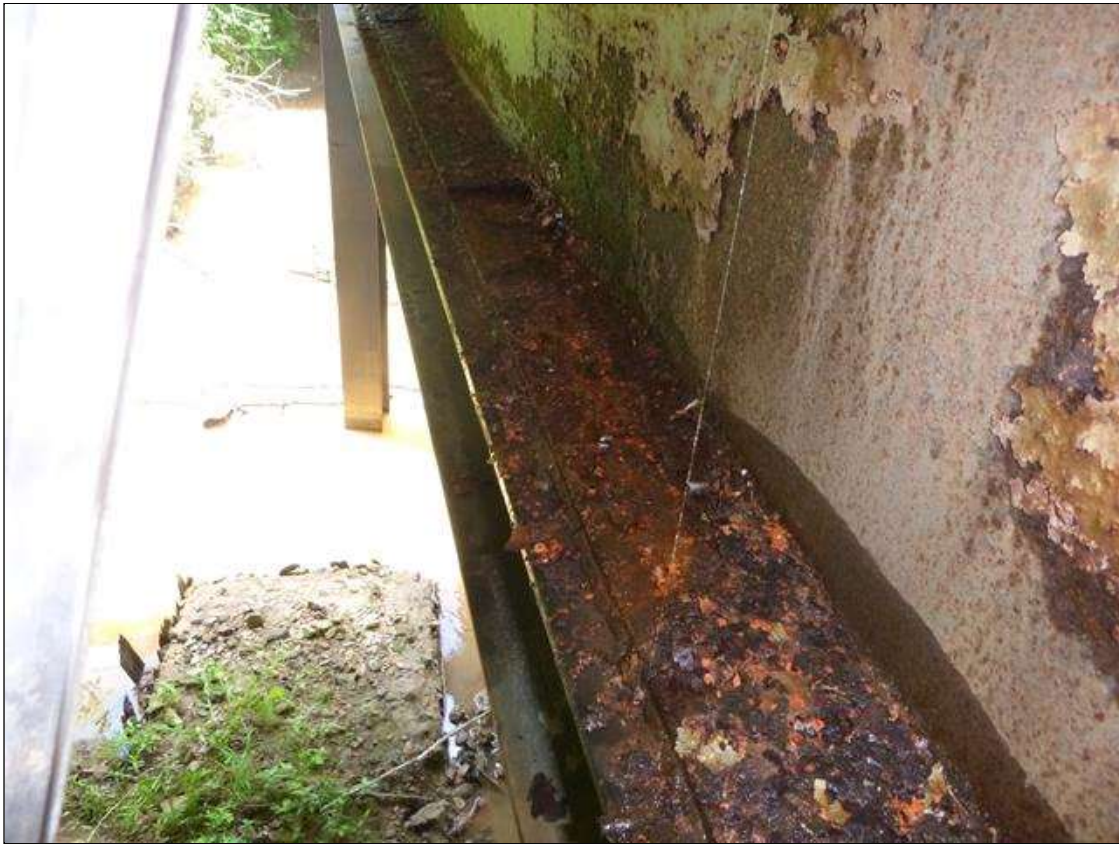
Bent 2 Cap : 11 Feet of Corrosion: 1/16" section loss is evident in the bottom flange under channels 4 to 9. Does not warrant structural review.

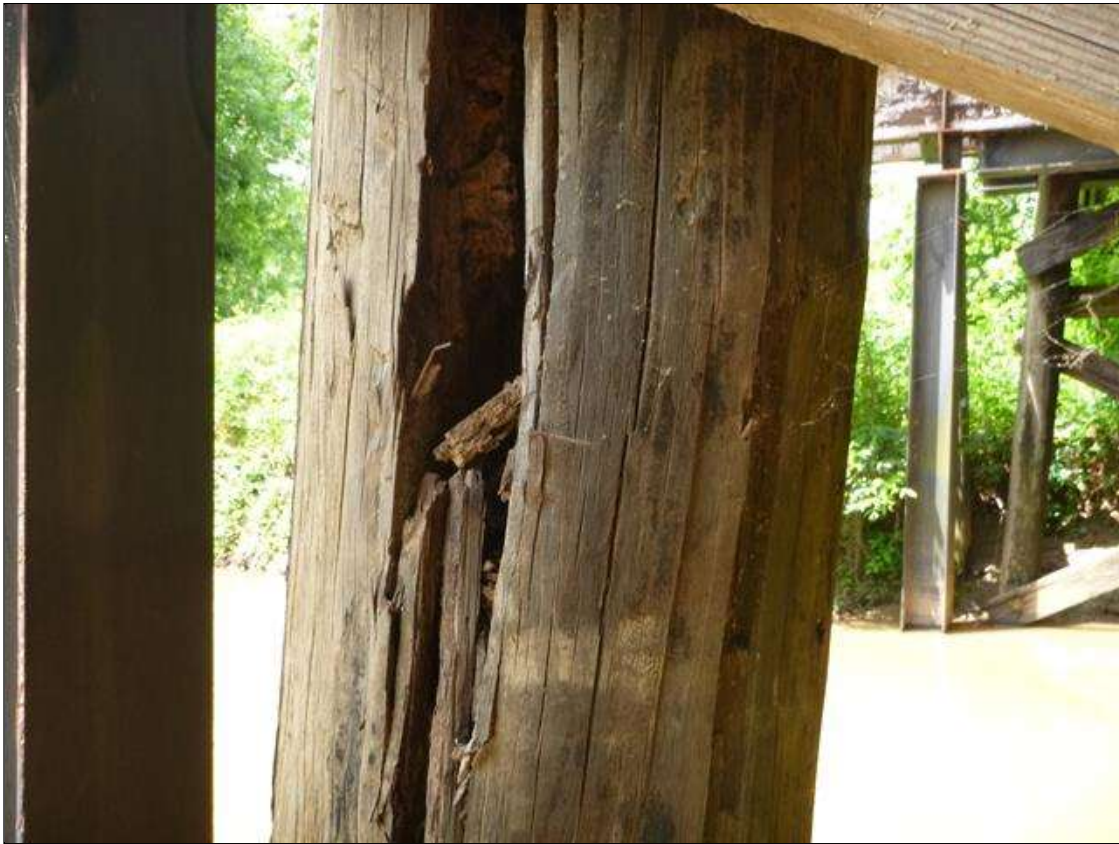
Bent 2 Pile 1: 1 Each of Decay/Section Loss: The condition warrants a structural review to determine the effect on strength or serviceability of the element or bridge; OR a structural review has been completed and the defects impact strength or serviceability of the element or bridge. 85% decay, 7' from streambed.

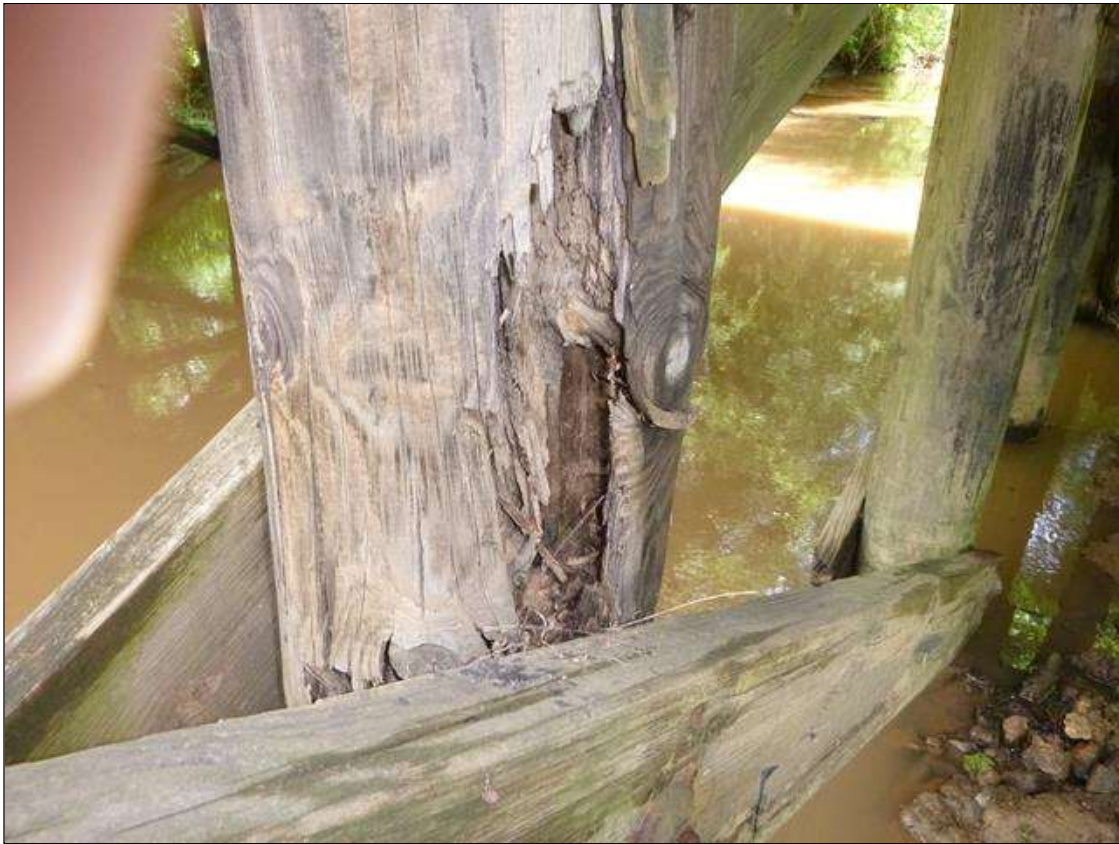
Bent 2 Pile 2: 1 Each of Decay/Section Loss: The condition warrants a structural review to determine the effect on strength or serviceability of the element or bridge; OR a structural review has been completed and the defects impact strength or serviceability of the element or bridge. 85% decay, 5' from streambed.

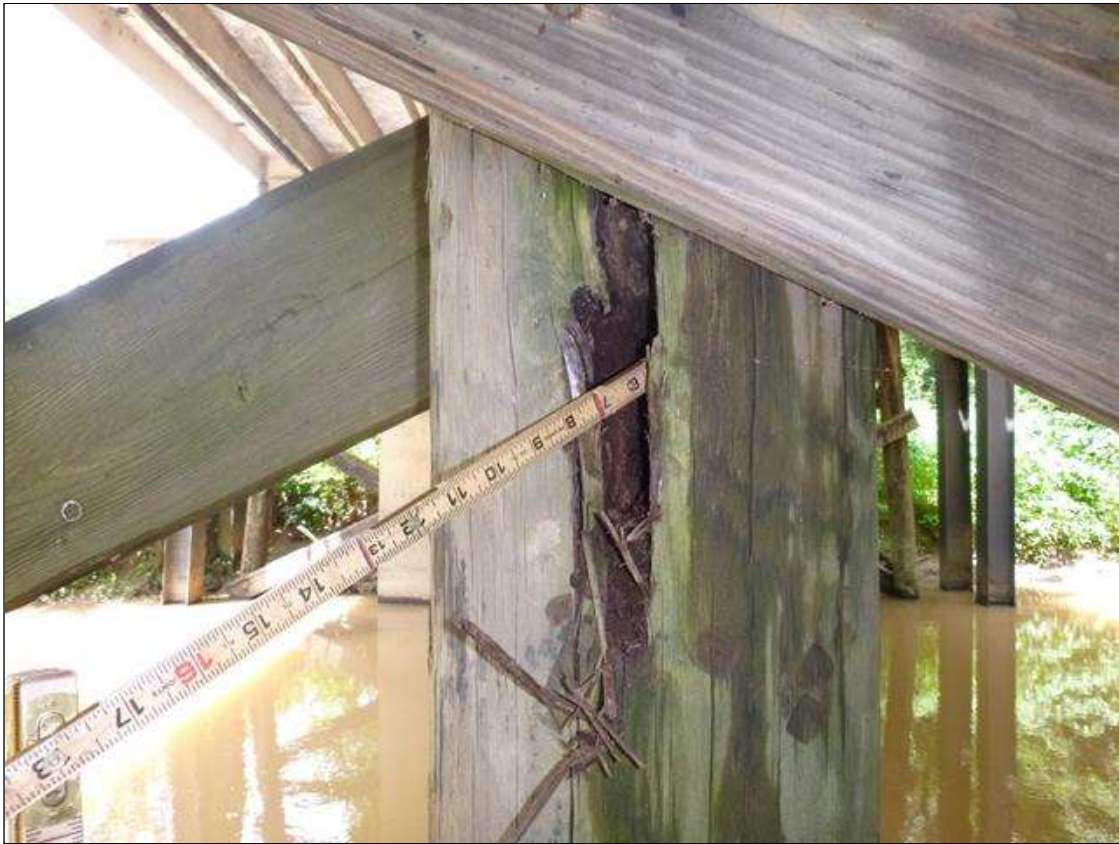
Bent 2 Pile 3: 1 Each of Decay/Section Loss: The condition warrants a structural review to determine the effect on strength or serviceability of the element or bridge; OR a structural review has been completed and the defects impact strength or serviceability of the element or bridge. 75% decay, 6' from streambed.

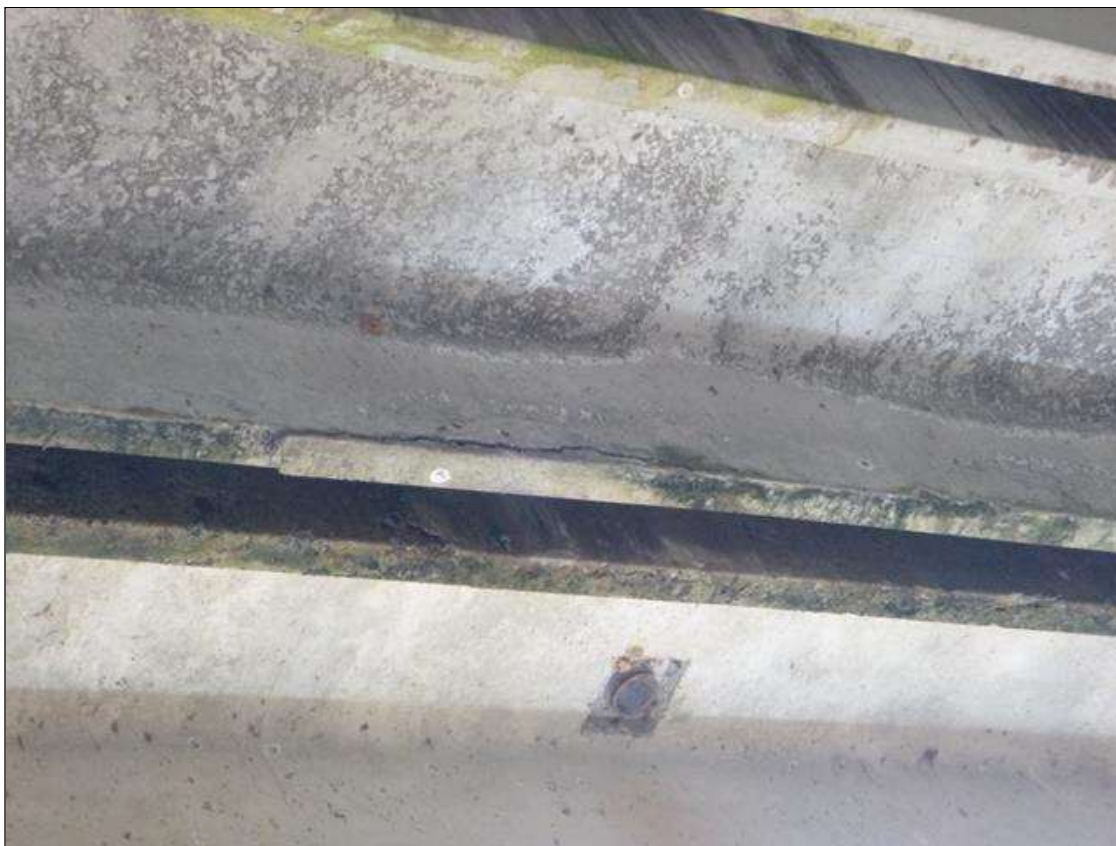
Span 3 Channel/Slab 2: 3 Feet of Delamination/Spall/Patched Area: Spall greater than 1 in. deep or greater than 6 in. diameter. Patched area that is unsound or showing distress. Does not warrant structural review. Delam in bottom of left leg 7' from bent 2.

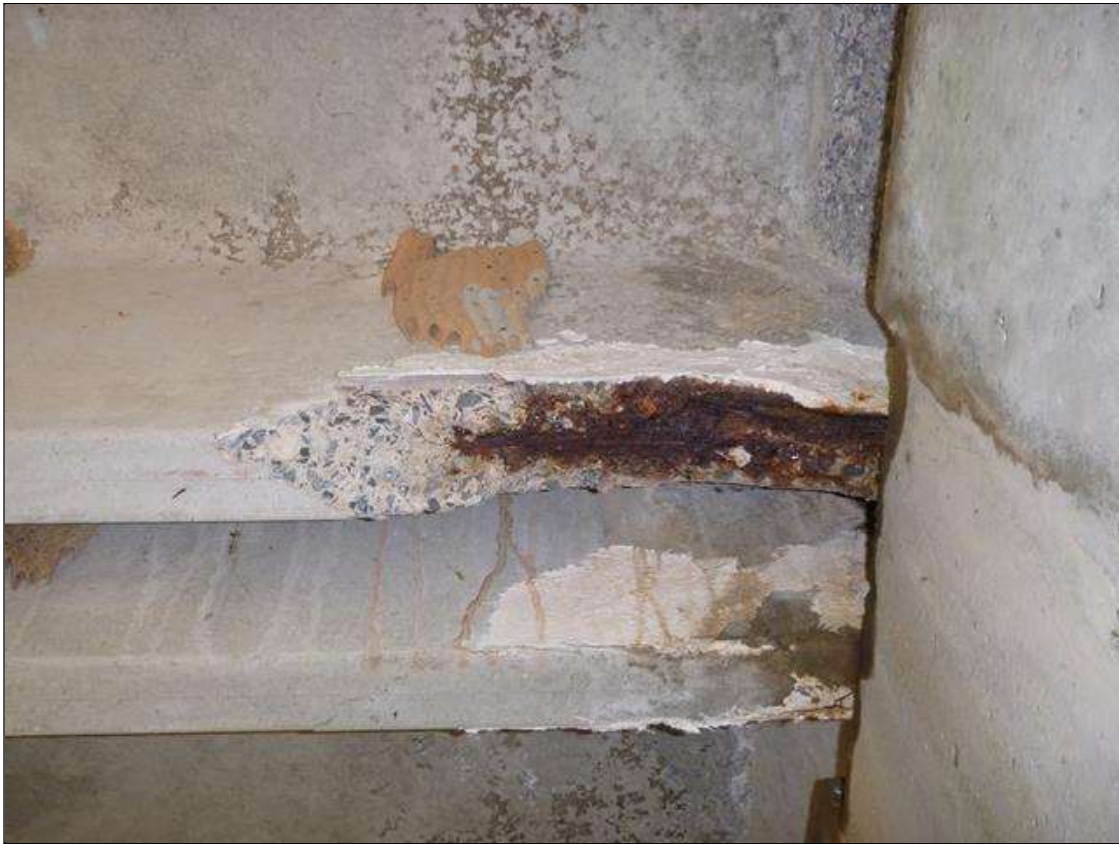
Span 3 Channel/Slab 5: 2 Feet of Exposed Prestressing: The condition warrants a structural review to determine the effect on strength or serviceability of the element or bridge; OR a structural review has been completed and the defects impact strength or serviceability of the element or bridge. 16" spall with exposed and broken strands in right leg at bent 2.

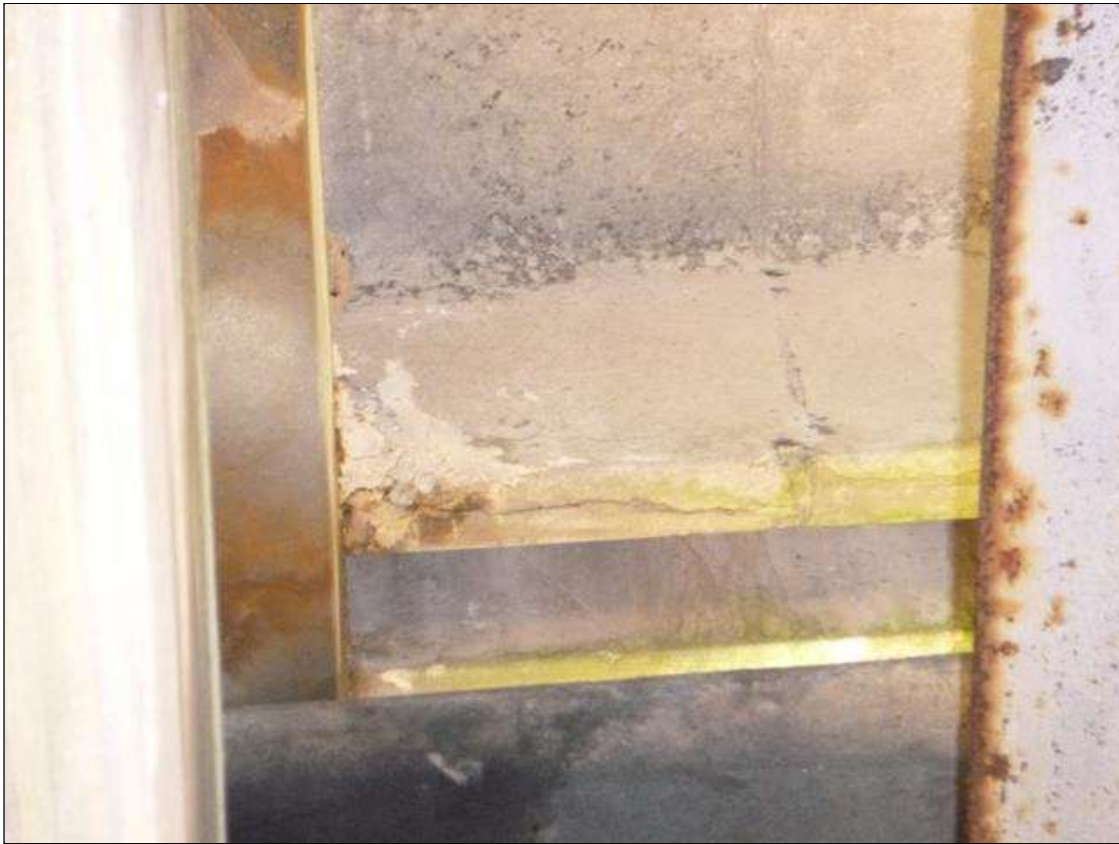
Span 3 Channel/Slab 3: 2 Feet of Cracking (PSC): Width greater than 0.009 in. or spacing less than 1 ft. 18" longitudinal crack with patch area in bottom of left leg at bent 2. Right leg has 8" long crack at well at bent 2.

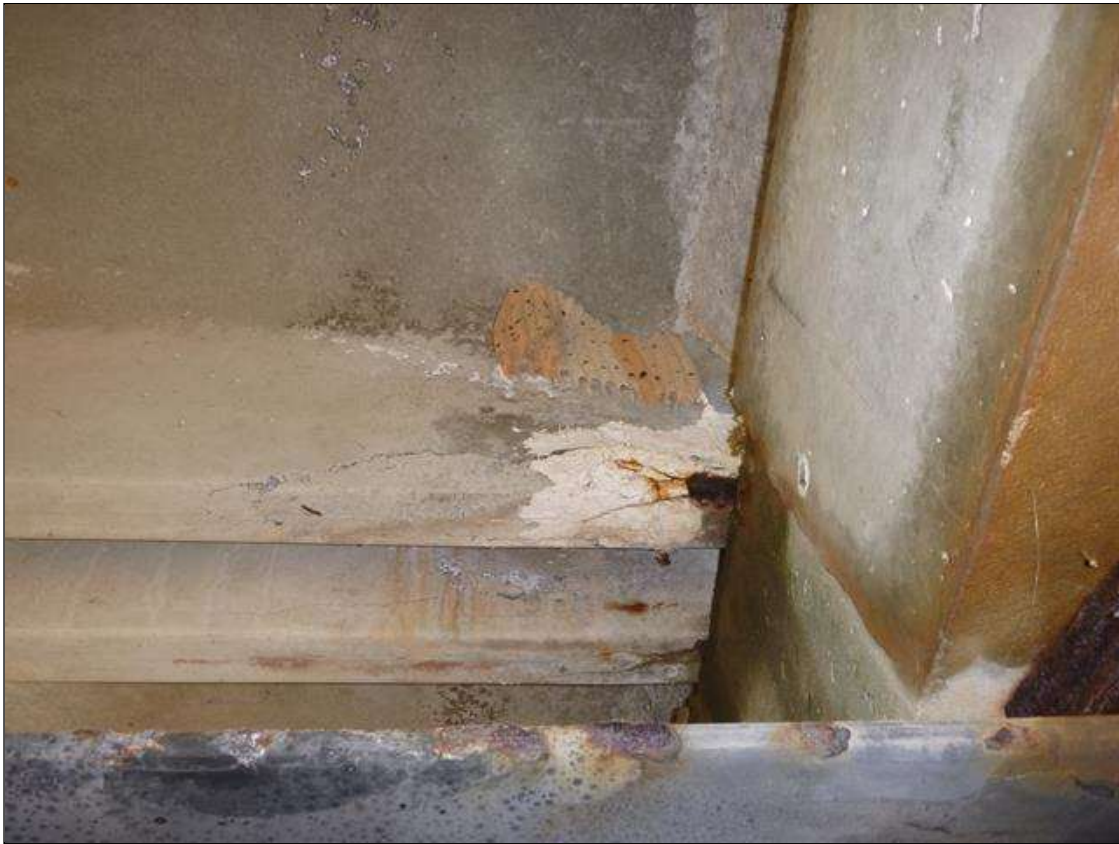
Span 3 Channel/Slab 4: 1 Feet of Delamination/Spall/Patched Area: Spall greater than 1 in. deep or greater than 6 in. diameter. Patched area that is unsound or showing distress. Does not warrant structural review. 16" delam in bottom of right leg at bent 2.

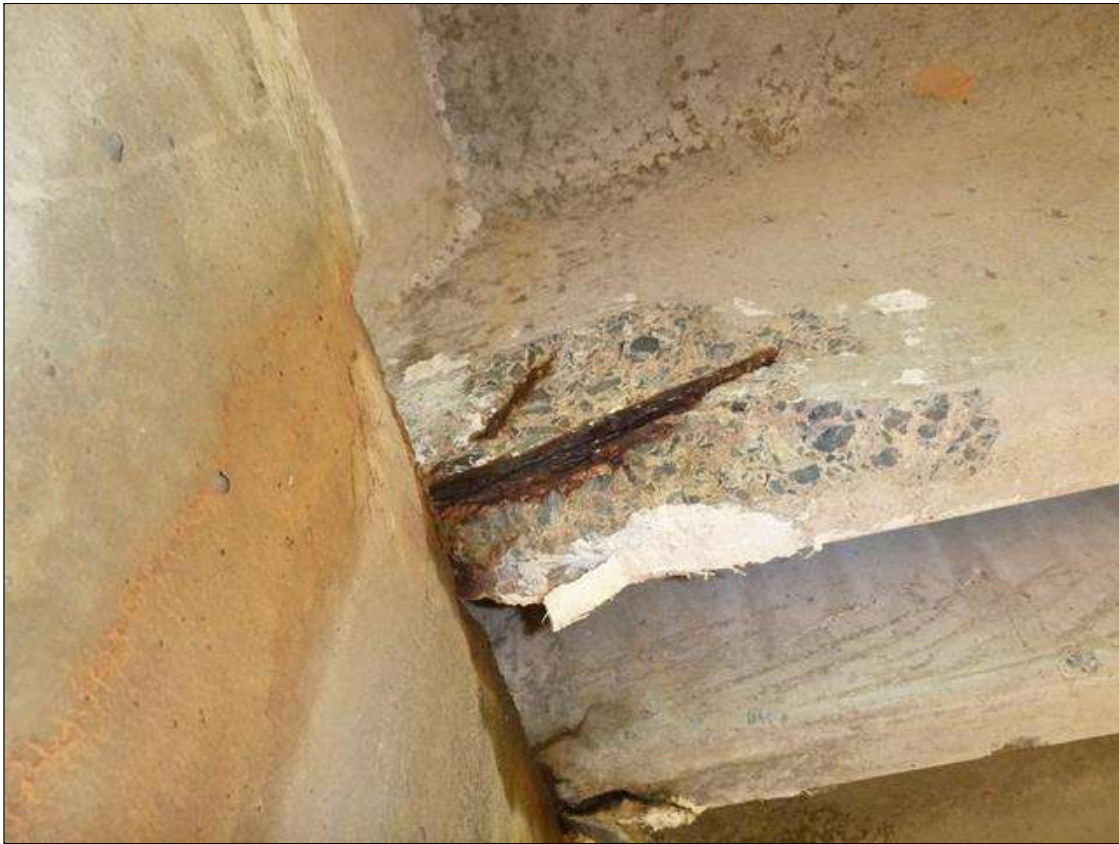
Span 3 Channel/Slab 8: 1 Feet of Delamination/Spall/Patched Area: Spall greater than 1 in. deep or greater than 6 in. diameter. Patched area that is unsound or showing distress. Does not warrant structural review. 5" x 8" x 1/2" spall with exposed rebar in left leg at bent 2.

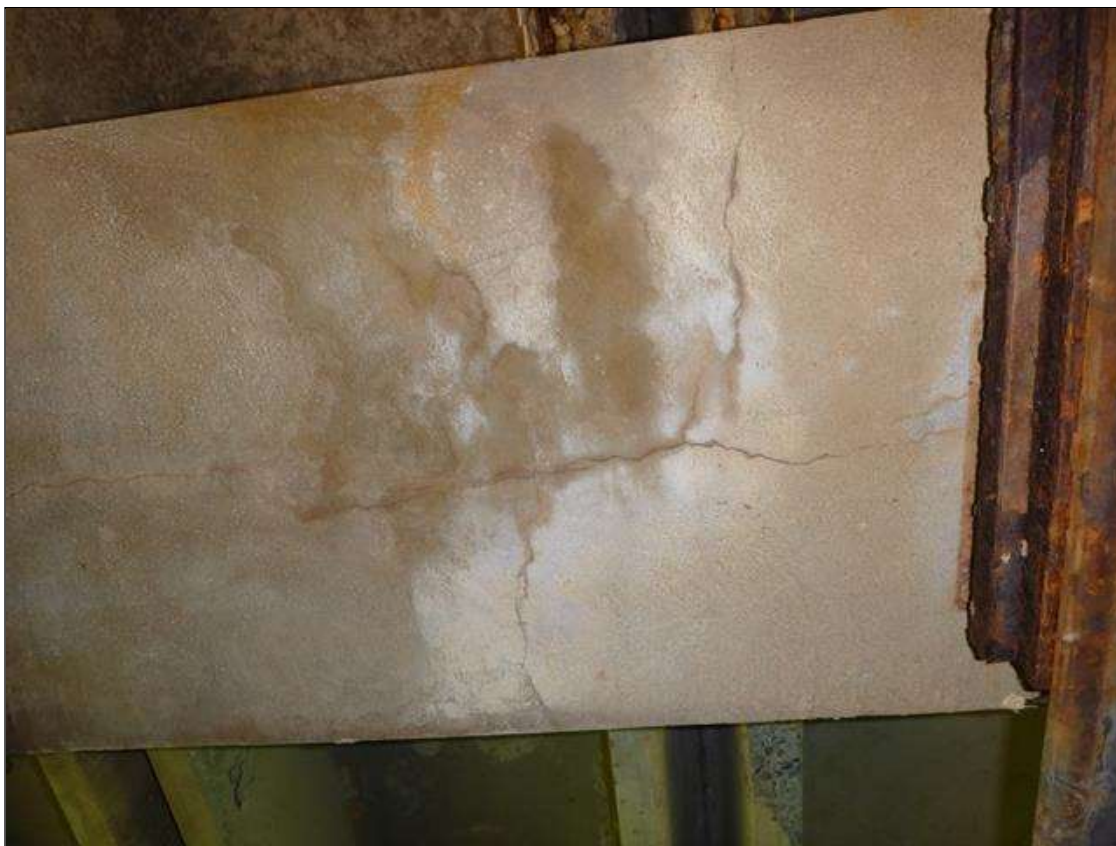
Bent 3 Cap : 4 Feet of Cracking (PSC): Width greater than 0.009 in. or spacing less than 1 ft. Longitudinal crack in bottom of cap between piles 3 and 4.

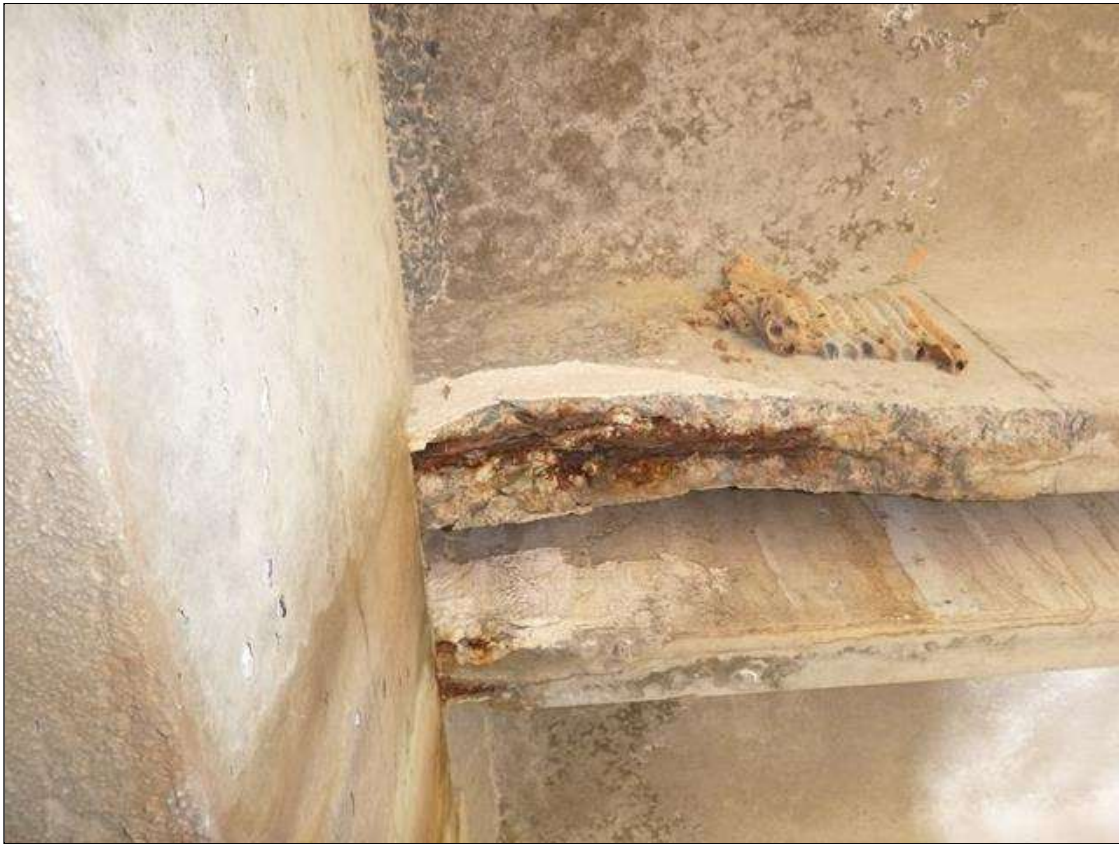
Span 3 Channel/Slab 6: 2 Feet of Exposed Prestressing: The condition warrants a structural review to determine the effect on strength or serviceability of the element or bridge; OR a structural review has been completed and the defects impact strength or serviceability of the element or bridge. 18" spall with exposed prestressing in bottom of right leg at bent 3.

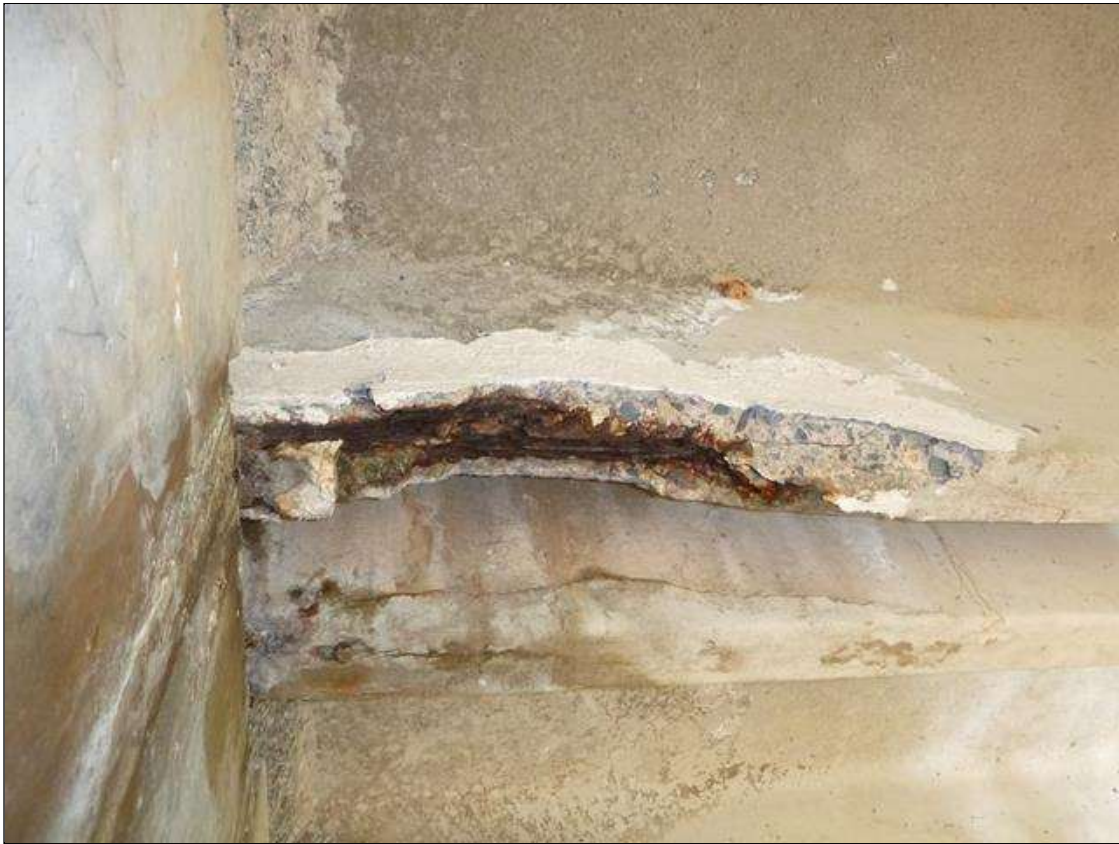
Span 3 Channel/Slab 4: 2 Feet of Exposed Prestressing: The condition warrants a structural review to determine the effect on strength or serviceability of the element or bridge; OR a structural review has been completed and the defects impact strength or serviceability of the element or bridge. 18" long spall with exposed strands in right leg at bent 3.

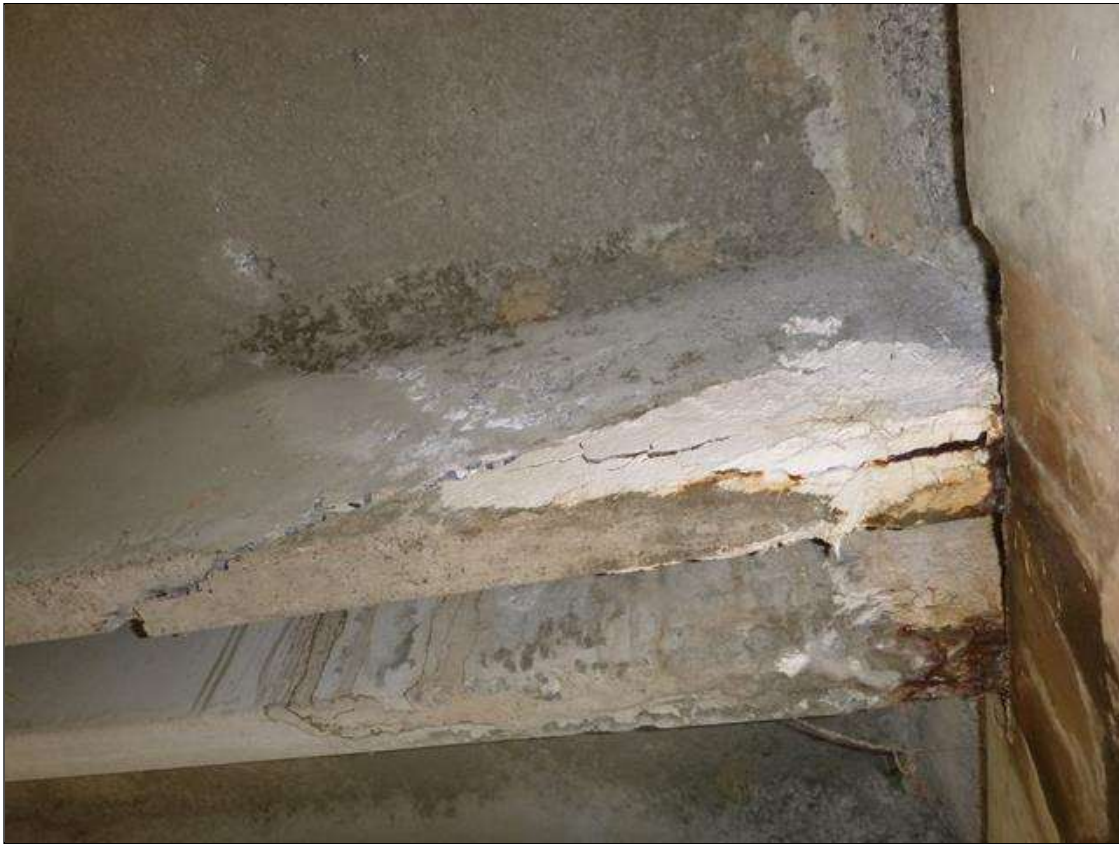
Span 3 Channel/Slab 4: 2 Feet of Delamination/Spall/Patched Area: Spall greater than 1 in. deep or greater than 6 in. diameter. Patched area that is unsound or showing distress. Does not warrant structural review. 24" Delam in left leg at bent 3.

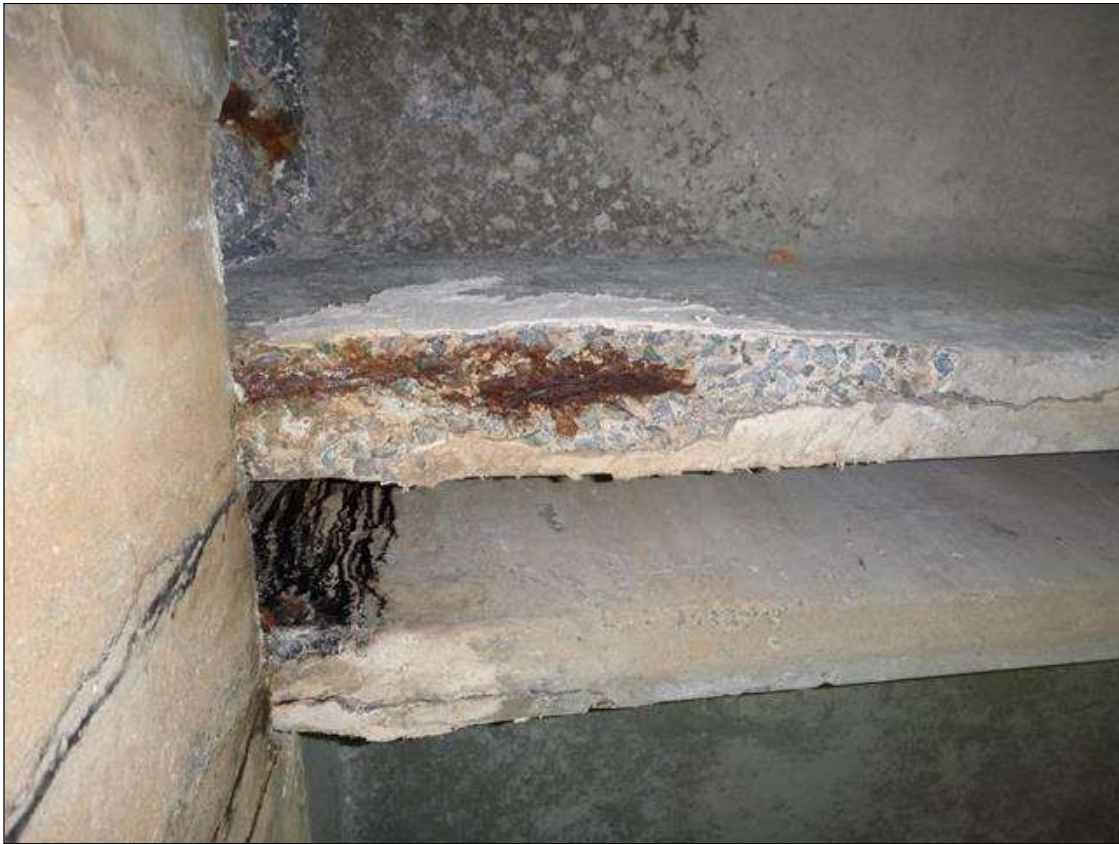
Span 4 Channel/Slab 5: 2 Feet of Exposed Prestressing: The condition warrants a structural review to determine the effect on strength or serviceability of the element or bridge; OR a structural review has been completed and the defects impact strength or serviceability of the element or bridge. 16" spall with exposed strands and 6" crack extending into span in bottom of left leg at bent 3.

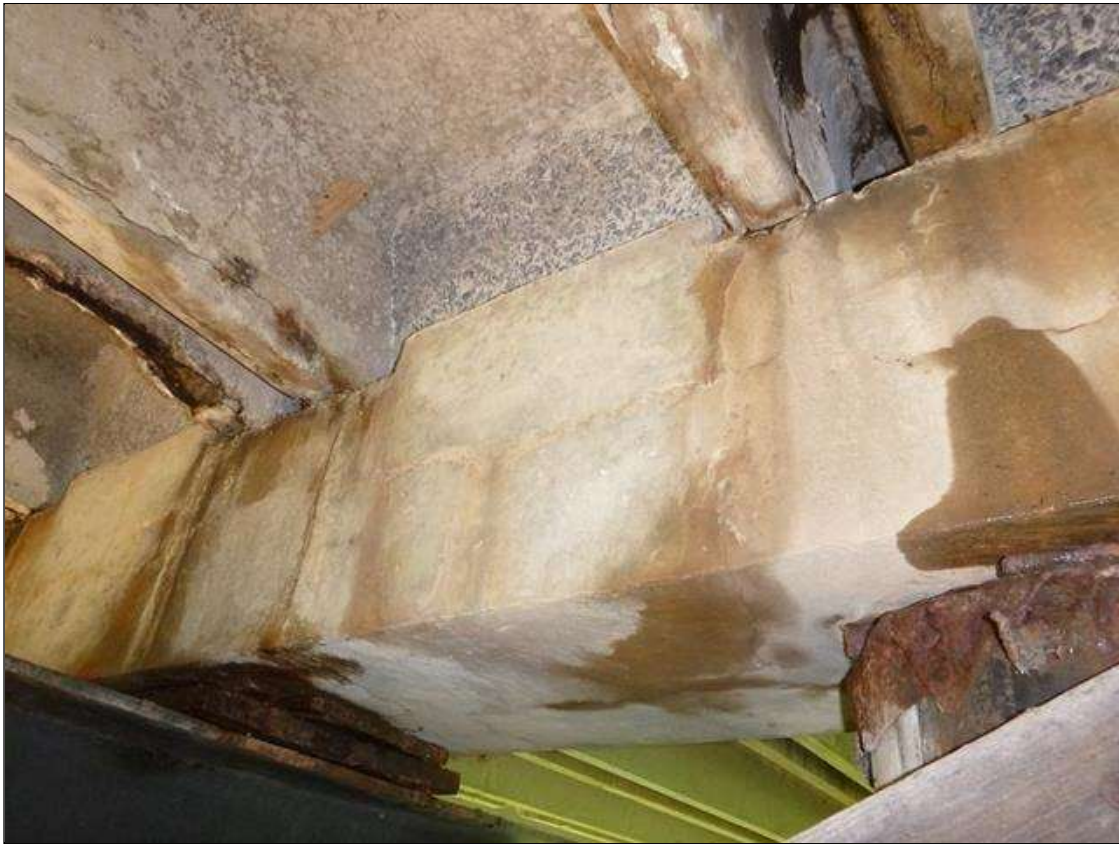
Bent 3 Cap : 16 Feet of Cracking (PSC): Width 0.004-0.009 in. or spacing 1.0-3.0 ft. Horizontal crack starting under channel 3 and extends to channel 9, 7" from bottom of cap on SOUTH face.

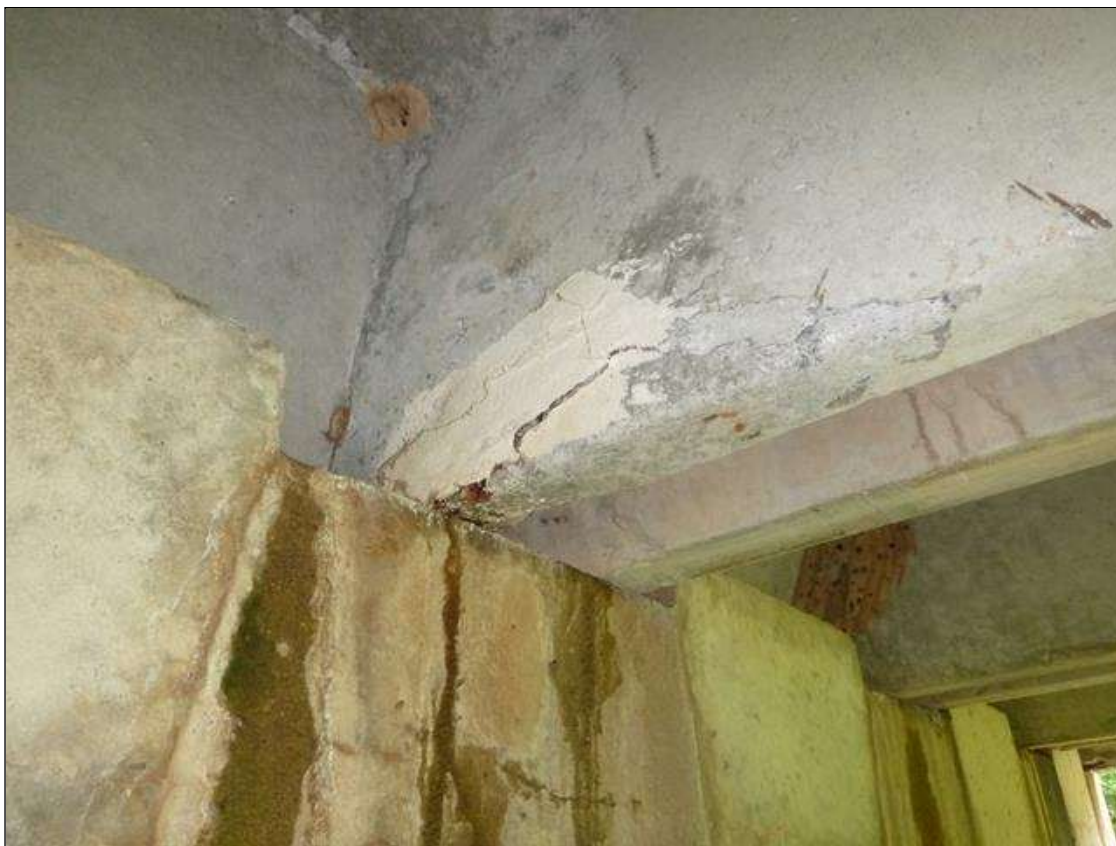
Span 4 Channel/Slab 4: 1 Feet of Delamination/Spall/Patched Area: Spall greater than 1 in. deep or greater than 6 in. diameter. Patched area that is unsound or showing distress. Does not warrant structural review. Delam in bottom of left left at bent 3.

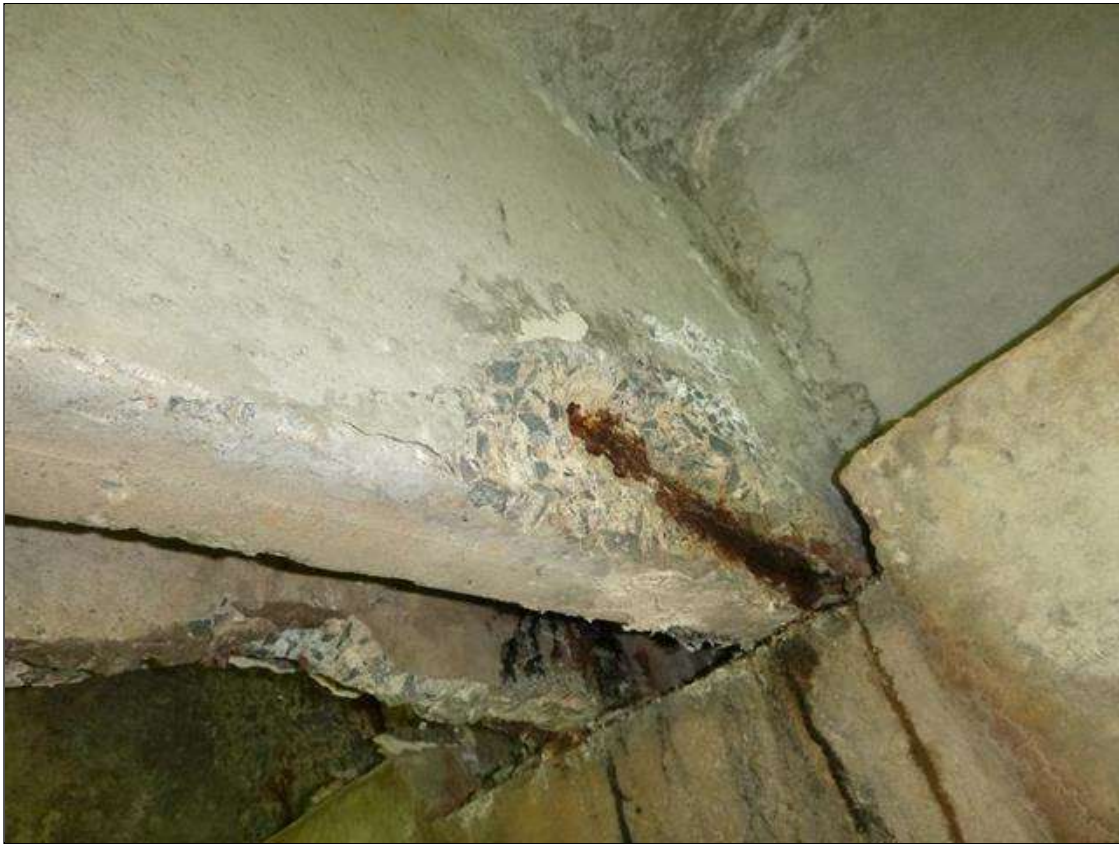
Span 4 Channel/Slab 4: 1 Feet of Delamination/Spall/Patched Area: Spall greater than 1 in. deep or greater than 6 in. diameter. Patched area that is unsound or showing distress. Does not warrant structural review. 8" x 3" x 1/4" deep with exposed rebar in bottom of right leg at bent 3.

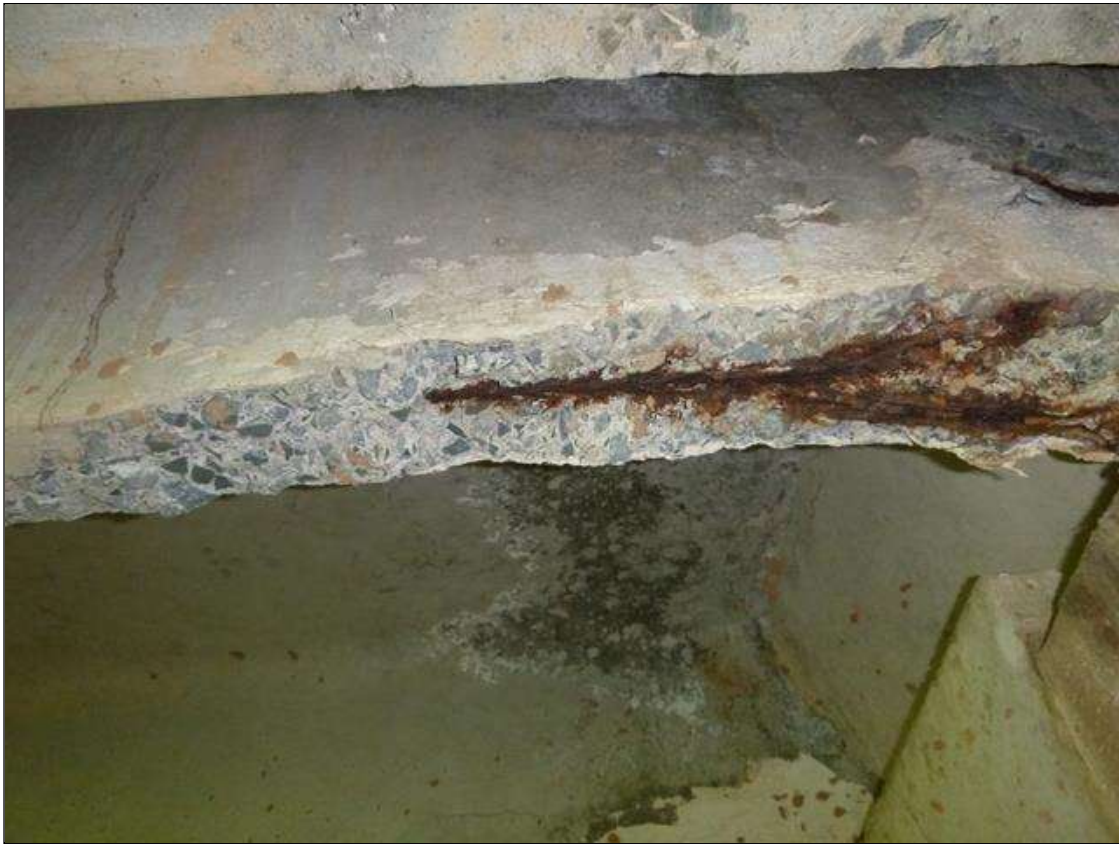
Span 4 Channel/Slab 7: 2 Feet of Exposed Prestressing: The condition warrants a structural review to determine the effect on strength or serviceability of the element or bridge; OR a structural review has been completed and the defects impact strength or serviceability of the element or bridge. 20" spall with exposed strands in bottom of left leg at bent 3.
