NC DEPARTMENT OF TRANSPORTATION  
DIVISION OF HIGHWAYS  
STRUCTURE MANAGEMENT UNIT

## Structure Safety Report

### Routine Element Inspection - Contract

COUNTY: YADKIN STRUCTURE NUMBER: 980010 FREQUENCY: 24 MONTHS

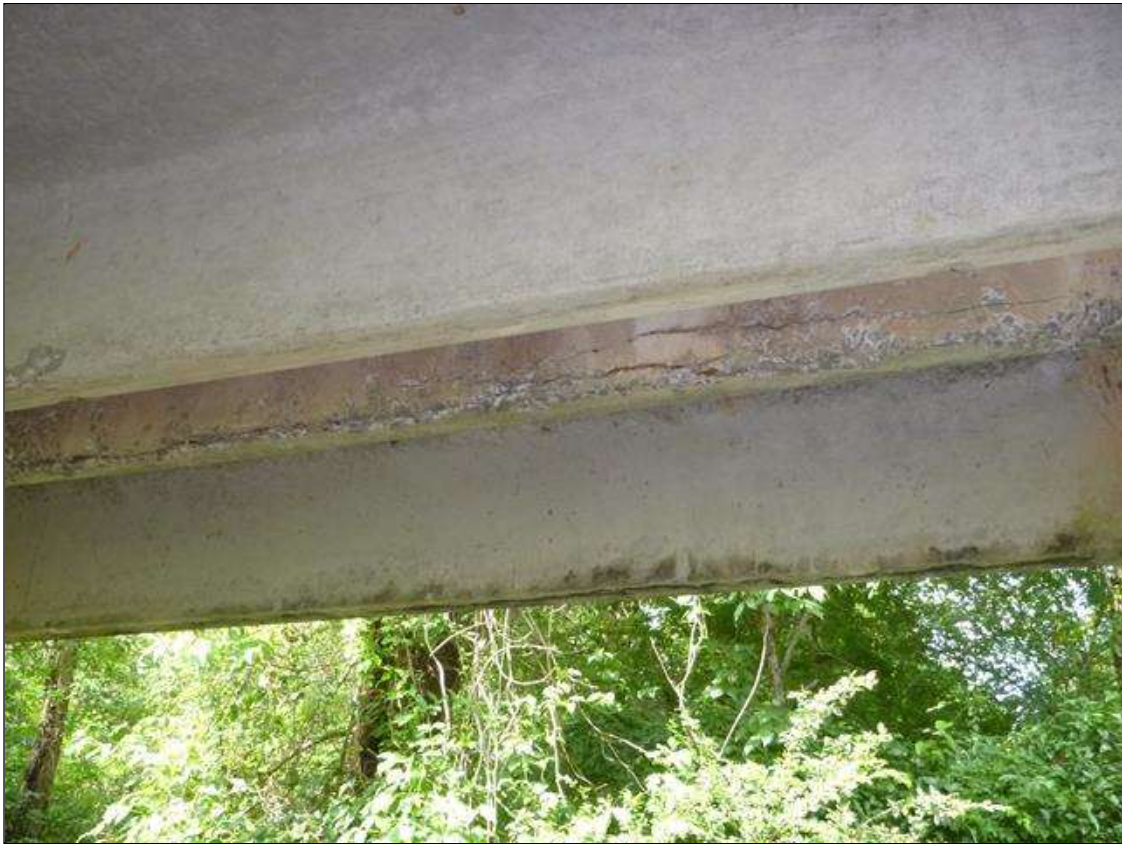
Span 4 Channel/Slab 10: 7 Feet of Cracking (PSC): Width greater than 0.009 in. or spacing less than 1 ft. Longitudinal crack with delam in bottom of left leg 3' from bent 3.

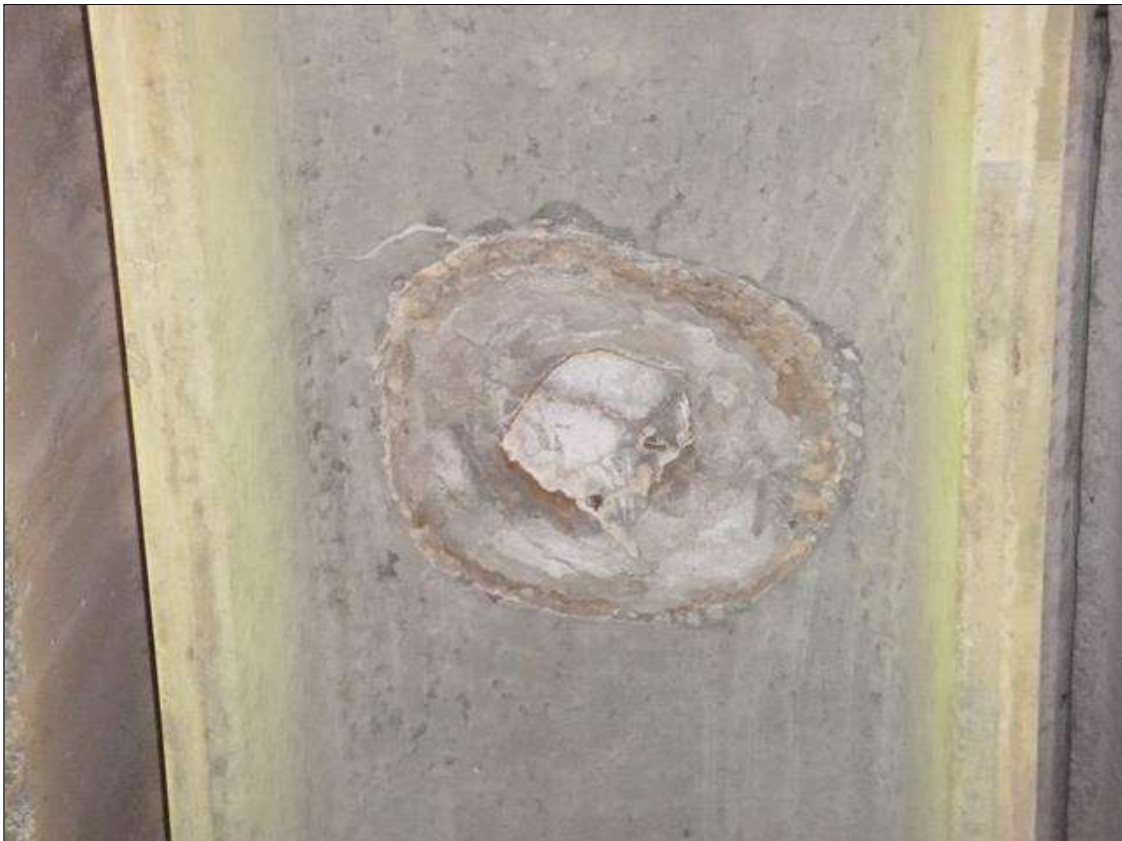
Span 4 Channel/Slab 9: 2 Square Feet of Delamination/Spall/Patched Area: Delaminated. Spall 1 in. or less deep or 6 in. or less in diameter. Patched area that is sound. 15" diameter patch 3' from bent 3.

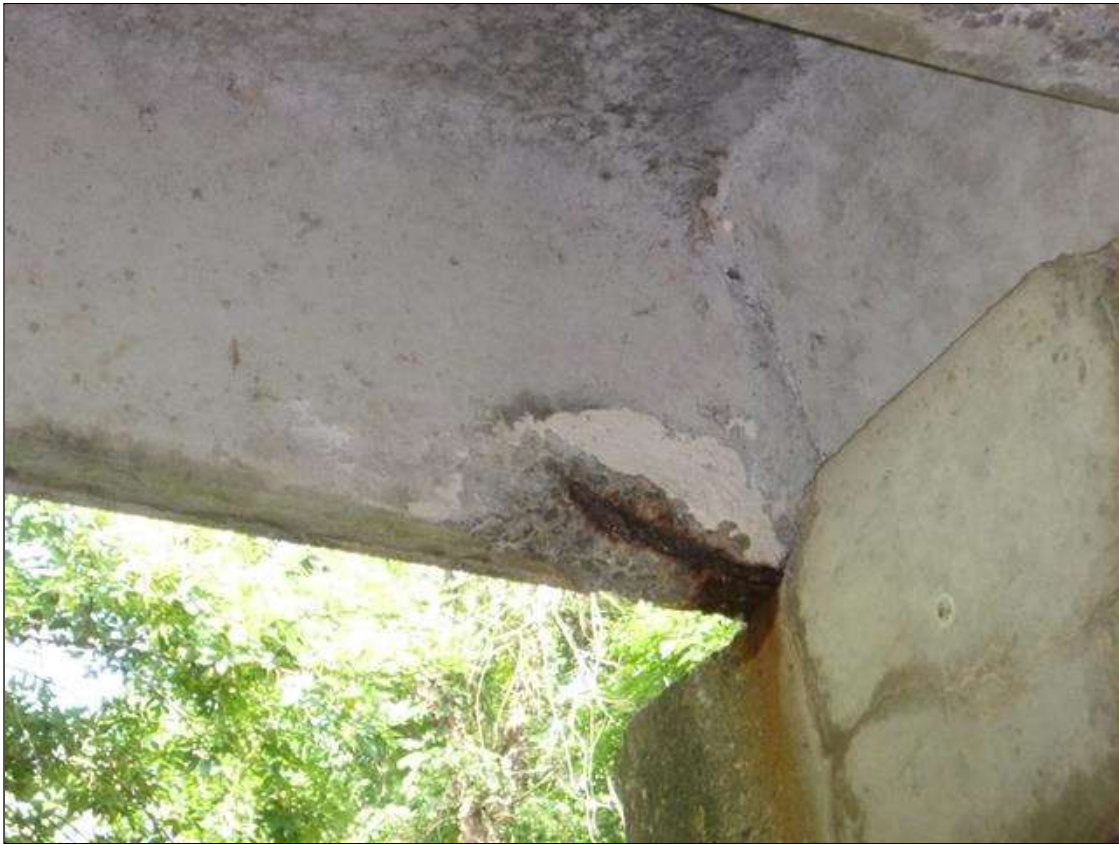
Span 4 Channel/Slab 10: 1 Feet of Delamination/Spall/Patched Area: Spall greater than 1 in. deep or greater than 6 in. diameter. Patched area that is unsound or showing distress. Does not warrant structural review. 8" x 4"  $\frac{3}{4}$ " deep spall with exposed rebar in bottom of right leg at bent 3.

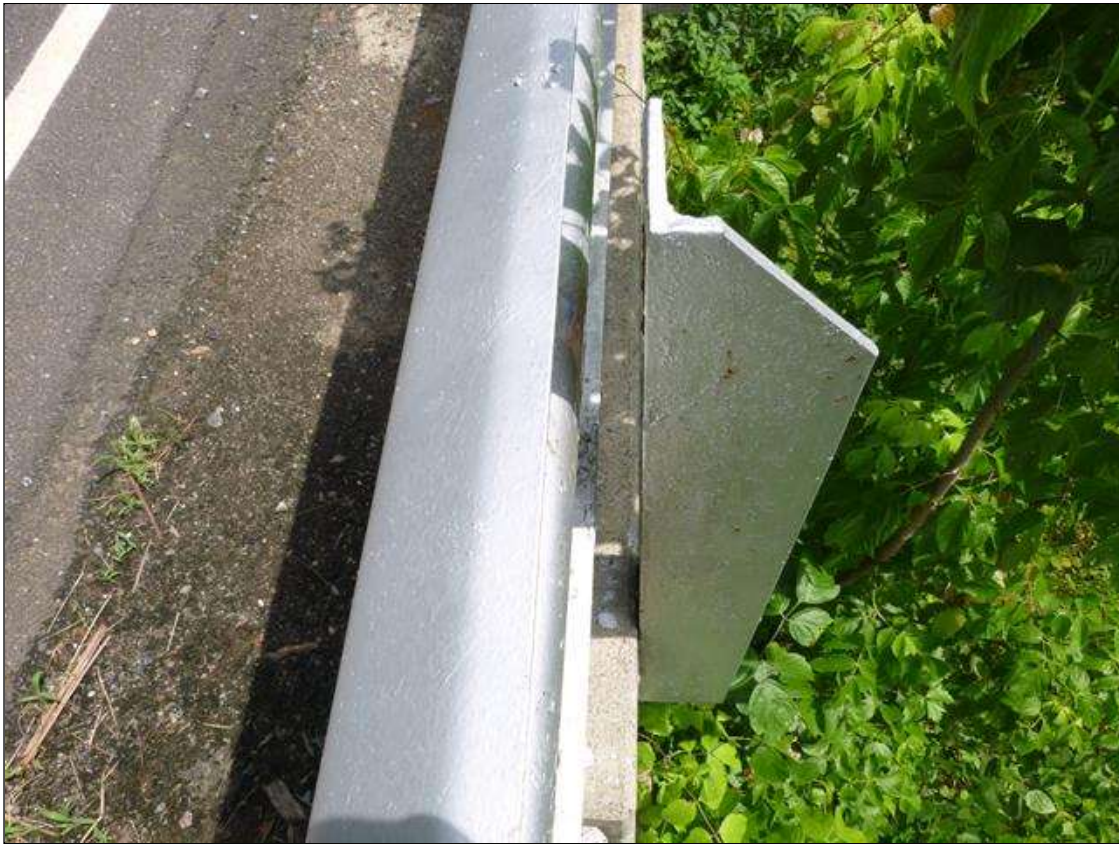
Span 4 Left Bridge Rail: 1 Feet of Connection: Missing bolts, rivets, or fasteners; broken welds; or pack rust with distortion but does not warrant a structural review.  
Missing rail bolt at bent 4

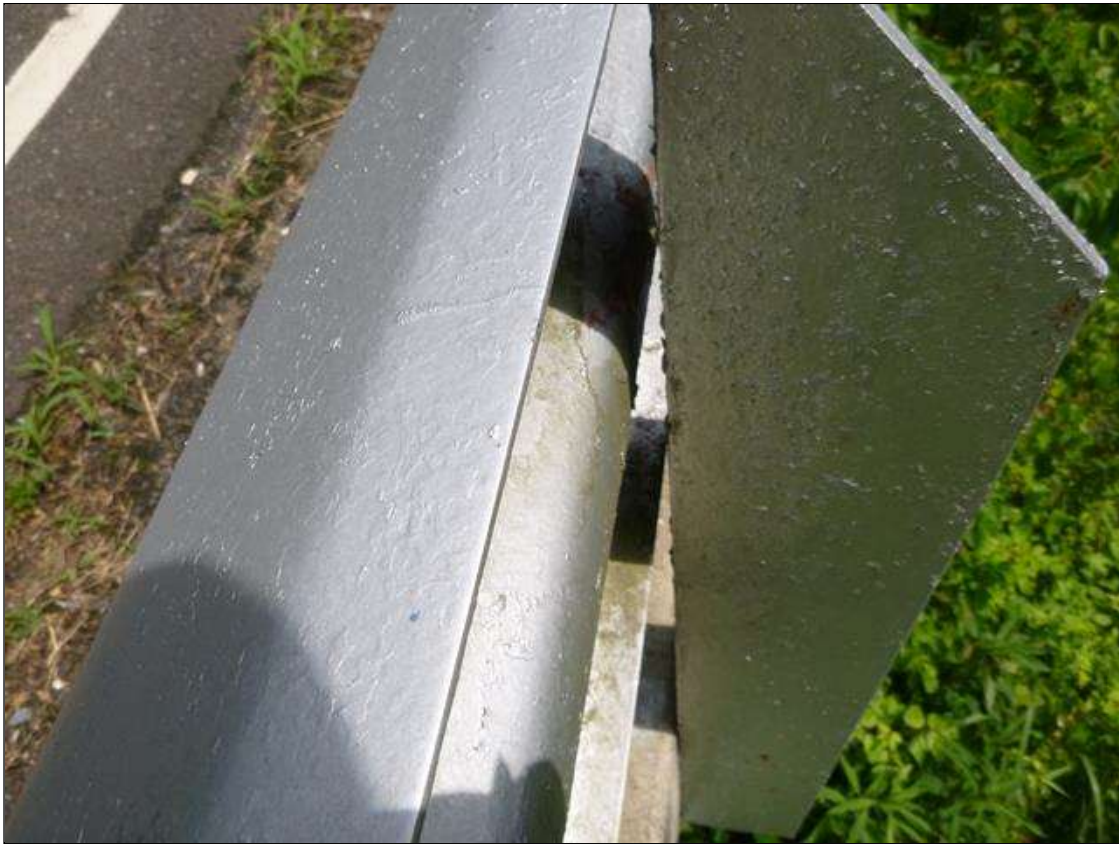
Span 5 Left Bridge Rail: 1 Feet of Connection: Missing bolts, rivets, or fasteners; broken welds; or pack rust with distortion but does not warrant a structural review.  
Missing rail bolt 7 ft. from bent 4

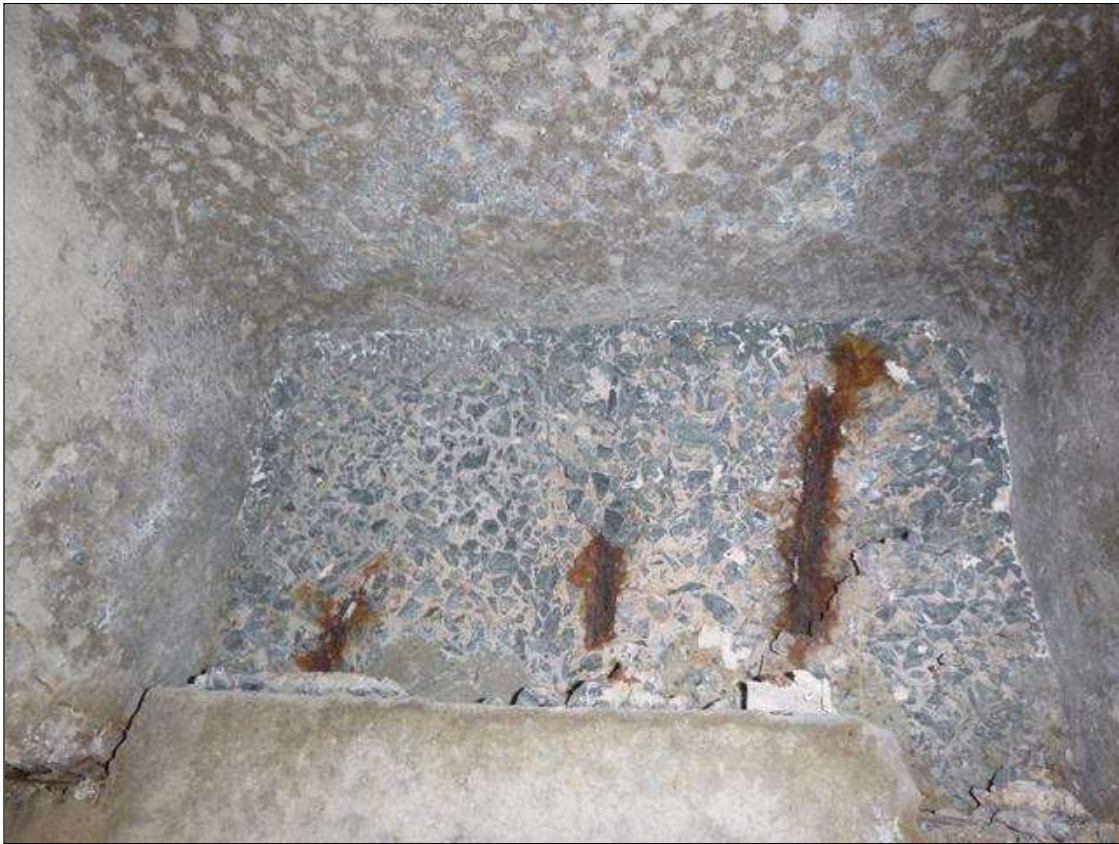
SPALLS WITH EXPOSED REBAR ON CHANNEL 5 BENT 3 DIAPHRAGM SPAN 4

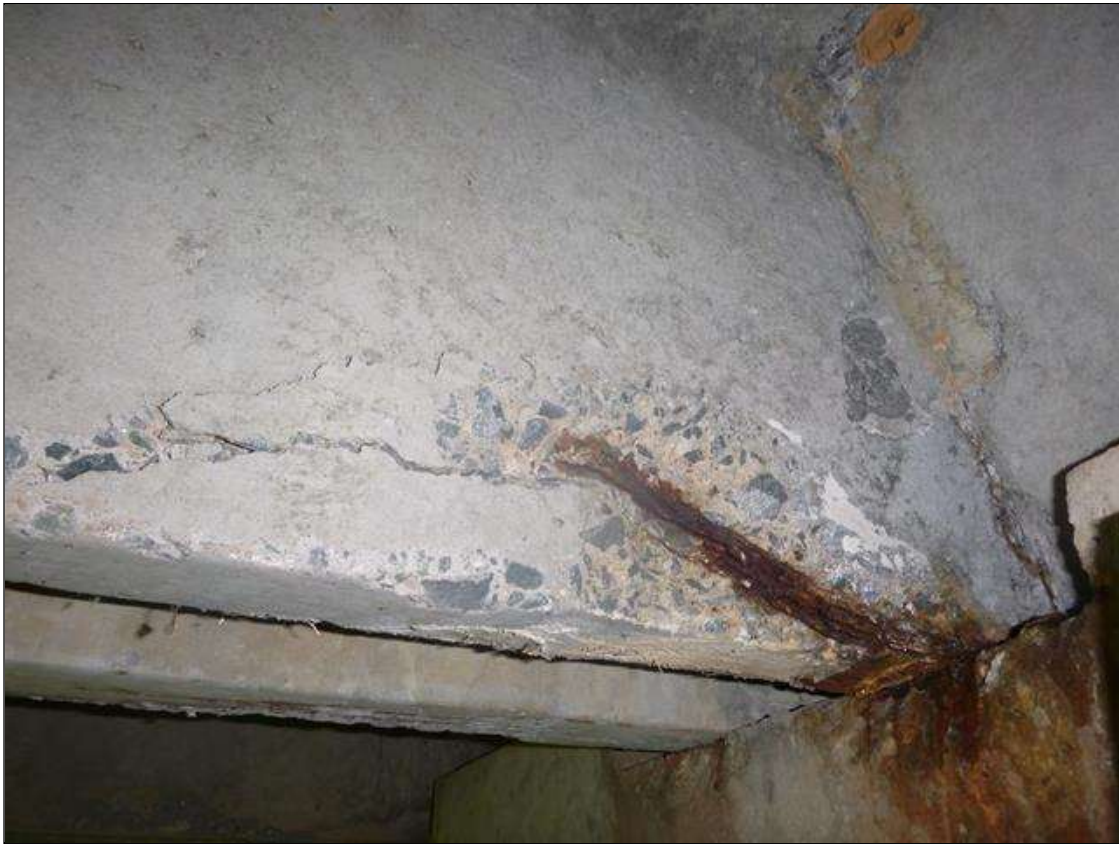
Span 4 Channel/Slab 4: 2 Feet of Delamination/Spall/Patched Area: Spall greater than 1 in. deep or greater than 6 in. diameter. Patched area that is unsound or showing distress. Does not warrant structural review. 9" x 3" x 1/2" deep spall with delamination and 14" long crack in bottom of left leg at bent 4.

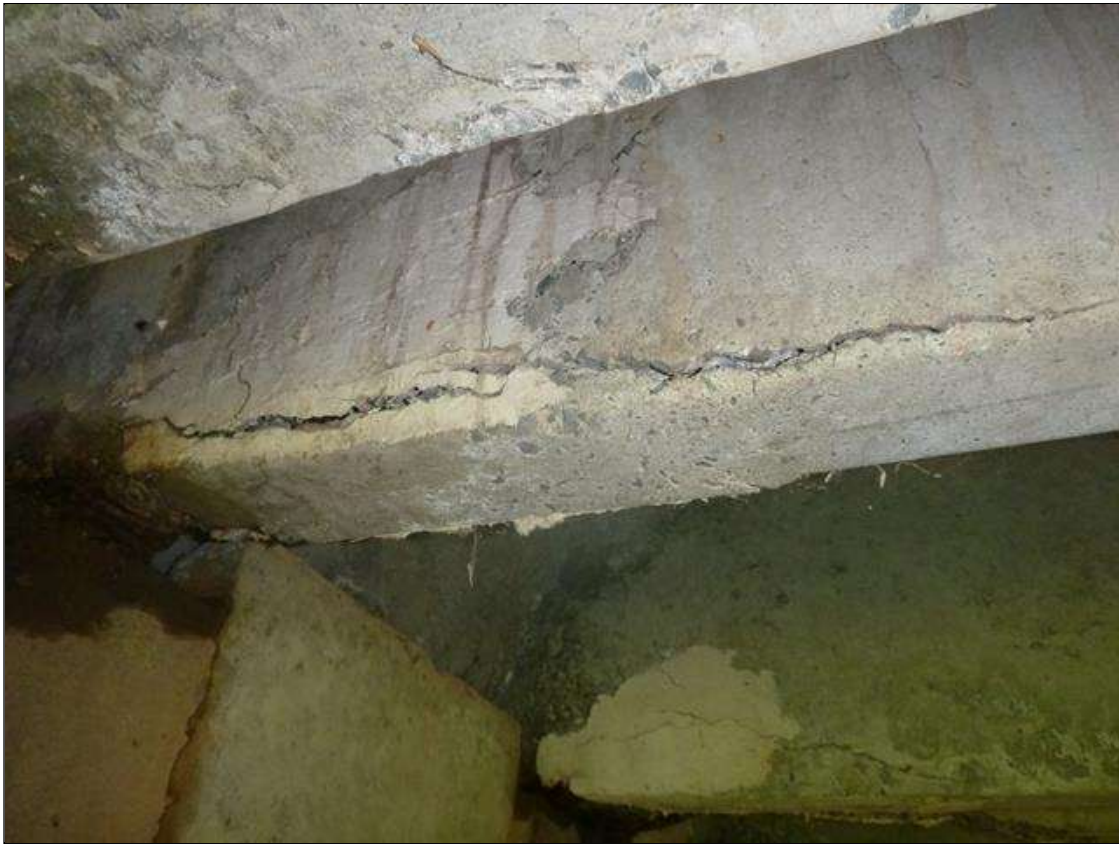
Span 4 Channel/Slab 5: 2 Feet of Delamination/Spall/Patched Area: Spall greater than 1 in. deep or greater than 6 in. diameter. Patched area that is unsound or showing distress. Does not warrant structural review. 18" delam along bottom of both legs at bent 4.

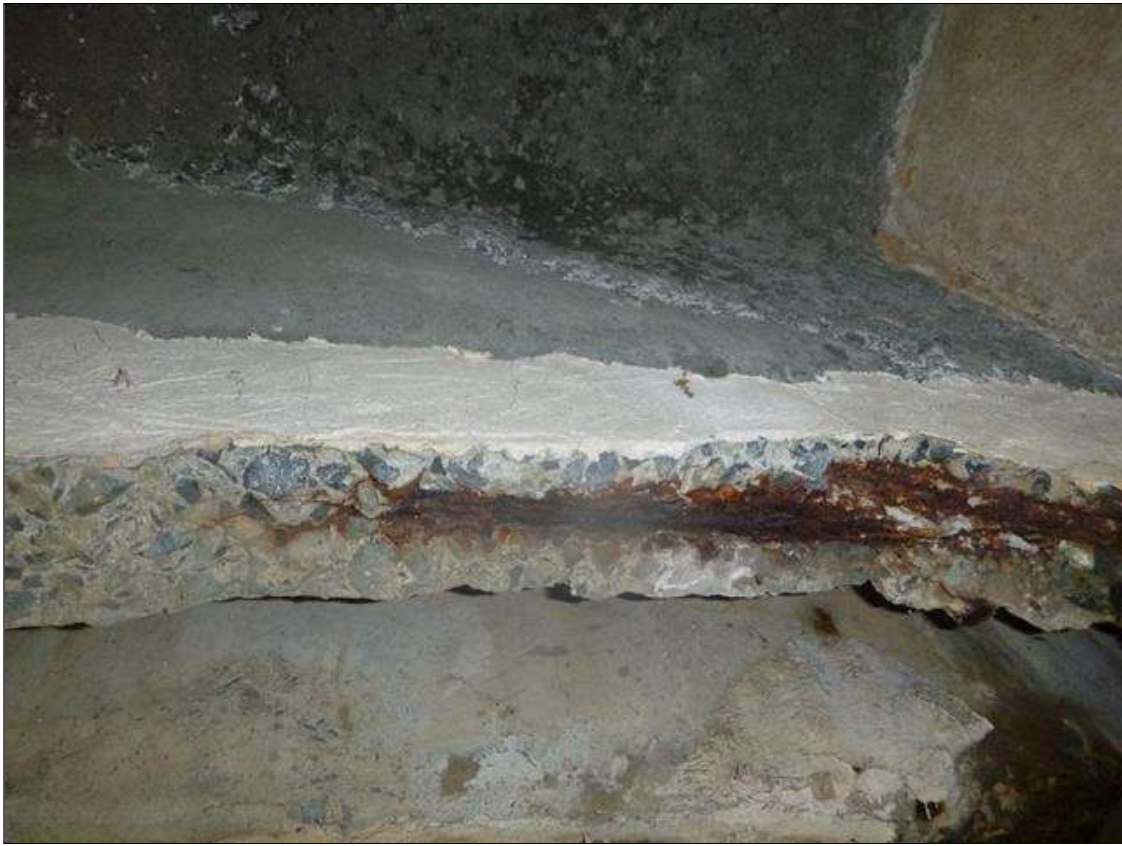
Span 4 Channel/Slab 6: 2 Feet of Exposed Prestressing: The condition warrants a structural review to determine the effect on strength or serviceability of the element or bridge; OR a structural review has been completed and the defects impact strength or serviceability of the element or bridge. 20" long spall with exposed cable on bottom of left leg at bent 4. Right leg also shows 20" of delam at bent 4.

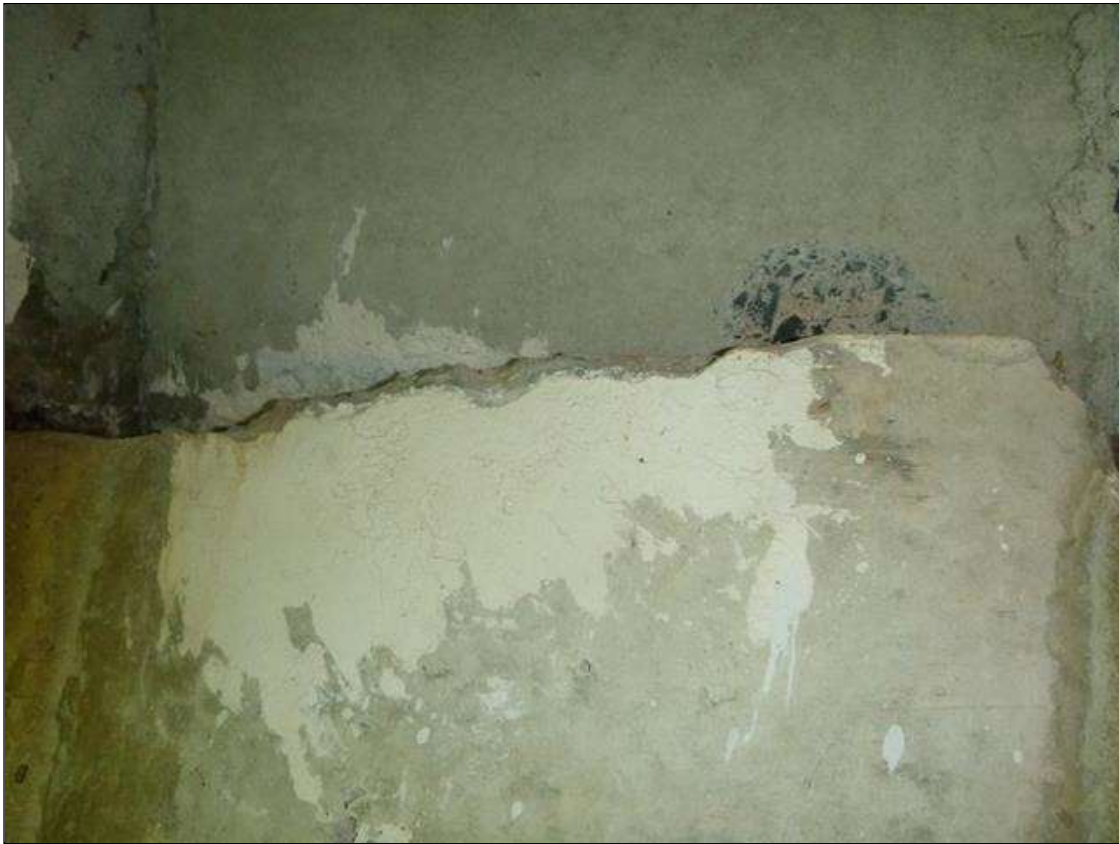
Bent 4 Cap : 1 Feet of Delamination/Spall/Patched Area: Spall greater than 1 in. deep or greater than 6 in. diameter. Patched area that is unsound or showing distress. Does not warrant structural review. 10" x 2.5" x 1.5" deep spall in top of cap under channel 1 on SOUTH face.

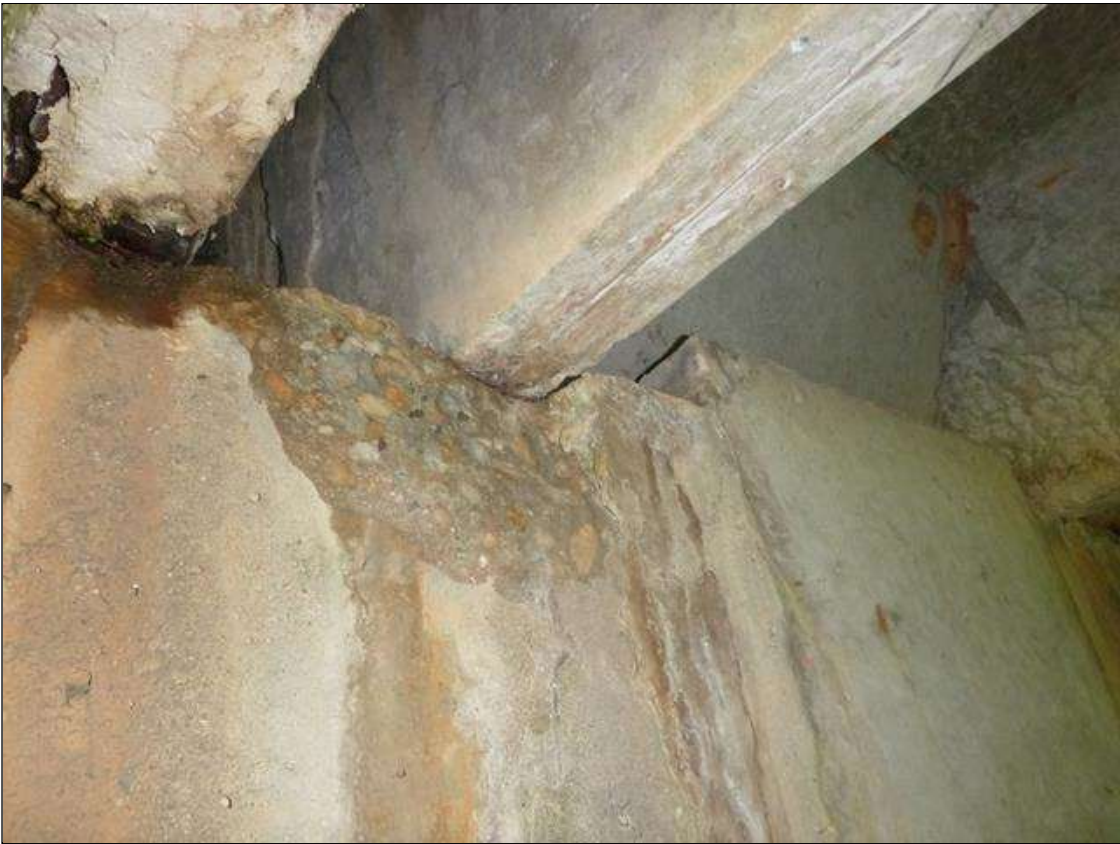
Bent 4 Cap : 1 Feet of Delamination/Spall/Patched Area: Delaminated. Spall 1 in. or less deep or 6 in. or less in diameter. 6" x 4' x 1" deep under left leg of channel 9 on SOUTH face.

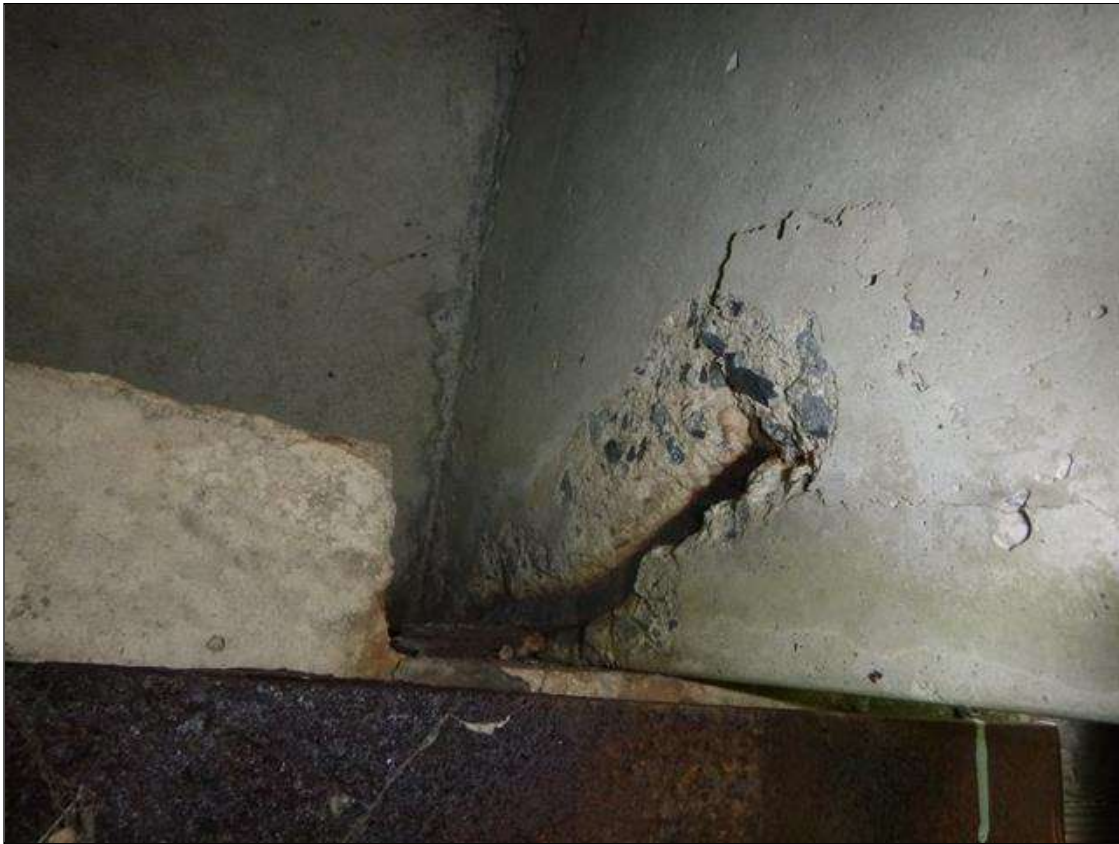
Span 5 Channel/Slab 10: 2 Feet of Cracking (PSC): Width greater than 0.009 in. or spacing less than 1 ft. Longitudinal crack with delam in bottom of left leg at end bent 2. Right leg has 7" x 2" x 1/2" deep spall on inside face of right leg and end bent 2.

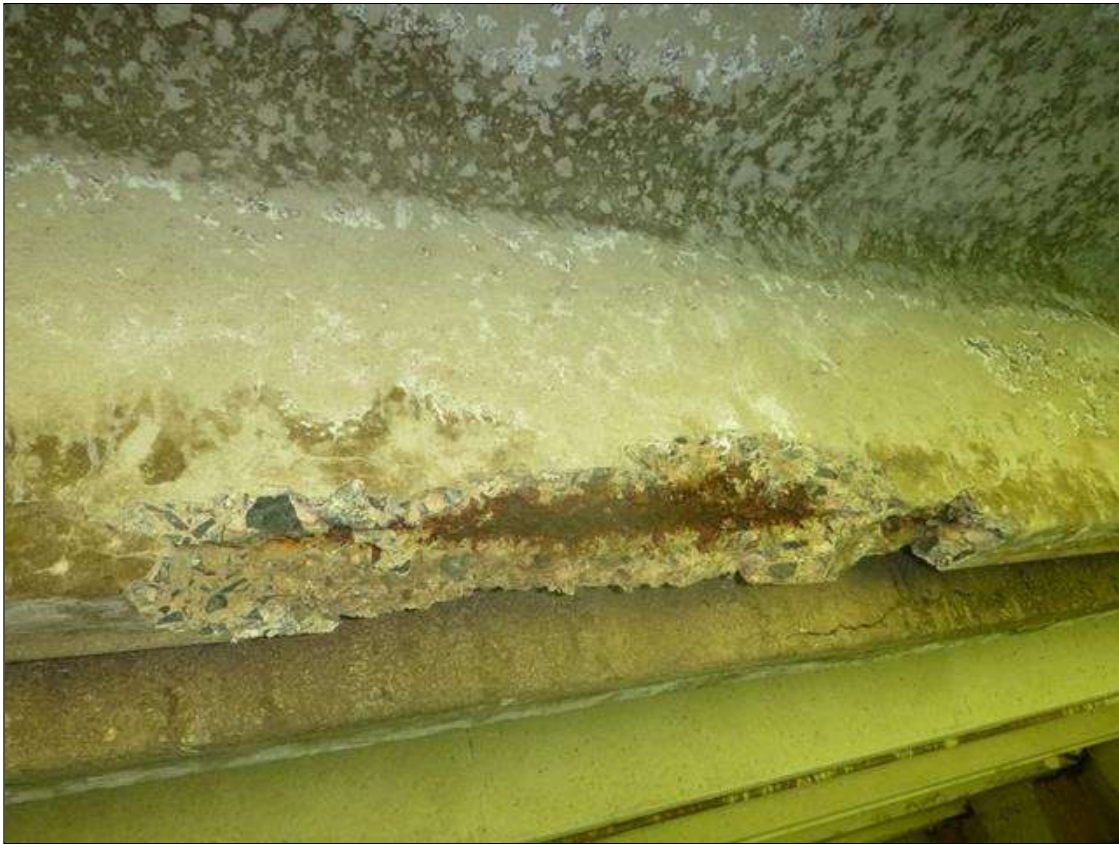
Span 5 Channel/Slab 2: 2 Feet of Exposed Prestressing: The condition warrants a structural review to determine the effect on strength or serviceability of the element or bridge; OR a structural review has been completed and the defects impact strength or serviceability of the element or bridge. 22" spall with exposed strands in bottom of right leg at midspan.

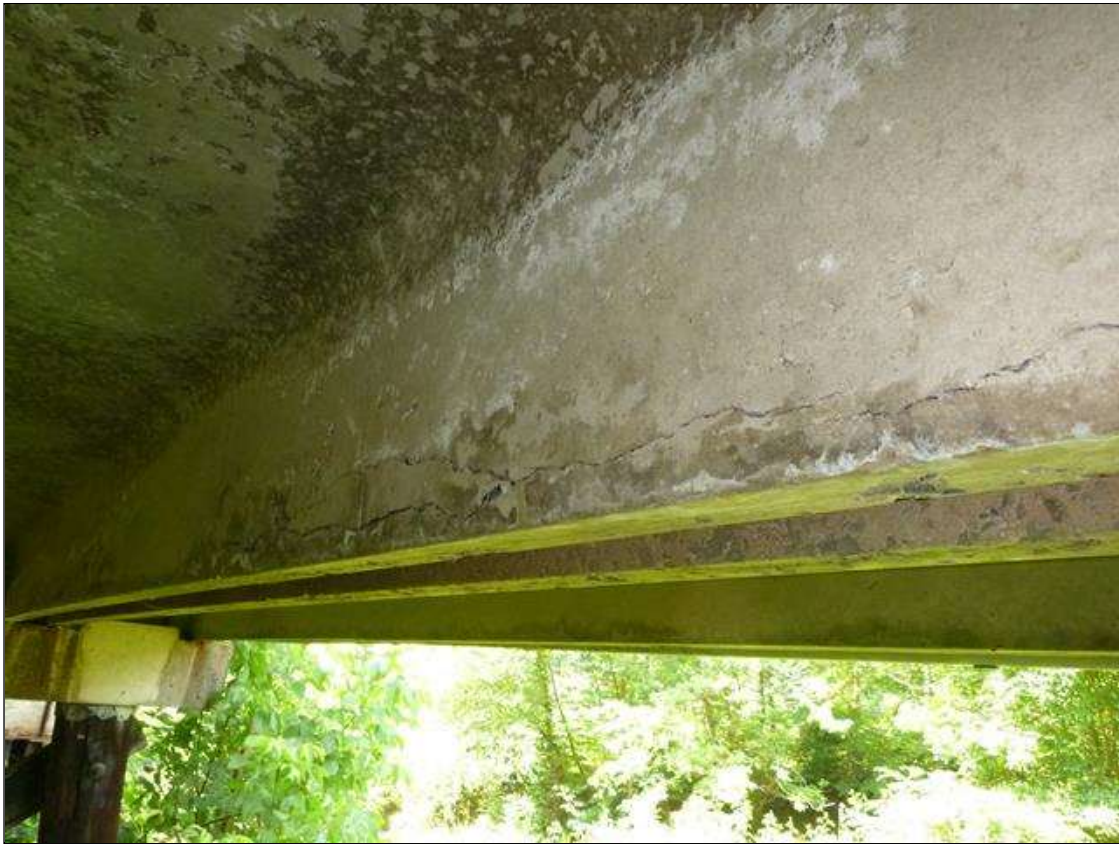
Span 5 Channel/Slab 2: 0 Feet of Cracking (PSC): Width greater than 0.009 in. or spacing less than 1 ft. Horizontal crack with delam 3" up from bottom of left leg near midspan.

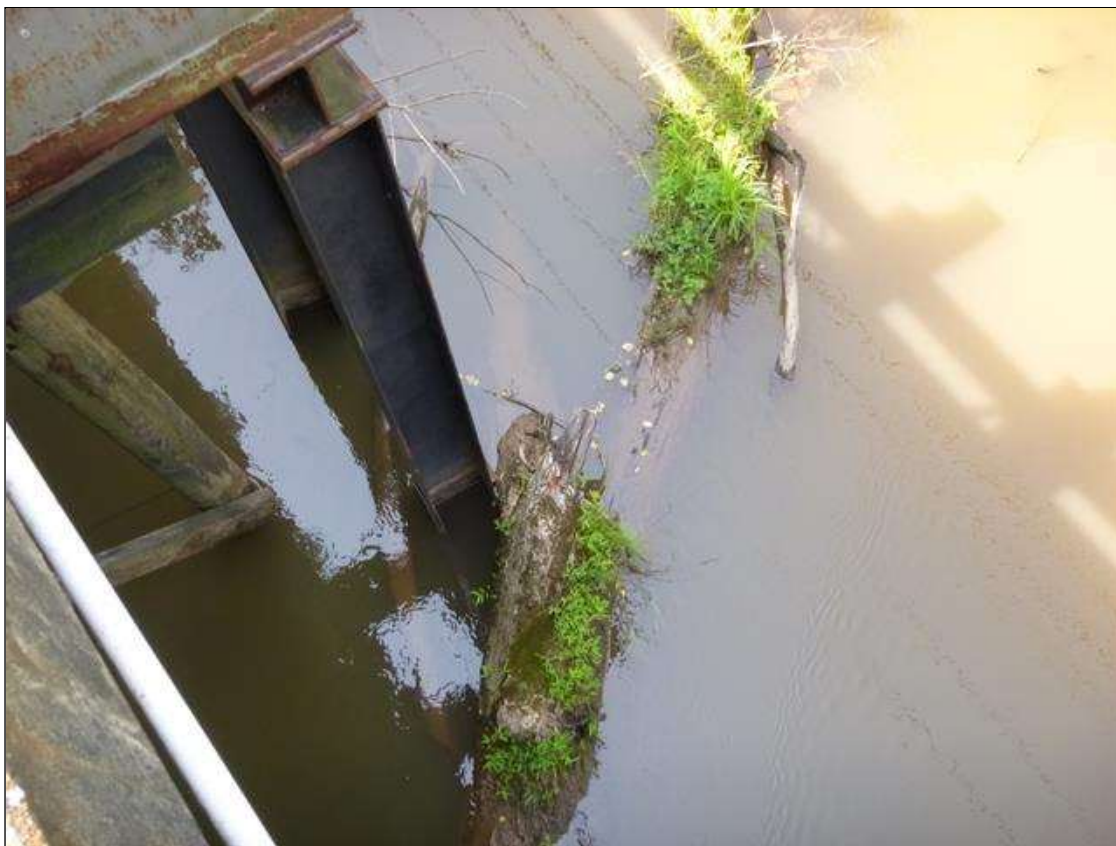
DRIFT AT BENT 2 ( 1.5 FT. X 40 FT.)

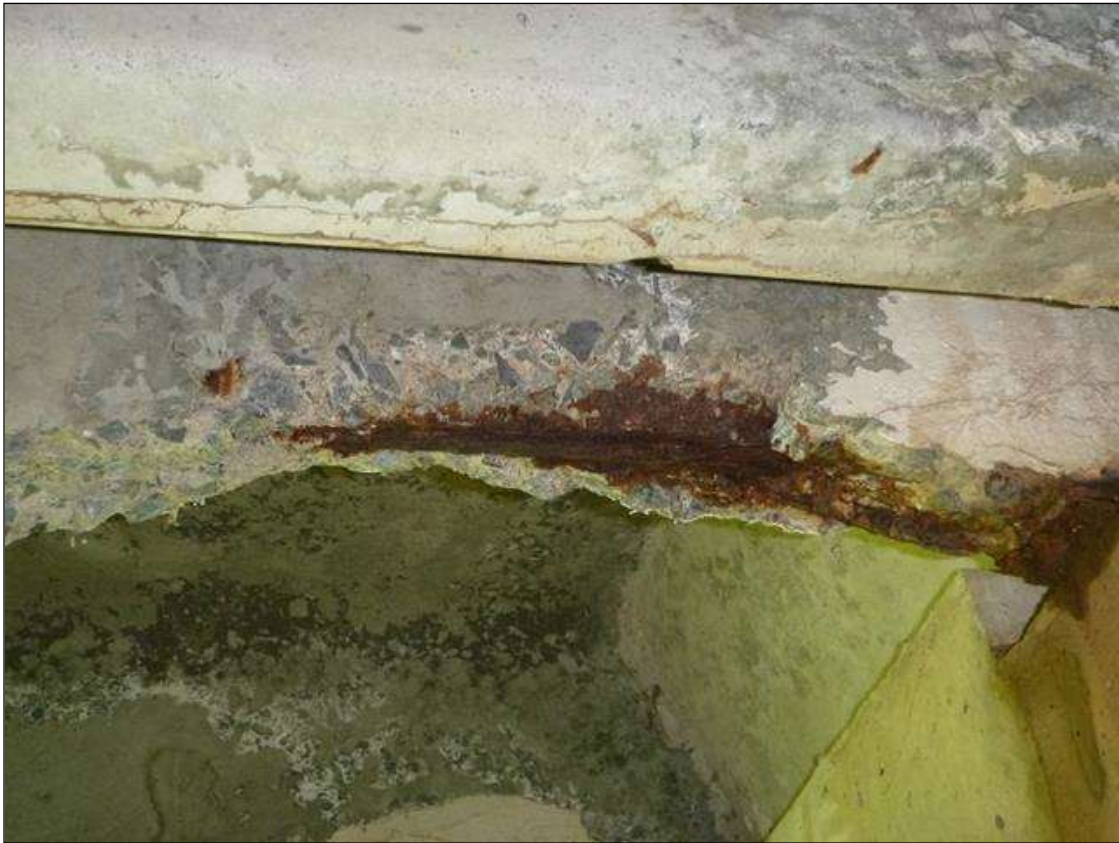
SPAN 1 CHANNEL/SLAB 2: 1 FEET OF EXPOSED PRESTRESSING: 16" X 3" X 2" DEEP SPALL ON BOTTOM OF RIGHT LEG AT BENT 1 WITH EXPOSED CABLE.

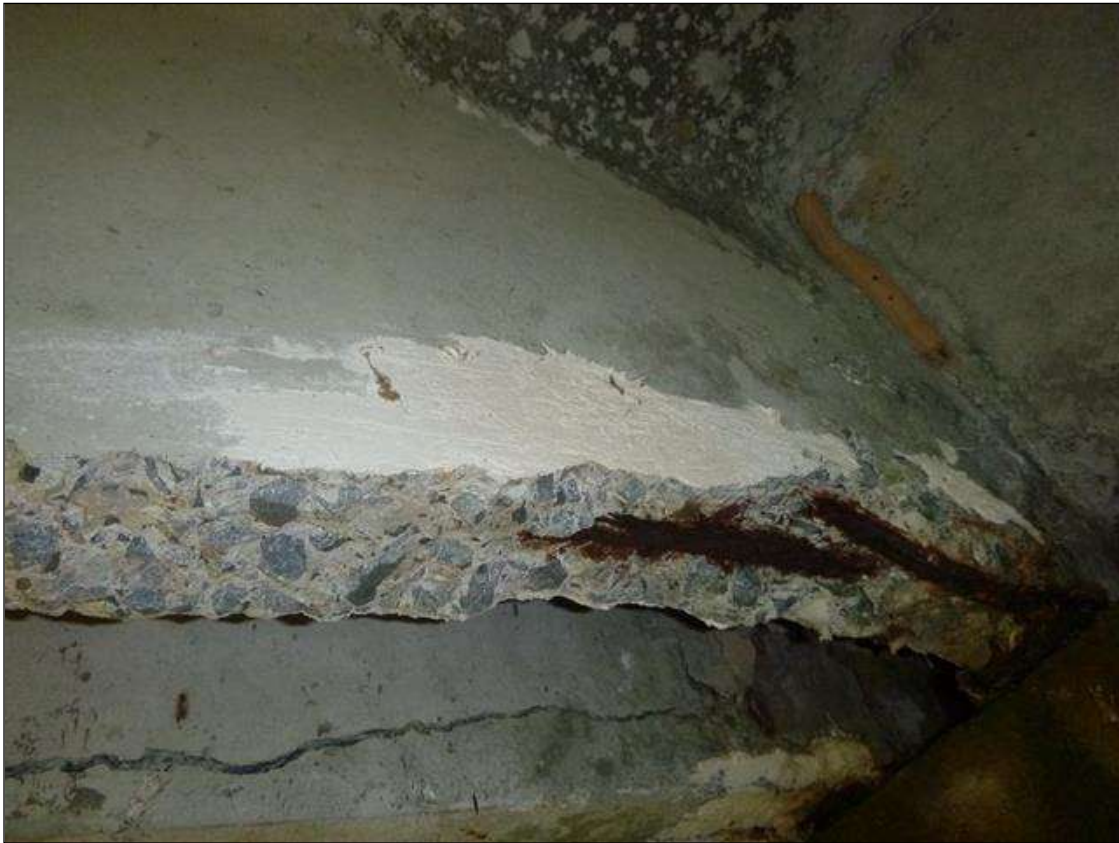
SPAN 2 CHANNEL/SLAB 5: 2 FEET OF EXPOSED PRESTRESSING: 21" SPALL WITH EXPOSED CABLE IN BOTTOM OF LEFT LEG AT BENT 2.
