NC DEPARTMENT OF TRANSPORTATION  
DIVISION OF HIGHWAYS  
STRUCTURE MANAGEMENT UNIT

## Structure Safety Report

### Routine Element Inspection - Contract

COUNTY: WAKE STRUCTURE NUMBER: 910084 FREQUENCY: 24 MONTHS

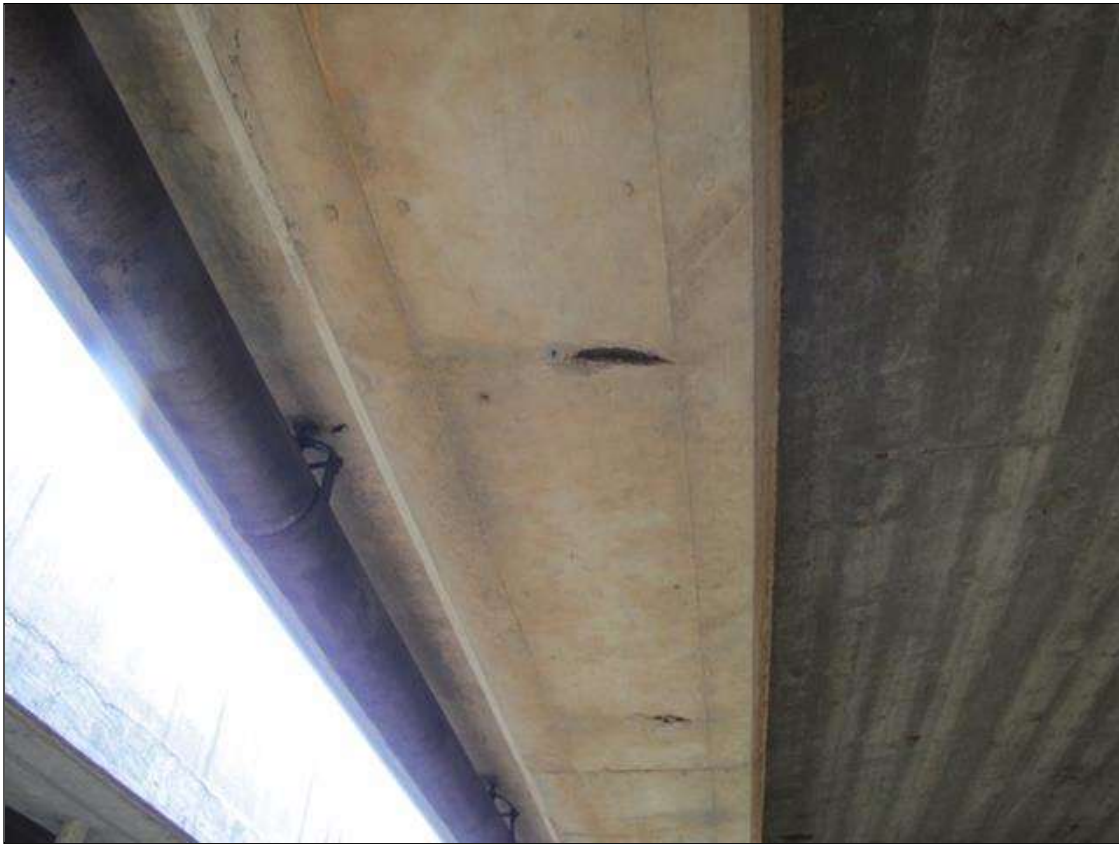
| Element Number | Defect Type | Defect Description | CS | CS Qty | Maint Qty |
|---|---|---|---|---|---|
| 110 | Delamination/Spall | (5)- SPALLS WITH EXPOSED REBAR UP TO 6" X 1" X 1/2" DEEP IN BOTTOM OF GIRDER AT 3 FT SPACINGS FROM BENT 1 | 3 | 5 | 5 Feet |

Span 1 Beam 1: 5 SPALL WITH EXPOSED REBAR UP TO 6" X 1" X 1/2" DEEP IN BOTTOM OF GIRDER AT 3 FT SPACINGS FROM BENT 1

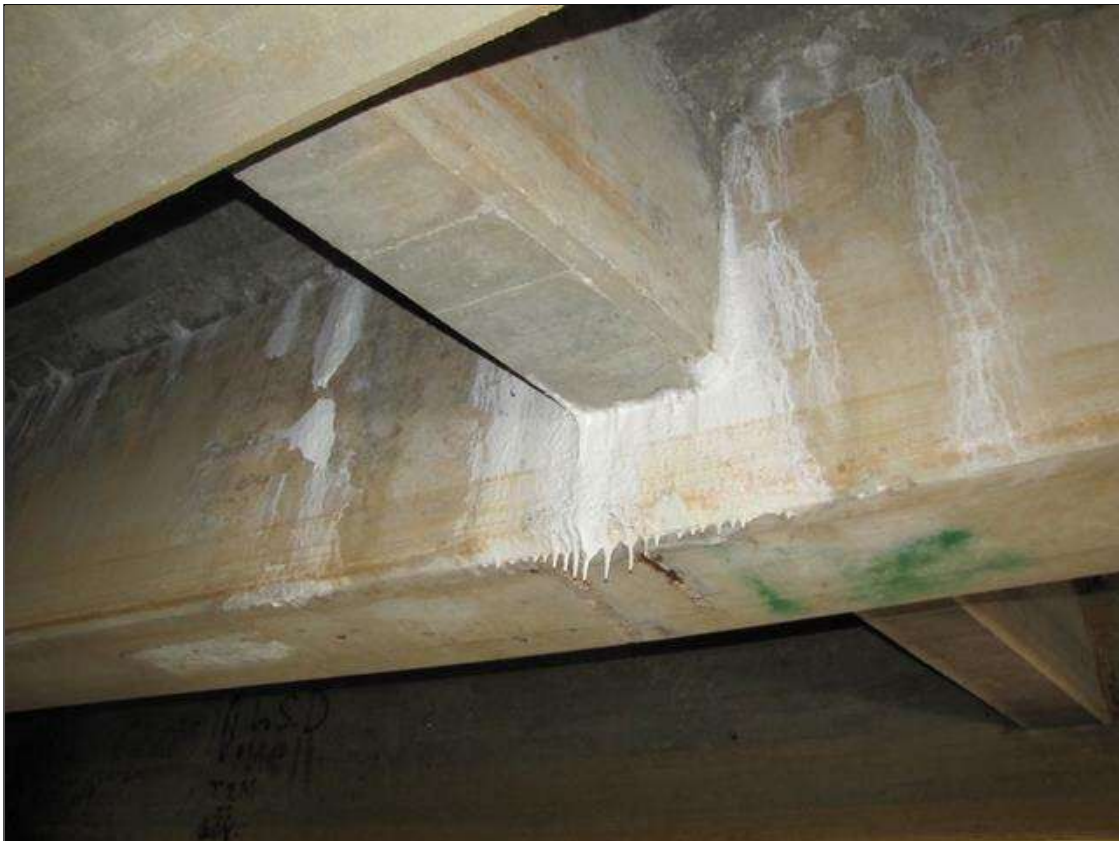
| Element Number | Defect Type | Defect Description | CS | CS Qty | Maint Qty |
|---|---|---|---|---|---|
| 110 | Efflorescence/Rust Staining | HEAVY EFFLORESCENCE SOUTH FACE NEAR MID SPAN | 3 | 5 | 5 Feet |

Span 1 Beam 3: HEAVY EFFLORESCENCE SOUTH FACE NEAR MID SPAN

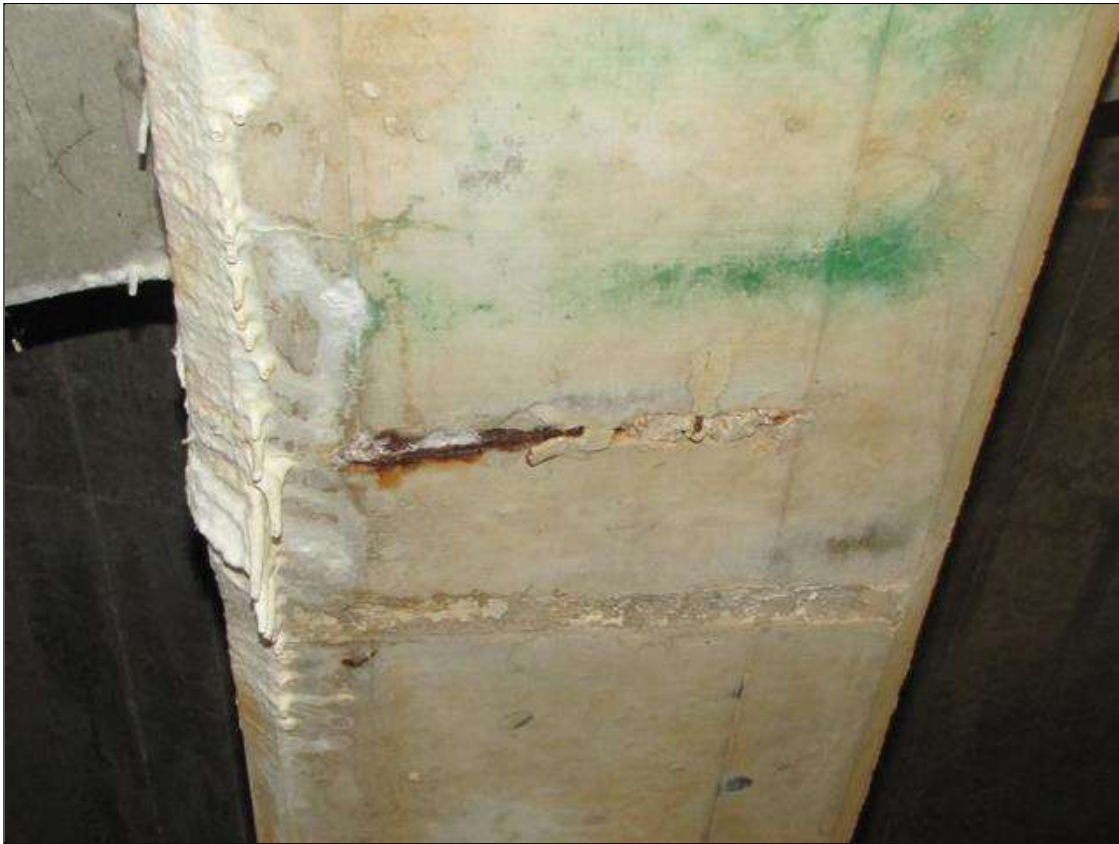
| Element Number | Defect Type | Defect Description | CS | CS Qty | Maint Qty |
|---|---|---|---|---|---|
| 110 | Delamination/Spall | SPALL WITH EXPOSED REBAR IN BOTTOM FACE 12" X 2"X 1/2" DEEP NEAR MID SPAN | 3 | 1 | 1 Feet |

Span 1 Beam 3: SPALL WITH EXPOSED REBAR IN BOTTOM FACE 12" X 2" X 1/2" DEEP NEAR MID SPAN

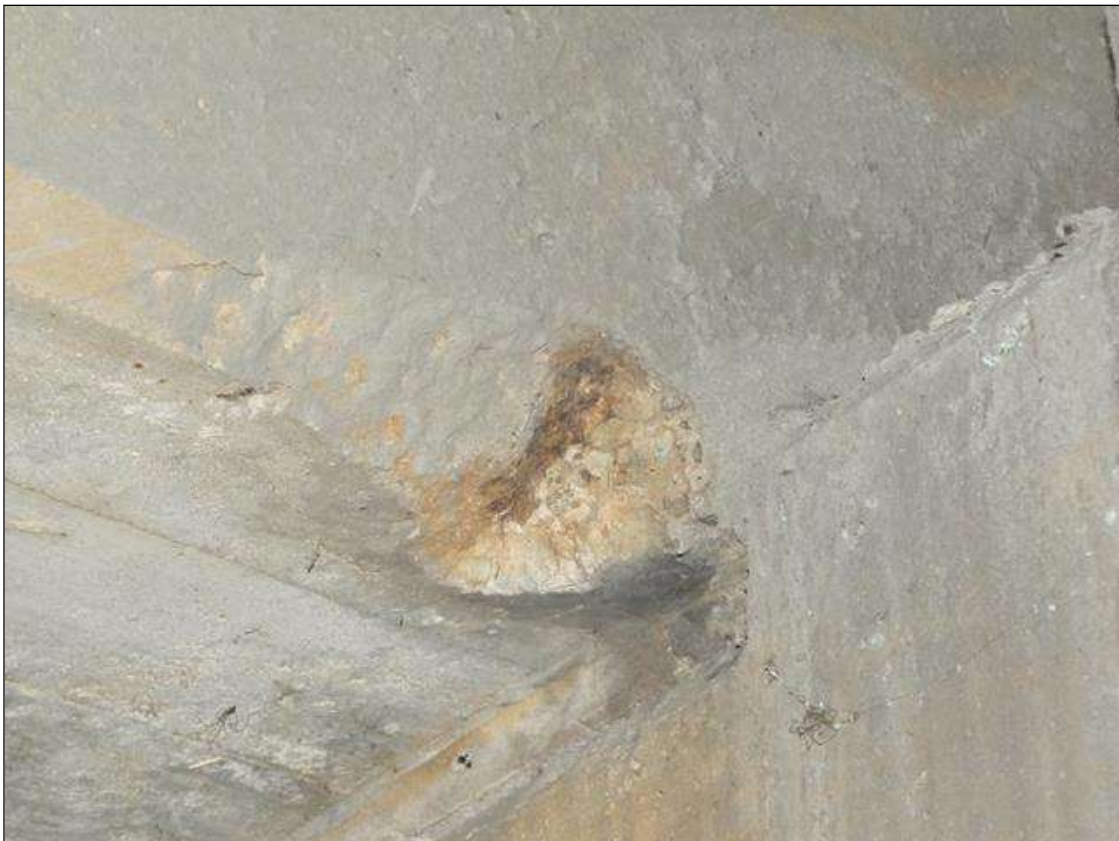
| Element Number | Defect Type | Defect Description | CS | CS Qty | Maint Qty |
|---|---|---|---|---|---|
| 110 | Delamination/Spall | 10" X 3" X 4" SPALL WITH EXPOSED REINFORCING, BOTTOM SOUTH CORNER, AT FAR BEARING. | 3 | 1 | 1 Feet |

Span 1 Beam 6: 10" X 3" X 4" SPALL WITH EXPOSED REINFORCING, BOTTOM SOUTH CORNER, AT FAR BEARING.

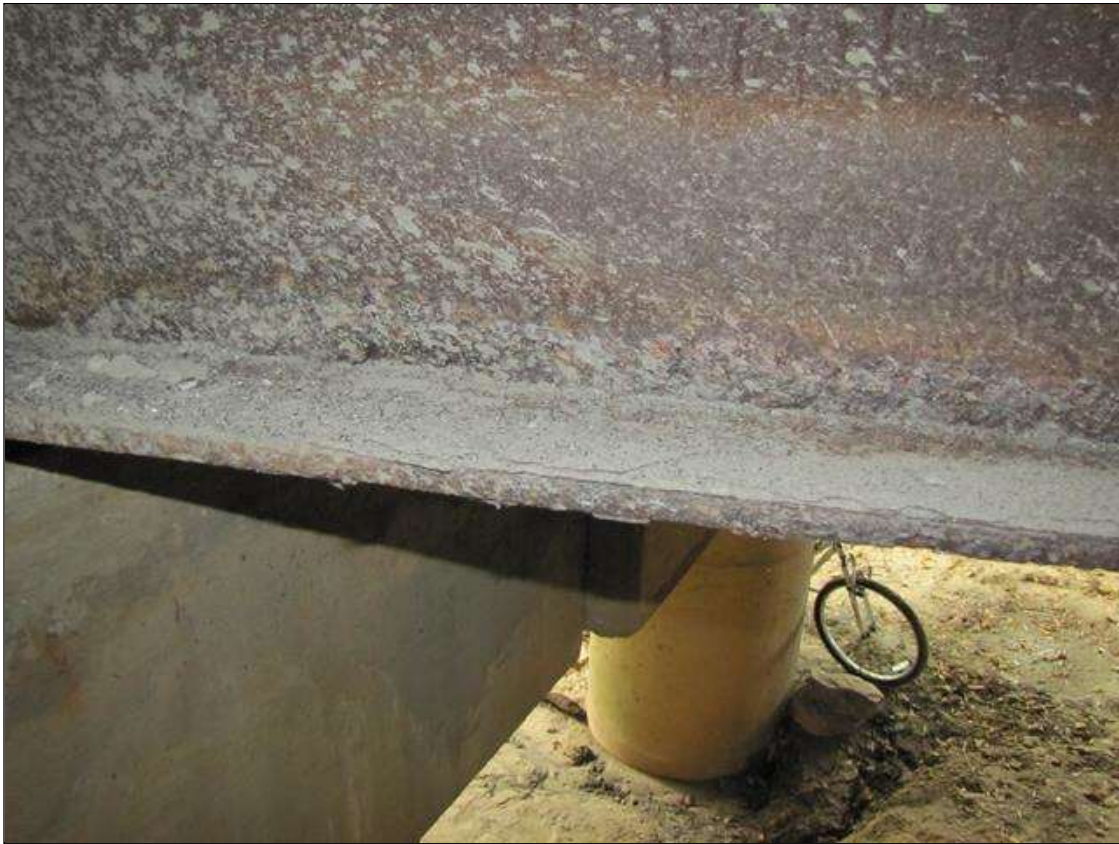
| Element Number | Defect Type | Defect Description | CS | CS Qty | Maint Qty |
|---|---|---|---|---|---|
| 107 | Corrosion | 6 FT CORROSION OF BOTTOM FLANGE NORTH SIDE WITH NO SECTION LOSS | 2 | 6 | Feet |

Span 1 Beam 7: 6 FT CORROSION OF BOTTOM FLANGE NORTH SIDE WITH NO SECTION LOSS

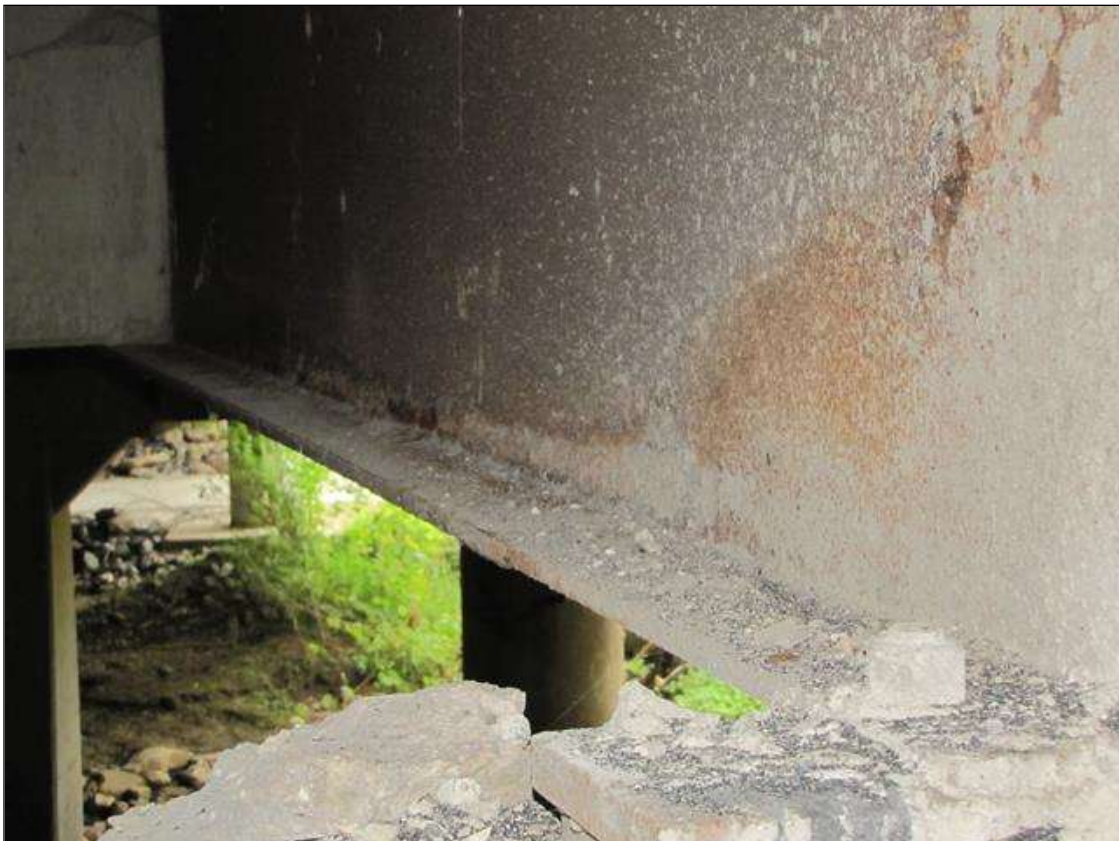
| Element Number | Defect Type | Defect Description | CS | CS Qty | Maint Qty |
|---|---|---|---|---|---|
| 107 | Corrosion | 7 FT CORROSION OF BOTTOM FLANGE NORTH SIDE AND 4" AT BASE OF WEB AT BENT 1 | 3 | 7 | 7 Feet |

Span 2 Beam 7: 7 FT CORROSION OF BOTTOM FLANGE NORTH SIDE AND 4" AT BASE OF WEB AT BENT 1

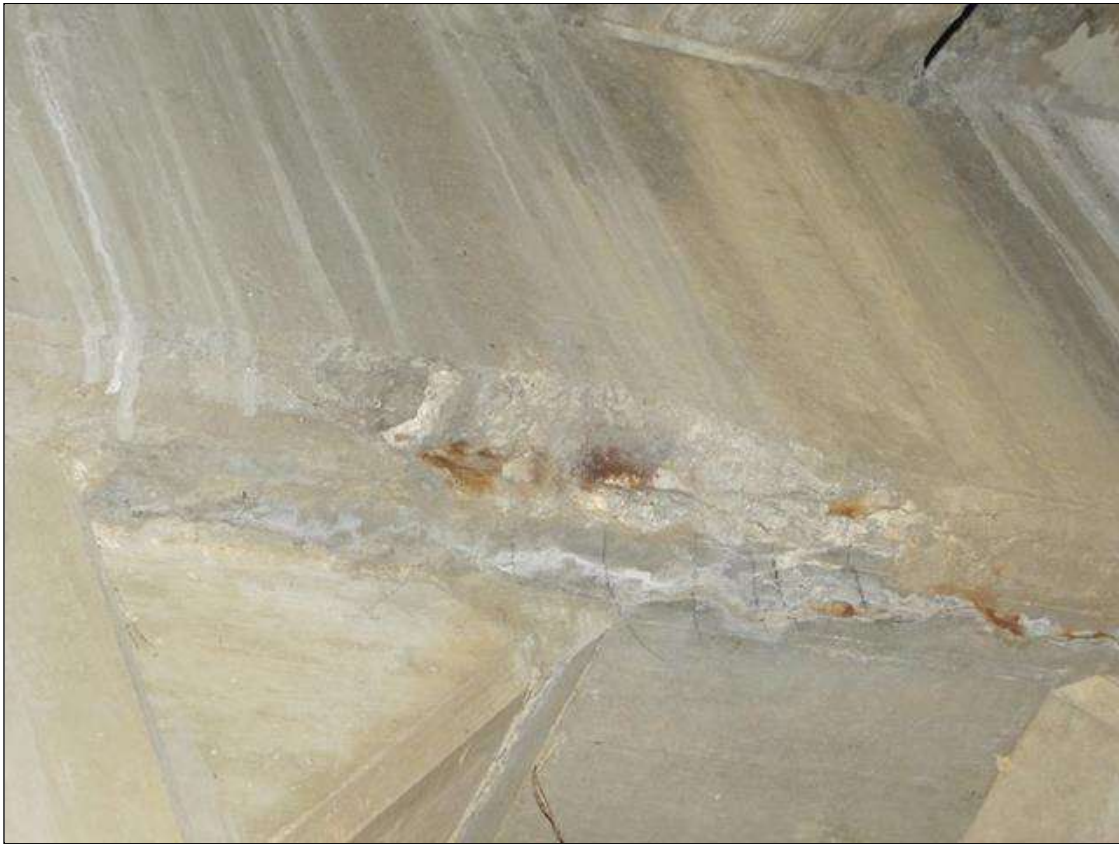
| Element Number | Defect Type | Defect Description | CS | CS Qty | Maint Qty |
|---|---|---|---|---|---|
| 234 | Delamination/Spall | 2 FT X 5" X 1 1/2" SPALL WITH EXPOSED MAIN STEEL IN EAST FACE UNDER BEAM 5 (PRIORITY MAINTENANCE). | 3 | 2 | 2 Feet |

Bent 1 Cap 2: 2 FT X 5" X 1 1/2" SPALL WITH EXPOSED REBAR IN EAST FACE UNDER BEAM 5 (PRIORITY MAINTENANCE).

| MMS Code | Description of Function | Unit | Quantity | Remarks | Est. Cost |
|---|---|---|---|---|---|
| 3348 | Maintain Concrete Substructure Components | LF | 2 | Bent 1 Cap 2: 2 FT X 5" X 1 1/2" DEEP SPALL WITH EXPOSED MAIN STEEL IN EAST FACE UNDER BEAM 5 (PRIORITY MAINTENANCE). | |

| MMS Code | MMS Description | Quantity |
|---|---|---|
| Bent 1 Cap 2: 2 FT X 5" X 1 1/2" DEEP SPALL WITH EXPOSED MAIN STEEL IN EAST FACE UNDER BEAM 5 (PRIORITY MAINTENANCE). | | |

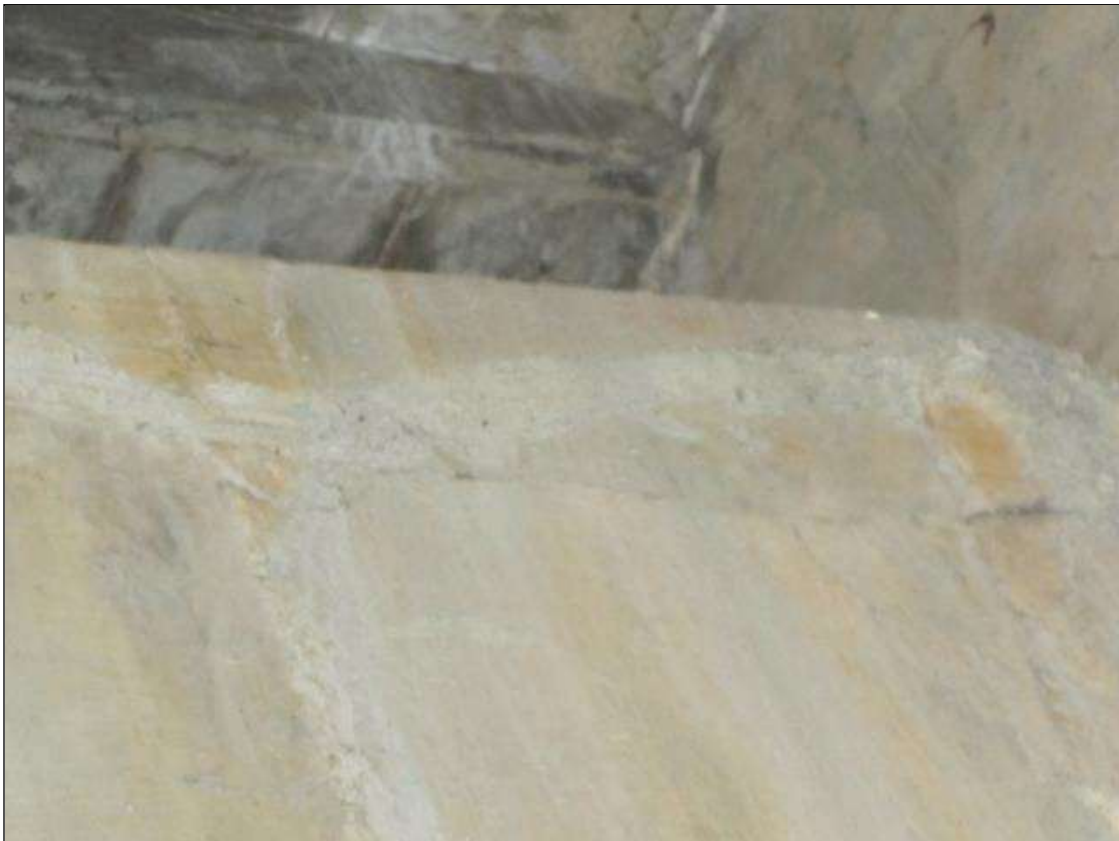
| Element Number | Defect Type | Defect Description | CS | CS Qty | Maint Qty |
|---|---|---|---|---|---|
| 234 | Delamination/Spall | 3 FT X 1 FT DELAMINATION UNDER BAY 3 | 2 | 3 | 3 Feet |

Bent 1 Cap 2: 3 FT X 1 FT DELAMINATION UNDER BAY 3

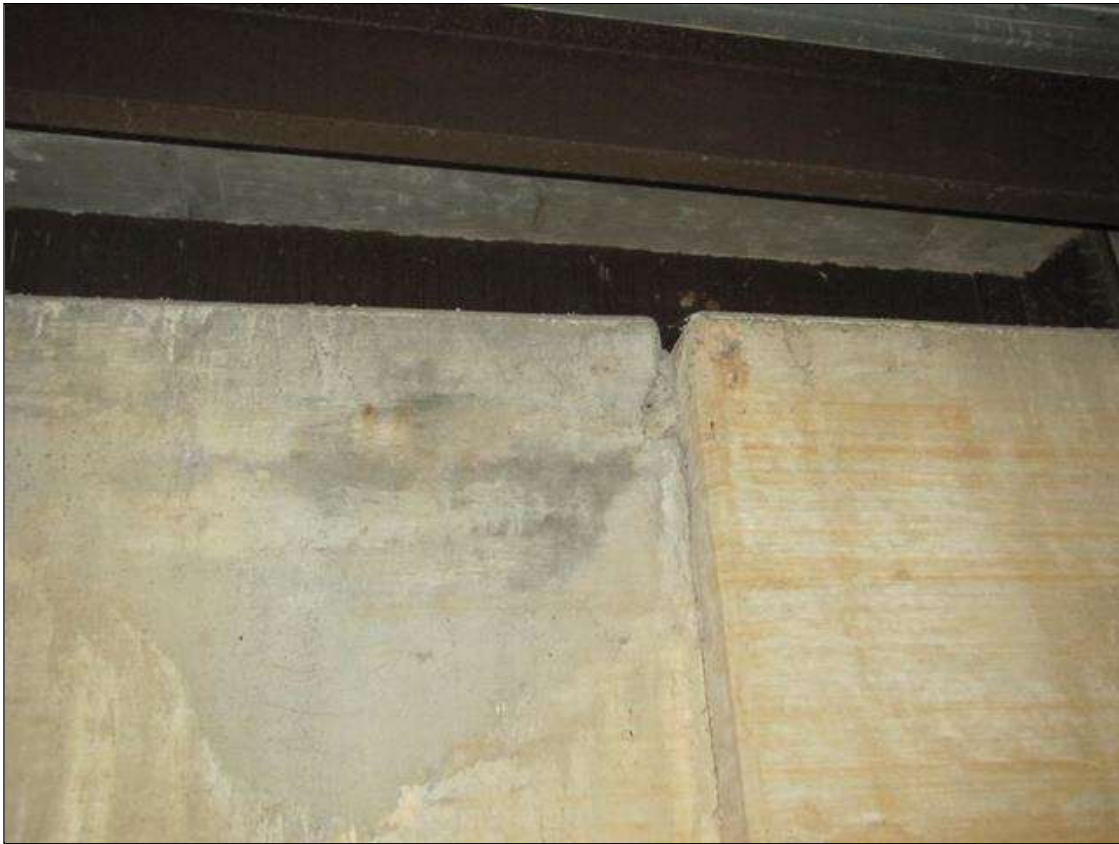
| Element Number | Defect Type | Defect Description | CS | CS Qty | Maint Qty |
|---|---|---|---|---|---|
| 234 | Delamination/Spall | 3" X 14" DELAMINATION WEST FACE SOUTH END OF CAP SEGMENT | 2 | 1 | 1 Feet |

Bent 1 Cap 2: 3" X 14" DELAMINATION WEST FACE SOUTH END OF CAP SEGMENT

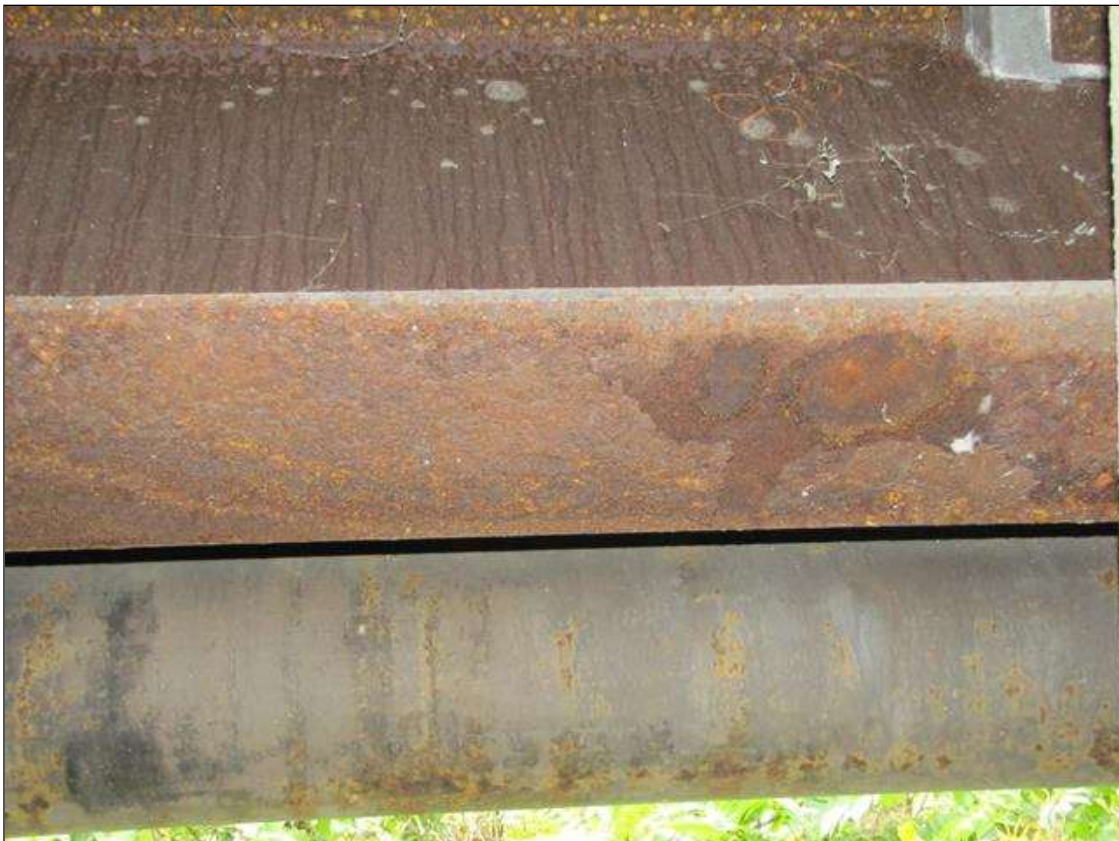
| Element Number | Defect Type | Defect Description | CS | CS Qty | Maint Qty | |
|---|---|---|---|---|---|---|
| 107 | Corrosion | 6 FT CORROSION BOTTOM OF BOTTOM FLANGE FULL WIDTH AT BENT 1 | 2 | 6 | | Feet |

Span 2 Beam 9: 6 FT CORROSION BOTTOM OF BOTTOM FLANGE FULL WIDTH AT BENT 1

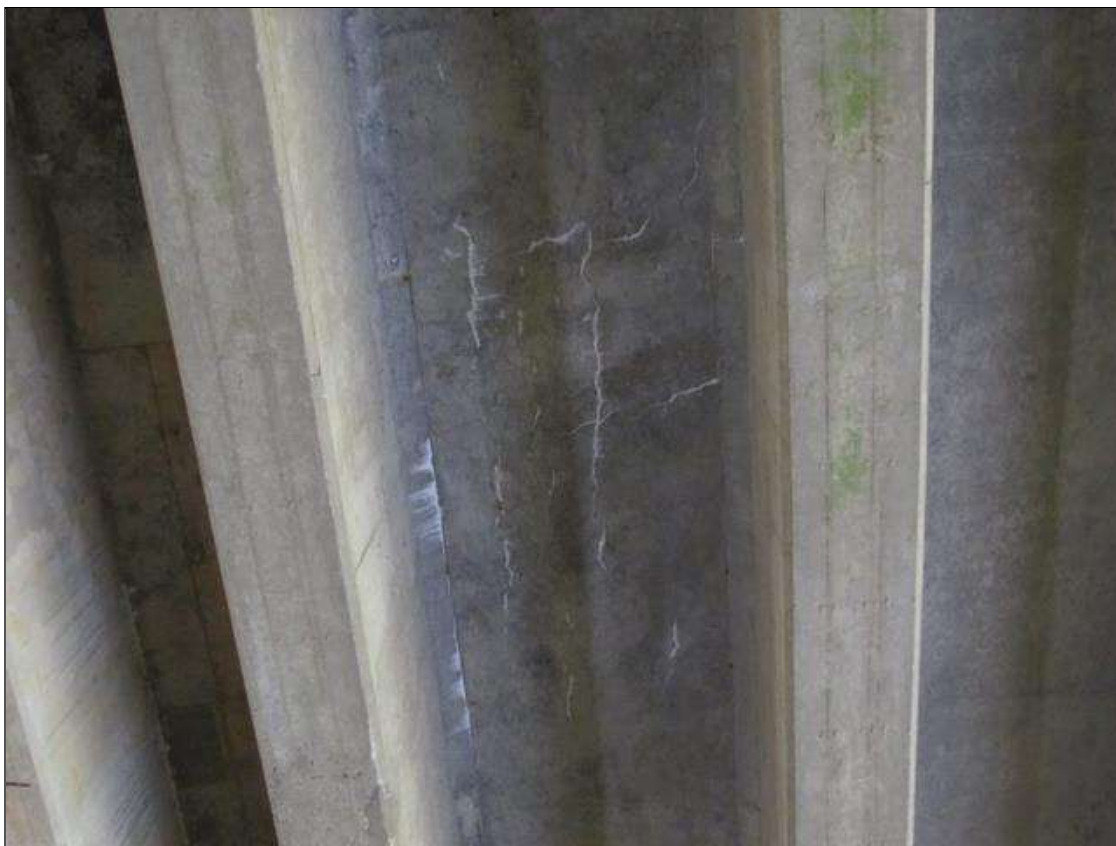
Span 2 Deck: TRANSVERSE AND LONGITUDINAL HAIRLINE CRACKS WITH EFFLORESCENCE IN UNDERSIDE BAY 4 AT RANDOM FULL LENGTH

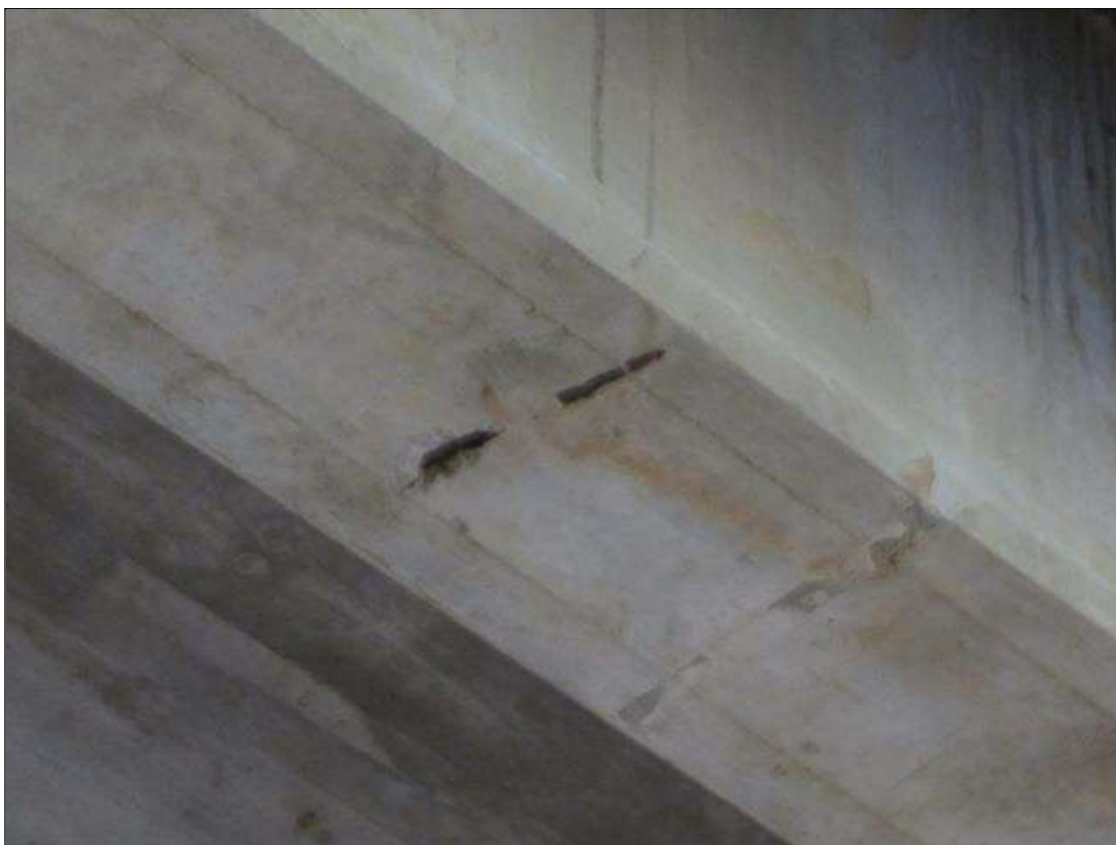
| Element Number | Defect Type | Defect Description | CS | CS Qty | Maint Qty | |
|---|---|---|---|---|---|---|
| 110 | Delamination/Spall | SPALL WITH EXPOSED REBAR 12" X 2" X 1/2" DEEP IN BOTTOM AT 15 FT FROM BENT 1 | 3 | 1 | 1 | Feet |

Span 2 Beam 3: SPALL WITH EXPOSED REBAR 12" X 2" X 1/2" DEEP IN BOTTOM AT 15 FT FROM BENT 1

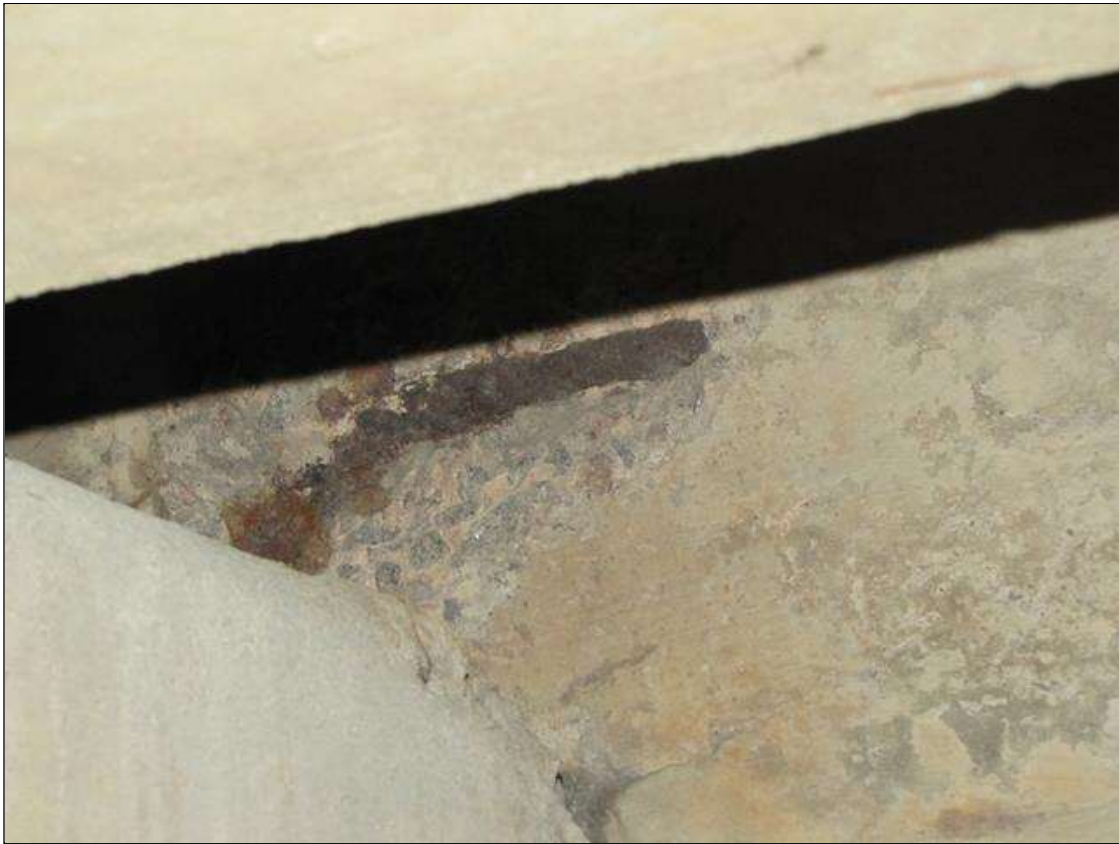
| Element Number | Defect Type | Defect Description | CS | CS Qty | Maint Qty | |
|---|---|---|---|---|---|---|
| 110 | Delamination/Spall | 18" X 10" X 2" SPALL WITH EXPOSED REBAR NORTH FACE AT BENT 2 | 3 | 2 | 2 | Feet |

Span 3 Beam 3: 18" X 10" X 2" SPALL WITH EXPOSED REBAR NORTH FACE AT BENT 2

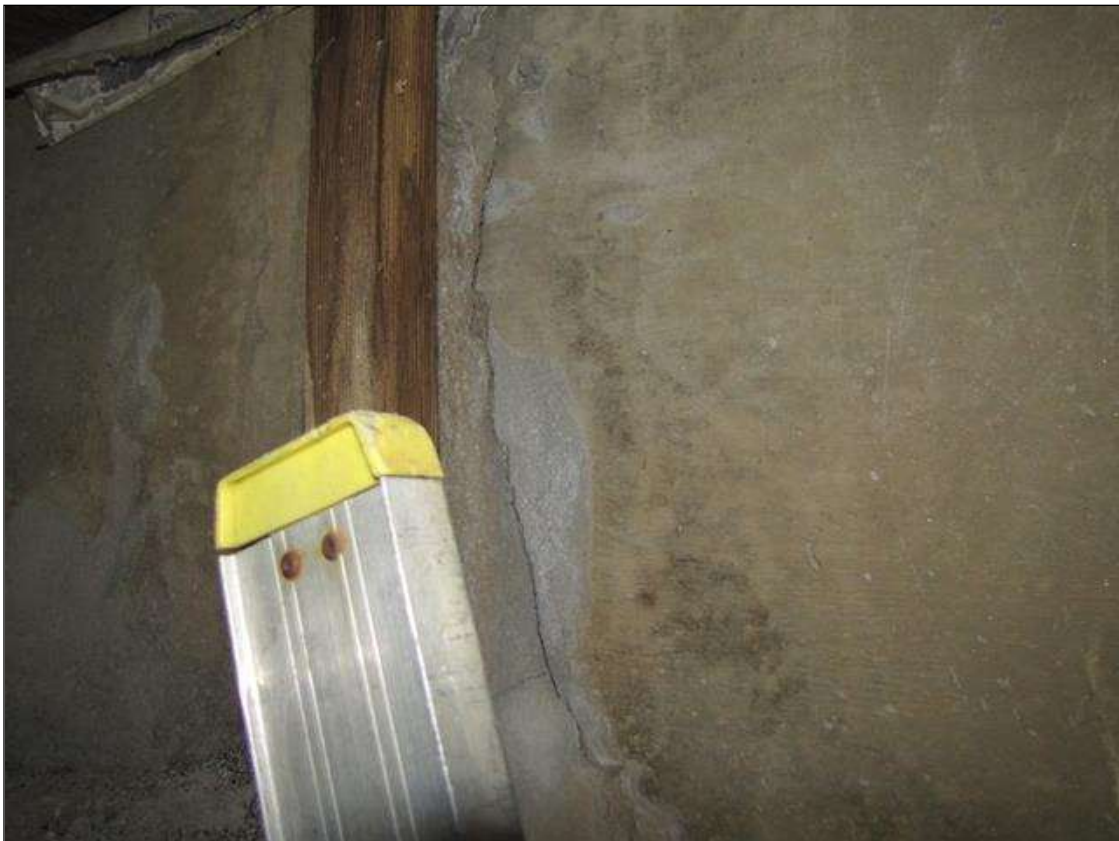
| Element Number | Defect Type | Defect Description | CS | CS Qty | Maint Qty | |
|---|---|---|---|---|---|---|
| 110 | Cracking (RC and Other) | 30" VERTICAL CRACK UP TO 3/16", NEAR END OF GIRDER, NORTH FACE, BENT 2. | 2 | 1 | 1 | Feet |

Span 3 Beam 4: 30" VERTICAL CRACK UP TO 3/16", NEAR END OF GIRDER, NORTH FACE, BENT 2.

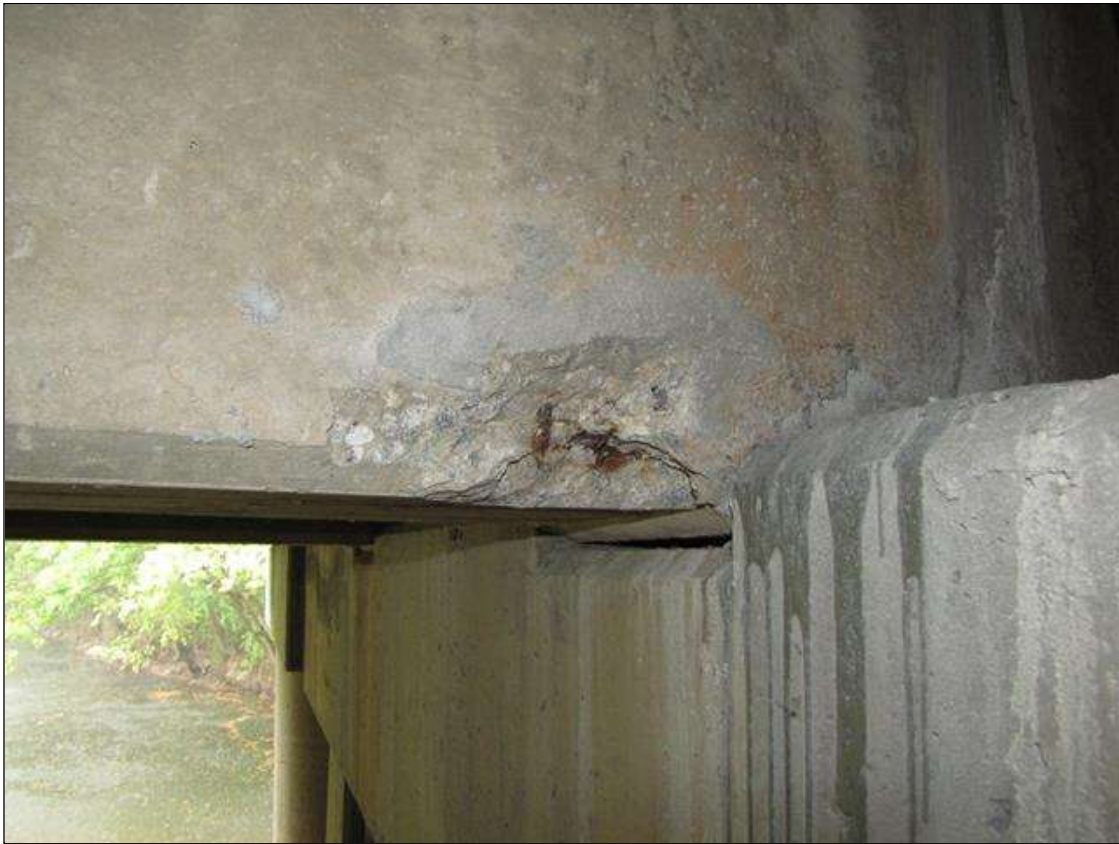
| Element Number | Defect Type | Defect Description | CS | CS Qty | Maint Qty |
|---|---|---|---|---|---|
| 110 | Delamination/Spall | 11" X 5" X 4" SPALL WITH EXPOSED REINFORCING, BOTTOM NORTH CORNER, NEAR BEARING. | 3 | 1 | Feet |

Span 3 Beam 5: 11" X 5" X 4" SPALL WITH EXPOSED REINFORCING, BOTTOM NORTH CORNER, NEAR BEARING.

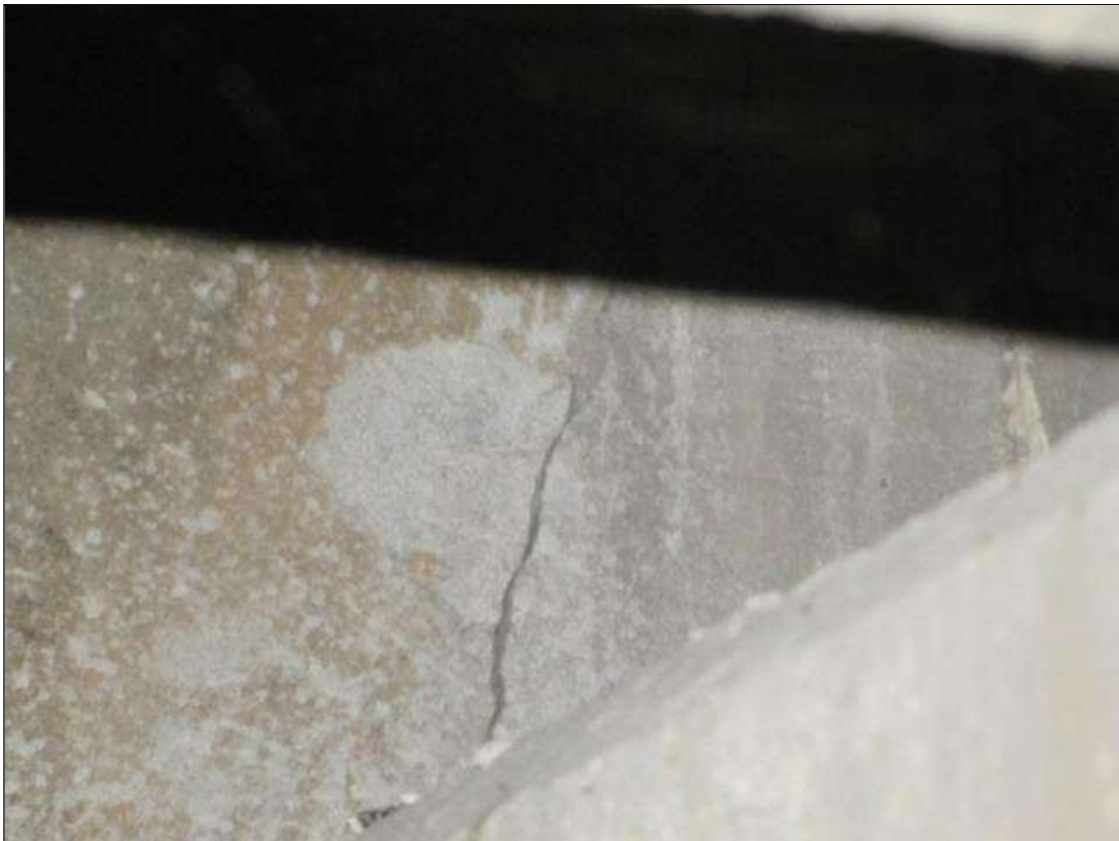
| Element Number | Defect Type | Defect Description | CS | CS Qty | Maint Qty |
|---|---|---|---|---|---|
| 110 | Delamination/Spall | 7" X 14" DELAMINATED PATCH BOTTOM NORTH FACE AT NEAR BEARING. | 2 | 1 | 1 Feet |

Span 3 Beam 6: 7" X 14" DELAMINATED PATCH BOTTOM NORTH FACE AT NEAR BEARING.

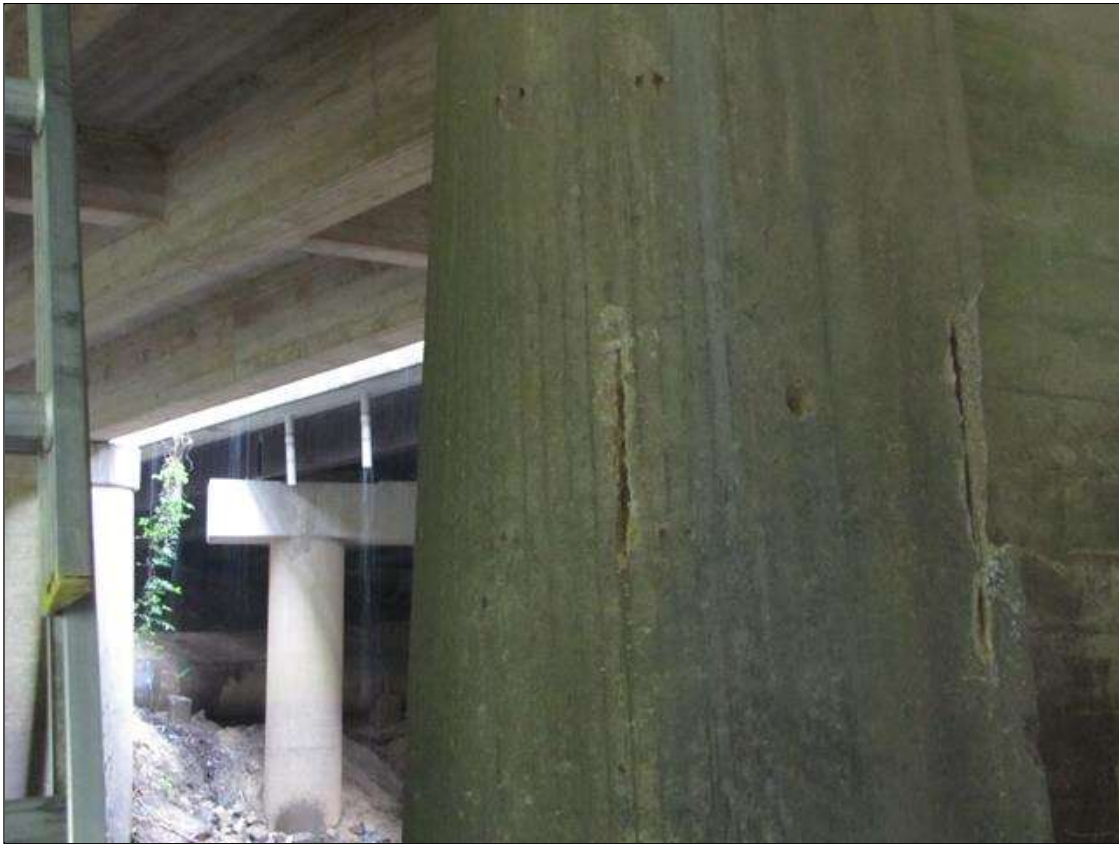
| Element Number | Defect Type | Defect Description | CS | CS Qty | Maint Qty | |
|---|---|---|---|---|---|---|
| 205 | Delamination/Spall | SPALL WITH EXPOSED MAIN STEEL REINFORCING, NORTHEAST CORNER, 2 FT X 3" X 1" DEEP, AT 6 FT ABOVE GROUND (PRIORITY MAINTENANCE). | 3 | | 2 | Each |

Bent 2 Pile 3: SPALL WITH EXPOSED REBAR AT NORTHEAST CORNER 2 FT X 3" X 1" DEEP AT 6 FT ABOVE GROUND (PRIORITY MAINTENANCE).

| MMS Code | Description of Function | Unit | Quantity | Remarks | Est. Cost |
|---|---|---|---|---|---|
| 3348 | Maintain Concrete Substructure Components | LF | 2 | Bent 2 Pile 3: SPALL WITH EXPOSED MAIN STEEL REINFORCING, NORTHEAST CORNER, 2 FT X 3" X 1" DEEP, AT 6 FT ABOVE GROUND (PRIORITY MAINTENANCE). | |

| MMS Code | MMS Description | Quantity |
|---|---|---|
| Bent 2 Pile 3: SPALL WITH EXPOSED MAIN STEEL REINFORCING, NORTHEAST CORNER, 2 FT X 3" X 1" DEEP, AT 6 FT ABOVE GROUND (PRIORITY MAINTENANCE). | | |

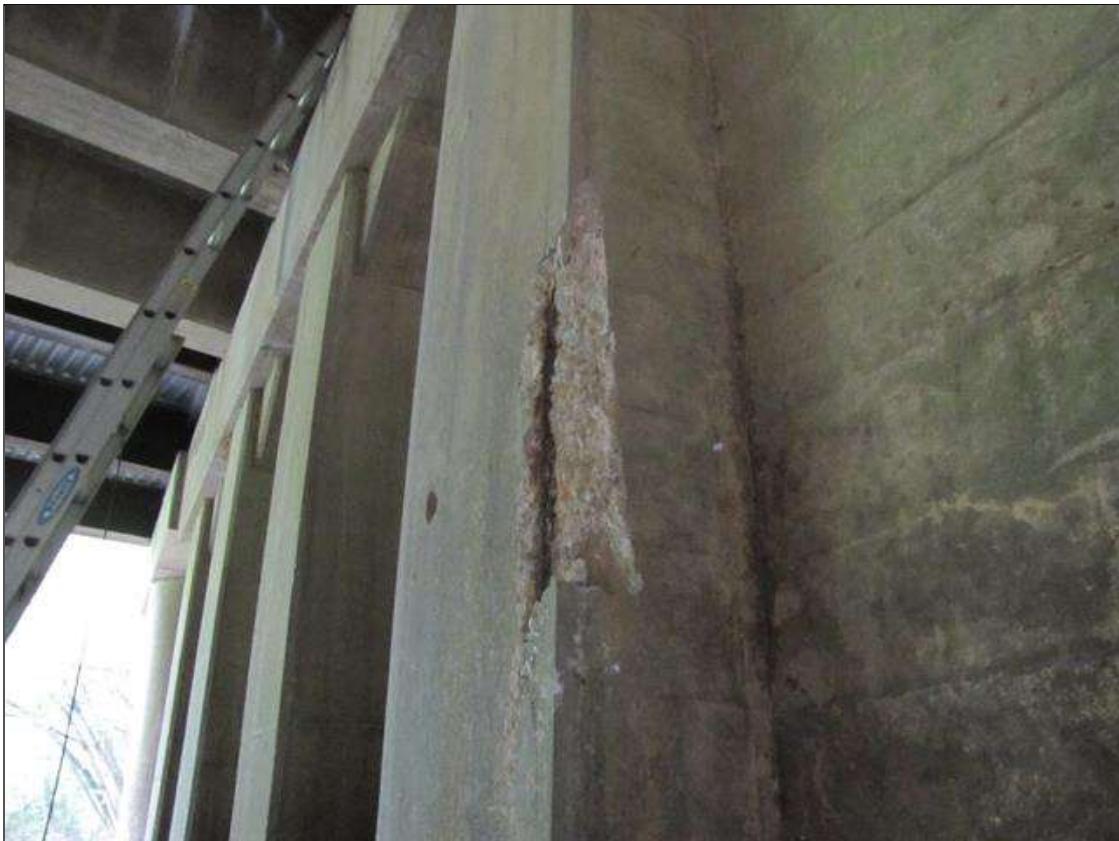
| Element Number | Defect Type | Defect Description | CS | CS Qty | Maint Qty | |
|---|---|---|---|---|---|---|
| 205 | Delamination/Spall | SPALL WITH EXPOSED MAIN STEEL 3 FT X 6" X 2" DEEP AT SOUTHEAST CORNER AT 6 FT ABOVE GROUND (PRIORITY MAINTENANCE). | 3 | 1 | 4 | Each |

Bent 2 Pile 3: SPALL WITH EXPOSED MAIN STEEL 3 FT X 6" X 2" DEEP AT SOUTHEAST CORNER AT 6 FT ABOVE GROUND (PRIORITY MAINTENANCE).

| MMS Code | Description of Function | Unit | Quantity | Remarks | Est. Cost |
|---|---|---|---|---|---|
| 3348 | Maintain Concrete Substructure Components | LF | 4 | Bent 2 Pile 3: SPALL WITH EXPOSED MAIN STEEL 3 FT X 6" X 2" DEEP AT SOUTHEAST CORNER AT 6 FT ABOVE GROUND (PRIORITY MAINTENANCE). | |

| MMS Code | MMS Description | Quantity |
|---|---|---|
| Bent 2 Pile 3: SPALL WITH EXPOSED MAIN STEEL 3 FT X 6" X 2" DEEP AT SOUTHEAST CORNER AT 6 FT ABOVE GROUND (PRIORITY MAINTENANCE). | | |

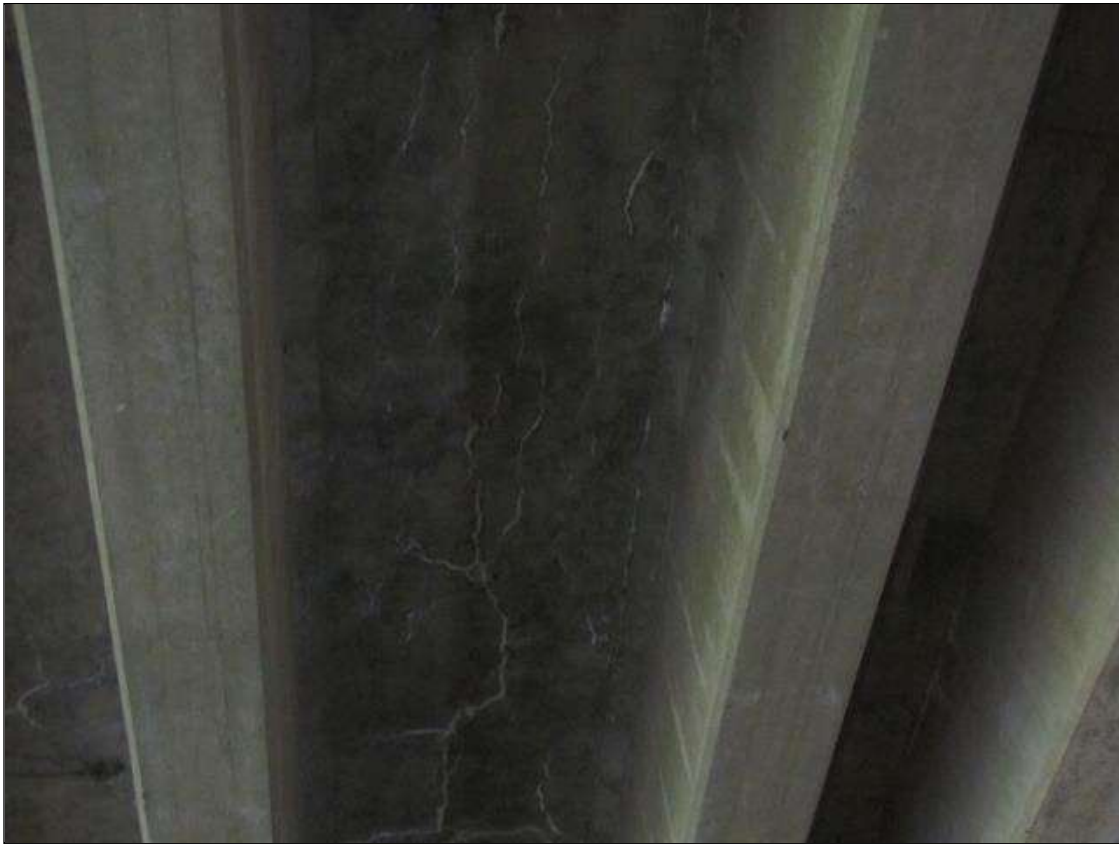
| Element Number | Defect Type | Defect Description | CS | CS Qty | Maint Qty | |
|---|---|---|---|---|---|---|
| 12 | Efflorescence/Rust Staining | TRANSVERSE AND LONGITUDINAL HAIRLINE CRACKS WITH EFFLORESCENCE IN UNDERSIDE BAY 4 AT RANDOM FULL LENGTH | 2 | 90 | | Square Feet |

Span 3 Deck: TRANSVERSE AND LONGITUDINAL HAIRLINE CRACKS WITH EFFLORESCENCE IN UNDERSIDE BAY 4 AT RANDOM FULL LENGTH

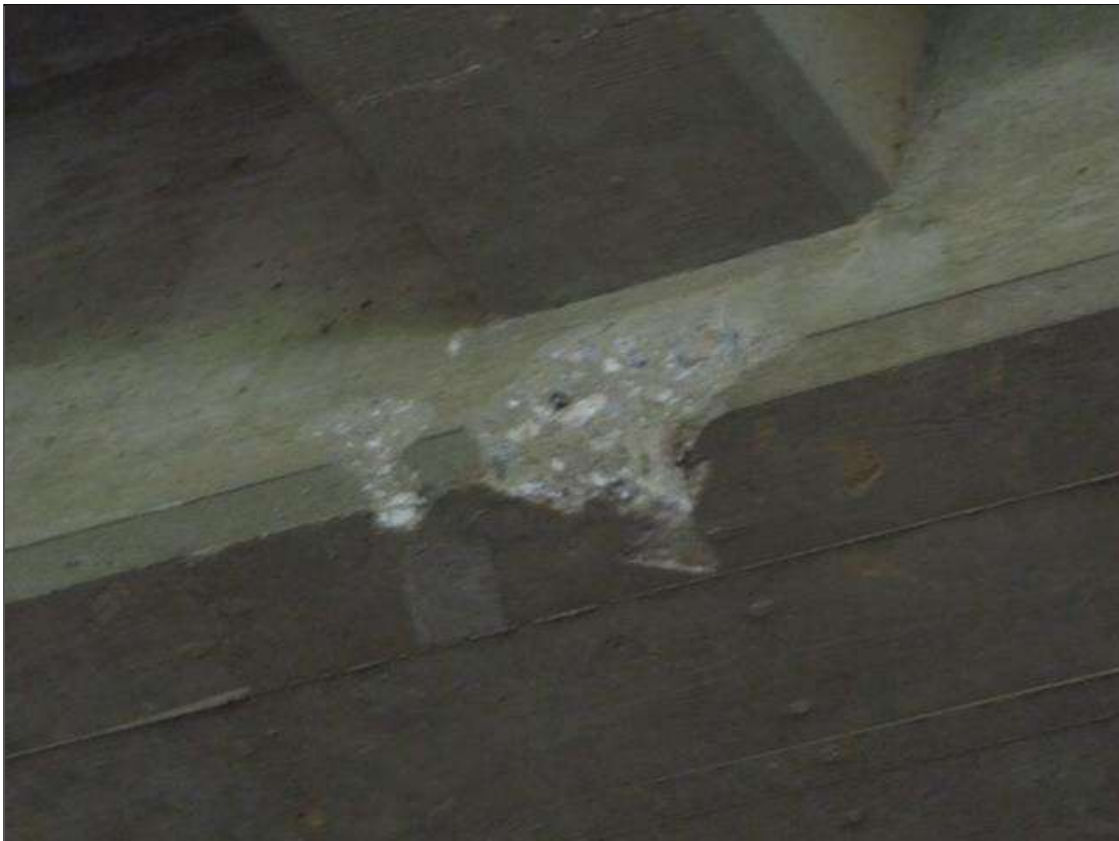
| Element Number | Defect Type | Defect Description | CS | CS Qty | Maint Qty |
|---|---|---|---|---|---|
| 110 | Delamination/Spall | 12" X 12" X 3" SPALL, BOTTOM SOUTH CORNER, AT MID SPAN. | 3 | 1 | 1 Feet |

Span 3 Beam 6: 12" X 12" X 3" SPALL, BOTTOM SOUTH CORNER, AT MID SPAN.

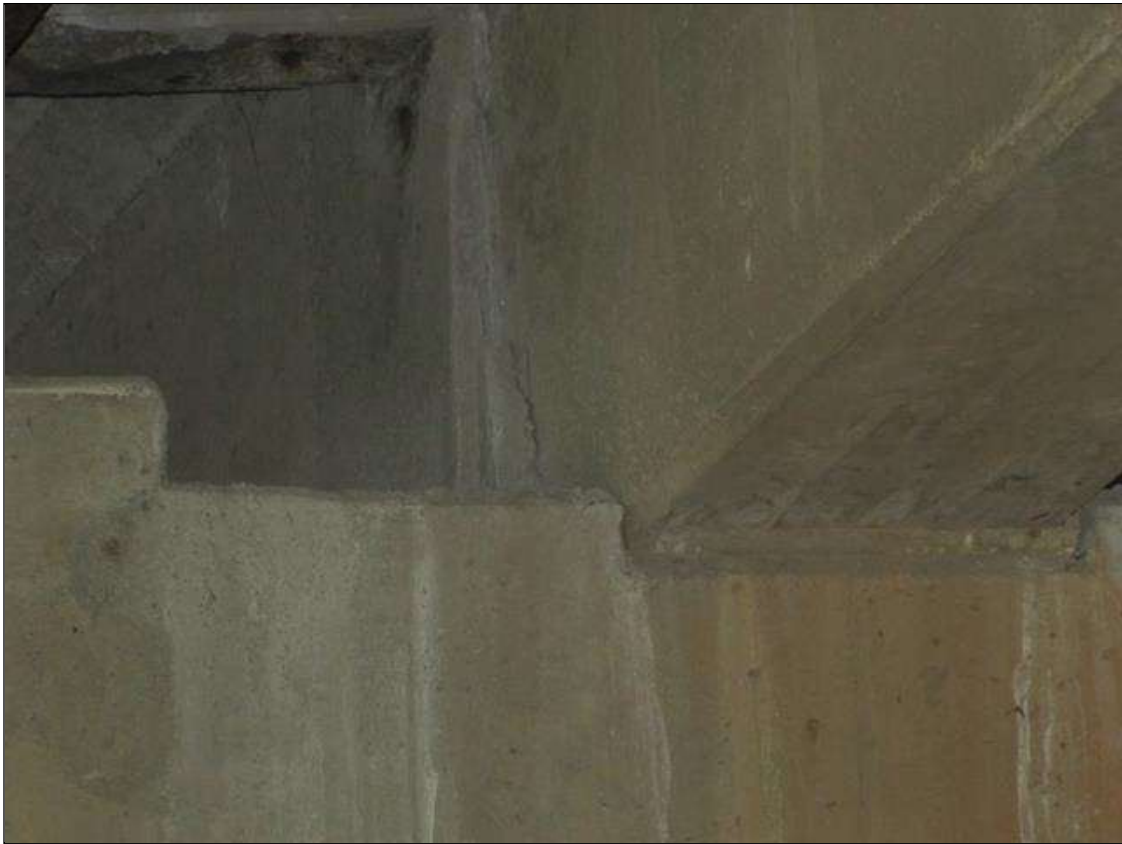
| Element Number | Defect Type | Defect Description | CS | CS Qty | Maint Qty |
|---|---|---|---|---|---|
| 110 | Delamination/Spall | 4" X 2" DELAMINATION WITH IMMINENT SPALL, SOUTH FACE, AT BENT 2. | 2 | 1 | 1 Feet |

Span 3 Beam 6: 4" X 2" DELAMINATION WITH IMMINENT SPALL, SOUTH FACE, AT BENT 2
