NC DEPARTMENT OF TRANSPORTATION  
DIVISION OF HIGHWAYS  
STRUCTURE MANAGEMENT UNIT

## Structure Safety Report

### Routine Element Inspection - Contract

COUNTY: WAKE STRUCTURE NUMBER: 910084 FREQUENCY: 24 MONTHS

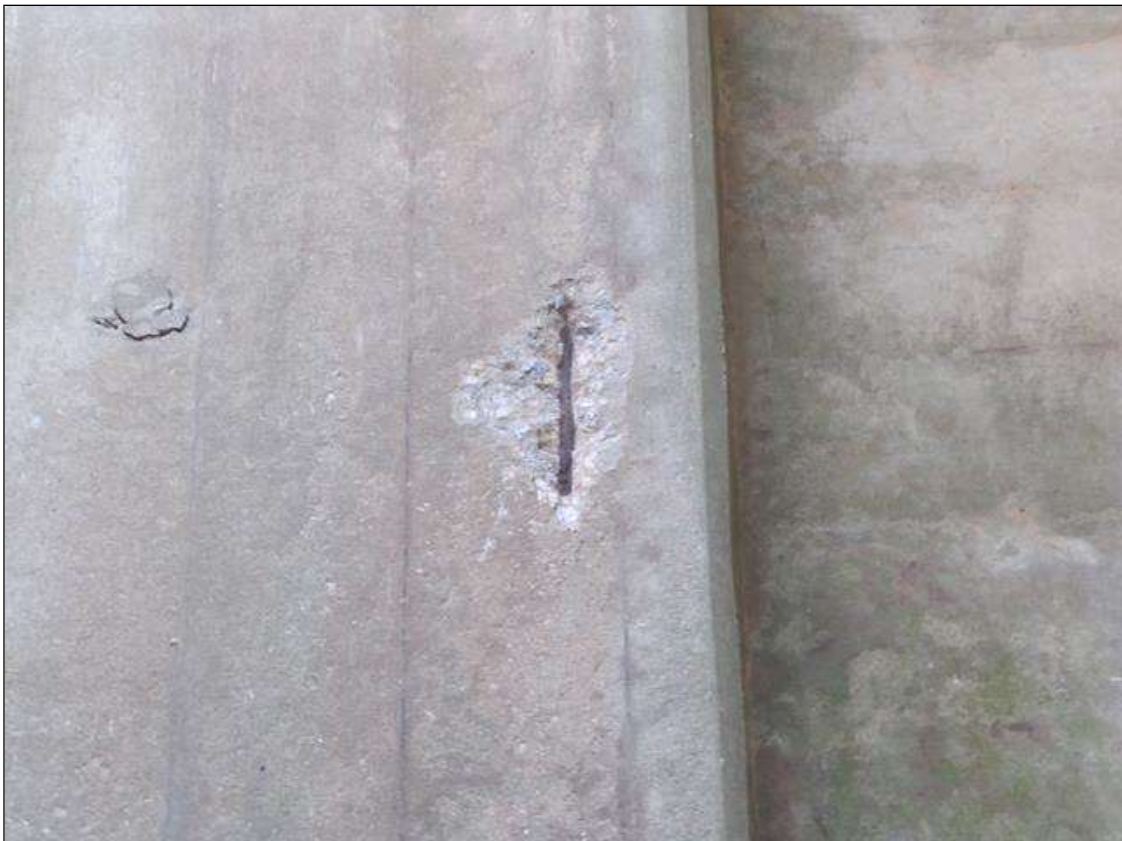
| Element Number | Defect Type | Defect Description | CS | CS Qty | Maint Qty | |
|---|---|---|---|---|---|---|
| 205 | Delamination/Spall | 1FT X 8IN X 1IN DEEP SPALL WITH EXPOSED REINFORCING, SOUTHWEST CORNER, 10FT FROM GROUND (PRIORITY MAINTENANCE). | 3 | 1 | 2 | Each |

Bent 2 Pile 1: 1FT X 8IN X 1IN SPALL WITH EXPOSED REINFORCING, SOUTHWEST CORNER, 10FT FROM GROUND (PRIORITY MAINTENANCE).

| MMS Code | Description of Function | Unit | Quantity | Remarks | Est. Cost |
|---|---|---|---|---|---|
| 3348 | Maintain Concrete Substructure Components | LF | 2 | Bent 2 Pile 1: 1FT X 8IN X 1IN DEEP SPALL WITH EXPOSED REINFORCING, SOUTHWEST CORNER, 10FT FROM GROUND (PRIORITY MAINTENANCE). | |

| MMS Code | MMS Description | Quantity |
|---|---|---|
| Bent 2 Pile 1: 1FT X 8IN X 1IN DEEP SPALL WITH EXPOSED REINFORCING, SOUTHWEST CORNER, 10FT FROM GROUND (PRIORITY MAINTENANCE). | | |

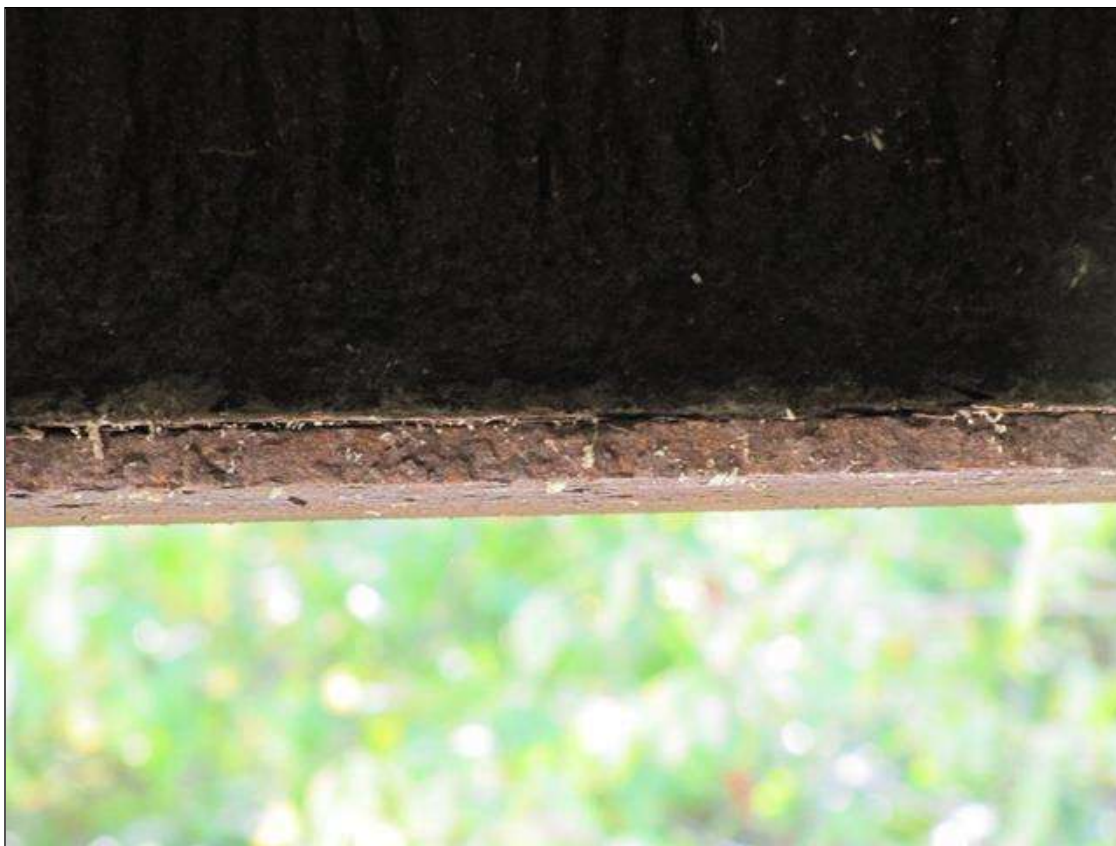
| Element Number | Defect Type | Defect Description | CS | CS Qty | Maint Qty |
|---|---|---|---|---|---|
| 107 | Corrosion | 4FT AREA OF SURFACE CORROSION, BOTTOM FLANGE WITH SCALE AT BENT 2, NO LOSS. | 2 | 4 | Feet |

Span 3 Beam 9: 4FT AREA OF SURFACE CORROSION, BOTTOM FLANGE WITH SCALE AT BENT 2, NO LOSS.

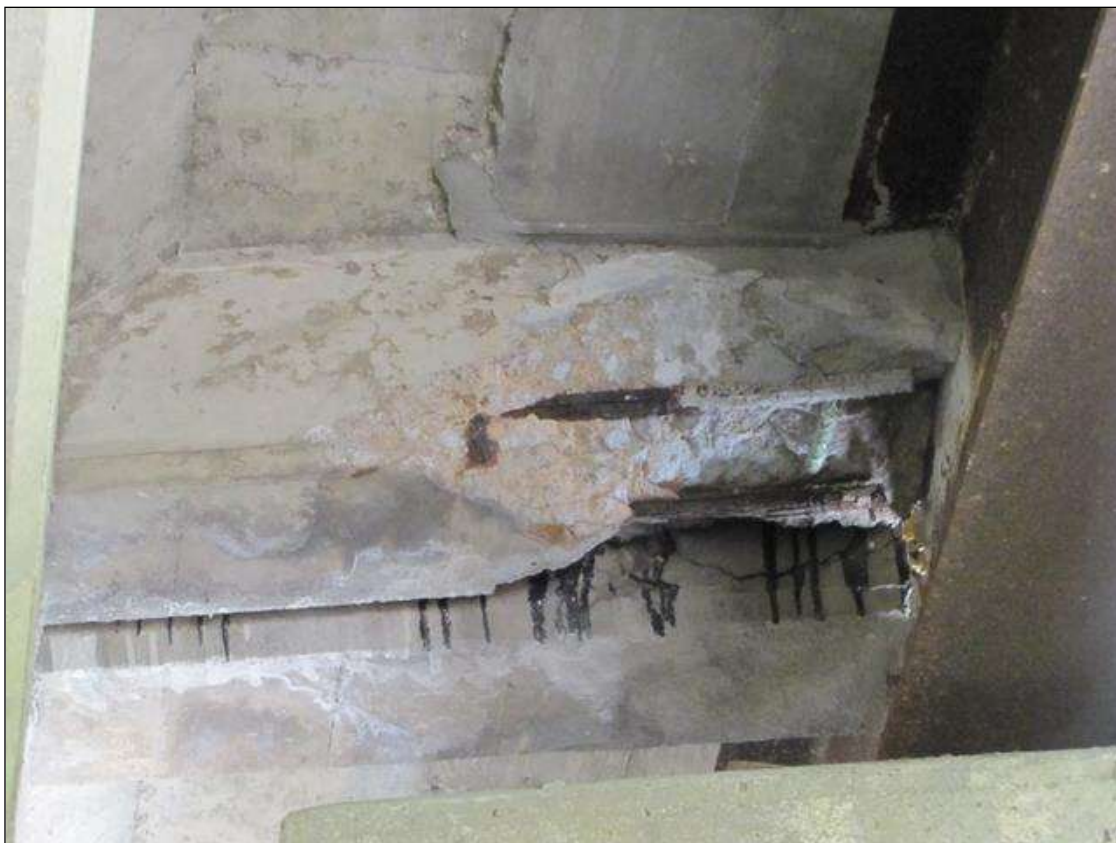
| Element Number | Defect Type | Defect Description | CS | CS Qty | Maint Qty |
|---|---|---|---|---|---|
| 110 | Delamination/Spall | 15IN X 6IN X 4IN SPALL WITH EXPOSED REINFORCING IN END DIAPHRAGM IN BAY 6 AT BENT 3. | 3 | 1 | 1 Feet |

Span 3 Beam 6: 15IN X 6IN X 4IN SPALL WITH EXPOSED REINFORCING, END DIAPHRAGM BAY 6 AT BENT 3.

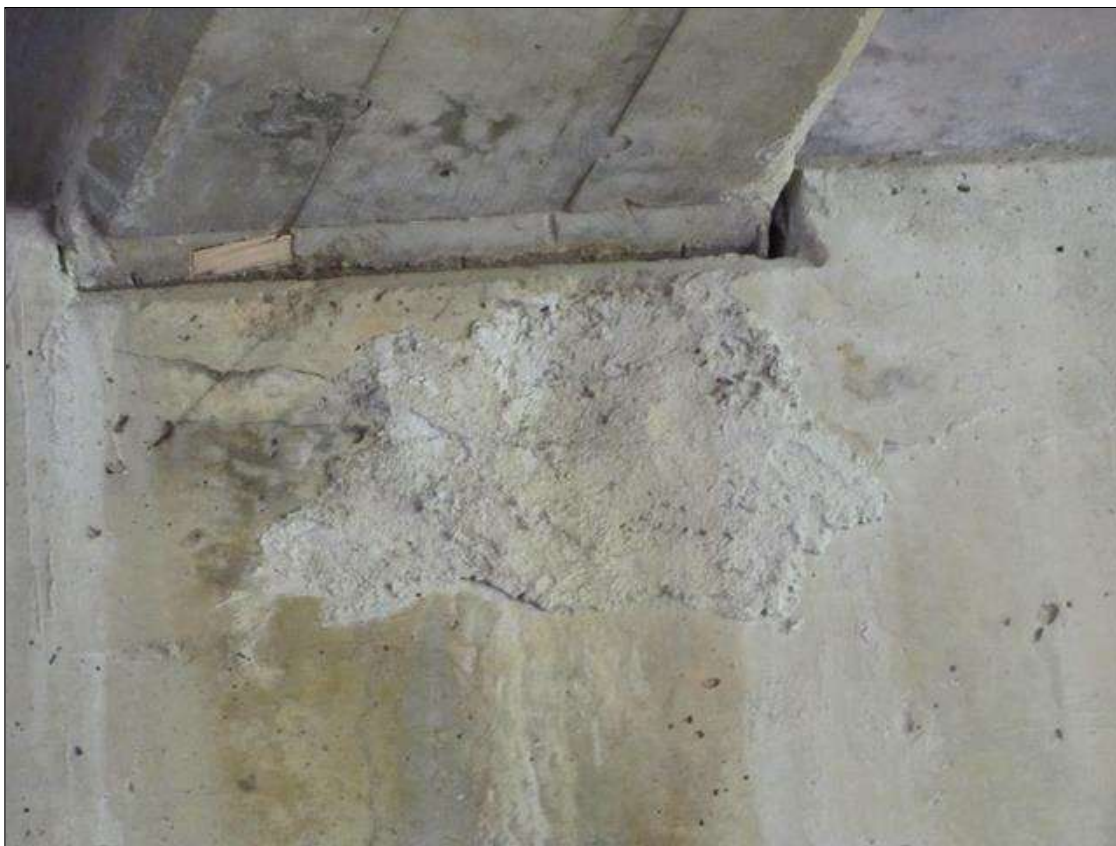
Bent 3 Cap 2: 2FT X 1FT SOUND PATCH, WEST FACE AT BEAM 4.

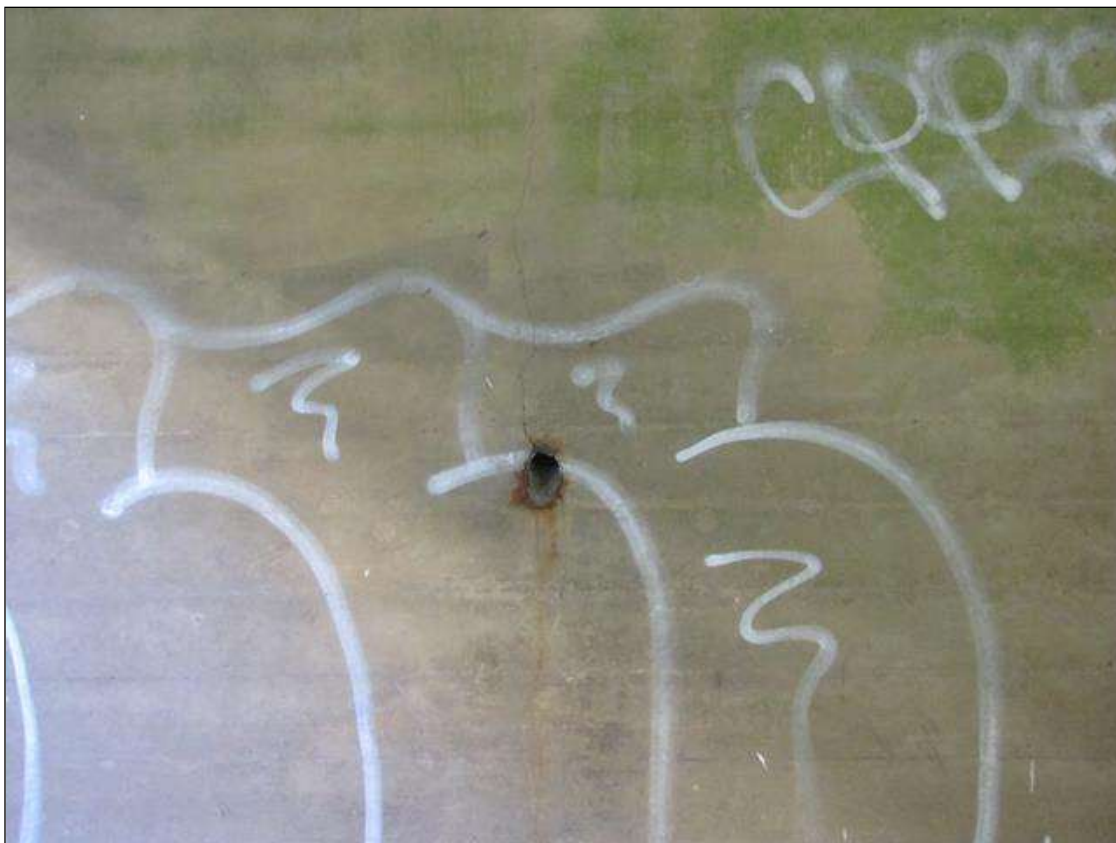
| Element Number | Defect Type | Defect Description | CS | CS Qty | Maint Qty | |
|---|---|---|---|---|---|---|
| 210 | Cracking (RC and Other) | (2) 9' VERTICAL CRACKS UP TO 1/16", (1) EACH FACE, MIDDLE OF PIER WALL. | 2 | 2 | 20 | Feet |

Bent 3 Pile 2: (2) 9' VERTICAL CRACKS UP TO 1/16", (1) EACH FACE, MIDDLE OF PIER WALL.

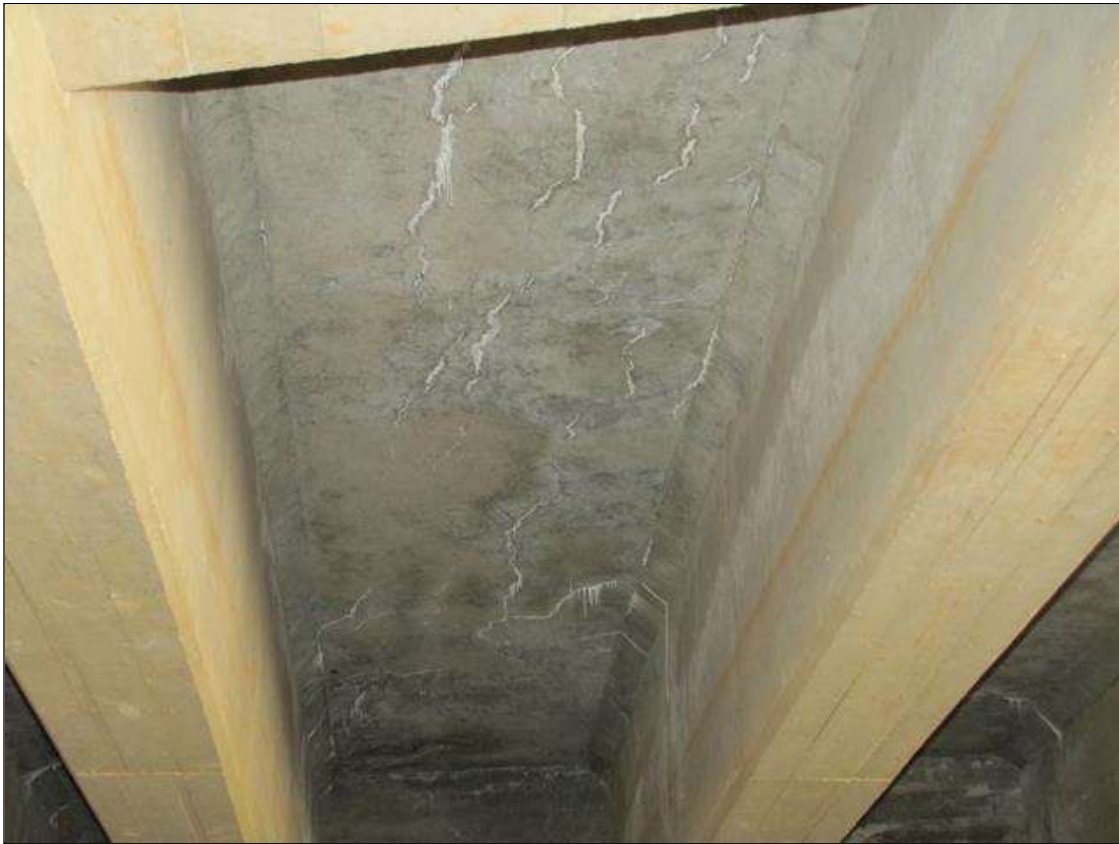
| Element Number | Defect Type | Defect Description | CS | CS Qty | Maint Qty |
|---|---|---|---|---|---|
| 12 | Cracking (RC and Other) | 60 SOUTH FACE MAP CRACKS WITH EFFLORESCENCE, UNDERSIDE BAYS 4 AND 5. | 2 | 60 | 60 Square Feet |

Span 4 Deck: 60 SOUTH FACE MAP CRACKS WITH EFFLORESCENCE, UNDERSIDE BAYS 4 AND 5.

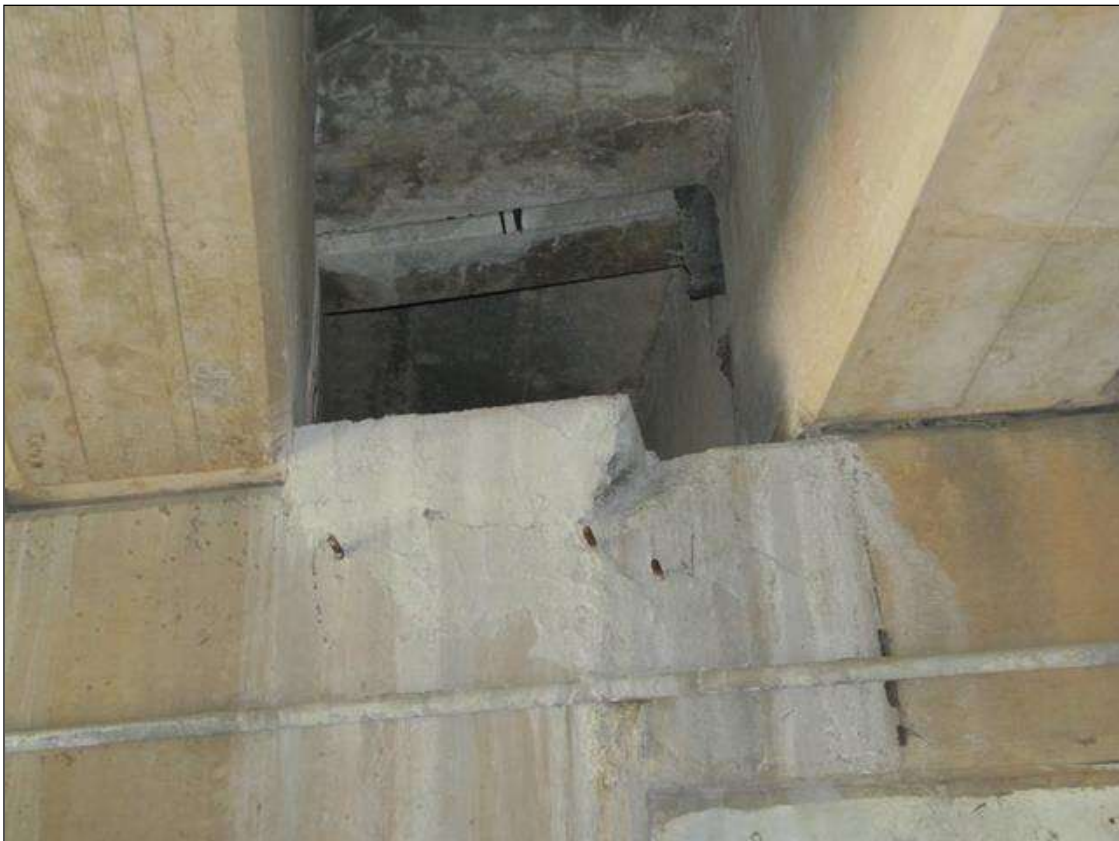
Bent 3 Cap 2: 1FT X 1FT SOUND PATCH, EAST FACE AT BEAM 4,

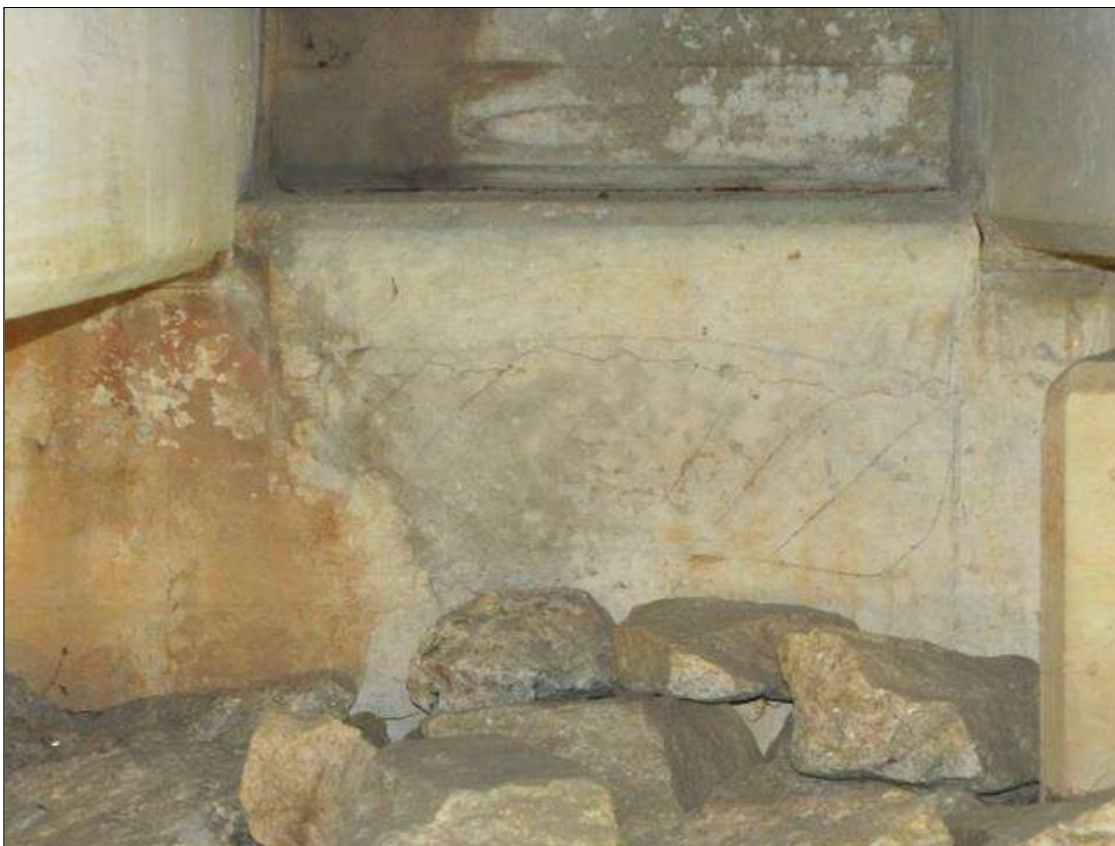
| Element Number | Defect Type | Defect Description | CS | CS Qty | Maint Qty | |
|---|---|---|---|---|---|---|
| 234 | Delamination/Spall | 2'-6" X 9" DELAMINATION, WEST FACE OF CAP, BELOW BAY 3. | 2 | 3 | 3 | Feet |

End Bent 2 Cap 1: 2'-6" X 9" DELAMINATION, WEST FACE OF CAP, BELOW BAY 3.

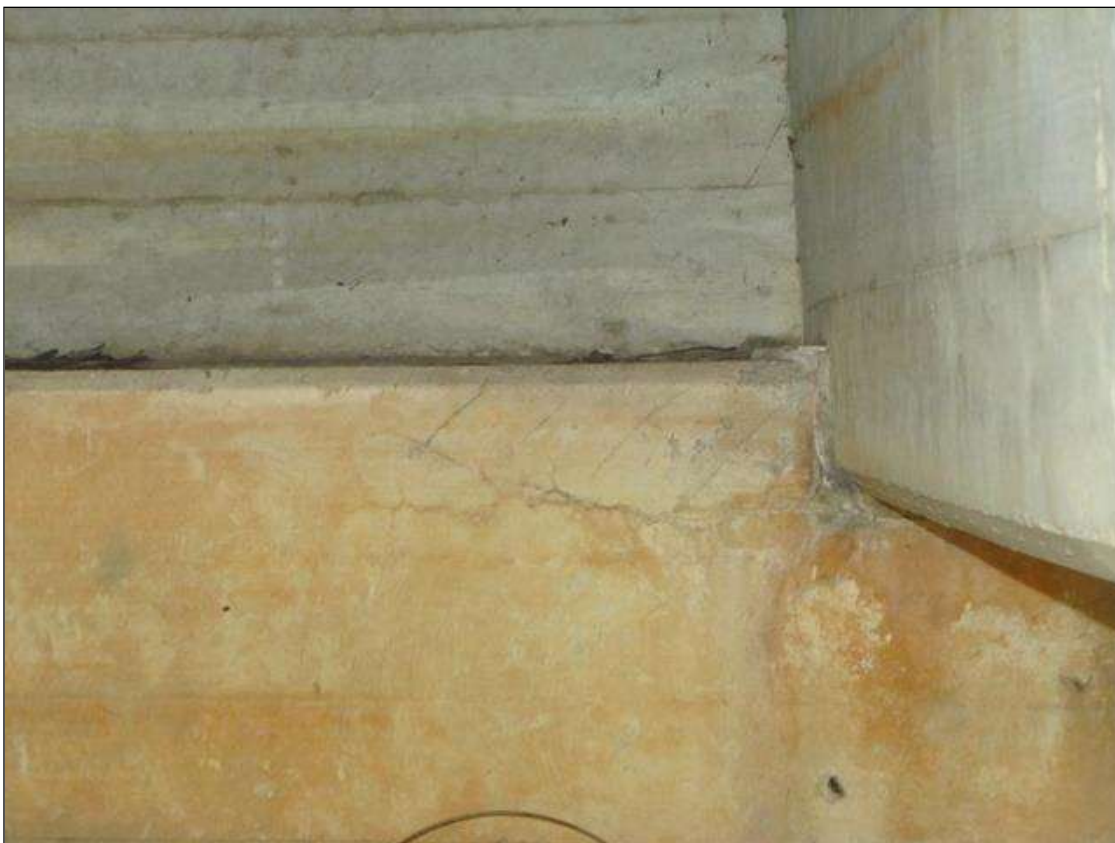
| Element Number | Defect Type | Defect Description | CS | CS Qty | Maint Qty | |
|---|---|---|---|---|---|---|
| 234 | Delamination/Spall | 20" X 7" X 15" DELAMINATION, TOP OF CAP, BELOW BAY 2, NEXT TO GIRDER 3. | 2 | 2 | 2 | Feet |

End Bent 2 Cap 1: 20" X 7" X 15" DELAMINATION, TOP OF CAP, BELOW BAY 2, NEXT TO GIRDER 3.

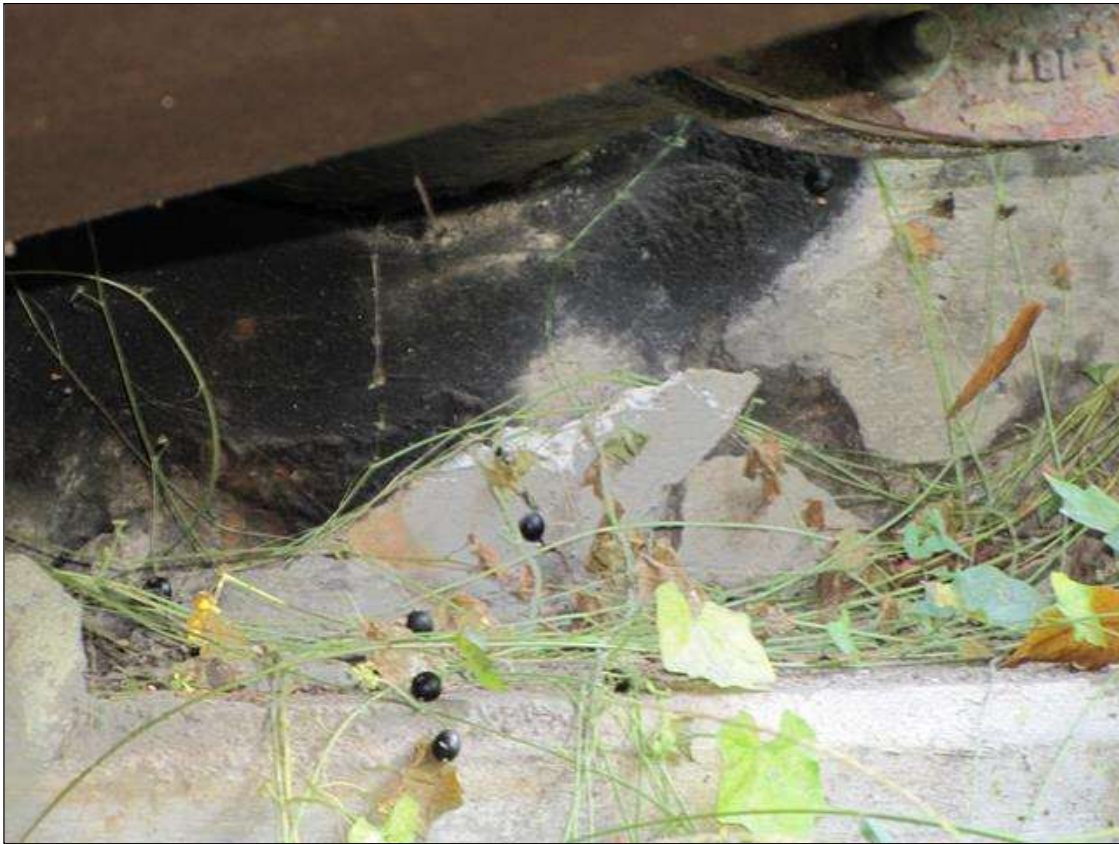
| Element Number | Defect Type | Defect Description | CS | CS Qty | Maint Qty | |
|---|---|---|---|---|---|---|
| 215 | Delamination/Spall | 2' X 6" X 1" SPALL, BOTTOM FACE OF CURTAIN WALL, BELOW UTILITY PENETRATION, OUTSIDE BEAM 9. | 3 | 2 | 2 | Feet |

End Bent 2 Abutment/Backwall : 2' X 6" X 1" SPALL, BOTTOM FACE OF CURTAIN WALL, BELOW UTILITY PENETRATION, OUTSIDE BEAM 9.

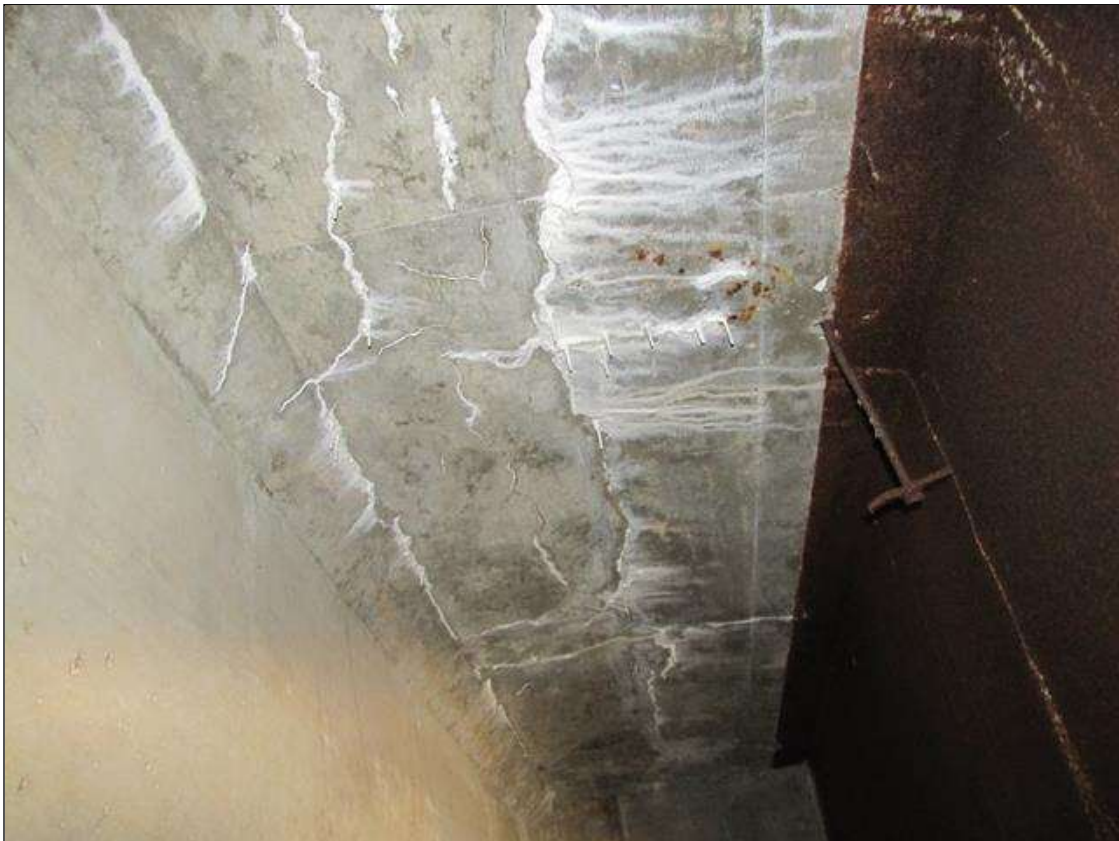
| Element Number | Defect Type | Defect Description | CS | CS Qty | Maint Qty |
|---|---|---|---|---|---|
| 12 | Cracking (RC and Other) | 6FTX 2FT AREA OF HAIRLINE MAP CRACKING WITH EFFLORESCENCE, UNDERSIDE BAY 6 AT END. | 2 | 12 | 12 Square Feet |

Span 4 Deck: 6FTX 2FT AREA OF HAIRLINE MAP CRACKING WITH EFFLORESCENCE, UNDERSIDE BAY 6 AT END.

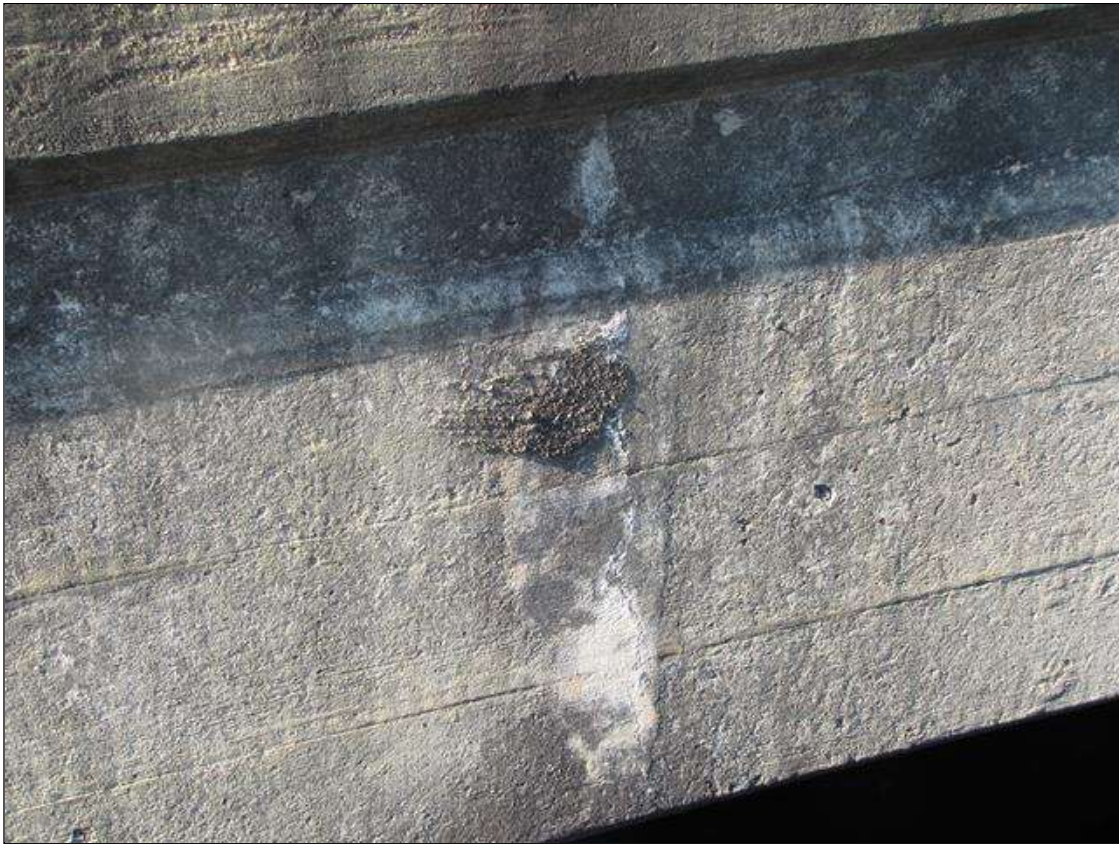
| Element Number | Defect Type | Defect Description | CS | CS Qty | Maint Qty | |
|---|---|---|---|---|---|---|
| 12 | Cracking (RC and Other) | VERTICAL CRACK UP TO 1/32IN WIDE, LEFT EDGE AT MIDSPAN. | 2 | 1 | 1 | Square Feet |

Span 2 Deck: VERTICAL CRACK UP TO 1/32IN WIDE, LEFT EDGE AT MIDSPAN.

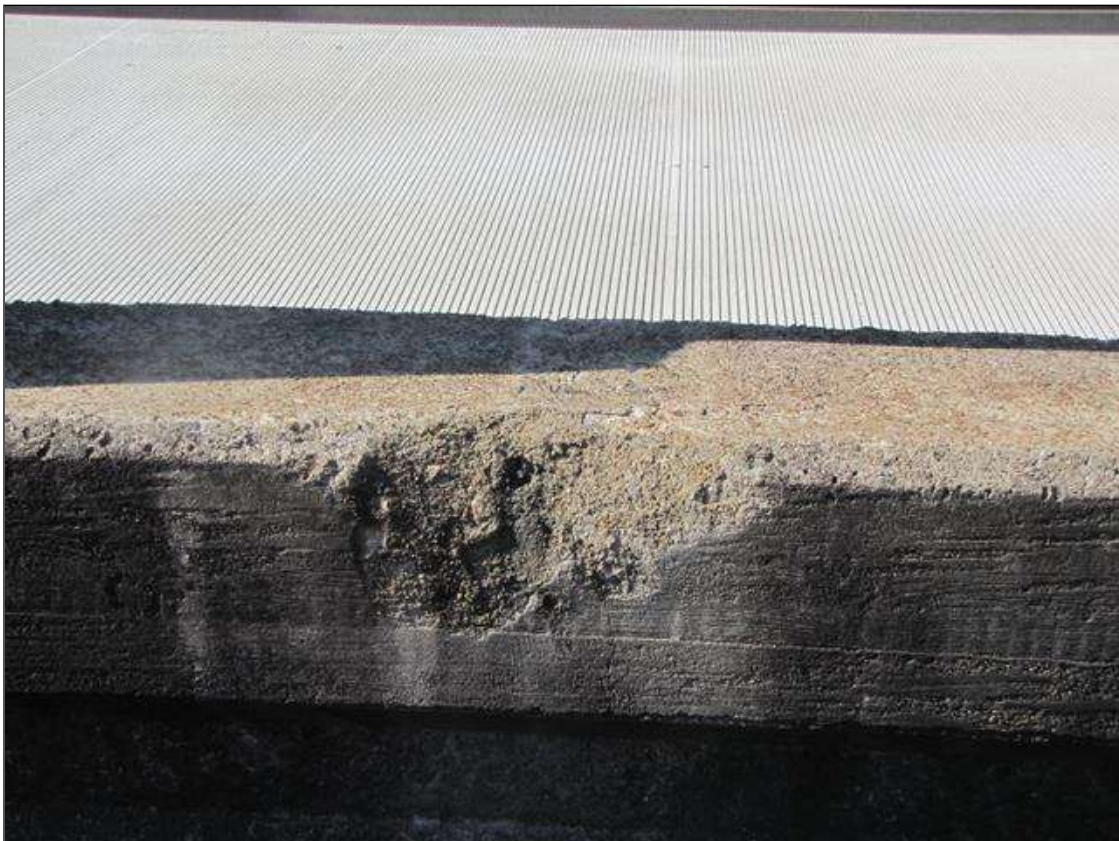
| Element Number | Defect Type | Defect Description | CS | CS Qty | Maint Qty | |
|---|---|---|---|---|---|---|
| 333 | Delamination/Spall | 8IN X 4IN X 1IN DEEP SPALL, IN BACK FACE OF CURB, NEAR MIDSPAN. | 3 | 1 | 1 | Feet |

Span 2 Left Bridge Rail: 8IN X 4IN X 1IN DEEP SPALL IN BACK FACE OF CURB, NEAR MIDSPAN.

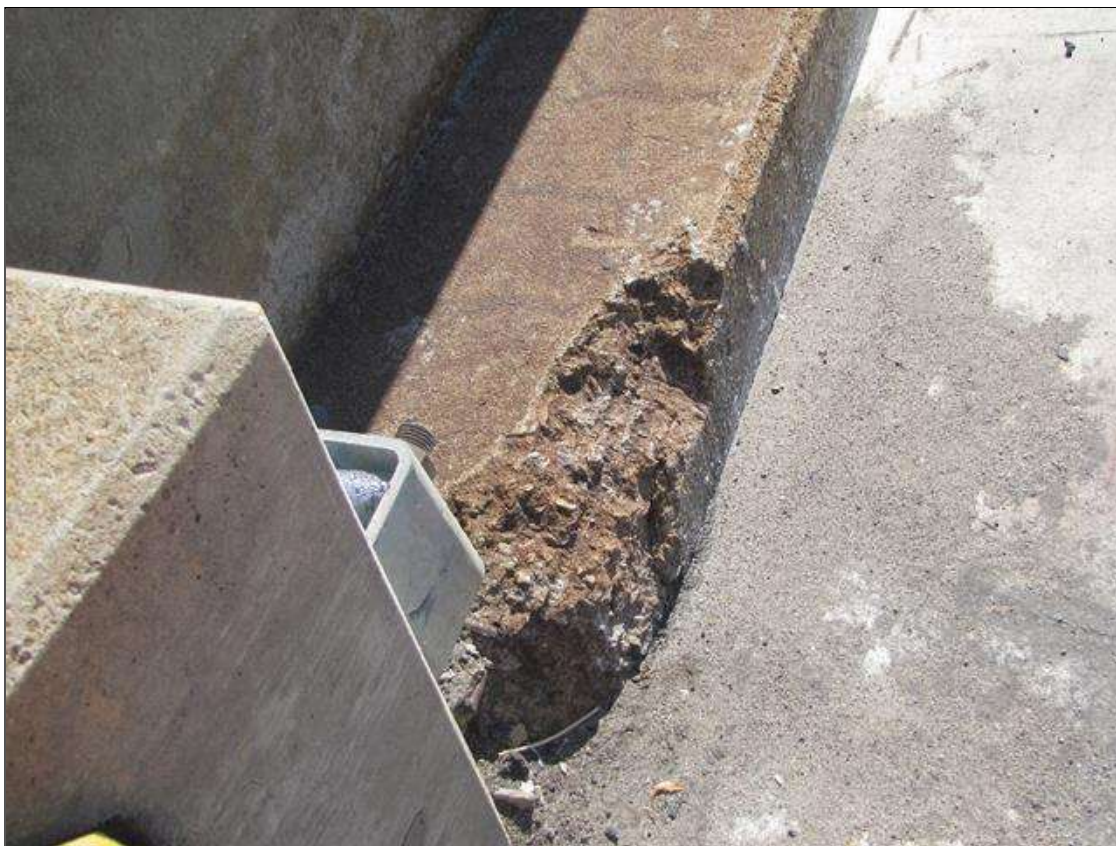
| Element Number | Defect Type | Defect Description | CS | CS Qty | Maint Qty | |
|---|---|---|---|---|---|---|
| 333 | Delamination/Spall | 24IN X 12IN X 3IN DEEP SPALL IN TRAFFIC FACE OF CURB, AT END BENT 1. | 3 | 2 | 2 | Feet |

Span 1 Right Bridge Rail: 24IN X 12IN X 3IN DEEP SPALL IN TRAFFIC FACE OF CURB, AT END BENT 1.

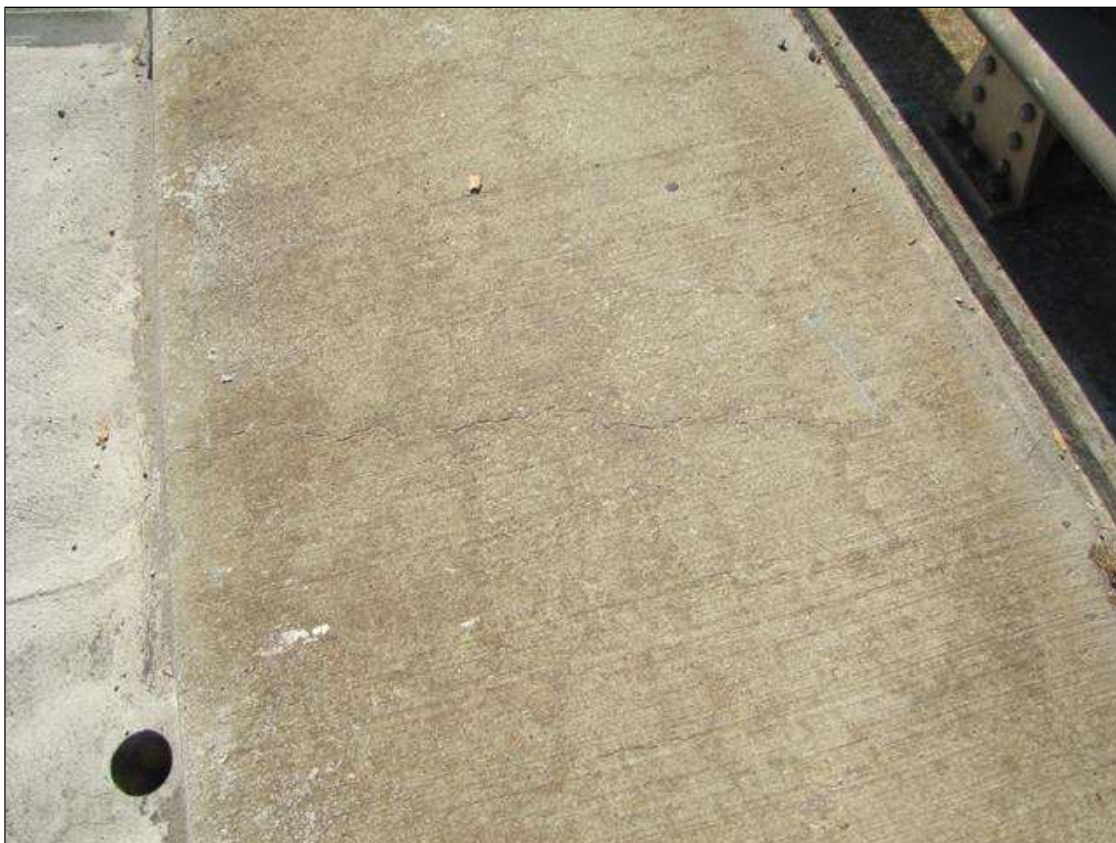
CRACK IN SIDEWALK (SPAN 3).
