# BRIDGE INSPECTION REPORT

INSPECTION TYPE: Routine Inspection

COUNTY WAKE BRIDGE NUMBER 910091 INSPECTION CYCLE 2 YRS

ROUTE US70 ACROSS CRABTREE CREEK M.P. 0

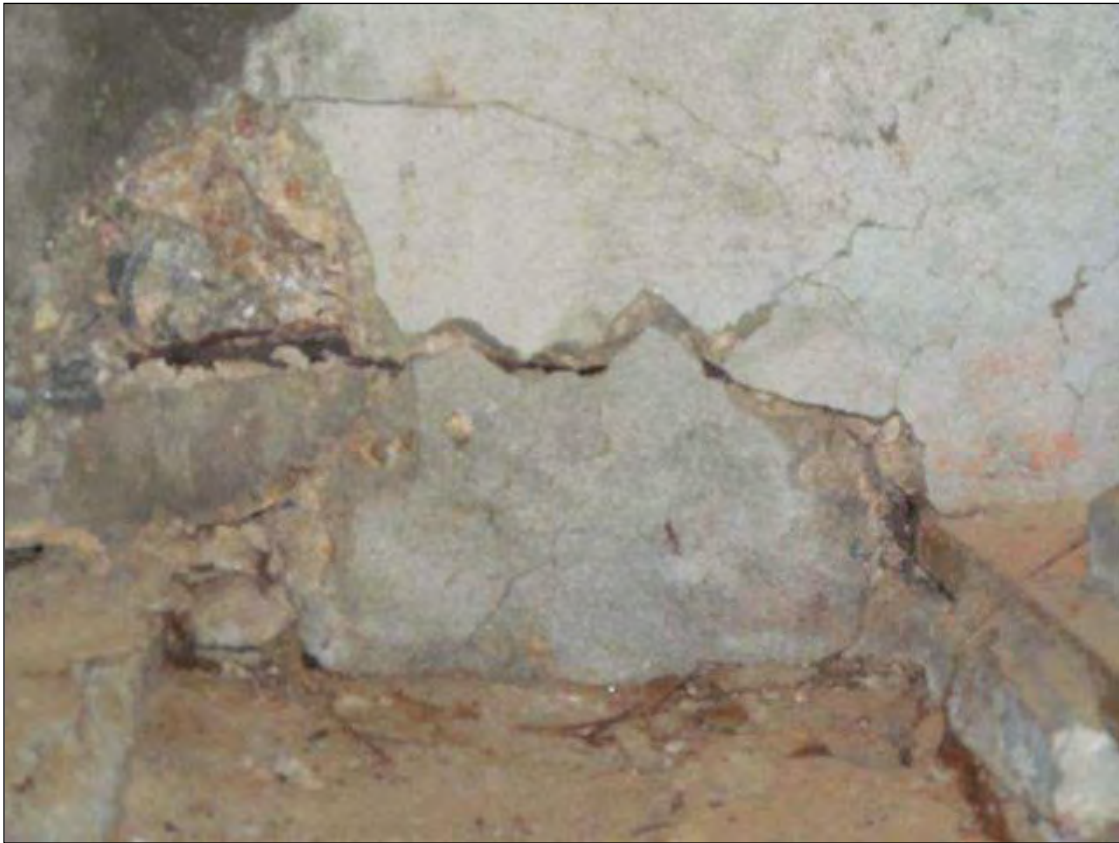
| Bridge I&A Form 1(82)H<br>State of North Carolina<br>Dept. of Transportation<br>Division of Highways | | <h1 style="text-align: center;">FIELD INSPECTION REPORT</h1> <p style="text-align: center;"><u>Bridge Inspection &amp; Analysis</u></p> | |
|---|---|---|--|
| 13 | F | END DIAPHRAGMS:<br>- PREVIOUSLY NOTED DEFECTS HAVE BEEN REPAIRED WITH EPOXY AND CEMENT.<br><br>- END BENT 1, BAY 12, CURTAIN WALL SPALLING AND DELAMINATING 5 IN. X 12 IN.<br>- END BENT 1, SOUTH OF GIRDER 14, CURTAIN WALL DELAMINATED 12 IN. X 12 IN. WITH SPALL OLD UT VOID NOT SPALLED. ( SEE PHOTO # 2778 )<br>- END BENT 2, SOUTH OF GIRDER 13, CURTAIN WALL SPALLED 5 IN. X 7 IN.<br>- END BENT 2, SOUTH OF GIRDER 14, CURTAIN WALL CRACKING AND DELAMINATING 12 IN. X 30 IN. | |

SPALL, CRACKS AND DELAMINATION IN BACKWALL BAY 12 END BENT 1

| MMS Code | Description of Function | Unit | Quantity | Remarks | Est. Cost |
|---|---|---|---|---|---|
| 3306 | Maintain Concrete Superstructure Components | SF | 50 | CONCRETE BEAMS AND DIAPHRAGMS CRACKED, DELAMINATED AND SPALLED. | |

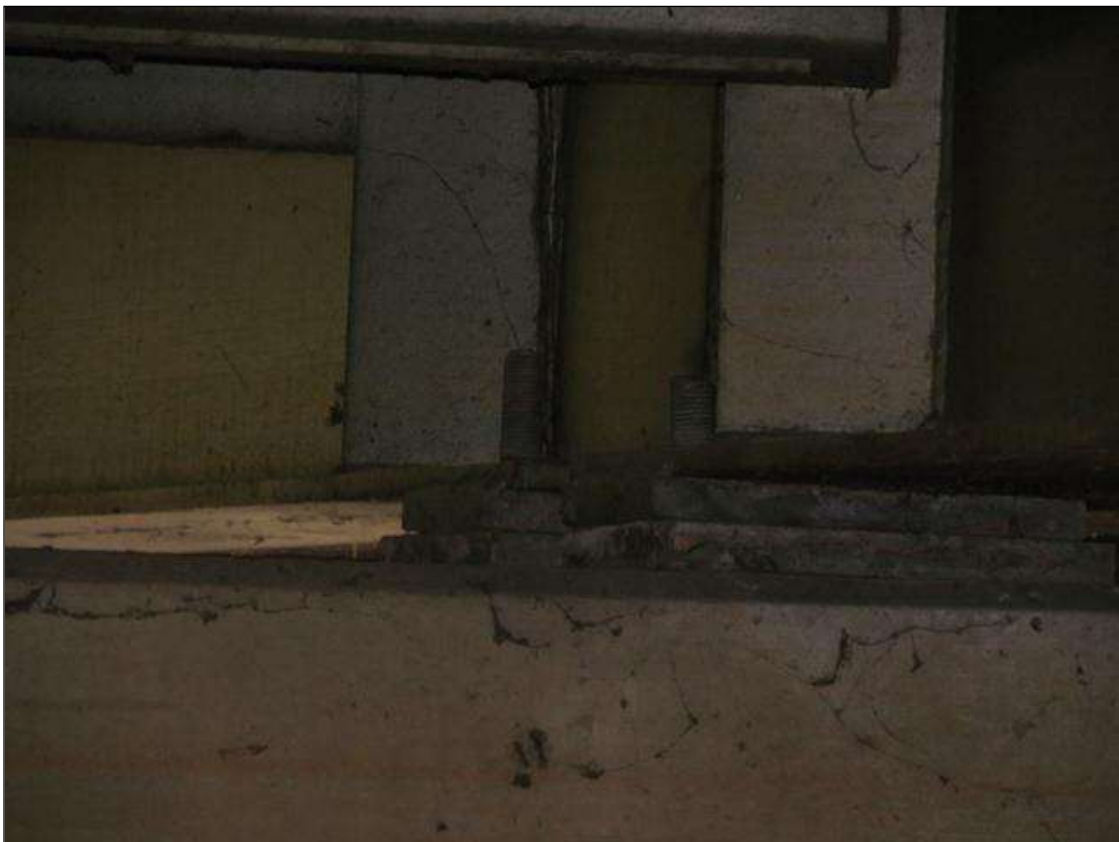
| Bridge I&A Form 1(82)H<br>State of North Carolina<br>Dept. of Transportation<br>Division of Highways | | <h1 style="text-align: center;">FIELD INSPECTION REPORT</h1> <p style="text-align: center;"><u>Bridge Inspection &amp; Analysis</u></p> | |
|---|---|---|--|
| 15 | G | BEARING ASSEMBLIES:<br>- BEAMS 12 AT BENT 1 SPANS 1 AND 2 HAS ( 3 ) ANCHOR BOLTS MISSING NUTS BETWEEN THE TWO BEAMS. | |

MISSING NUTS GIRDER 12 BENT 1 SPAN 1 AND SPAN 2

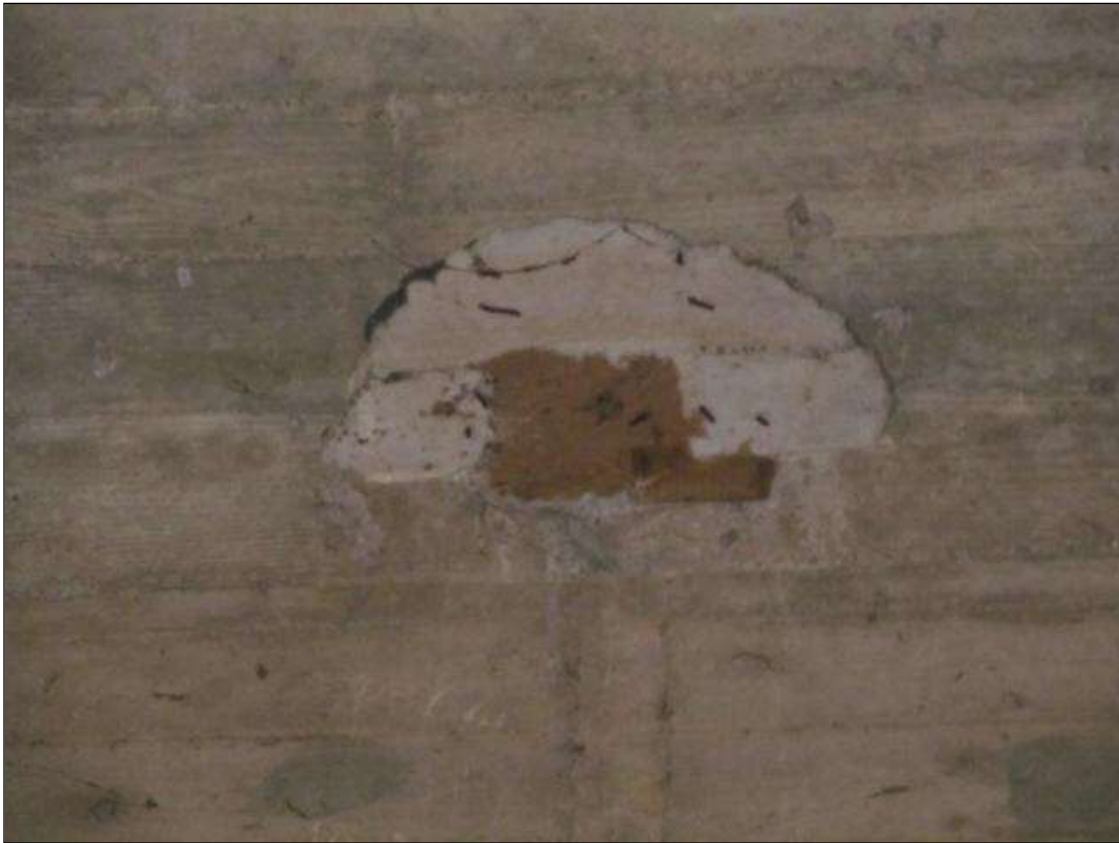
SPALL BAY 5 SPAN 3 (RANDOM BAY 5 SPAN 3)

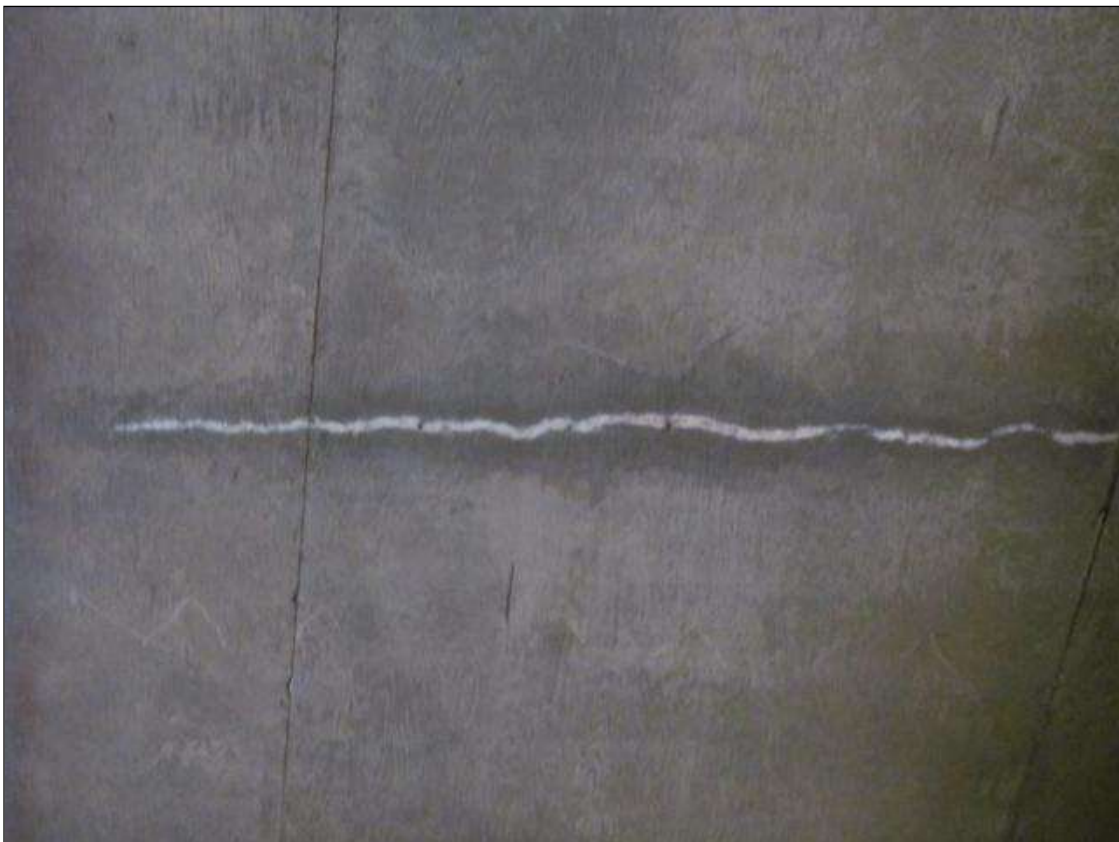
| Bridge I&A Form 1(82)H<br>State of North Carolina<br>Dept. of Transportation<br>Division of Highways | | <h1 style="text-align: center;">FIELD INSPECTION REPORT</h1> <p style="text-align: center;"><u>Bridge Inspection &amp; Analysis</u></p> | |
|---|---|---|--|
| 2a | F | CONCRETE DECK:<br>- UNDERSIDE OF DECK IN SPAN 2 HAS TRANSVERSE CRACKS WITH EFFLO. IN BAY 11, SIMILAR IN OTHER SPANS.<br>- TOP OF DECK IN SPAN 2 ALONG JOINT OVER BENT 2 HAS PATCHES NEAR CENTERLINE, 14 SQ.FT.<br>- TOP OF DECK HAS FEW SCATTERED TRANSVERSE H/L CRACKS NEAR BENT 3, SIMILAR NEAR OTHER BENTS.<br>- TOP OF DECK IN SPAN 4 HAS LARGE PATCH NEAR LEFT CURB AT EAST END OF DECK 48 SQ.FT. | |

TRANSVERSE CRACK WITH EFFLORESCENCE BOTTOM OF DECK BAY 3 SPAN 2 (RANDOM THROUGHOUT)

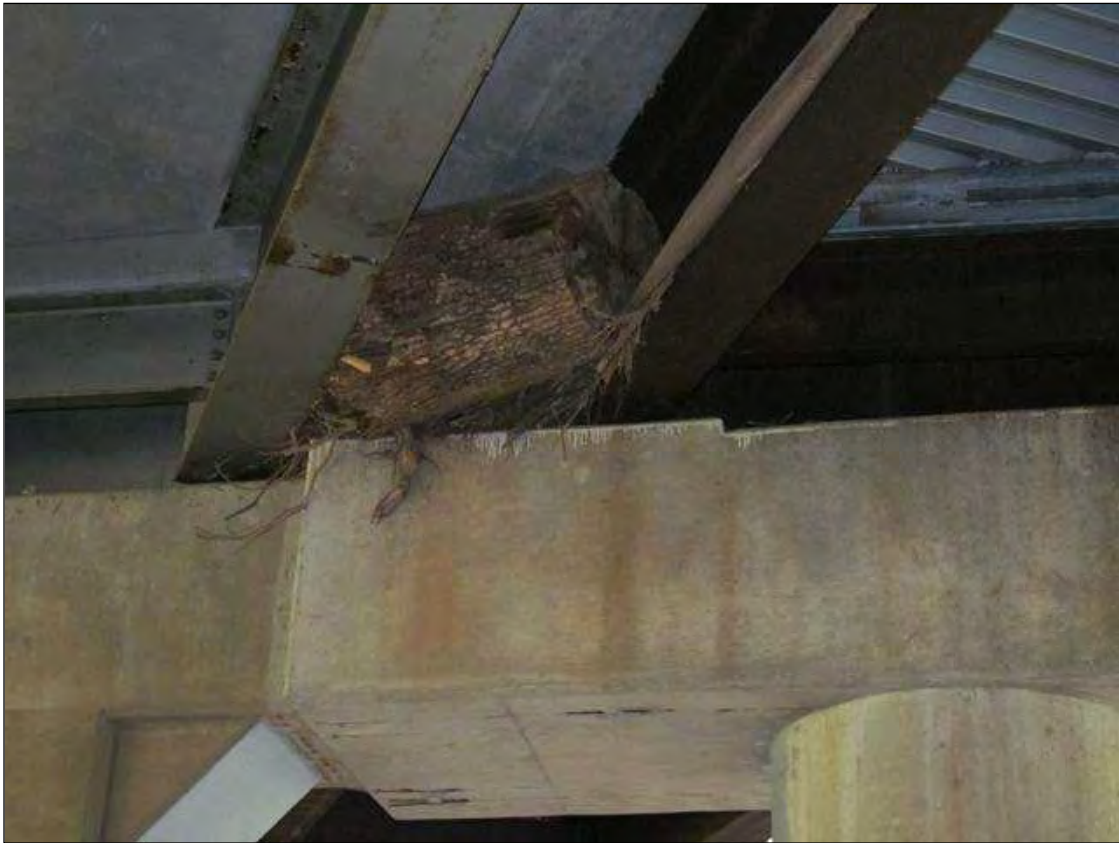
| Bridge I&A Form 1(82)H<br>State of North Carolina<br>Dept. of Transportation<br>Division of Highways | | <h1 style="text-align: center;">FIELD INSPECTION REPORT</h1> <p style="text-align: center;"><u>Bridge Inspection &amp; Analysis</u></p> | |
|---|---|---|--|
| 41 | F | DRIFT:<br>- DRIFT IN SUPERSTRUCTURE. | |

DRIFT BAY 2 BENT 1 SPAN 1

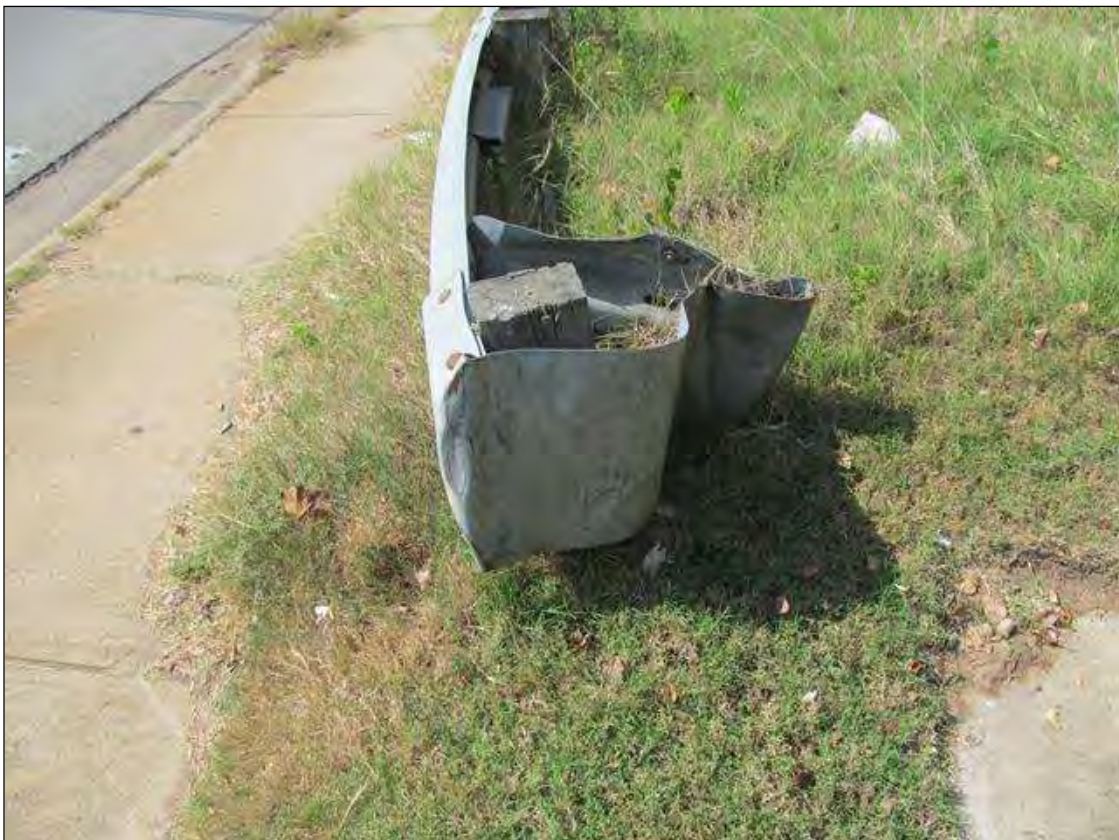
| Bridge I&A Form 1(82)H<br>State of North Carolina<br>Dept. of Transportation<br>Division of Highways | | <h1 style="text-align: center;">FIELD INSPECTION REPORT</h1> <p style="text-align: center;"><u>Bridge Inspection &amp; Analysis</u></p> | |
|---|---|---|--|
| 50 | F | APPROACH ROADWAY:<br>- WEST APPROACH CRACKING AND BREAKING UP ALONG END OF DECK.<br>- SOUTH APPROACH CRACKING AND BREAKING UP IN SPOTS NEAR END OF SPAN 4 DECK.<br>- GUARD RAIL TERMINAL END AT NE CORNER DAMAGED. | |

DAMAGED TERMINAL END OF GUARDRAIL NORTHEAST CORNER

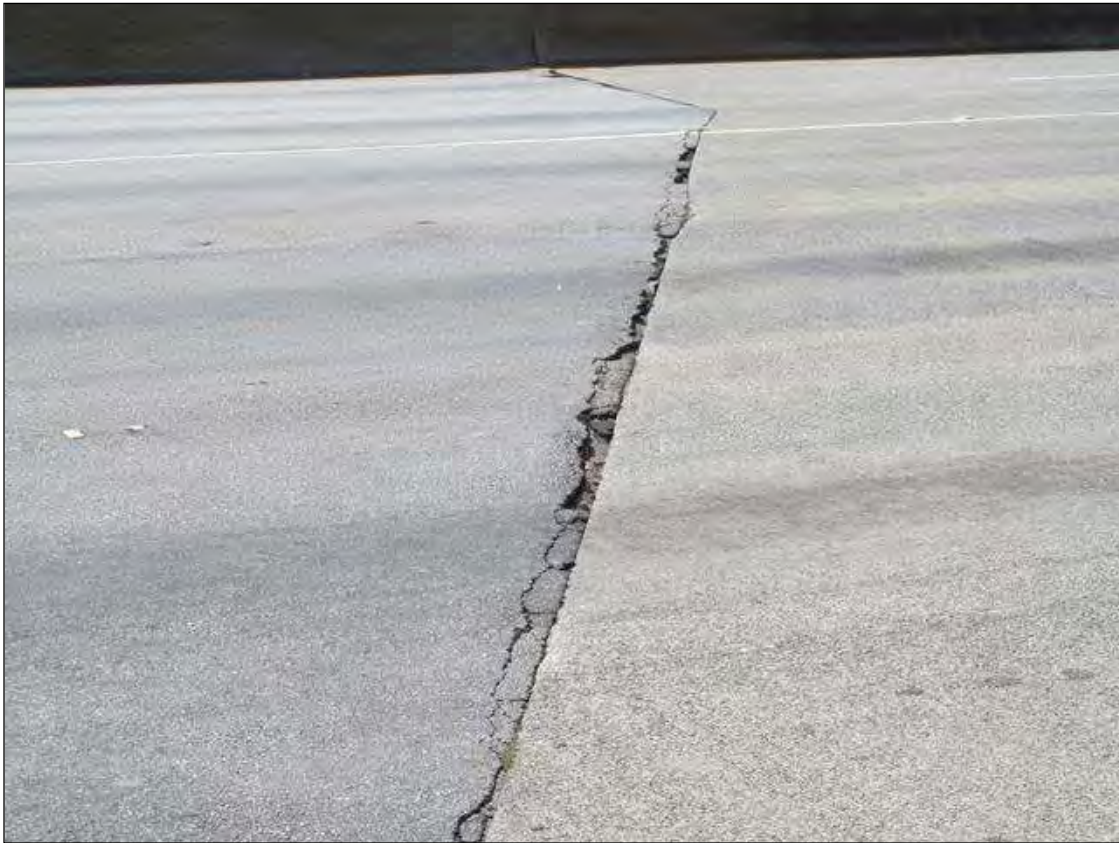
| Bridge I&A Form 1(82)H<br>State of North Carolina<br>Dept. of Transportation<br>Division of Highways | | <h1 style="text-align: center;">FIELD INSPECTION REPORT</h1> <p style="text-align: center;"><u>Bridge Inspection &amp; Analysis</u></p> | |
|---|---|---|--|
| 6d | F | STANDARD JOINTS:<br>- EXPANSION JOINTS ARE DETERIORATED AND ARE ALLOWING DRAINAGE ON TO THE SUBSTRUCTURE.<br>- EXPANSION JOINT AT END BENT 2 IS COVERED WITH AWS, CRACKING AND BREAKING UP OVER JOINT. | |

CRACKS VOIDS IN ASPHALT WEARING SURFACE END BENT 2 JOINT (END BENT 1 SIMILAR)

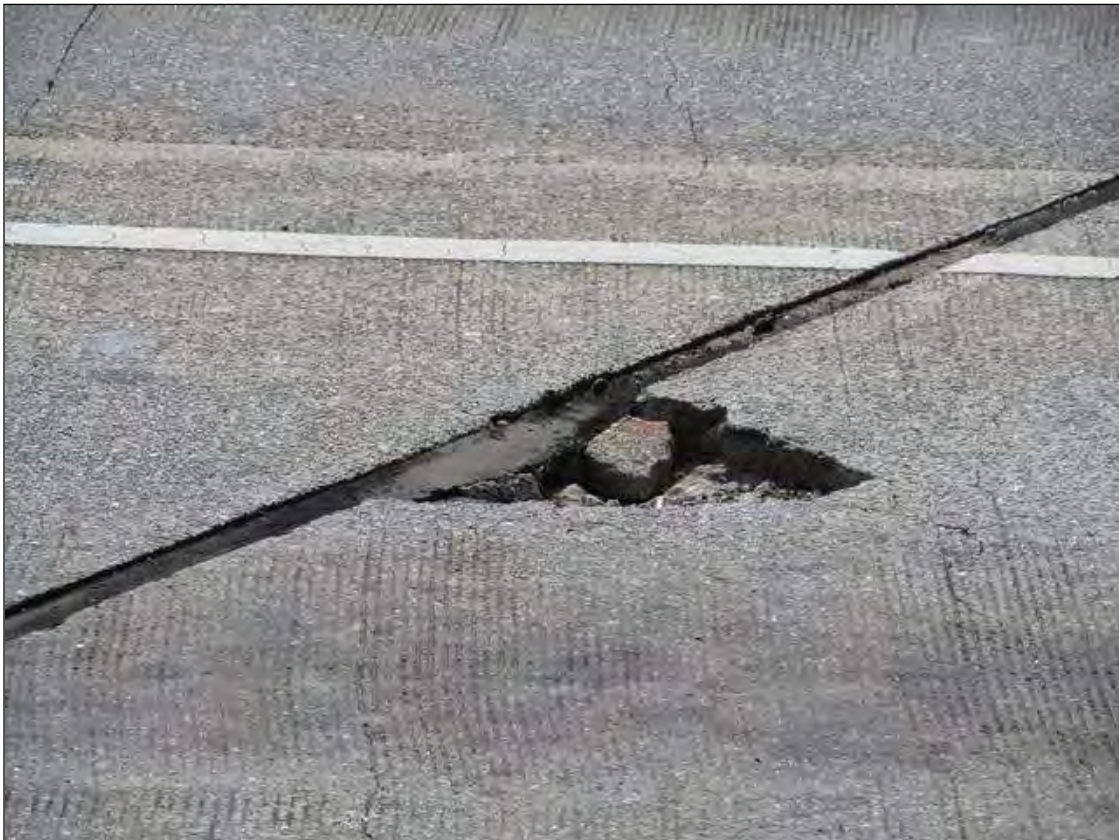
SPALL BENT 1 JOINT SPAN 1 SIDE

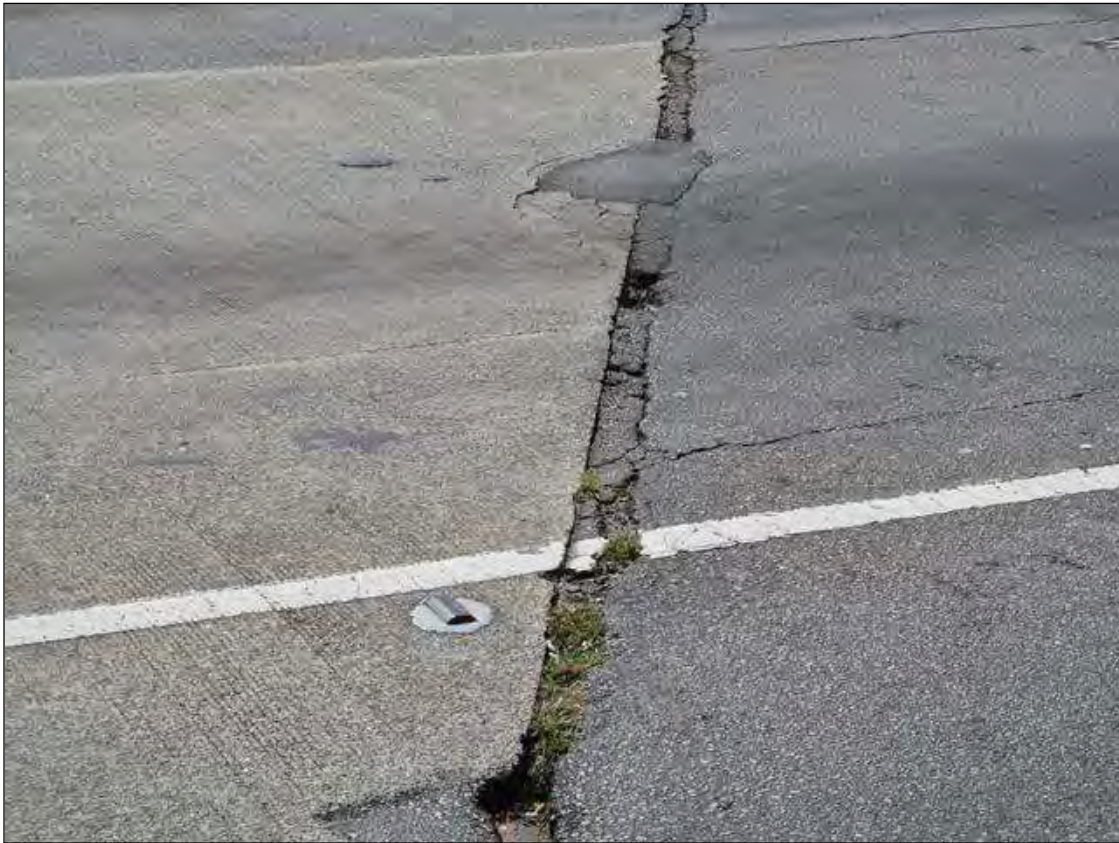
CRACKS AND VOIDS IN TOP OF DECK AND ASPHALT WEARING SURFACE END BENT 1 JOINT

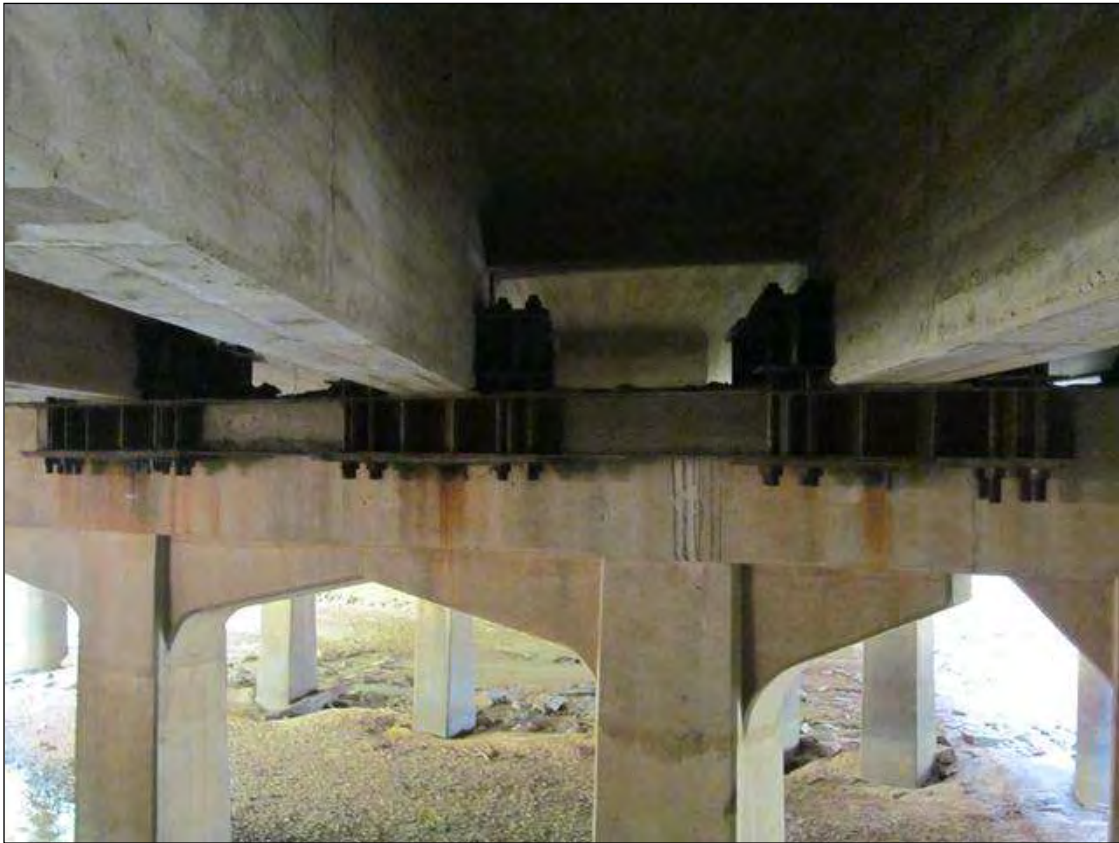
Steels Saddles have been placed under Beams 8, 9 & 10 @ Bt. 1 Span 1 side.

SADDLE SUPPORT BENT 1 GIRDERS 8 THROUGH 10

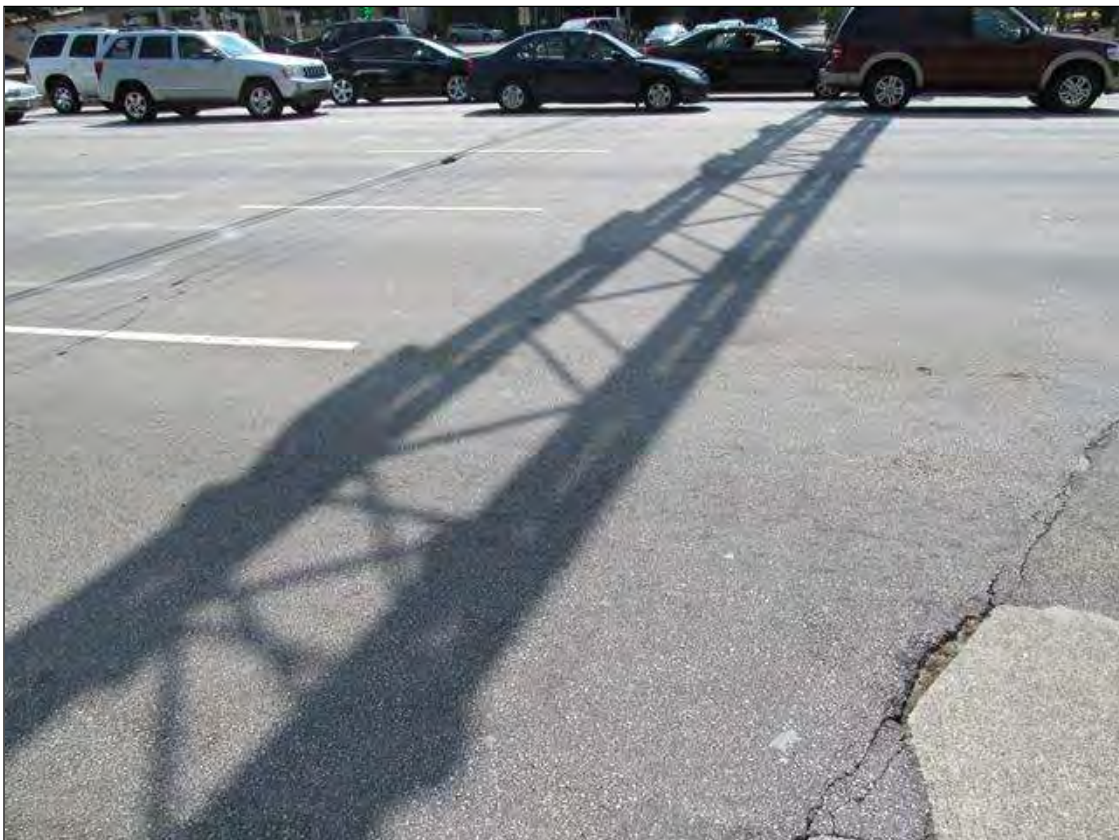
APPROACH ROADWAY ASPHALT WEARING SURFACE EAST END (OTHER END SIMILAR)

| MMS Code | Description of Function | Unit | Quantity | Remarks | Est. Cost |
|---|---|---|---|---|---|
| 2816 | Asphalt Surface Repair or Replacement | SY | 20 | APPROACHES CRACKING AND BREAKING UP AT EDGES OF DECK | |

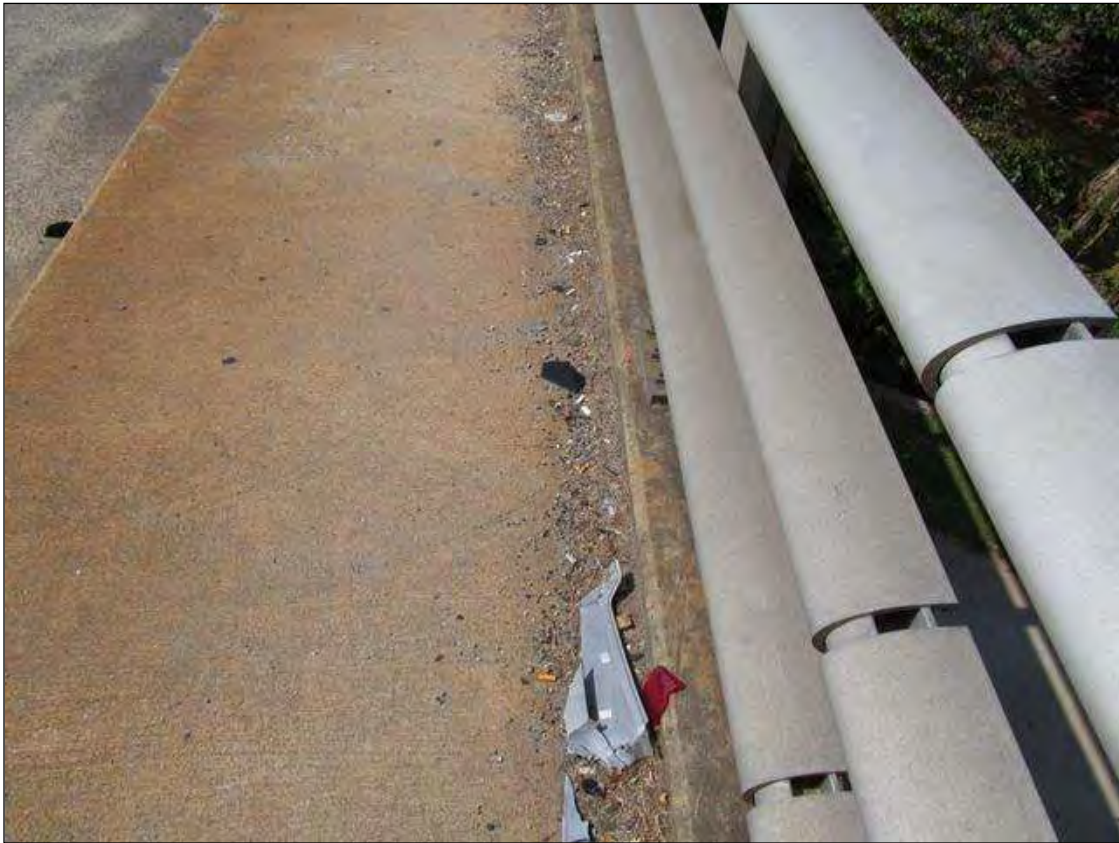
DIRT AND DEBRIS LEFT SIDEWALK
