NC DEPARTMENT OF TRANSPORTATION  
DIVISION OF HIGHWAYS  
STRUCTURE MANAGEMENT UNIT

## Structure Safety Report

### Routine Element Inspection - Contract

COUNTY: WAKE STRUCTURE NUMBER: 910091 FREQUENCY: 24 MONTHS

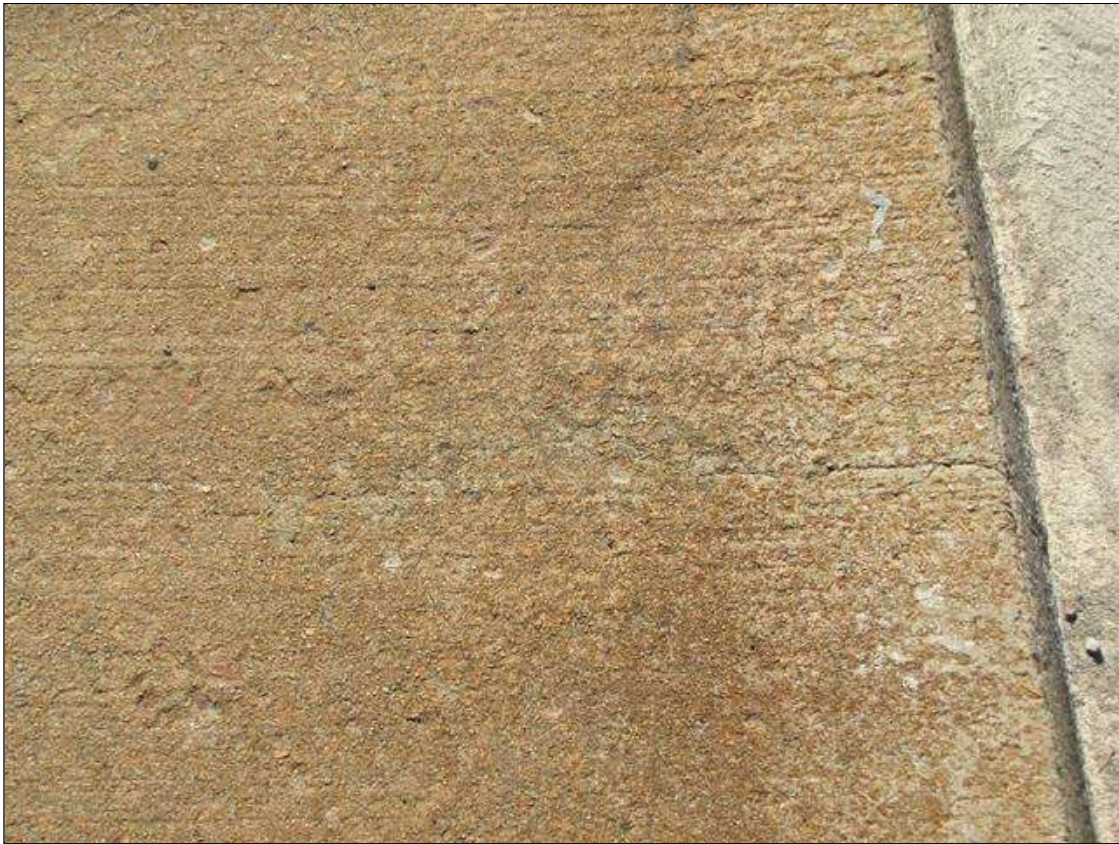
Details SIDEWALK CRACK IN SPAN 3.

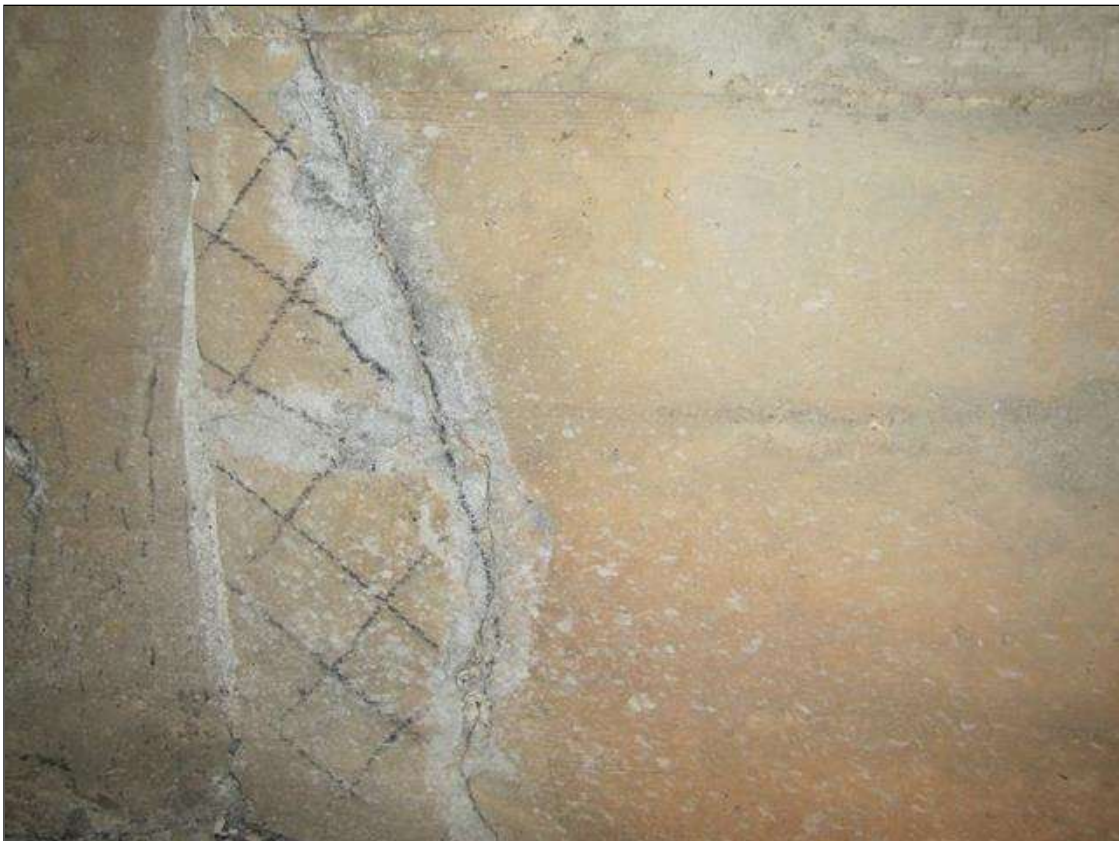
| Element Number | Defect Type | Defect Description | CS | CS Qty | Maint Qty | |
|---|---|---|---|---|---|---|
| 110 | Cracking (RC and Other) | DIAGONAL CRACK UP TO 1/32" WIDE IN RIGHT FACE AT BENT 3. | 2 | 1 | 1 | Feet |

Span 4 Beam 4: DIAGONAL CRACK UP TO 1/32" WIDE IN RIGHT FACE AT BENT 3.

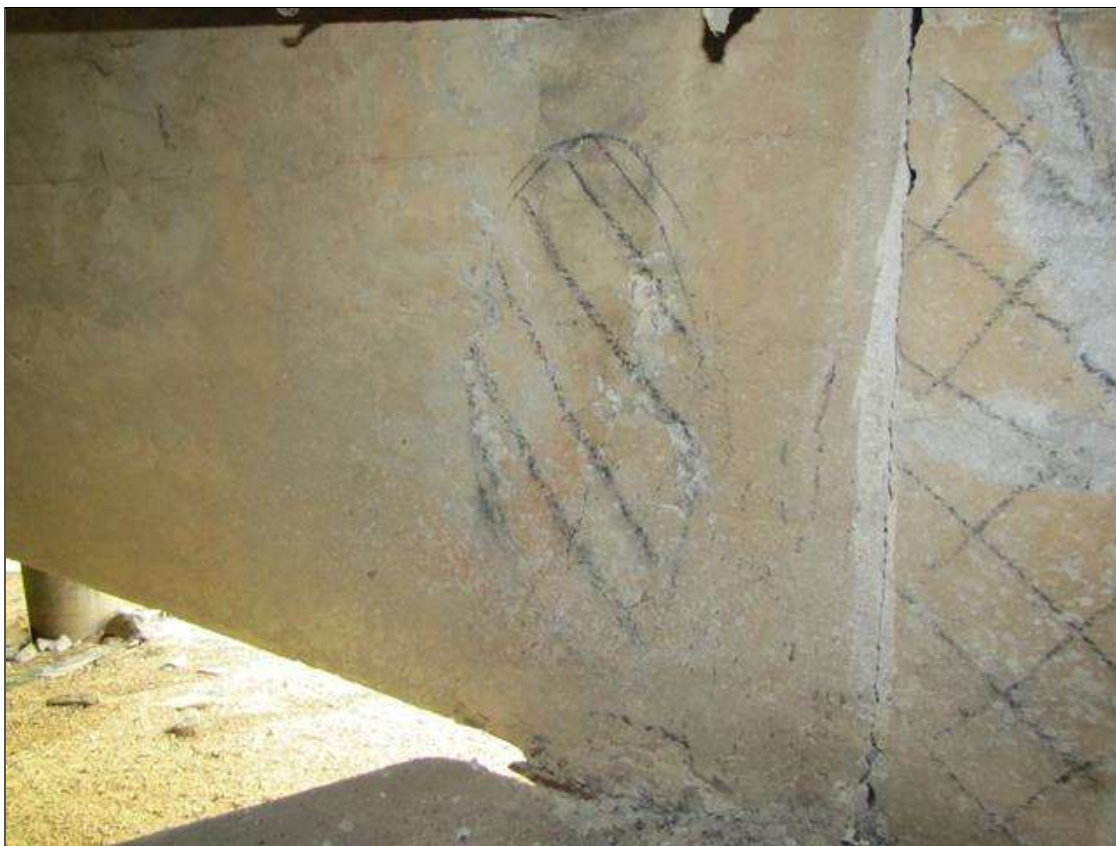
| Element Number | Defect Type | Defect Description | CS | CS Qty | Maint Qty |
|---|---|---|---|---|---|
| 110 | Patched Area | 9 IN X 24 IN DELAMINATED PATCH WITH CRACKS UP TO 1/8" WIDE IN RIGHT FACE AT BENT 3. | 3 | 1 | 1 Feet |

Span 4 Beam 6: 9 IN X 24 IN DELAMINATED PATCH WITH CRACKS UP TO 1/8" WIDE IN RIGHT FACE AT BENT 3.

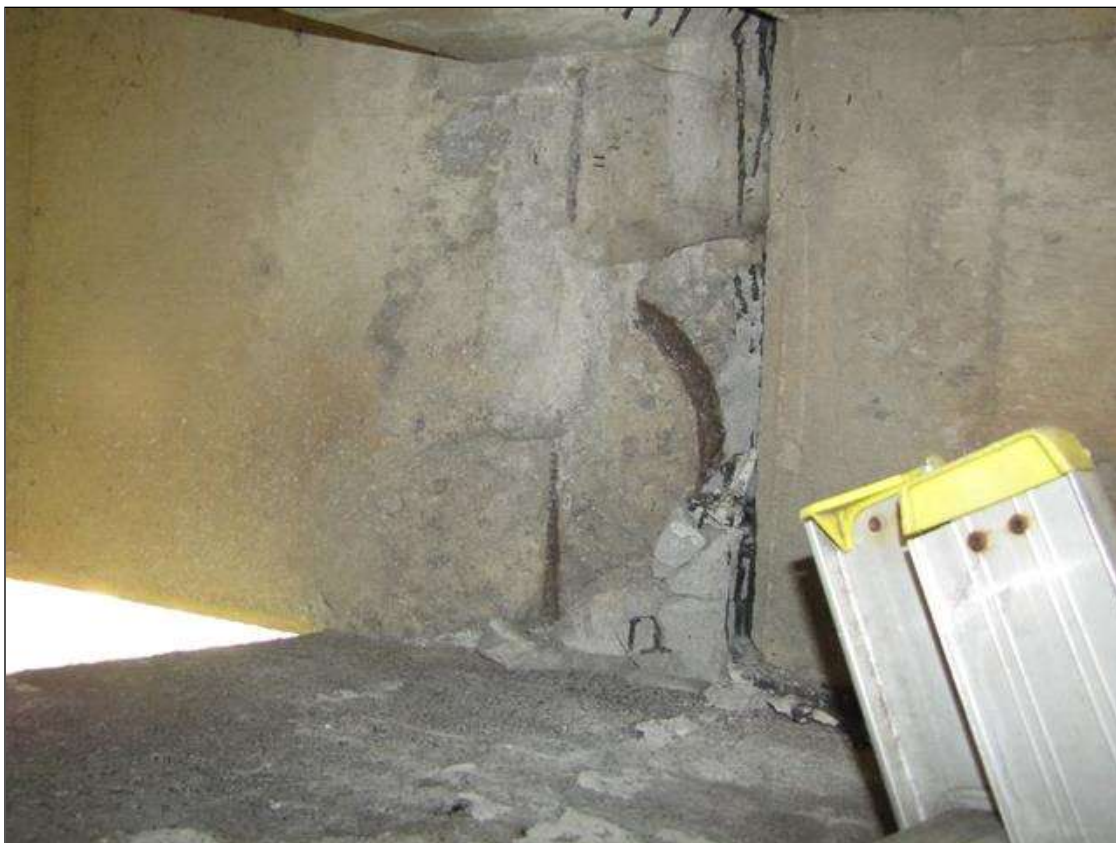
Span 3 Beam 6: 9 IN X 18 IN DELAMINATION IN RIGHT FACE AT BENT 3.

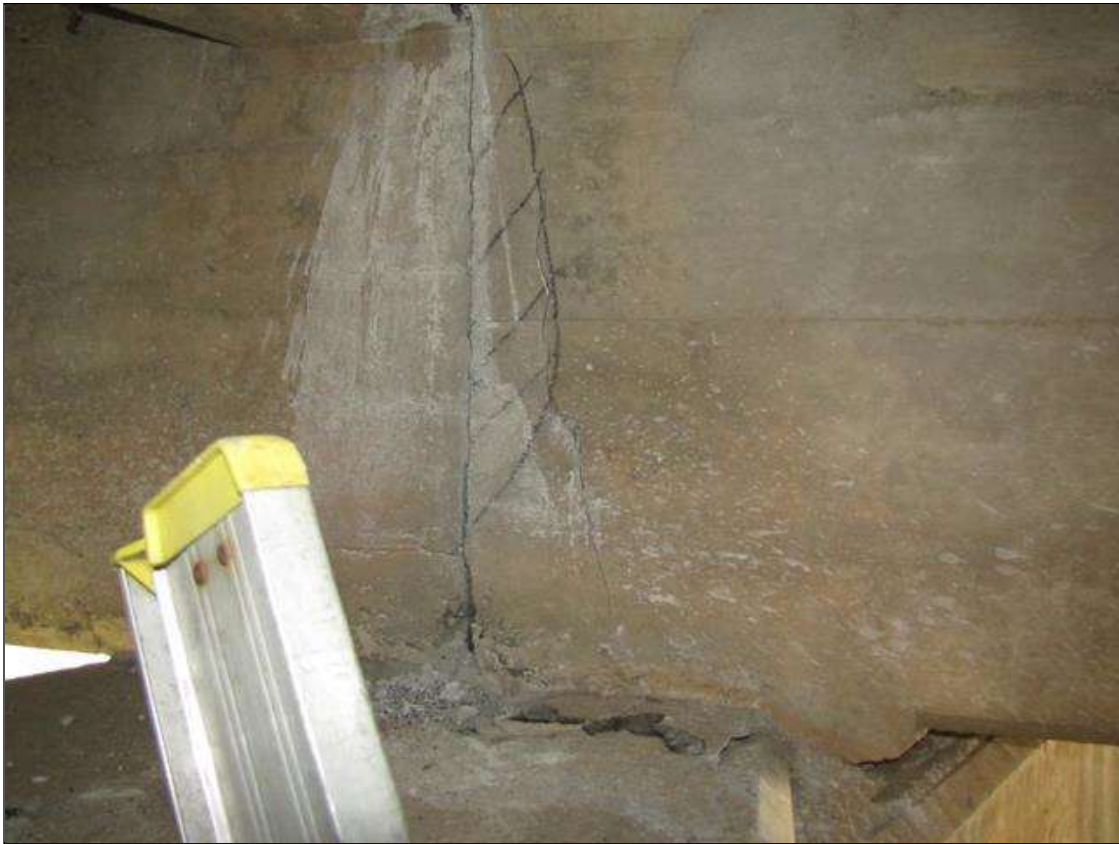
Span 3 Beam 4: 18 IN X 18 IN X 2 IN DEEP SPALL WITH EXPOSED REBAR IN RIGHT FACE AT BENT 3 (PM)

| MMS Code | Description of Function | Unit | Quantity | Remarks | Est. Cost |
|---|---|---|---|---|---|
| 3306 | Maintain Concrete Superstructure Components | SF | 2 | Span 3 Beam 4: 18 IN X 18 IN X 2 IN DEEP SPALL WITH EXPOSED REBAR IN RIGHT FACE AT BENT 3 (PM) | |

| MMS Code | MMS Description | Quantity |
|---|---|---|
| Span 3 Beam 4: 18 IN X 18 IN X 2 IN DEEP SPALL WITH EXPOSED REBAR IN RIGHT FACE AT BENT 3 (PM) | | |

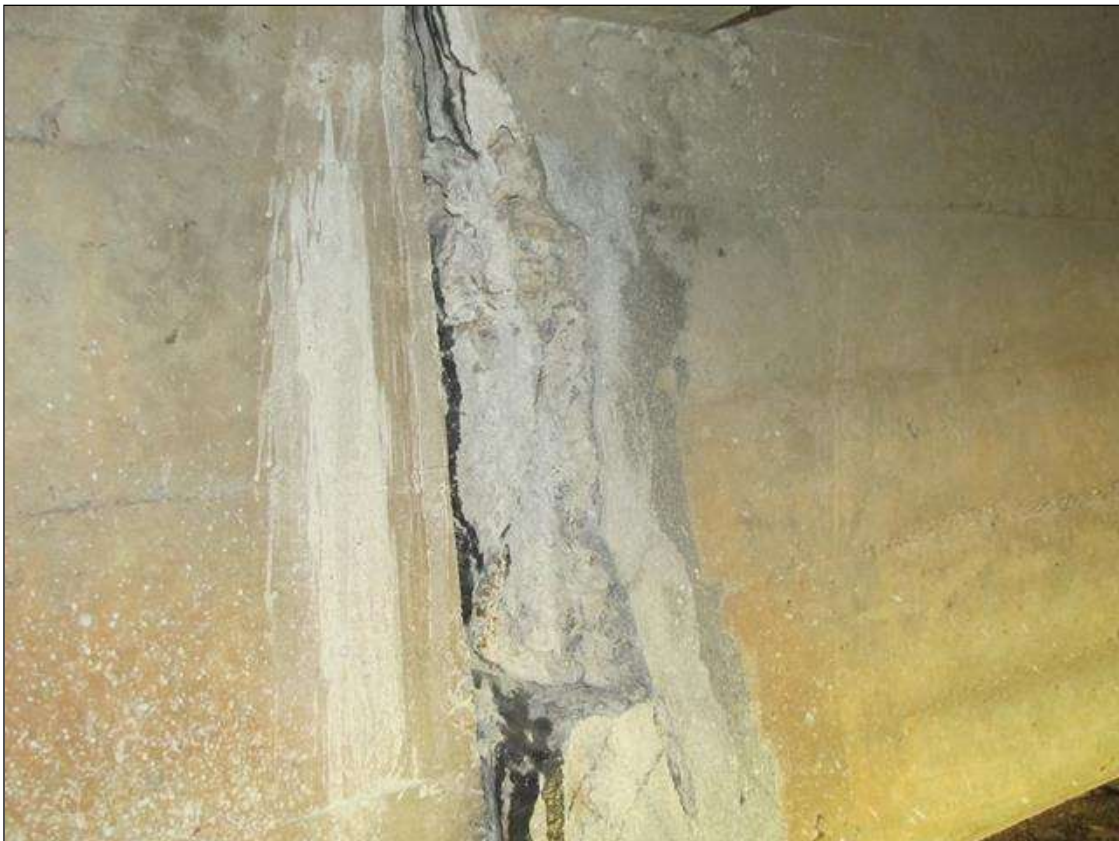
| Element Number | Defect Type | Defect Description | CS | CS Qty | Maint Qty | |
|---|---|---|---|---|---|---|
| 110 | Cracking (RC and Other) | 6 IN X 30 IN DELAMINATION WITH CRACKS UP TO 1/8" WIDE IN RIGHT FACE AT BENT 3. | 3 | 1 | 1 | Feet |

Span 4 Beam 7: 6 IN X 30 IN DELAMINATION WITH CRACKS UP TO 1/8" WIDE IN RIGHT FACE AT BENT 3.

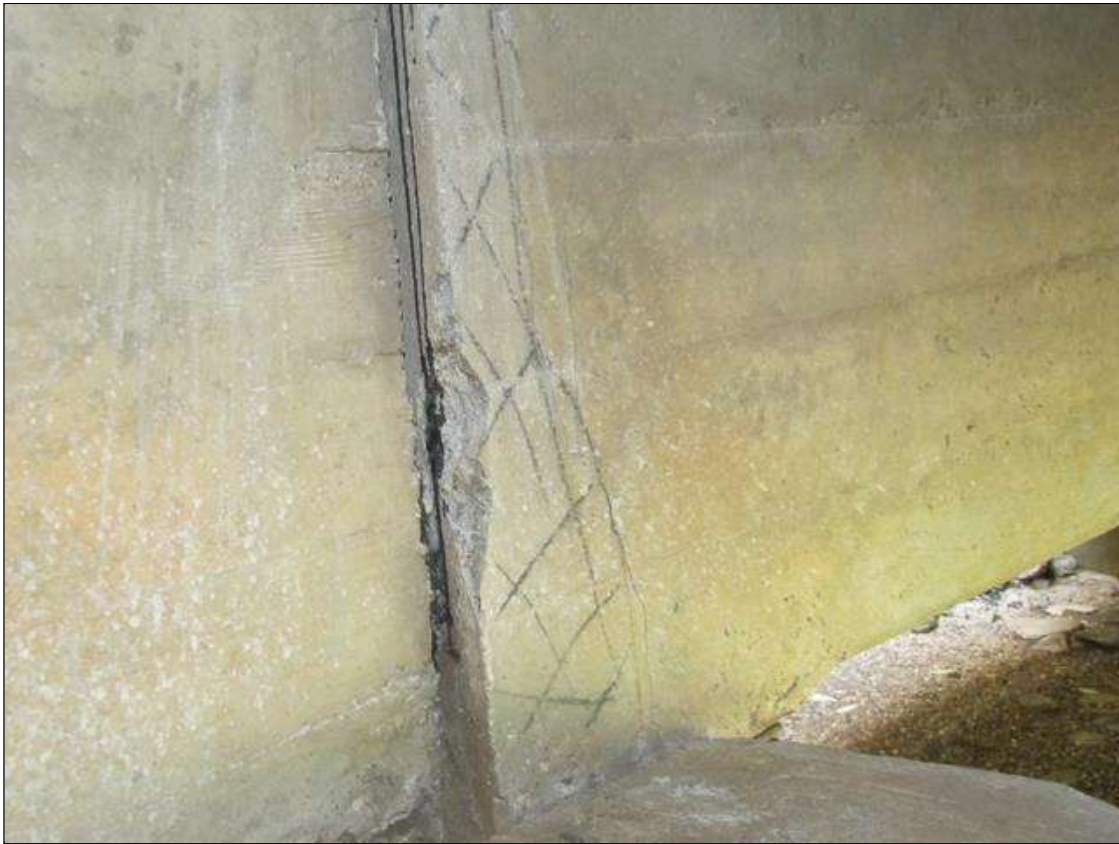
| Element Number | Defect Type | Defect Description | CS | CS Qty | Maint Qty |
|---|---|---|---|---|---|
| 110 | Delamination/Spall | 9 IN X 30 IN X 2 IN DEEP SPALL IN LEFT FACE AT BENT 3. | 3 | 1 | 1 Feet |

Span 3 Beam 8: 9 IN X 30 IN X 2 IN DEEP SPALL IN LEFT FACE AT BENT 3.

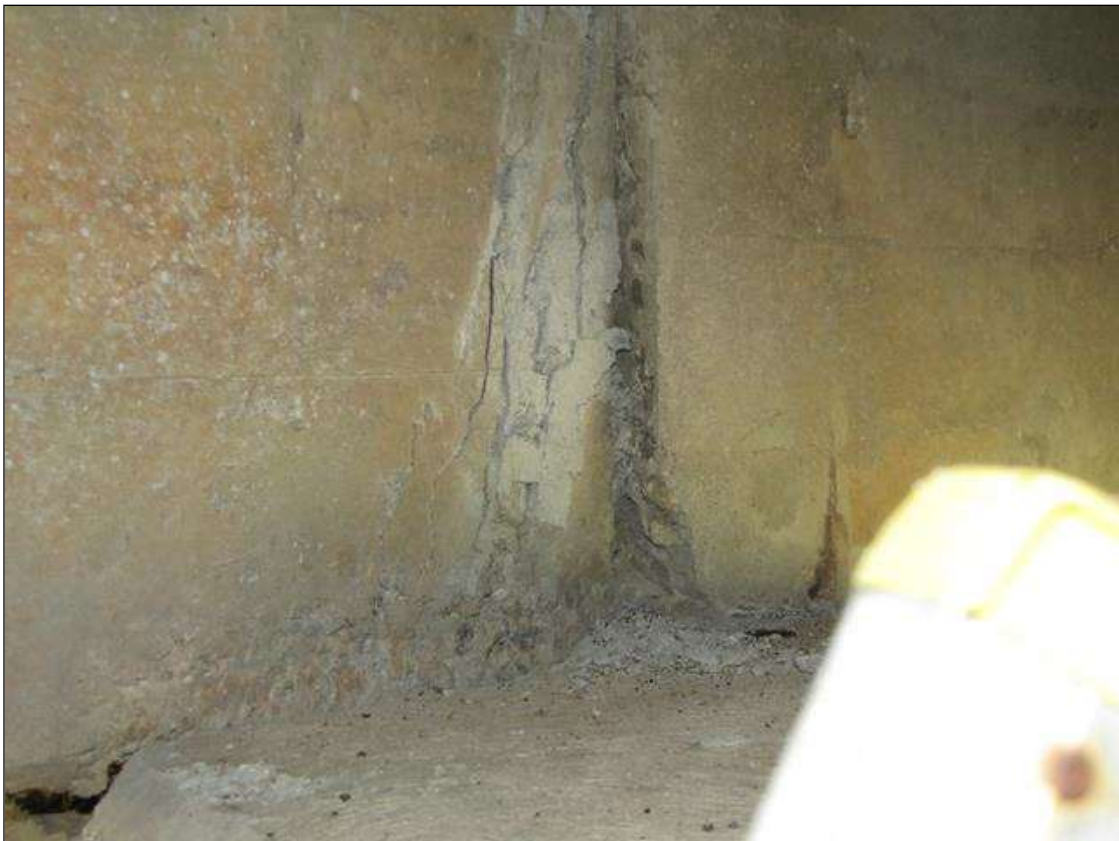
| Element Number | Defect Type | Defect Description | CS | CS Qty | Maint Qty | |
|---|---|---|---|---|---|---|
| 110 | Cracking (RC and Other) | 9 IN X 30 IN DELAMINATION WITH CRACK UP TO 1/16" WIDE IN LEFT FACE AT BENT 3. | 2 | 1 | 1 | Feet |

Span 3 Beam 9: 9 IN X 30 IN DELAMINATION WITH CRACK UP TO 1/16" WIDE IN LEFT FACE AT BENT 3.

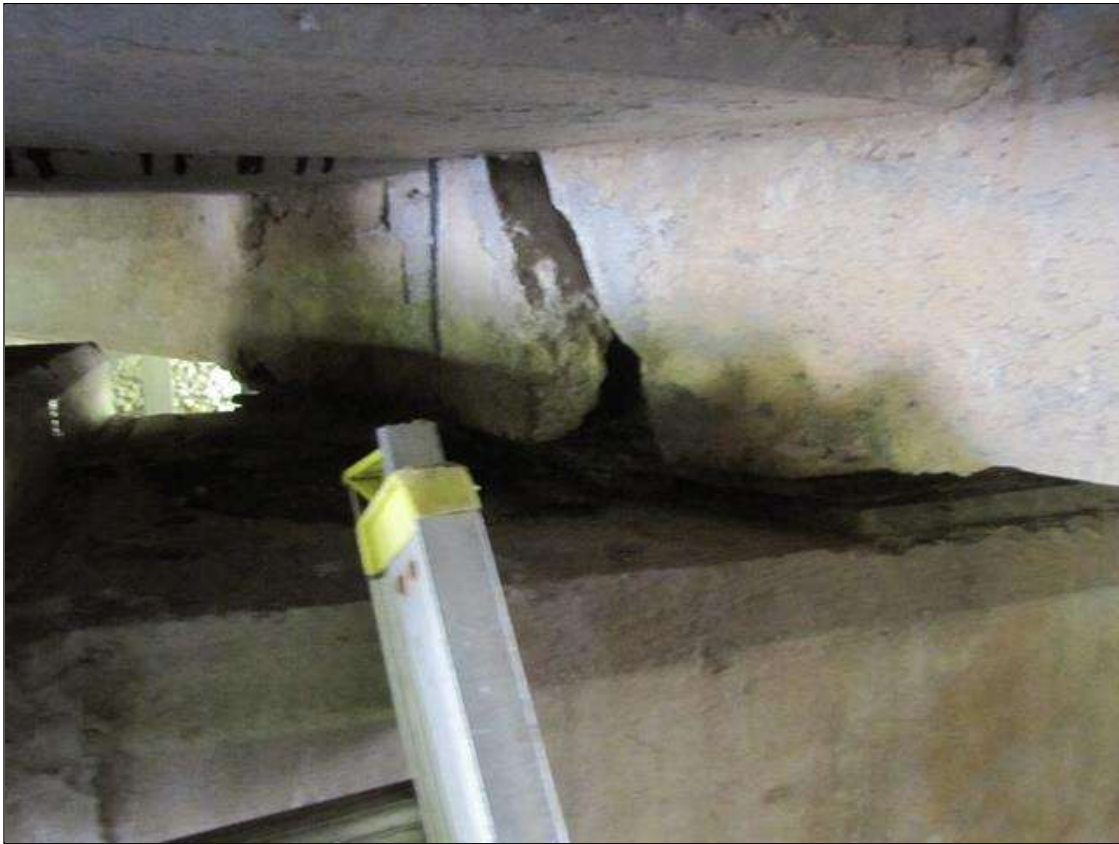
| Element Number | Defect Type | Defect Description | CS | CS Qty | Maint Qty |
|---|---|---|---|---|---|
| 110 | Delamination/Spall | 9 IN X 30 IN DELAMINATION IN LEFT FACE AT BENT 3. | 2 | 1 | 1 Feet |

Span 4 Beam 10: 9 IN X 30 IN DELAMINATION IN LEFT FACE AT BENT 3.

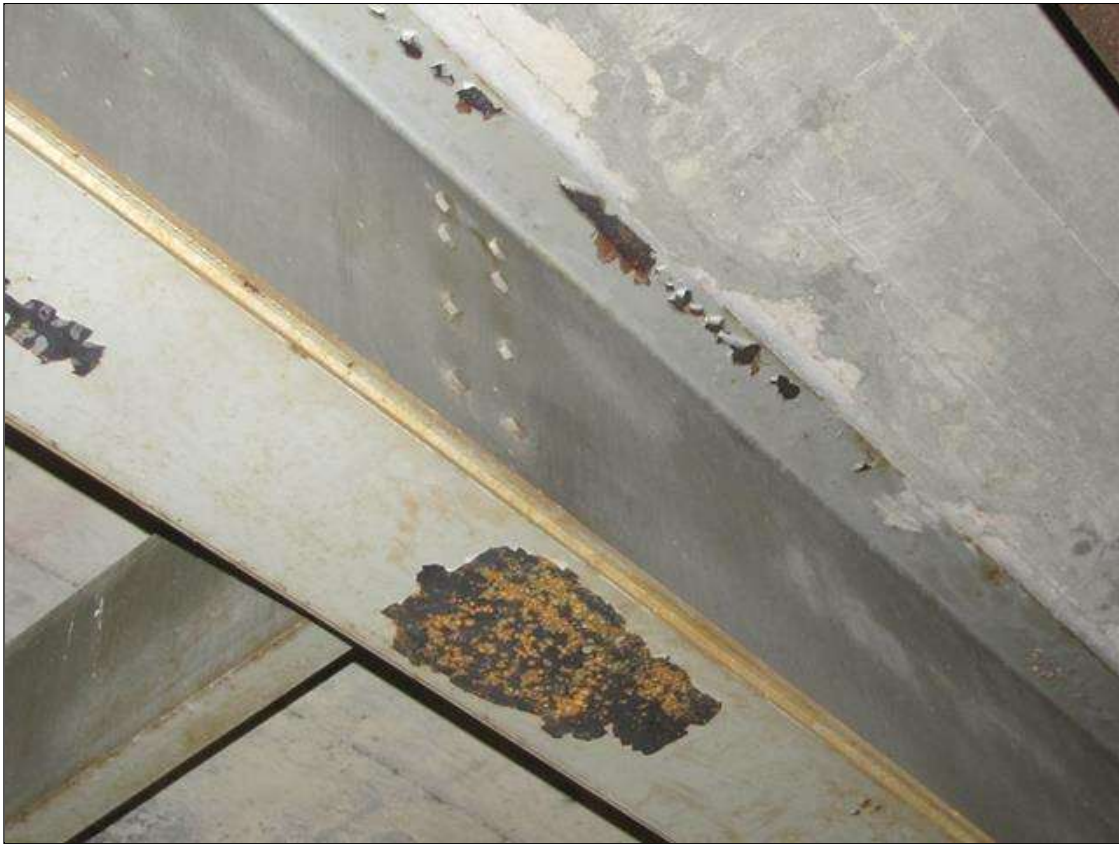
| Element Number | Defect Type | Defect Description | CS | CS Qty | Maint Qty | |
|---|---|---|---|---|---|---|
| 515 | Peeling/Bubbling/Cracking (steel Protective Coatings) | AREAS OF PEELING PAINT AT RANDOM ALONG BOTTOM OF TOP FLANGE. | 2 | 25 | 25 | Square Feet |

Span 4 Beam 11: AREAS OF PEELING PAINT AT RANDOM ALONG BOTTOM OF TOP FLANGE.

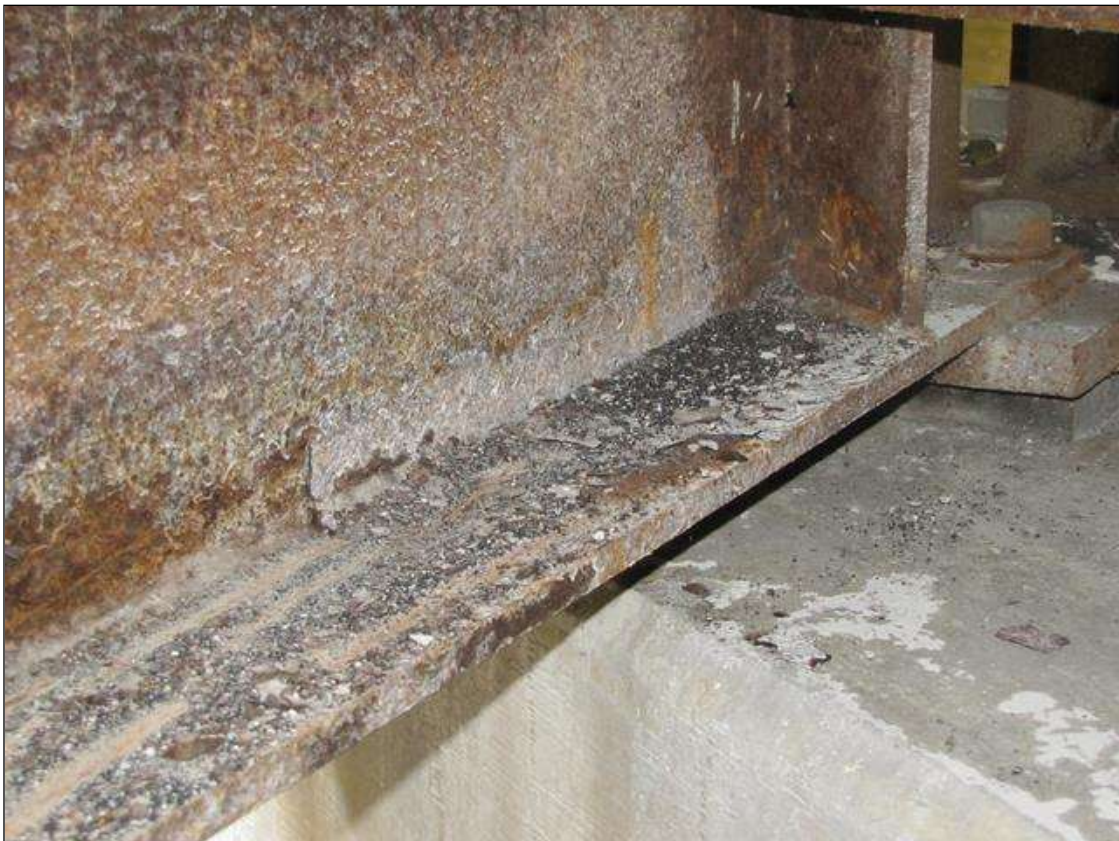
| Element Number | Defect Type | Defect Description | CS | CS Qty | Maint Qty | |
|---|---|---|---|---|---|---|
| 515 | Peeling/Bubbling/Cracking (steel Protective Coatings) | AREAS OF PEELING PAINT AT RANDOM ALONG BOTTOM OF TOP AND BOTTOM FLANGES. | 2 | 35 | 35 | Square Feet |

Span 4 Beam 12: AREAS OF PEELING PAINT AT RANDOM ALONG BOTTOM OF TOP AND BOTTOM FLANGES.

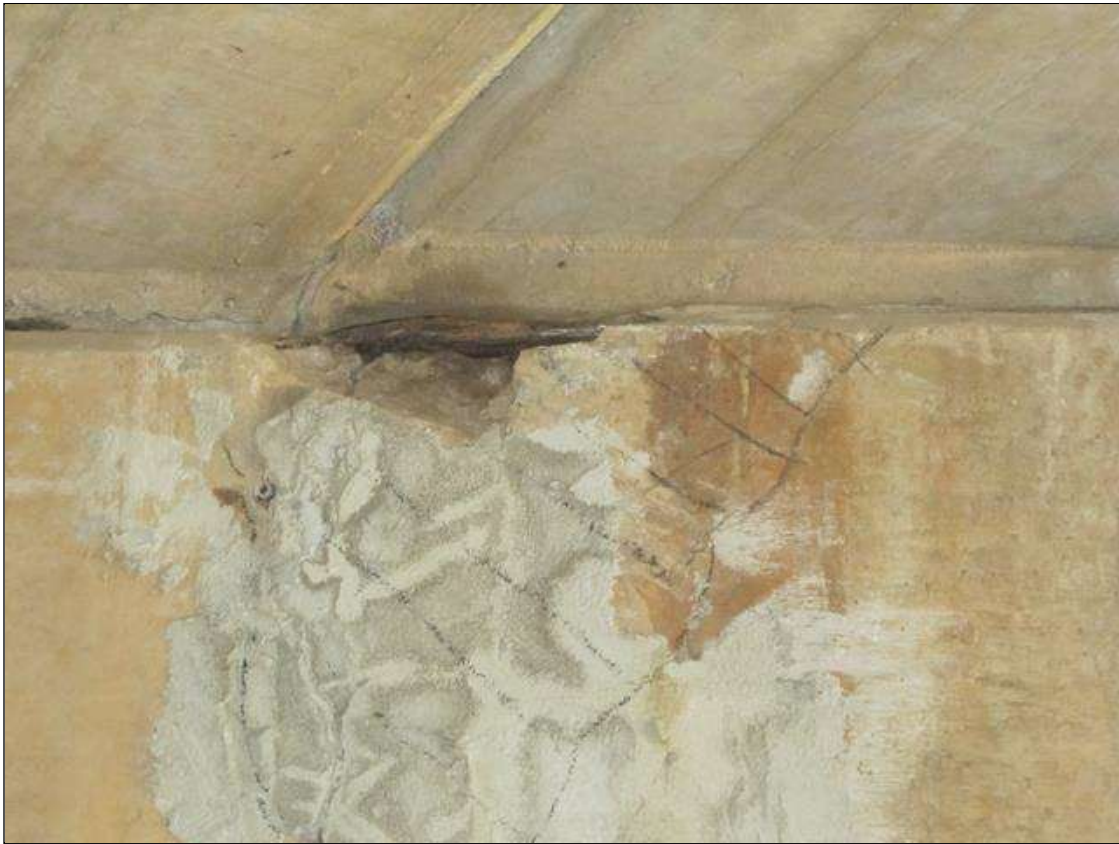
| Element Number | Defect Type | Defect Description | CS | CS Qty | Maint Qty | |
|---|---|---|---|---|---|---|
| 107 | Corrosion | SURFACE CORROSION ALONG BOTTOM FLANGE AT BENT 3. | 2 | 3 | | Feet |

Span 4 Beam 14: SURFACE CORROSION ALONG BOTTOM FLANGE AT BENT 3.

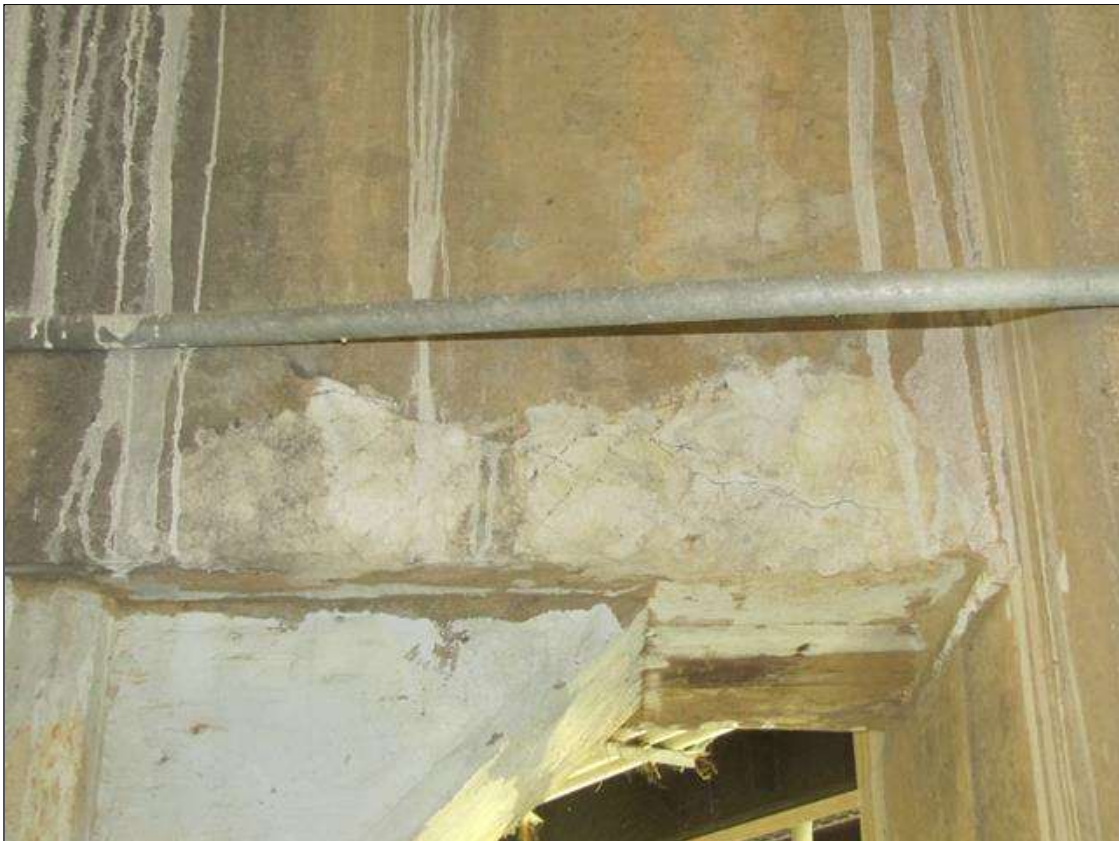
| Element Number | Defect Type | Defect Description | CS | CS Qty | Maint Qty |
|---|---|---|---|---|---|
| 234 | Delamination/Spall | 15 IN X 18 IN X 3 IN DEEP SPALL AND AREA OF DELAMINATION WITH LOSS OF BEARING BELOW BEAM 5 IN EAST FACE (PM). | 2 | 2 | 2 Feet |

Bent 3 Cap 2: 15 IN X 18 IN X 3 IN DEEP SPALL AND AREA OF DELAMINATION WITH LOSS OF BEARING BELOW BEAM 5 IN EAST FACE (PM).

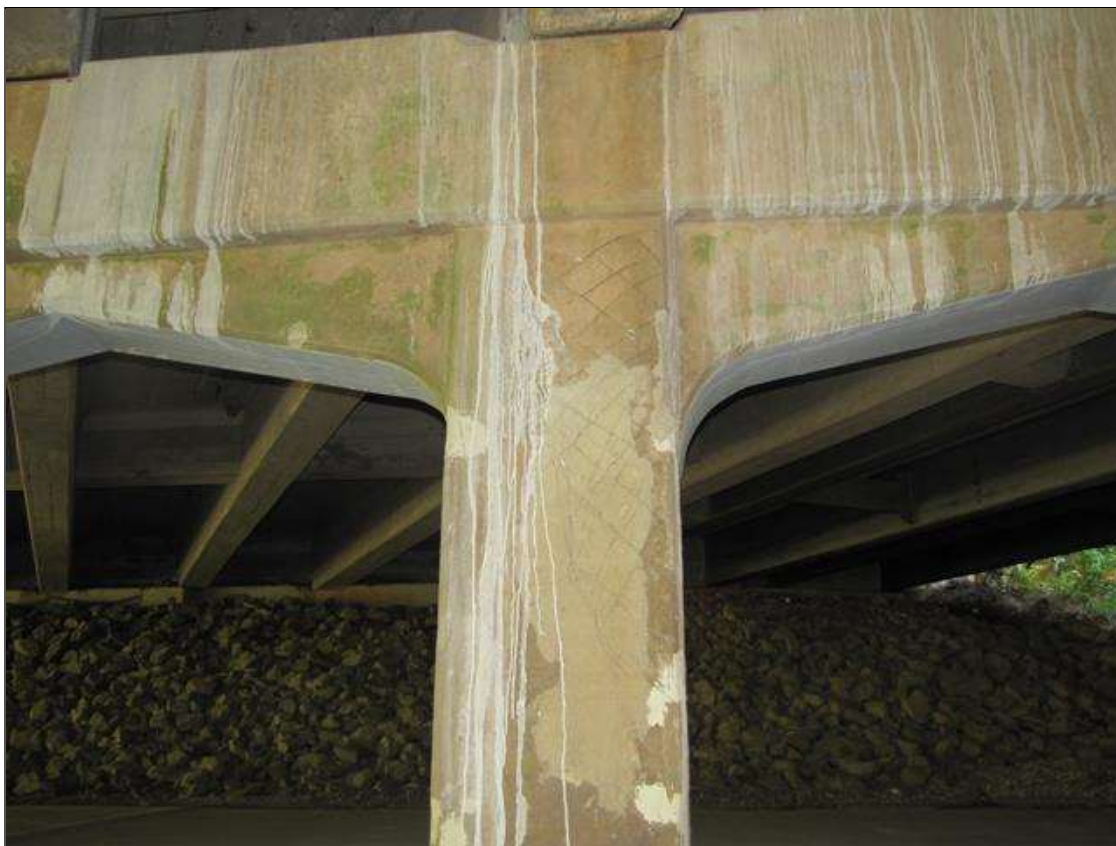
Bent 3 Cap 2: 24 IN X 9 IN UNSOUND PATCH IN EAST FACE BELOW BEAM 4.

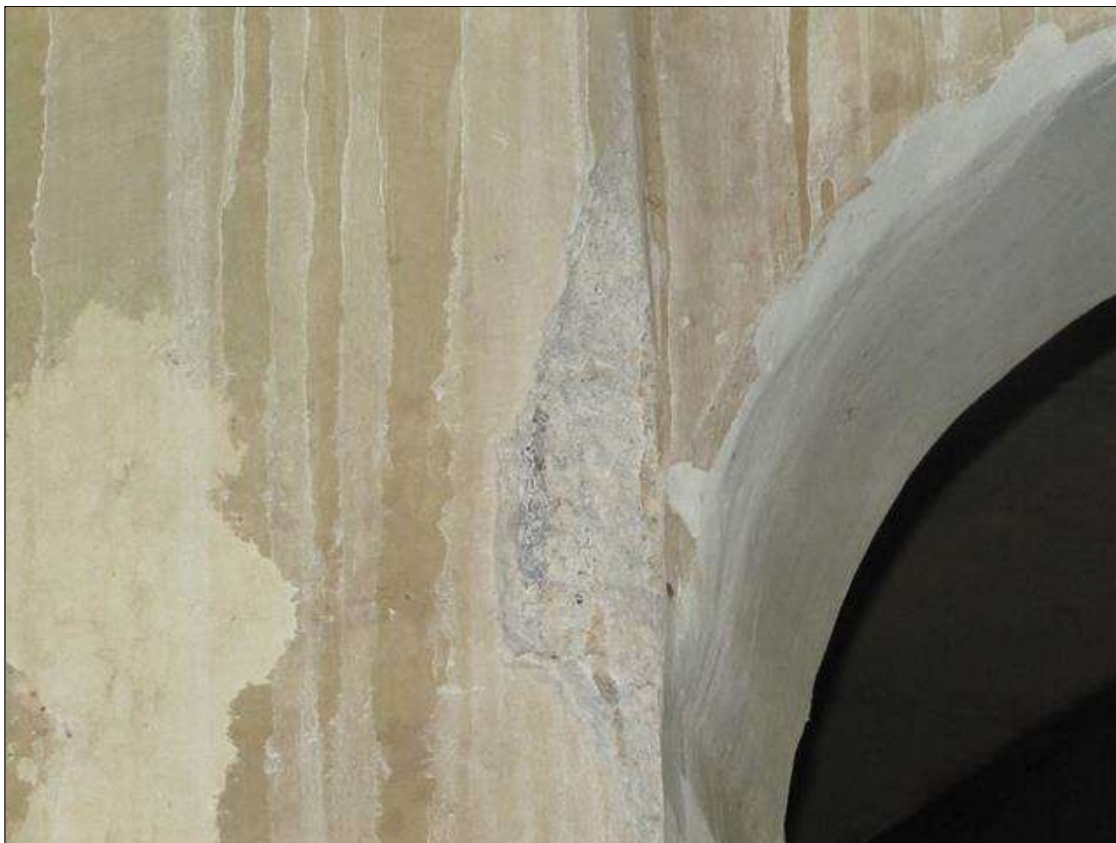
| Element Number | Defect Type | Defect Description | CS | CS Qty | Maint Qty |
|---|---|---|---|---|---|
| 205 | Delamination/Spall | 2 FT WIDE X 8 FT TALL AREA OF DELAMINATION WITH 12 IN X 24 IN X 1 IN DEEP SPALL IN WEST FACE. | 3 | 1 | 8 Each |

Bent 3 Pile 5: 2 FT WIDE X 8 FT TALL AREA OF DELAMINATION WITH 12 IN X 24 IN X 1 IN DEEP SPALL IN WEST FACE.

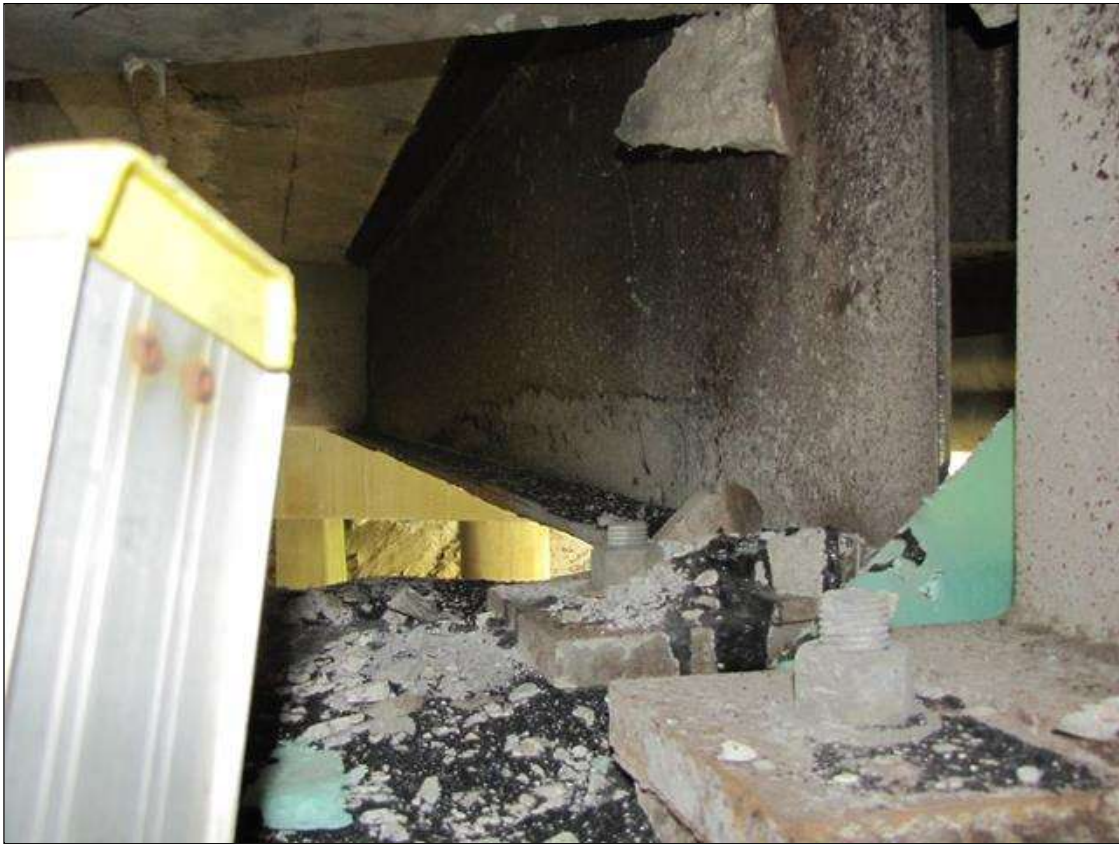
Span 3 Beam 3: RUST FLAKING WITH LOSS OF SECTION ALONG BOTTOM FLANGE EXTENDING 4 IN INTO WEB. FULL WIDTH X  $\frac{9}{16}$ " REMAINING SECTION IN BOTTOM FLANGE, FULL HEIGHT X  $\frac{7}{16}$ " REMAINING SECTION IN WEB. STARTING AT BENT 2 EXTENDING 7 FT INTO SPAN.

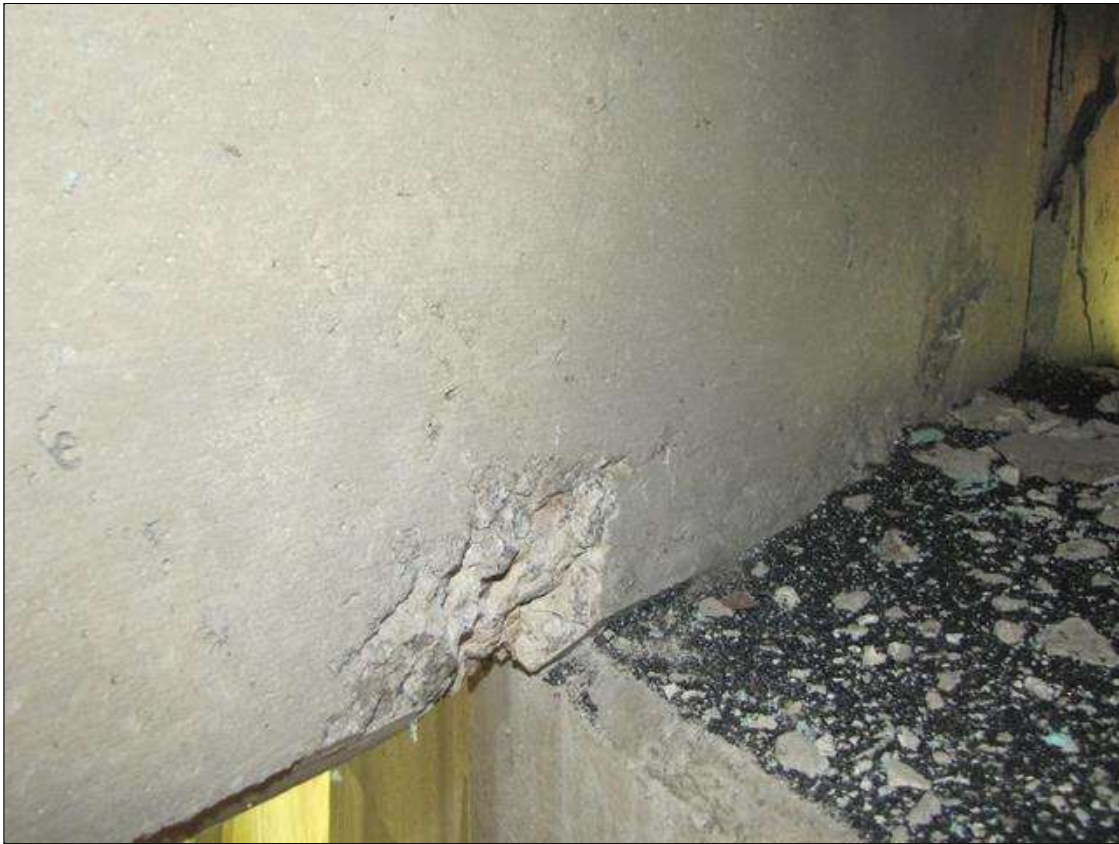
| Element Number | Defect Type | Defect Description | CS | CS Qty | Maint Qty | |
|---|---|---|---|---|---|---|
| 107 | Corrosion | RUST FLAKING WITH LOSS OF SECTION ALONG BOTTOM FLANGE EXTENDING 4 IN INTO WEB. FULL WIDTH X 9/16" REMAINING SECTION IN BOTTOM FLANGE, FULL HEIGHT X 7/16" REMAINING SECTION IN WEB. STARTING AT BENT 2 EXTENDING 7 FT INTO SPAN. | 3 | 7 | 7 | Feet |

Span 2 Beam 3: RUST FLAKING WITH LOSS OF SECTION ALONG BOTTOM FLANGE EXTENDING 4 IN INTO WEB. FULL WIDTH X 9/16" REMAINING SECTION IN BOTTOM FLANGE, FULL HEIGHT X 7/16" REMAINING SECTION IN WEB. STARTING AT BENT 2 EXTENDING 7 FT INTO SPAN.

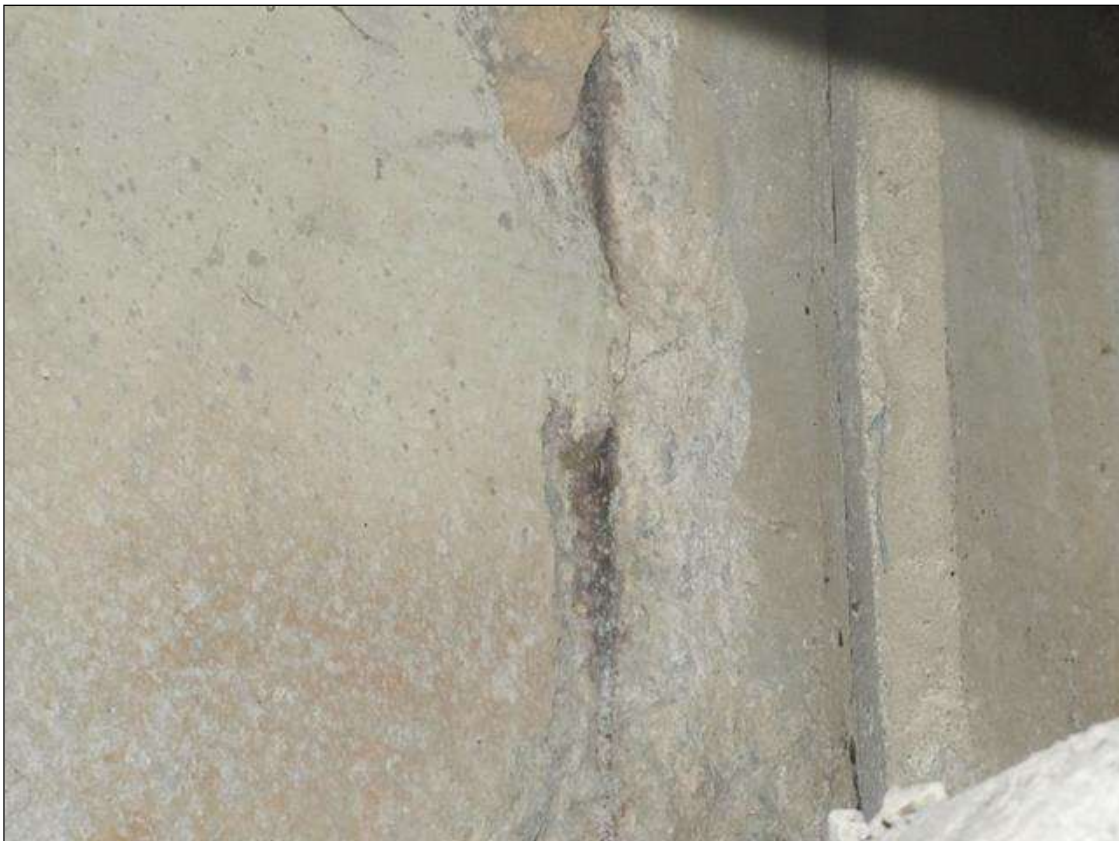
Span 3 Beam 4: 6 IN X 3 IN X 1 IN DEEP SPALL AND 9 IN X 6 IN X 1 IN DEEP SPALL IN LEFT FACE AT BENT 2.

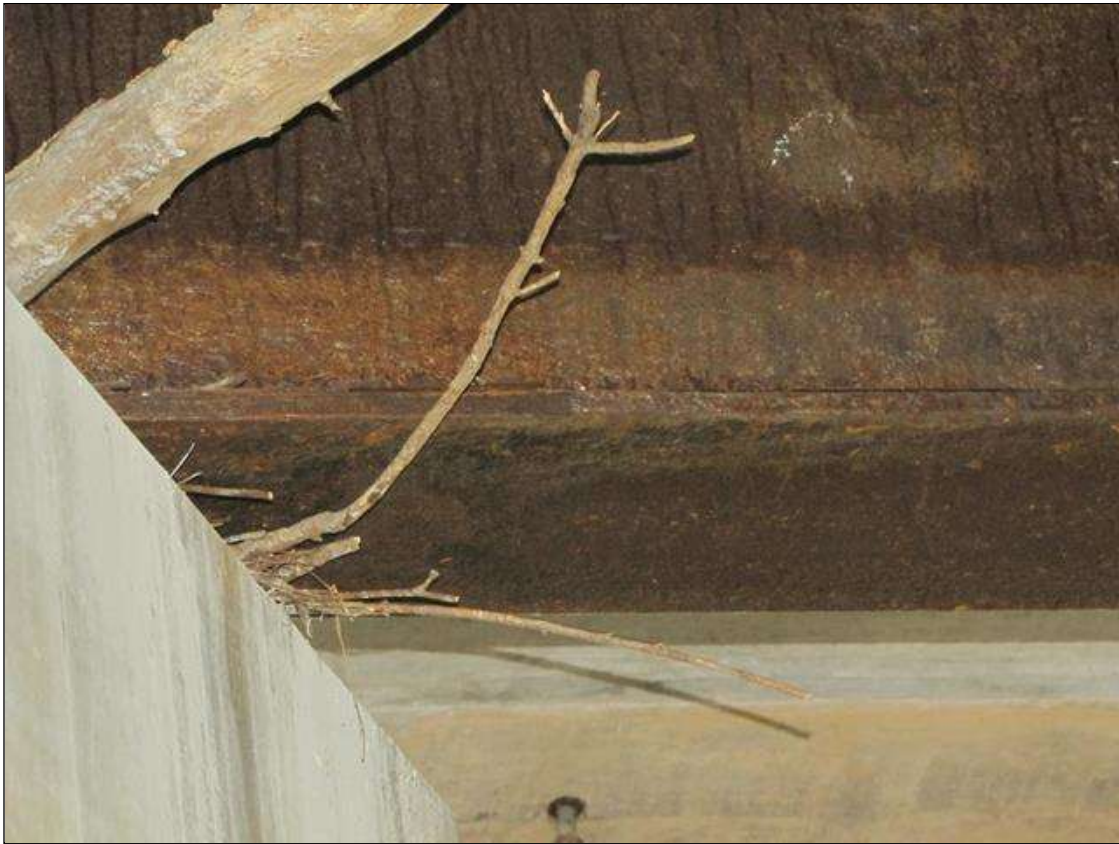
| Span 3 | | | Beam 5 | | | | |
|---|---|---|---|---|---|---|---|
| 110 | Delamination/Spall | 4 IN X 30 IN X 1 IN DEEP SPALL WITH EXPOSED REBAR IN LEFT FACE AT BENT 2. | | 2 | 1 | 1 | Feet |

Span 3 Beam 5: 4 IN X 30 IN X 1 IN DEEP SPALL WITH EXPOSED REBAR IN LEFT FACE AT BENT 2.

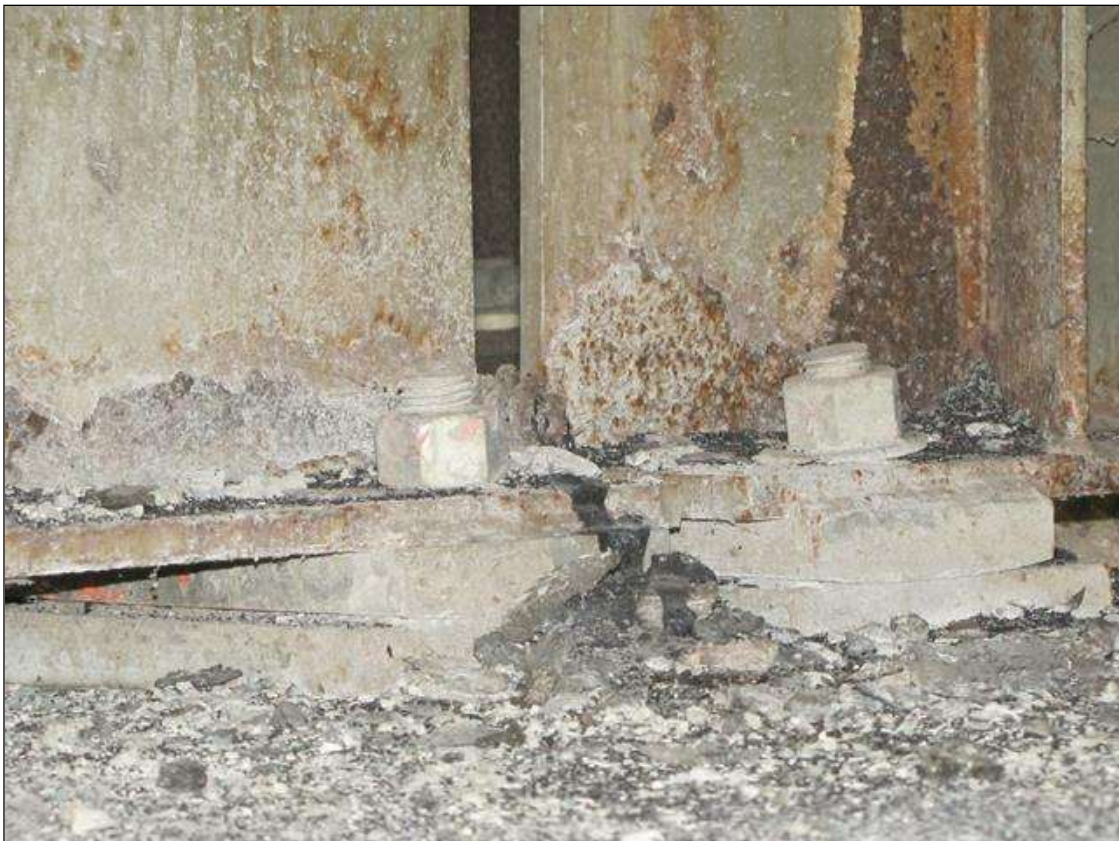
| Element Number | Defect Type | Defect Description | CS | CS Qty | Maint Qty | |
|---|---|---|---|---|---|---|
| 107 | Corrosion | SURFACE CORROSION ALONG BOTTOM FLANGE AND BASE OF WEB AT BENT 3. | 2 | 7 | | Feet |

Span 3 Beam 14: SURFACE CORROSION ALONG BOTTOM FLANGE AND BASE OF WEB AT BENT 3.

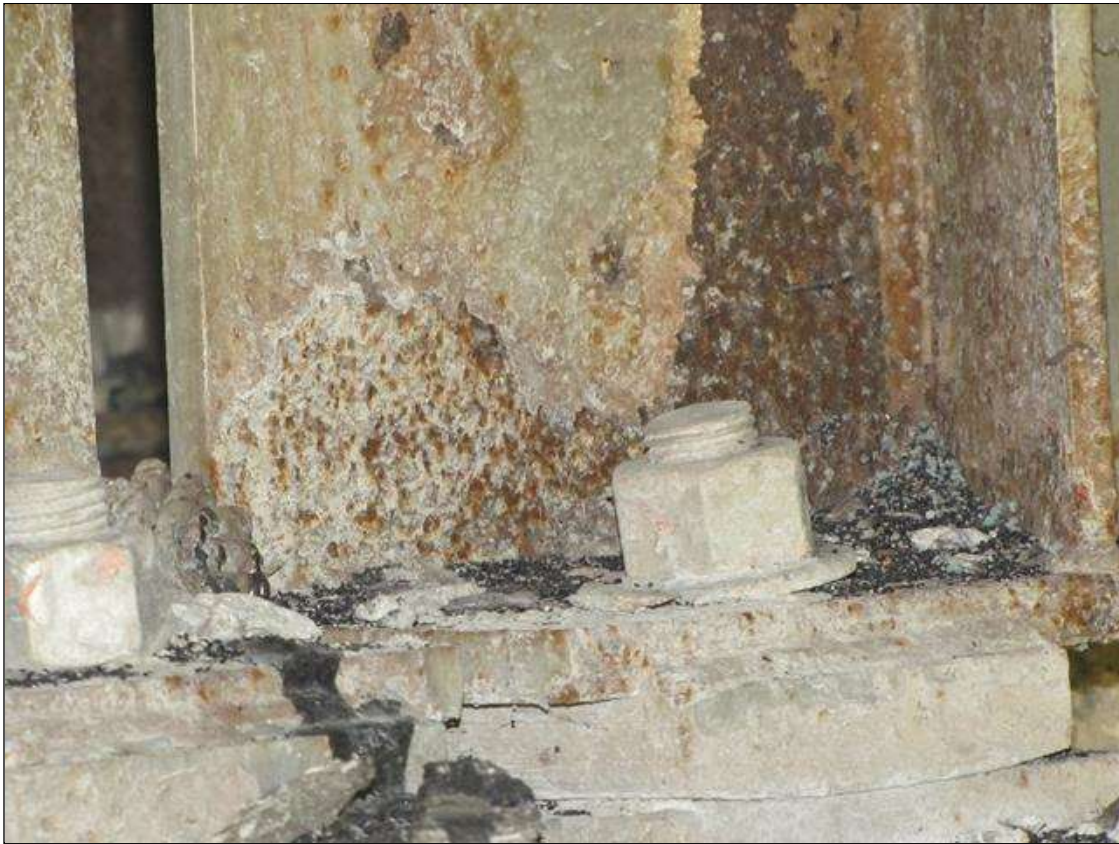
| Element Number | Defect Type | Defect Description | CS | CS Qty | Maint Qty | |
|---|---|---|---|---|---|---|
| 107 | Corrosion | 9 IN X 6 IN AREA OF CORROSION WITH LOSS OF SECTION IN WEB AT BASE. 7/16 IN REMAINING SECTION AT BENT 2. | 3 | 1 | 1 | Feet |

Span 3 Beam 12: 9 IN X 6 IN AREA OF CORROSION WITH LOSS OF SECTION IN WEB AT BASE. 7/16 IN REMAINING SECTION AT BENT 2.

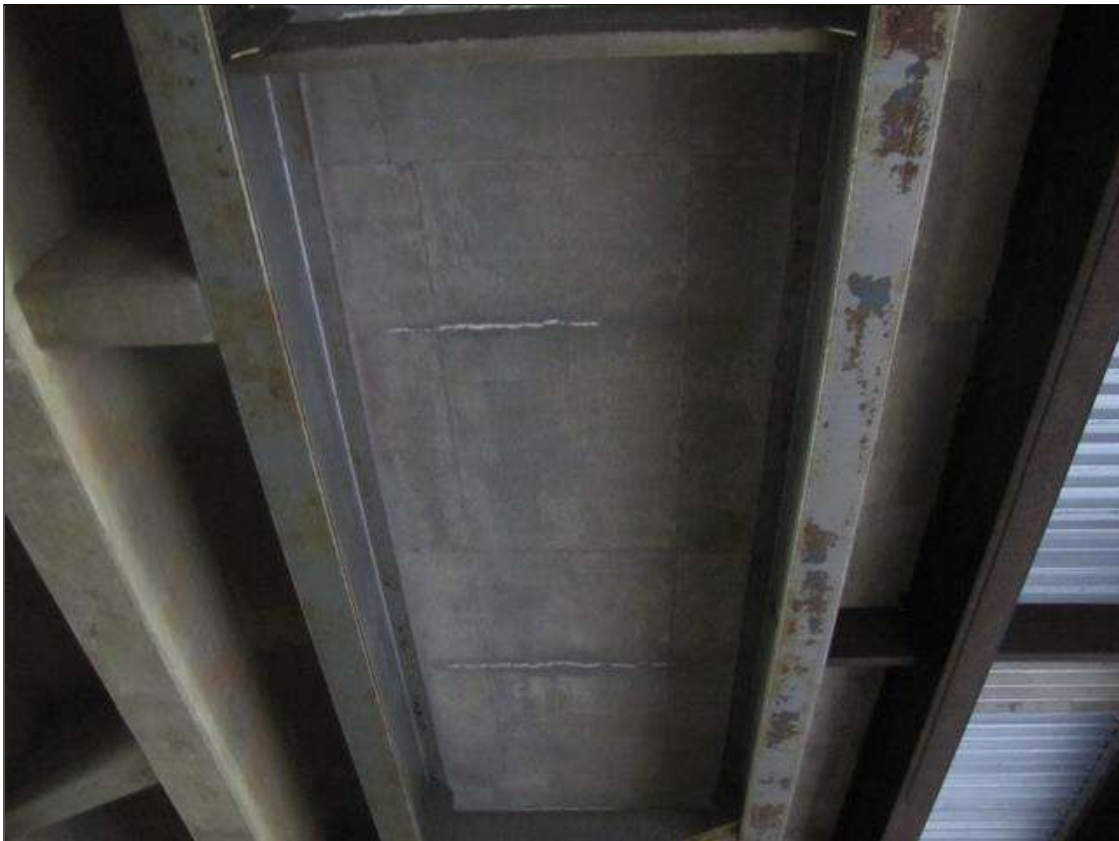
| Element Number | Defect Type | Defect Description | CS | CS Qty | Maint Qty |
|---|---|---|---|---|---|
| 107 | Corrosion | 9 IN X 6 IN AREA OF CORROSION WITH LOSS OF SECTION IN WEB AT BASE. 7/16 IN REMAINING SECTION AT BENT 2. | 3 | 1 | 1 Feet |

Span 2 Beam 12: 9 IN X 6 IN AREA OF CORROSION WITH LOSS OF SECTION IN WEB AT BASE. 7/16 IN REMAINING SECTION AT BENT 2.
