NC DEPARTMENT OF TRANSPORTATION  
DIVISION OF HIGHWAYS  
STRUCTURE MANAGEMENT UNIT

## Structure Safety Report

### Routine Element Inspection - Contract

COUNTY: WAKE STRUCTURE NUMBER: 910091 FREQUENCY: 24 MONTHS

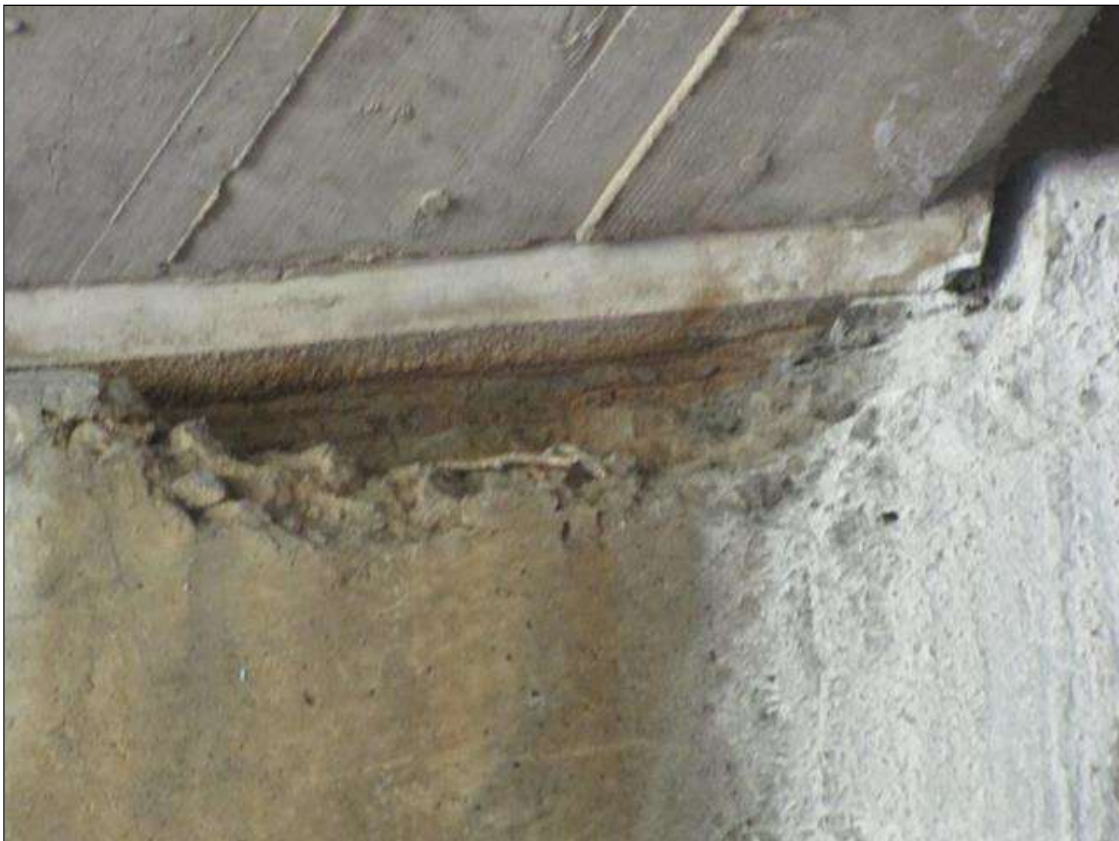
| Element Number | Defect Type | Defect Description | CS | CS Qty | Maint Qty | |
|---|---|---|---|---|---|---|
| 205 | Delamination/Spall | 16 IN X 18 IN X 1/2 IN DEEP SPALL WITH EXPOSED SPIRAL REINFORCING IN NORTHEAST FACE. | 3 | 1 | 2 | Each |

Bent 2 Pile 1: 16 IN X 18 IN X 1/2 IN DEEP SPALL WITH EXPOSED SPIRAL REINFORCING IN NORTHEAST FACE.

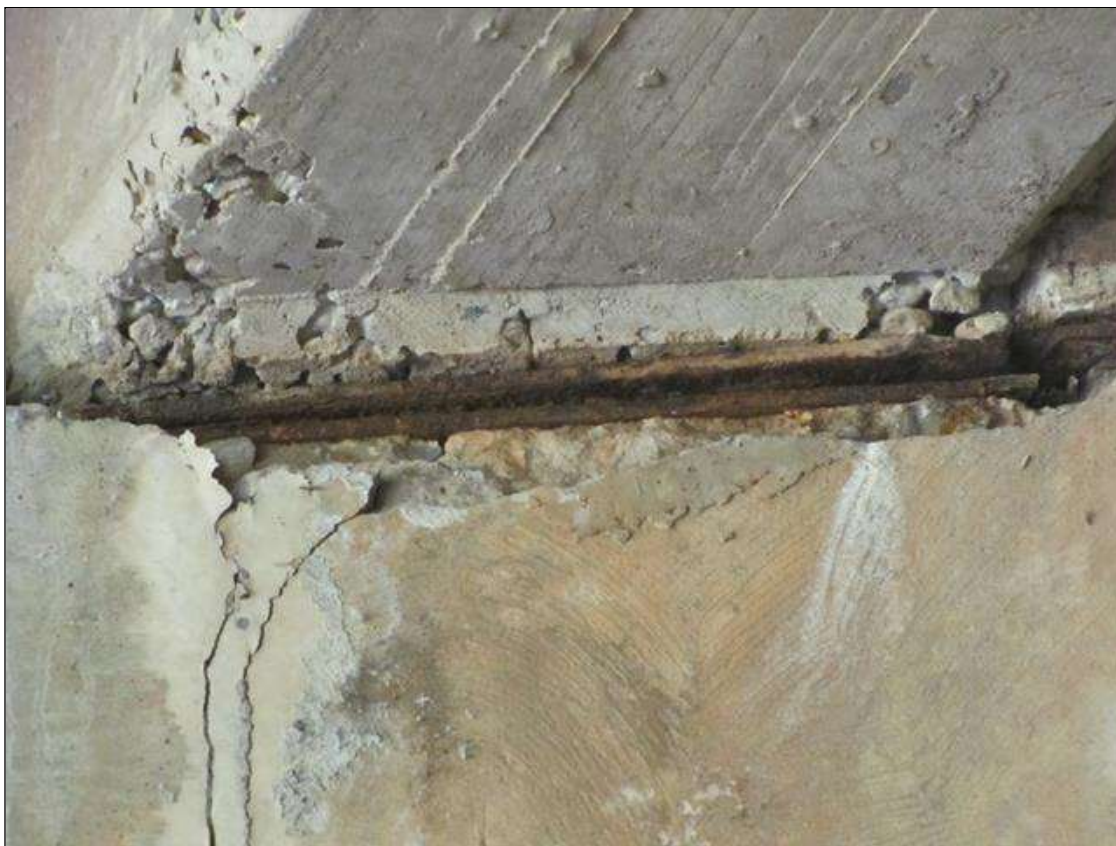
| Element Number | Defect Type | Defect Description | CS | CS Qty | Maint Qty | |
|---|---|---|---|---|---|---|
| 234 | Delamination/Spall | 15 IN X 6 IN X 3 IN DEEP SPALL BELOW BEAM 4 IN WEST FACE WITH LOSS OF BEARING AREA (PM). | 3 | 2 | 2 | Feet |

Bent 2 Cap 2: 15 IN X 6 IN X 3 IN DEEP SPALL BELOW BEAM 4 IN WEST FACE WITH LOSS OF BEARING AREA (PM).

| MMS Code | Description of Function | Unit | Quantity | Remarks | Est. Cost |
|---|---|---|---|---|---|
| 3348 | Maintain Concrete Substructure Components | LF | 2 | Bent 2 Cap 2: 15 IN X 6 IN X 3 IN DEEP SPALL BELOW BEAM 4 WITH LOSS OF BEARING AREA (PM). | |

| MMS Code | MMS Description | Quantity |
|---|---|---|
| Bent 2 Cap 2: 15 IN X 6 IN X 3 IN DEEP SPALL BELOW BEAM 4 WITH LOSS OF BEARING AREA (PM). | | |

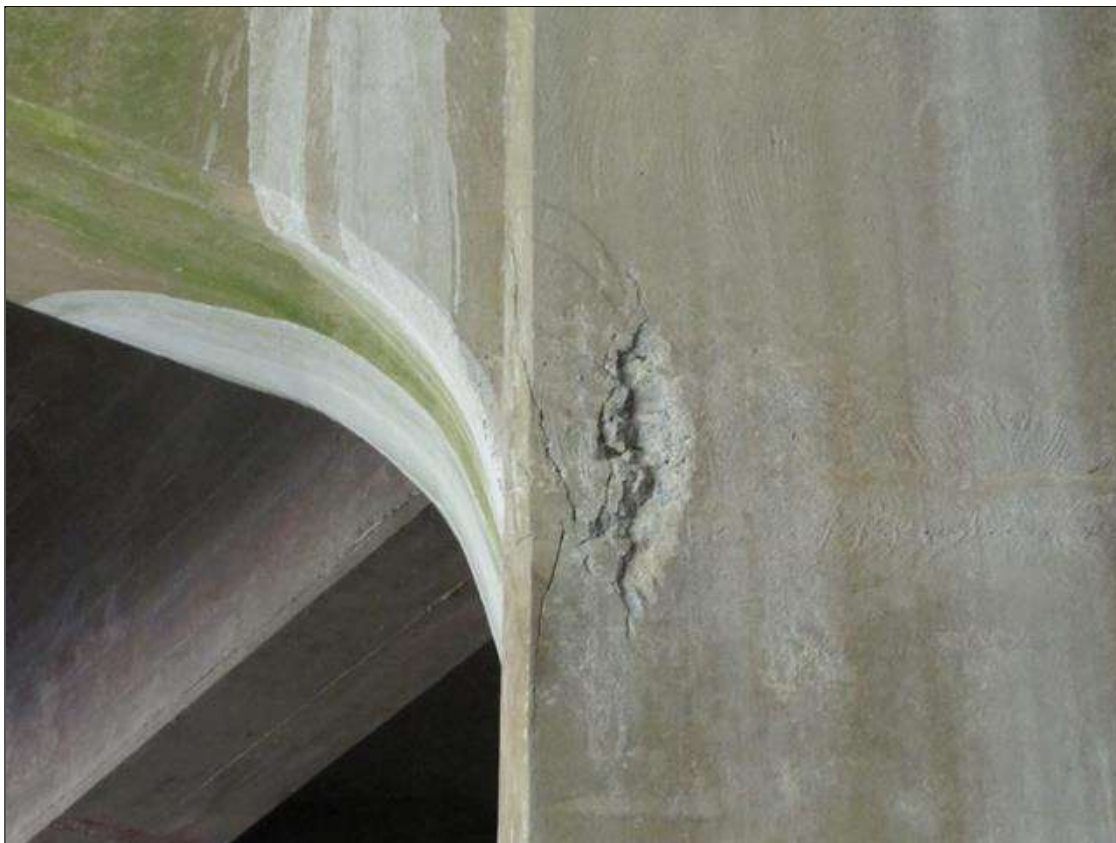
| Element Number | Defect Type | Defect Description | CS | CS Qty | Maint Qty | |
|---|---|---|---|---|---|---|
| 234 | Delamination/Spall | 18 IN X 4 IN X 3 IN DEEP SPALL BELOW BEAM 5 IN WEST FACE WITH LOSS OF BEARING AREA (PM). | 3 | 2 | 2 | Feet |

Bent 2 Cap 3: 18 IN X 4 IN X 3 IN DEEP SPALL BELOW BEAM 5 IN WEST FACE WITH LOSS OF BEARING AREA (PM).

| MMS Code | Description of Function | Unit | Quantity | Remarks | Est. Cost |
|---|---|---|---|---|---|
| 3348 | Maintain Concrete Substructure Components | LF | 2 | Bent 2 Cap 3: 18 IN X 4 IN X 3 IN DEEP SPALL BELOW BEAM 5 IN WEST FACE WITH LOSS OF BEARING AREA (PM). | |

| MMS Code | MMS Description | Quantity |
|---|---|---|
| Bent 2 Cap 3: 18 IN X 4 IN X 3 IN DEEP SPALL BELOW BEAM 5 IN WEST FACE WITH LOSS OF BEARING AREA (PM). | | |

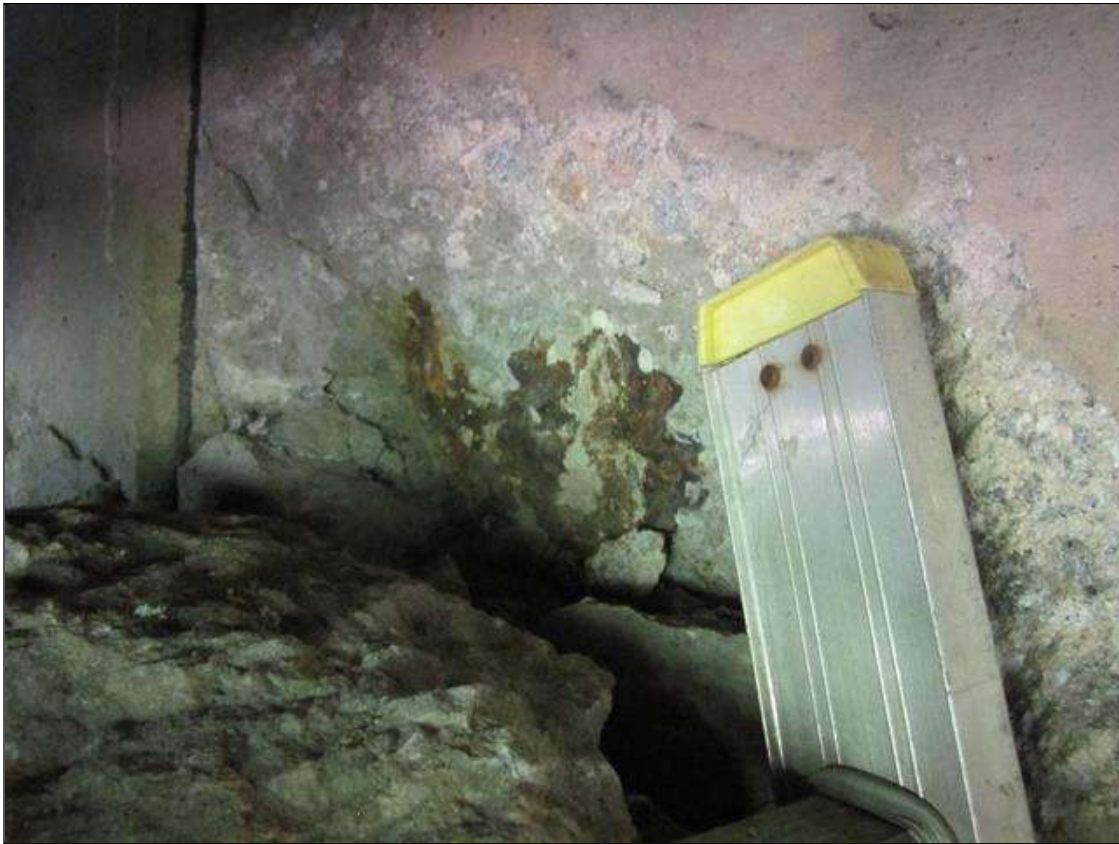
| Element Number | Defect Type | Defect Description | CS | CS Qty | Maint Qty | |
|---|---|---|---|---|---|---|
| 205 | Delamination/Spall | 8 IN X 20 IN X 1 IN DEEP SPALL IN WEST FACE, 2 FT BELOW CAP. | 2 | 1 | 2 | Each |

Bent 2 Pile 4: 8 IN X 20 IN X 1 IN DEEP SPALL IN WEST FACE, 2 FT BELOW CAP.

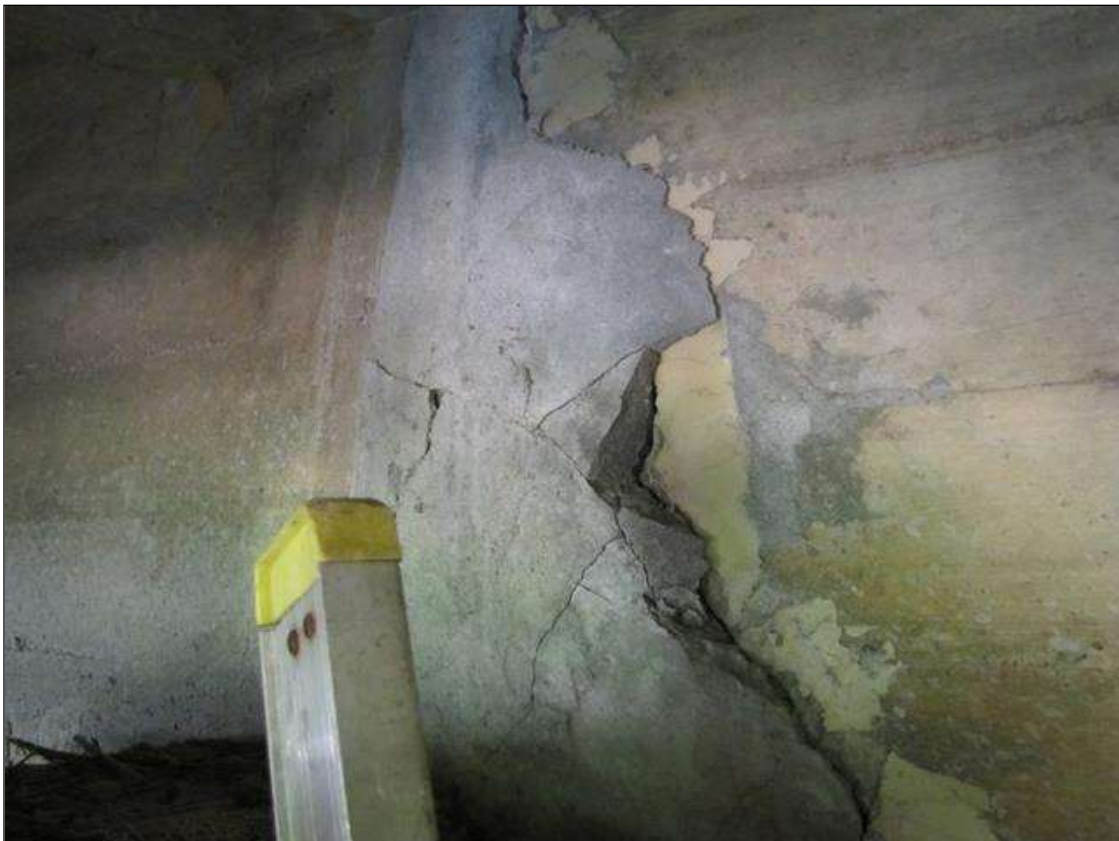
| Element Number | Defect Type | Defect Description | CS | CS Qty | Maint Qty | |
|---|---|---|---|---|---|---|
| 110 | Delamination/Spall | 24 IN X 16 IN X 3 IN DEEP SPALL WITH EXPOSED REBAR IN LEFT FACE AT BENT 2 (PM). | 3 | 2 | 2 | Feet |

Span 2 Beam 4: 24 IN X 16 IN X 3 IN DEEP SPALL WITH EXPOSED REBAR IN LEFT FACE AT BENT 2 (PM).

| MMS Code | Description of Function | Unit | Quantity | Remarks | Est. Cost |
|---|---|---|---|---|---|
| 3306 | Maintain Concrete Superstructure Components | SF | 2 | Span 2 Beam 4: 24 IN X 16 IN X 3 IN DEEP SPALL WITH EXPOSED REBAR IN LEFT FACE AT BENT 2 (PM). | |

| MMS Code | MMS Description | Quantity |
|---|---|---|
| Span 2 Beam 4: 24 IN X 16 IN X 3 IN DEEP SPALL WITH EXPOSED REBAR IN LEFT FACE AT BENT 2 (PM). | | |

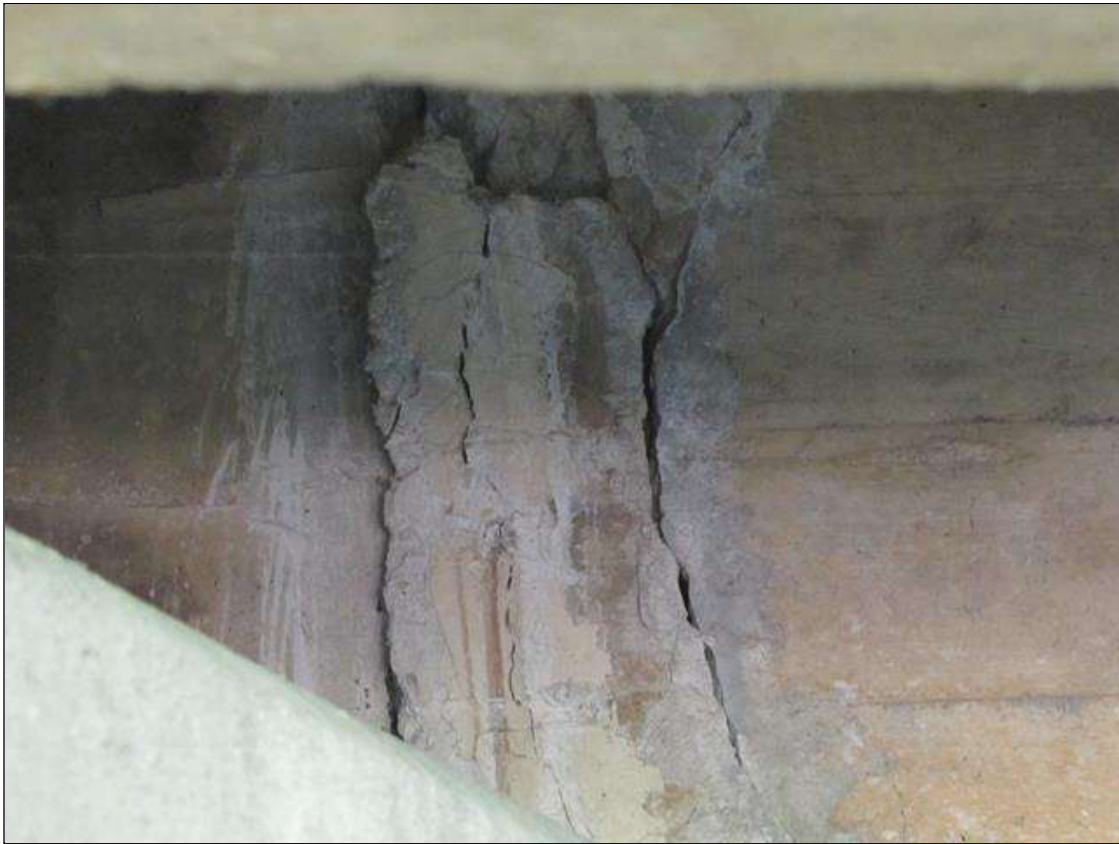
Span 2 Beam 7: 18 IN X 30 IN DELAMINATED PATCH IN LEFT FACE AT BENT 2.

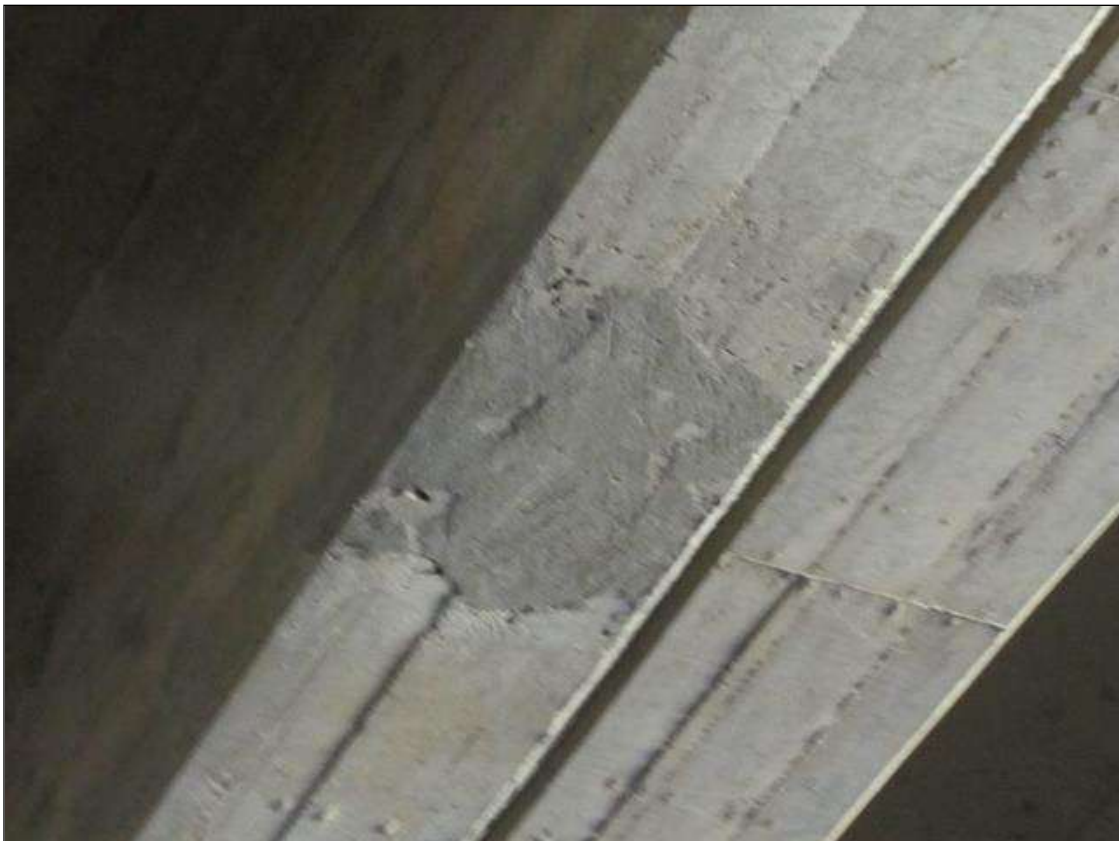
| Element Number | Defect Type | Defect Description | CS | CS Qty | Maint Qty | |
|---|---|---|---|---|---|---|
| 110 | Delamination/Spall | 12 IN X 30 IN DELAMINATION AND SPALL IN LEFT FACE AT BENT 2. | 3 | 1 | 1 | Feet |

Span 2 Beam 8: 12 IN X 30 IN DELAMINATION AND SPALL IN LEFT FACE AT BENT 2.

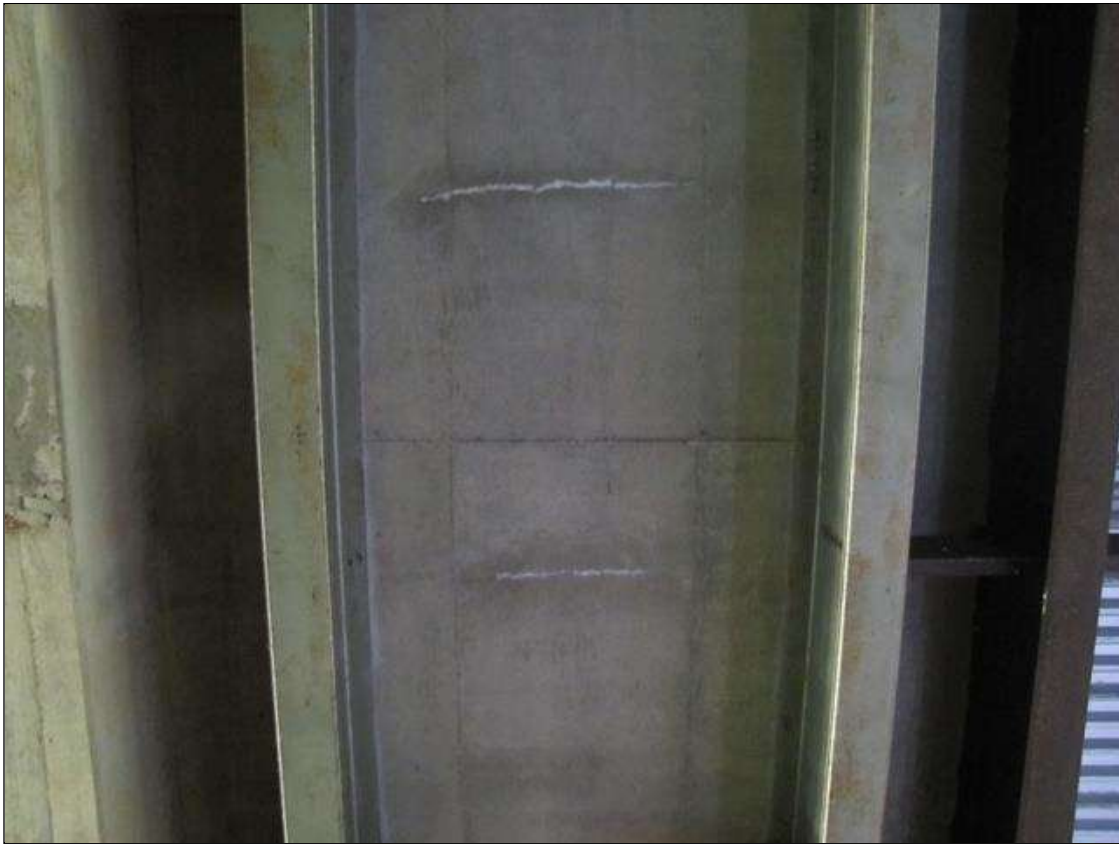
Span 2 Beam 6: 24 IN X 18 IN SOUND PATCH IN UNDERSIDE OF BEAM, 20 FT FROM BENT 1.

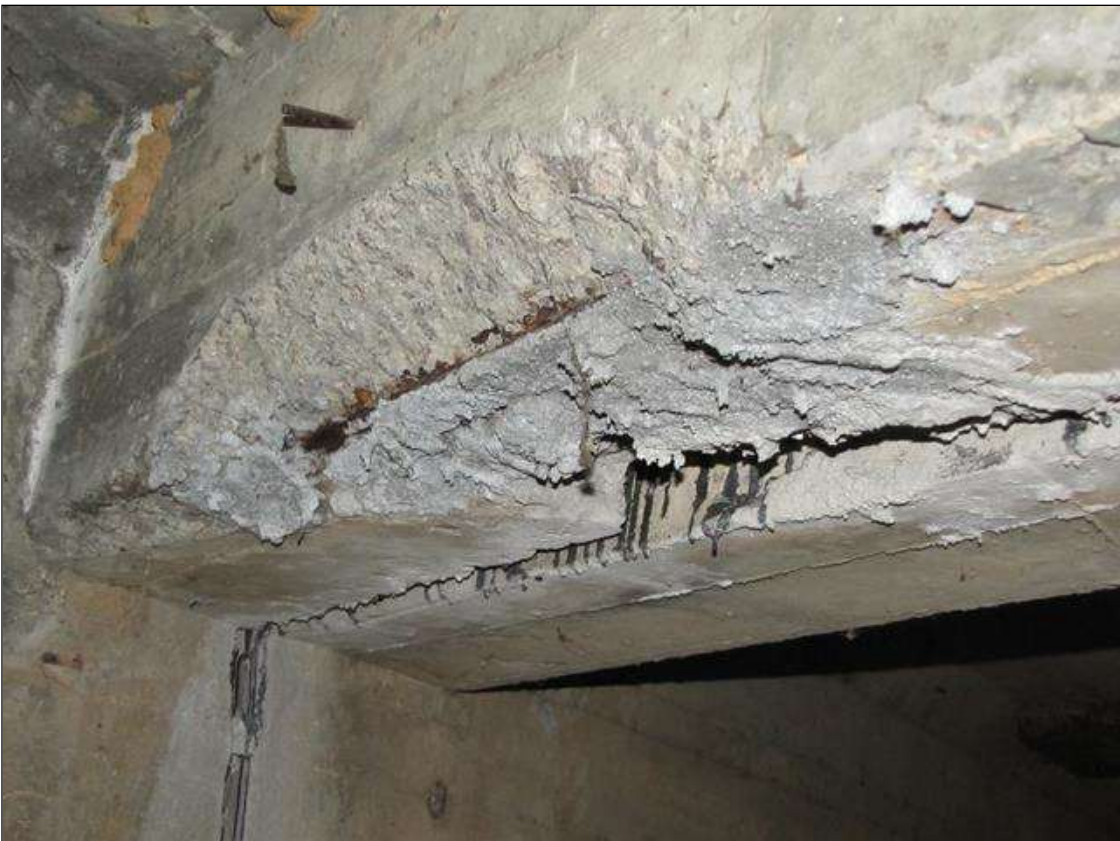
Span 2 Beam 7: 6" X 24" HIGH X 3" SPALL WITH EXPOSED REINFORCING, NORTH FACE, AT BENT 1

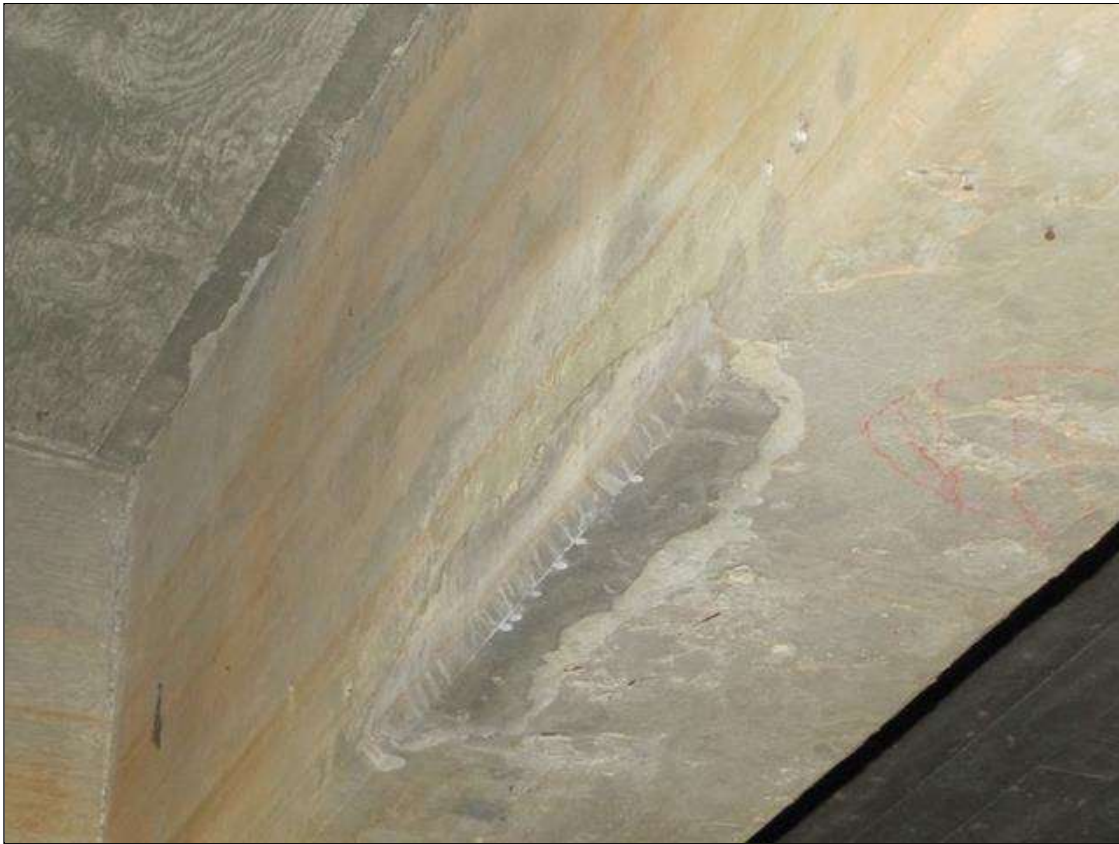
| Span 1 | | Beam 6 | | | | |
|---|---|---|---|---|---|---|
| 2 FT X 1 FT X 1.5" SPALL WITH EXPOSED REBAR, IN END DIAPHRAGM, AT BENT 1 SPAN 1, ADJACENT TO BEAM 6. | | | | | | |

SPAN 1 BEAM 6 DIAPHRAGM: 2 FT X 1 FT X 1.5" SPALL WITH EXPOSED REBAR IN END DIAPHRAGM AT BENT 1 SPAN 1 ADJACENT TO BEAM 6

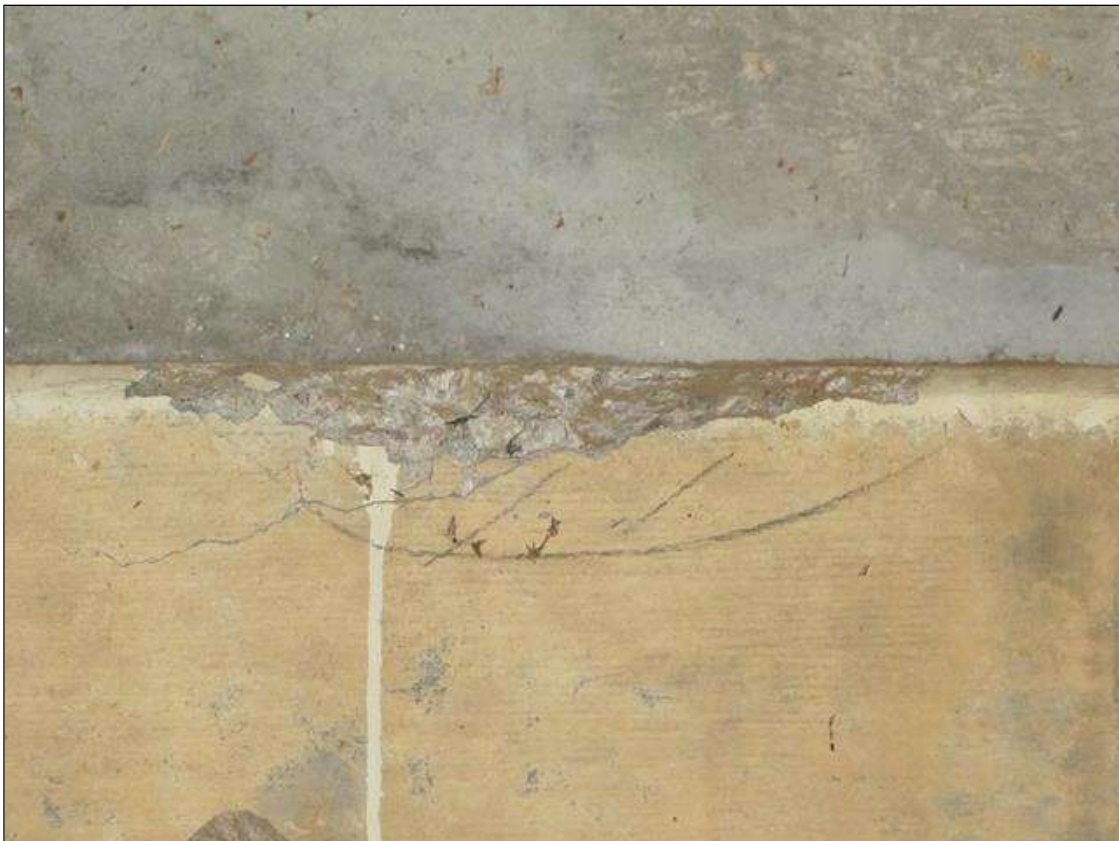
| Span 1 | | | Deck | | | | |
|---|---|---|---|---|---|---|---|
| 12 | Efflorescence/Rust Staining | HAIRLINE CRACK WITH EFFLORESCENCE IN UNDERSIDE DECK BAY 4 NEAR END BENT 1 | | | 2 | 4 | |

Span 1 Deck: HAIRLINE CRACK WITH EFFLORESCENCE IN UNDERSIDE DECK BAY 4 NEAR END BENT 1

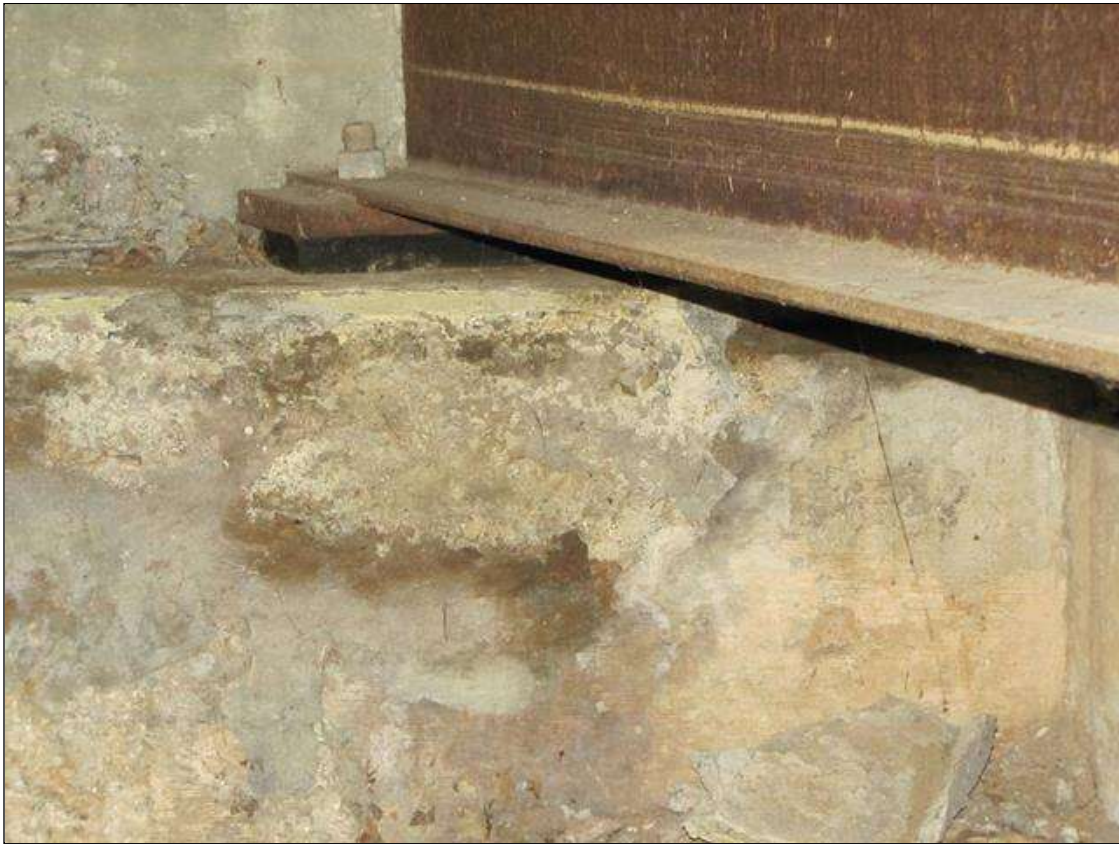
| Element Number | Defect Type | Defect Description | CS | CS Qty | Maint Qty | |
|---|---|---|---|---|---|---|
| 215 | Delamination/Spall | SPALL WITH EXPOSED REBAR 16" X 6" X 1/2" DEEP IN BAY 12 | 3 | 2 | 2 | Feet |

End Bent 1 Abutment/Backwall : SPALL WITH EXPOSED REBAR 16" X 6" X 1/2" DEEP IN BAY 12

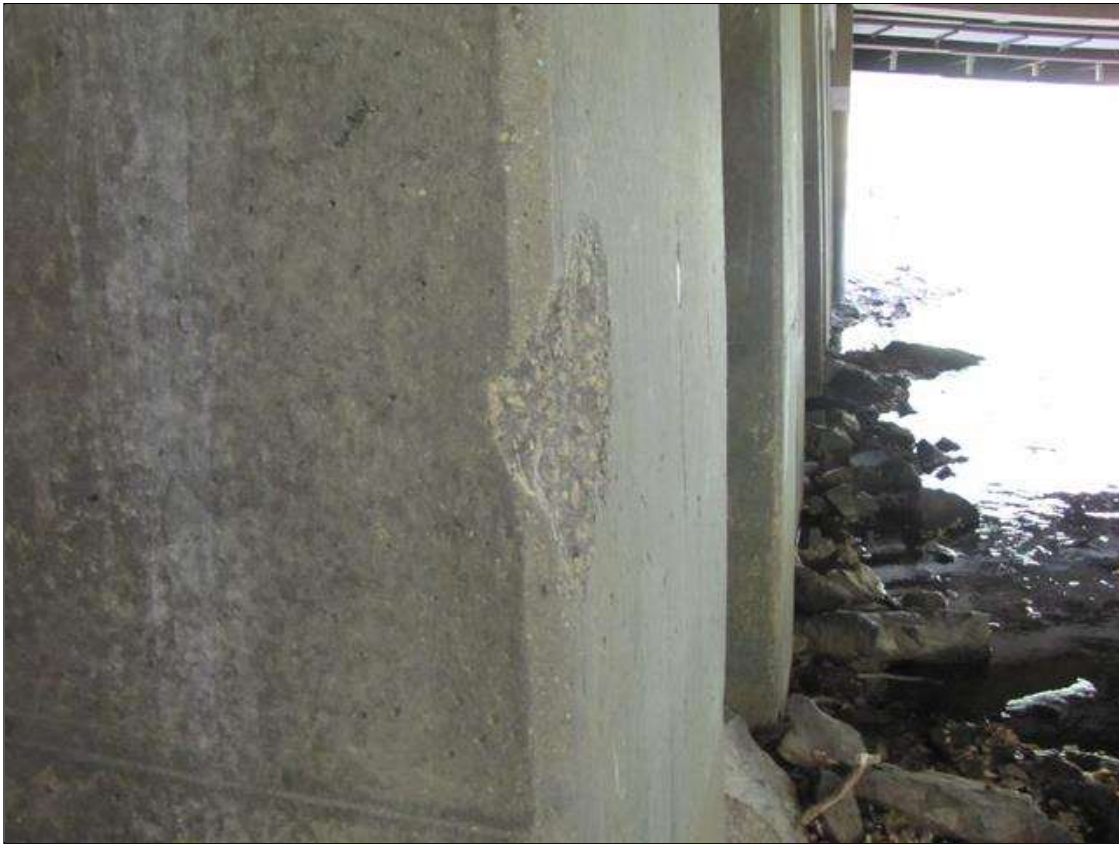
| Element Number | Defect Type | Defect Description | CS | CS Qty | Maint Qty | |
|---|---|---|---|---|---|---|
| 215 | Delamination/Spall | DELAMINATION 1 FT X 8" IN BAY 13 | 2 | 1 | 1 | Feet |

End Bent 1 Abutment/Backwall : DELAMINATION 1 FT X 8" IN BAY 13

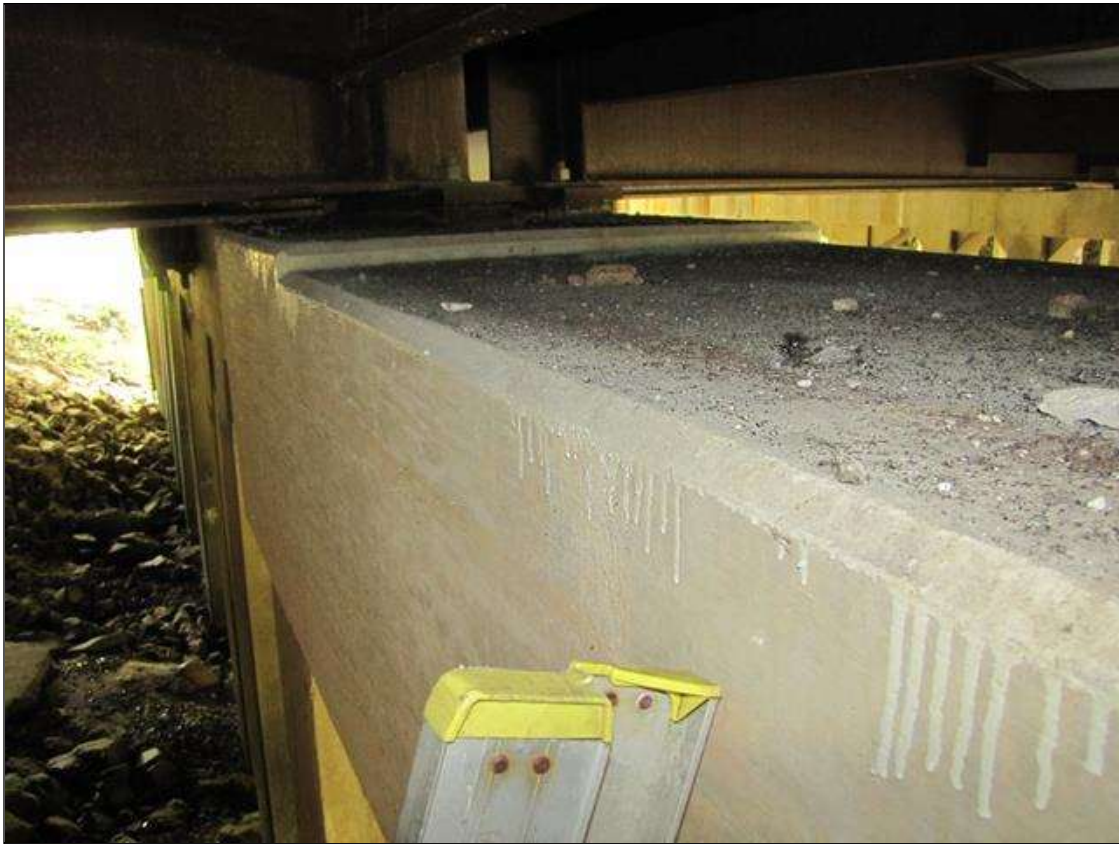
RUSTED TEMPORARY REPAIR SUPPORTING GIRDERS 8 - 10.

CAP REPAIR AT BENT 1 UNDER BEAMS 8, 9, 10 IN SPANS 1 AND 2 (WEST SIDE SHOWN)
