# Structure Safety Report

## Routine Element Inspection - Contract

COUNTY: WAKE STRUCTURE NUMBER: 910249 FREQUENCY: 24 MONTHSFACILITY CARRIED: GLEN EDEN MILE POST: LOCATION: 0.9 MI.N.SR1676 0.9 MILES NORTH OF JUNCTION WITH SR 1676FEATURE INTERSECTED: I440LATITUDE: 35° 49' 35.17" LONGITUDE: 78° 41' 1.17"SUPERSTRUCTURE: RC FLOOR ON I-BEAMSSUBSTRUCTURE: E.BTS:REINF.CONC.CAPS/PPC PILES;INT.BTS:RCP&BEAM3@56'-0"; 1@48'-0"SPANS: 3@56";1@48"☐ FRACTURE CRITICAL ☐ TEMPORARY SHORING ☐ SCOUR CRITICAL ☐ SCOUR PLAN OF ACTIONPRESENT CONDITION: Fair INSPECTION DATE: 03/09/2015POSTED SV: Not Posted POSTED TTST: Not PostedOTHER SIGNS PRESENT: NONE

Structure Number: 910249

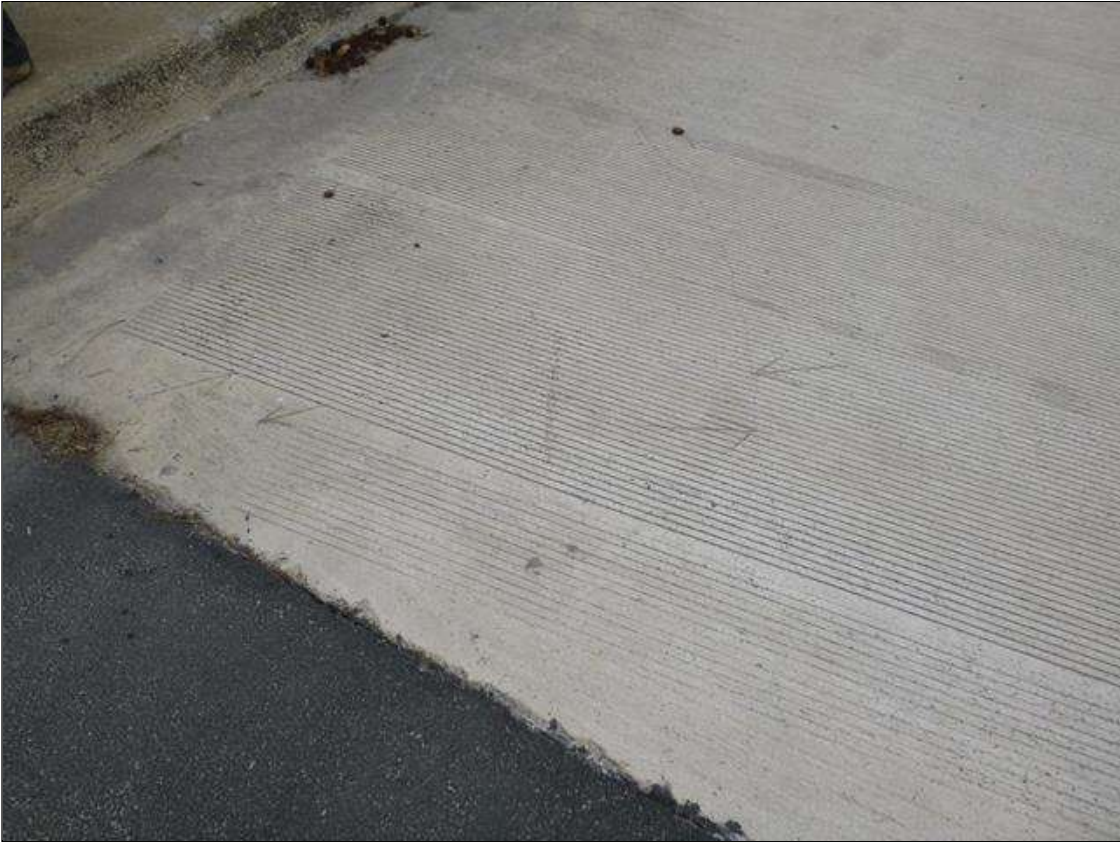
64 SF OF 10' DIAGONAL CRACKS UP TO 0.03" AT 4' CENTERS IN DECK SURFACE, SOUTHEAST CORNER.

Span 4 Deck: 64 SF OF 10' DIAGONAL CRACKS UP TO 0.03" AT 4' CENTERS IN DECK SURFACE, SOUTHEAST CORNER.

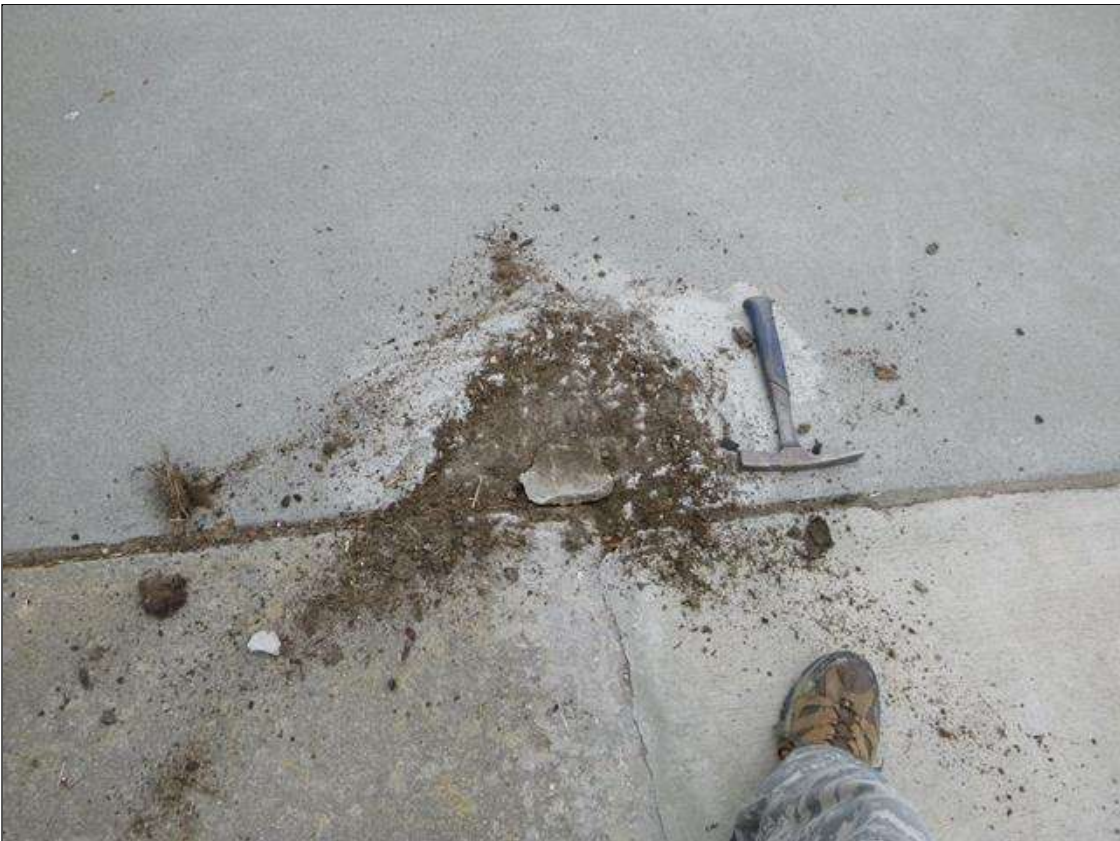
18" DIAMETER X 2" SPALL IN LEFT APPROACH SIDEWALK SURFACE ADJACENT TO END BENT 2 CONCRETE

Expansion Joint 5 : 18" DIAMETER X 2" SPALL IN LEFT APPROACH SIDEWALK SURFACE ADJACENT TO END BENT 2 CONCRETE HEADER.

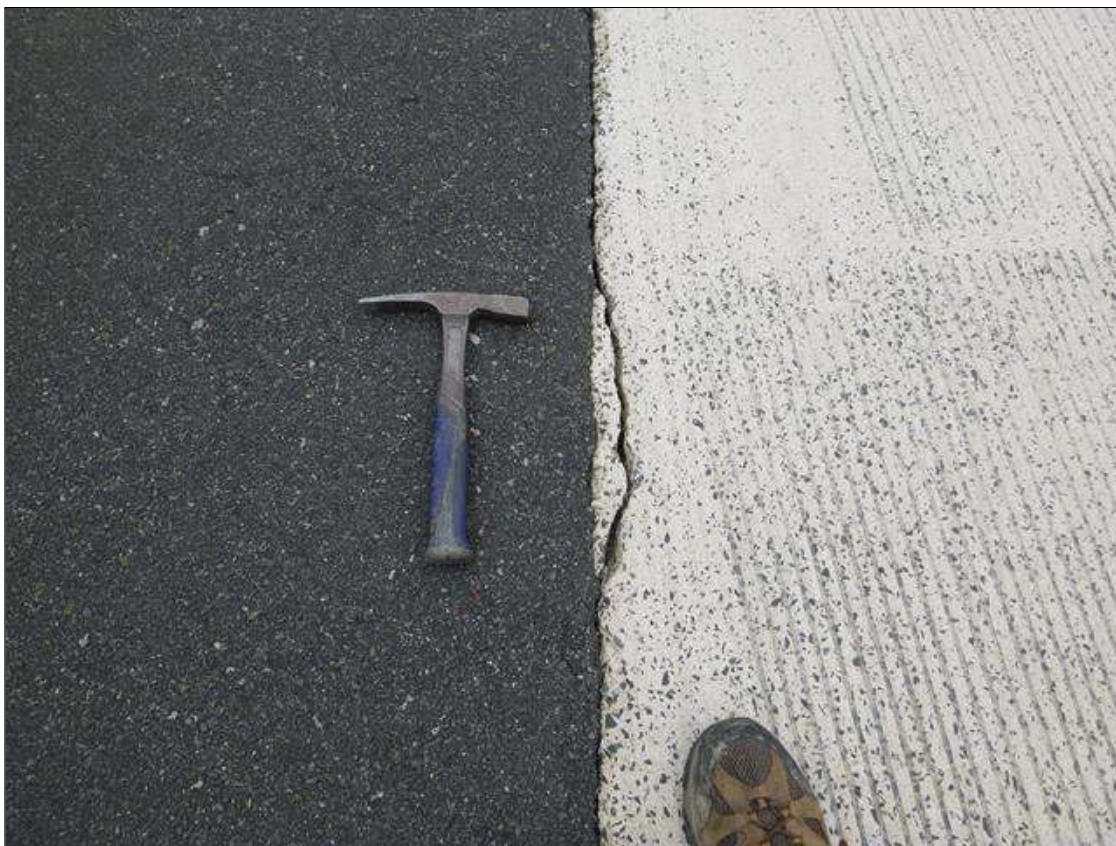
1' X 4" X 1" SPALL IN DECK SURFACE AT END BENT 2, 7' FROM LEFT CURB.

Span 4 Deck: 1' X 4" X 1" SPALL IN DECK SURFACE AT END BENT 2, 7' FROM LEFT CURB.

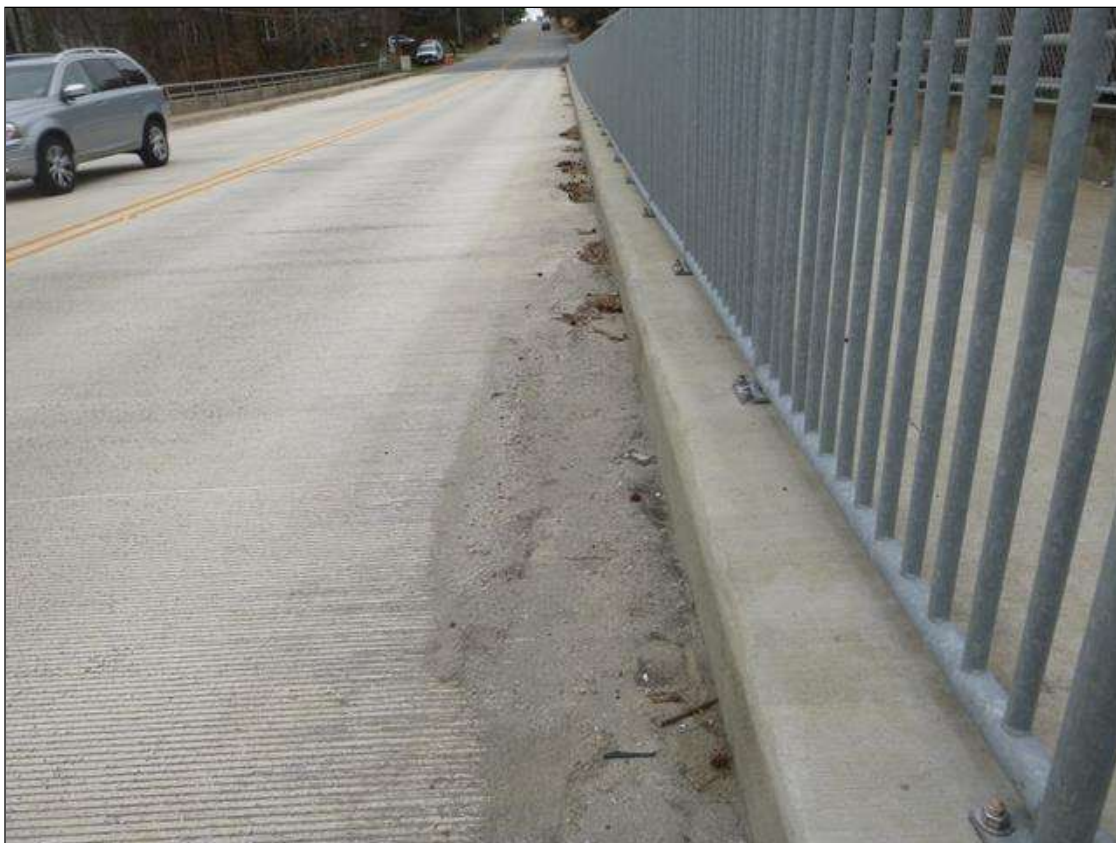
UP TO 2' WIDE X FULL LENGTH OF SAND AND DEBRIS IN LEFT CURB LINE.

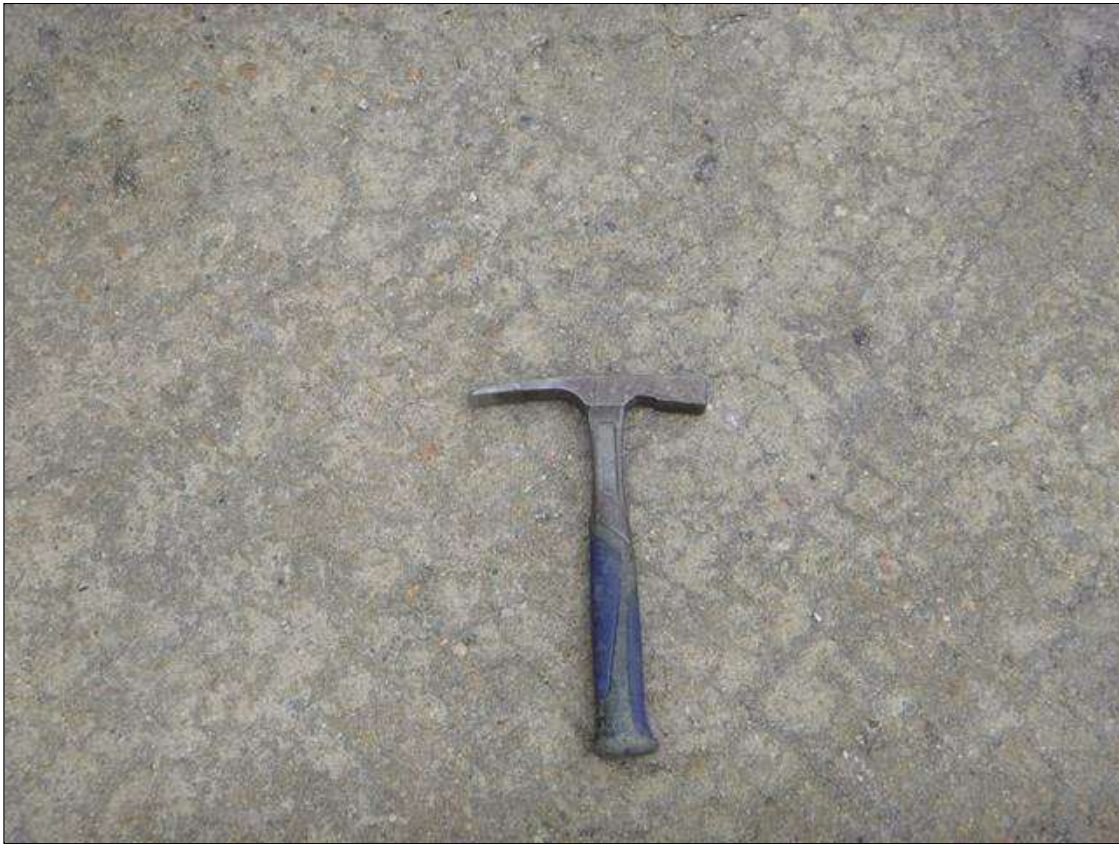
RIGHT SIDEWALK, CURB, AND PARAPET ARE HEAVILY WORN WITH MAP CRACKING AT 2" CENTERS.

Span 4 Right Bridge Rail: RIGHT SIDEWALK, CURB, AND PARAPET ARE HEAVILY WORN WITH MAP CRACKING AT 2" CENTERS.

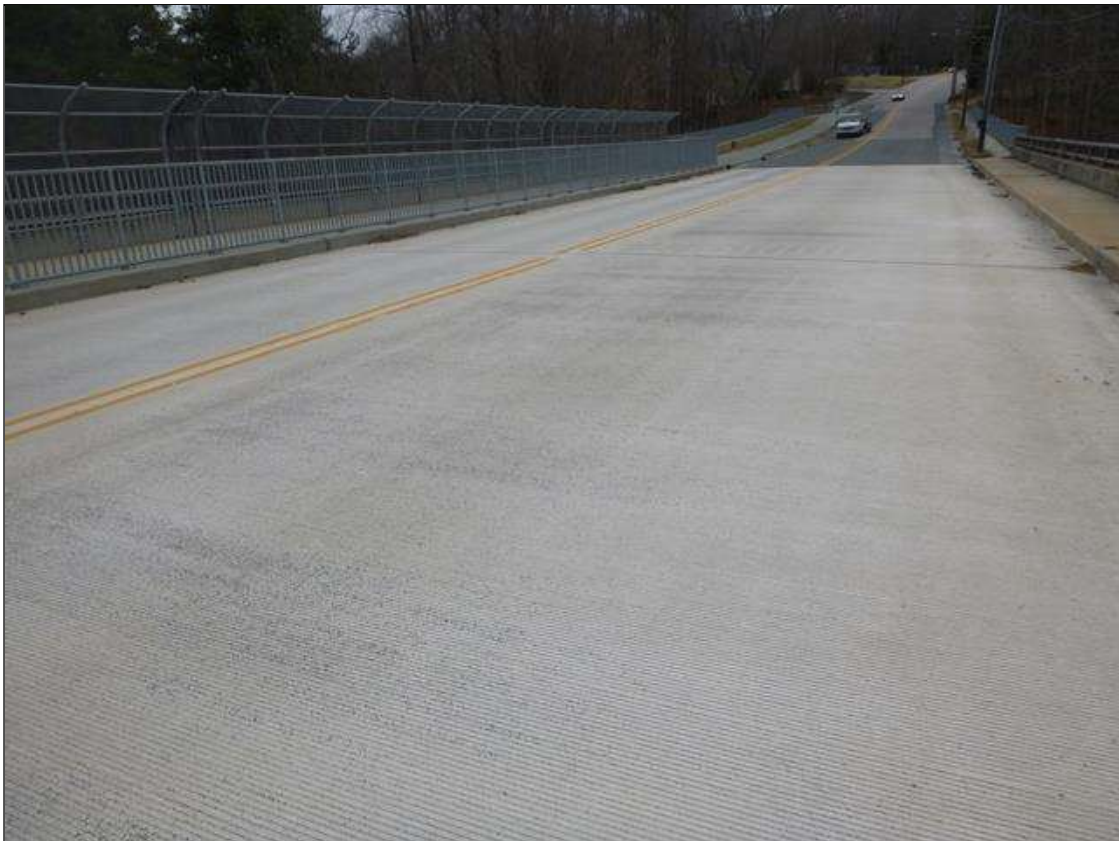
WORN DECK SURFACE WITH LARGE AGGREGATE EXPOSED IN TRAVEL LANES.

Span 2 Deck: WORN DECK SURFACE WITH LARGE AGGREGATE EXPOSED IN TRAVEL LANES.

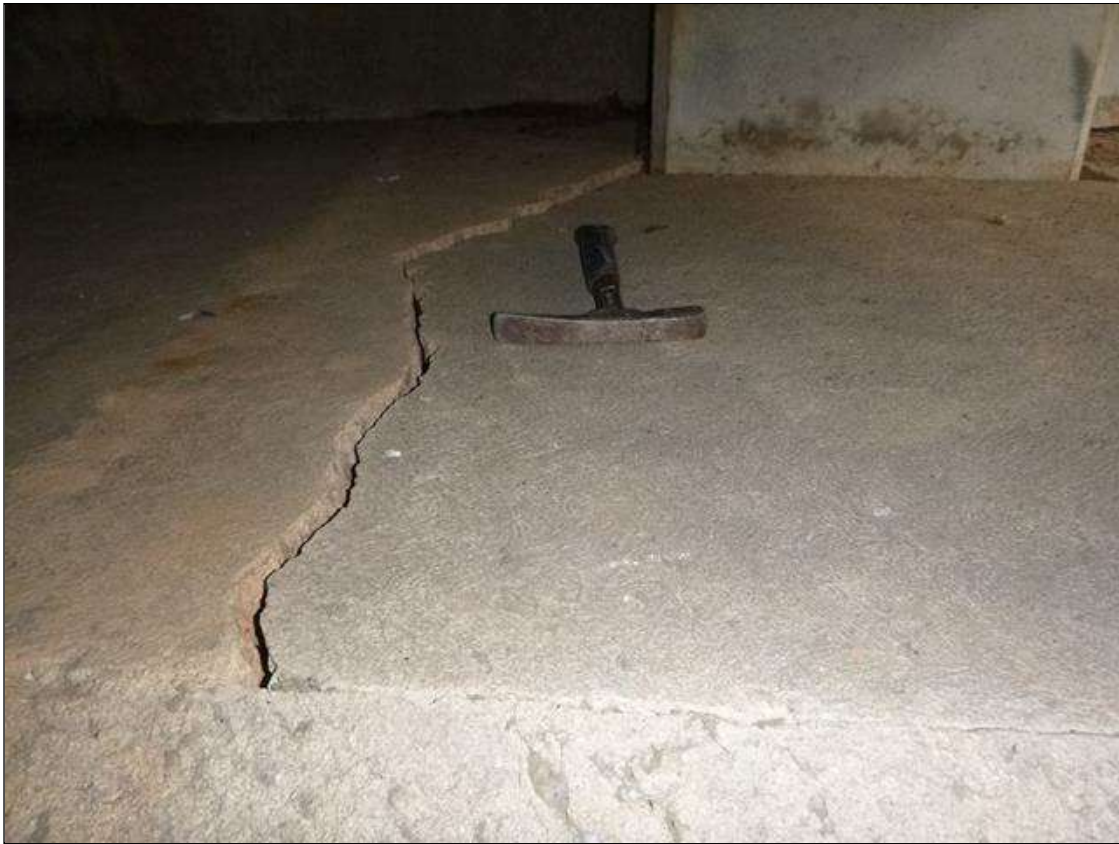
8' TRANSVERSE CRACK IN SLOPE PROTECTION BERM AT END BENT 1 EXTERIOR BRACE PILE CAPS, UP TO 1/2" WITH UP TO 1/2" OF VERTICAL DISPLACEMENT.

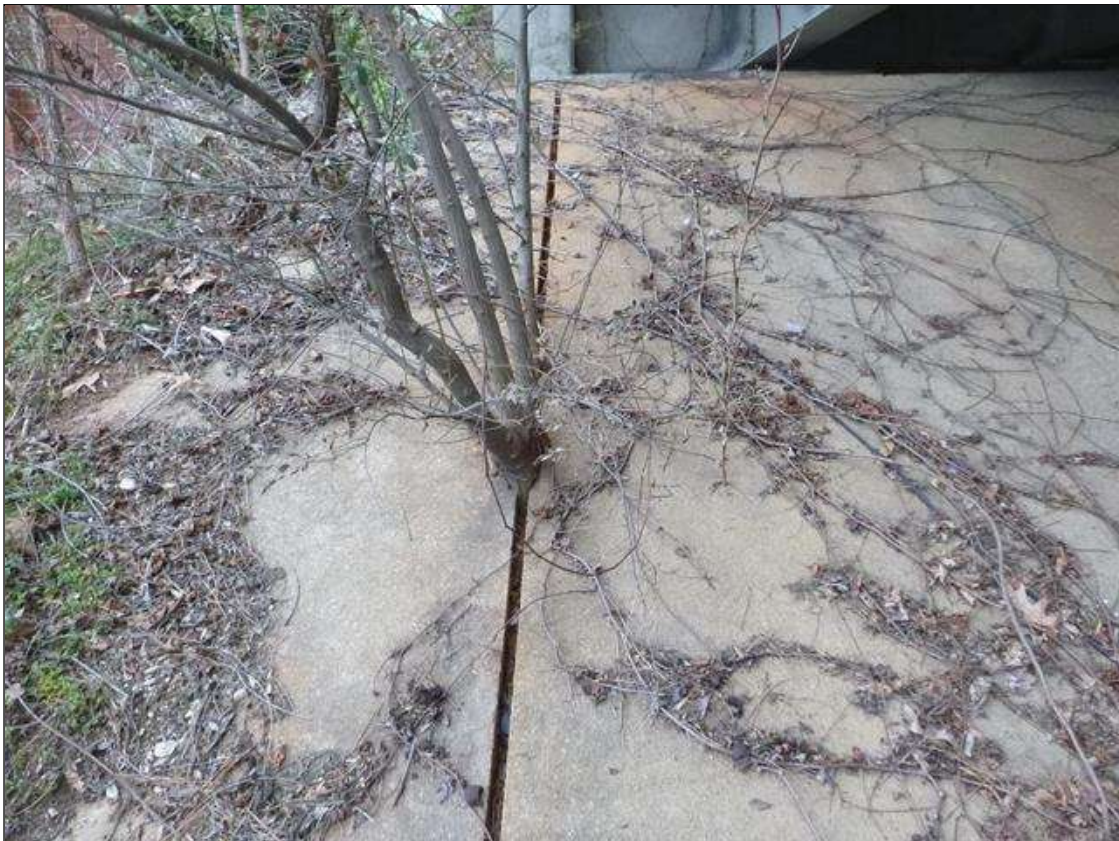
EXTERIOR END BENT 1 SLOPE PROTECTION PANEL UNDER BEAM 8 HAS A 40' X 1" LONGITUDINAL CRACK DUE TO VEGETATION GROWTH.

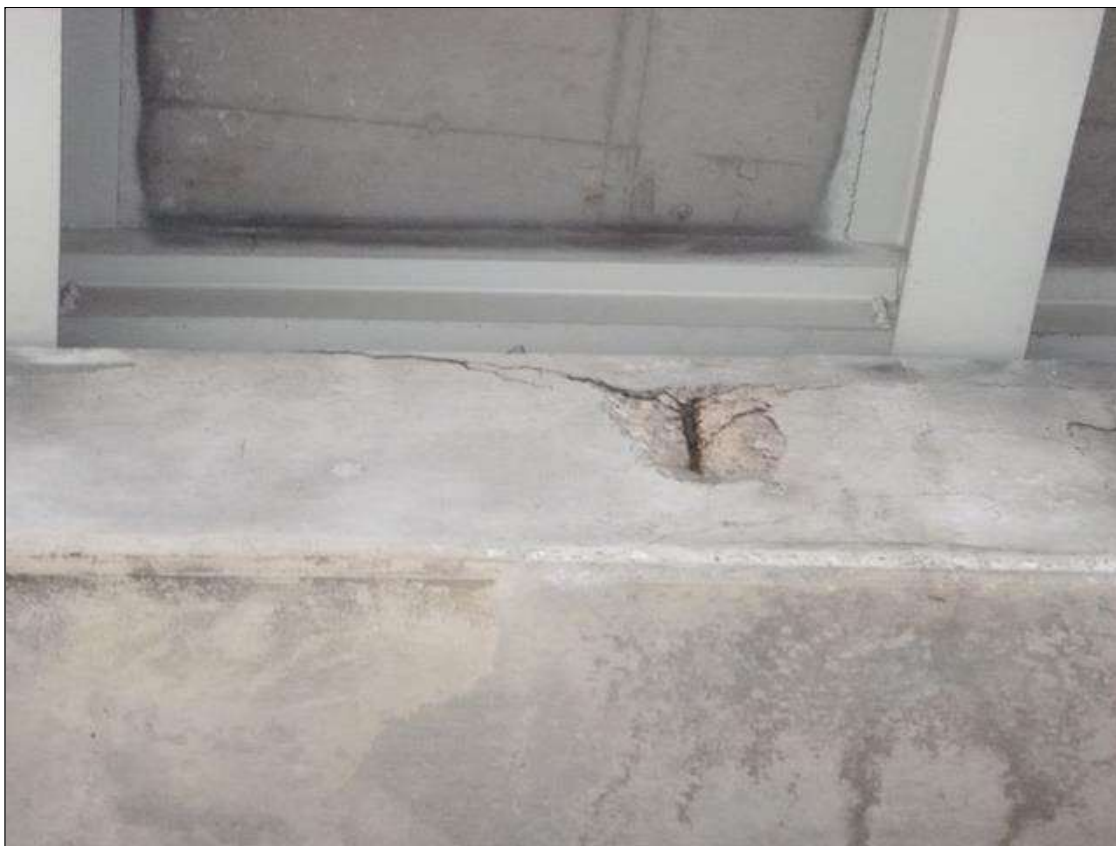
Bent 1 Cap : 24" X 12" X 3" SPALL WITH EXPOSED REINFORCING ON EAST FACE OF CAP, BETWEEN BEAMS 6 AND 7.

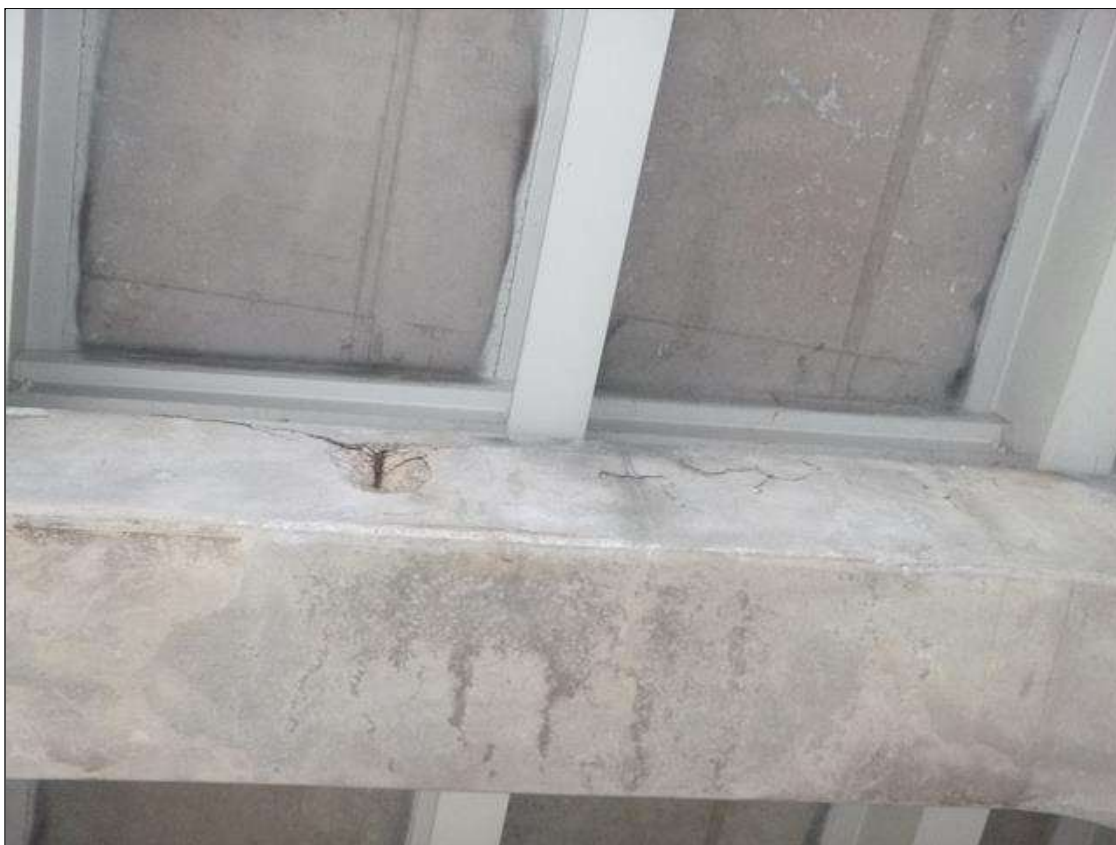
Bent 1 Cap : 14' X 2' DELAMINATION ON EAST FACE OF CAP, BETWEEN BEAMS 5 AND 7.

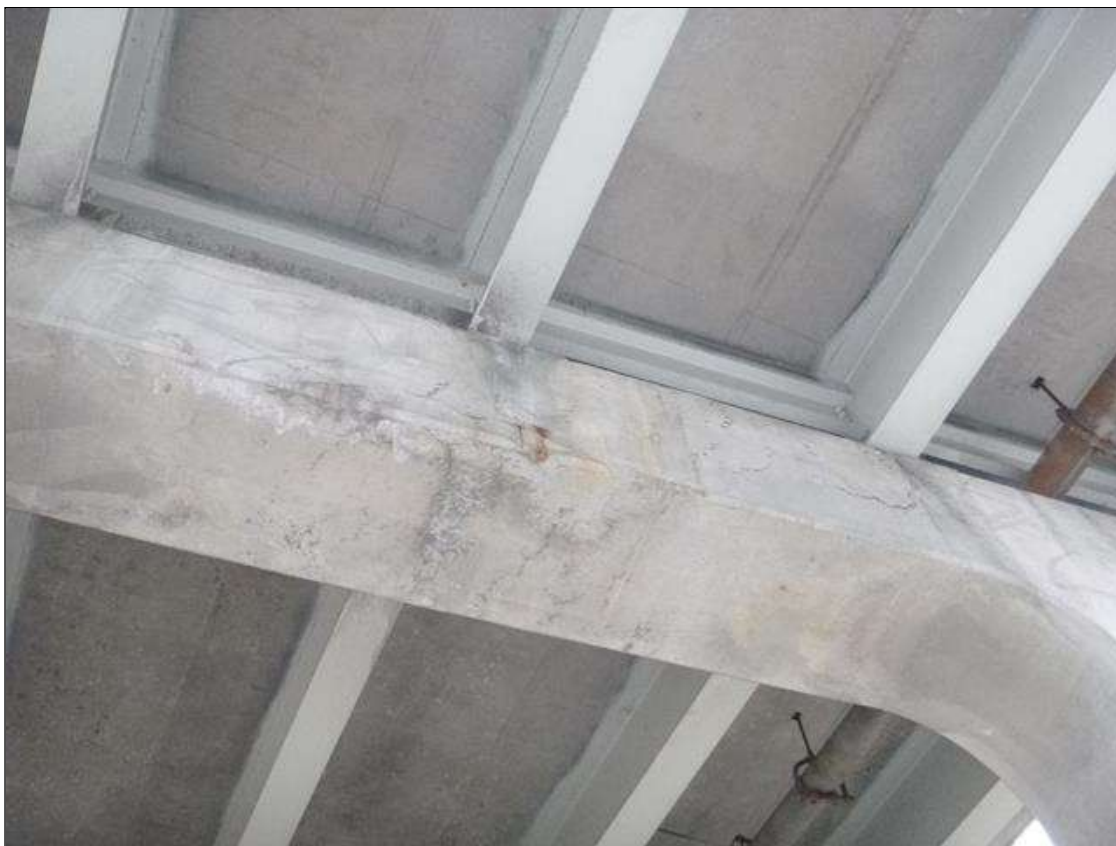
Bent 1 Cap : 11' X 3' DELAMINATION ON EAST FACE OF CAP, BETWEEN BEAMS 2 AND 4.

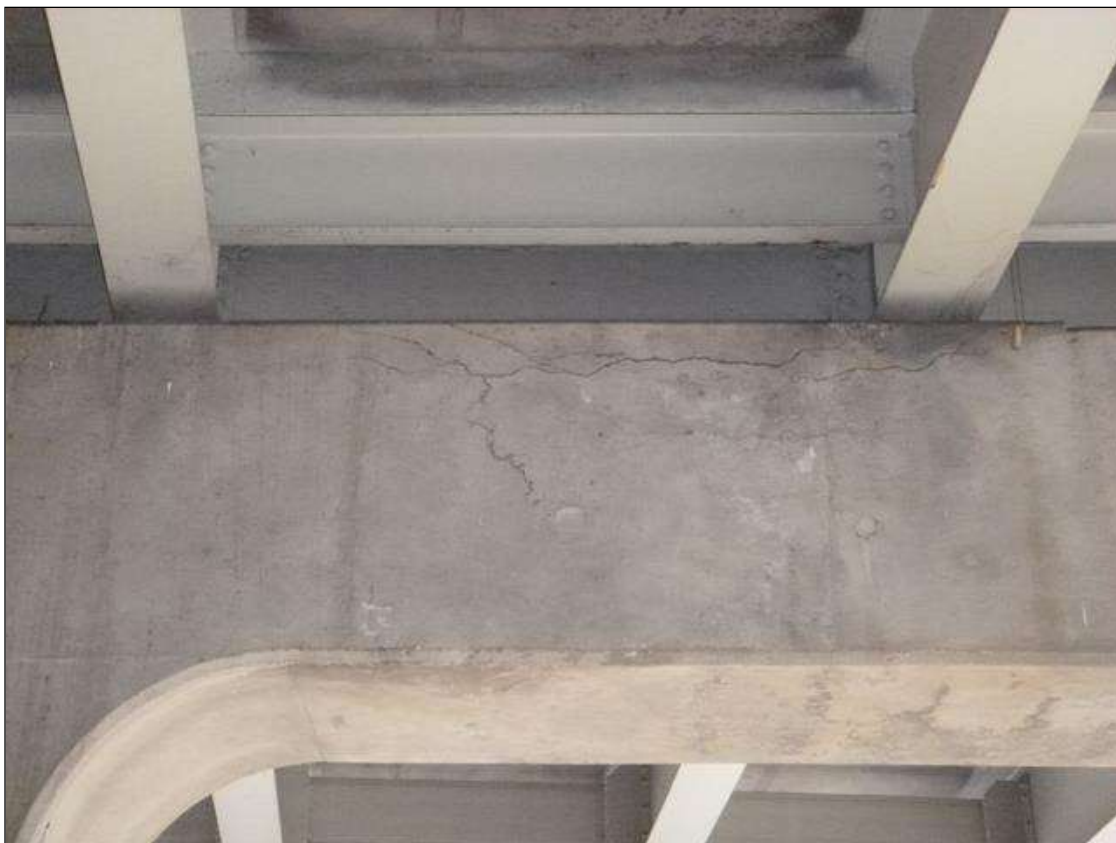
Bent 1 Cap : 7' X 2' DELAMINATION ON WEST FACE OF CAP, BETWEEN BEAMS 5 AND 6.

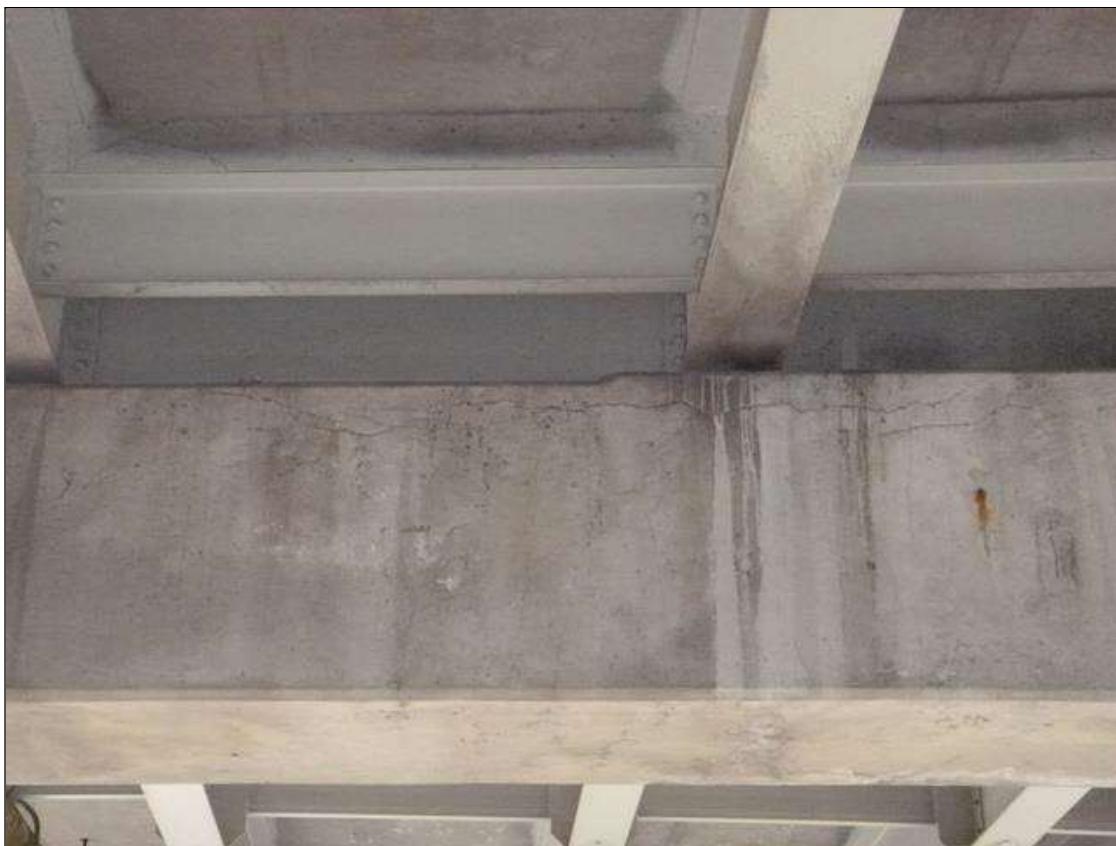
Bent 1 Cap : 11' X 2' DELAMINATION ON WEST FACE OF CAP, BEGINNING AT BEAM 2.

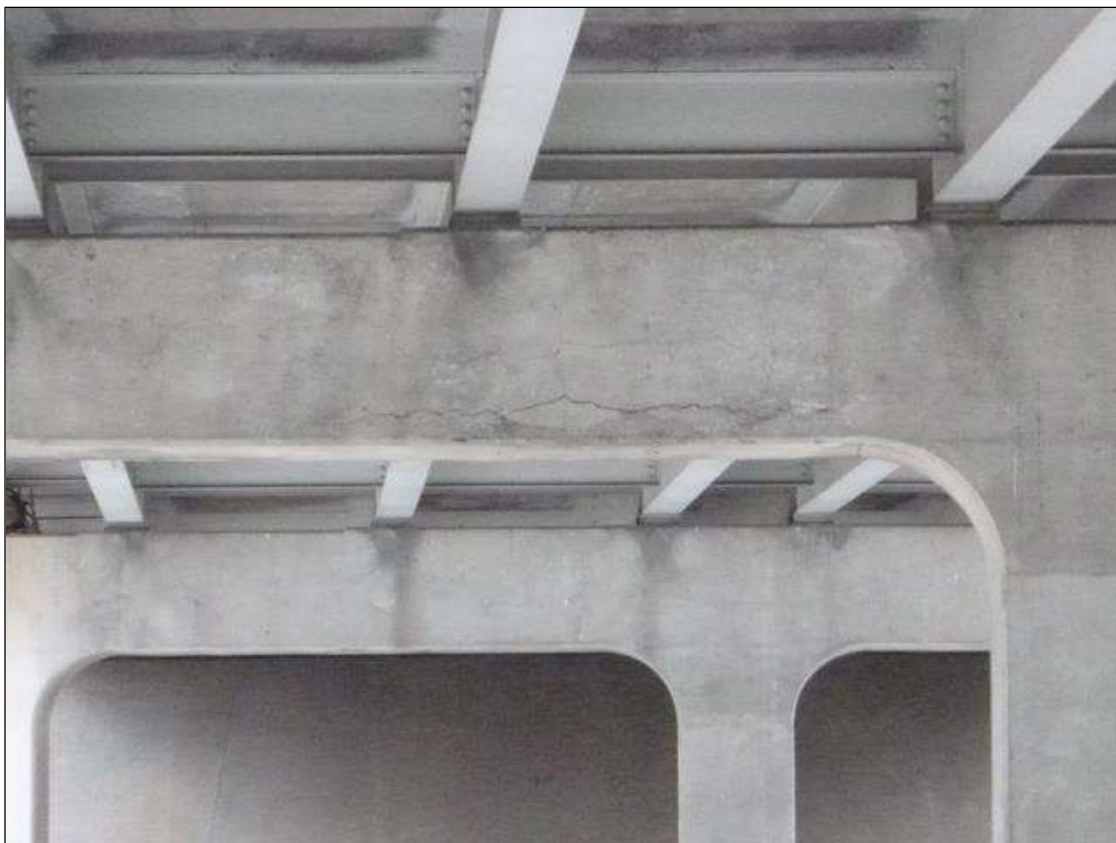
Bent 2 Cap : 7' X 2' DELAMINATION ON WEST FACE OF CAP, UNDER BEAM 3.

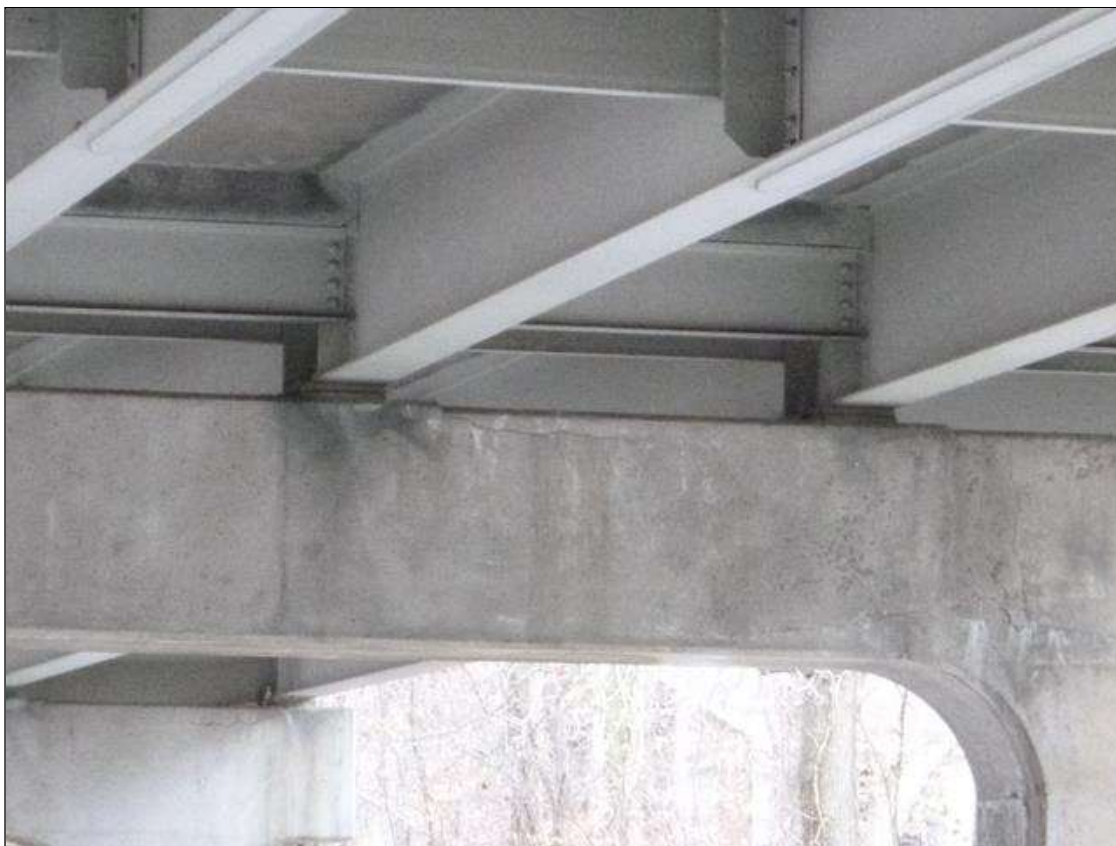
Bent 2 Cap : 4' X 1' DELAMINATION ON WEST FACE OF CAP, BEGINNING UNDER BEAM 6.

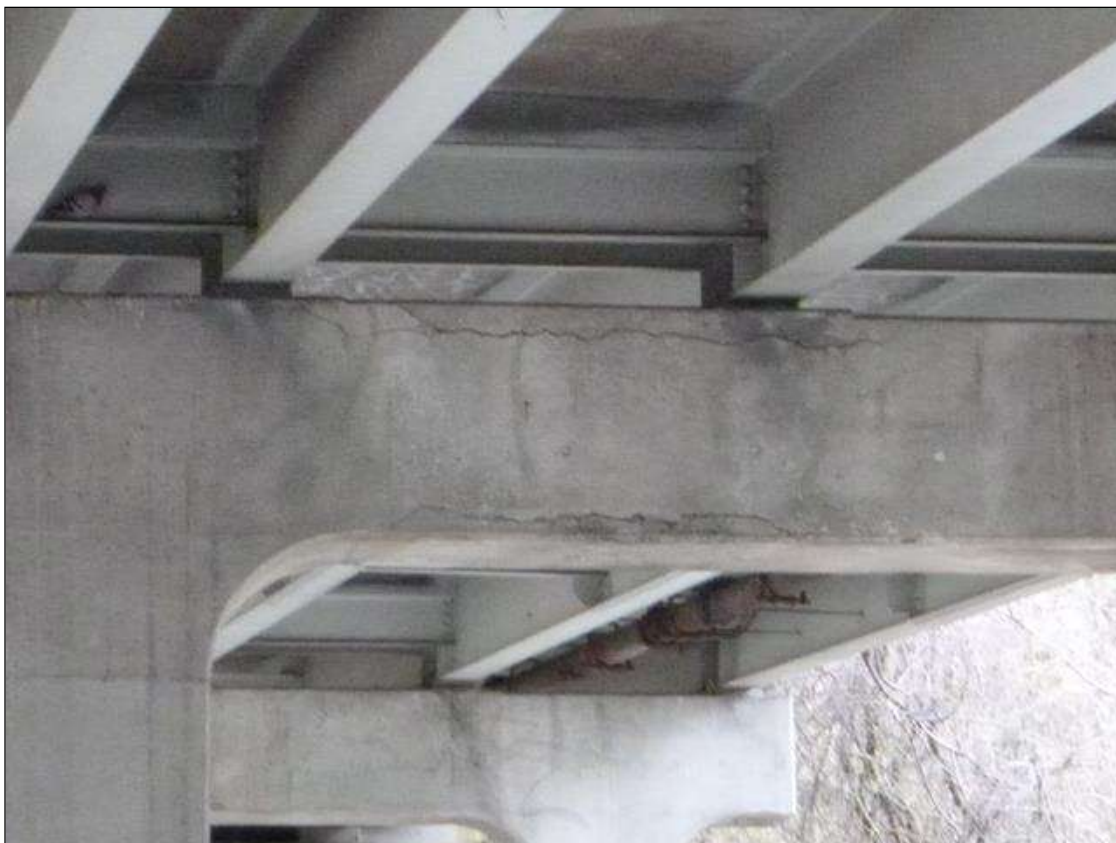
Bent 2 Cap : 7' X 1' DELAMINATION AT TOP AND BOTTOM OF CAP ON EAST FACE, BEGINNING UNDER BEAM  
3.

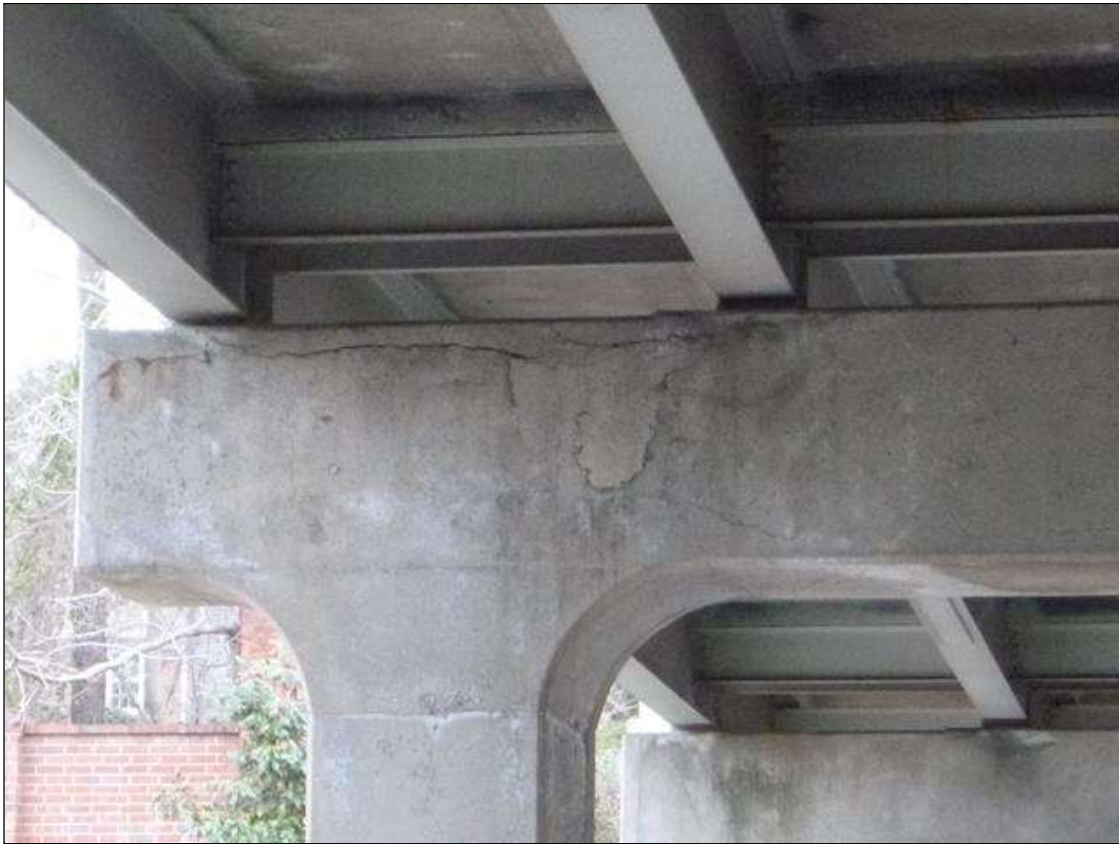
Bent 2 Cap : 7' X 1' DELAMINATION AT TOP EAST FACE OF CAP, BEGINNING UNDER BEAM 7.

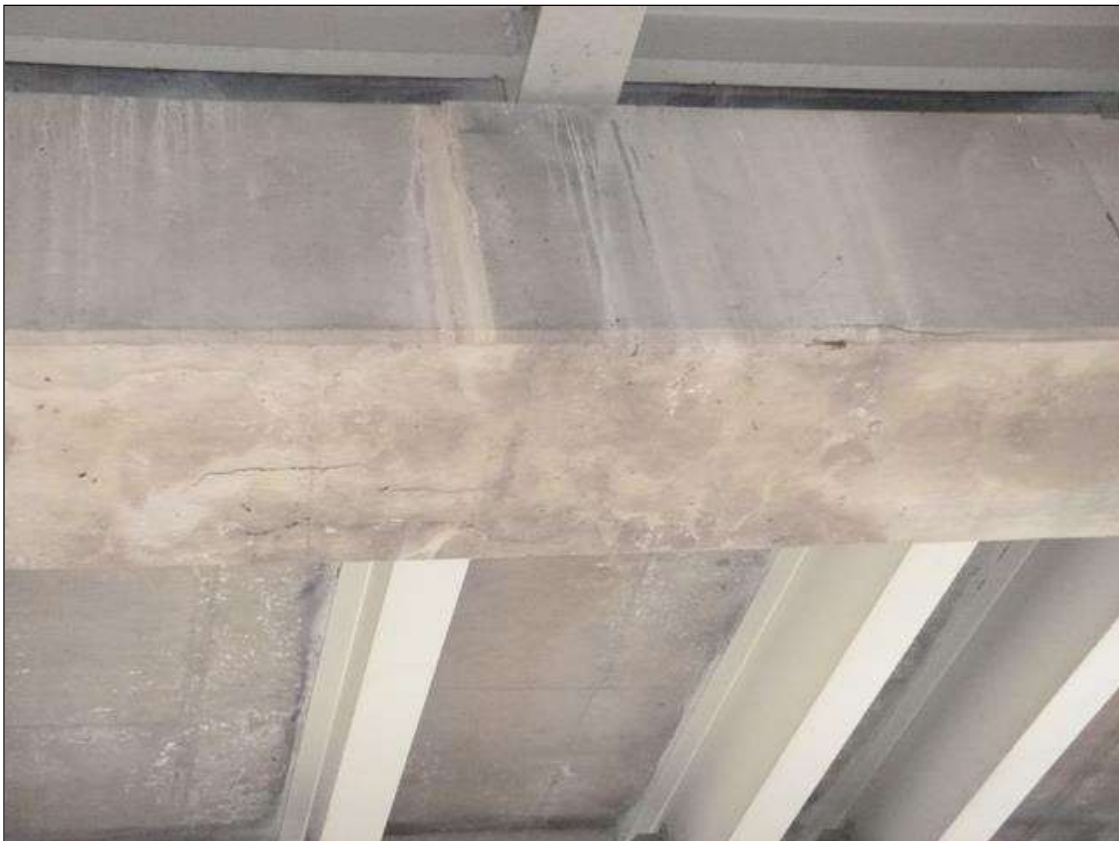
Bent 3 Cap : 7' X 2' DELAMINATION ON UNDERSIDE OF CAP, BETWEEN COLUMNS 2 AND 3.

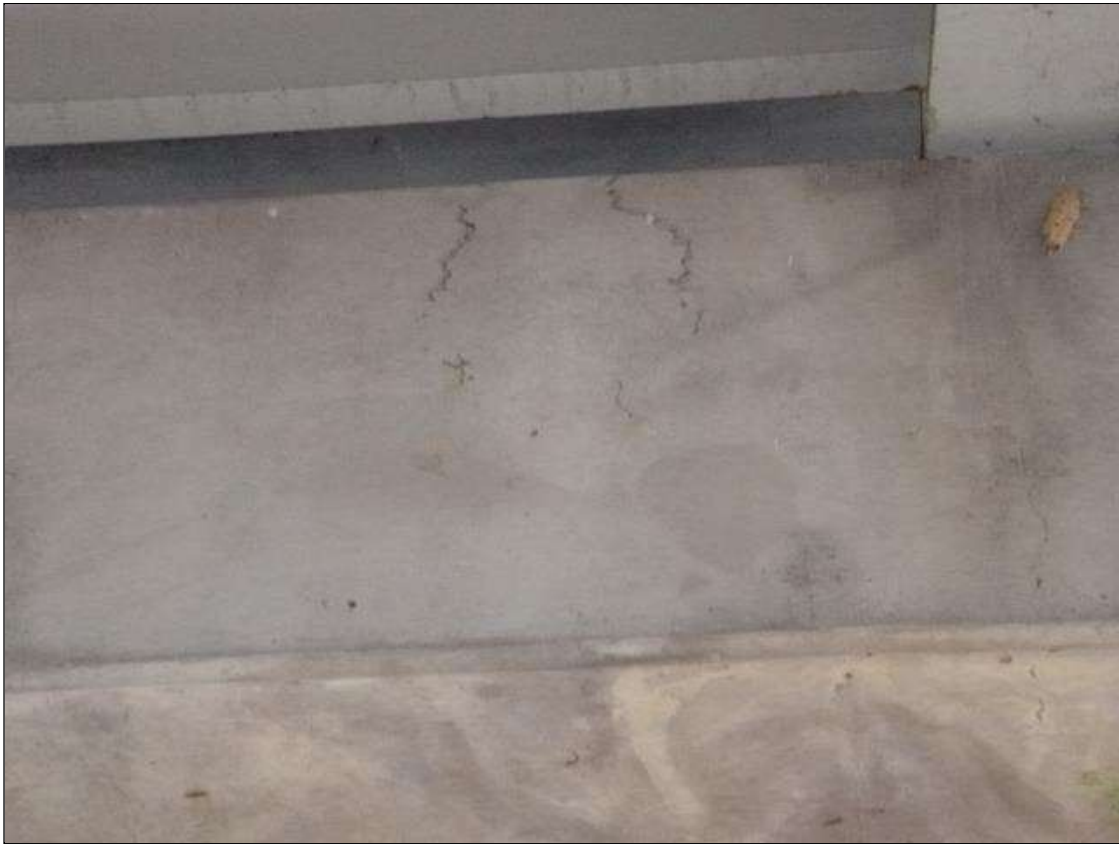
Bent 3 Cap : 1' X 2' DELAMINATION ON EAST FACE OF CAP, BETWEEN BEAMS 3 AND 4.

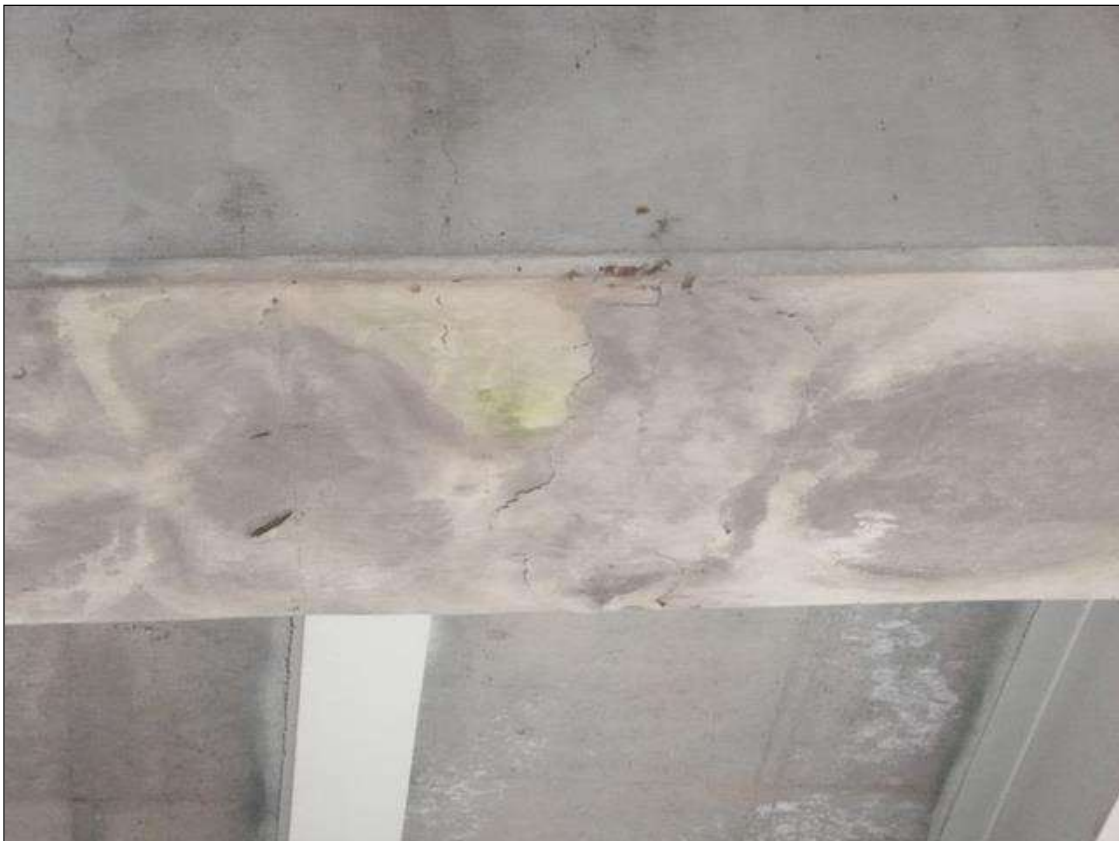
Bent 3 Cap : 4' X 3' DELAMINATION ON UNDERSIDE OF CAP, BELOW BEAM 3.

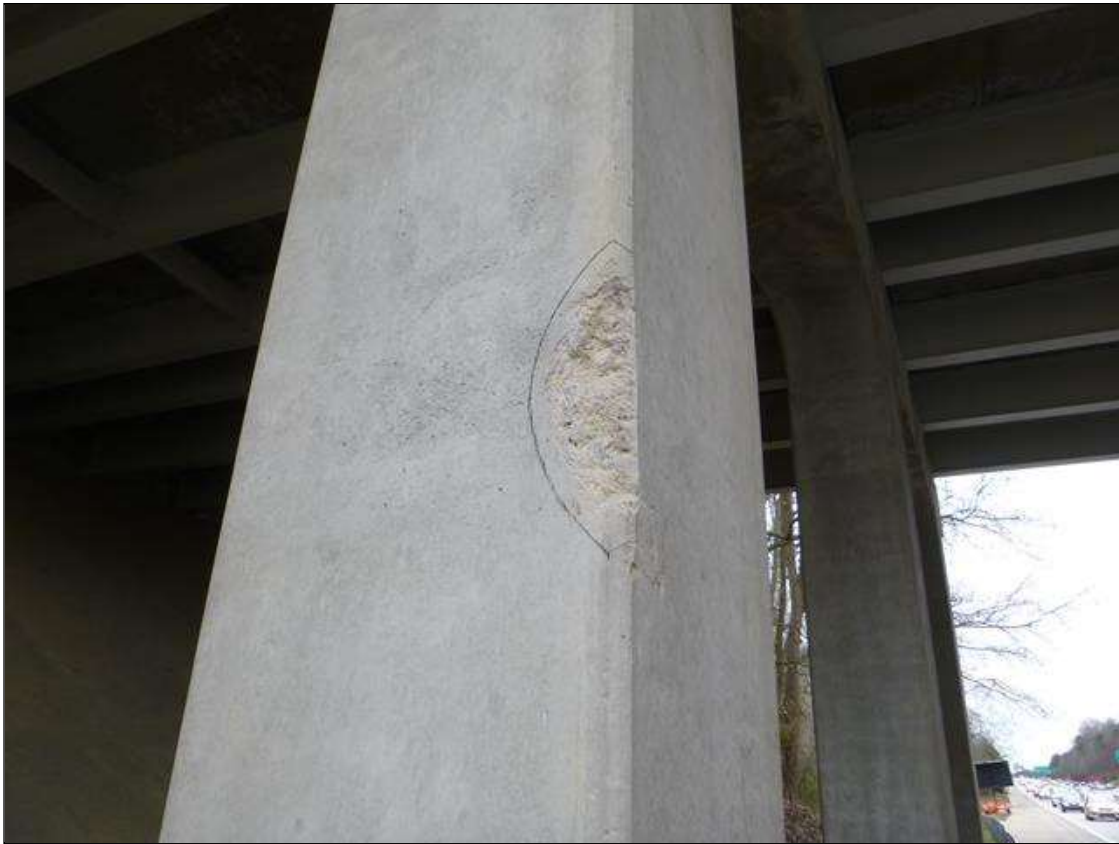
21" X 6" X 1" SPALL ON NORTH FACE OF COLUMN, 7' ABOVE GRADE.

Bent 3 Pile 3: 21" X 6" X 1" SPALL ON NORTH FACE OF COLUMN, 7' ABOVE GRADE.

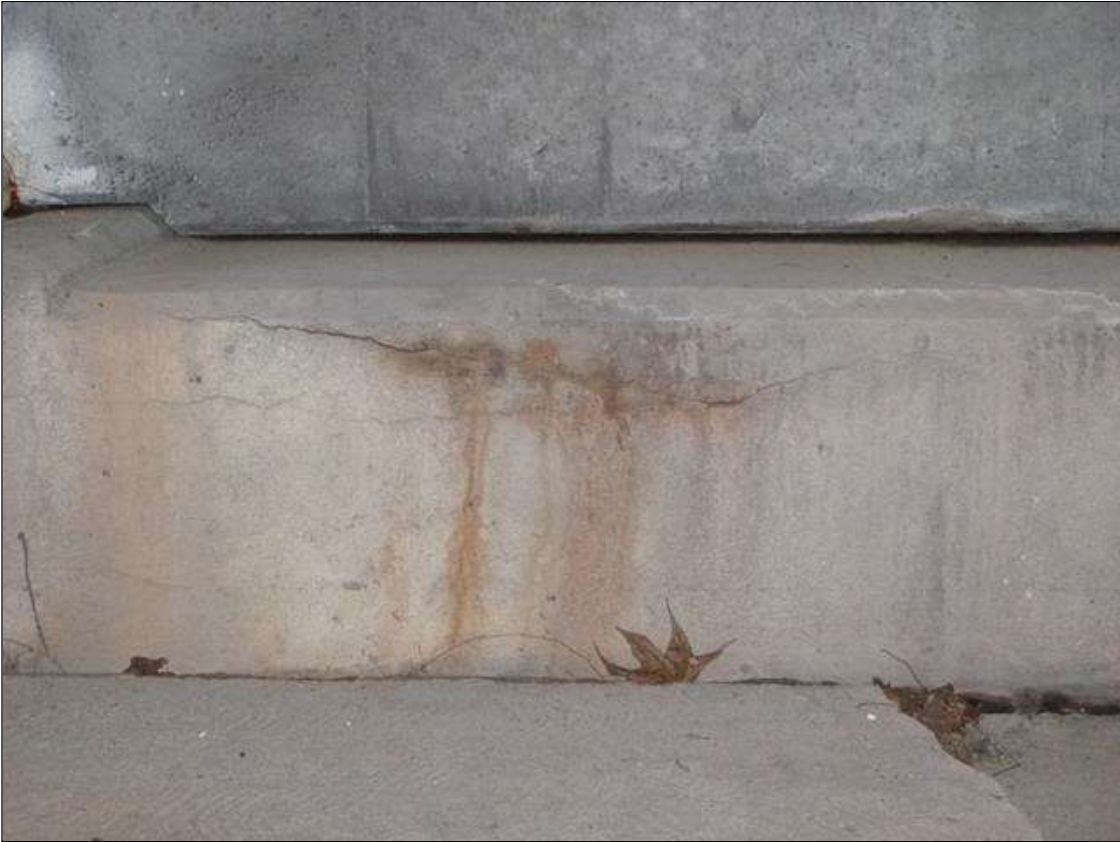
3' LONGITUDINAL CRACK UP TO 0.06" WITH RUST STAINING ON FACE OF CAP, BETWEEN BEAMS 6 AND 7.

End Bent 2 Cap : 3' LONGITUDINAL CRACK UP TO 0.06" WITH RUST STAINING ON FACE OF CAP, BETWEEN BEAMS 6 AND 7.

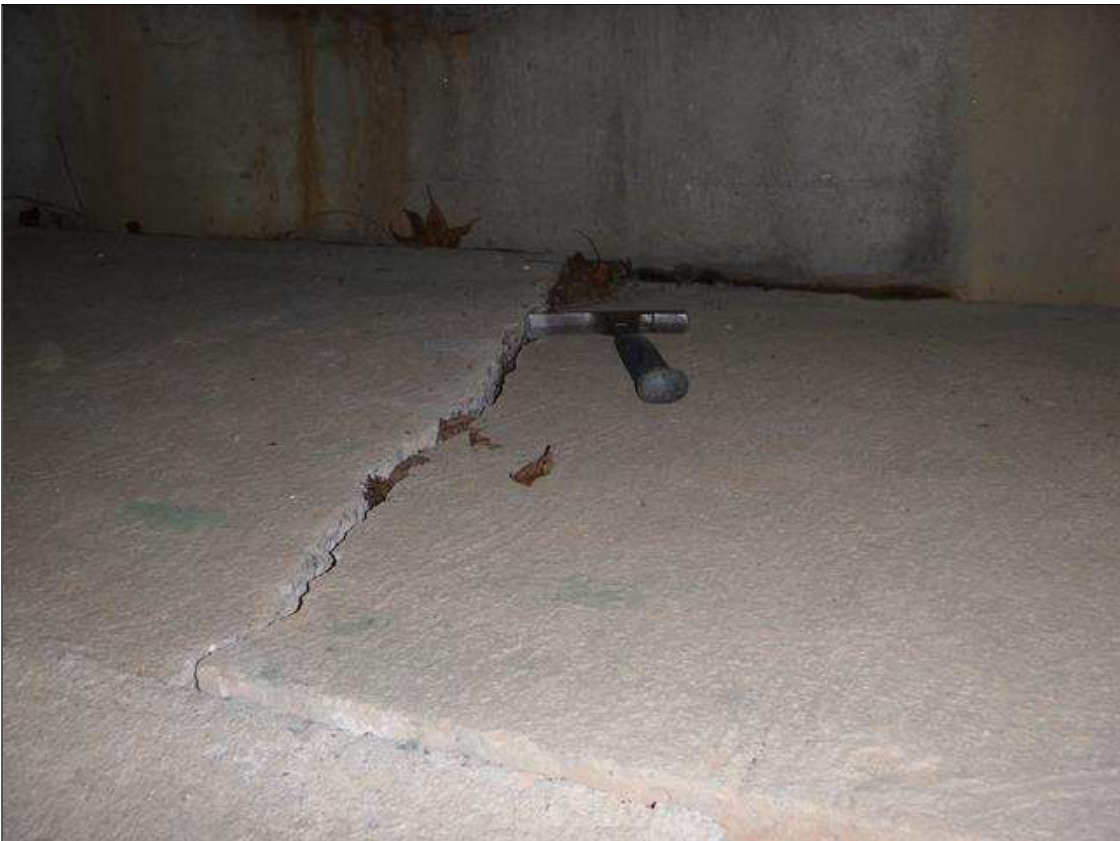
3.5' TRANVERSE CRACK UP TO 1/2" WITH 1" VERTICAL DISPLACEMENT ON END BENT 2 SLOPE PROTECTION BERM, BETWEEN BEAMS 6 AND 7.
