# Structure Safety Report

## Routine Element Inspection - Contract

COUNTY: WAKE STRUCTURE NUMBER: 910249 FREQUENCY: 24 MONTHSFACILITY CARRIED: GLEN EDEN MILE POST: LOCATION: 0.9 MI.N.SR1676 0.9 MILES NORTH OF JUNCTION WITH SR 1676FEATURE INTERSECTED: I440LATITUDE: 35° 49' 35.17" LONGITUDE: 78° 41' 1.17"SUPERSTRUCTURE: RC FLOOR ON I-BEAMSSUBSTRUCTURE: E.BTS:REINF.CONC.CAPS/PPC PILES;INT.BTS:RCP&BEAM3@56'-0"; 1@48'-0"SPANS: 3@56";1@48"☐ FRACTURE CRITICAL ☐ TEMPORARY SHORING ☐ SCOUR CRITICAL ☐ SCOUR PLAN OF ACTIONPRESENT CONDITION: Fair INSPECTION DATE: 03/09/2015POSTED SV: Not Posted POSTED TTST: Not PostedOTHER SIGNS PRESENT: NONE

Structure Number: 910249

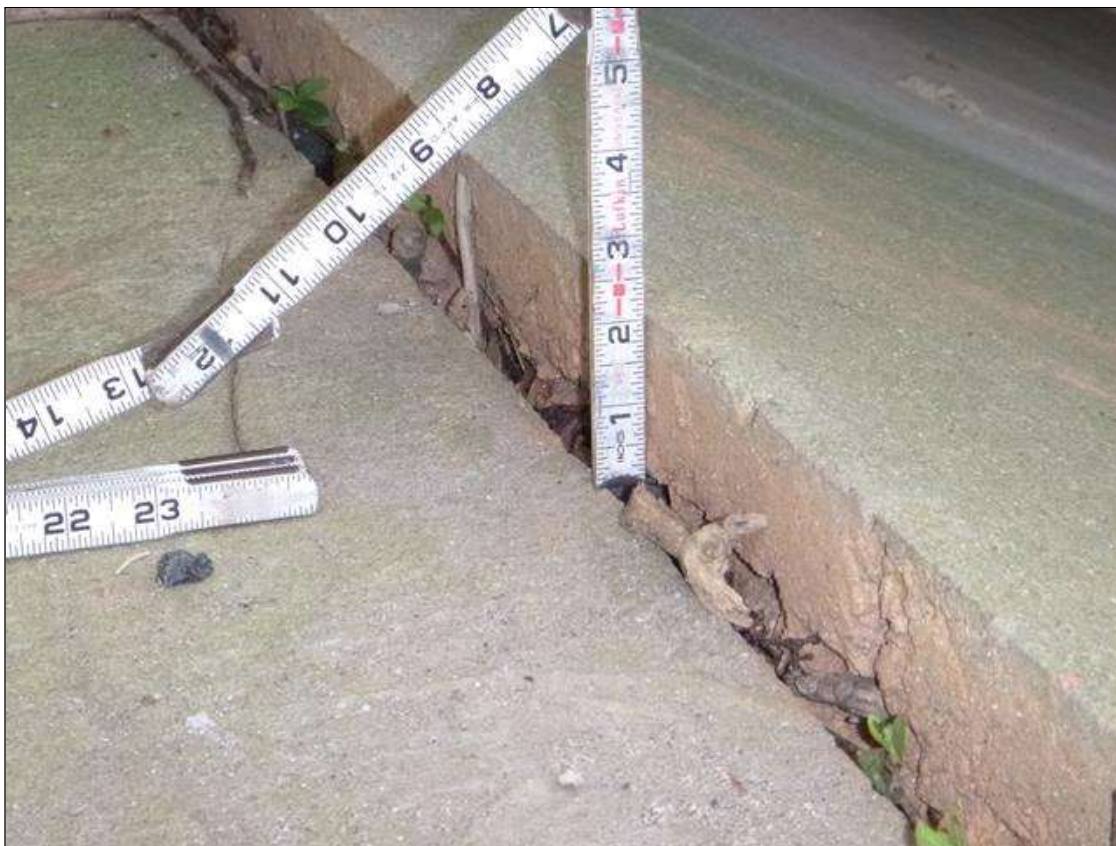
2" OF SETTLEMENT IN END BENT 2 SLOPE PROTECTION BERM, BEGINNING OUTSIDE OF BEAM 1.
