NC DEPARTMENT OF TRANSPORTATION  
DIVISION OF HIGHWAYS  
STRUCTURE MANAGEMENT UNIT

## Structure Safety Report

### Routine Element Inspection - Contract

COUNTY: WAKE STRUCTURE NUMBER: 910252 FREQUENCY: 24 MONTHS

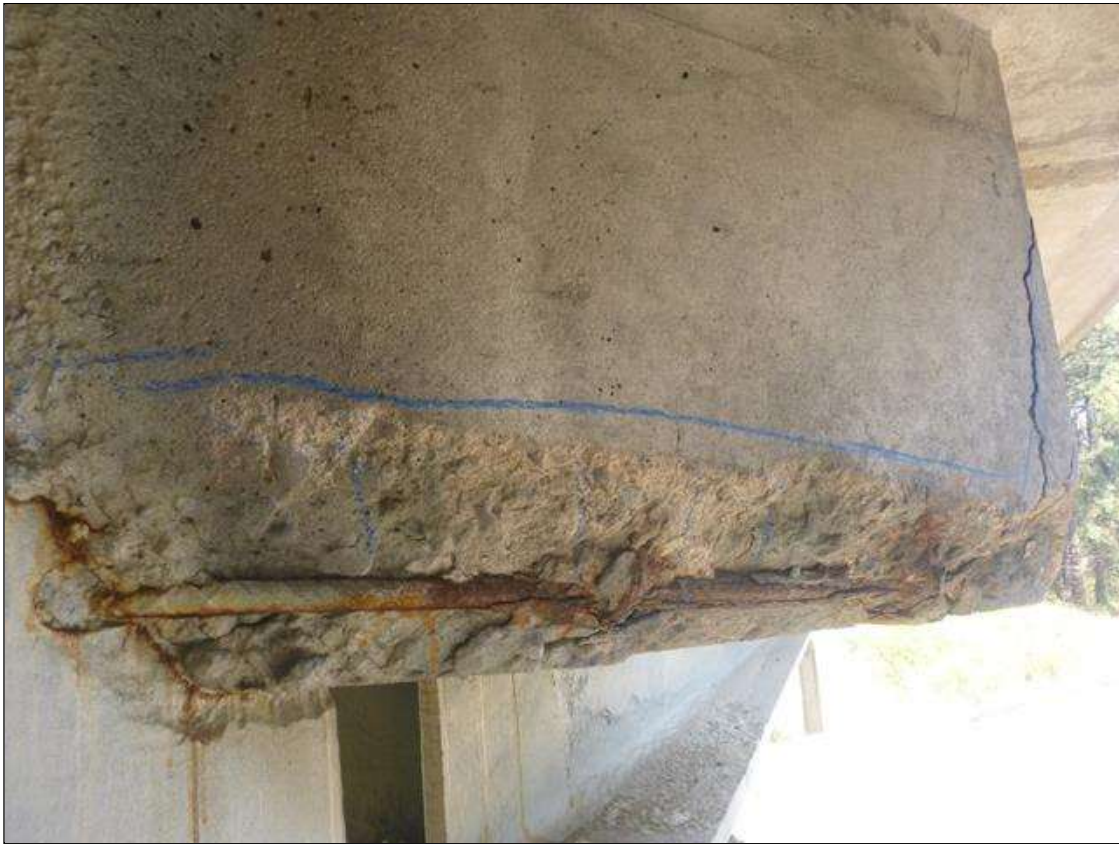
SPAN 3, BENT 2, BENT DIAPHRAGM HAS A SPALL ON THE BOTTOM UNDER THE LEFT OVERHANG, 5 IN. HIGH X 35 IN. LONG X 4 IN. DEEP WITH EXPOSED REBAR

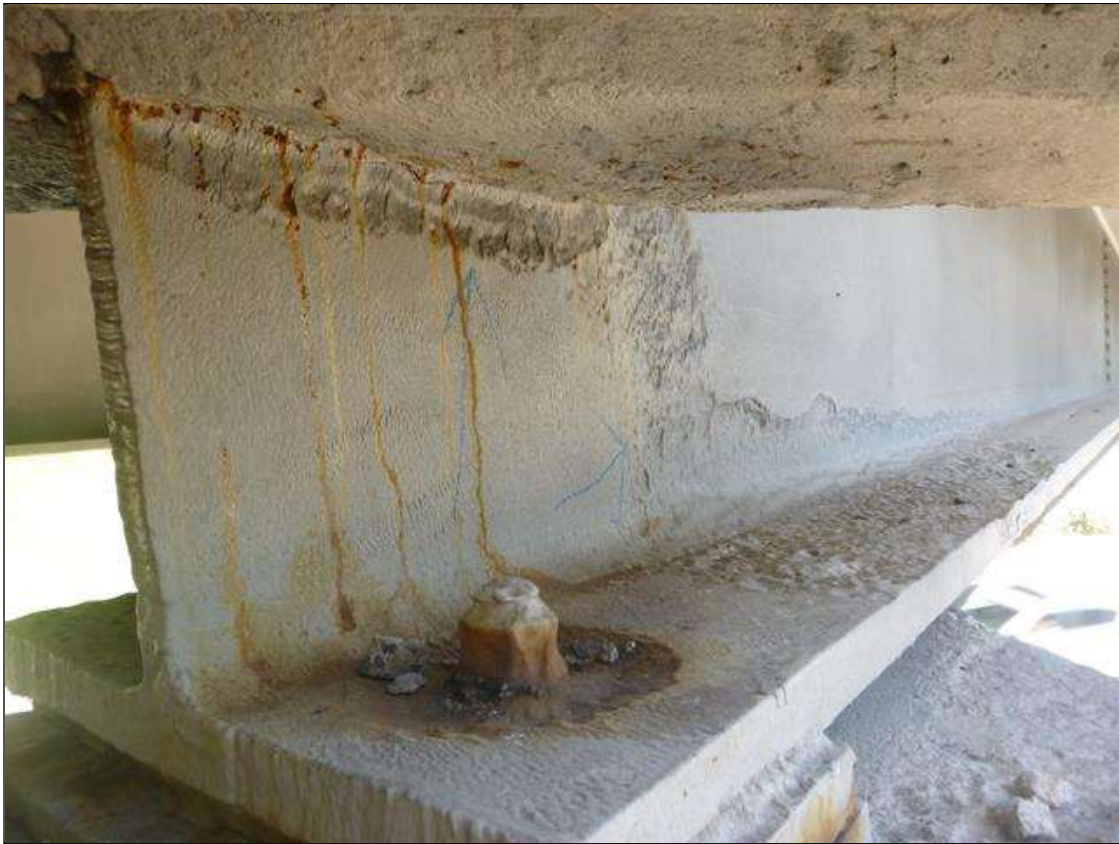
Span 2 Beam 1: SPAN 2, BEAM 1 AT BENT 2 HAS 1/4 IN. X FULL WIDTH SECTION LOSS FROM PREVIOUS RUST ON THE LEFT BOTTOM FLANGE FROM THE BEAM END OUT 6 FT. THE LEFT WEB HAS 1/4 IN. LOSS FROM PREVIOUS RUST AT THE CONCRETE DIAPHRAGM CONNECTION, 1 IN. WIDE X 11 IN. LONG AND SECTION LOSS ON THE LOWER WEB, 4 IN. HIGH X 6 FT. LONG. BEAM HAS BEEN CLEANED AND PAINTED.

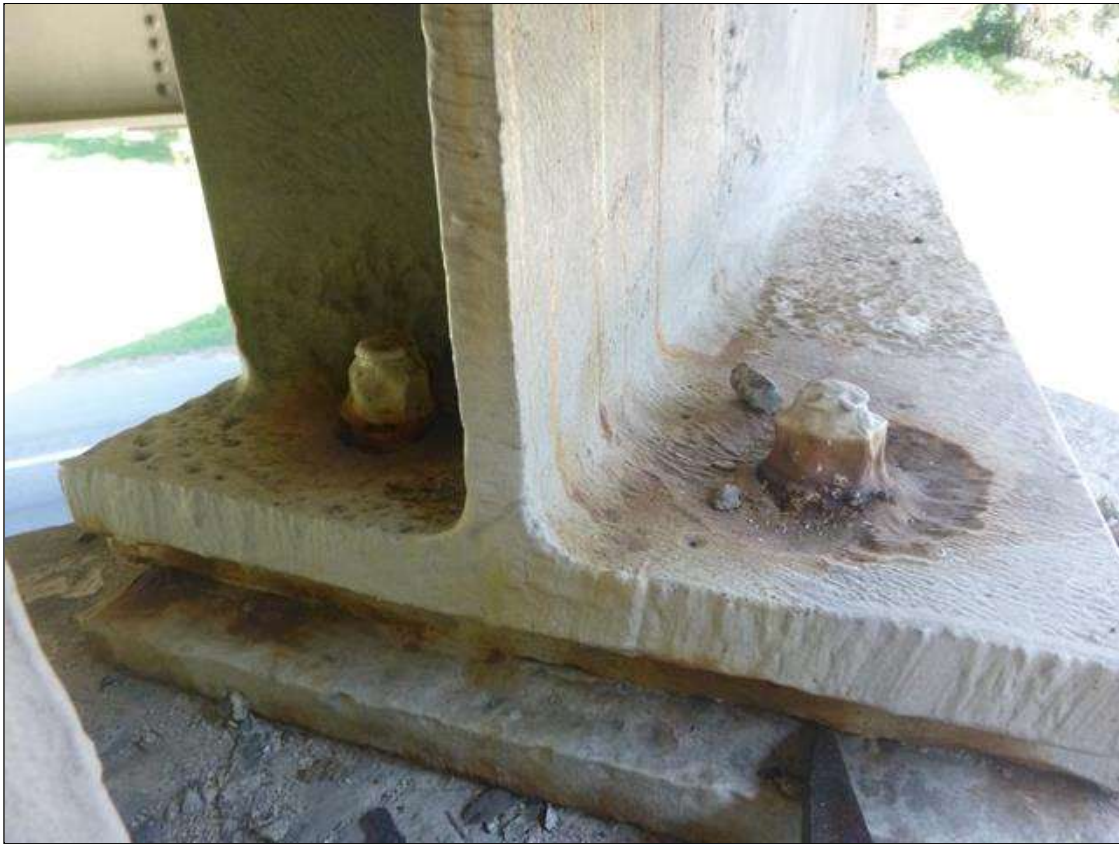
Span 2 Beam 1 Far Bearing: SPAN 2, BENT 2, FAR BEARING, BOTH ANCHOR NUTS ARE UP TO 60% RUSTED AWAY DUE TO PREVIOUS RUST. BEARING HAS BEEN CLEANED AND PAINTED.

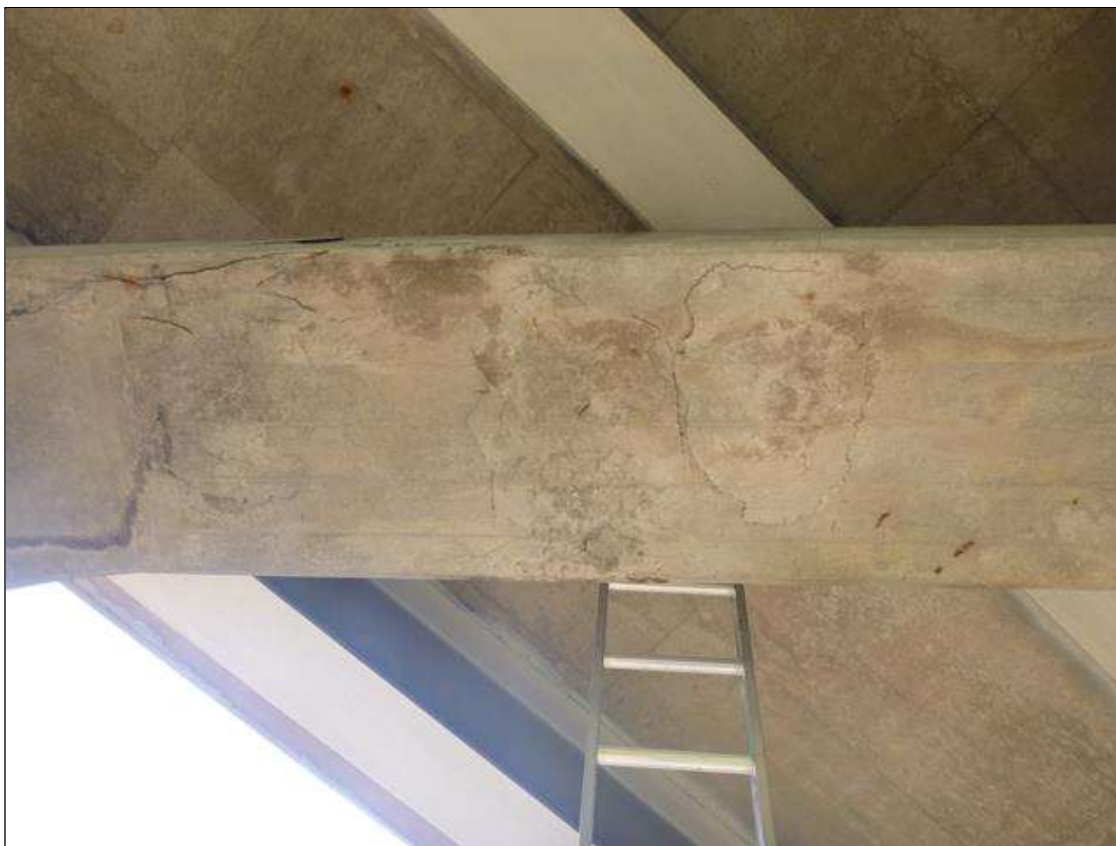
Bent 2 Cap 1: BENT 2 CAP, BETWEEN COLUMNS 1 AND 2 HAS A AREA OF DELAMINATION, 24 IN. WIDE X 6 FT. LONG

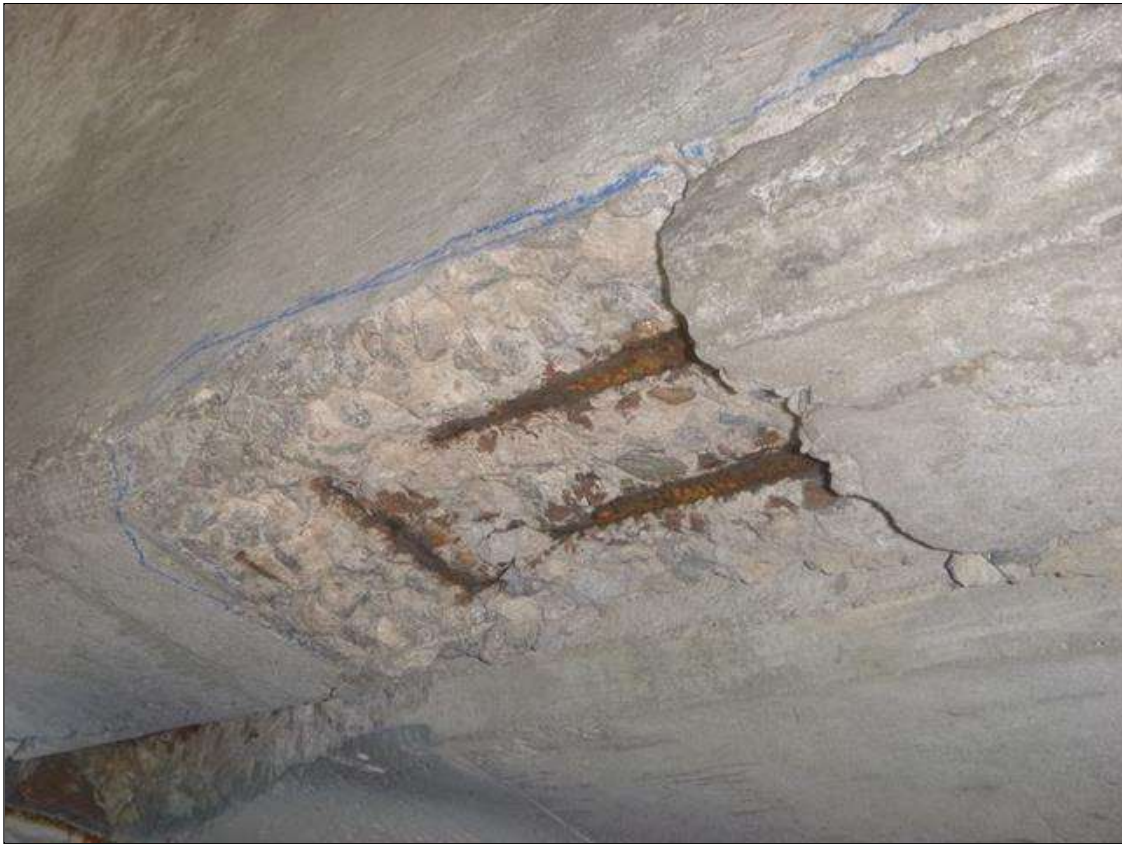
SPAN 3, BENT 2, BAY 2, BENT DIAPHRAGM HAS A SPALL ON THE BOTTOM, 10 IN. WIDE X 14 IN. LONG X 2 IN. DEEP WITH REBAR EXPOSED

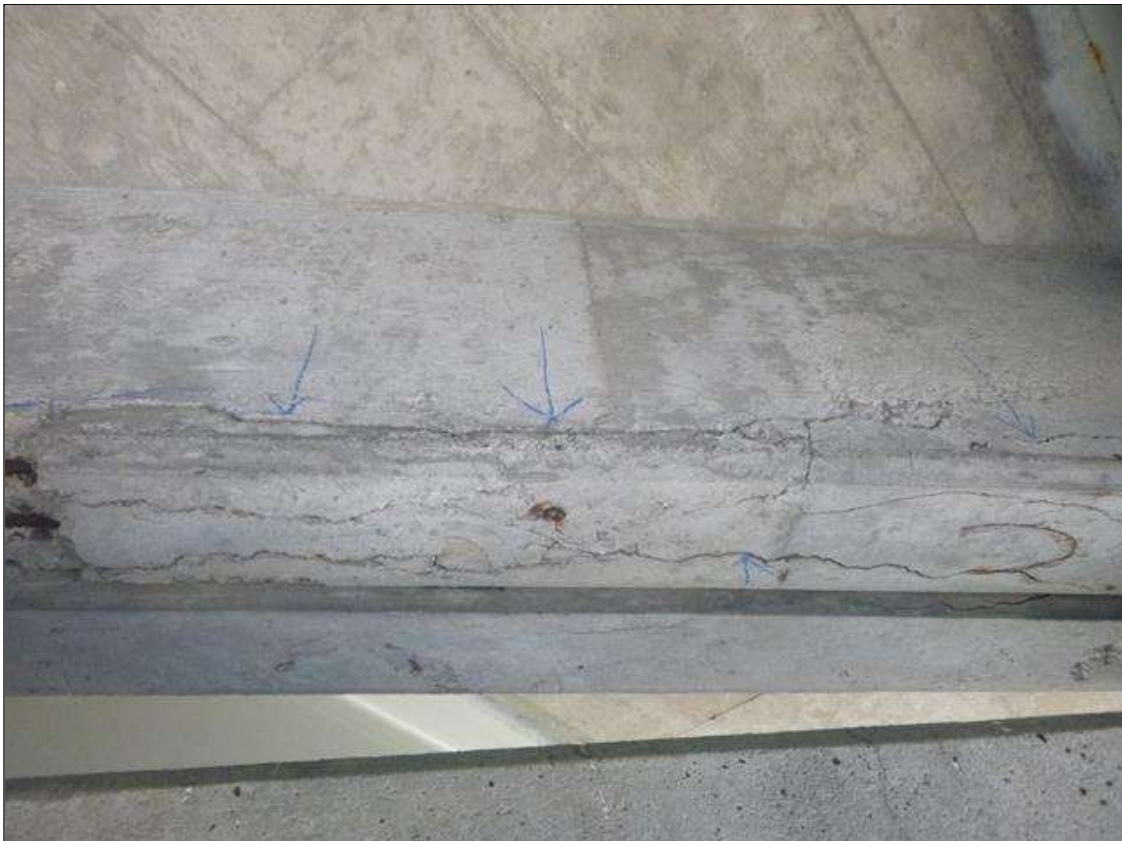
SPAN 3, BENT 2, BAY 2, BENT DIAPHRAGM HAS 1/4 IN. WIDE HORIZONTAL CRACKING ON THE BOTTOM, 6 FT. LONG

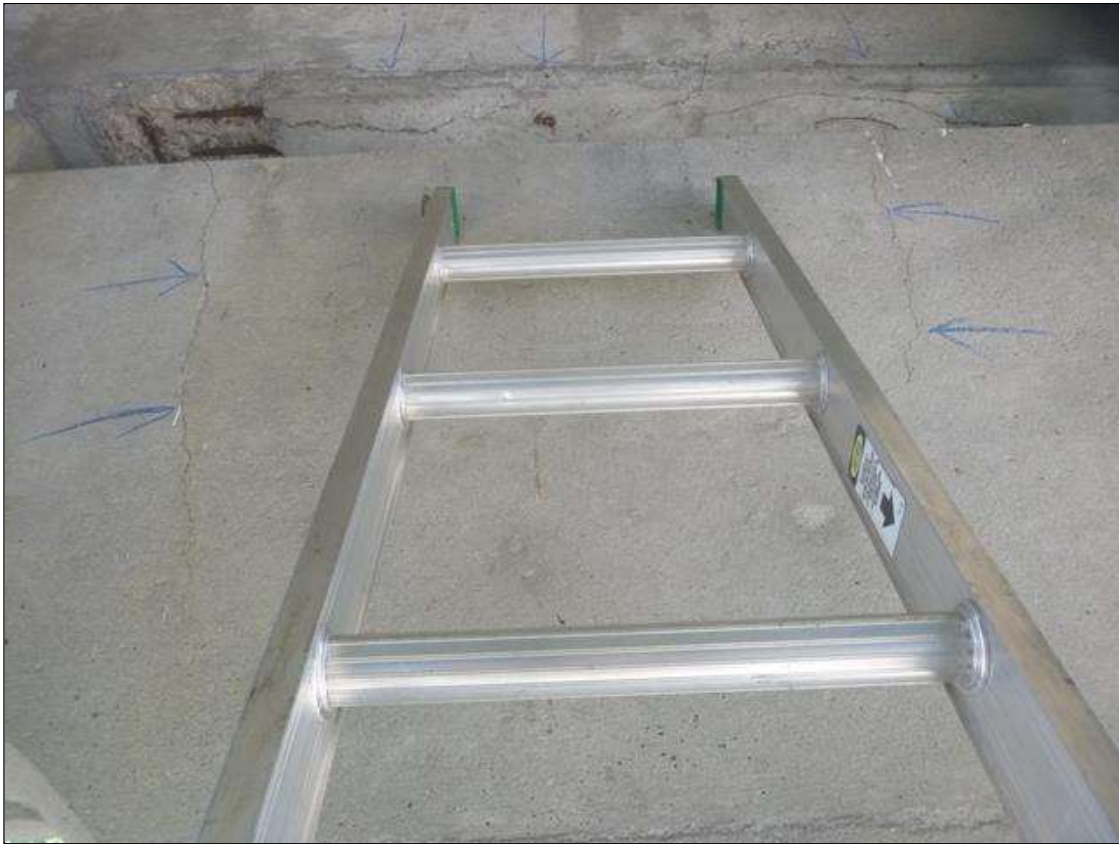
Bent 2 Cap 1: BENT 2 CAP, SPAN 3 SIDE HAS 2 VERTICAL CRACKS IN THE FACE OF THE CAP, OVER COLUMN 2, 3 FT. HIGH X 1/16 IN. WIDE

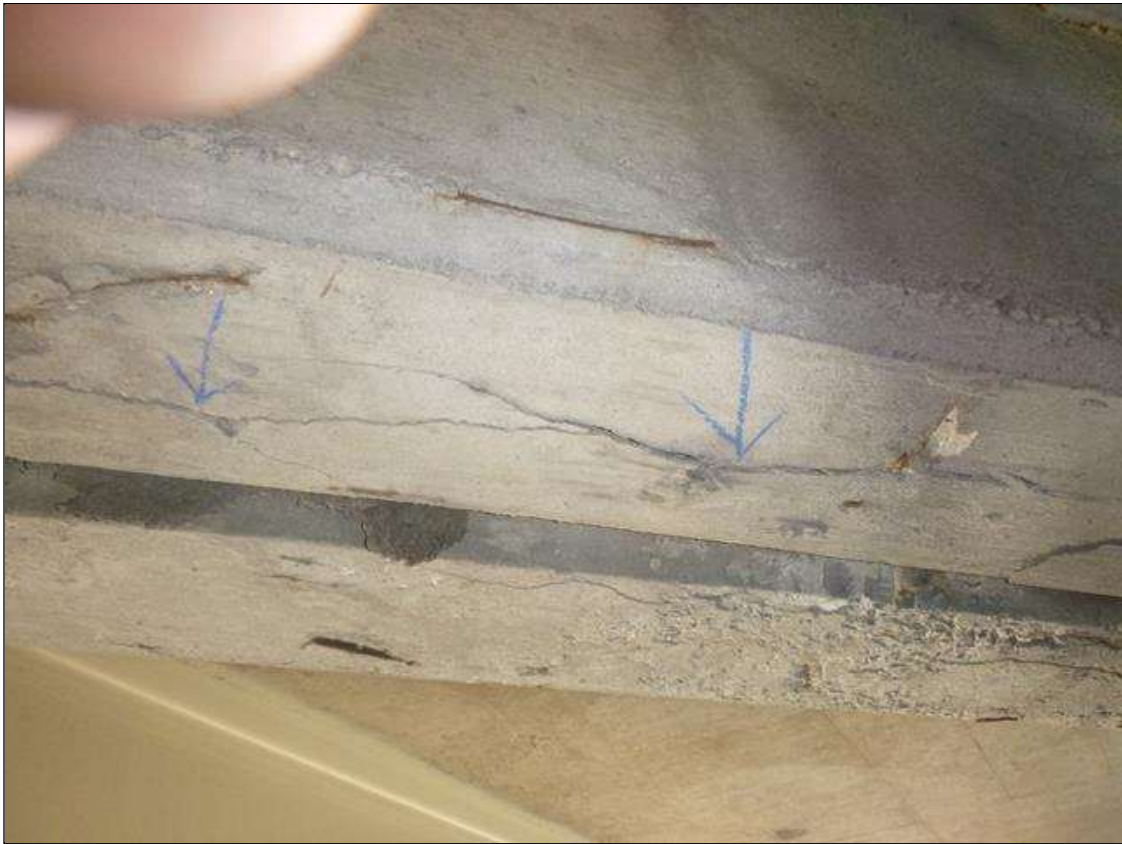
SPAN 3, BENT 2, BAY 3, BENT DIAPHRAGM HAS LONGITUDINAL CRACKING ON THE BOTTOM, 1/8 IN. WIDE X 4 FT. LONG

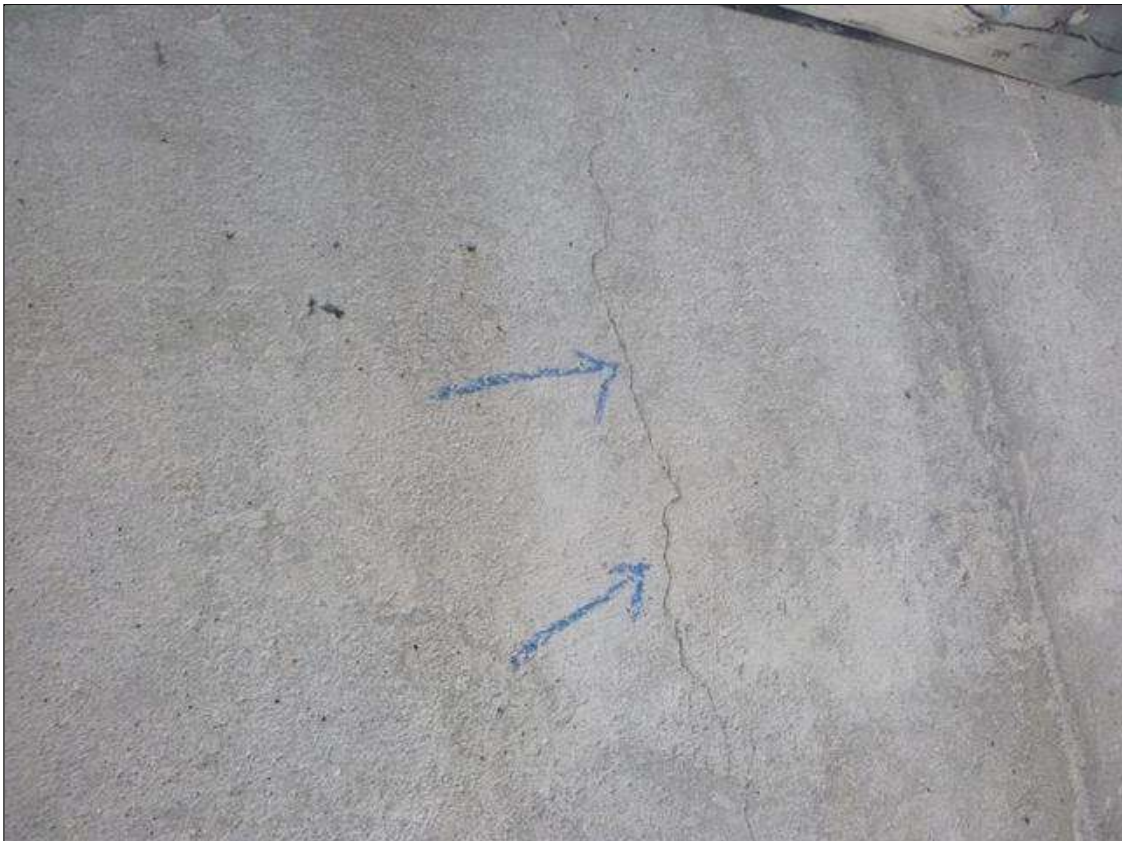
Bent 2 Cap 1: BENT 2 CAP, SPAN 3 SIDE, HAS A HAIRLINE VERTICAL CRACK IN THE FACE OF THE CAP UNDER BEAM 3, 36 IN. HIGH

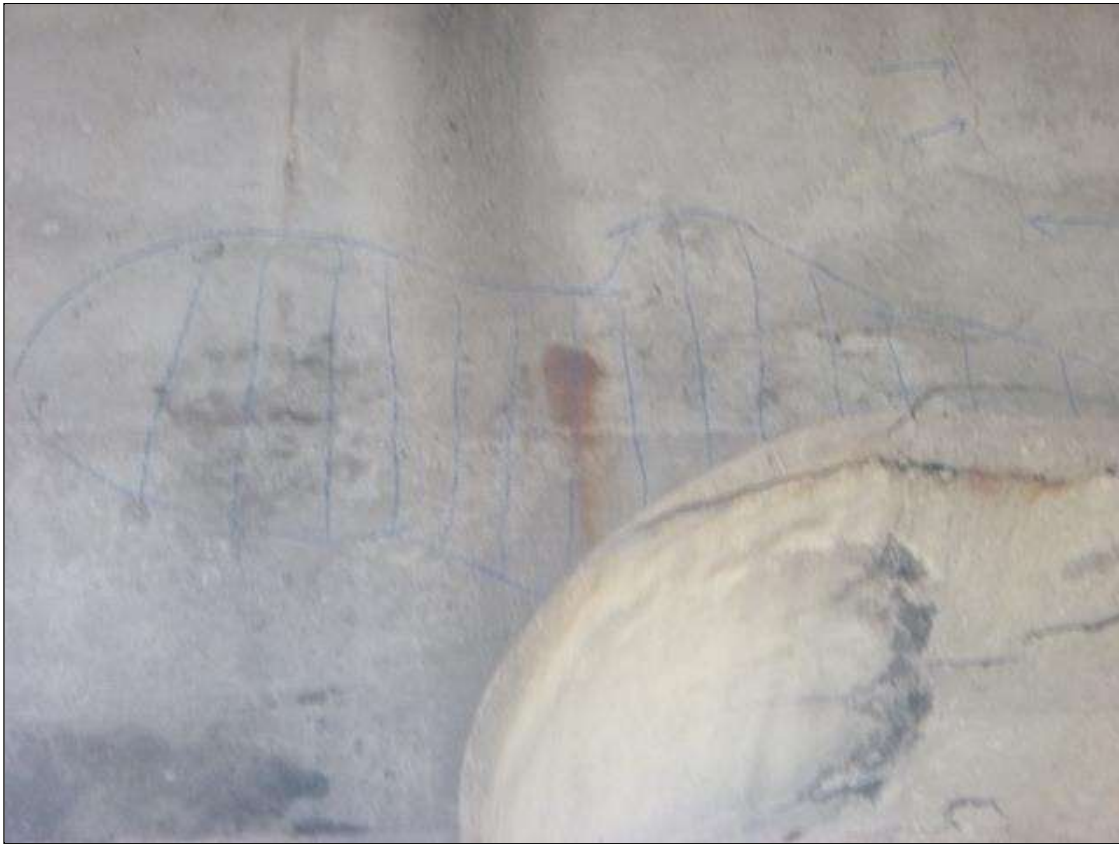
Bent 2 Cap 1: BENT 2 CAP, SPAN 3 SIDE HAS AN AREA OF DELAMINATION IN THE FACE OF THE CAP ABOVE COLUMN 3, 4 FT. WIDE X 2 FT. HIGH, WITH RUST STAINS

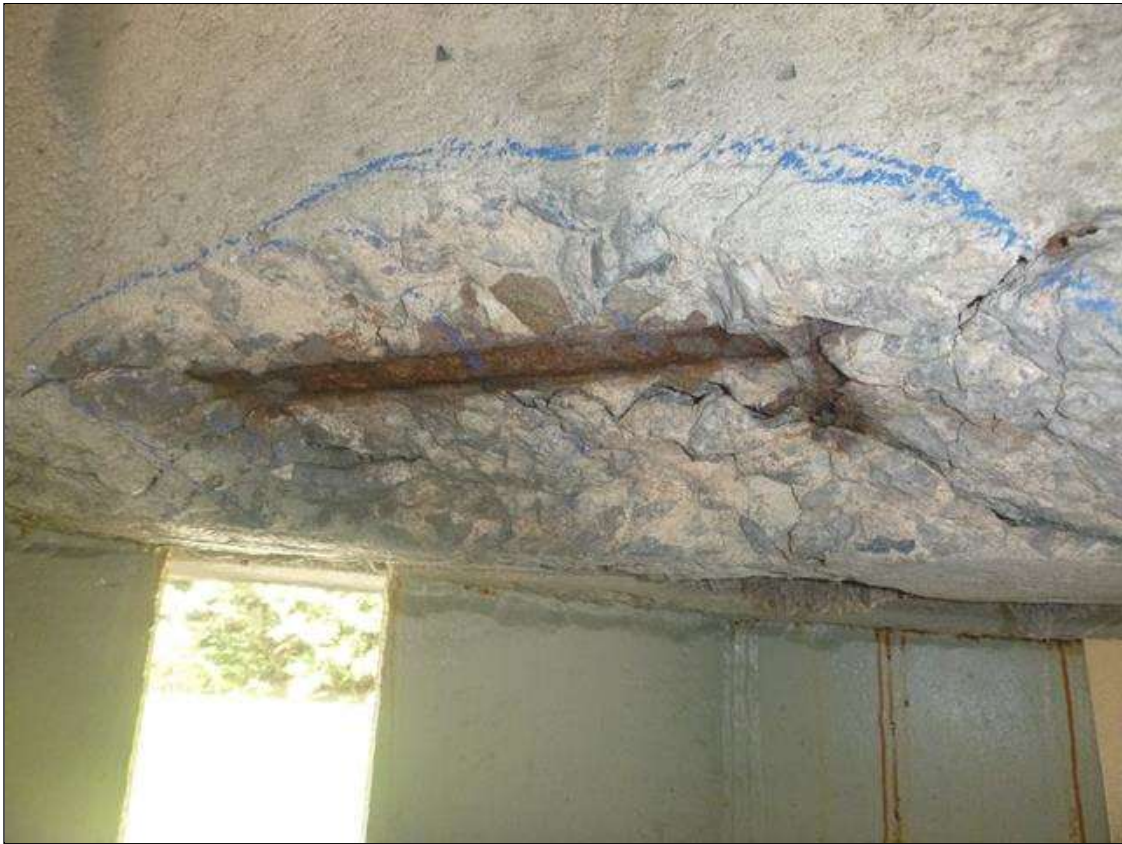
SPAN 3, BENT 2, BAY 3, BENT DIAPHRAGM HAS A SPALL ON THE BOTTOM, 8 IN. WIDE X 15 IN. LONG X 2.5 IN. DEEP, WITH REBAR EXPOSED, LEFT OF GIRDER 4

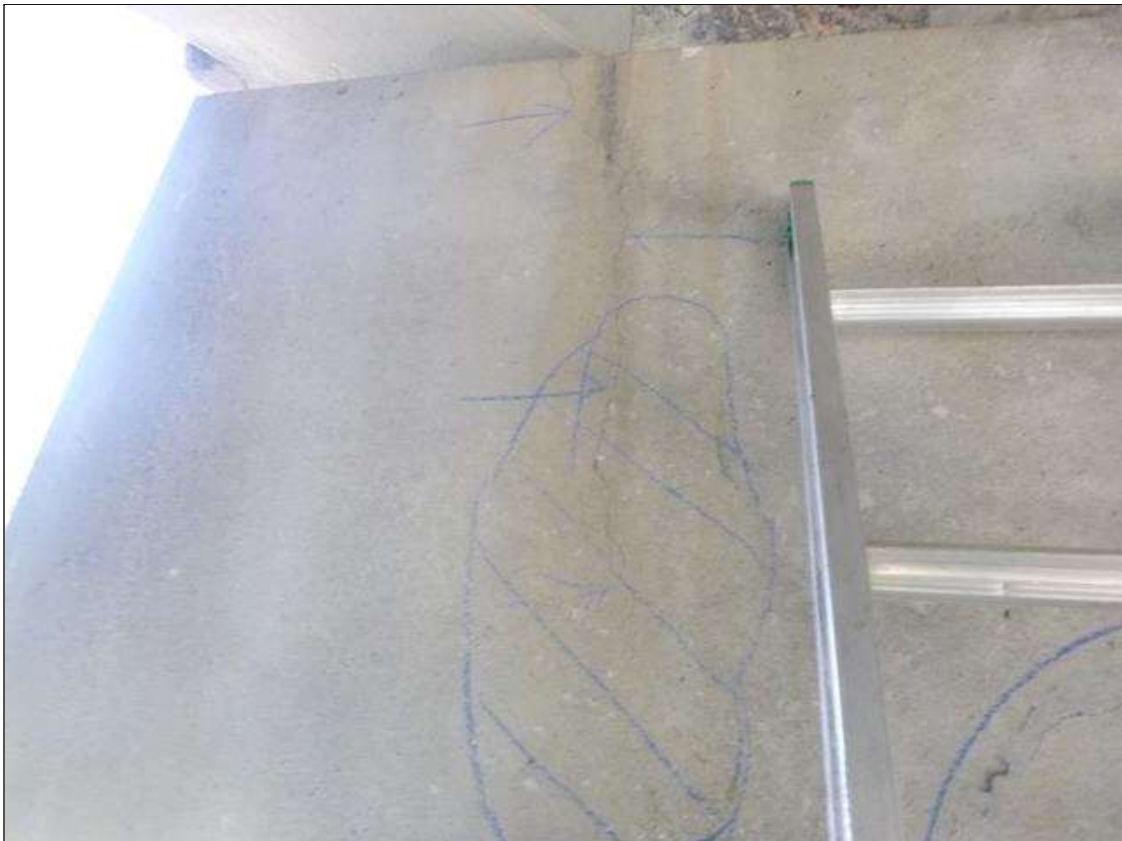
Bent 2 Cap 1: BENT 2 CAP, SPAN 3 SIDE HAS A 1/16 IN. WIDE VERTICAL CRACK RUNNING DOWN THE FACE OF THE CAP, ABOVE COLUMN 3, WITH ADJACENT DELAMINATION, 1 FT. WIDE X 2 FT. HIGH

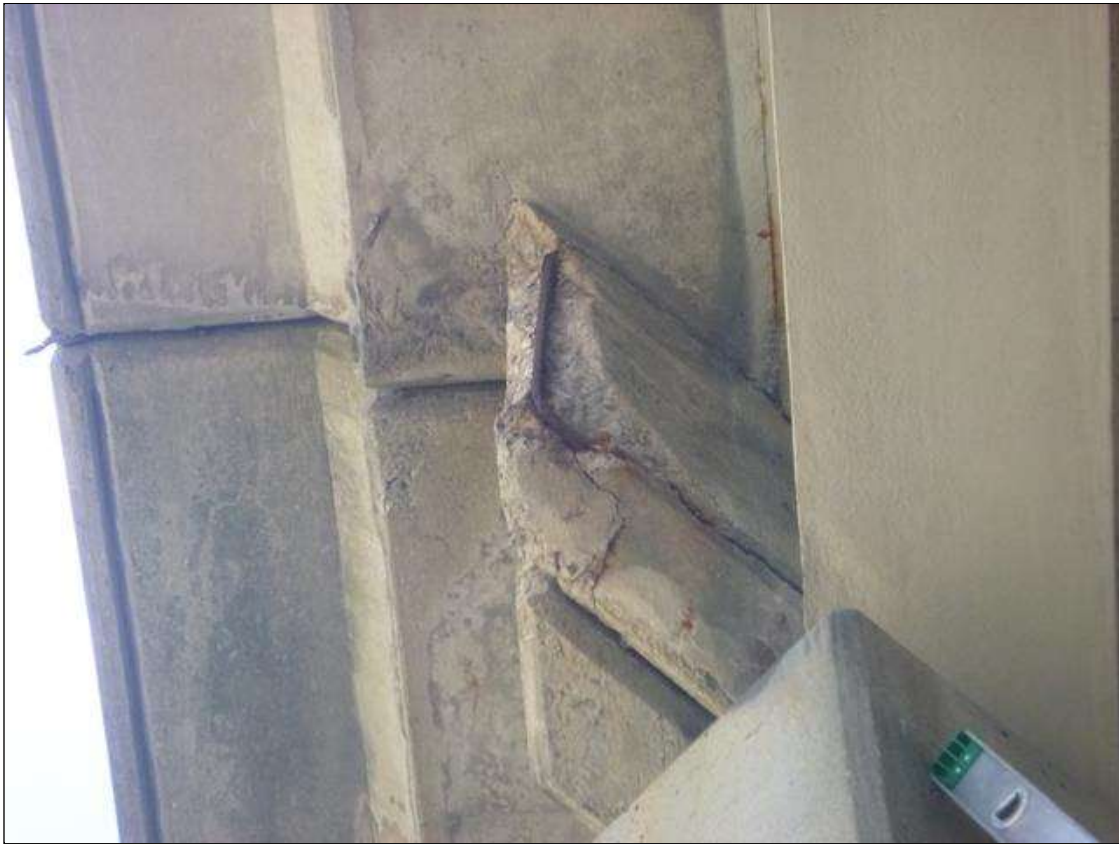
SPAN 3, BENT 2, BENT DIAPHRAGM UNDER THE RIGHT OVERHANG HAS A SPALL, 1 FT. WIDE X 30 IN. LONG X 3 IN. DEEP, WITH REBAR EXPOSED

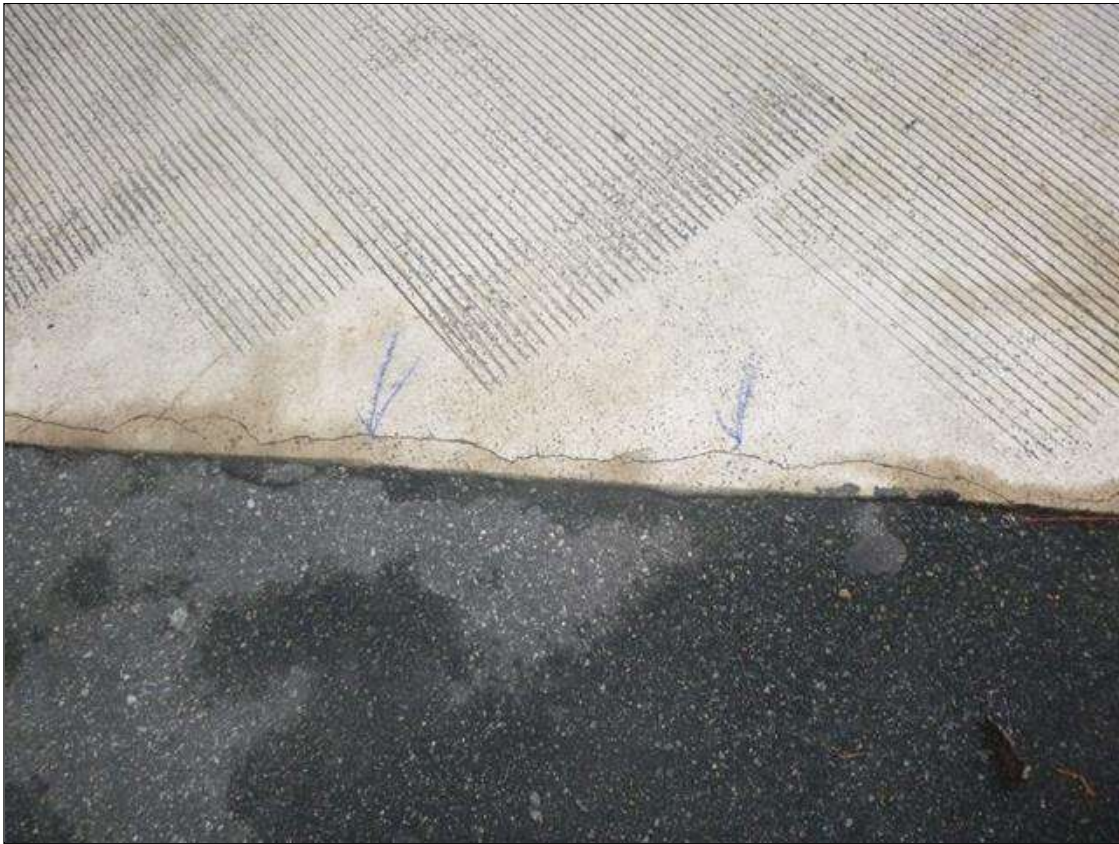
Span 5 Deck: SPAN 5, TOP OF DECK HAS A TRANSVERSE CRACK 1/8 IN. WIDE X 9 FT. LONG IN THE LEFT LANE, ADJACENT TO END BENT 2 JOINT

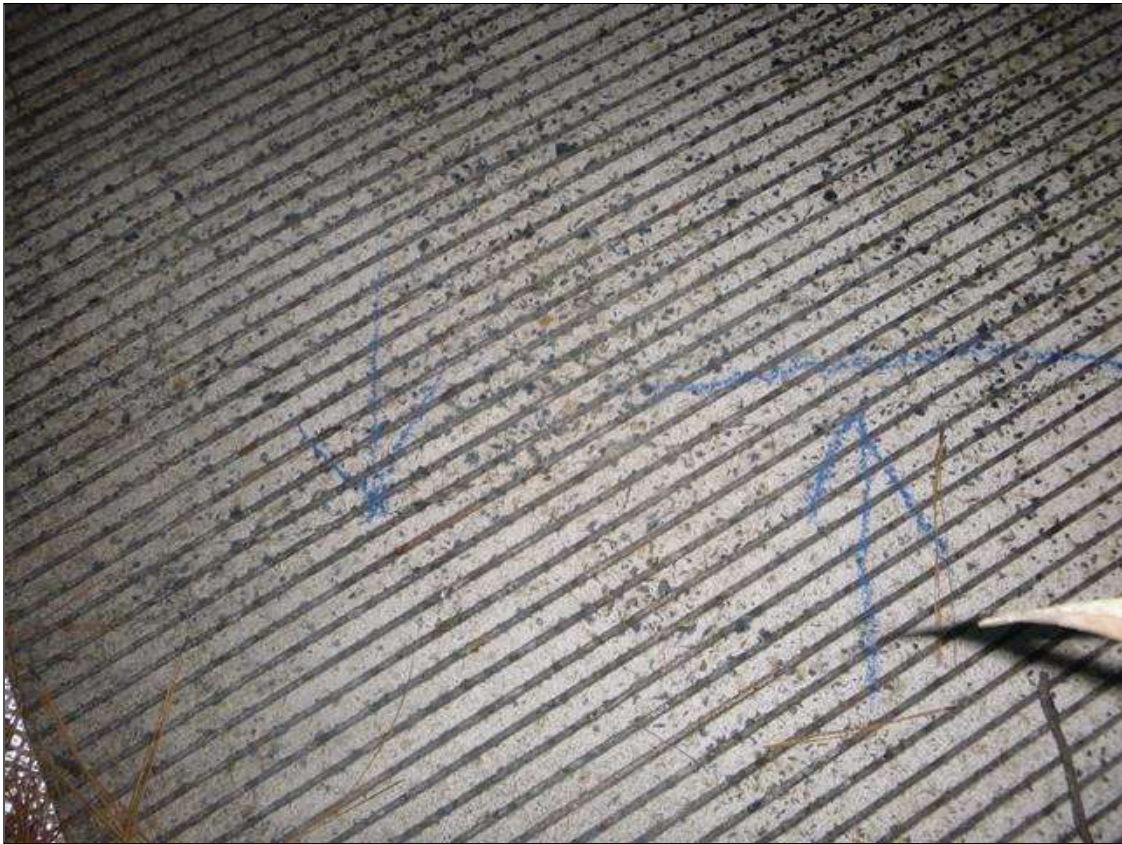
Span 5 Deck: SPAN 5, TOP OF DECK HAS 120 SQ FT. OF HAIRLINE TRANSVERSE CRACKING, NEAR END BENT 2

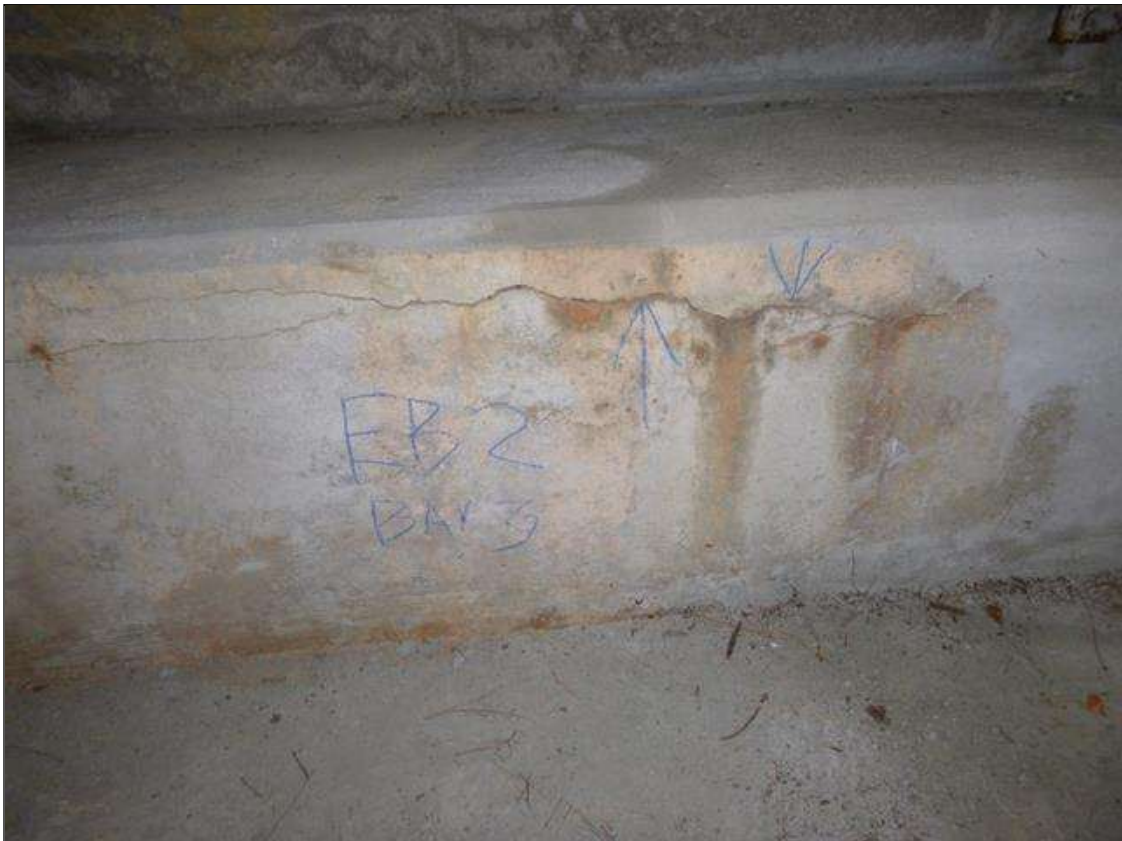
End Bent 2 Cap 1: END BENT 2 CAP, BAY 3 HAS A HORIZONTAL CRACK IN THE FACE OF THE CAP, NEAR TOP EDGE, UP TO 1/4 IN. WIDE X 5 FT. LONG

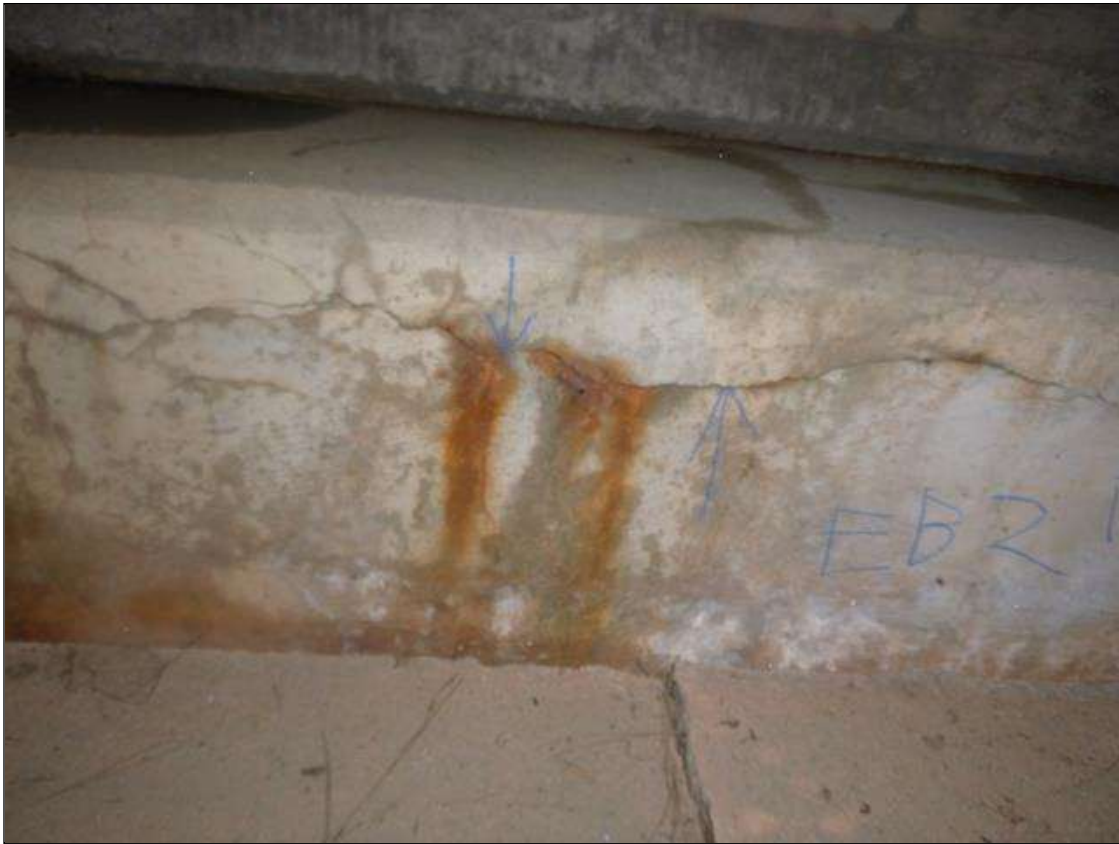
End Bent 2 Cap 1: END BENT 2 CAP, BAY 2 HAS A HORIZONTAL CRACK IN THE FACE OF THE CAP, NEAR TOP EDGE, UP TO 3/16 IN. WIDE X 8 FT. LONG, WITH RUST STAINS

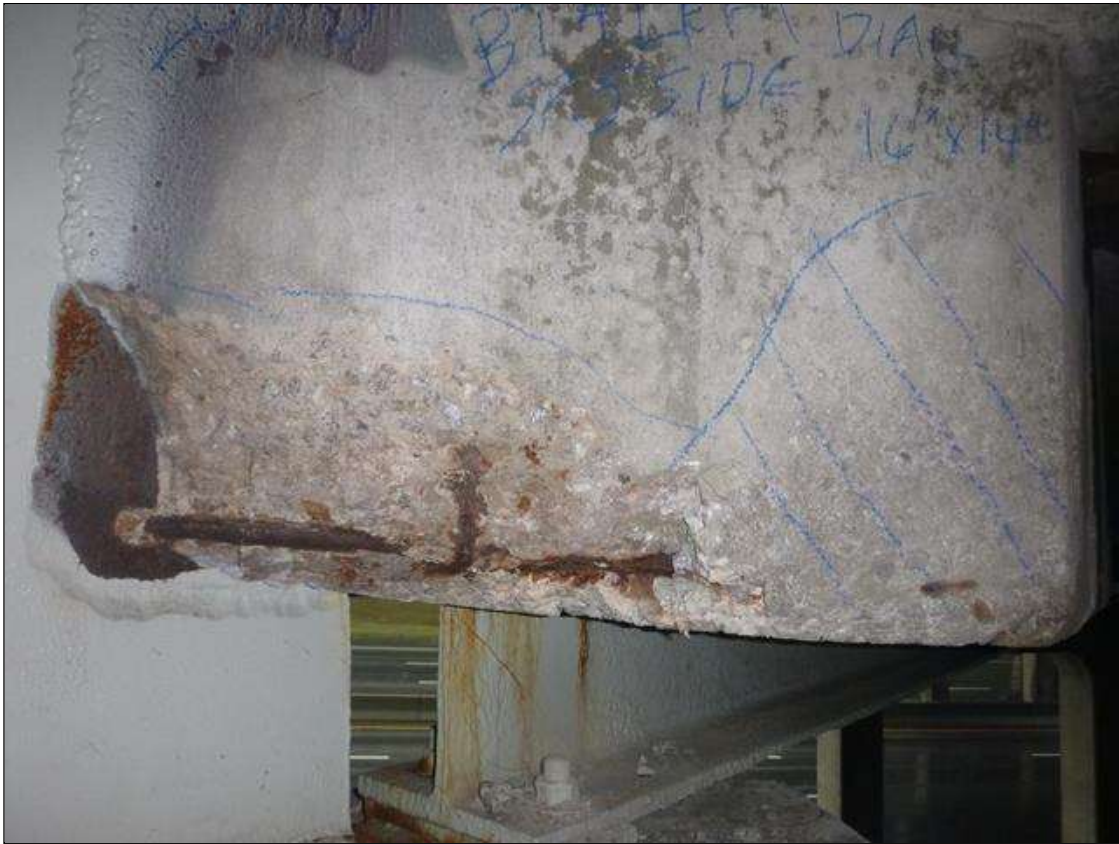
SPAN 5, BENT 4, BENT DIAPHRAGM UNDER THE LEFT OVERHANG HAS A SPALL, 20 IN. LONG X 8 IN. HIGH X 6 IN. DEEP WITH EXPOSED REBAR AND ADJACENT DELAMINATION, 16 IN. HIGH X 14 IN. WIDE

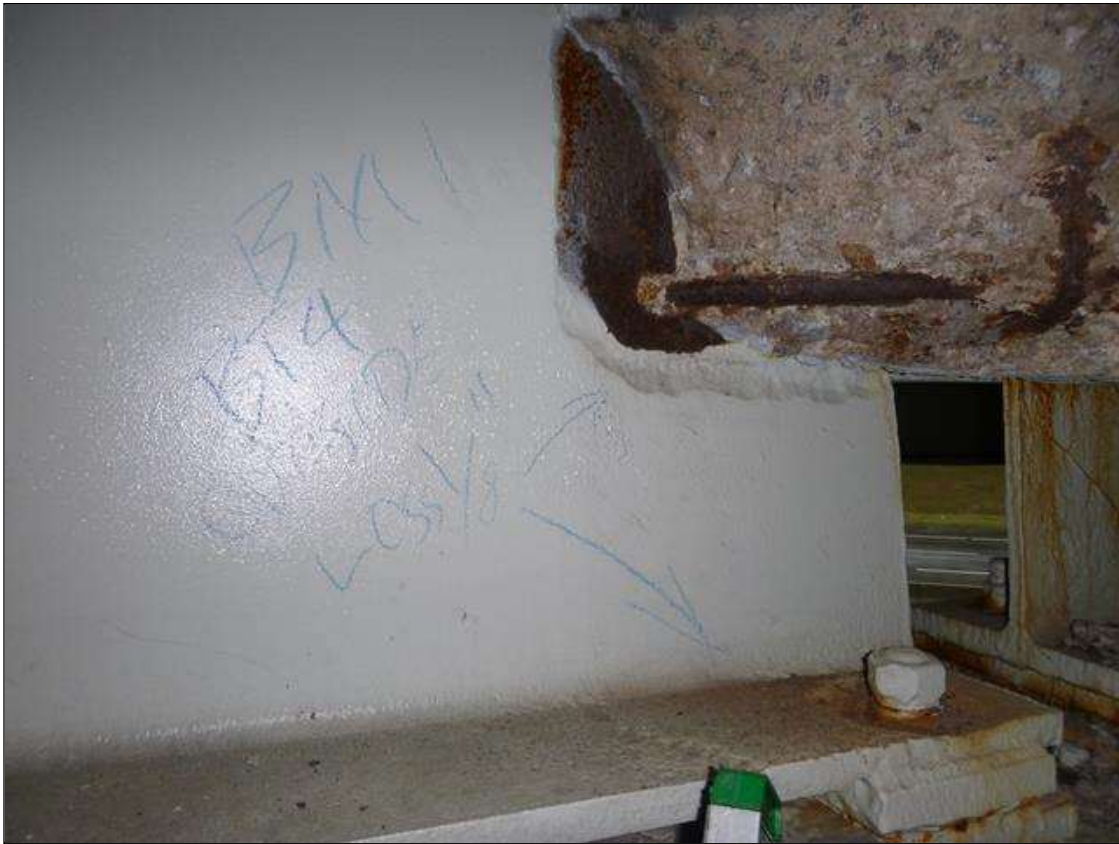
Span 5 Beam 1: SPAN 5, BENT 4, BEAM 1 HAS UP TO 1/8 IN. SECTION LOSS ON THE BOTTOM FLANGE, FULL WIDTH X 1 FT. LONG AT THE BEARING AREA, AND THE WEB AT THE DIAPHRAGM CONNECTION DUE TO PREVIOUS RUST. BEAM HAS BEEN CLEANED AND PAINTED.

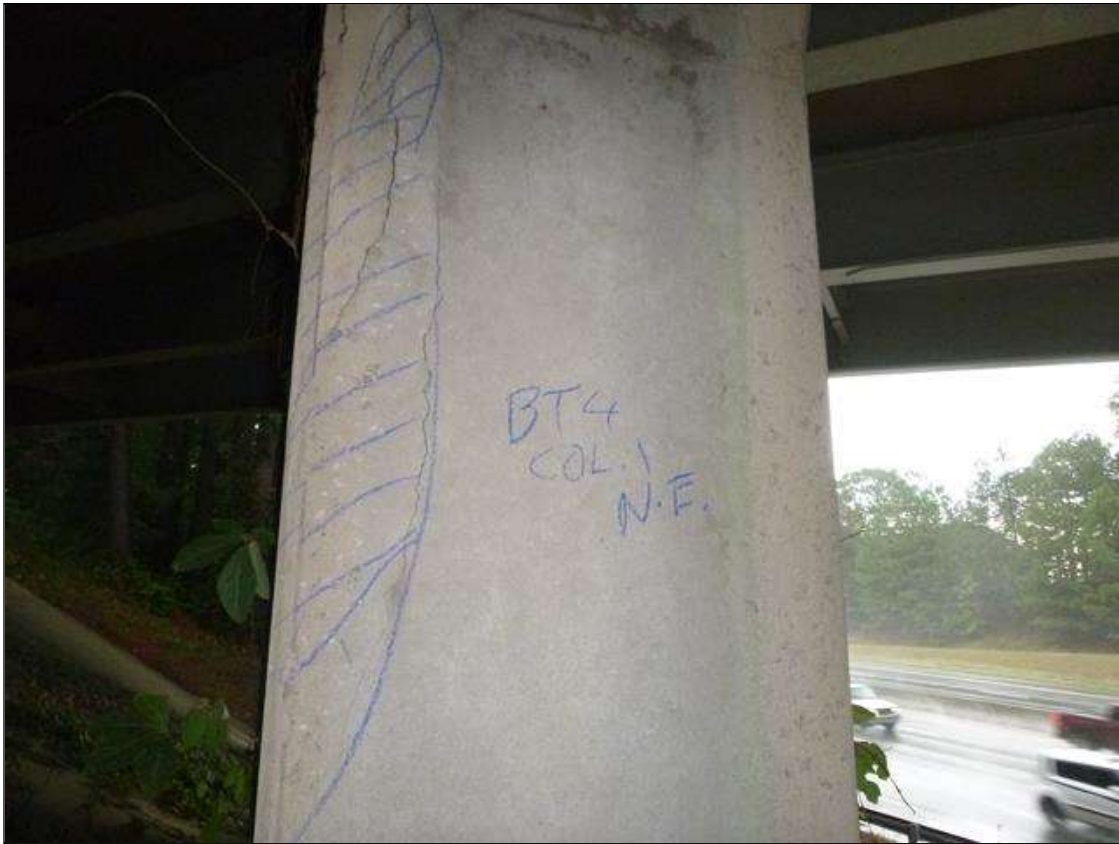
Bent 4 Pile 1: BENT 4, PILE 1 HAS A VERTICAL CRACK ON THE NORTH EAST FACE, 1/4 IN. WIDE X 4 FT. HIGH, WITH ADJACENT DELAMINATION, 3.5 FT. HIGH X 6 IN. WIDE

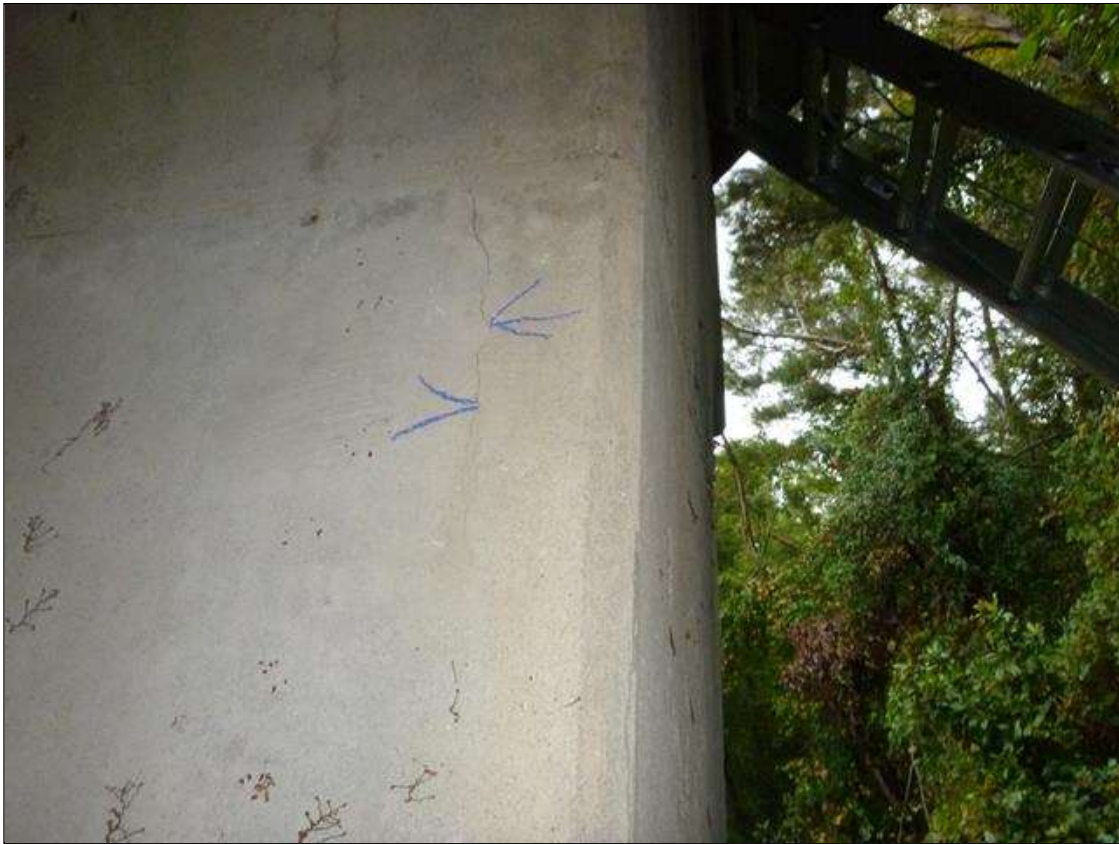
Bent 4 Pile 1: BENT 4, PILE 1 HAS A VERTICAL HAIRLINE CRACK IN THE SOUTH EAST FACE, 16 IN. HIGH, 2 FT. BELOW THE BOTTOM OF THE CAP

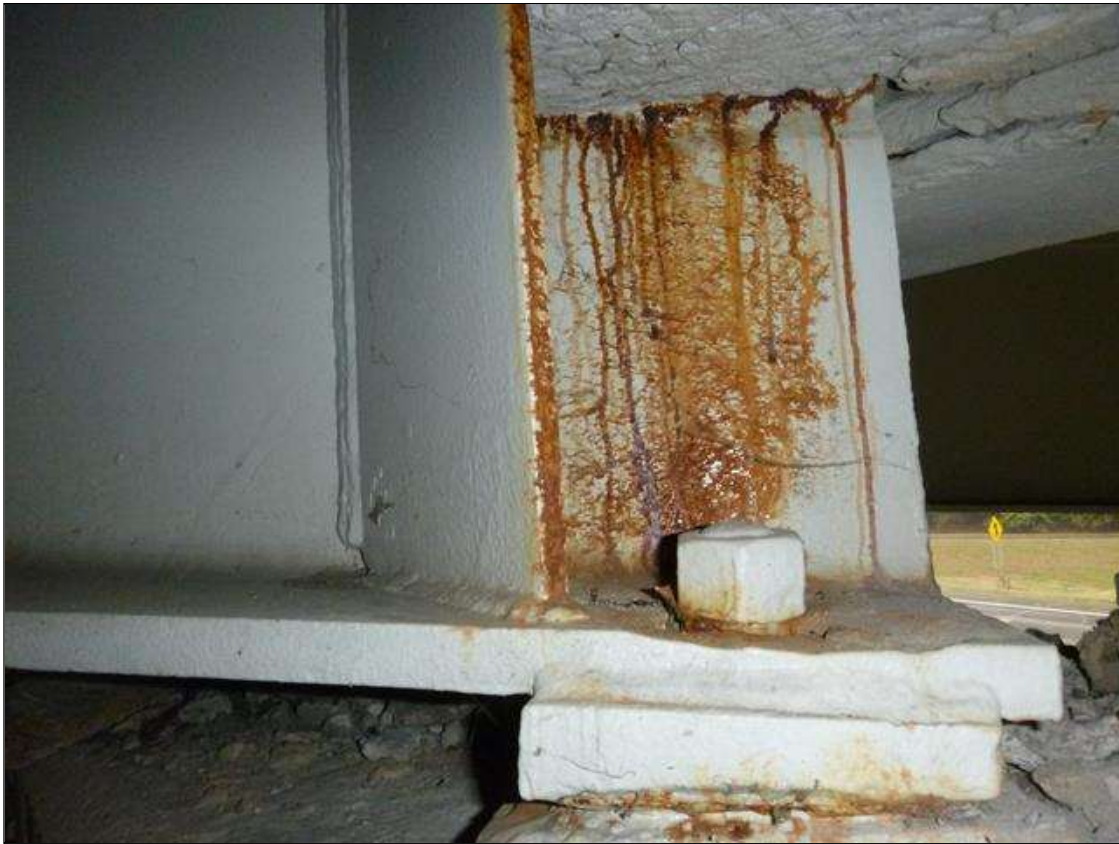
Span 5 Beam 2: SPAN 5, BENT 4, BEAM 2 HAS UP TO 1/4 IN. SECTION LOSS FROM PREVIOUS RUST ON THE BOTTOM FLANGE AT THE BEARING AREA, 2 FT. LONG X FULL WIDTH OF BOTTOM FLANGE, AND UP TO 1/4 IN. LOSS IN THE WEB AT THE DIAPHRAGM CONNECTION DUE TO PREVIOUS RUST. BEAM HAS BEEN CLEANED AND PAINTED.

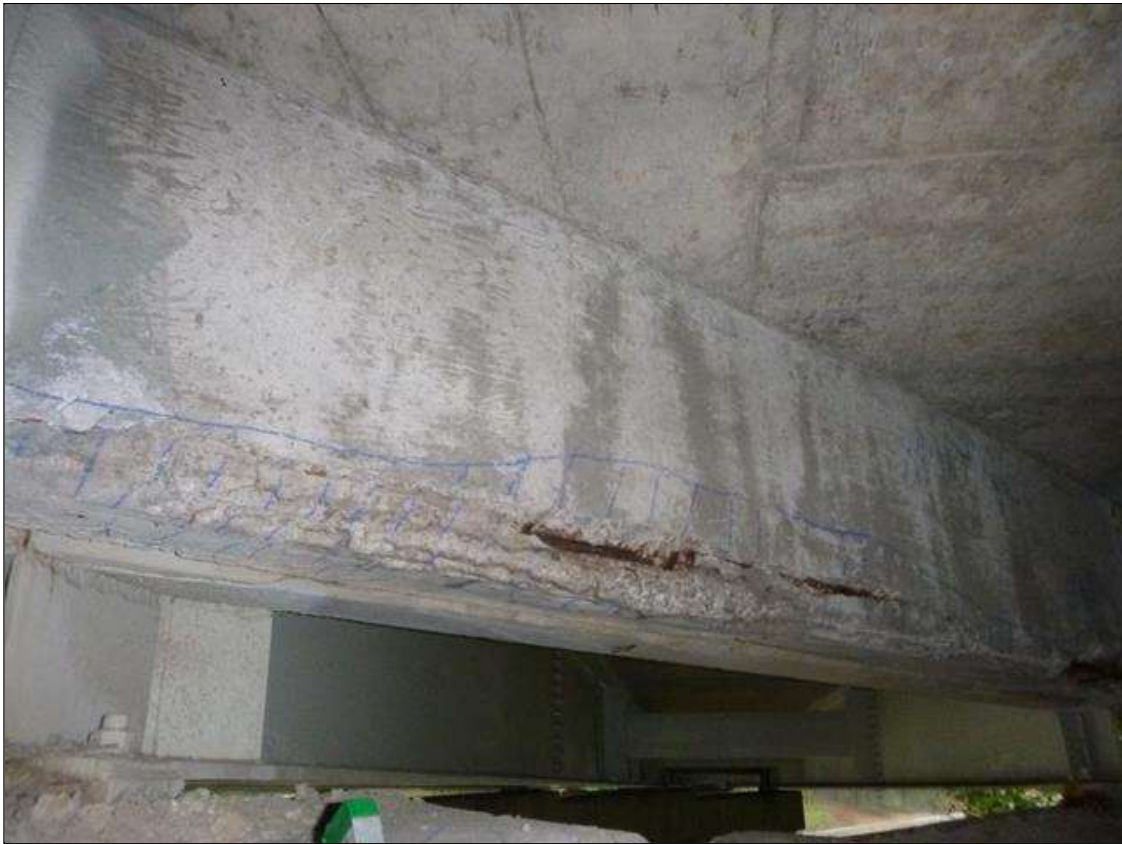
SPAN 5, BENT 4, BAY 1, BENT DIAPHRGM IS CRACKED AND SPALLED WITH DELAMINATION, FULL WIDTH OF THE BOTTOM X 8 IN. HIGH, WITH EXPOSED REBAR
