NC DEPARTMENT OF TRANSPORTATION  
DIVISION OF HIGHWAYS  
STRUCTURE MANAGEMENT UNIT

## Structure Safety Report

### Routine Element Inspection - Contract

COUNTY: WAKE STRUCTURE NUMBER: 910252 FREQUENCY: 24 MONTHS

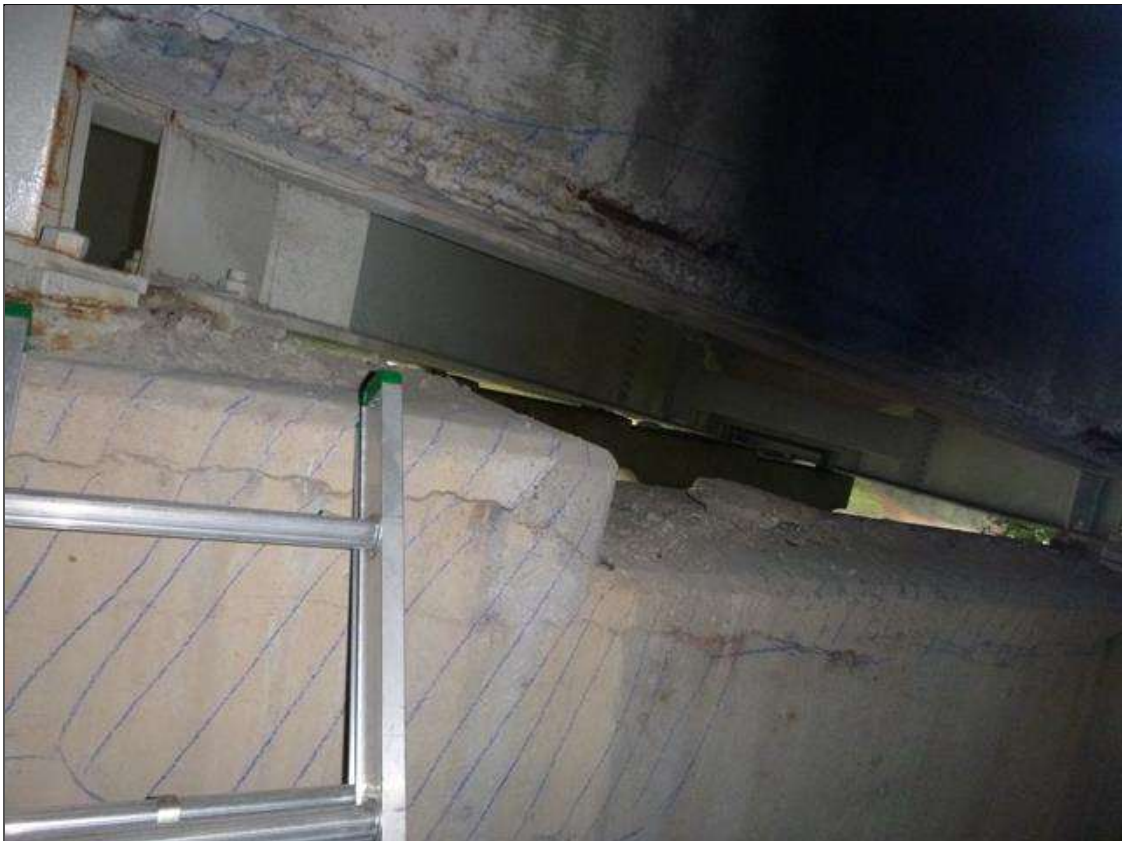
Bent 4 Cap 1: BENT 4 CAP, SPAN 5 SIDE HAS AREA OF DELAMINATION UNDER BAY 1, 12 FT, LONG X 2 FT. DOWN THE FACE X 1 FT. ACROSS THE TOP, WITH 1/4 IN. WIDE CRACKING

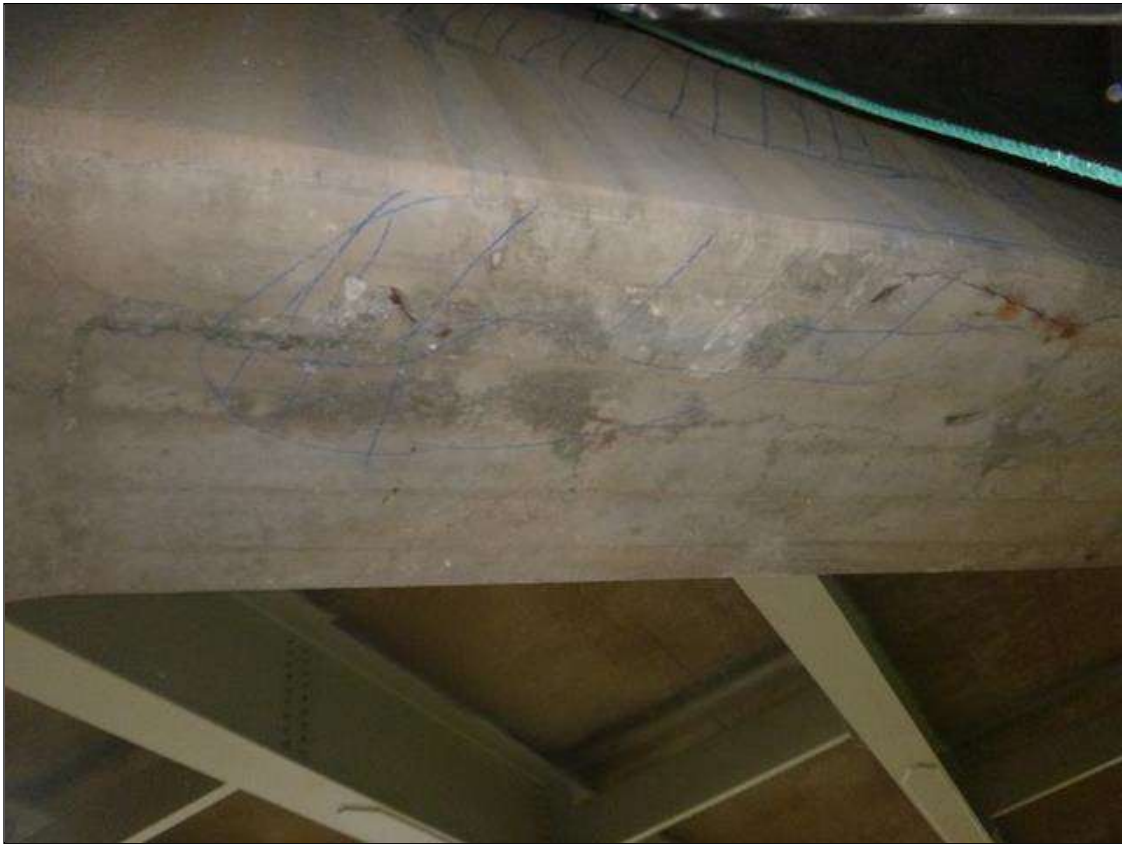
Bent 4 Cap 1: BENT 4 CAP, HAS AN AREA OF DELAMINATION IN THE BOTTOM BETWEEN PILES 1 AND 2, 20 IN. WIDE X 6 FT. LONG

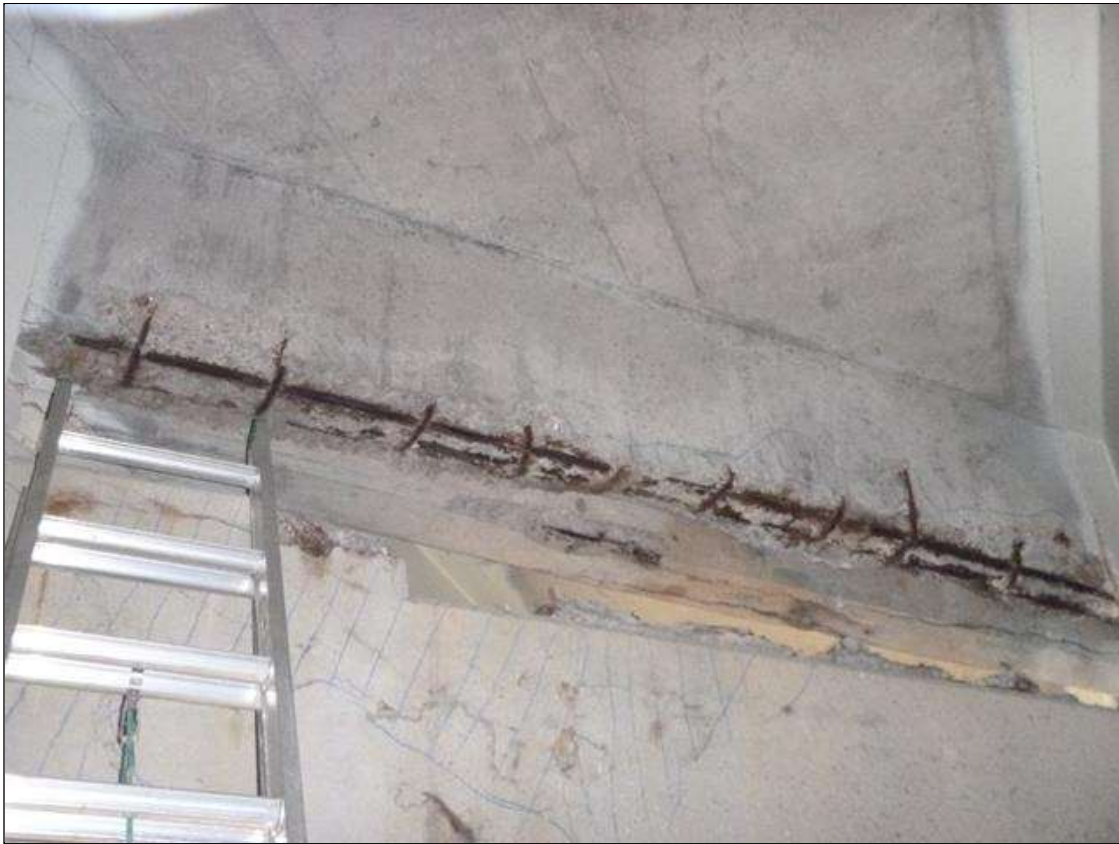
SPAN 5, BENT 4, BAY 2, BENT DIAPHRAGM HAS A SPALL ON THE BOTTOM SECTION, FULL LENGTH X FULL WIDTH X 4 IN. DEEP WITH EXPOSED REBAR

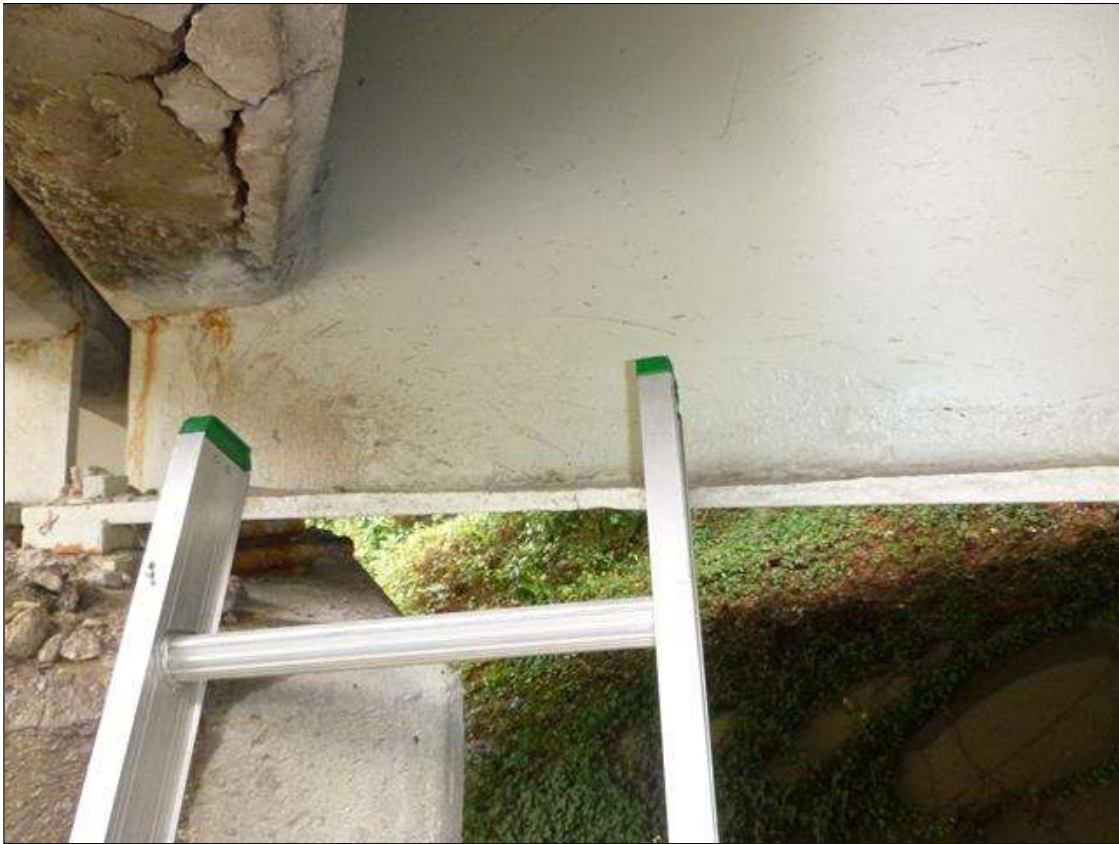
Span 5 Beam 4: SPAN 5, BENT 4, BEAM 4 HAS 3/8 IN. SECTION LOSS ON THE BOTTOM FLANGE AT THE BEARING AREA FROM PREVIOUS RUST X FULL WIDTH X 3 FT. LONG. BEAM HAS BEEN CLEANED AND PAINTED.

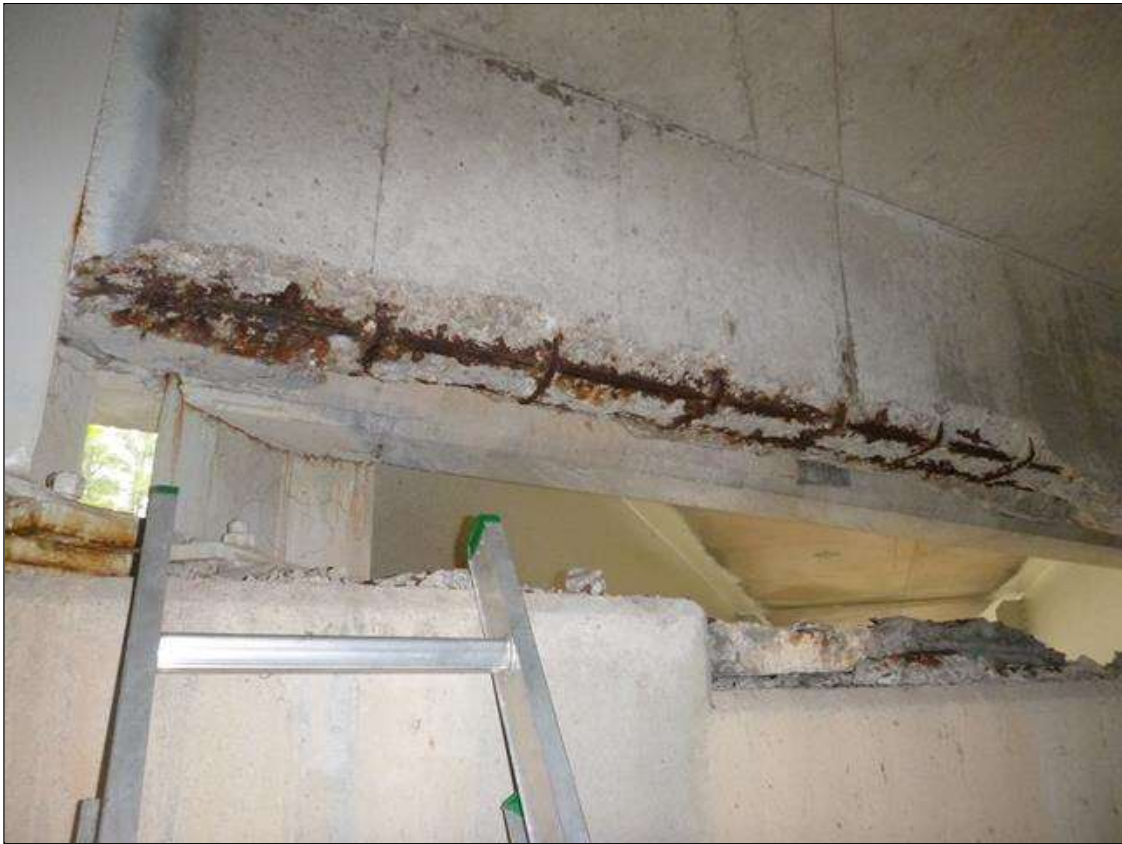
SPAN 5, BENT 4, BAY 3 BENT DIAPHRAGM HAS A SPALL ON THE BOTTOM, FULL WIDTH X 8 IN. HIGH X 4 IN. DEEP X 8 FT. LONG WITH REBAR EXPOSED

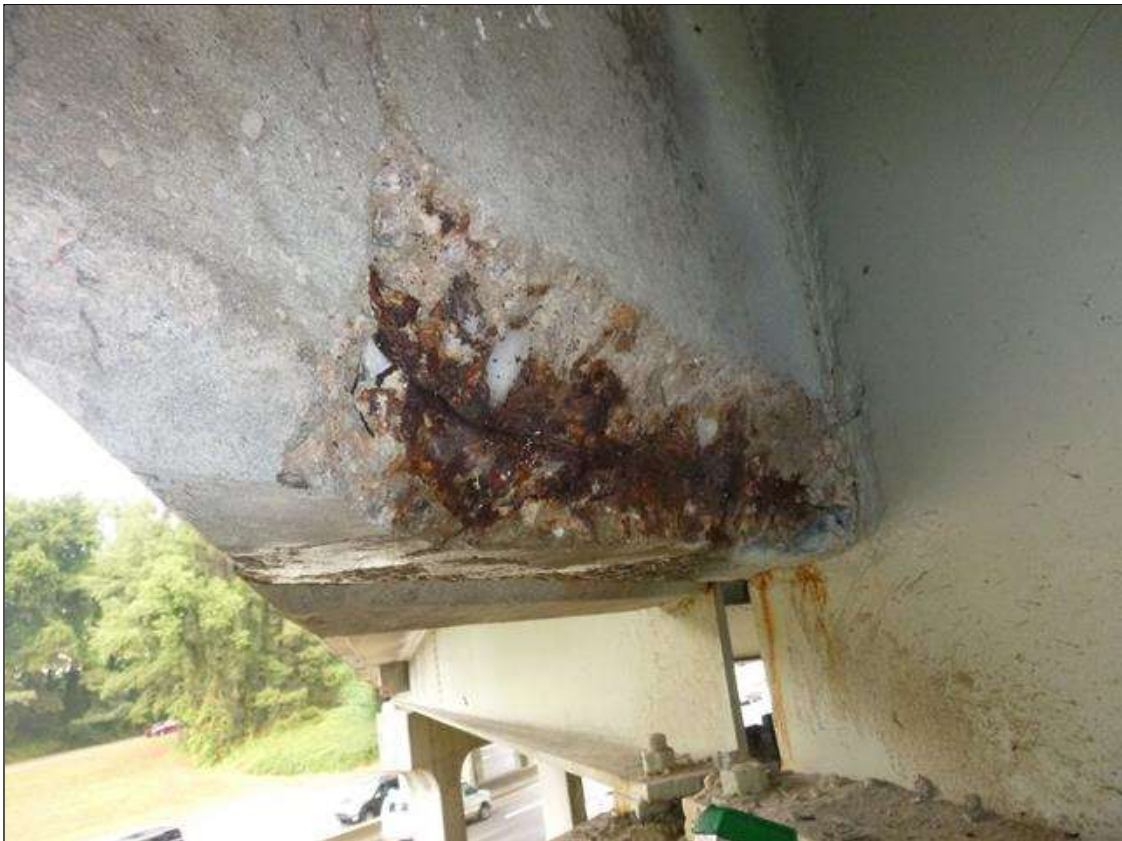
SPAN 5, BENT 4, BENT DIAPHRAGM IN THE RIGHT OVERHANG HAS A SPALL 33 IN. LONG X 3 IN. WIDE X 4 IN. DEEP WITH REBAR EXPOSED

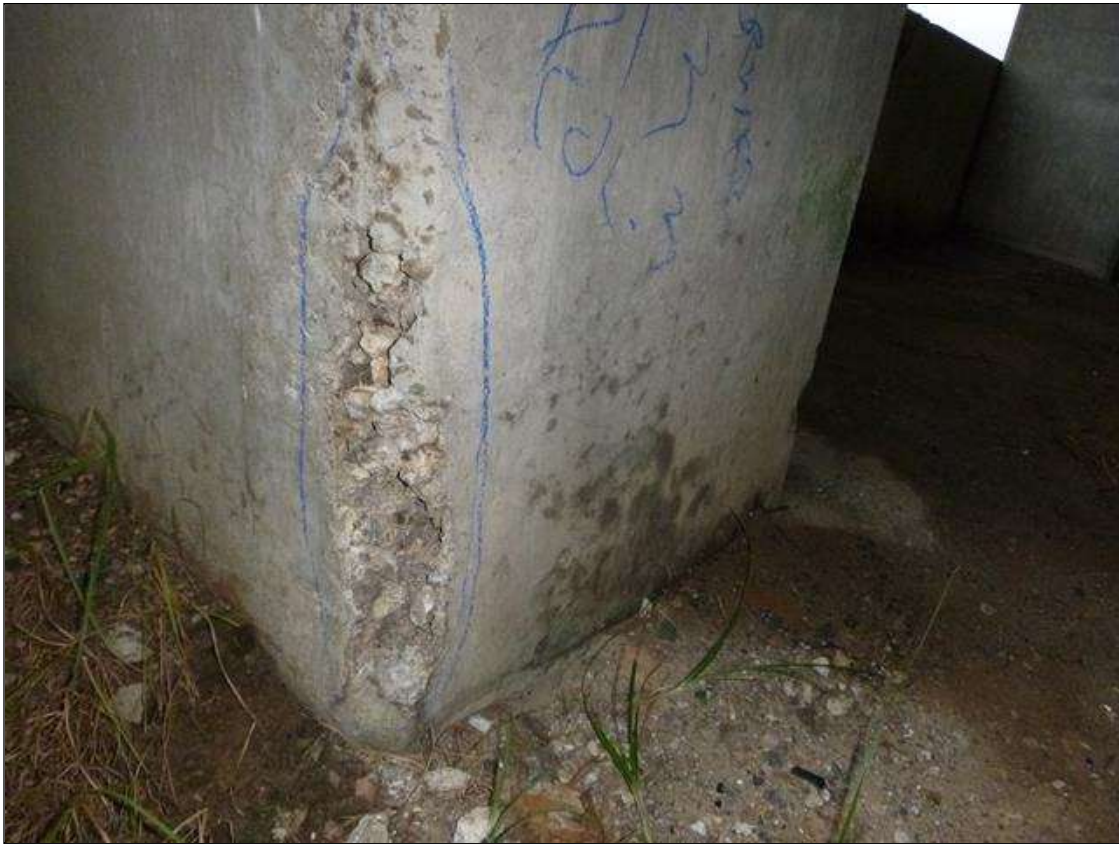
Bent 3 Pile 3: BENT 3, PILE 3 HAS AN AREA OF AGGREGATE EXPOSED ON THE SOUTH EAST CORNER, AT THE GROUNDLINE, 16 IN. HIGH X 4 IN. WIDE

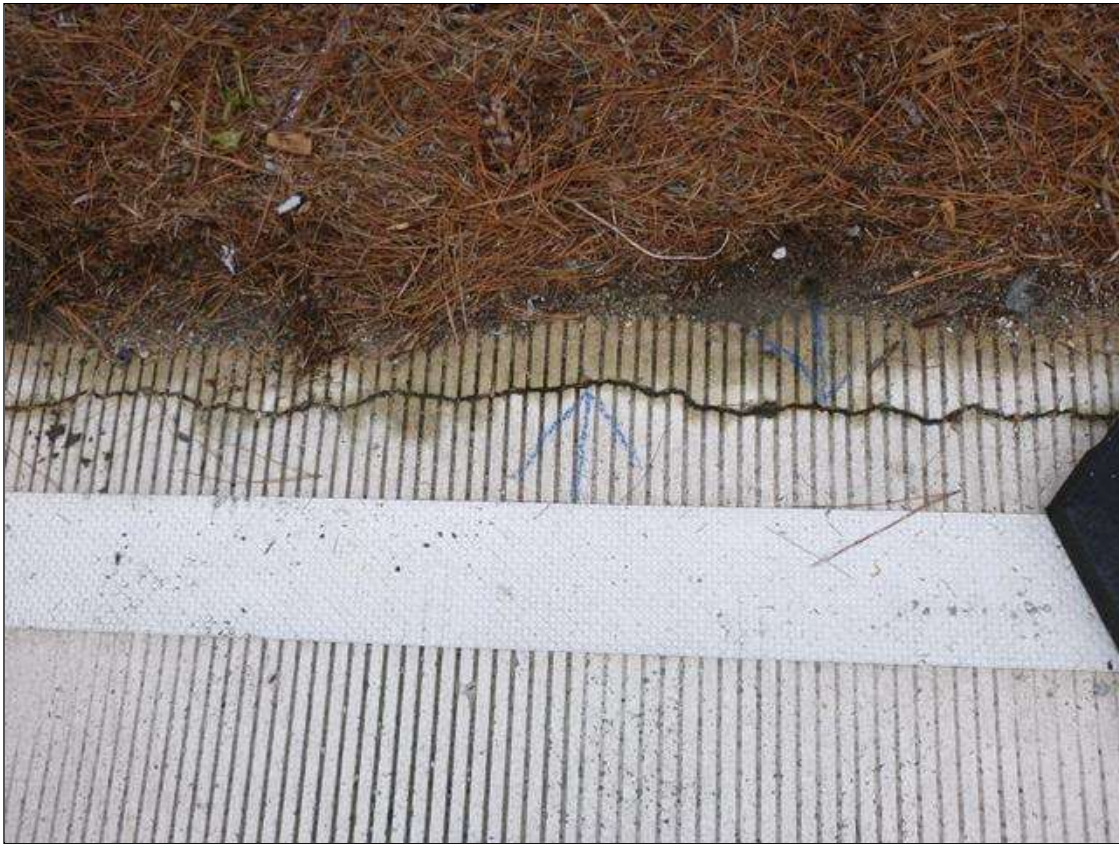
Approach 1: APPROACH SLAB 1, HAS A LONGITUDINAL CRACK ON BOTH SIDES OF THE SLAB AT THE GUTTER LINE 1/4 IN. WIDE X 30 FT. LONG

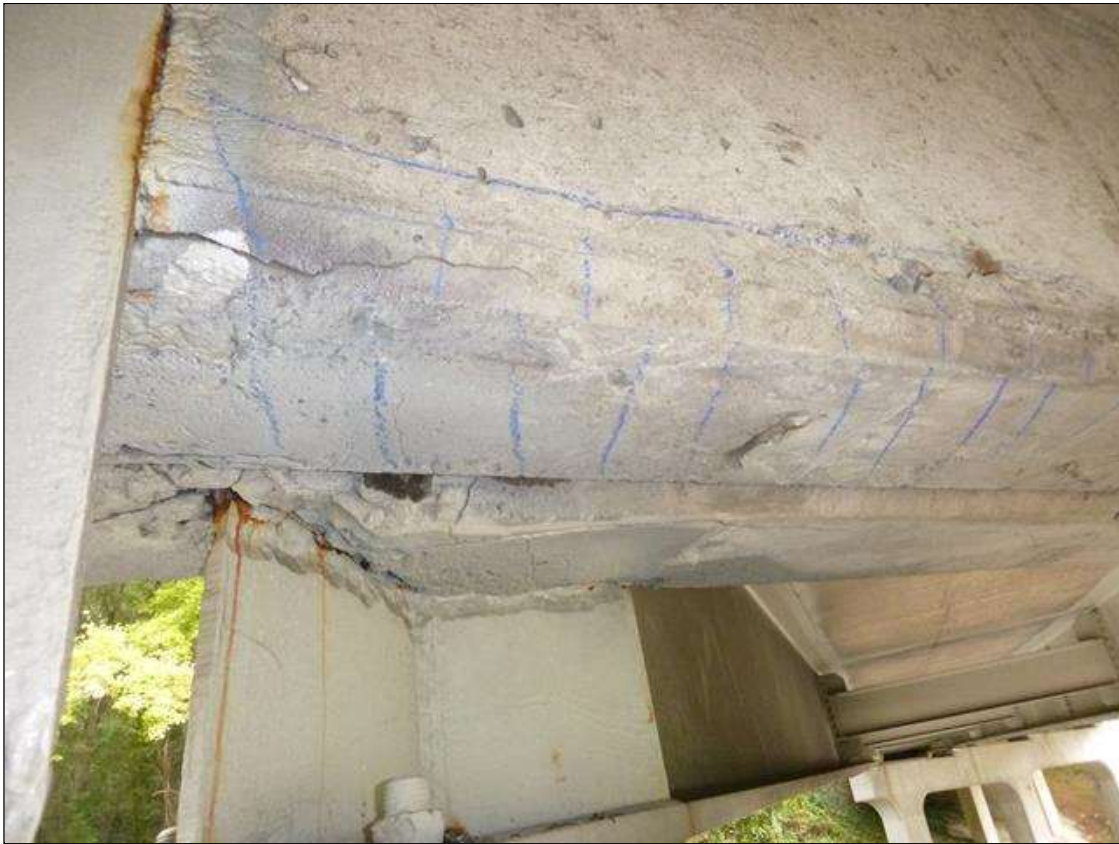
SPAN 2, BENT 2, BAY 1, BENT DIAPHRAGM HAS AN AREA OF DELAMINATION ON THE BOTTOM NEAR GIRDER 1, 2.5 FT. LONG X FULL WIDTH X 3 IN. HIGH

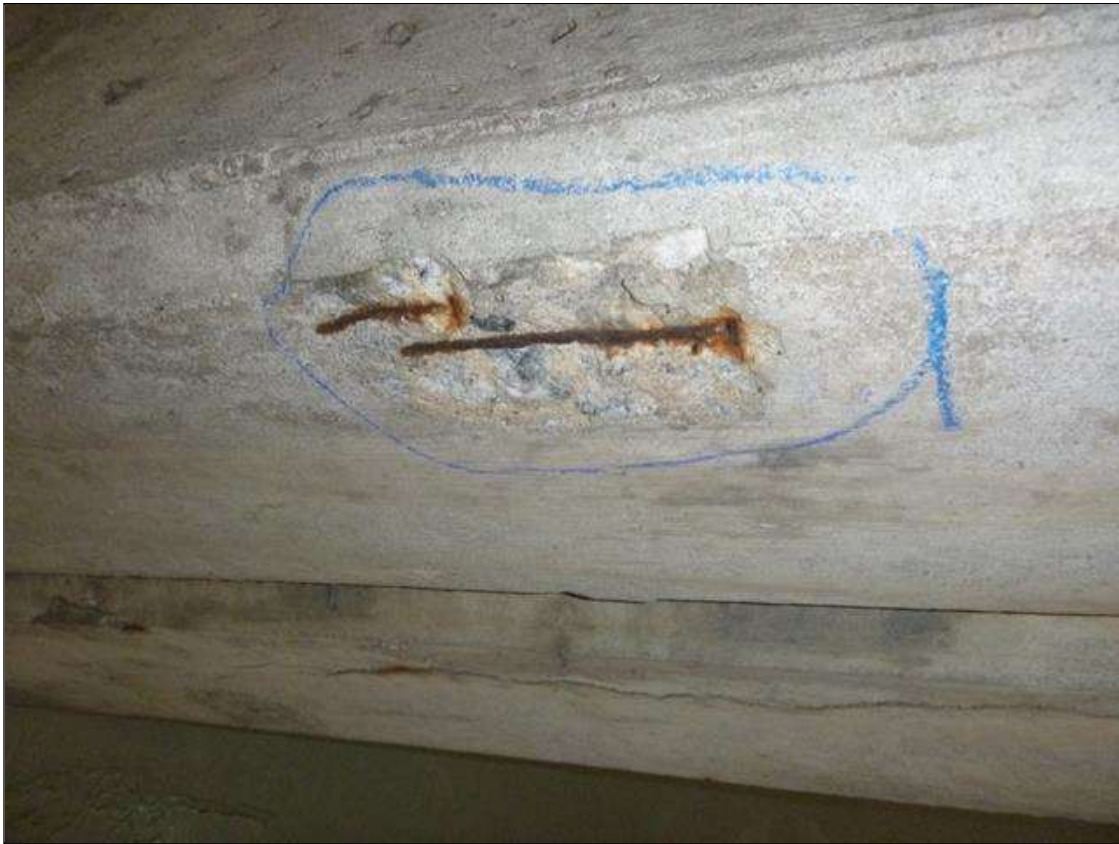
SPAN 2, BENT 2, BAY 1, BENT DIAPHRAGM HAS A SPALL ON THE BOTTOM, 3 IN. WIDE X 6 IN. LONG X .5 IN. DEEP WITH REBAR EXPOSED

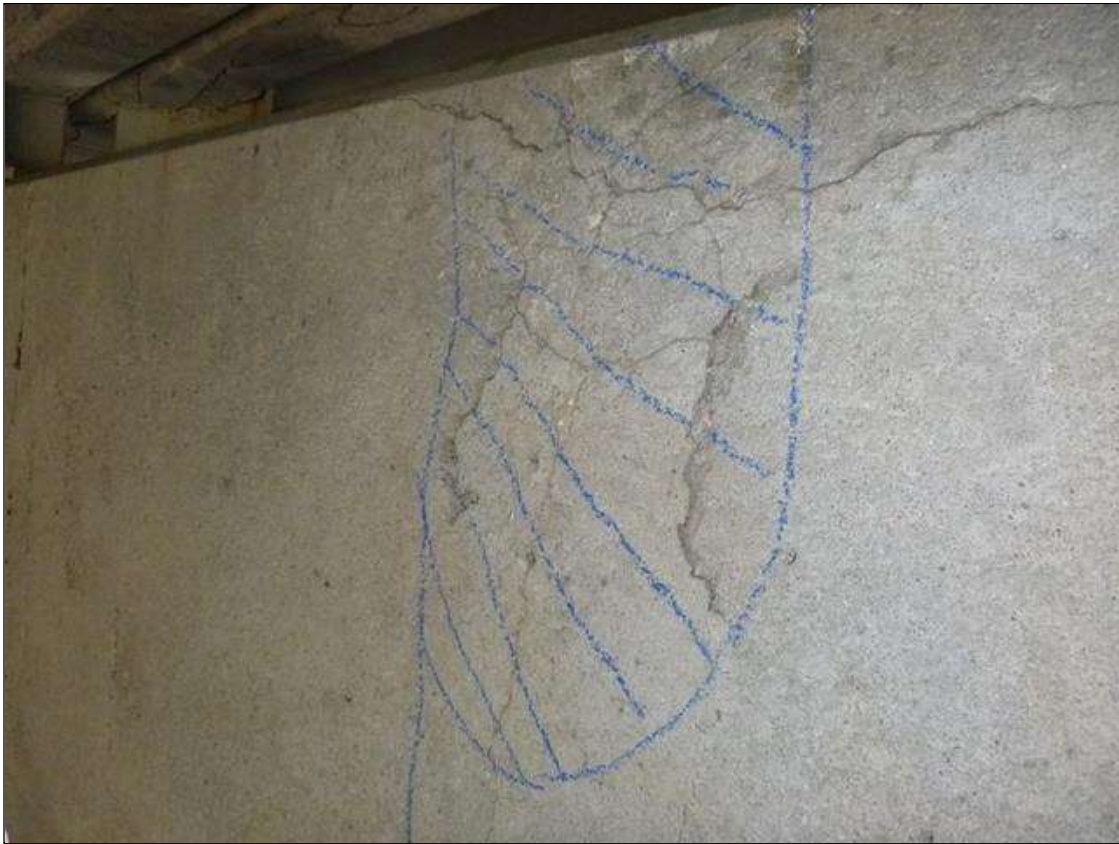
Bent 2 Cap 1: BENT 2 CAP, SPAN 2 SIDE HAS AN AREA OF DELAMINATION ON THE FACE OF THE CAP IN BAY 2, NEAR GIRDER 3, 10 IN. LONG X 1.5 FT. HIGH, WITH 1/16 IN. WIDE VERTICAL CRACKING

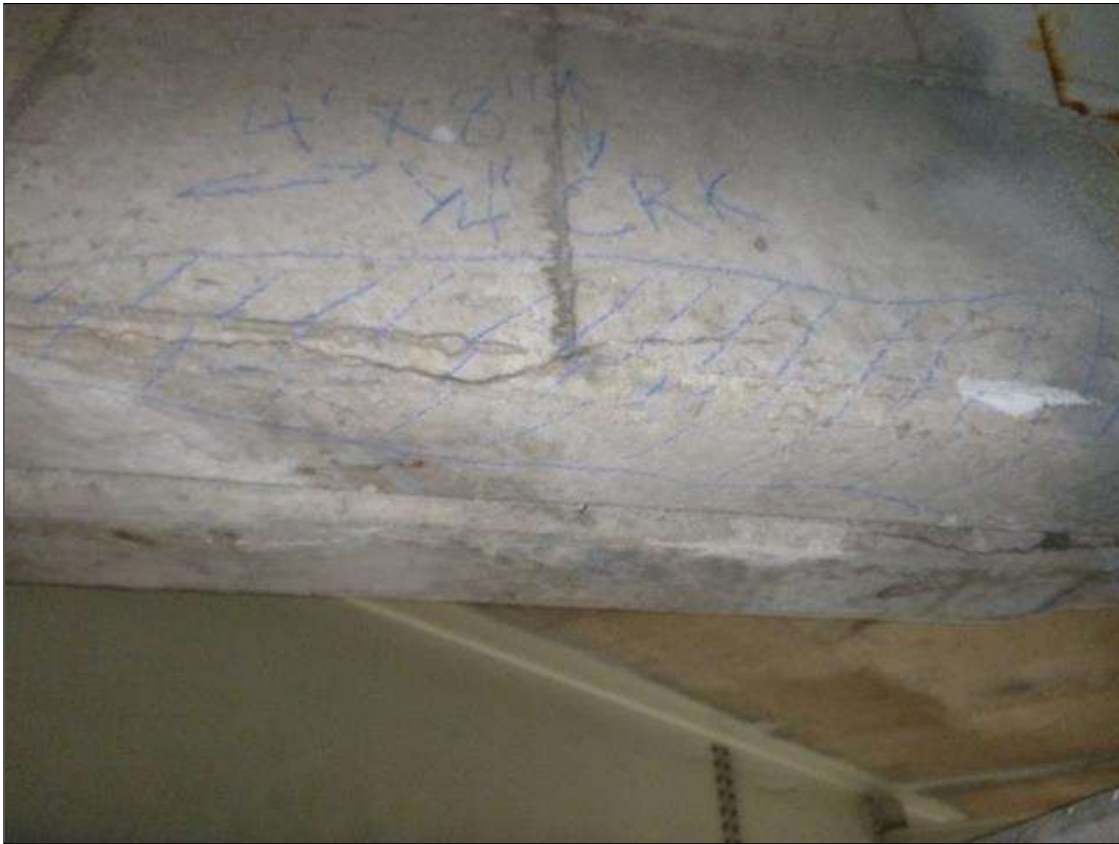
SPAN 2, BENT 2, BAY 3, BENT DIAPHRAGM HAS AN AREA OF DELAMINATION ON THE BOTTOM, 4 FT. LONG X FULL WIDTH X 8 IN. HIGH ON THE FACE, WITH 1/4 IN. WIDE CRACKING

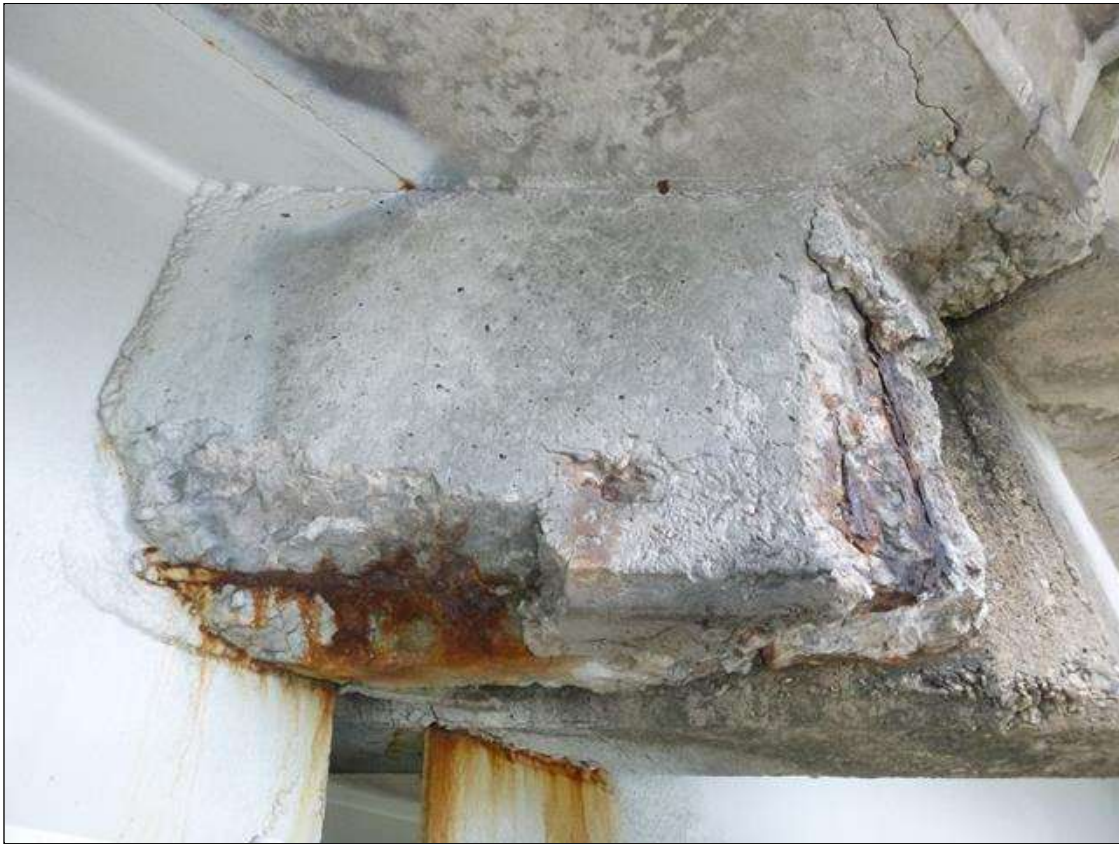
SPAN 2, BENT 1, BENT DIAPHRAGM IN THE LEFT OVERHANG IS SPALLED, 2.5 FT. LONG X 18 IN. HIGH X 6 IN. DEEP, WITH REBAR EXPOSED

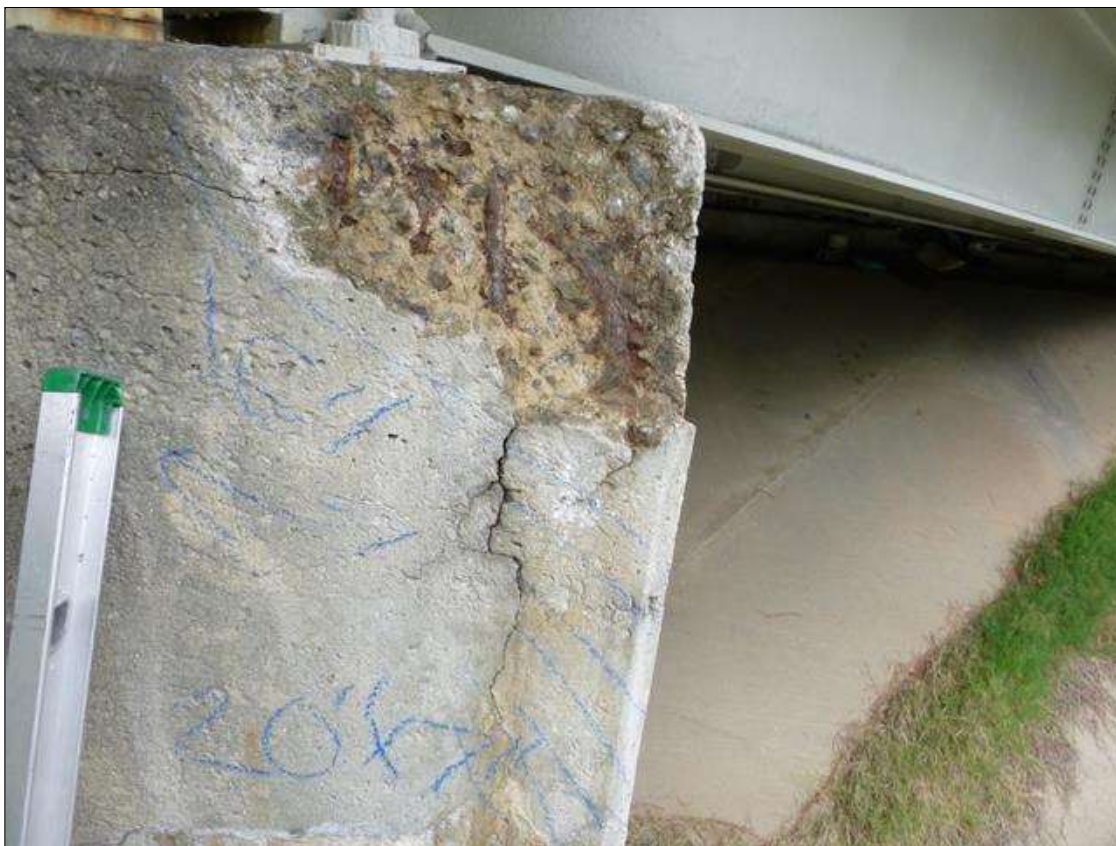
Bent 1 Cap 1: BENT 1 CAP, SPAN 2 SIDE LEFT END HAS A SPALL, 16 IN. LONG X 1 FT. HIGH X 8 IN. WIDE WITH REBAR EXPOSED, ALSO HAS ADJACENT DELAMINATION, 7 IN. WIDE X 20 IN. HIGH, WITH RUST STAINS AND EFFLO.

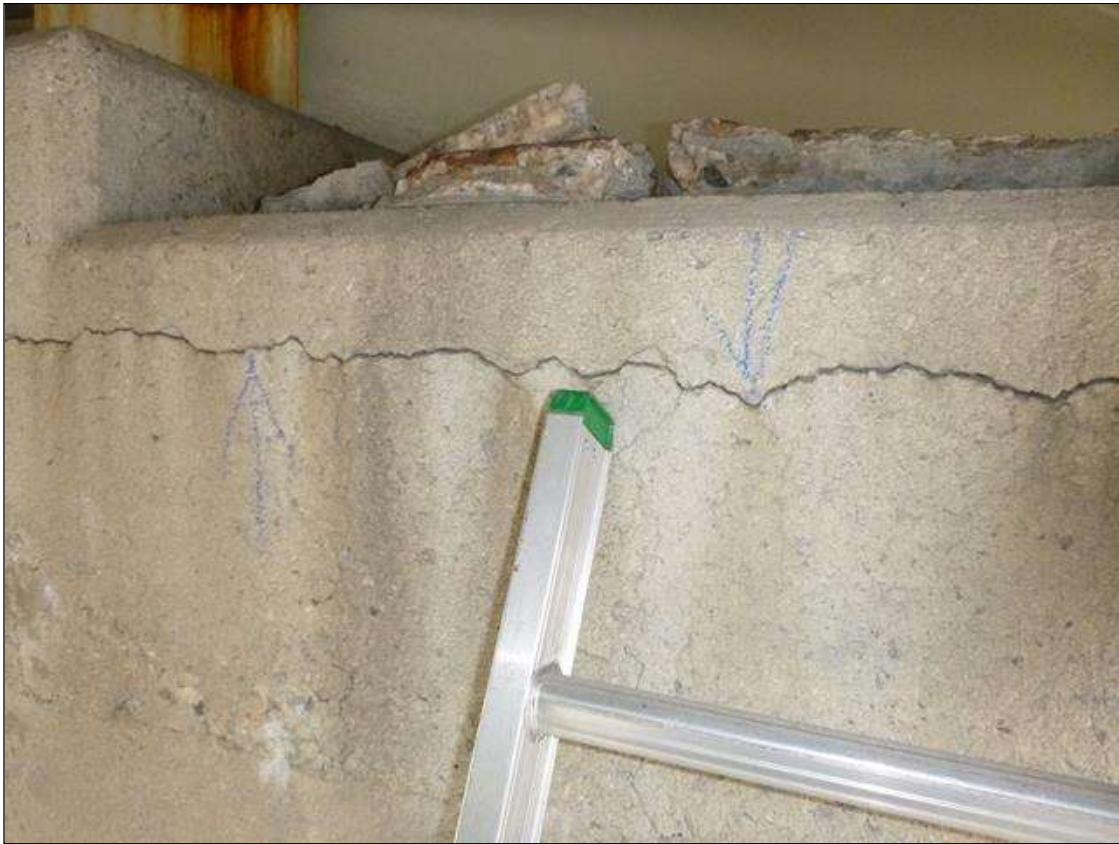
Bent 1 Cap 1: BENT 1 CAP, SPAN 2 SIDE HAS A HORIZONTAL CRACK, 1/4 IN. WIDE X 11 FT. LONG IN BAY 1, NEAR TOP EDGE

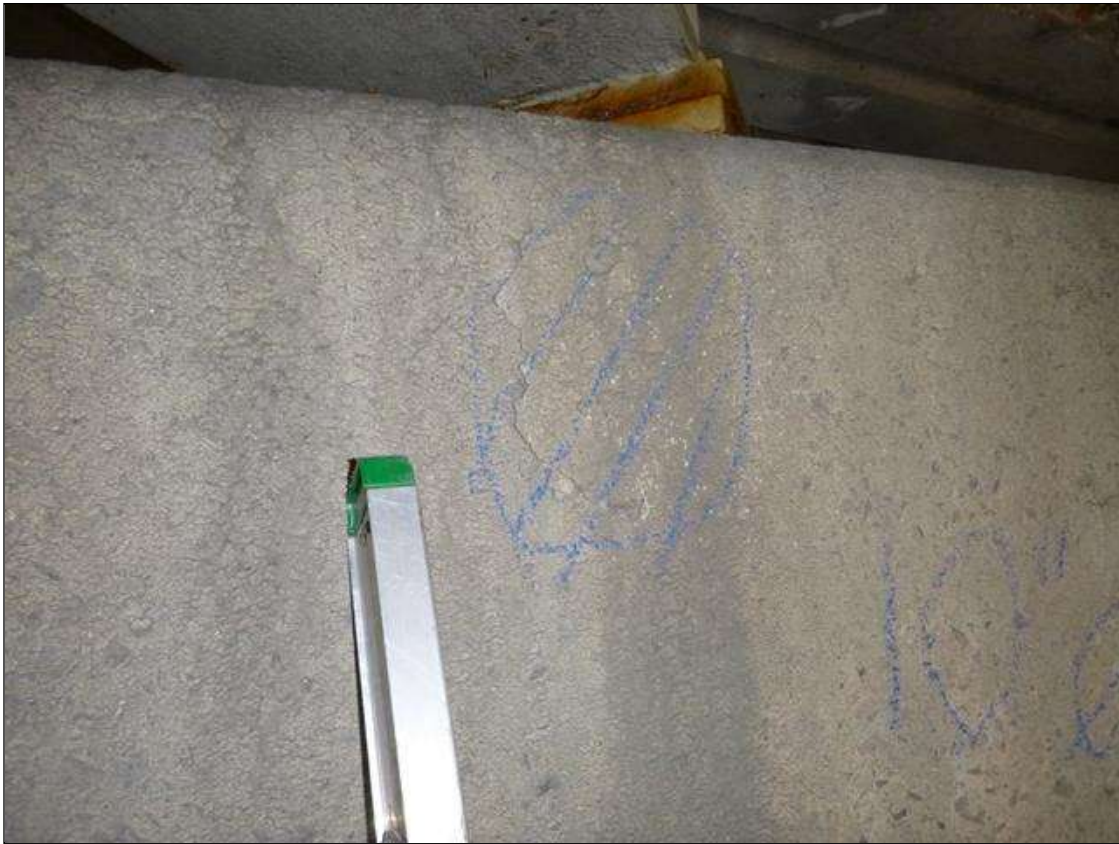
Bent 1 Cap 1: BENT 1 CAP, SPAN 2 SIDE HAS AN AREA OF DELAMINATION IN THE FACE OF THE CAP, 10 IN. IN DIAMETER, NEAR TOP EDGE, UNDER BEAM 2

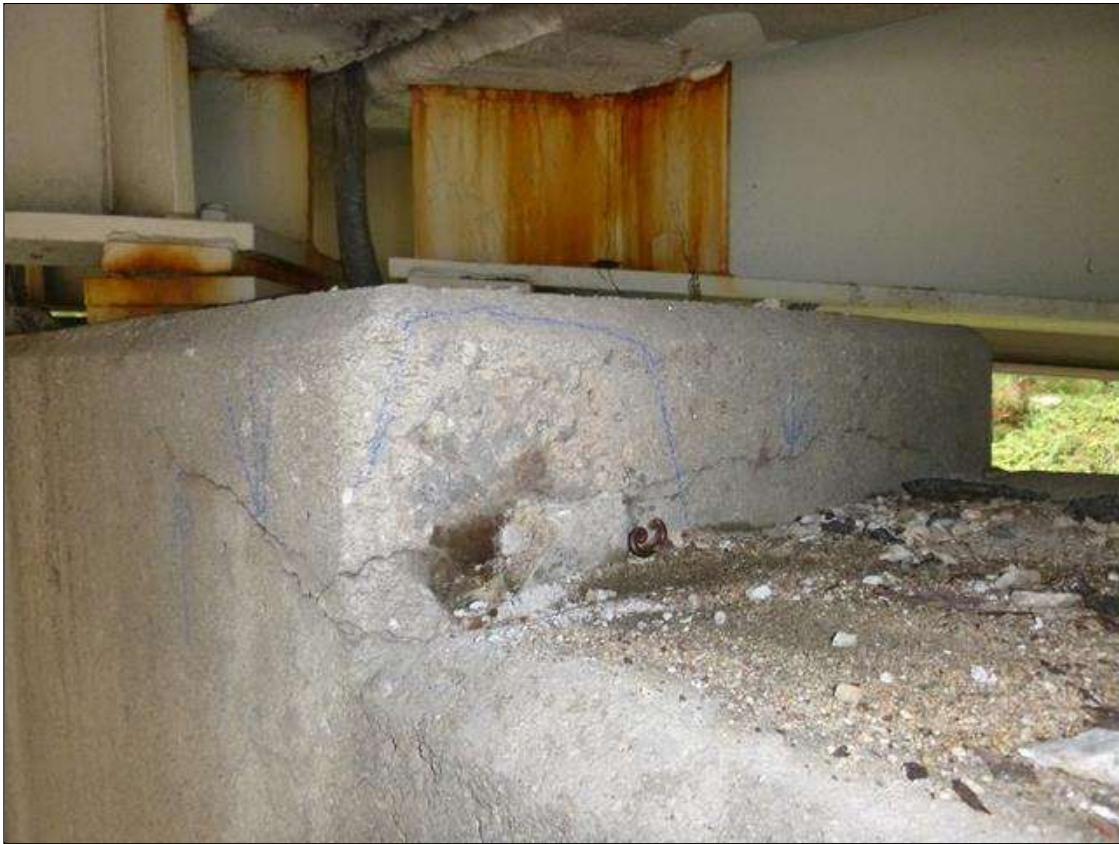
Bent 1 Cap 1: BENT 1 CAP, BAY 2, TOP SIDE HAS A SPALL AT THE STEPUP, 6 IN. WIDE X 5 IN. HIGH WITH EXPOSED REBAR, WITH ADJACENT 1/16 IN. WIDE CRACK

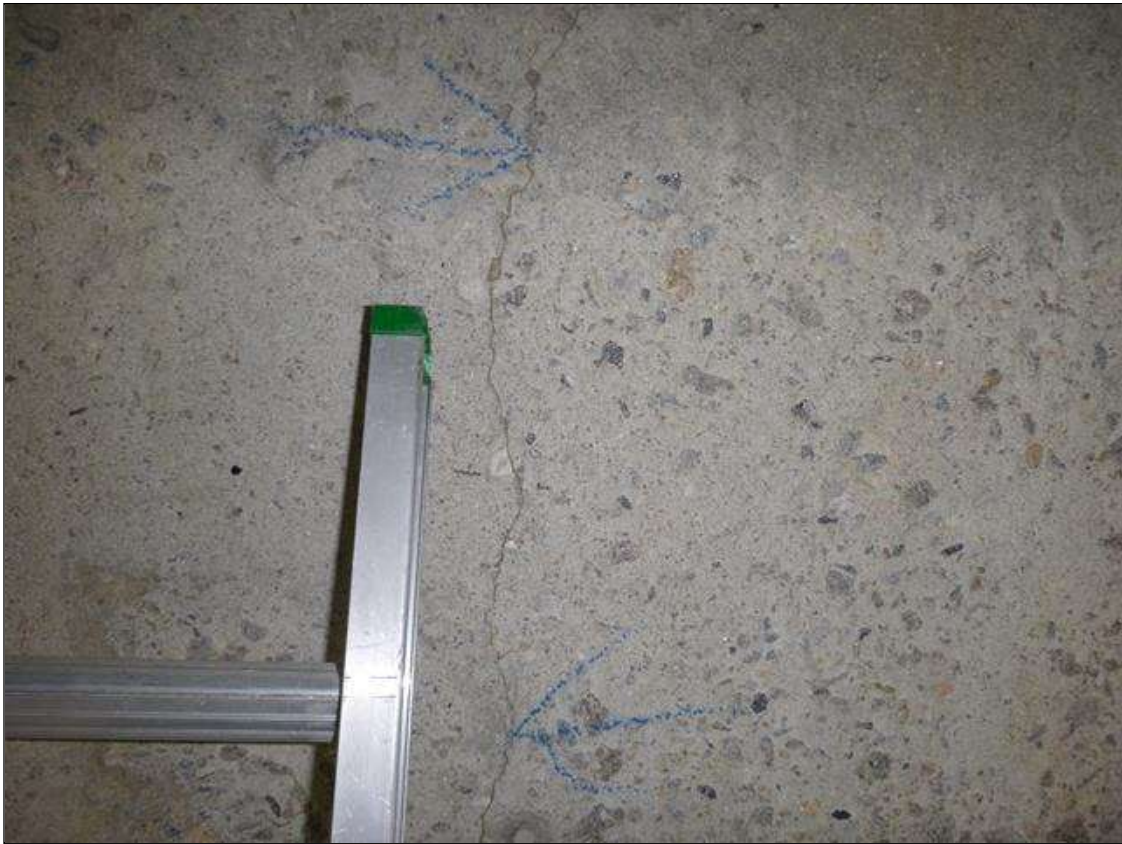
Bent 1 Cap 1: BENT 1 CAP, SPAN 2 SIDE IN BAY 3, HAS A VERTICAL HAIRLINE CRACK, 2.5 FT. HIGH, OVER COLUMN 3

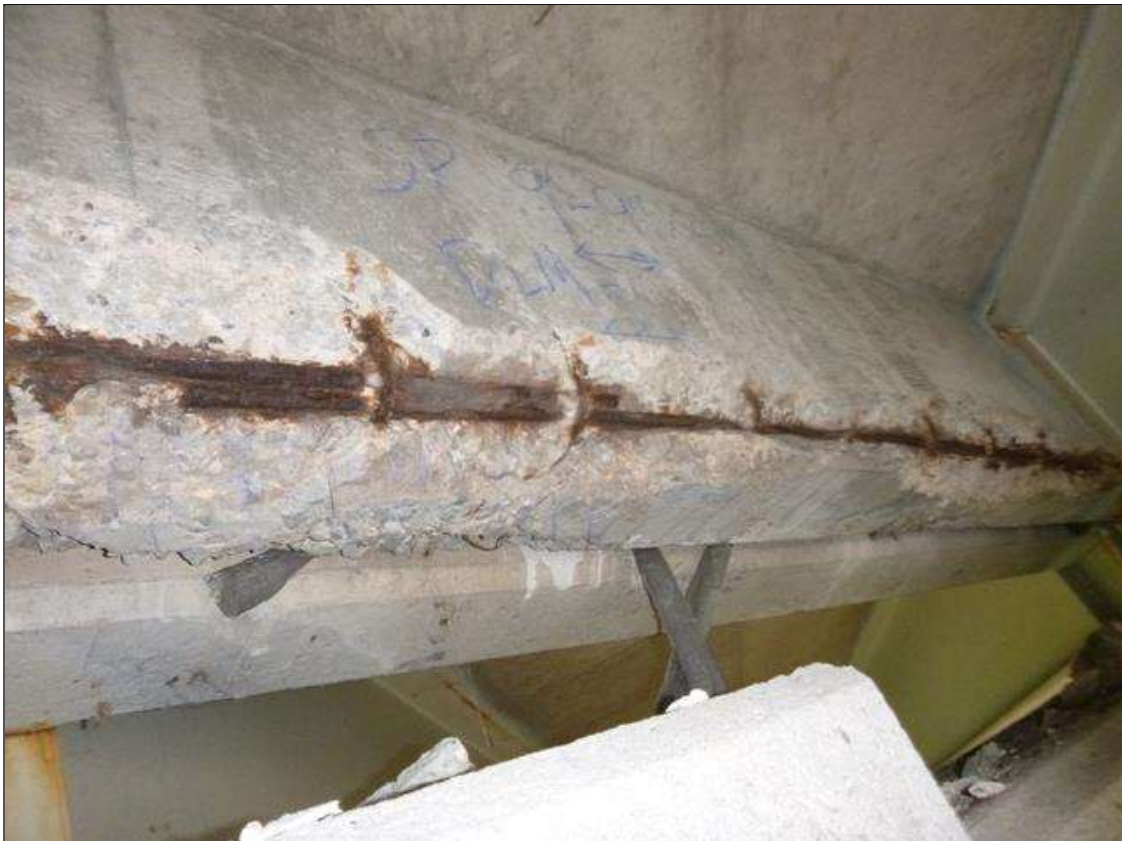
SPAN 2, BENT 1, BAY 3, BENT DIAPHRAGM HAS A SPALL, 9 FT. LONG X 6 IN. UP THE FACE X 6 IN. ACROSS THE BOTTOM X 3 IN. DEEP WITH REBAR EXPOSED, ALSO WITH 5 FT. OF DELAMINATION ON THE BOTTOM.

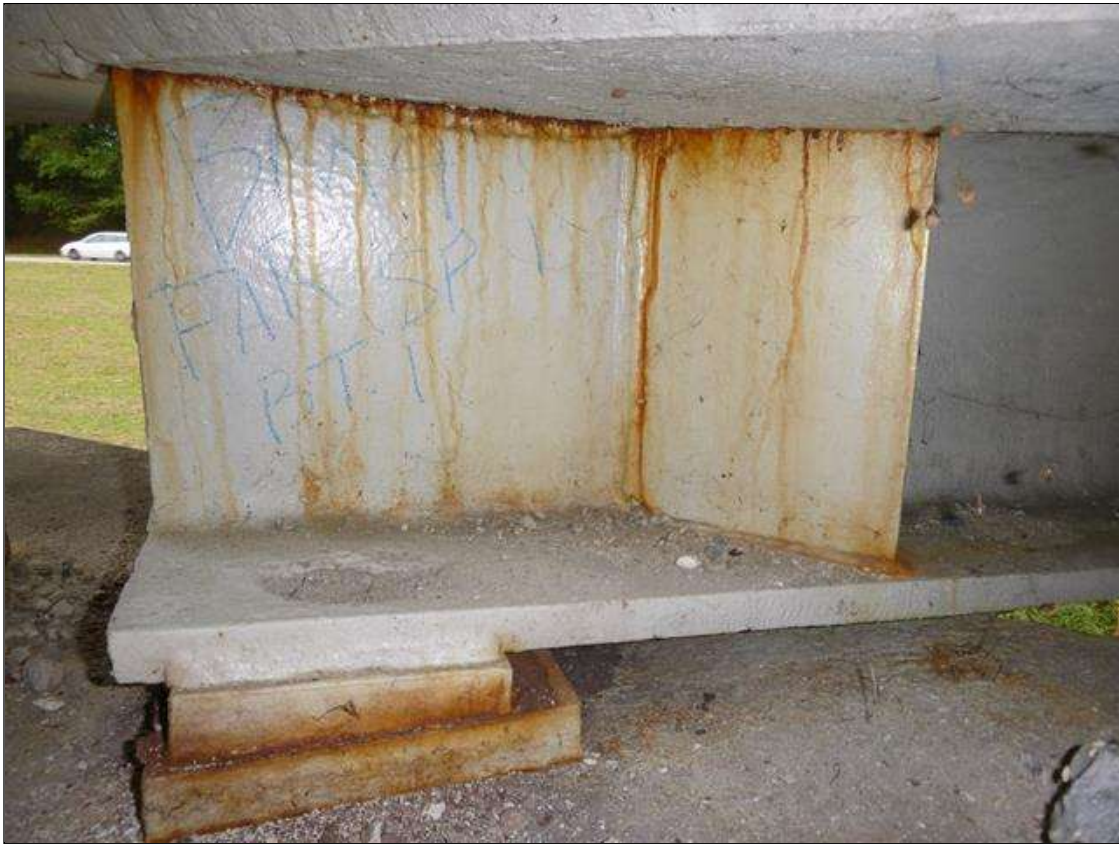
Span 1 Beam 4 Far Bearing: SPAN 1, BEAM 4, FAR BEARING HAS AN ANCHOR BOLT MISSING ON THE LEFT SIDE

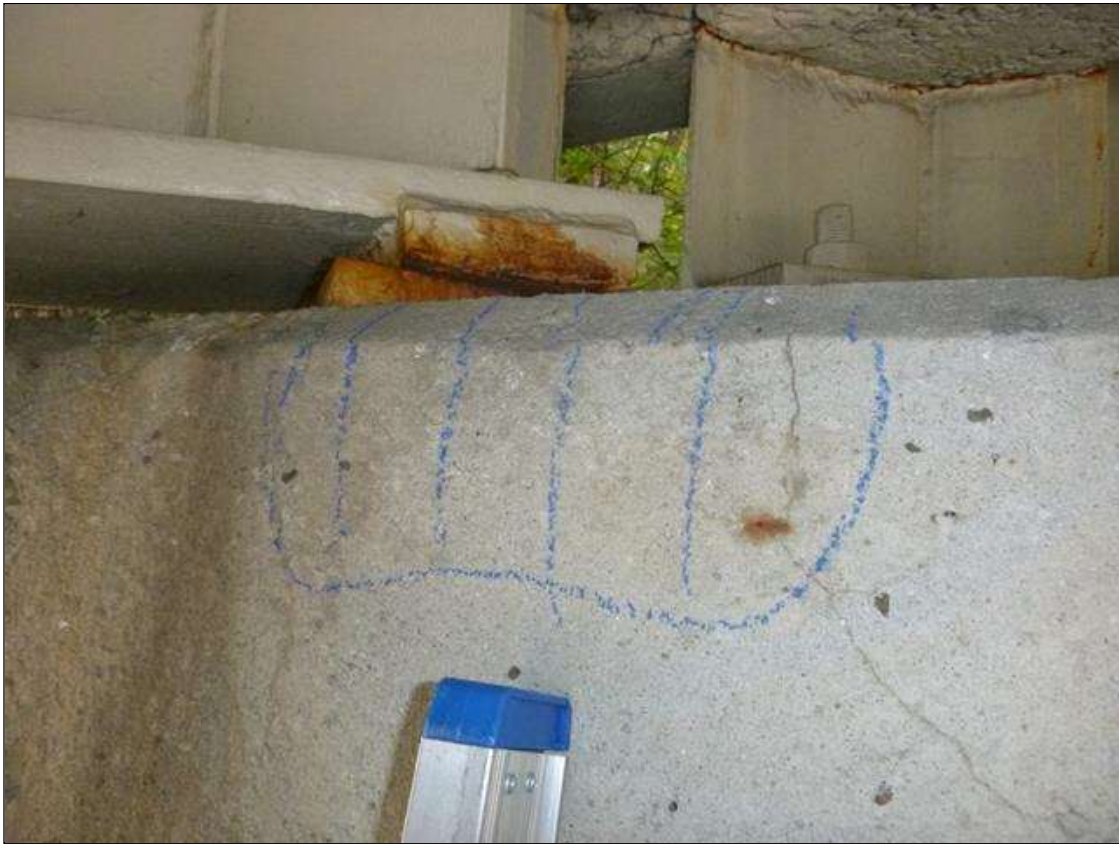
Bent 3 Cap 1: BENT 3 CAP, SPAN 3 SIDE HAS AN AREA OF DELAMINATION IN THE FACE OF THE CAP IN BAY 1, NEAR GIRDER 1, 10 IN. LONG X 6 IN. HIGH AT TOP EDGE, WITH HAIRLINE MAP CRACKING

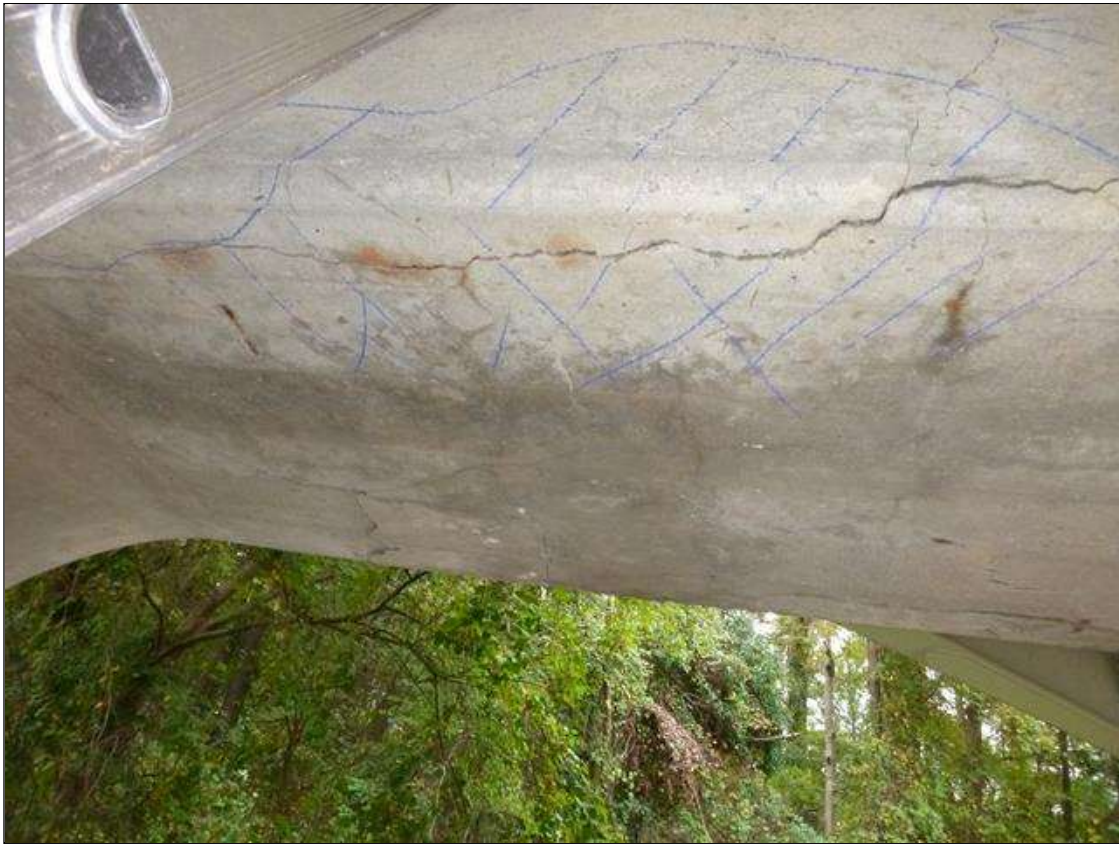
Bent 3 Cap 1: BENT 3 CAP, SPAN 3 SIDE HAS AN AREA OF DELAMINATION IN THE FACE OF THE CAP NEAR THE BOTTOM, 3 FT. LONG X 1 FT. HIGH AND ON THE BOTTOM BETWEEN COLUMNS 1 AND 2, FULL WIDTH X 7 FT. LONG

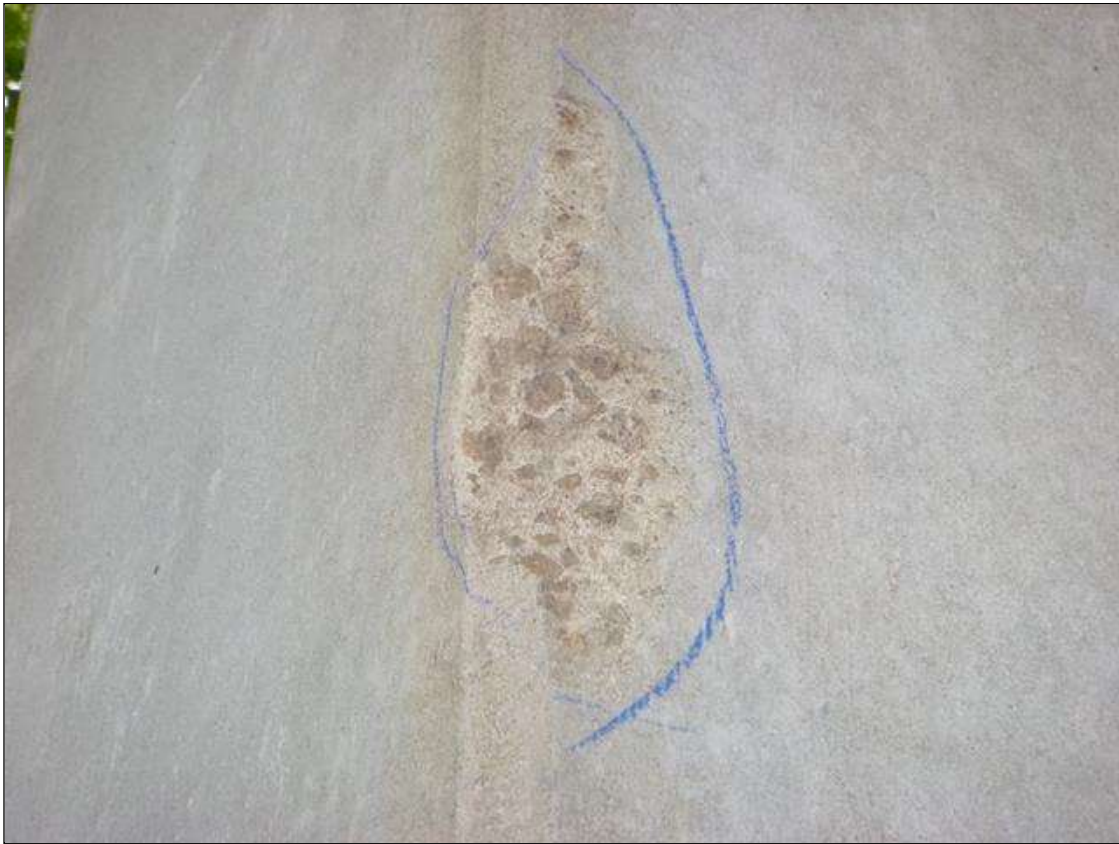
Bent 3 Pile 1: BENT 3, PILE 1, HAS A SPALL ON THE SOUTH EAST CORNER, 4 IN. WIDE X 1 FT. HIGH X 3/4 IN. DEEP, 11 FT. FROM BOTTOM OF THE CAP
