NC DEPARTMENT OF TRANSPORTATION  
DIVISION OF HIGHWAYS  
STRUCTURE MANAGEMENT UNIT

## Structure Safety Report

### Routine Element Inspection - Contract

COUNTY: WAKE STRUCTURE NUMBER: 910252 FREQUENCY: 24 MONTHS

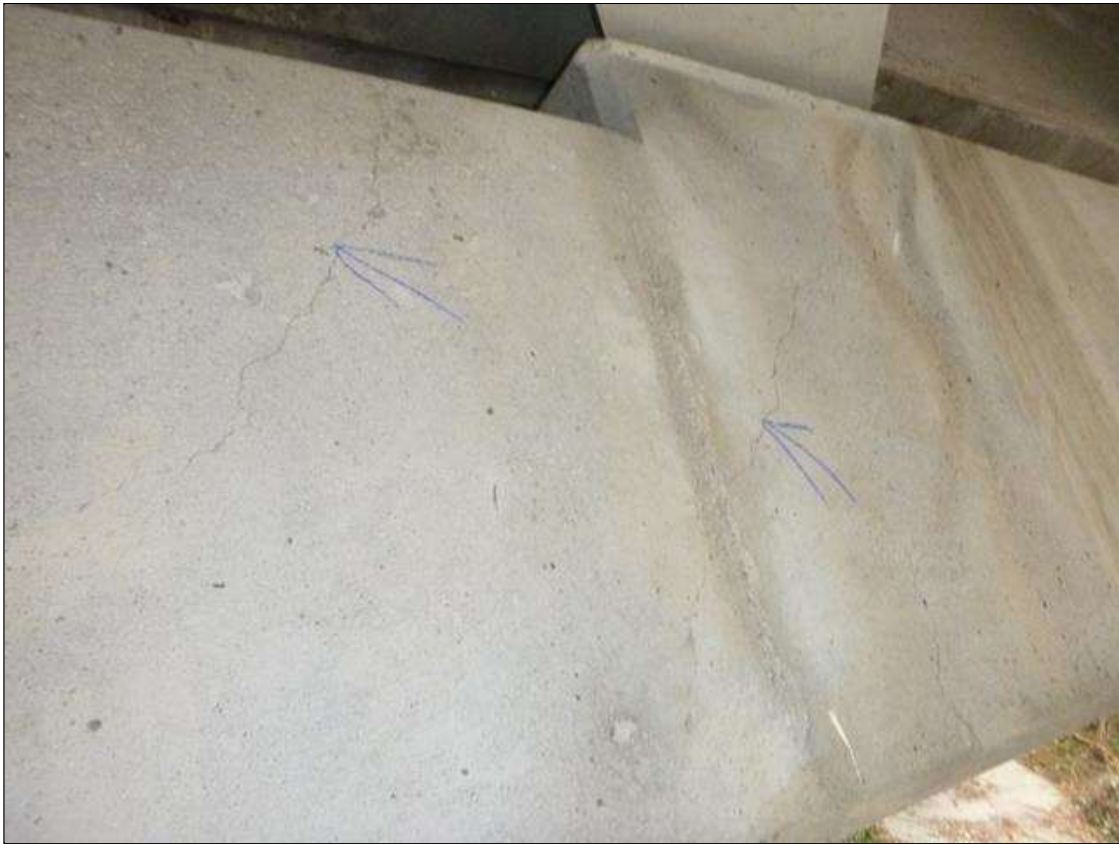
Bent 3 Cap 1: BENT 3 CAP, SPAN 3 SIDE HAS 2- 1/16 IN. WIDE DIAGONAL CRACKS IN THE FACE UNDER BEAM 3, 3 FT. LONG

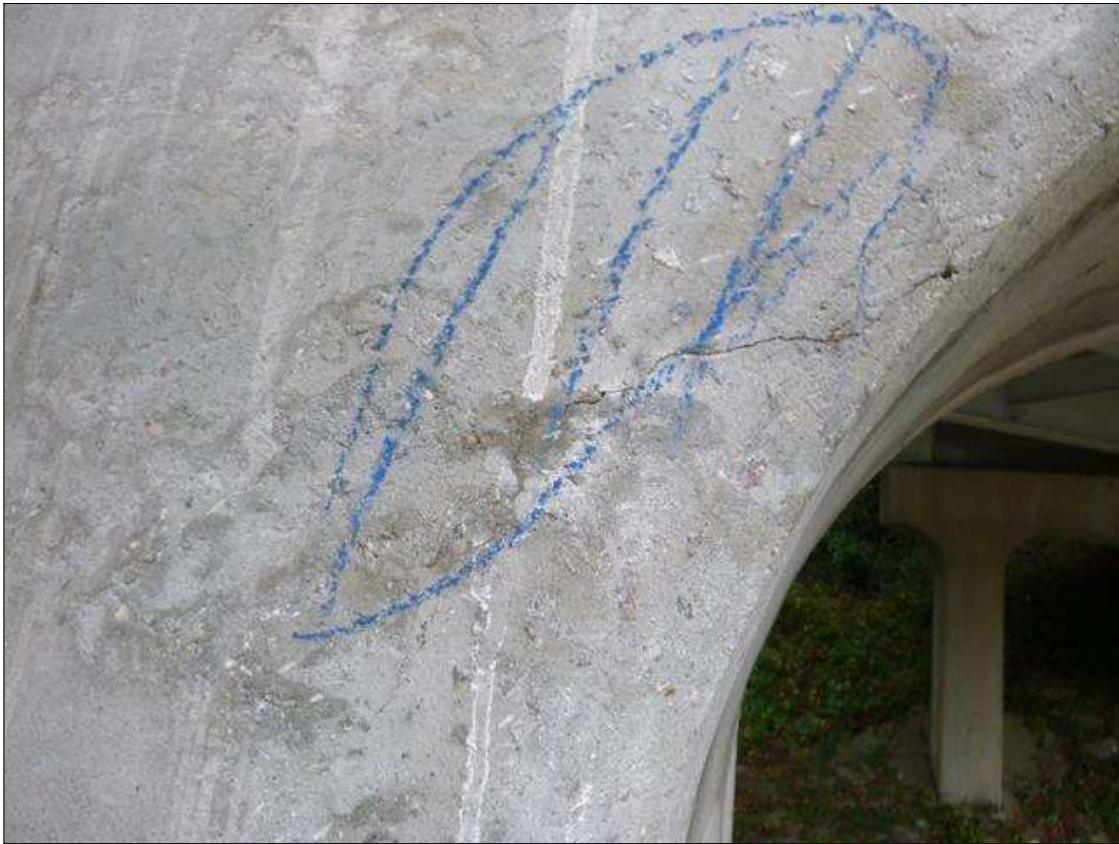
Bent 3 Pile 3: BENT 3, PILE 3 HAS AN AREA OF DELAMINATION ON THE EAST FACE, 6 IN. WIDE X 10 IN. HIGH, 1 FT. BELOW BOTTOM OF THE CAP

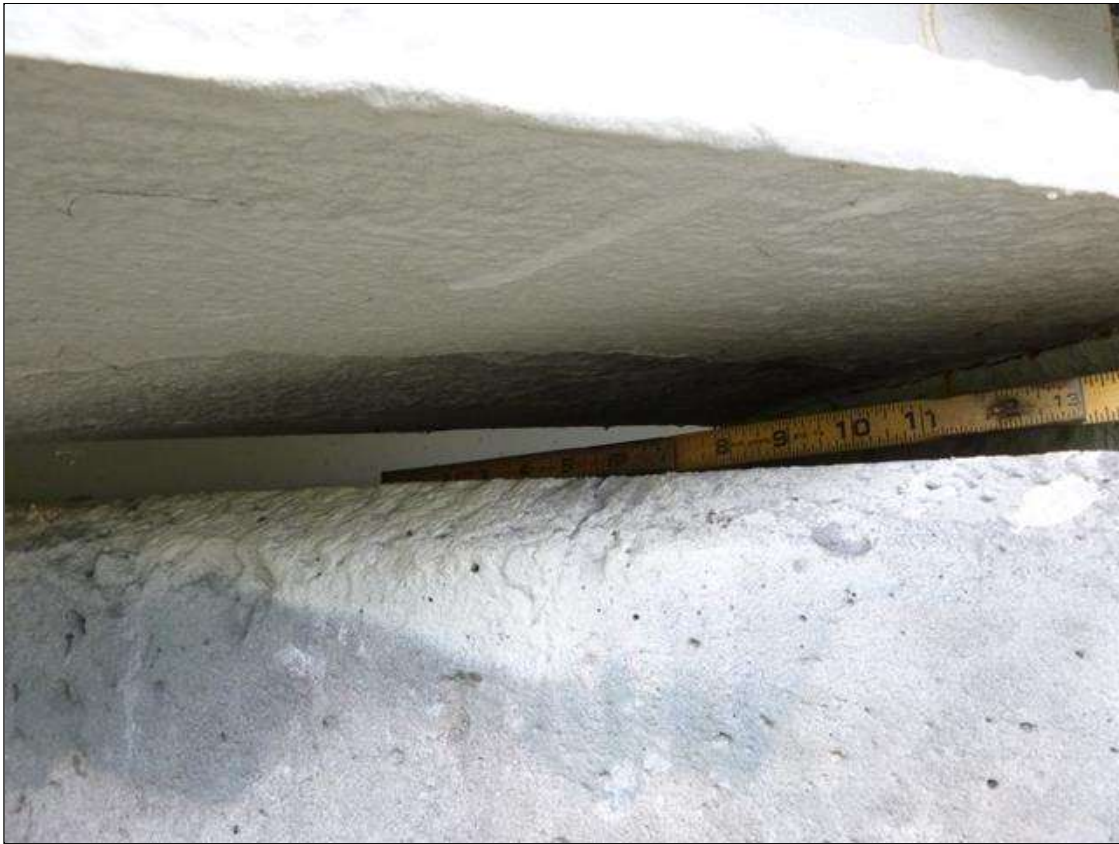
| Element Number | Defect Type | Defect Description | CS | CS Qty | Maint Qty |
|---|---|---|---|---|---|
| 107 | Corrosion | SPAN 3, BENT 3, BEAM 4 HAS 3/16 IN. SECTION LOSS FROM PREVIOUS RUST ON THE BOTTOM FLANGE X FULL WIDTH FROM THE BEAM END OUT 3 FT. THE WEB HAS UP TO 3/16 IN. SECTION LOSS AROUND THE CONCRETE DIAPHRAGM CONNECTION FROM PREVIOUS RUST. BEAM HAS BEEN CLEANED AND PAINTED | 3 | 3 | 3 Feet |

Span 3 Beam 4: SPAN 3, BENT 3, BEAM 4 HAS 3/16 IN. SECTION LOSS FROM PREVIOUS RUST ON THE BOTTOM FLANGE X FULL WIDTH FROM THE BEAM END OUT 3 FT. THE WEB HAS UP TO 3/16 IN. SECTION LOSS AROUND THE CONCRETE DIAPHRAGM CONNECTION FROM PREVIOUS RUST. BEAM HAS BEEN CLEANED AND PAINTED

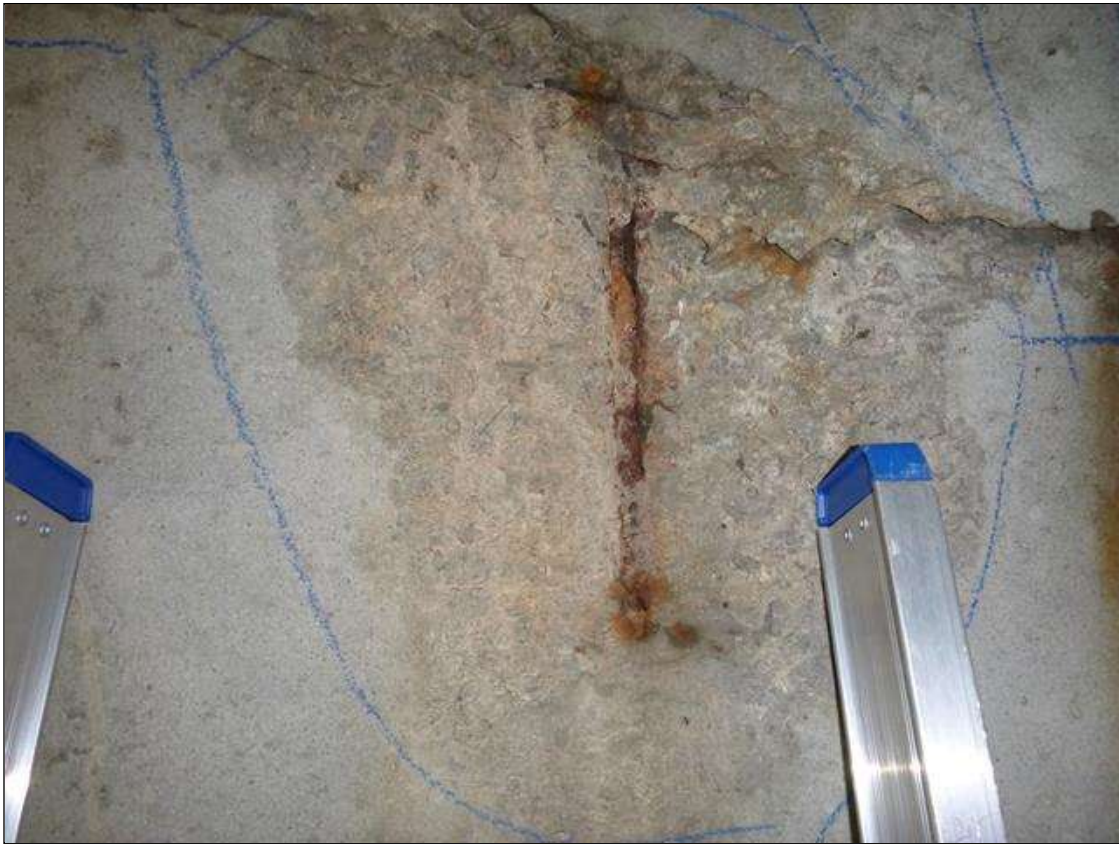
Bent 3 Cap 1: BENT 3 CAP, SPAN 4 SIDE HAS A SPALL ON THE FACE OF THE CAP IN BAY 3, NEAR TOP EDGE, 12 IN. WIDE X 16 IN. HIGH X 1 IN. DEEP WITH REBAR EXPOSED

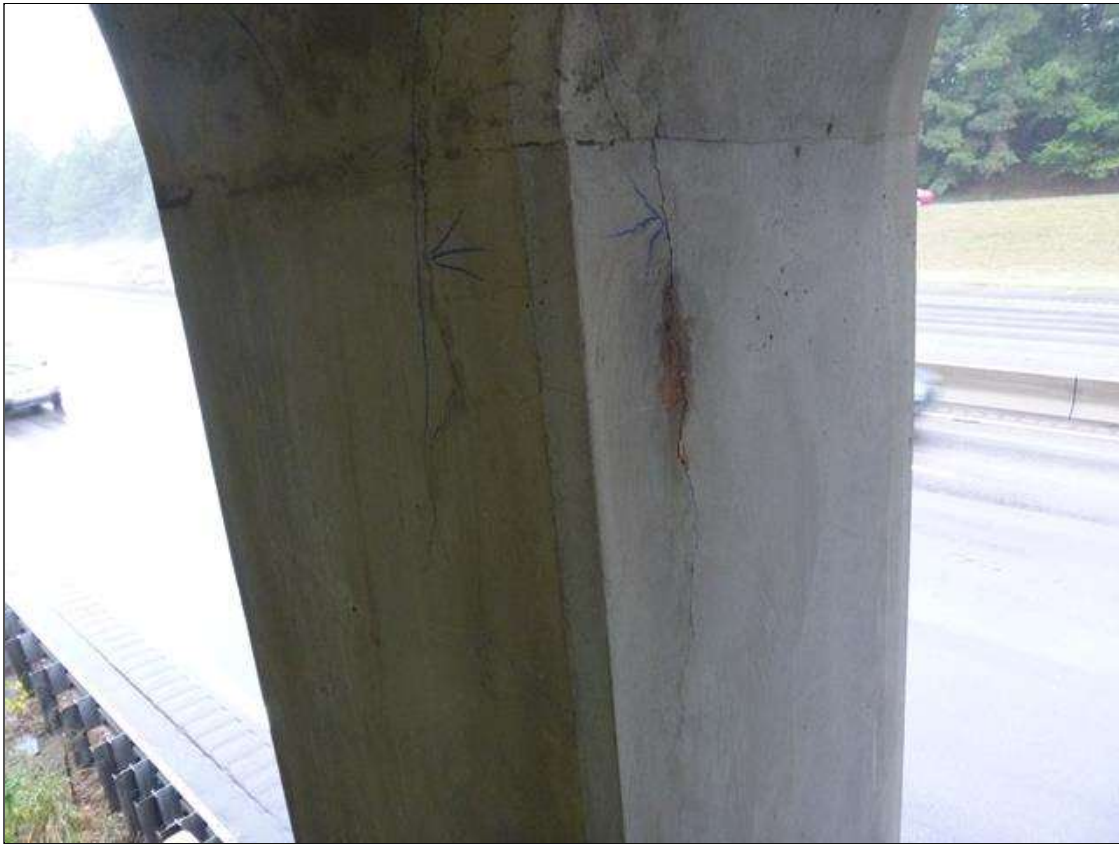
Bent 3 Pile 3: BENT 3, PILE 3 HAS A VERTICAL CRACK, 1/16 IN. WIDE ON THE EAST FACE, 2 FT. LONG, 1 FT. BELOW THE BOTTOM OF THE CAP

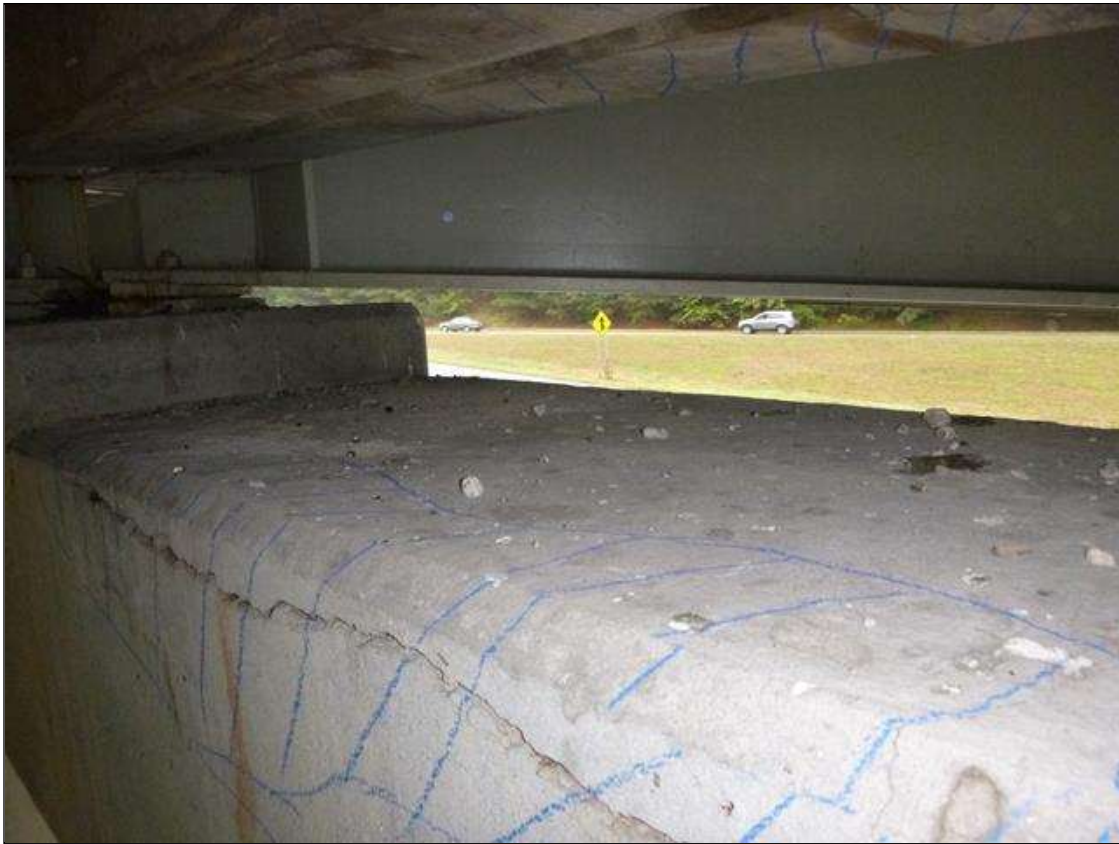
Bent 3 Cap 1: BENT 3 CAP, SPAN 4 SIDE HAS AN AREA OF DELAMINATION IN THE FACE OF THE CAP OVER COLUMN 2, 5 FT. LONG, 10 IN. DOWN THE FACE X 5 IN. ACROSS THE TOP, WITH 1/4 IN. WIDE HORIZONTAL CRACKING

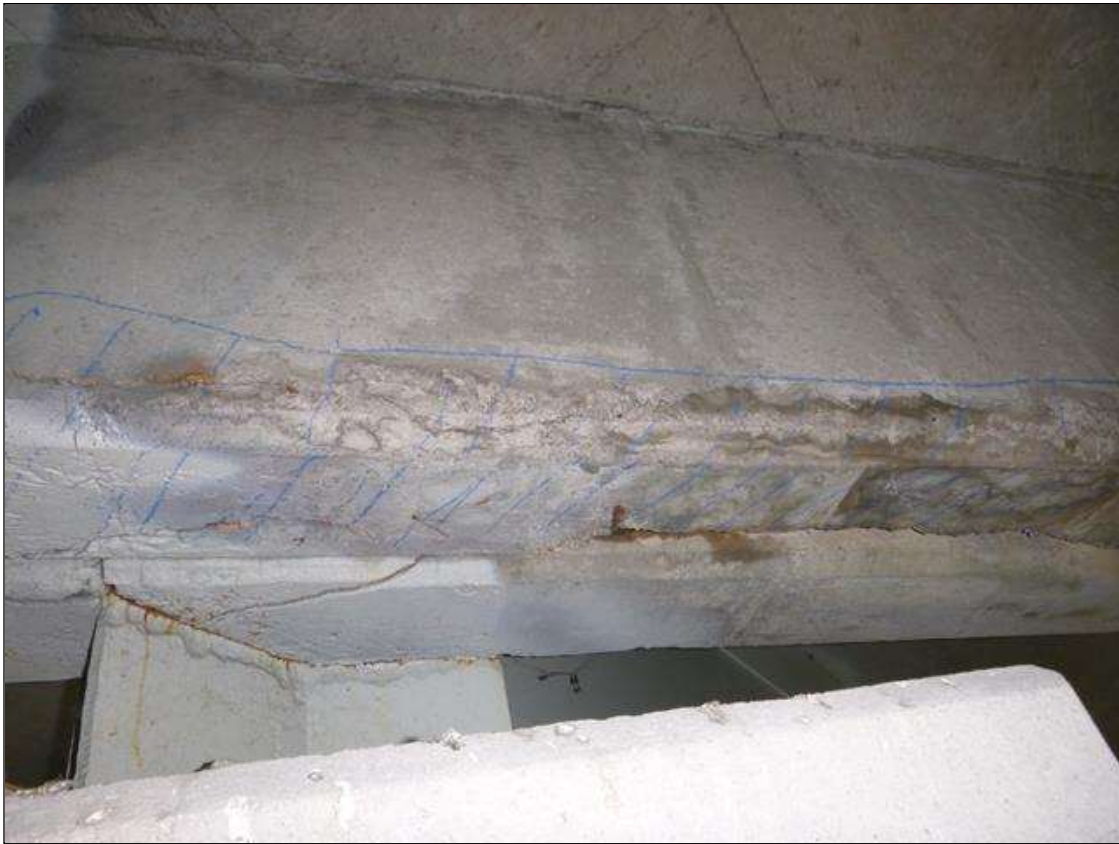
SPAN 4, BENT 3, BAY 1, BENT DIAPHRAGM HAS AREA OF DELAMINATION ON THE BOTTOM, FULL WIDTH X 5 FT. LONG X 5 IN. HIGH ON THE FACE

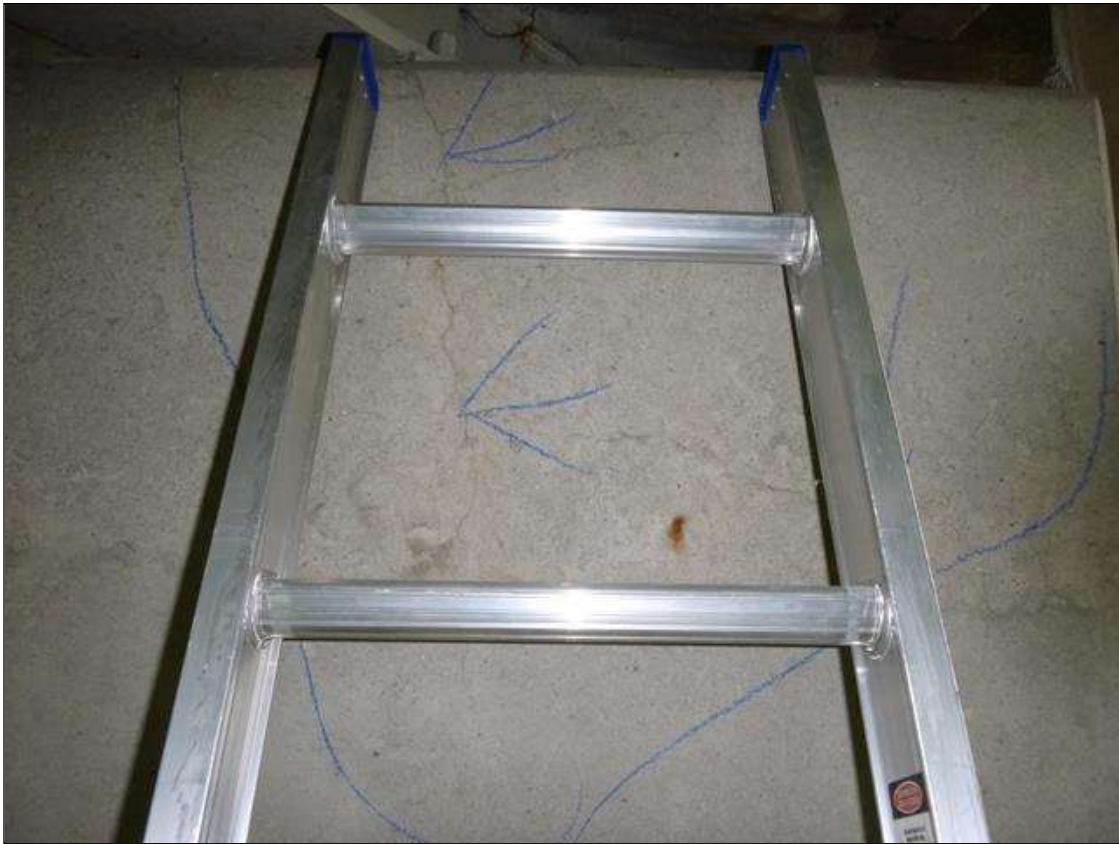
Bent 3 Cap 1: BENT 3 CAP, SPAN 4 SIDE HAS A 2 FT. X 2 FT. AREA OF HAIRLINE MAP CRACKING IN THE FACE OF THE CAP UNDER BEAM 1

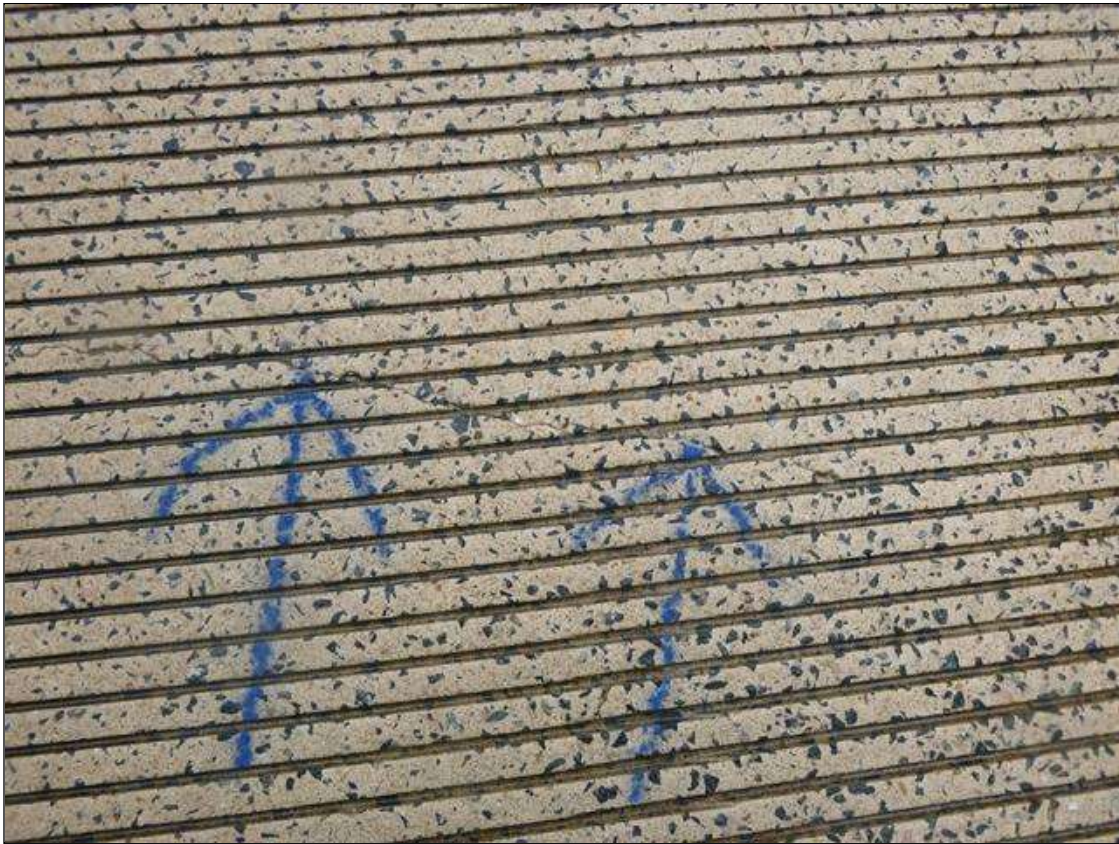
| Element Number | Defect Type | Defect Description | CS | CS Qty | Maint Qty | |
|---|---|---|---|---|---|---|
| 12 | Cracking (RC and Other) | TRANSVERSE HAIRLINE CRACKING, THROUGHOUT THE SPAN. | 2 | 150 | 150 | Square Feet |

Span 1 Deck: TRANSVERSE HAIRLINE CRACKING, THROUGHOUT THE SPAN.

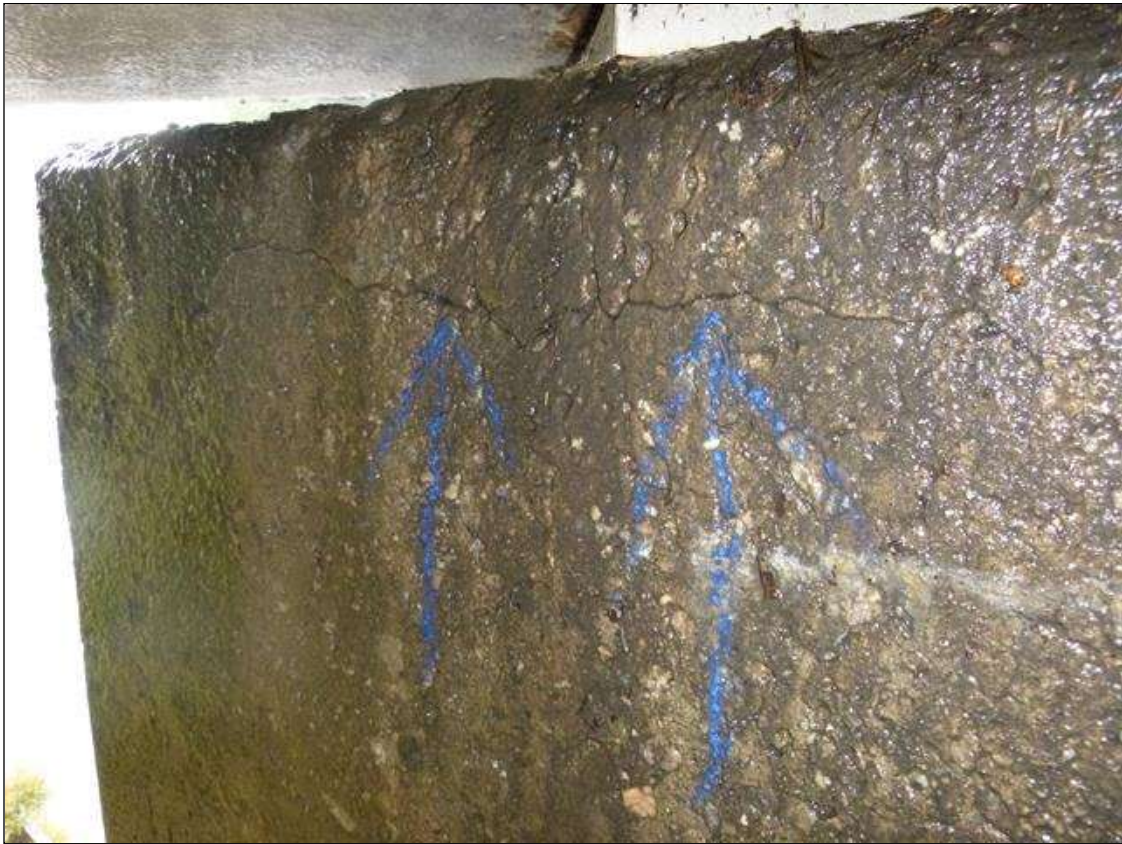
Bent 1 Cap 1: HORIZONTAL CRACK, 1/16 IN. WIDE X 2 FT. LONG, NEAR TOP OF THE CAP ON SPAN 1 SIDE UNDER BEAM 1.

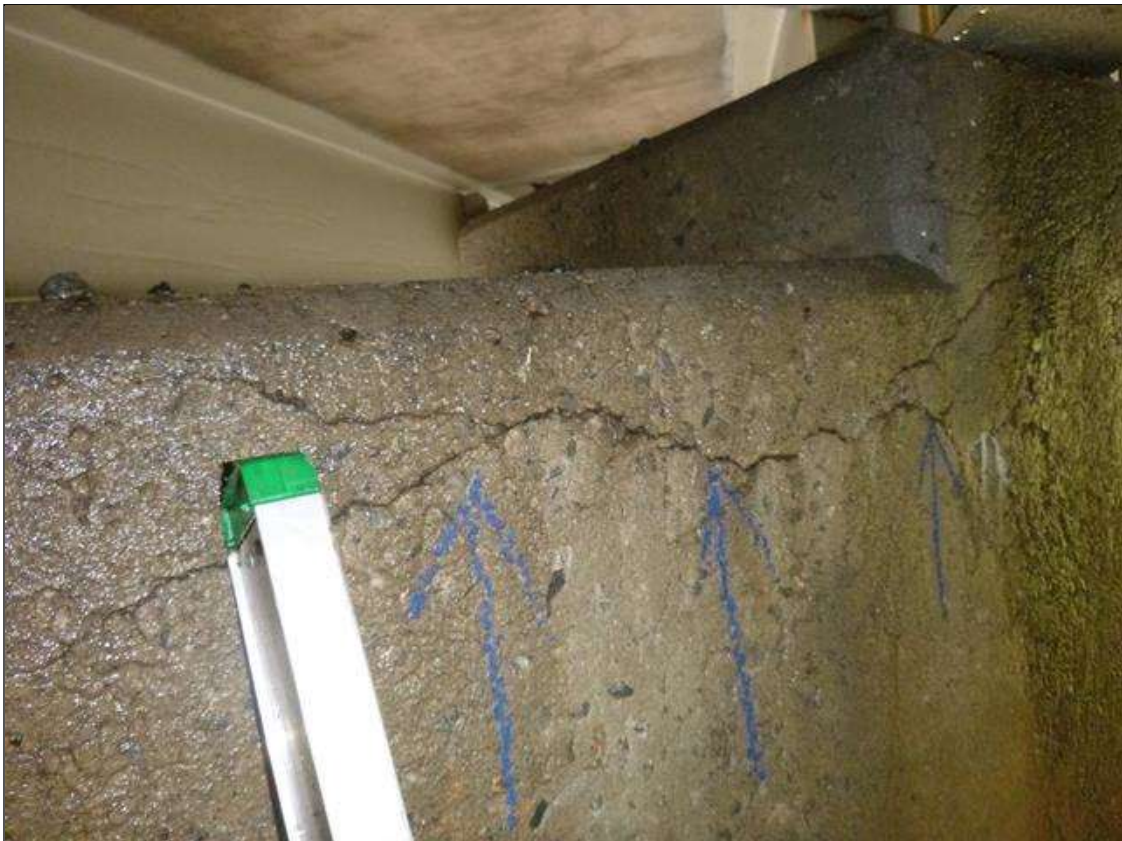
Bent 1 Cap 1: HORIZONTAL CRACK 1/8 IN. WIDE X 4 FT. LONG NEAR TOP OF CAP ON SPAN 1 FACE NEAR BEAM 2.

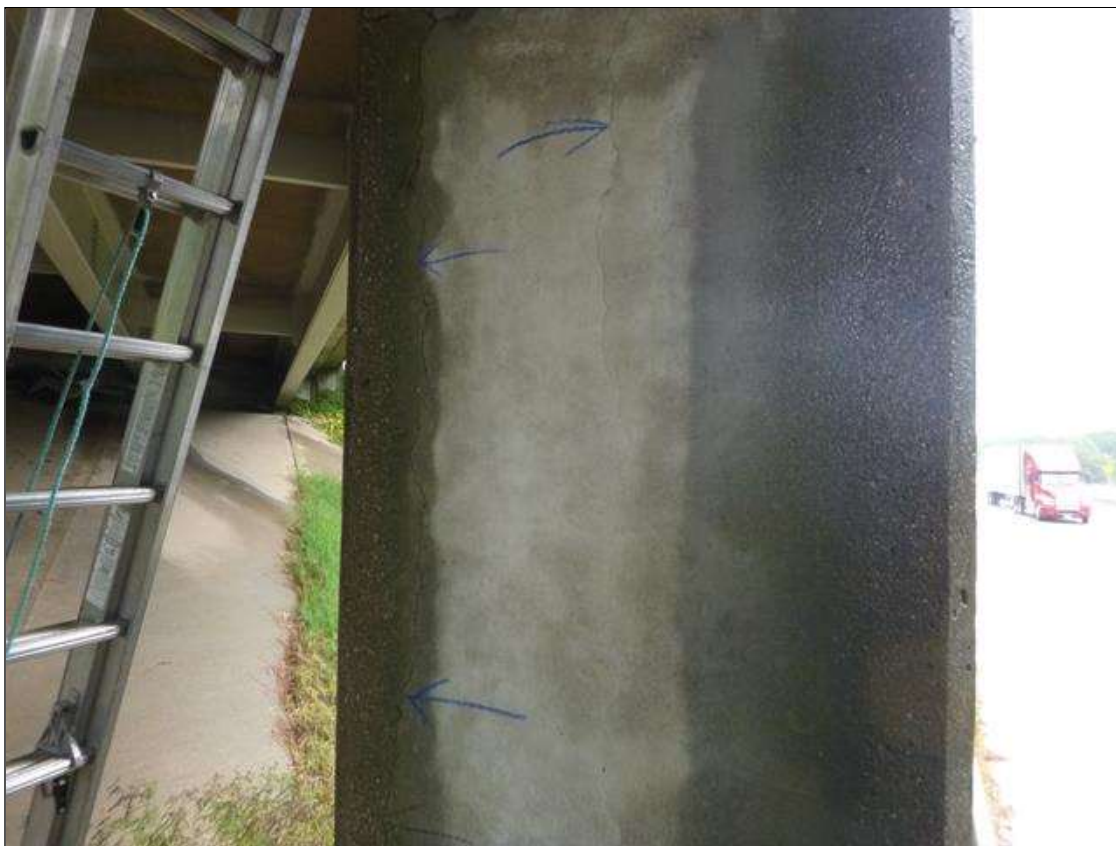
Bent 1 Pile 1: 2-VERTICAL CRACKS, 1/16 IN. WIDE X 4 FT. LONG ON SOUTH FACE OF COLUMN NEAR CAP.

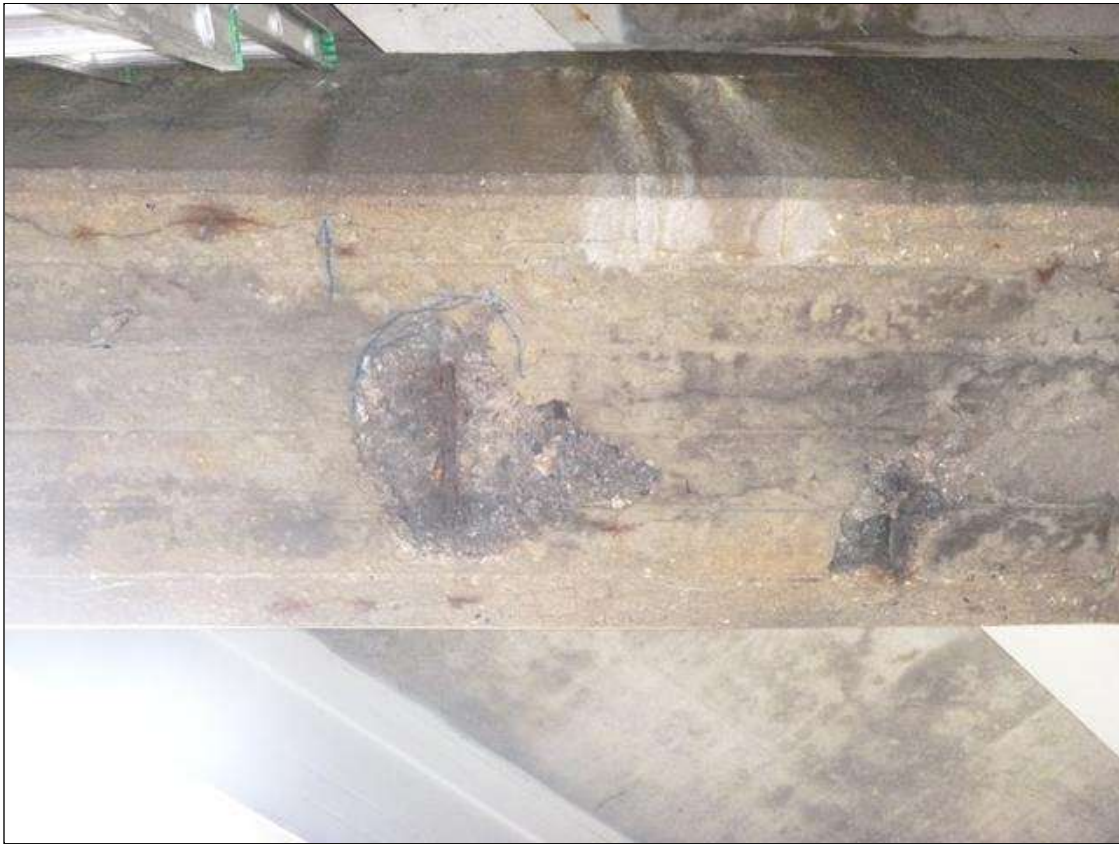
Bent 1 Cap 1: 2- SPALLS ON THE BOTTOM OF 1- 18 IN. DIAMETER AND 1- 8 IN., DIAMETER, BOTH 1 IN. DEEP WITH REBAR EXPOSED, WITH ADJACENT DELAMINATION AND 1/16 IN. WIDE CRACKING, ON BOTTOM OF CAP BETWEEN COLUMNS 1 AND 2.

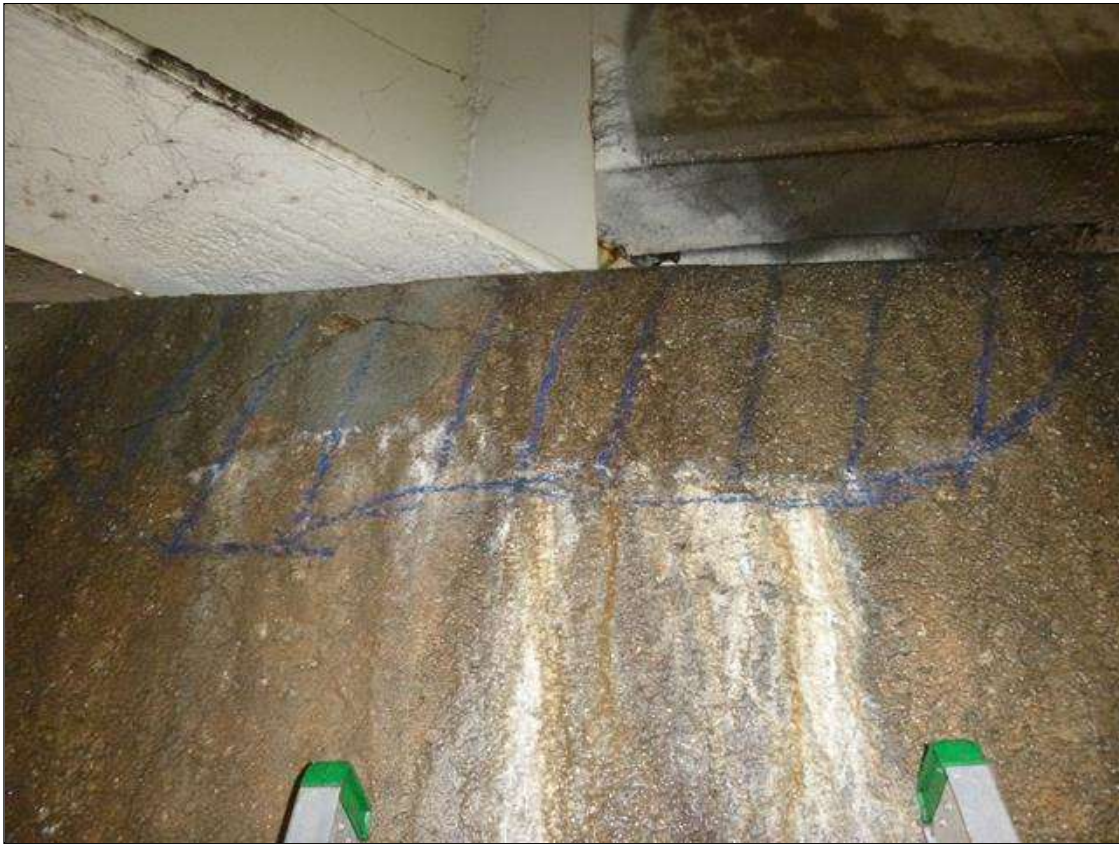
Bent 1 Cap 1: DELAMINATION 3 FT. LONG X 1 FT. HIGH X 3 IN. ON TOP OF CAP ON SPAN 1 SIDE UNDER BEAM 2.

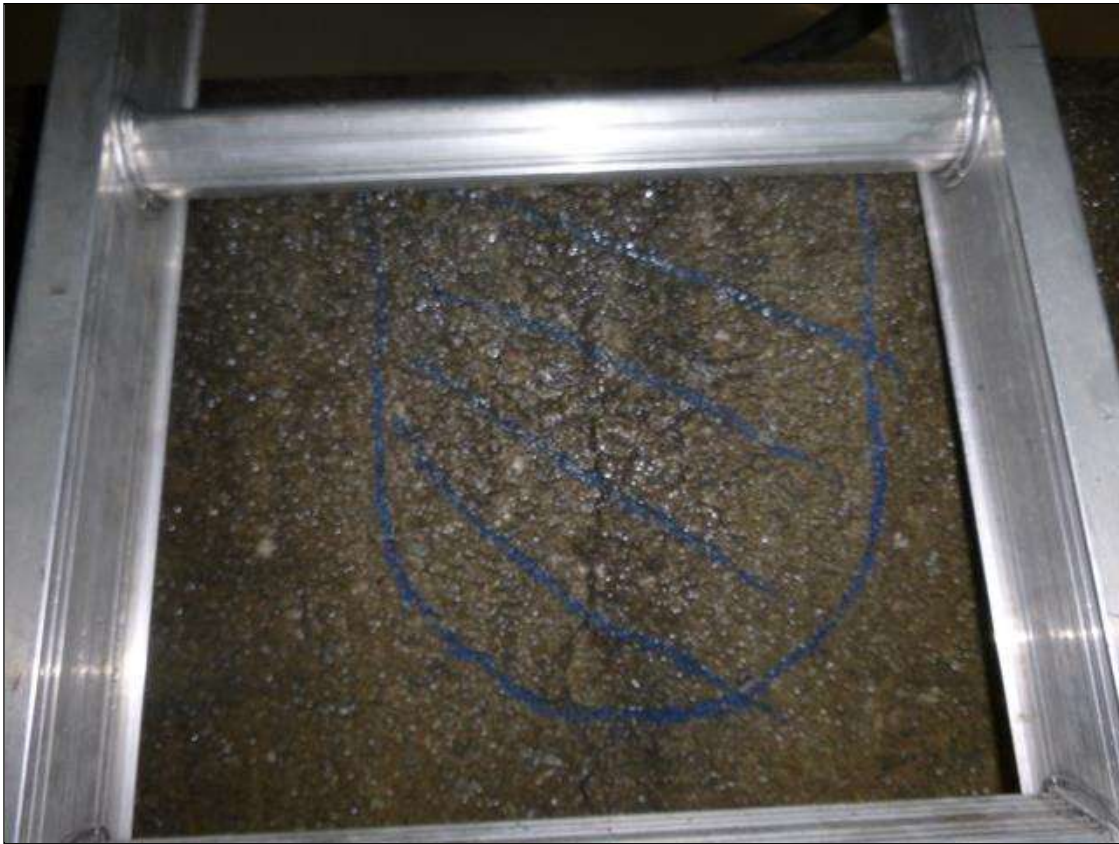
Bent 1 Cap 1: AREA OF DELAMINATION WITH VERTICAL, 1/16 IN. WIDE CRACKING IN BAY 2, SPAN 1 SIDE, NEAR TOP OF CAP.

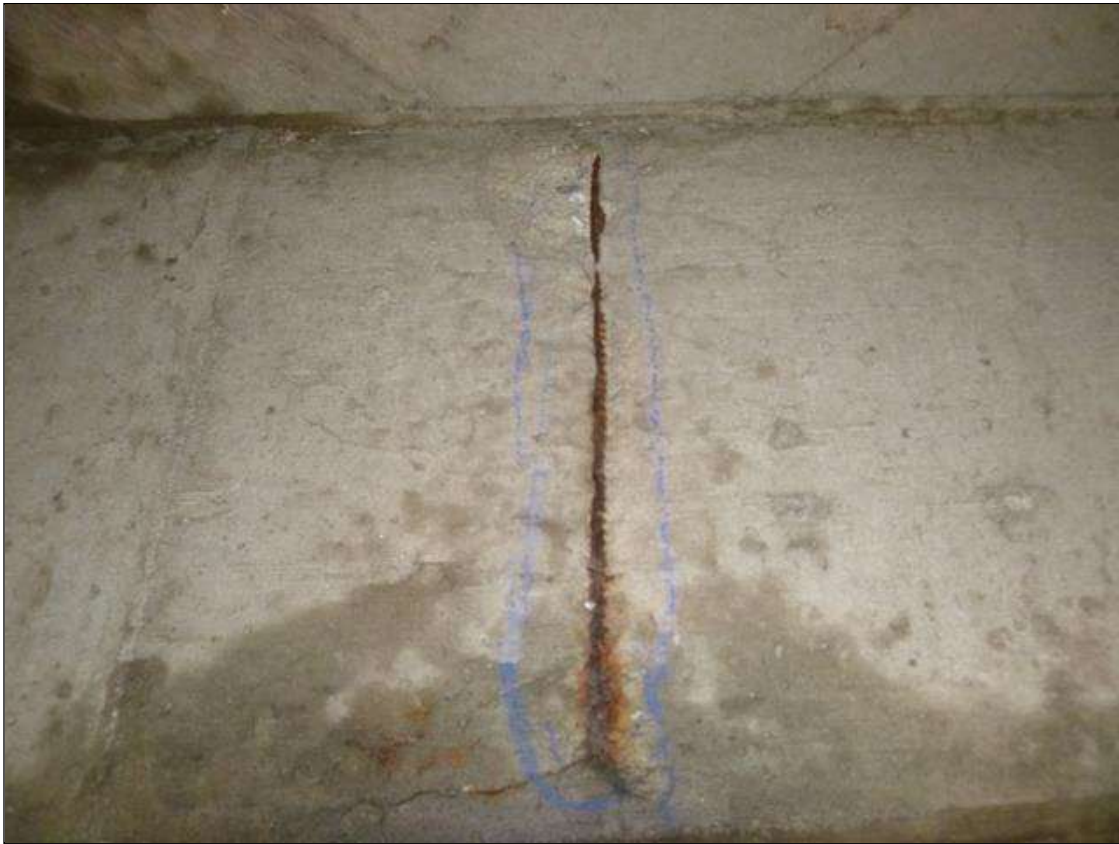
SPAN 1 BENT 1 BAY 2 DIAPHRAGM, SPALL, 3 IN. WIDE X 2 FT. TALL X 1/2 IN. DEEP WITH EXPOSED REBAR

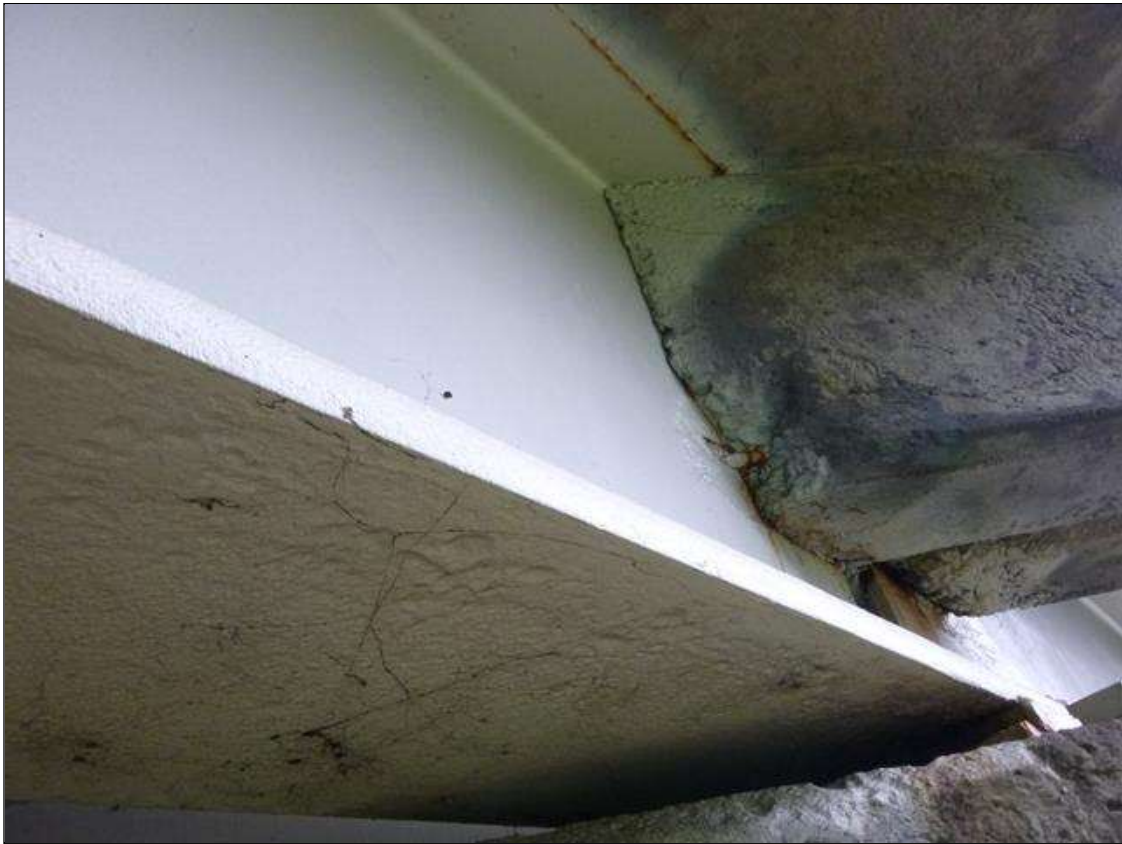
Span 1 Beam 4: SECTION LOSS FROM PREVIOUS RUST OF UP TO 3/16 IN. ON THE BOTTOM FLANGE AND ON WEB NEAR DIAPHRAGM. BEAM HAS BEEN CLEANED AND PAINTED.

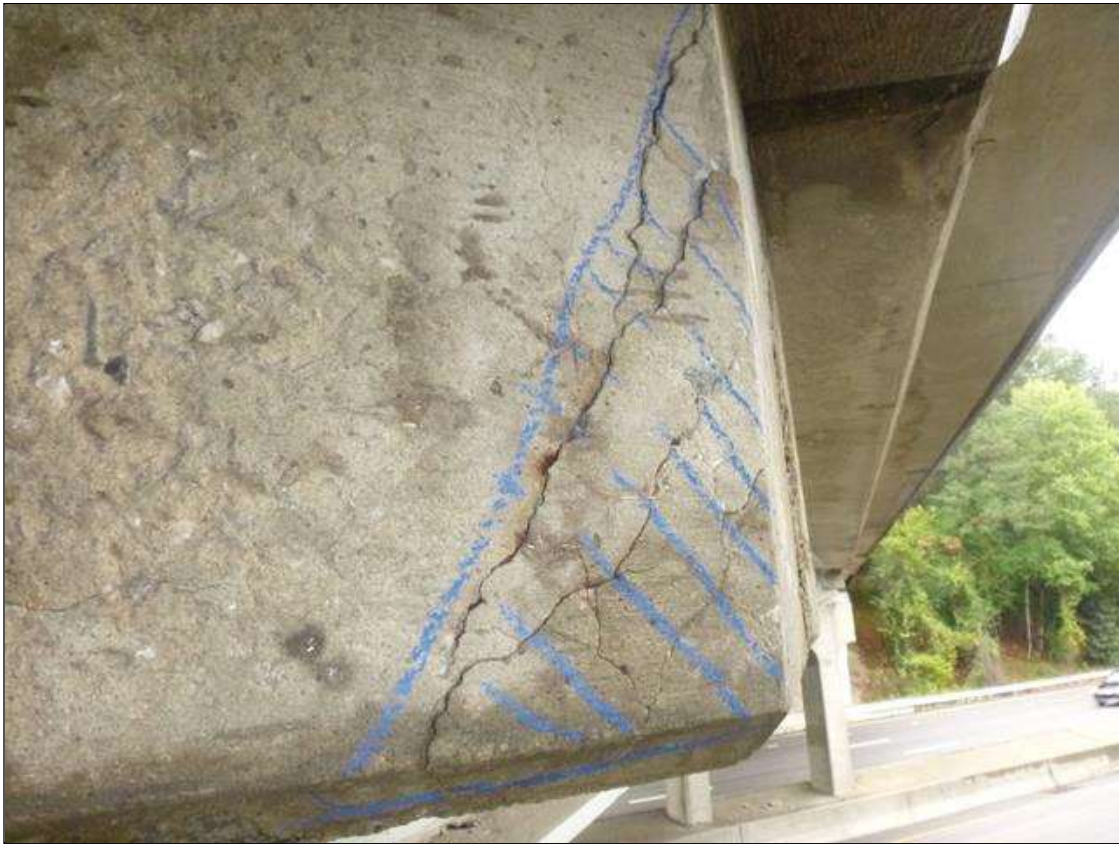
SPAN 1 BENT 1 RIGHT OVERHANG DIAPHRAGM, AREA OF DELAMINATION, 18 IN. HIGH X 8 IN. WIDE AT END OF DIAPHRAGM

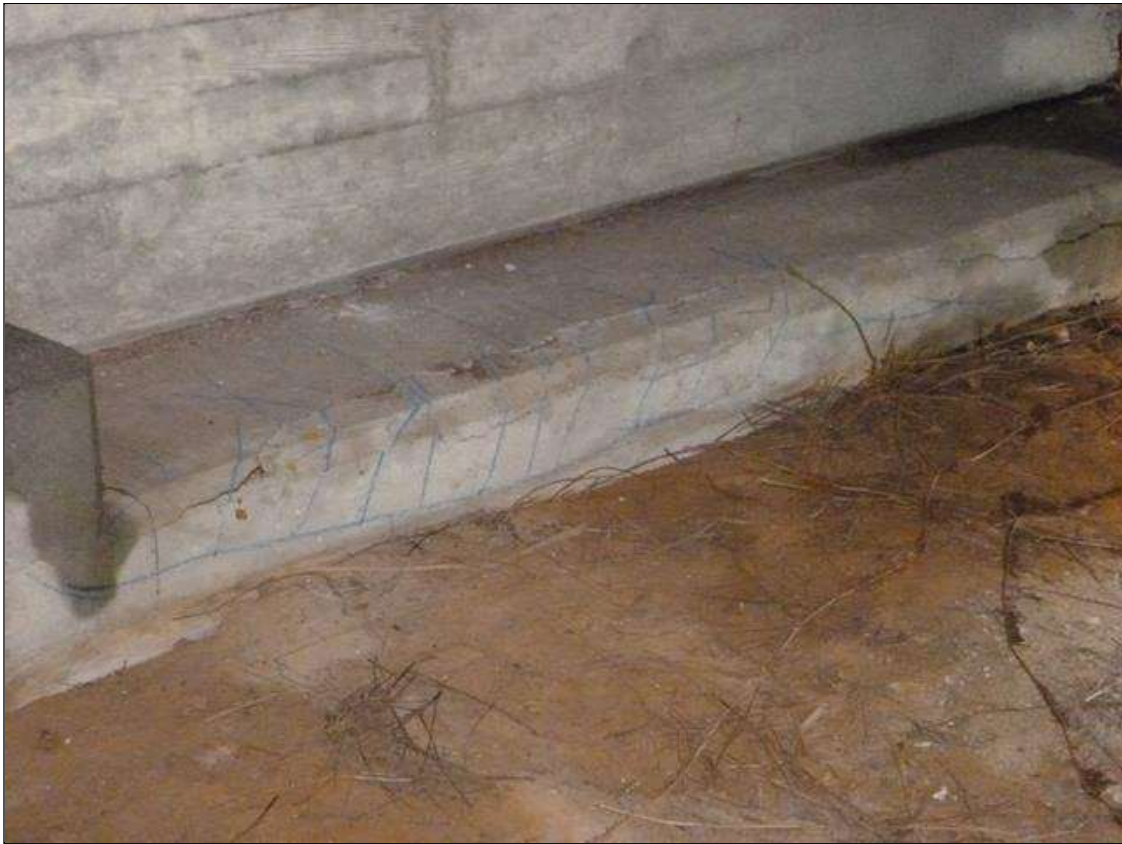
End Bent 1 Cap 1: DELAMINATION IN BAY 1, 10 FT. LONG X 8 IN. HIGH X 18 IN. ON TOP, WITH ADJACENT 1/4 IN. CRACK ALONG THE LENGTH.

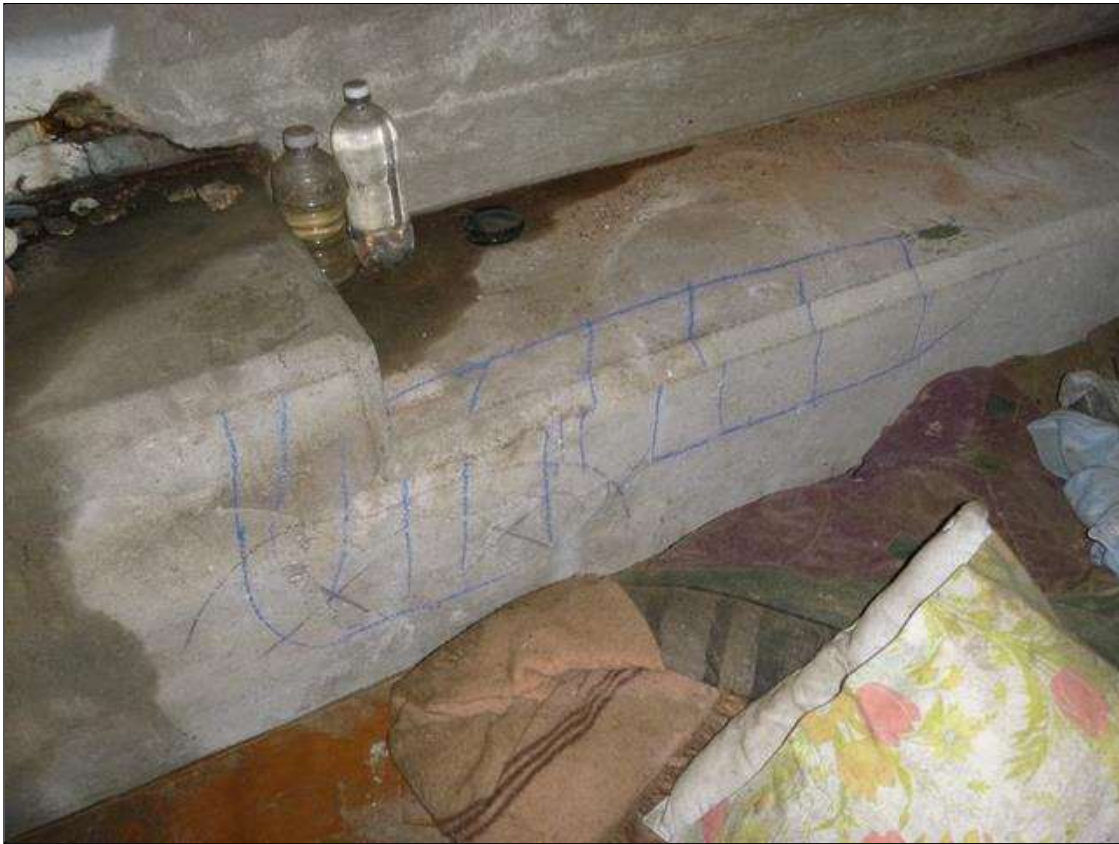
End Bent 1 Cap 1: DELAMINATION IN BAY 2, 4 FT. LONG X 12 IN. HIGH X 4 IN. ON TOP, WITH ADJACENT 1/16 IN. CRACK ALONG THE LENGTH.

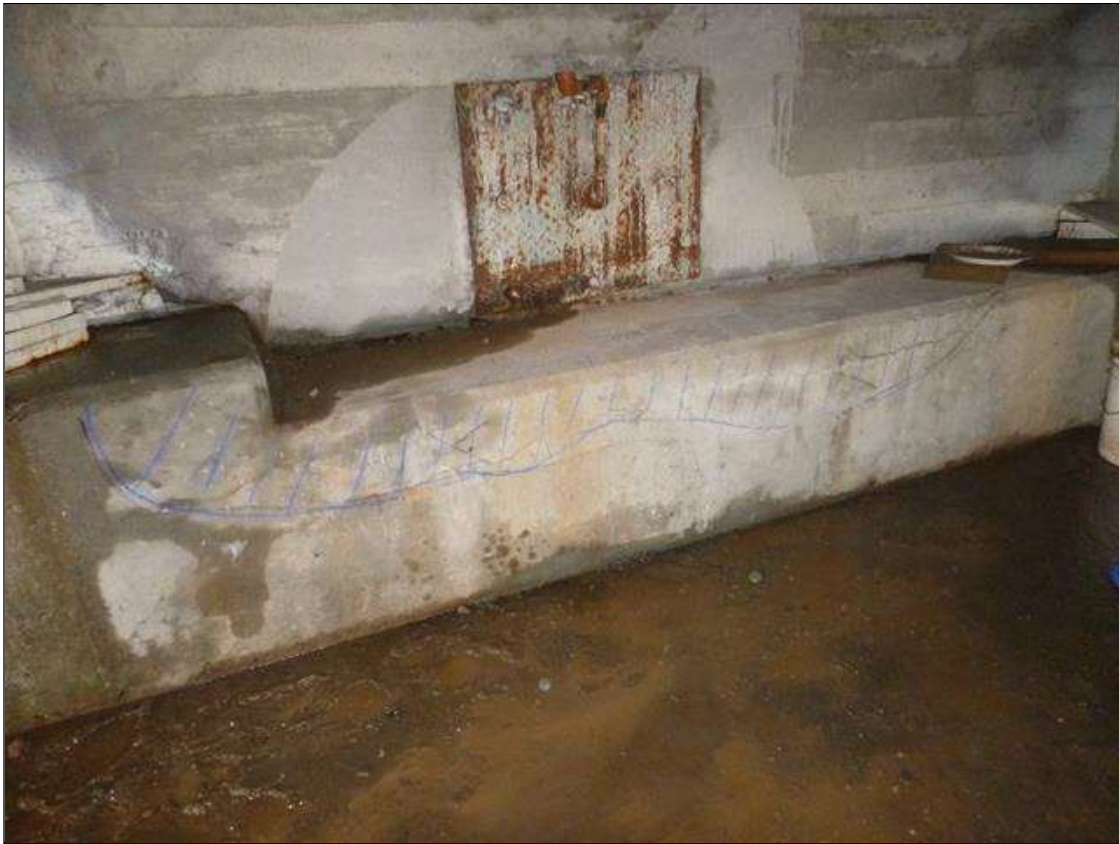
End Bent 1 Cap 1: DELAMINATION IN BAY 3, 7 FT. LONG X 12 IN. HIGH X 12 IN. ON TOP, WITH ADJACENT 1/4 IN. CRACK ALONG THE LENGTH.

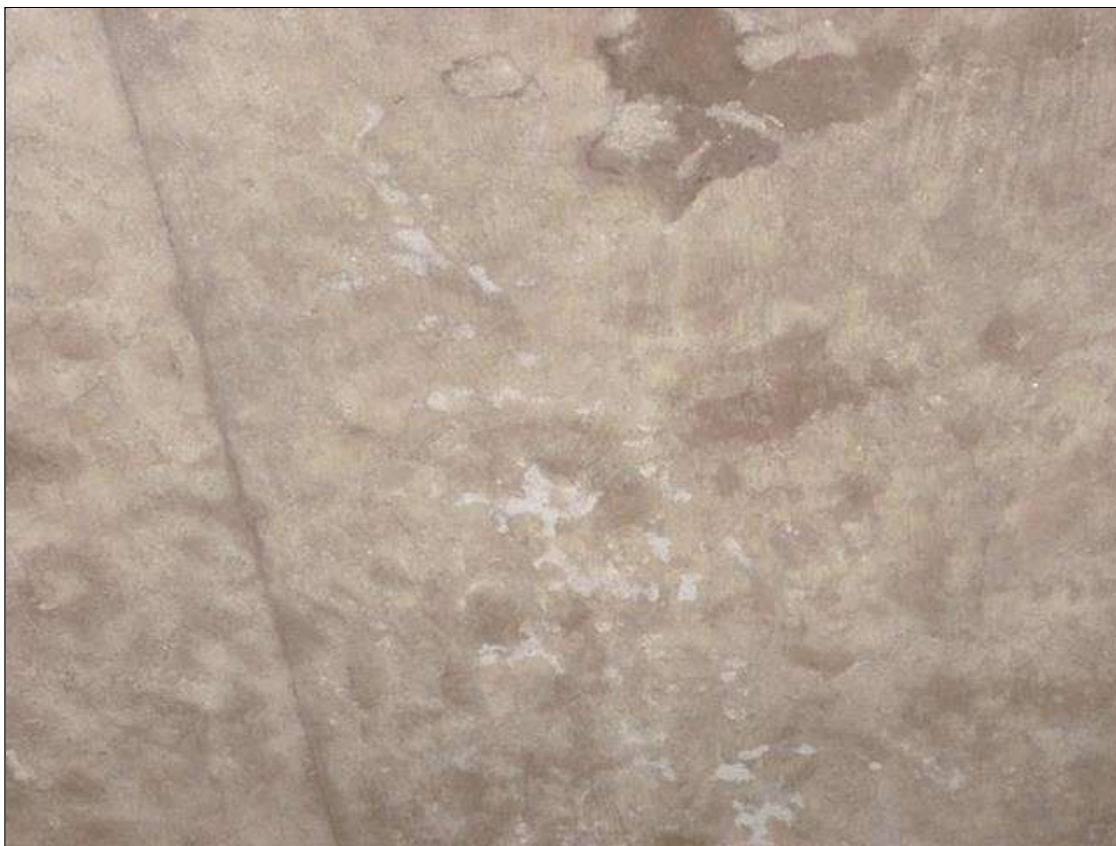
| Element Number | Defect Type | Defect Description | CS | CS Qty | Maint Qty | |
|---|---|---|---|---|---|---|
| 12 | Cracking (RC and Other) | MAP CRACKING ON BOTTOM OF DECK IN BAYS 1,2, AND 3 LESS THAN 6 IN. SPACING THROUGH OUT SPAN. | 3 | 600 | 600 | Square Feet |

Span 1 Deck: MAP CRACKING ON BOTTOM OF DECK IN BAYS 1,2, AND 3 LESS THAN 6 IN. SPACING THROUGH OUT SPAN.

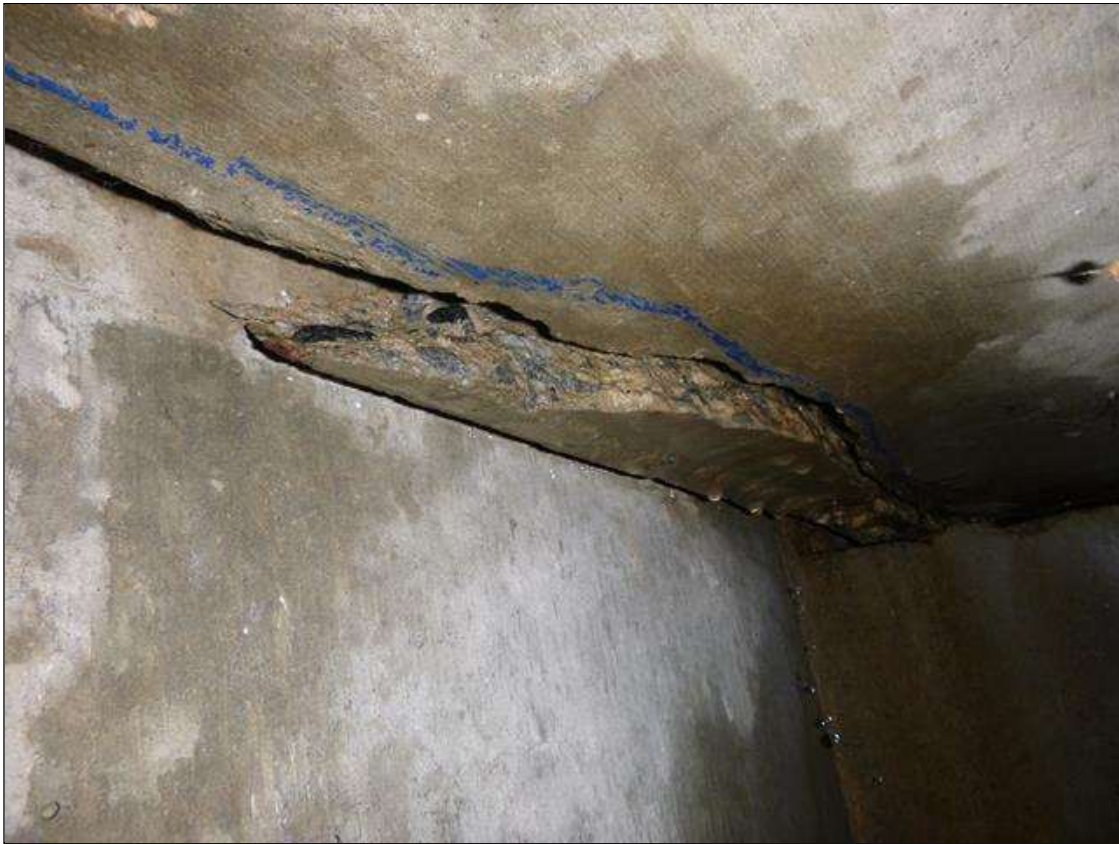
| Element Number | Defect Type | Defect Description | CS | CS Qty | Maint Qty | |
|---|---|---|---|---|---|---|
| 12 | Delamination/Spall | SPALL IN RIGHT OVERHANG NEAR END BENT 1 20 IN. LONG X 4 IN. WIDE . | 3 | 2 | 2 | Square Feet |

Span 1 Deck: SPALL IN RIGHT OVERHANG NEAR END BENT 1, 20 IN. LONG X 4 IN. WIDE .
