NC DEPARTMENT OF TRANSPORTATION  
DIVISION OF HIGHWAYS  
STRUCTURE MANAGEMENT UNIT

## Structure Safety Report

### Routine Element Inspection - Contract

COUNTY: WAKE STRUCTURE NUMBER: 910260 FREQUENCY: 24 MONTHS  
FACILITY CARRIED: I440 MILE POST: 6.5  
LOCATION: 1.88 MI.N.E.SR1676  
FEATURE INTERSECTED: US70  
LATITUDE: 35° 50' 7.05" LONGITUDE: 78° 40' 10.1"  
SUPERSTRUCTURE: RC FLOOR/I-BEAMS(WIDENED)  
SUBSTRUCTURE: EBTS:RC CAP/PRESTR.CONC.PILES;BTS:RCP&B/PILE FTGS.  
SPANS: 2@67';1@70'6;1@45'  
☐ FRACTURE CRITICAL ☐ TEMPORARY SHORING ☐ SCOUR CRITICAL ☐ SCOUR PLAN OF ACTION  
PRESENT CONDITION: Fair INSPECTION DATE: 07/12/2016  
POSTED SV: Not Posted POSTED TTST: Not Posted  
OTHER SIGNS PRESENT: None

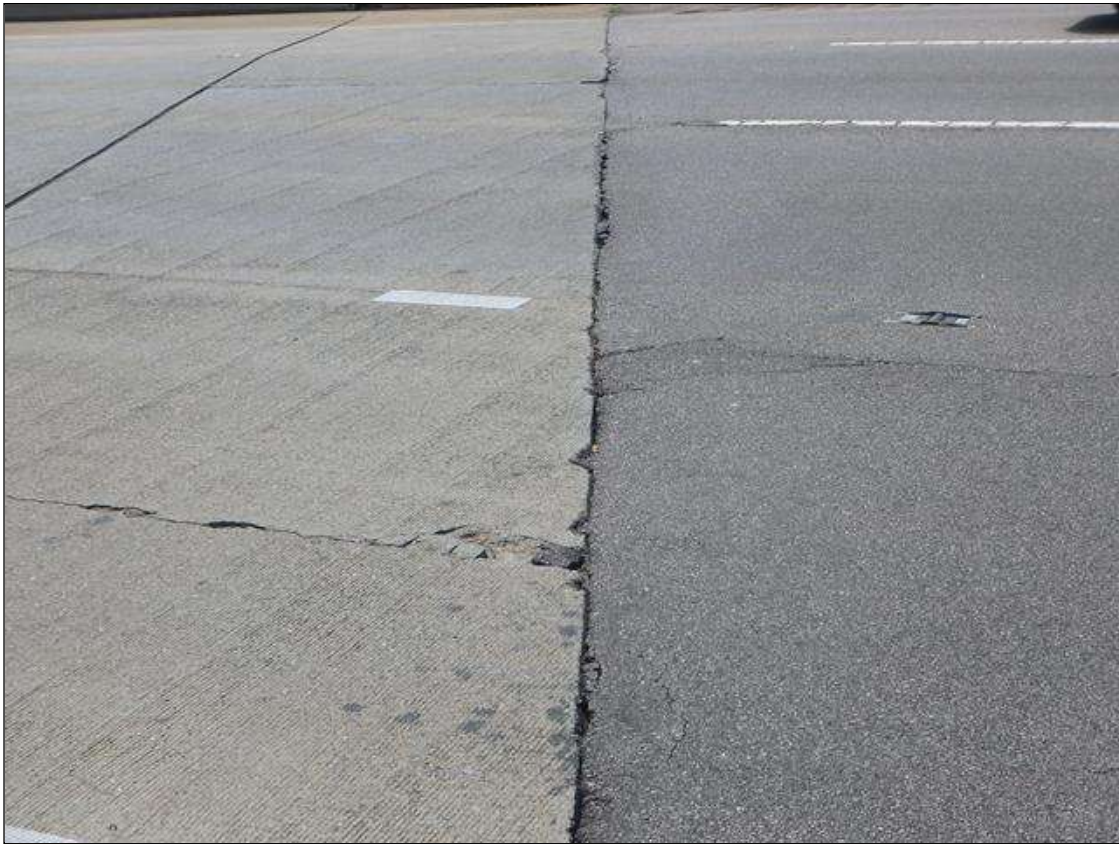
South Approach Roadway (I-440 outer): cracking at the approach slab up to (1 1/2") wide

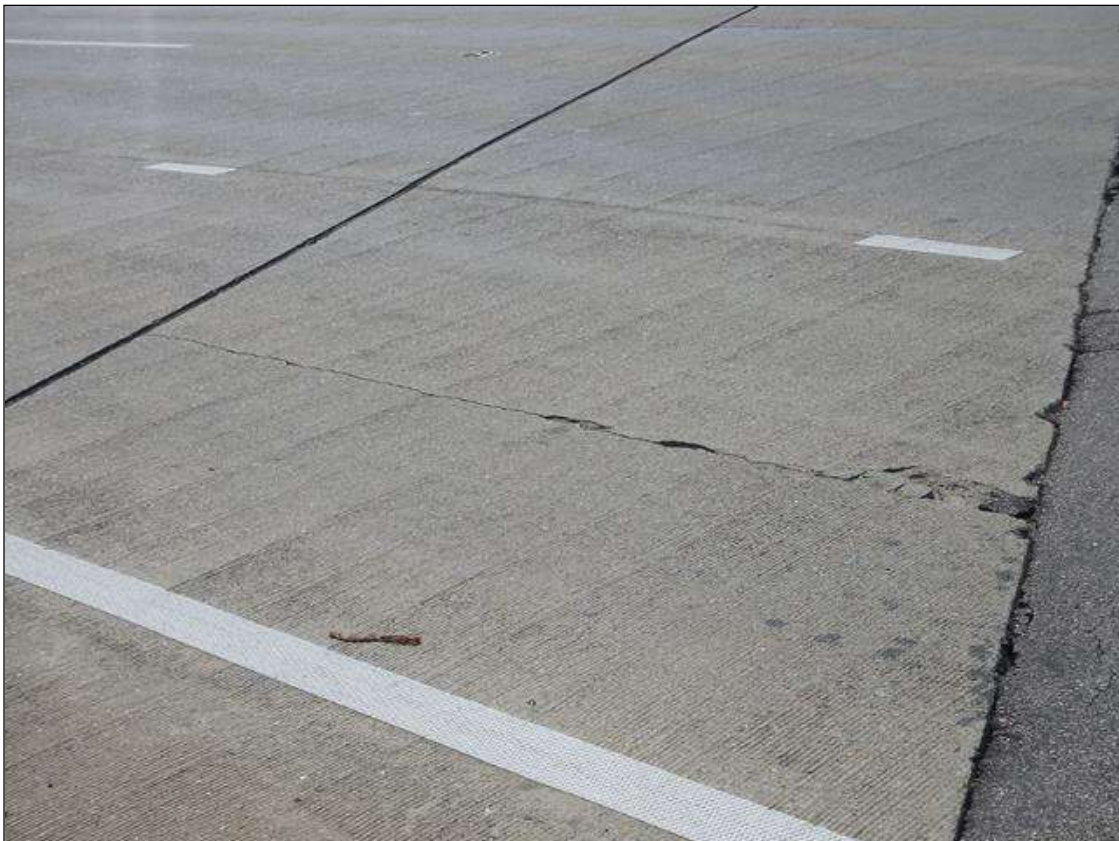
South Approach Slab (I-440 outer): longitudinal cracking up to (1") wide

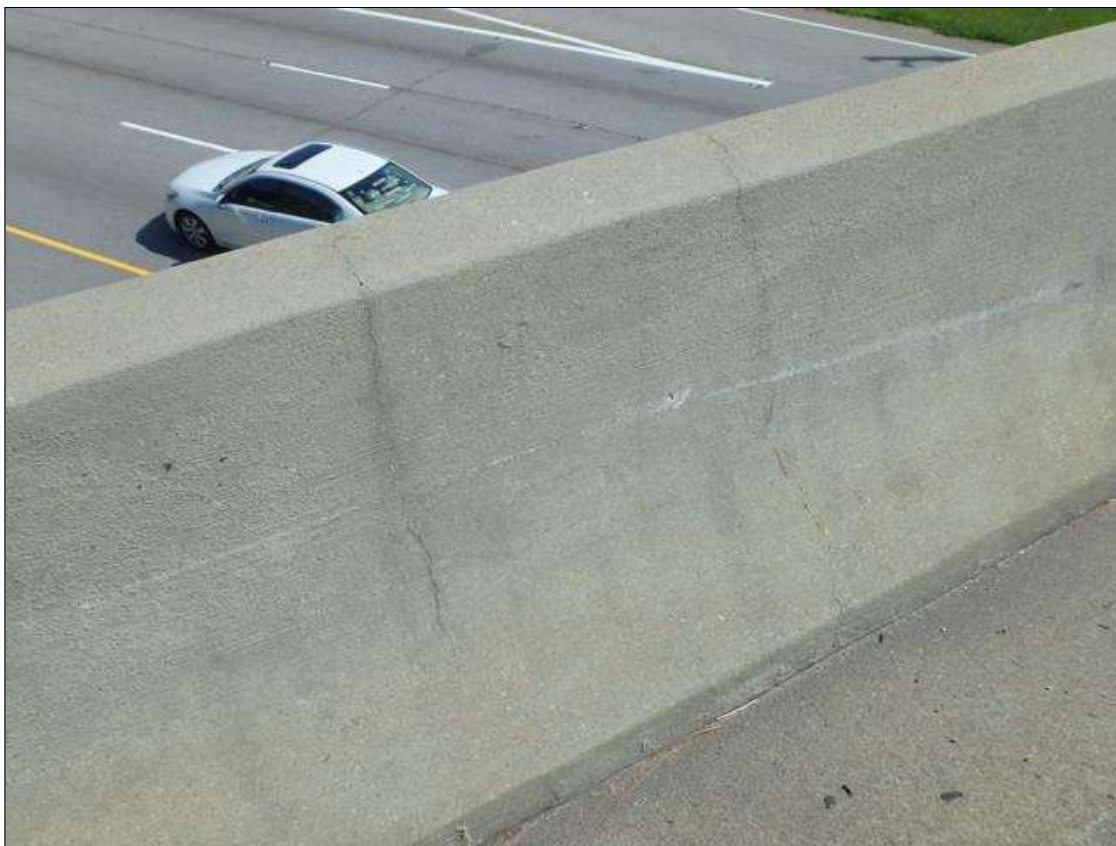
Span 2 Left Rail: vertical cracking up to (1/64") wide with surface efflorescence (similar throughout)

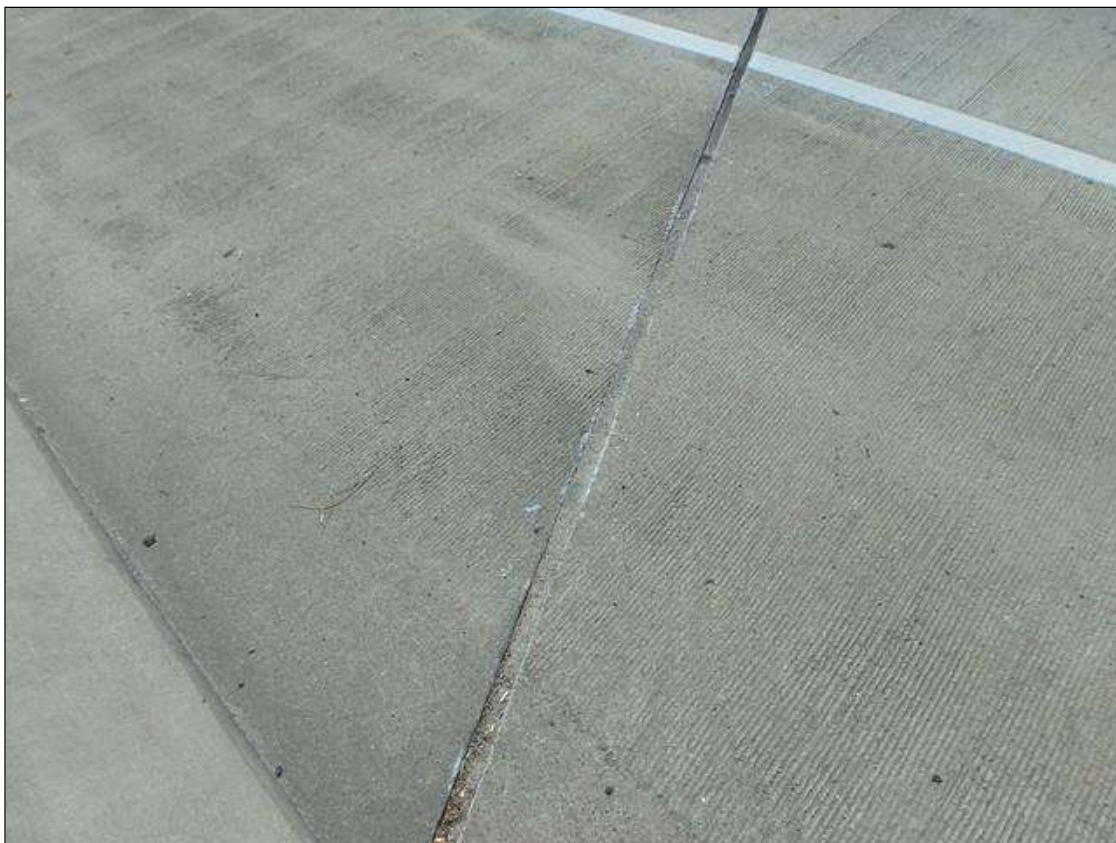
Joint over Bent 3 (I-440 outer): light debris at the joint ends (other joints similar)

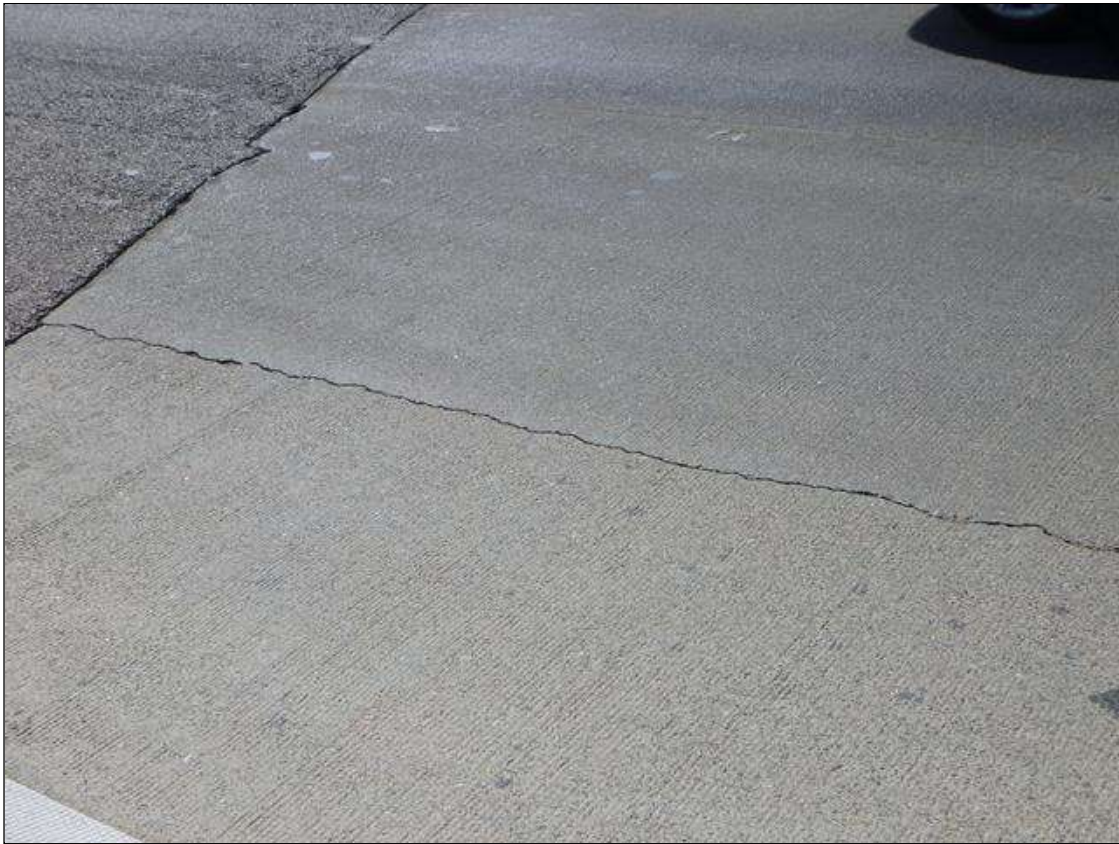
North Approach Slab (I-440 outer): longitudinal cracking up to (1/8") wide

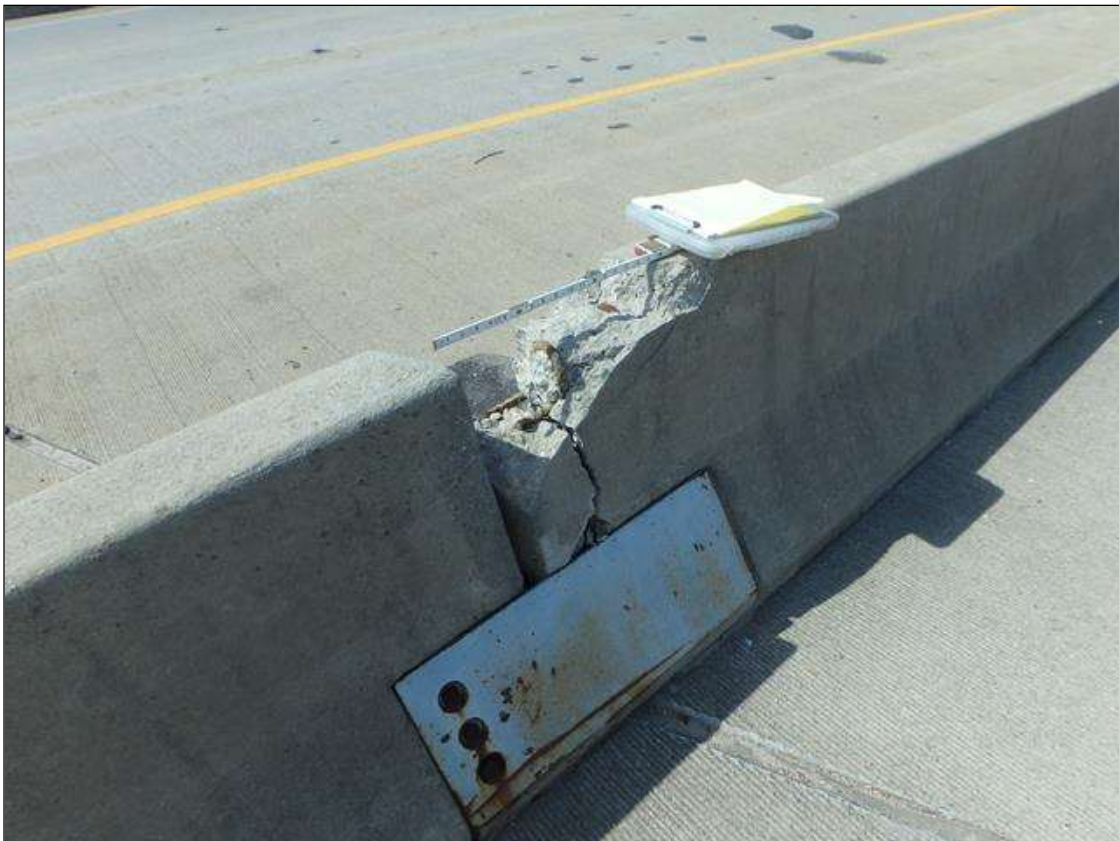
Span 3 Median Rail at Bent 3: delamination and spall with exposed rebar (22" x 20" x 9") (PM)

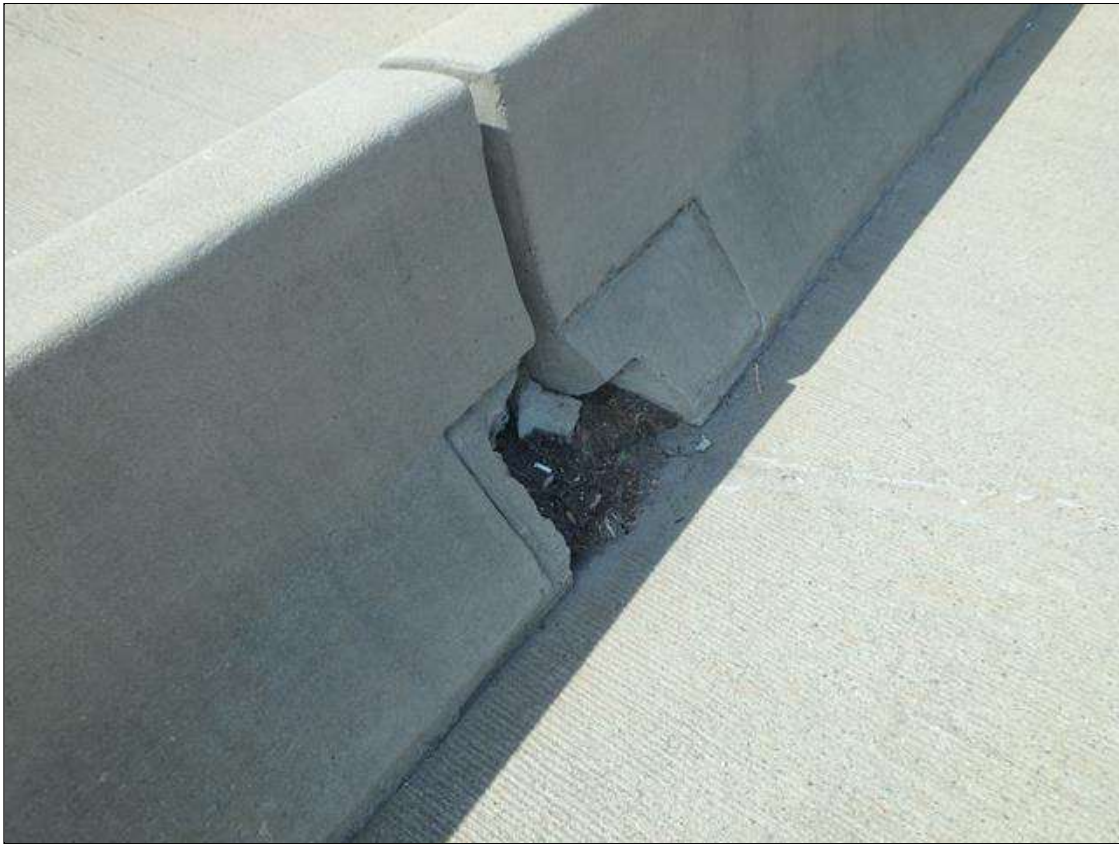
Missing the expansion plate on the left face at end bent 1

Span 1 Median Rail Left Face at End Bent 1: missing plate

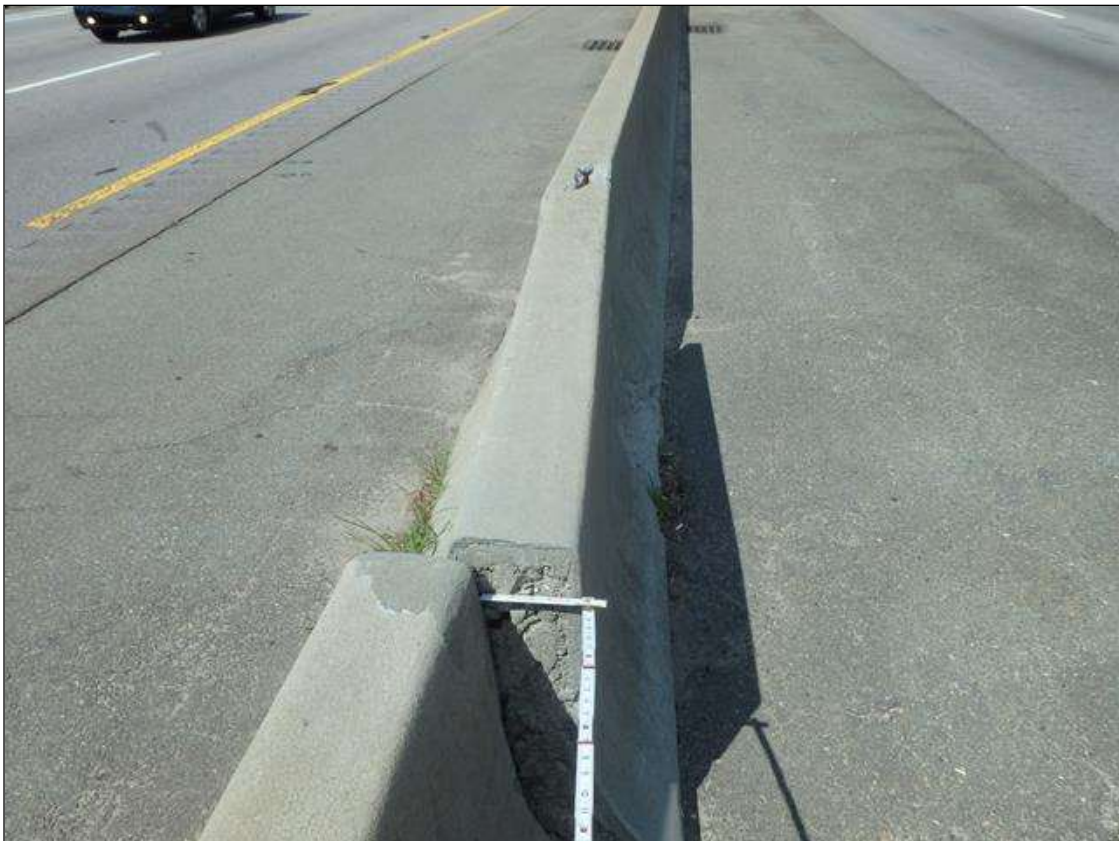
South Approach Median Rail at the approach slab: misaligned 6" toward the outer lanes pointed toward oncoming traffic with impact damage (PM)

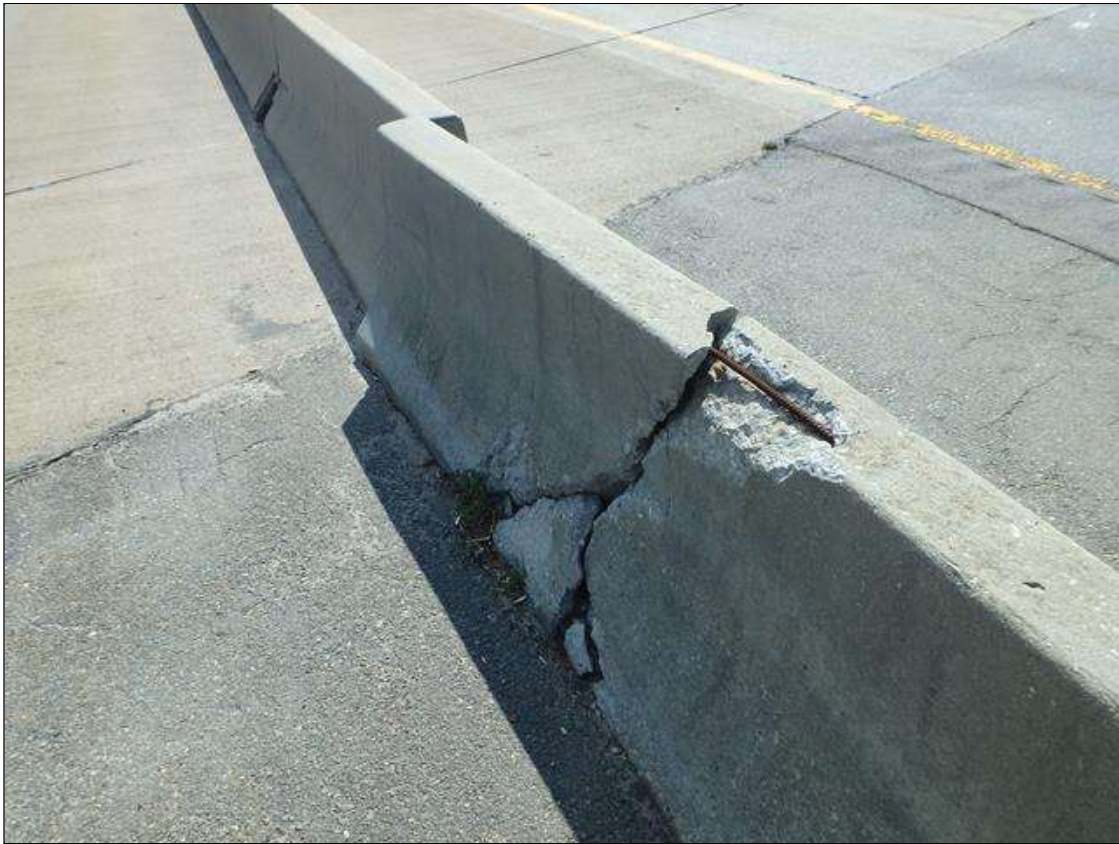
South Approach Median Rail at the approach slab: misaligned 6" toward the outer lanes pointed toward oncoming traffic with impact damage (PM)

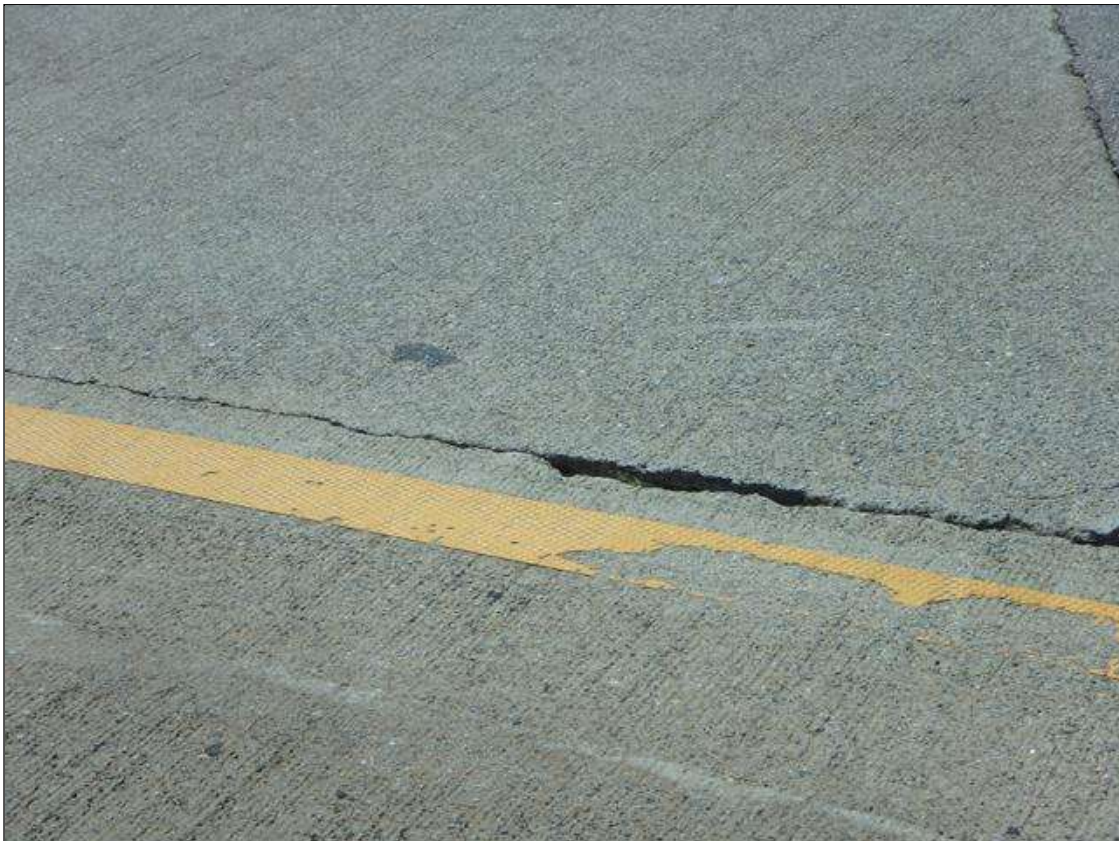
South Approach Slab (I-440 inner): longitudinal cracking up to (1 1/2") wide

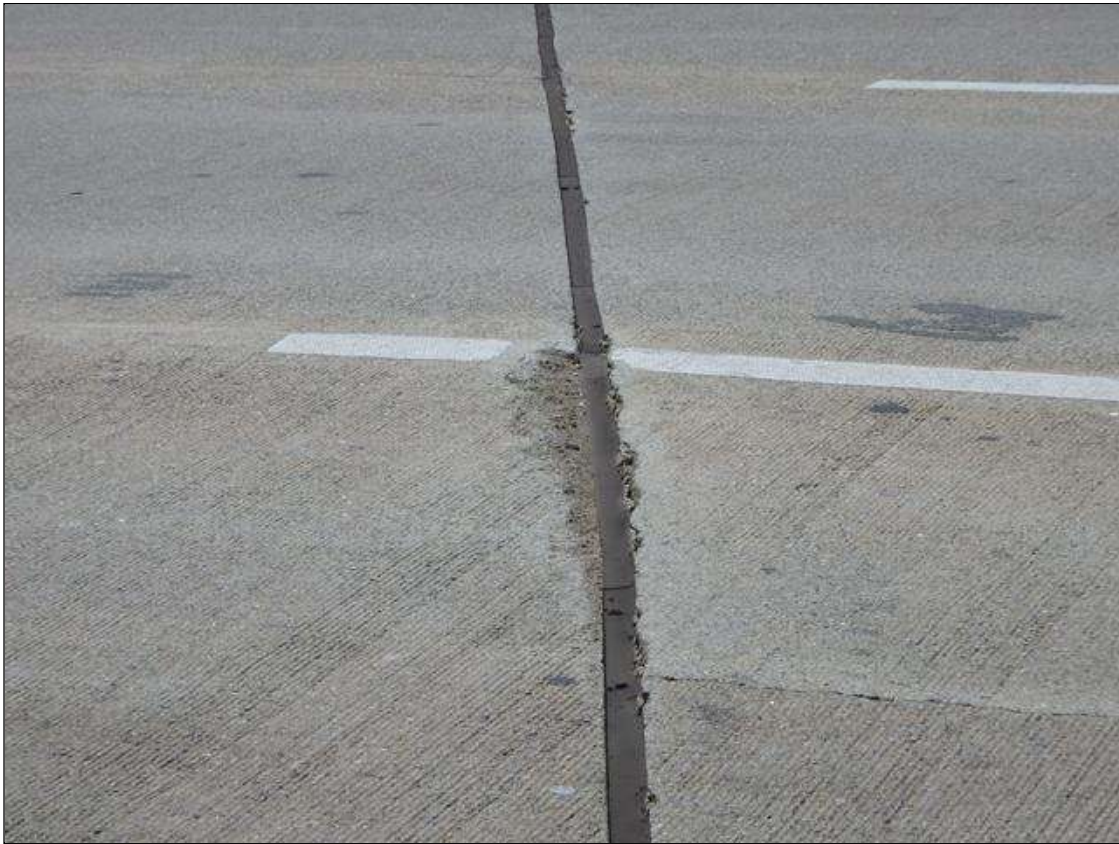
Joint over End Bent 2 (I-440 inner) Left Lane: spall with no exposed steel (60" x 8" x 1 1/2")

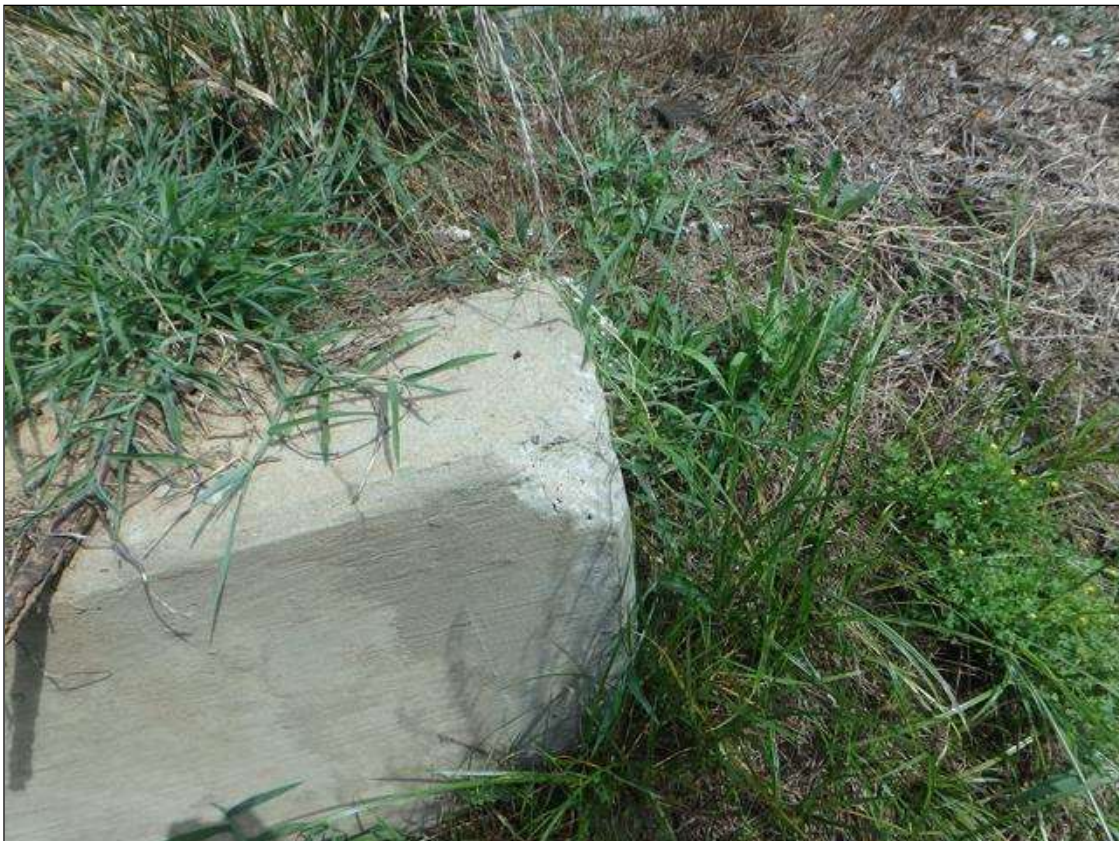
**Details** Northwest Wing Wall: spall with no exposed steel (4" x 3" x 2")

Northwest Wing Wall: spall with no exposed steel (4" x 3" x 2")

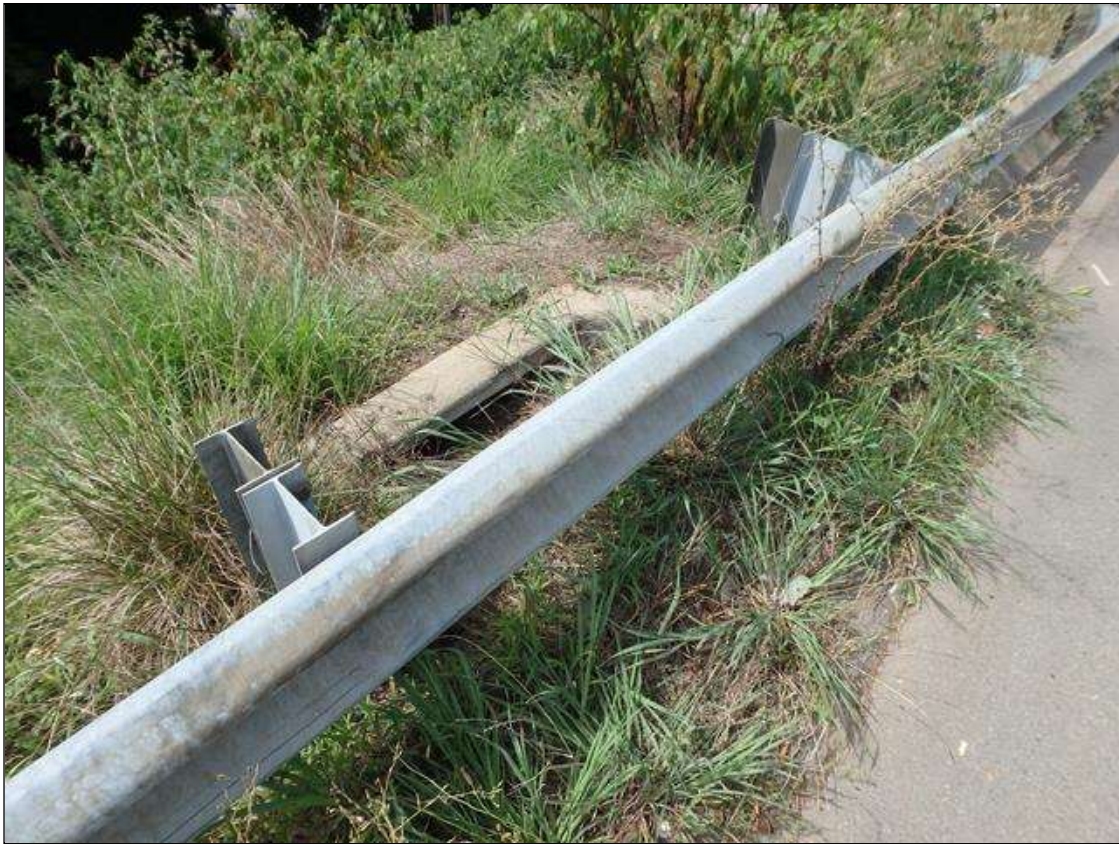
Blocked Catch Basin at the Northeast Approach

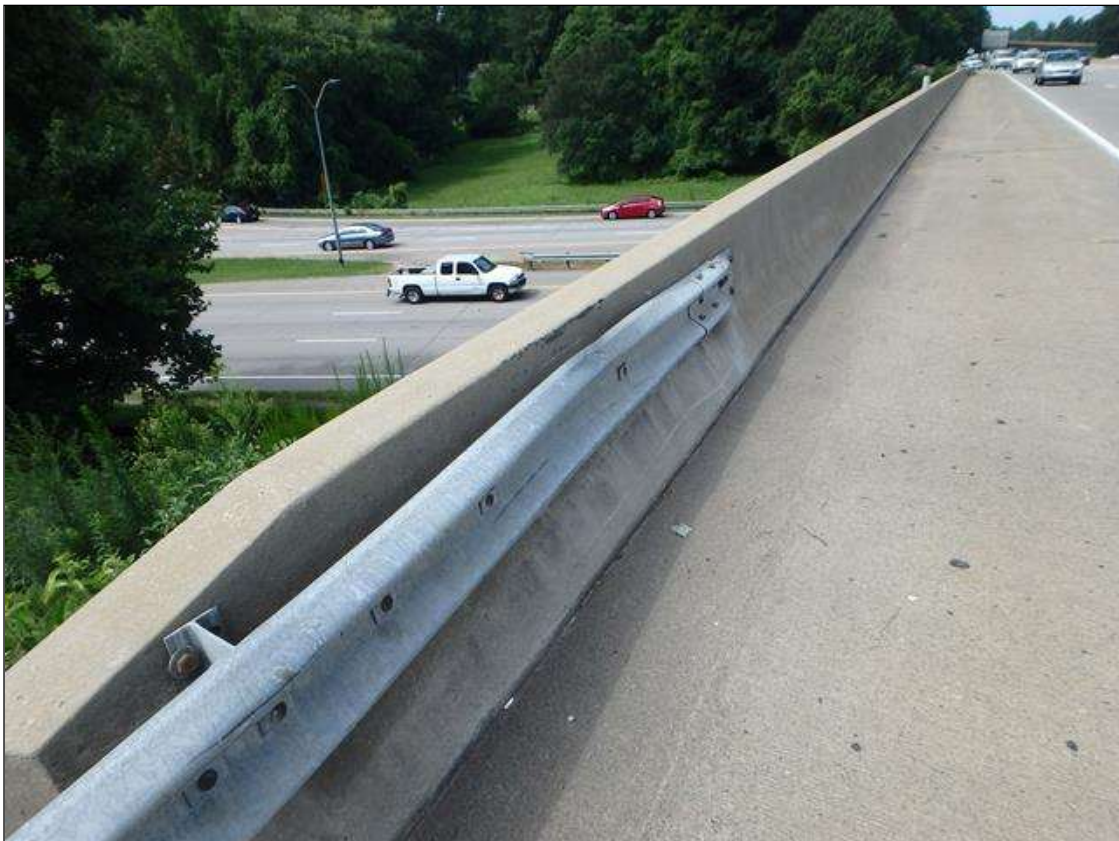
Northeast Transition: impact damage

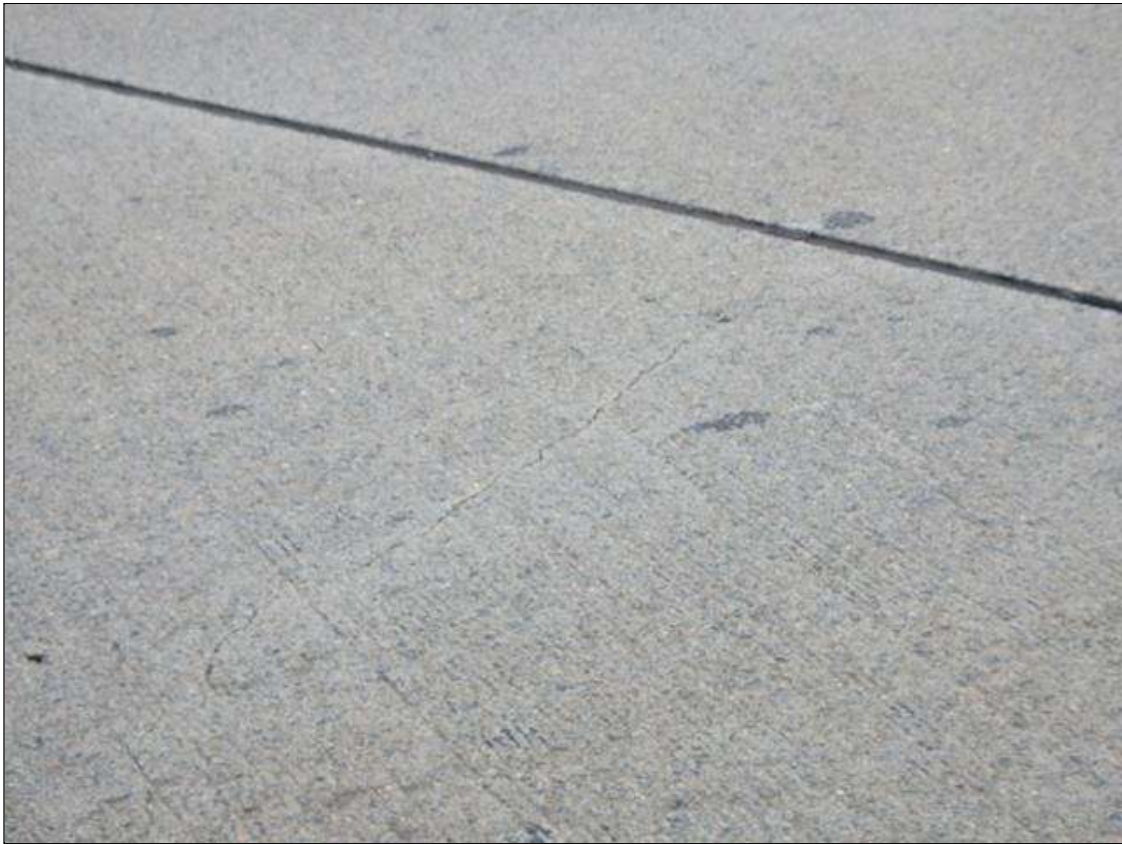
Span 4 Deck Surface (I-440 inner) Right Lane: perpendicular cracking at End Bent 2 up to (1/16") wide (similar throughout)

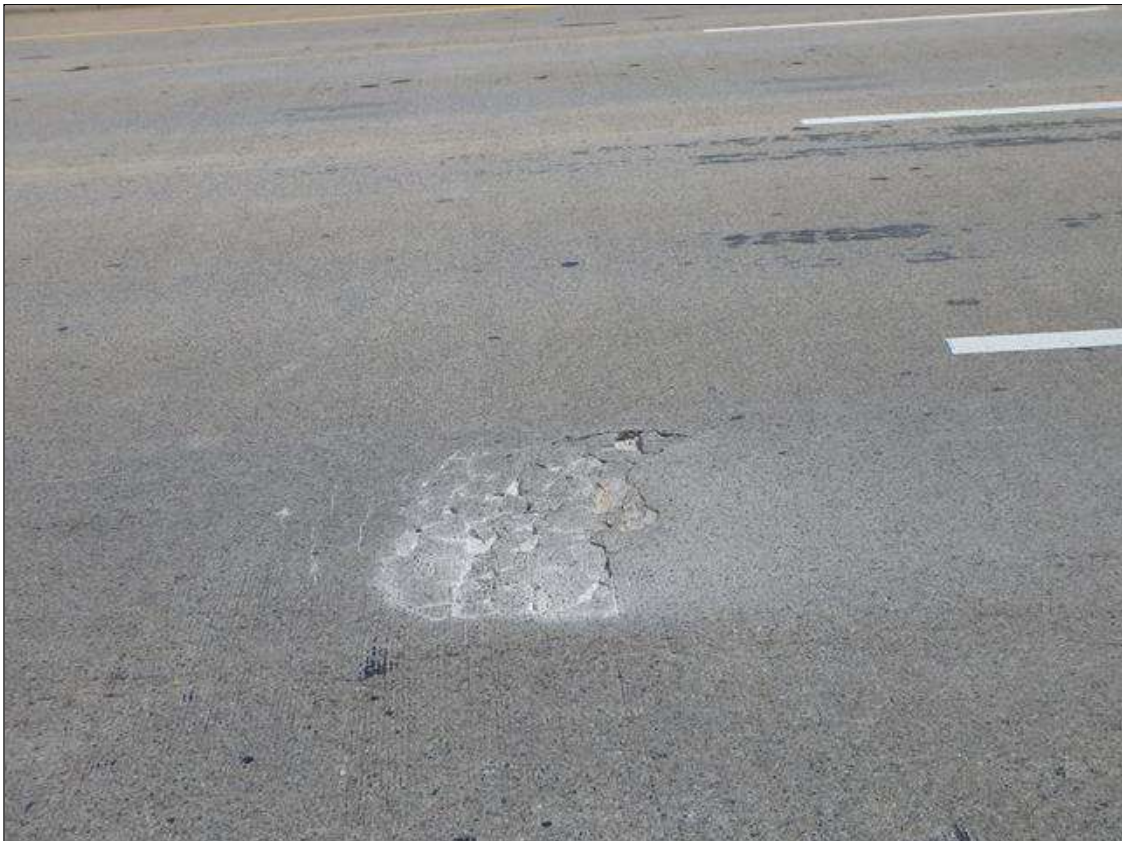
Span 3 Deck Surface (I-440 inner) Right Lane at 9' from Bent 2: deterioration/spall with no exposed steel (36" x 48" x 1 1/2")

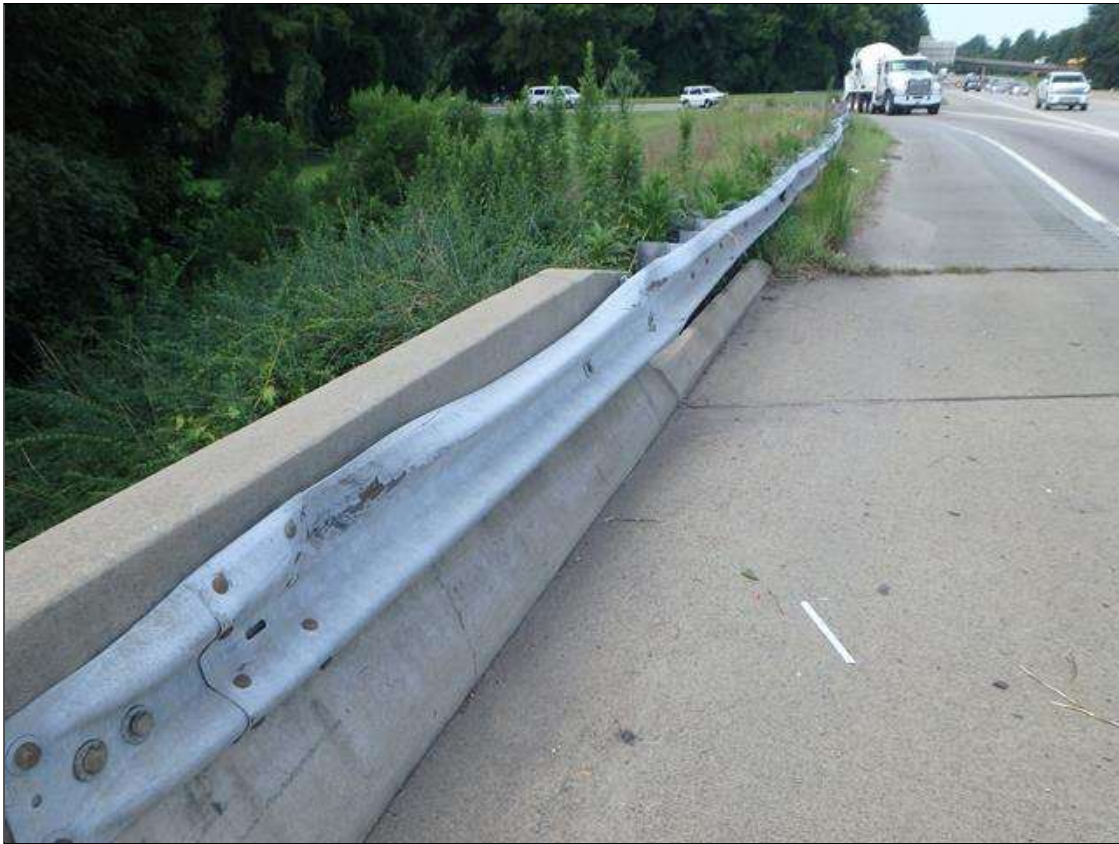
Southeast Transition: multiple areas of impact damage

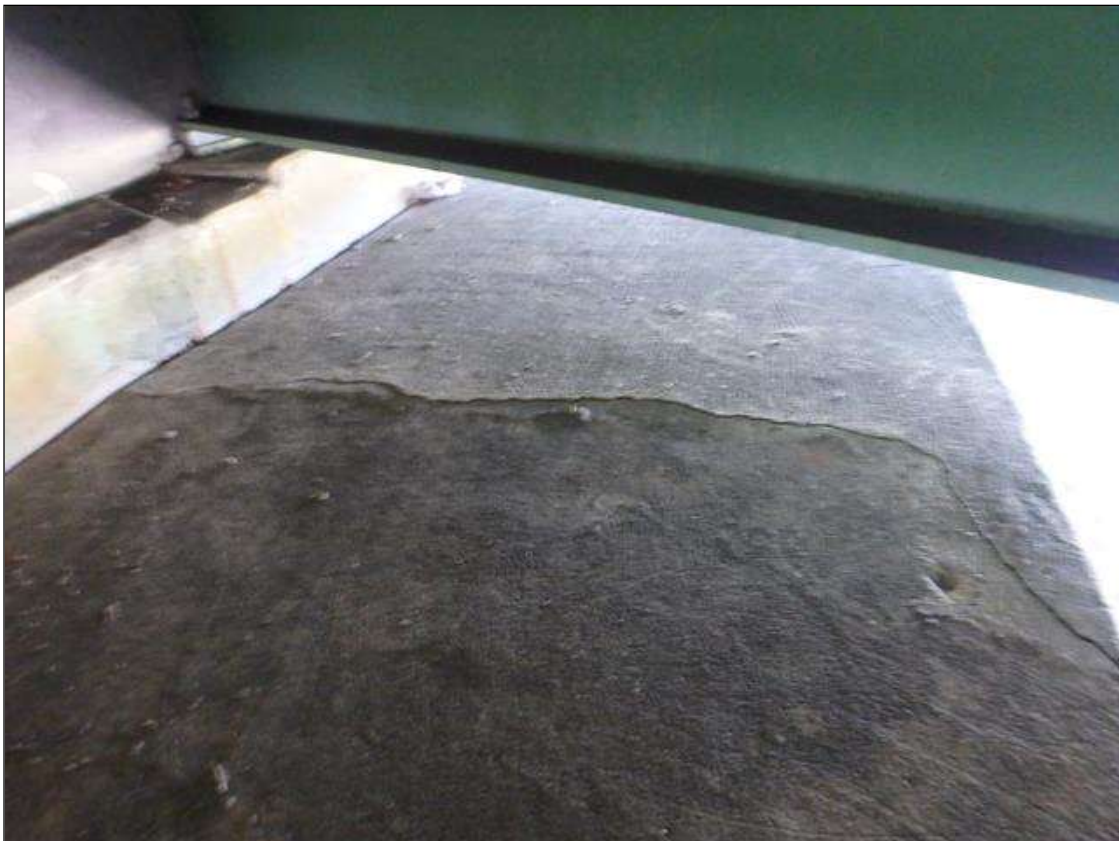
End Bent 1 Slope at top Bay 2: cracking up to (1/8") wide (similar throughout)

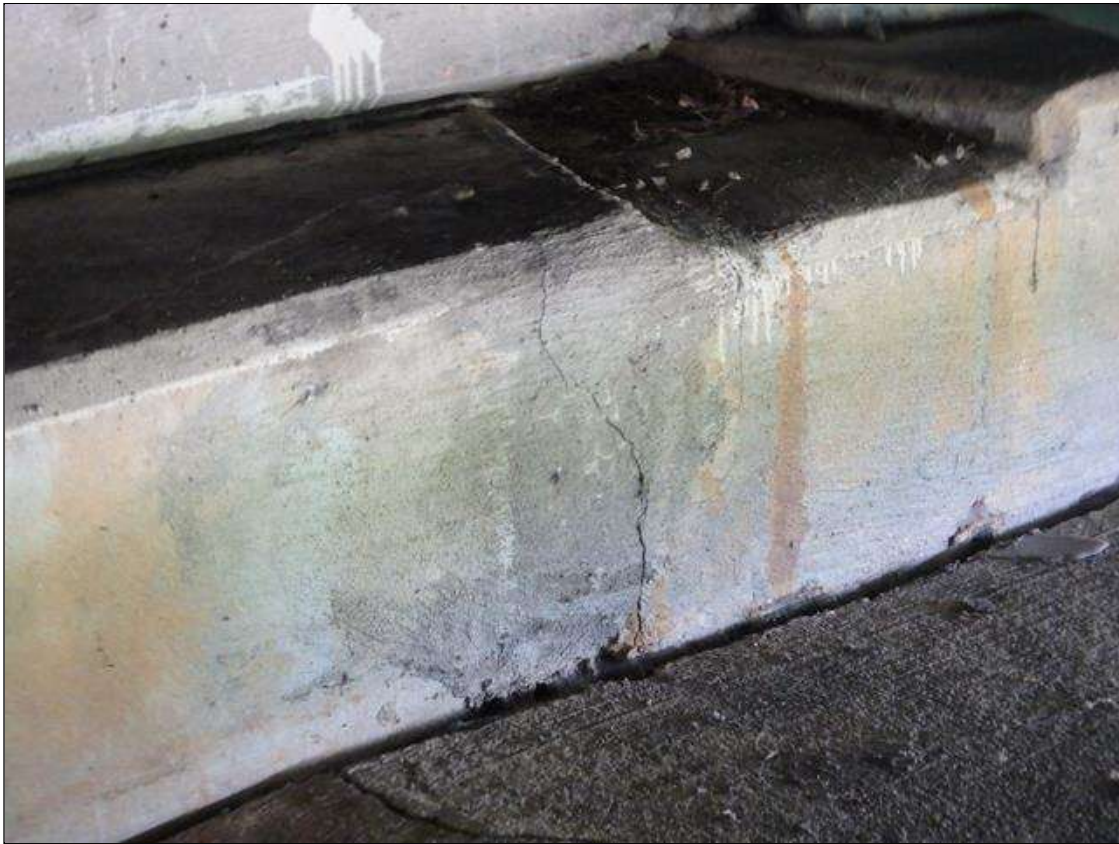
End Bent 1 Cap Bay 2: cracking up to (1/32") wide

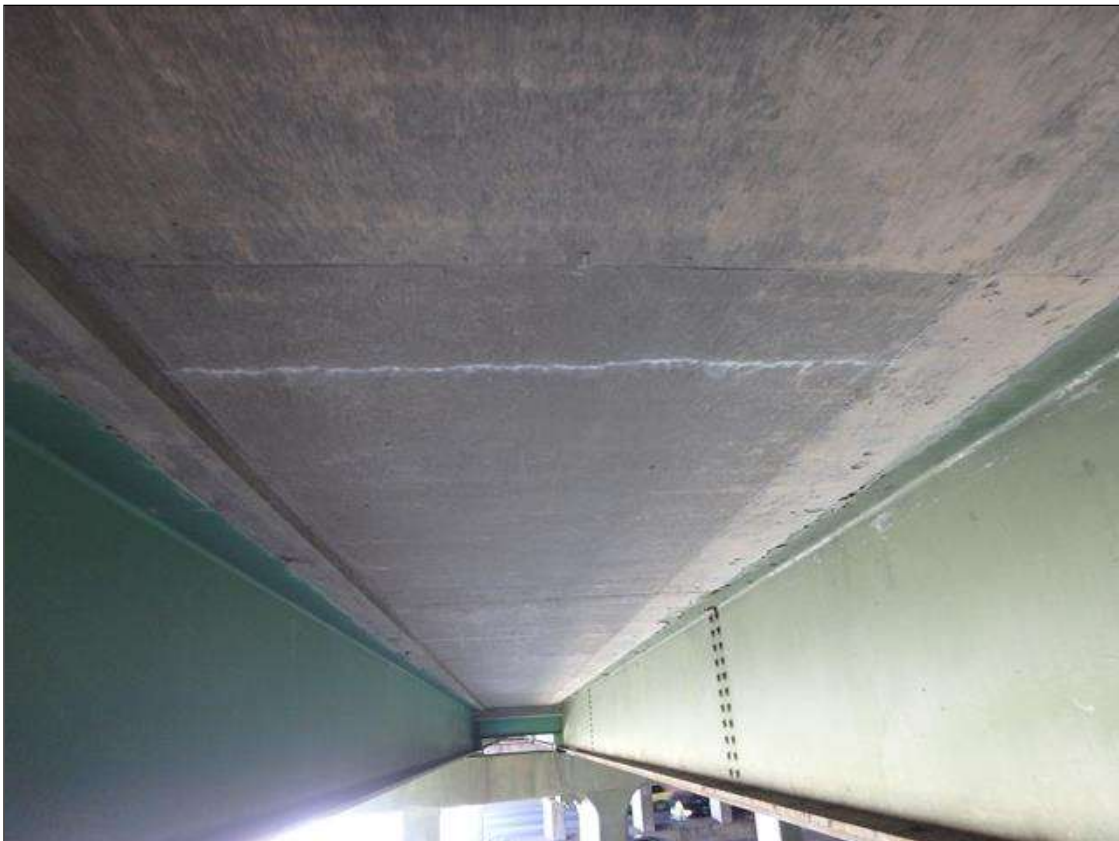
Span 1 Deck Bottom Bay 2: transverse surface efflorescence (similar throughout)

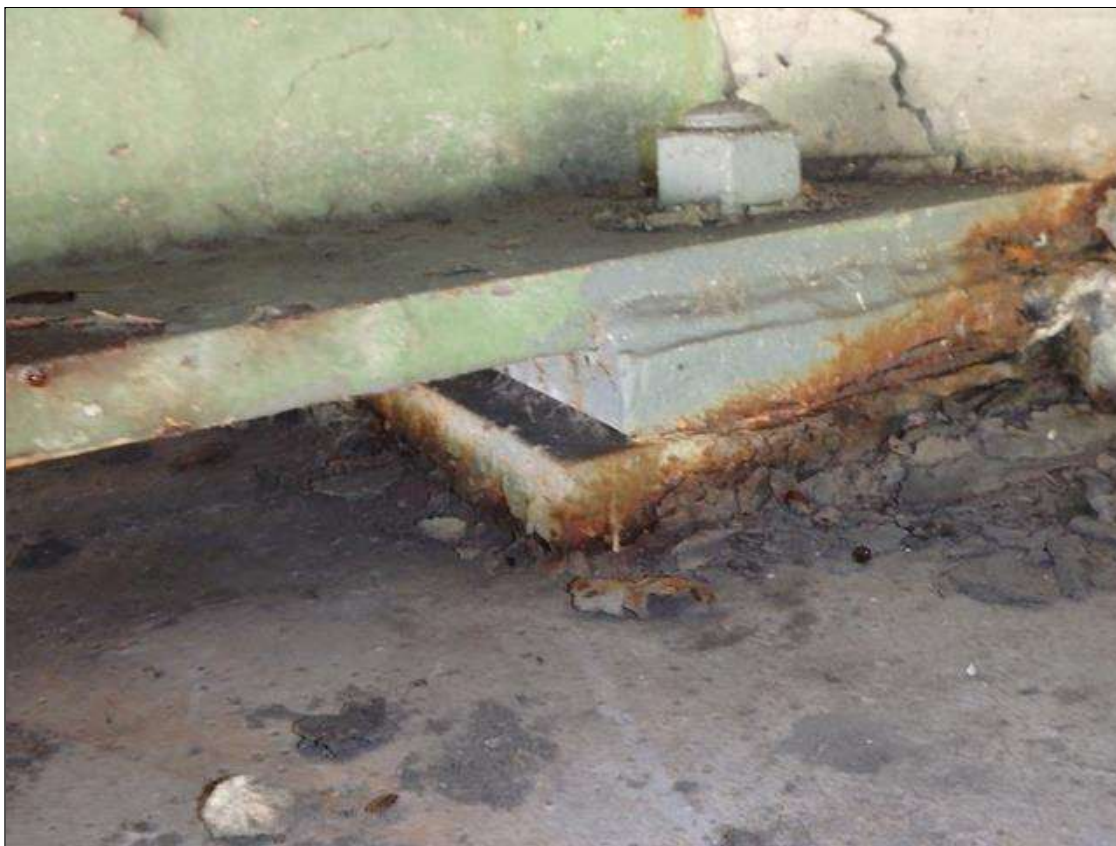
Bearing 3 at End Bent 1: corrosion and scale (other bearings similar)

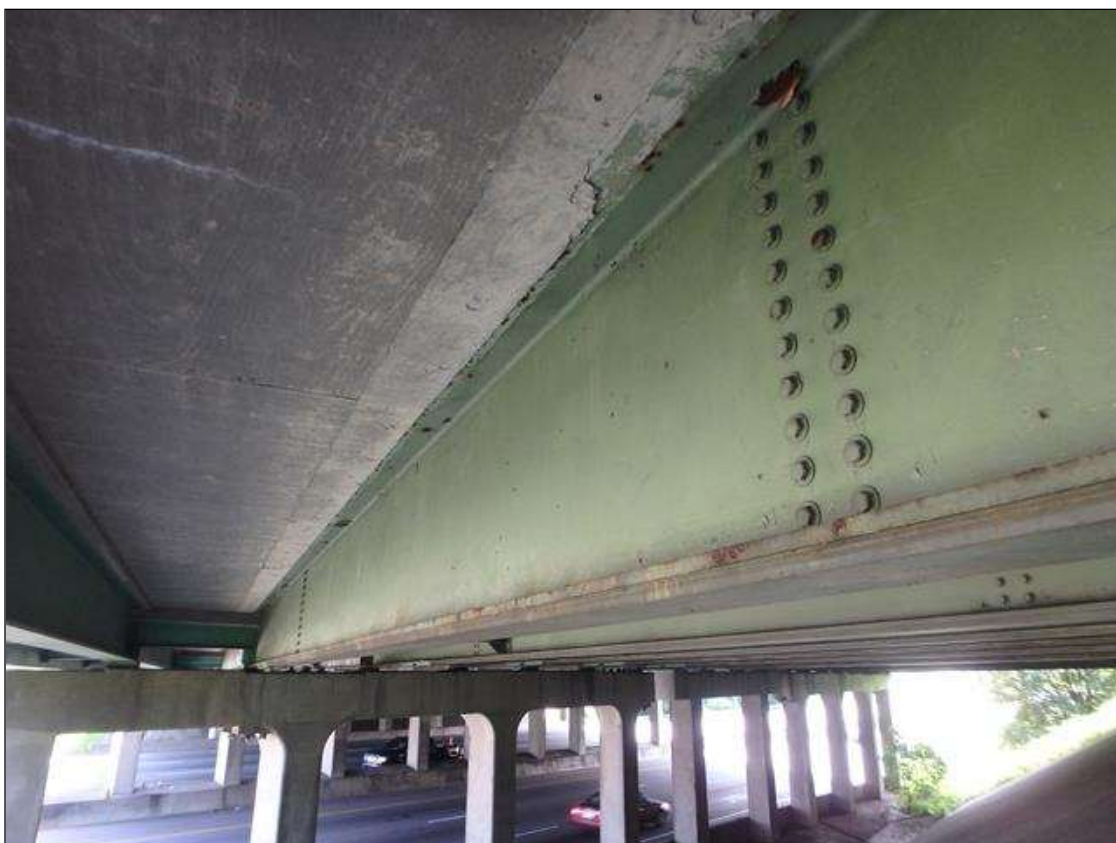
Span 1 Beam 3: surface corrosion on the edges of the flanges and peeling paint (similar throughout)

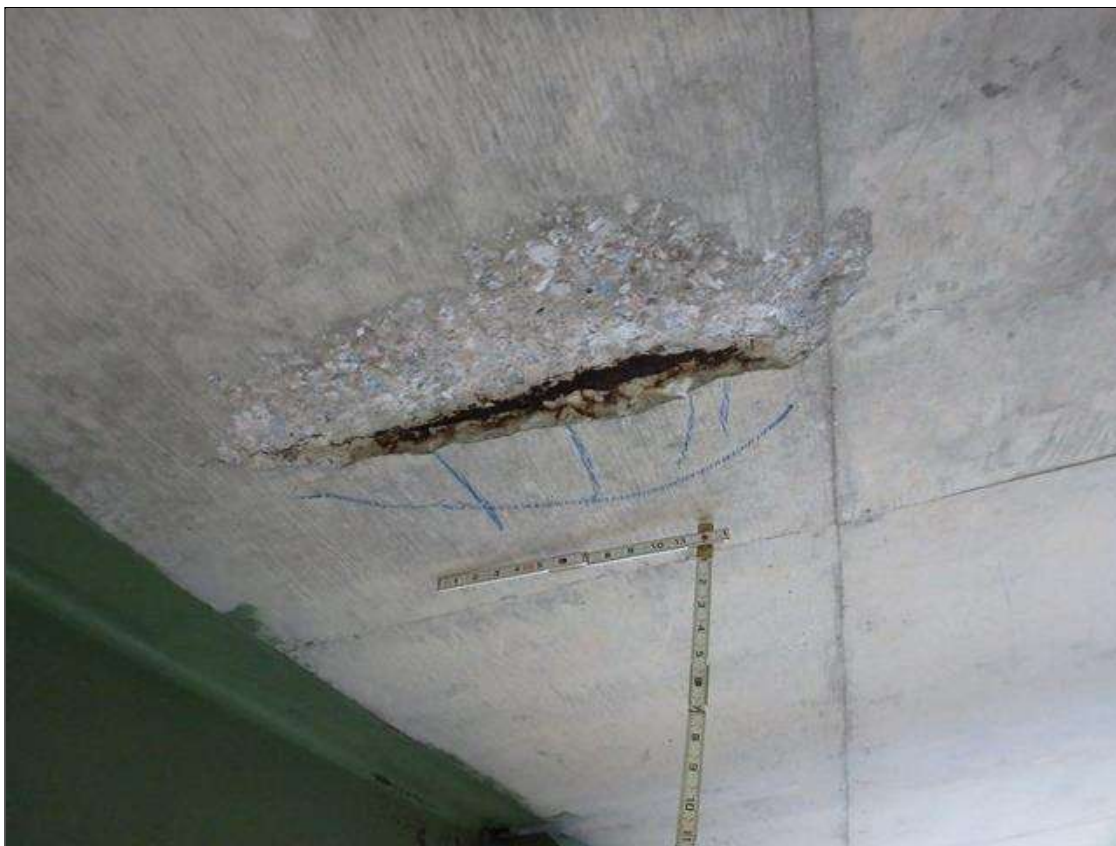
| Element Number | Defect Type | Defect Description | CS | CS Qty | Maint Qty | |
|---|---|---|---|---|---|---|
| 12 | Delamination/Spall | Deck Bottom Bay 3 at first diaphragm: delam/spall with exposed rebar (24" x 12" x 1 1/2") | 3 | 2 | 2 | Square Feet |

Span 1 Deck Bottom Bay 3 at first diaphragm: delam/spall with exposed rebar (24" x 12" x 1 1/2")
