NC DEPARTMENT OF TRANSPORTATION  
DIVISION OF HIGHWAYS  
STRUCTURE MANAGEMENT UNIT

## Structure Safety Report

### Routine Element Inspection - Contract

COUNTY: WAKE STRUCTURE NUMBER: 910260 FREQUENCY: 24 MONTHS  
FACILITY CARRIED: I440 MILE POST: 6.5  
LOCATION: 1.88 MI.N.E.SR1676  
FEATURE INTERSECTED: US70  
LATITUDE: 35° 50' 7.05" LONGITUDE: 78° 40' 10.1"  
SUPERSTRUCTURE: RC FLOOR/I-BEAMS(WIDENED)  
SUBSTRUCTURE: EBTS:RC CAP/PRESTR.CONC.PILES;BTS:RCP&B/PILE FTGS.  
SPANS: 2@67';1@70'6;1@45'  
☐ FRACTURE CRITICAL ☐ TEMPORARY SHORING ☐ SCOUR CRITICAL ☐ SCOUR PLAN OF ACTION  
PRESENT CONDITION: Fair INSPECTION DATE: 07/12/2016  
POSTED SV: Not Posted POSTED TTST: Not Posted  
OTHER SIGNS PRESENT: None

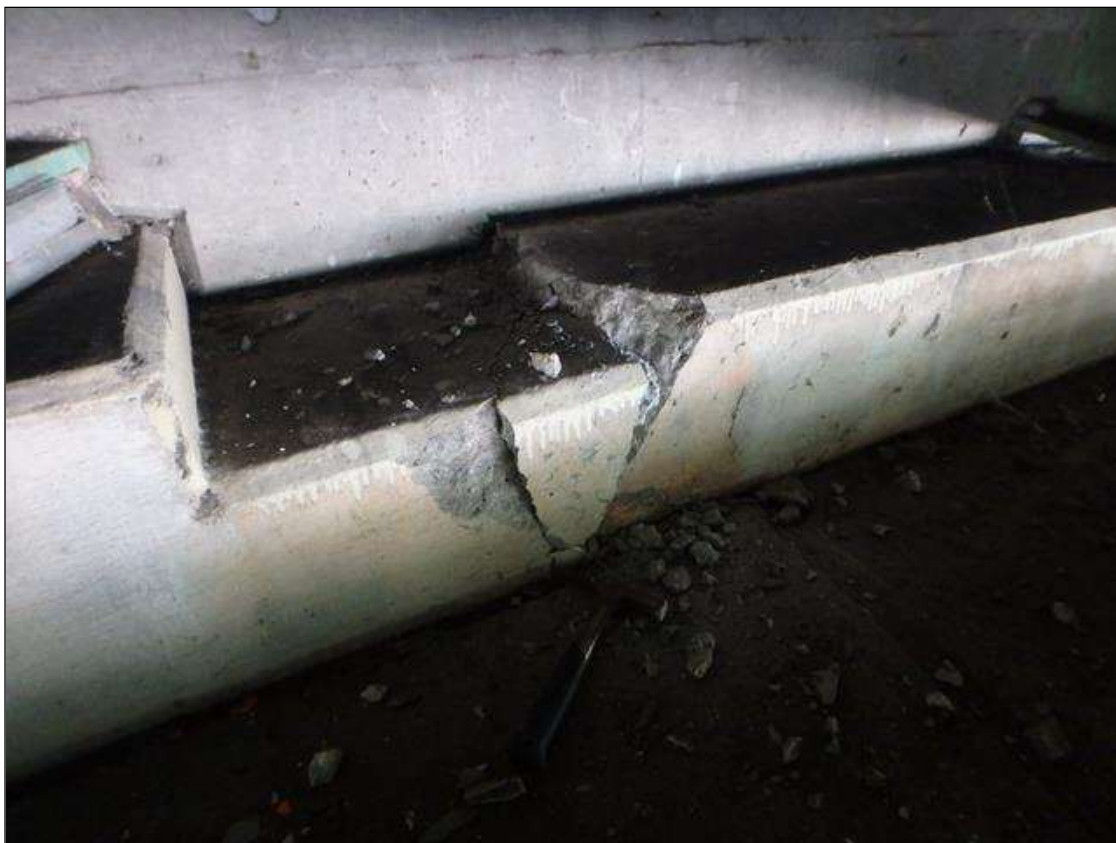
End Bent 1 Cap Bay 8: delamination and spall with no exposed steel (12" x 14" x 9")

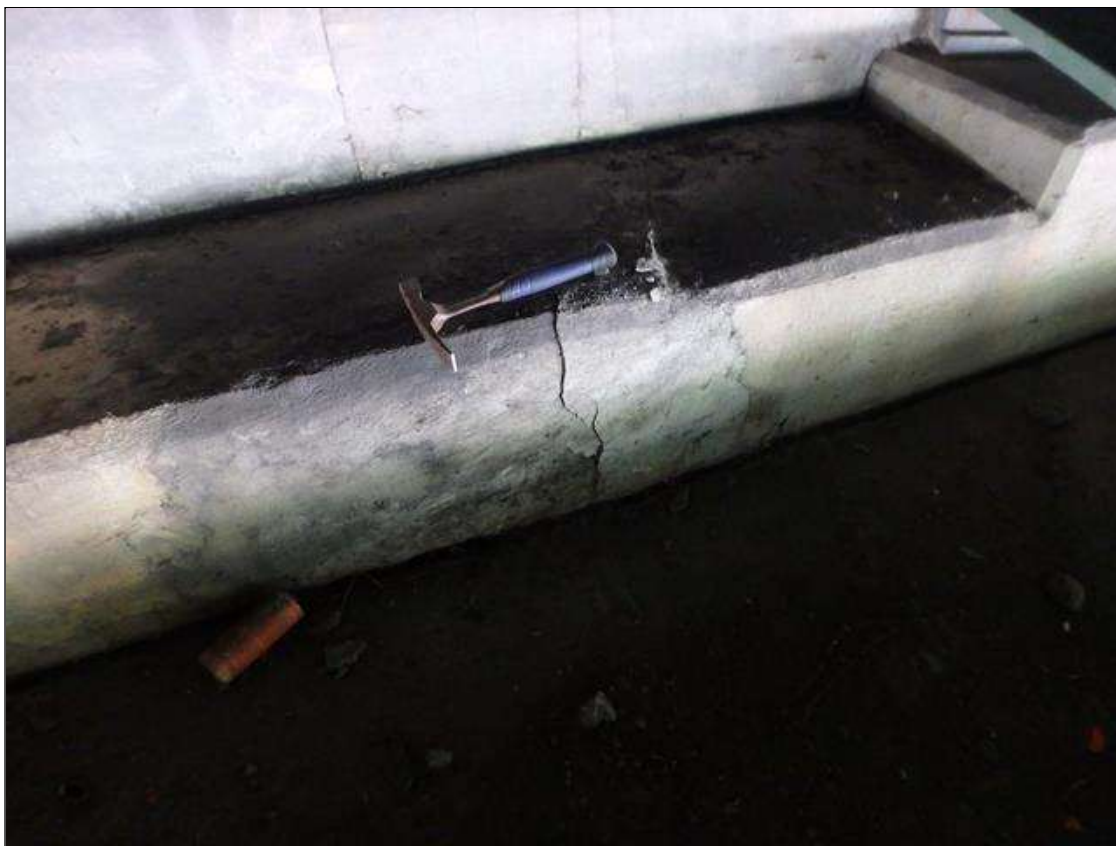
End Bent 1 Cap Bay 12: unsound patch

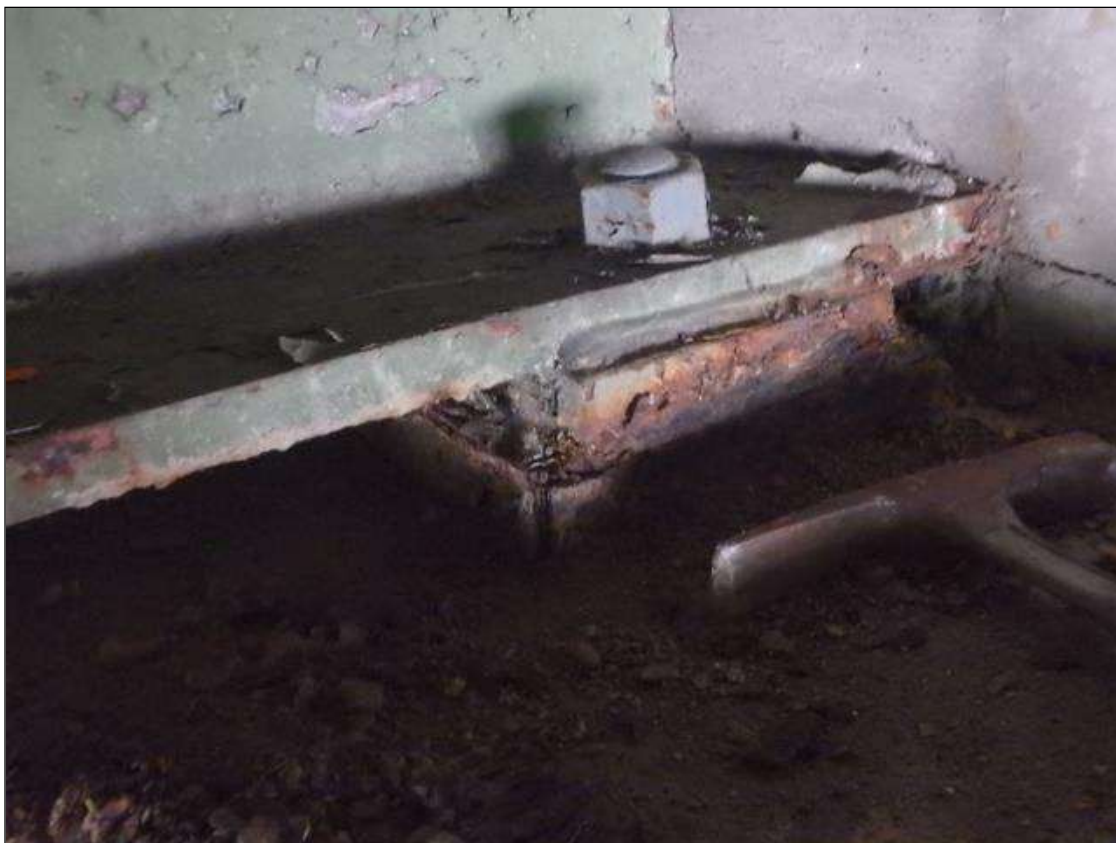
Bearing 13 at End Bent 1: corrosion and scale (other bearings similar)

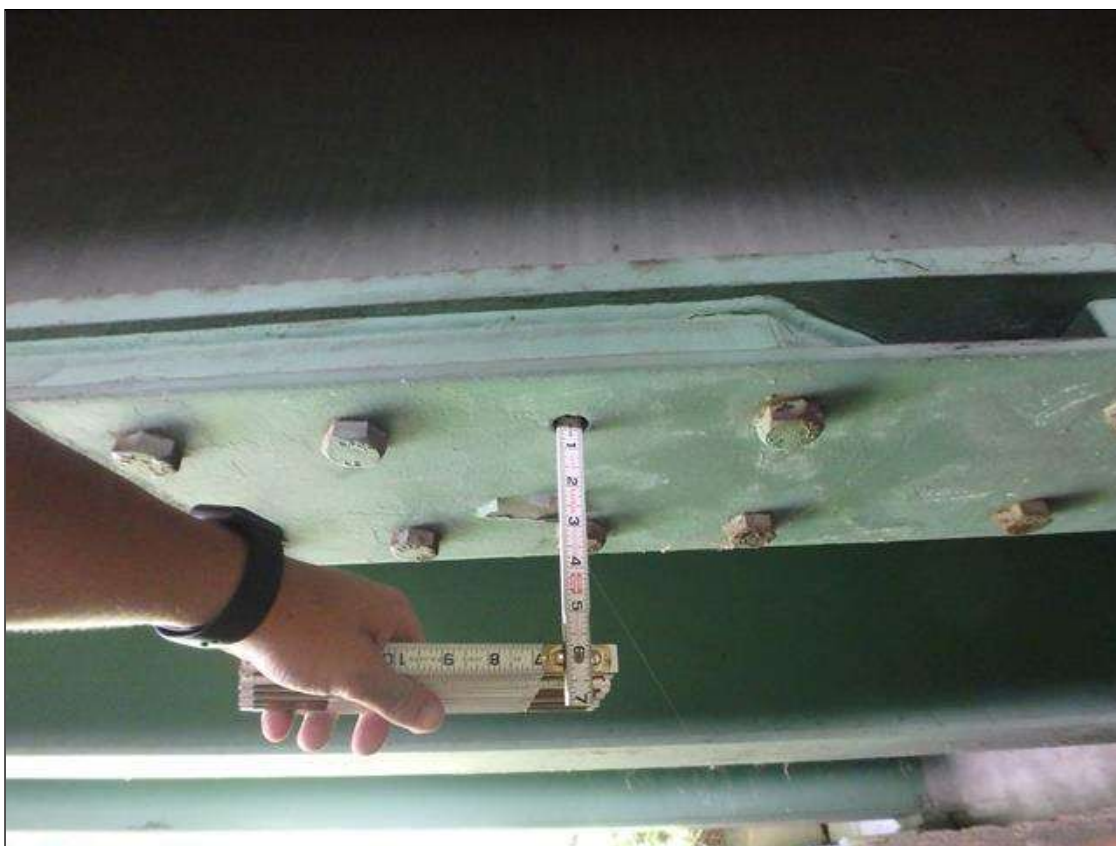
Span 1 Beam 18 first bottom flange splice: missing (x1) bolt (hole does not go through the bottom flange of the beam)

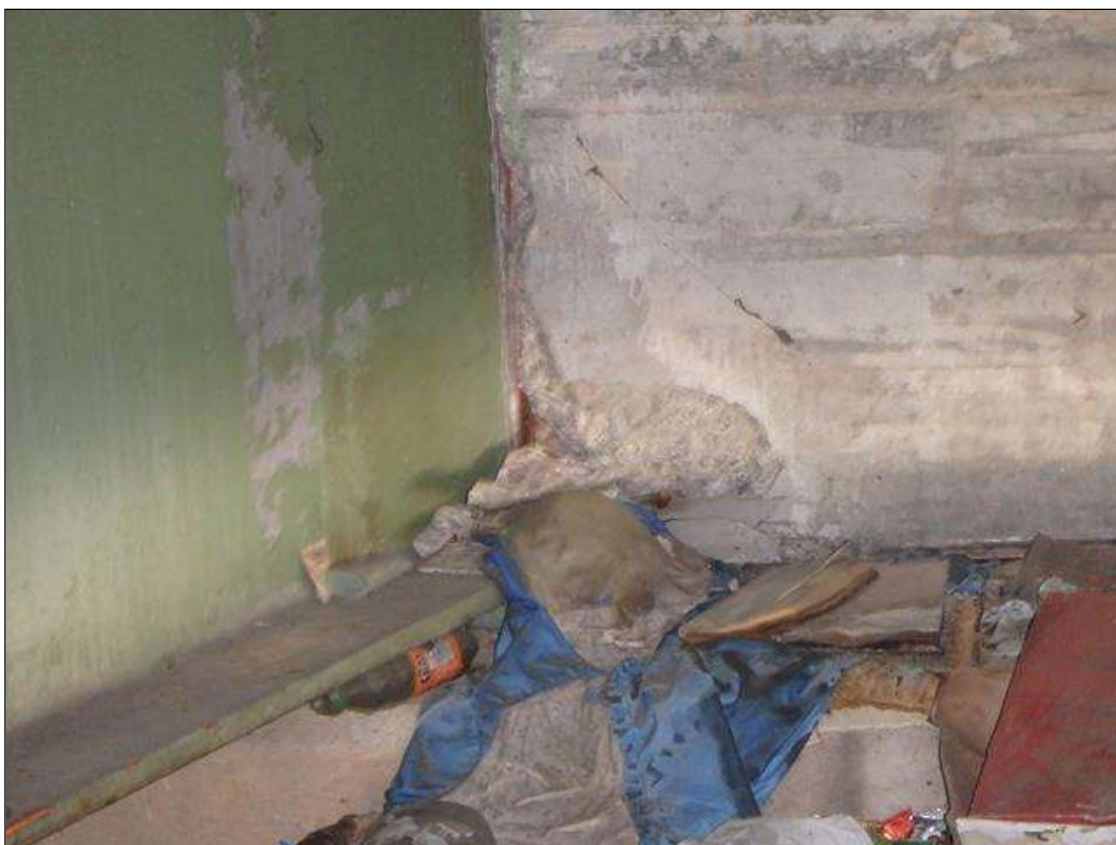
End Bent Backwall Bay 17 at Beam 18: spall with exposed rebar (30" x 16" x 1")

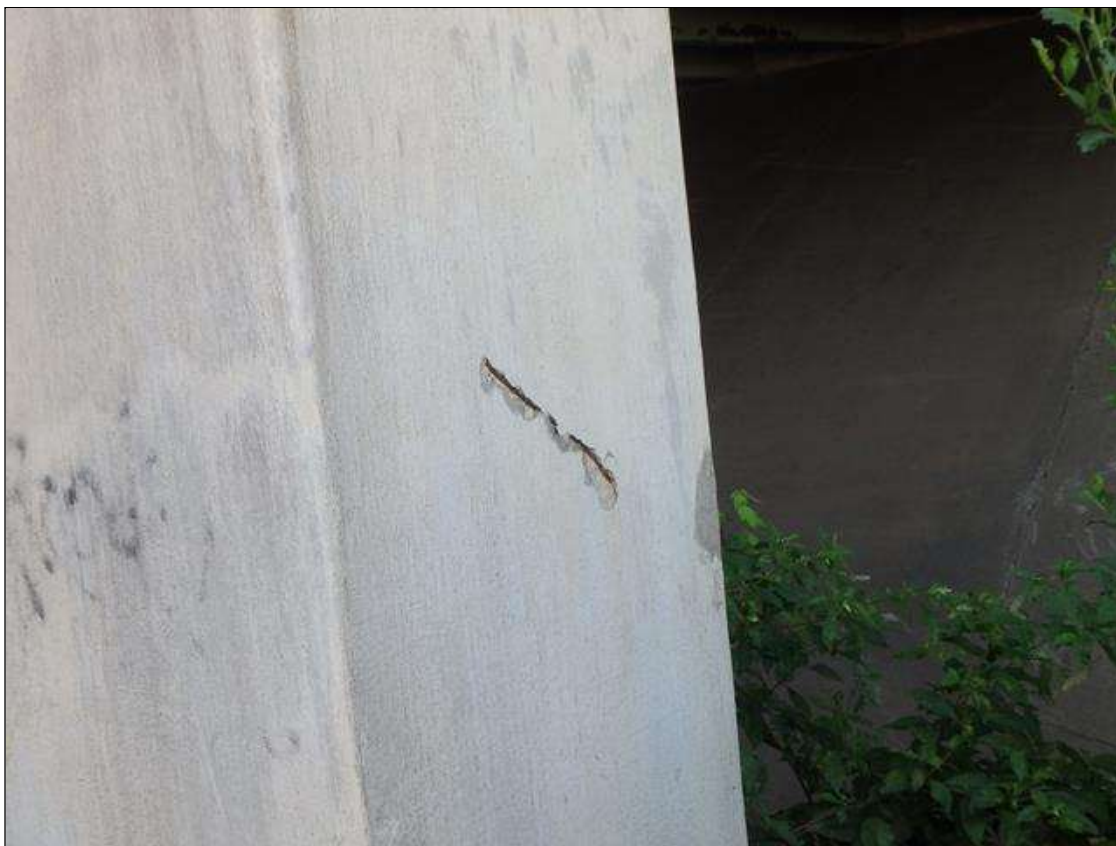
Column 1 at Bent 1 West Face: spall with exposed rebar (14" x 2" x 1/4")

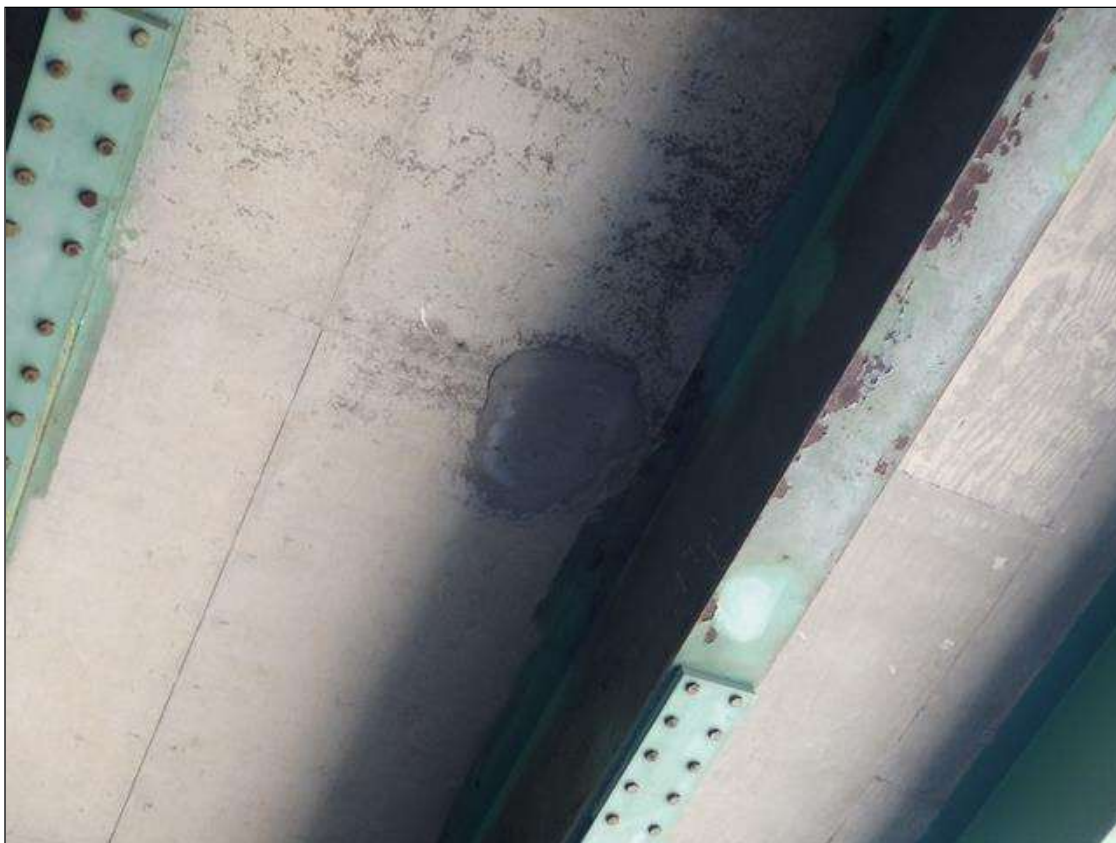
Span 3 Deck Bottom Bay 17 at 10' from Bent 3: sound patch

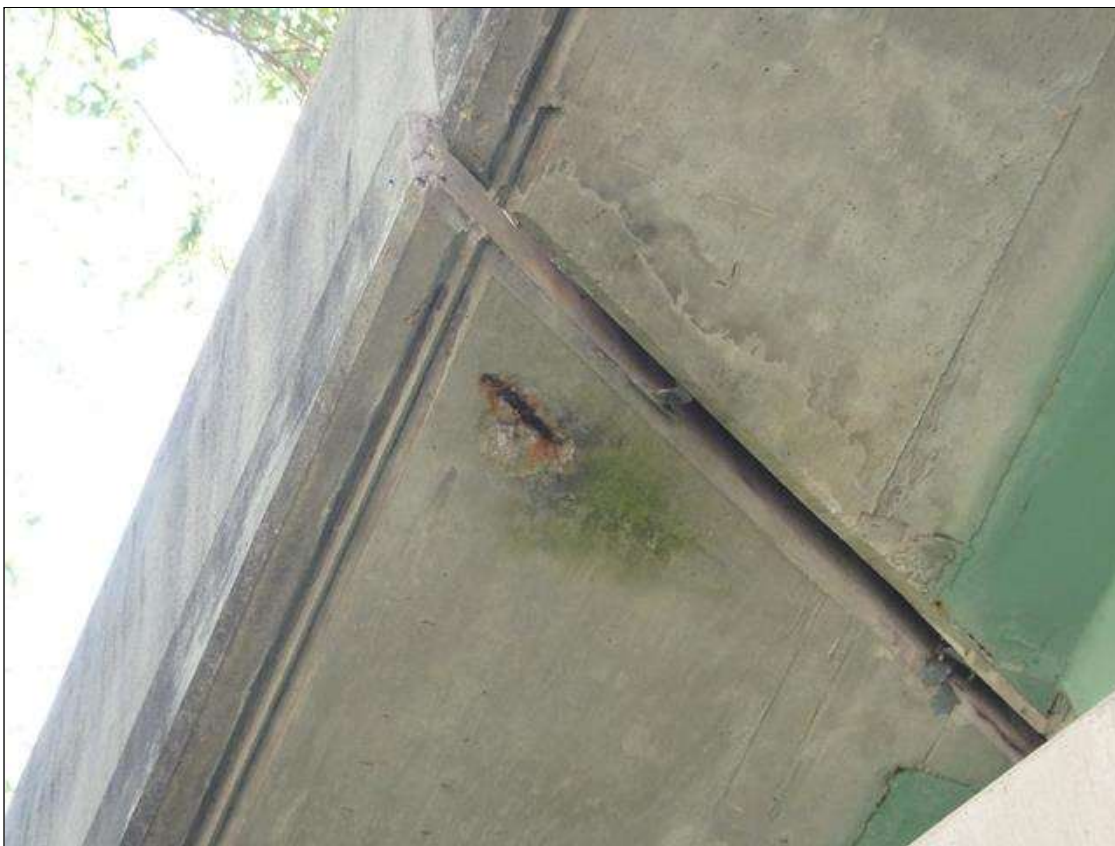
Span 4 Deck Bottom Left Overhang at Bent 3: spall with exposed rebar (6" x 3" x 1")

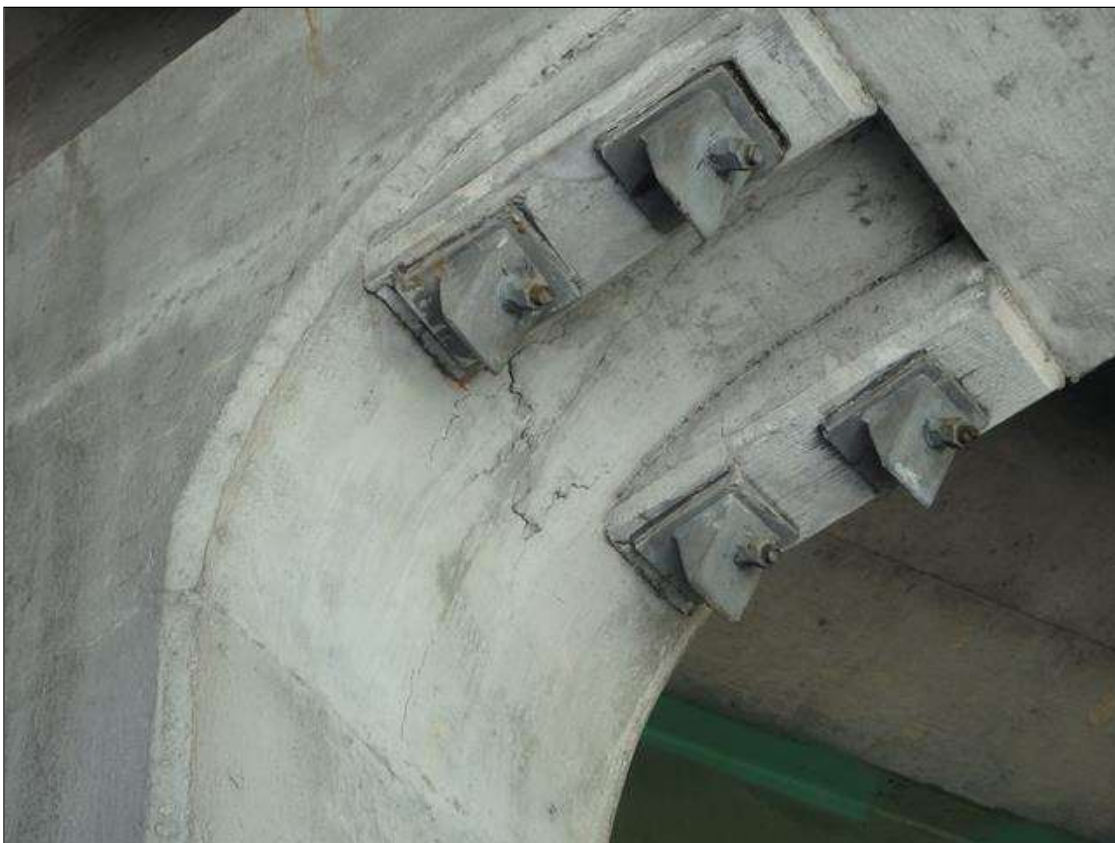
Bent 3 Cap Bottom Face between columns 9 and 10 at postensioning connection: delam area (10" x 8")

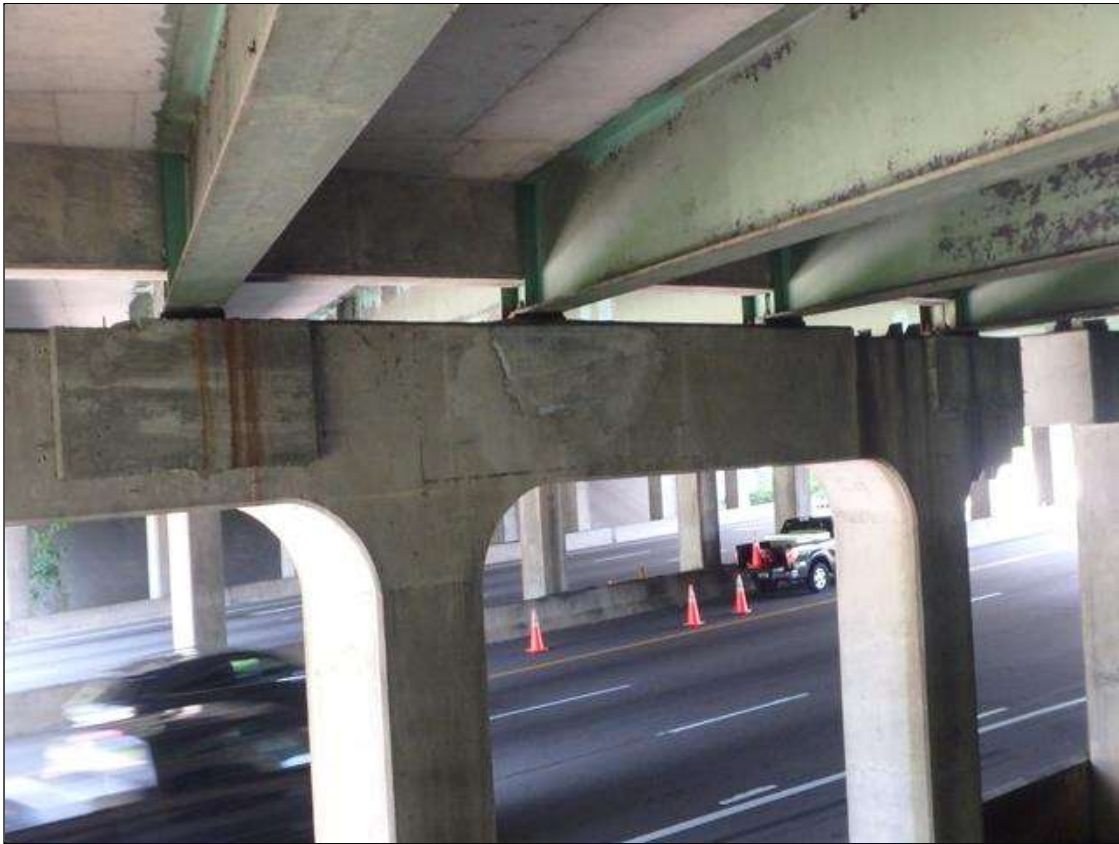
Bent 3 Cap North Faces Bays 13 - 16: sound patches for 15 linear feet

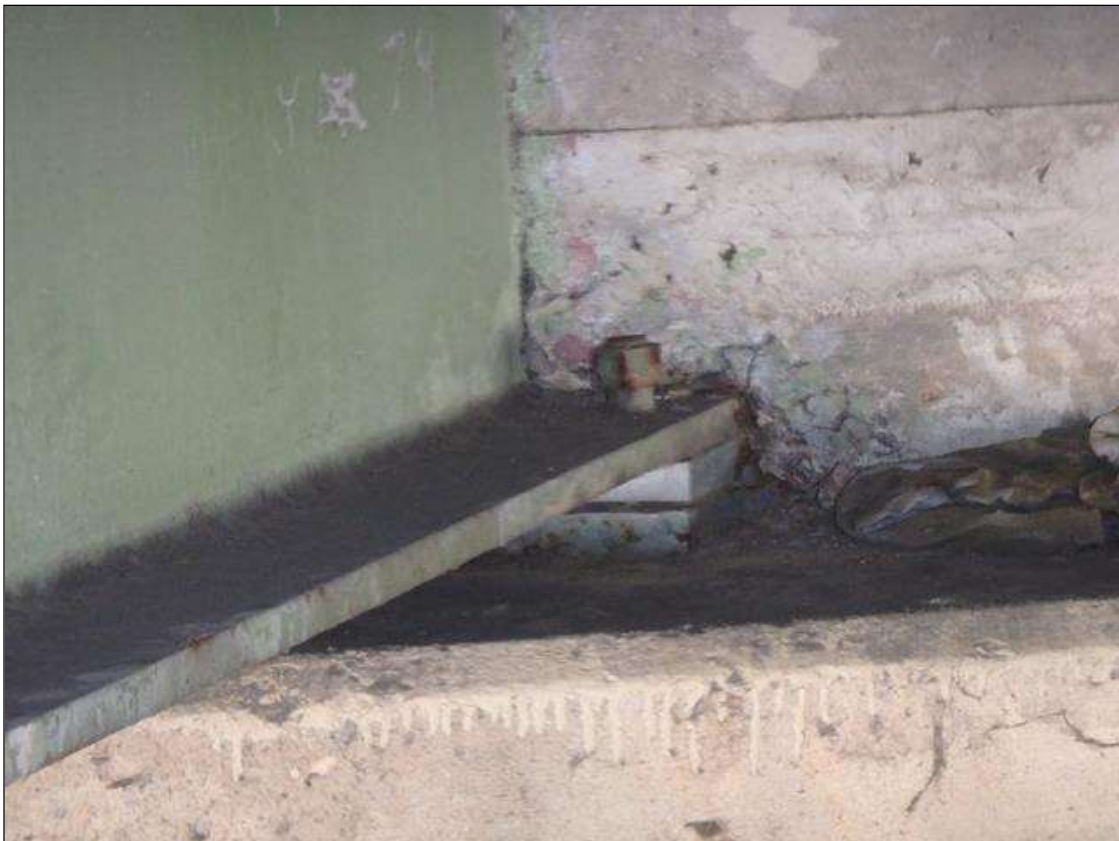
Bearing 3 at End Bent 2: right anchor bolt nut is not tight

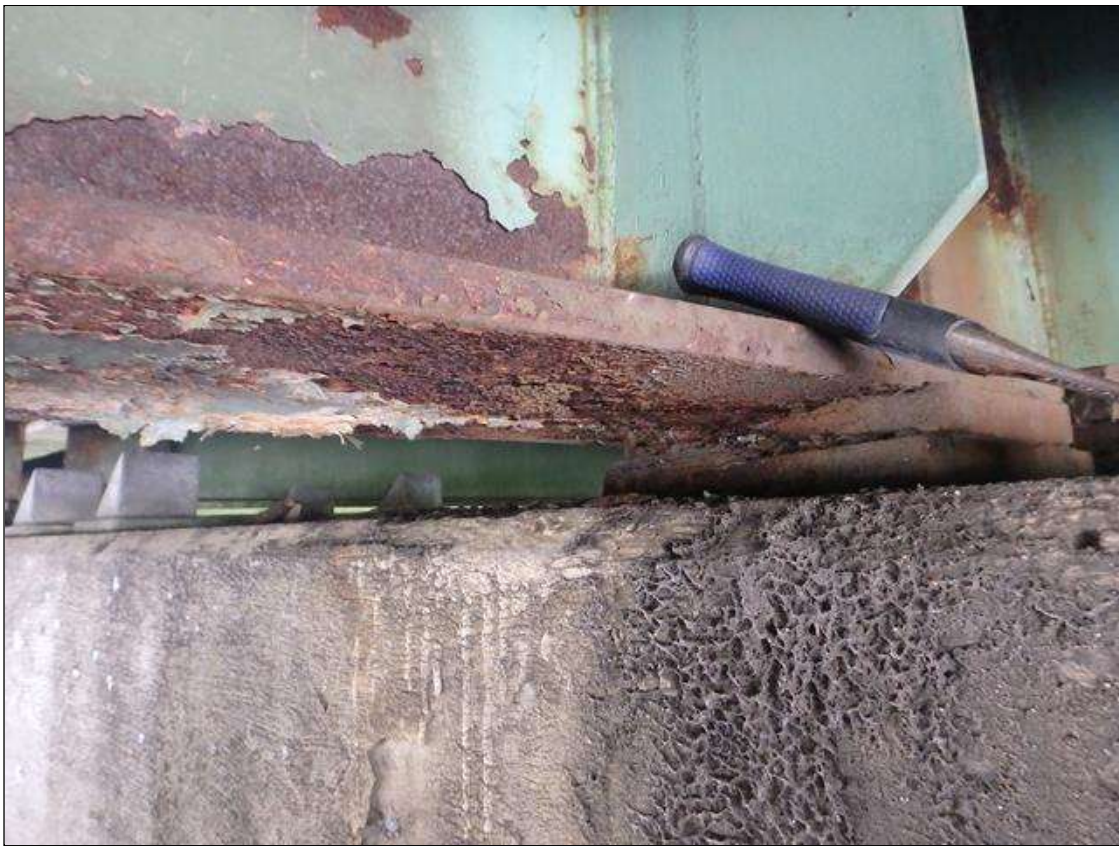
Span 2 Beam and Bearing 13 at Bent 1: corrosion and scale with no measureable section loss

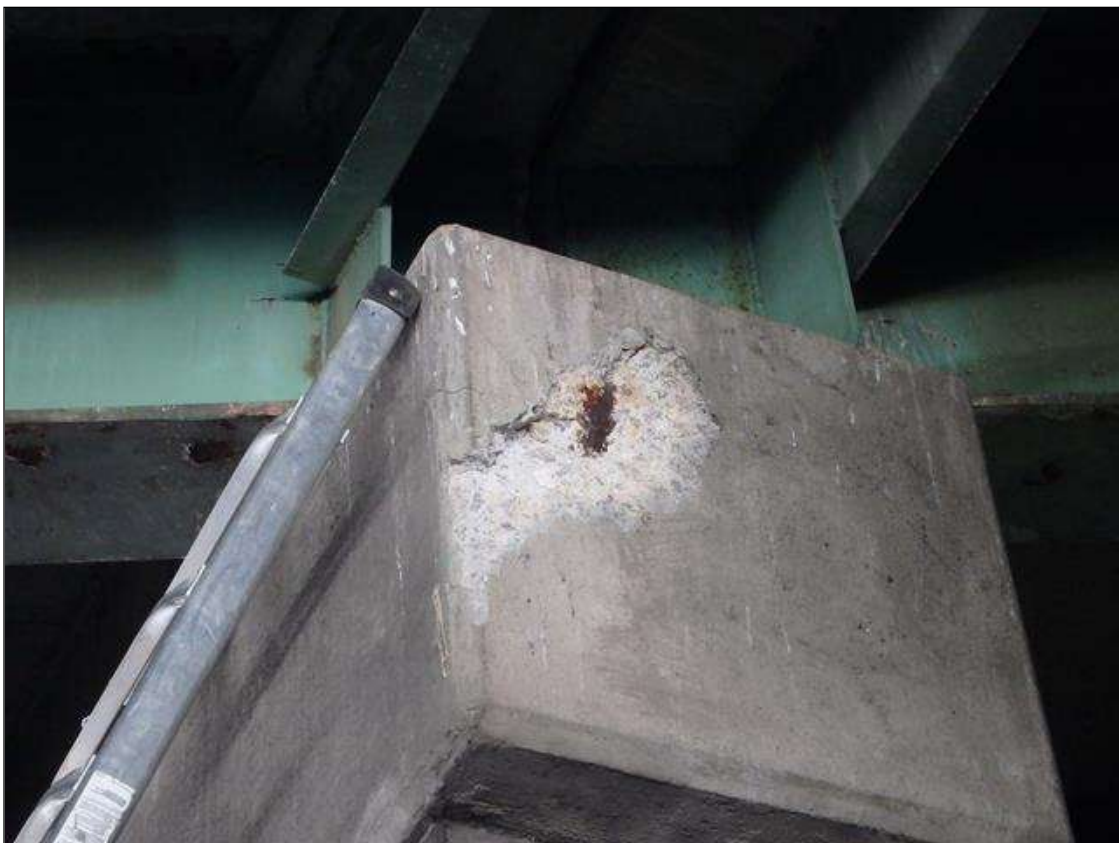
Bent 3 Cap East Face under Bay 8: spall with exposed rebar (19" x 19" x 1 1/4")

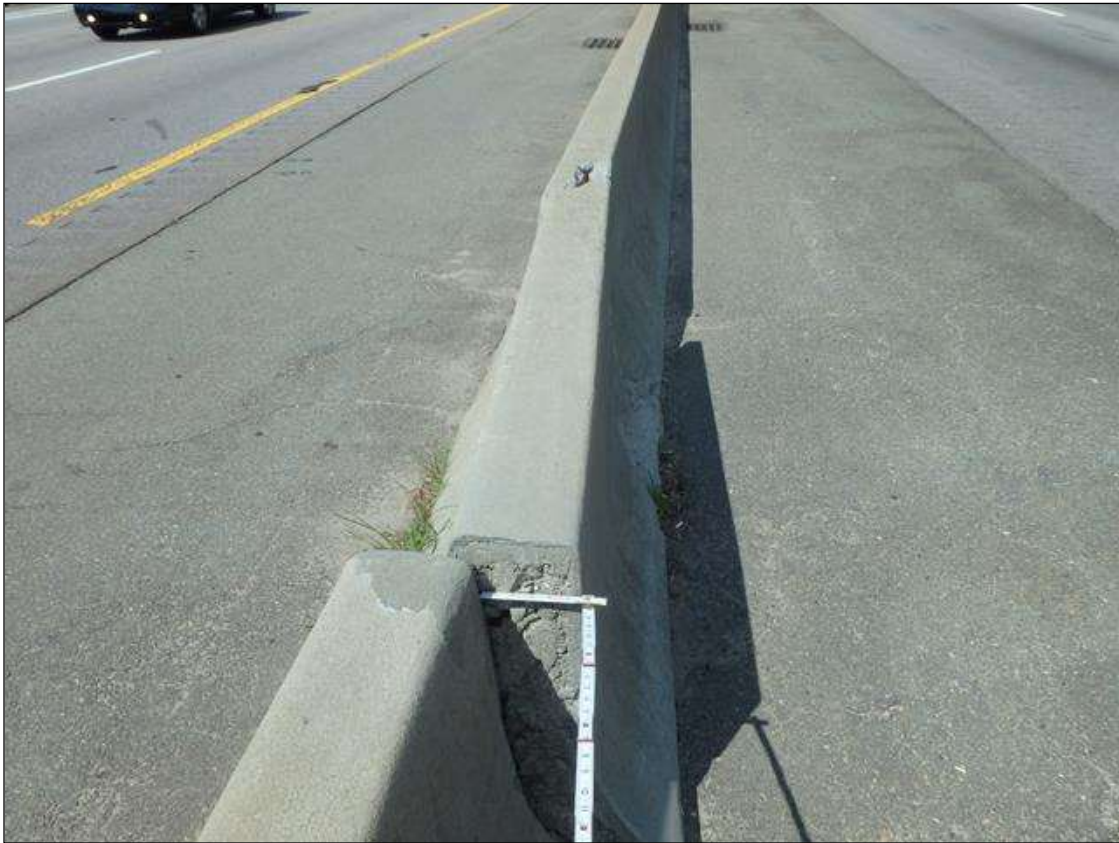
| MMS Code | MMS Description | Quantity |
|---|---|---|
| SOUTH APPROACH MEDIAN RAIL AT THE APPROACH SLAB: MISALIGNED 6" TOWARD THE OUTER LANES POINTED TOWARD ONCOMING TRAFFIC WITH IMPACT DAMAGE.<br>- | | |

SOUTH APPROACH MEDIAN RAIL AT THE APPROACH SLAB: MISALIGNED 6" TOWARD THE OUTER LANES  
POINTED TOWARD ONCOMING TRAFFIC WITH IMPACT DAMAGE (PM)

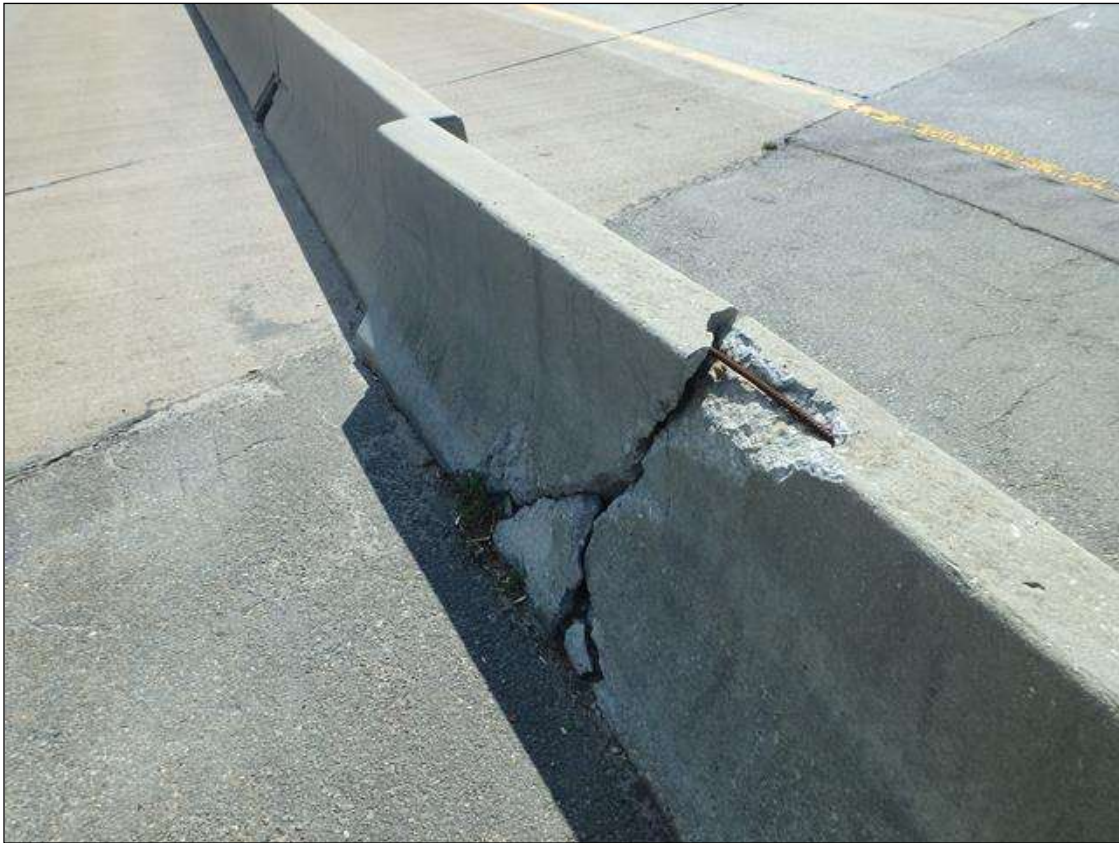
SOUTH APPROACH MEDIAN RAIL AT THE APPROACH SLAB: MISALIGNED 6" TOWARD THE OUTER LANES  
POINTED TOWARD ONCOMING TRAFFIC WITH IMPACT DAMAGE (PM)
