NC DEPARTMENT OF TRANSPORTATION  
DIVISION OF HIGHWAYS  
STRUCTURE MANAGEMENT UNIT

## Structure Safety Report

### Routine Element Inspection - Contract

COUNTY: WAKE STRUCTURE NUMBER: 910494 FREQUENCY: 24 MONTHS

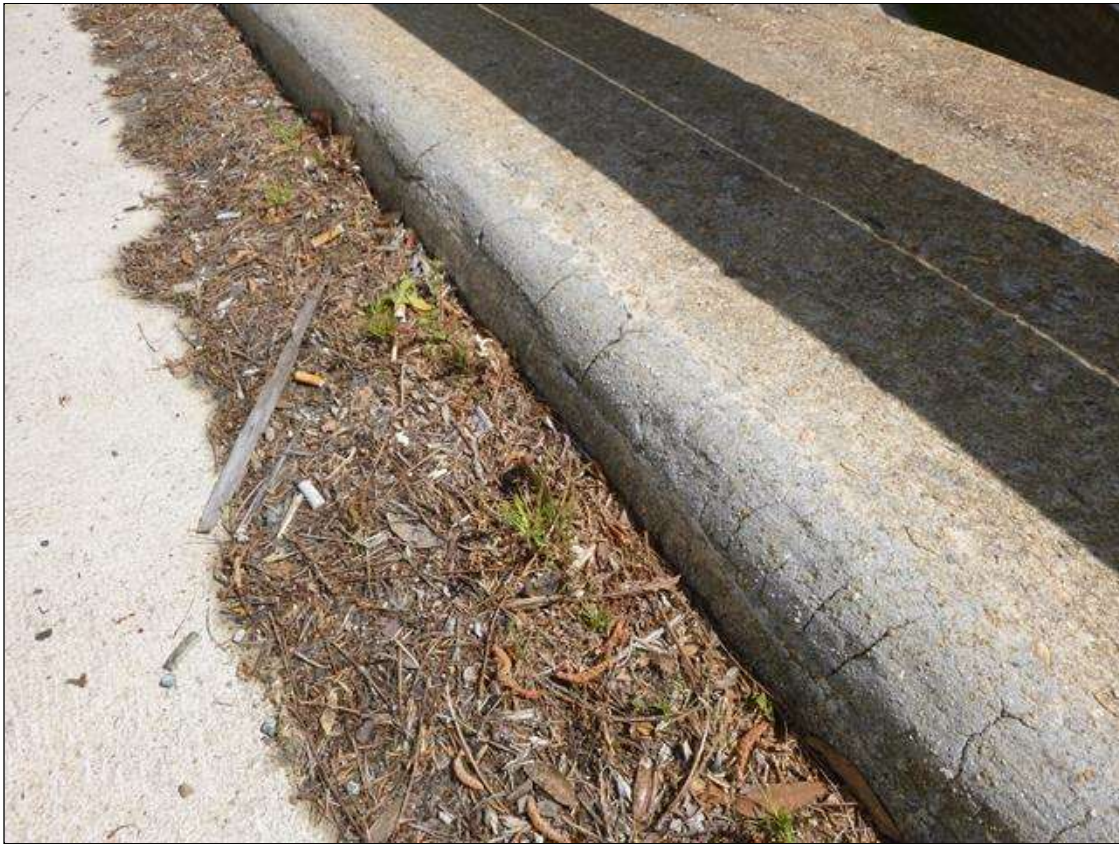
1' X 2' UNSOUND TEMPORARY REPAIR ALONG RIGHT CURB, BETWEEN RAIL POST 2 AND 3.

Span 1 Right Bridge Rail: 1' X 2' UNSOUND TEMPORARY REPAIR ALONG RIGHT CURB, BETWEEN RAIL POST 2 AND 3.

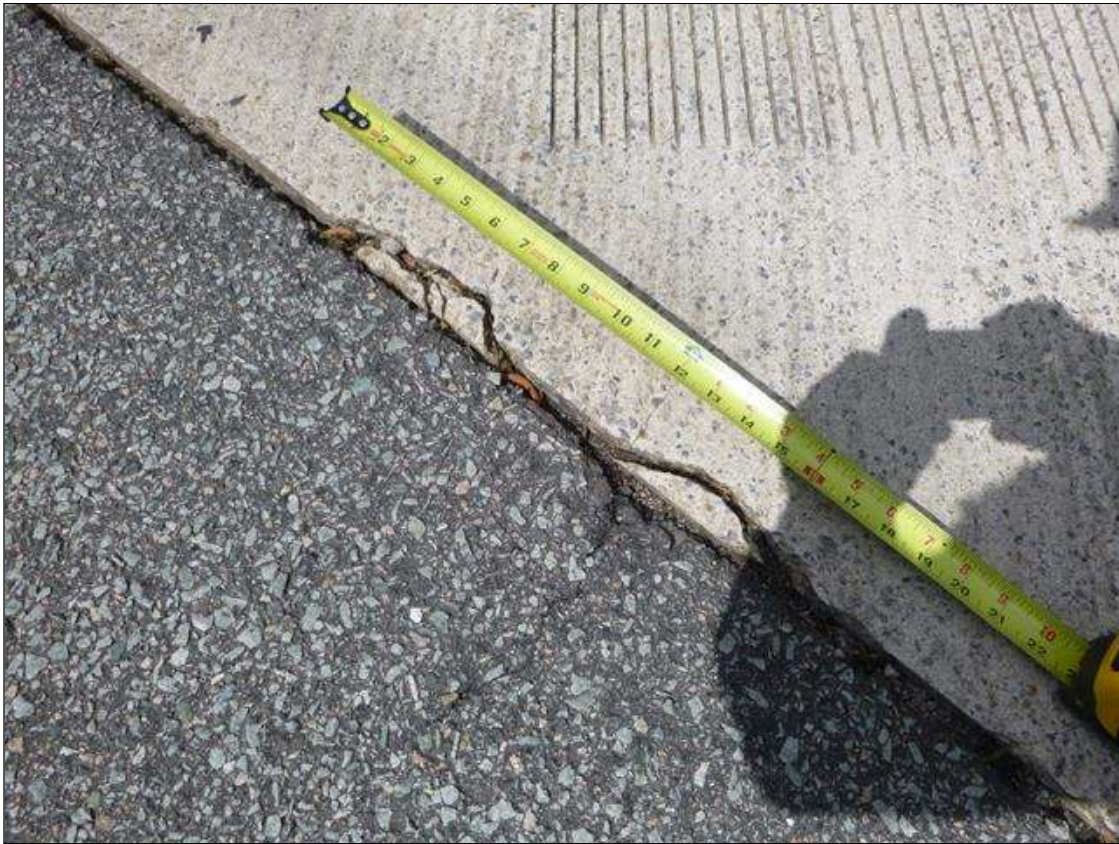
15' TOTAL FT OF TEMPORARY REPAIR, DECK SURFACE, ALONG SOUTH EDGE OF DECK, OVER END BENT 1, NORTH BOUND LANE.

Span 1 Deck: 15' TOTAL FT OF TEMPORARY REPAIR, DECK SURFACE, ALONG SOUTH EDGE OF DECK, OVER END BENT 1, NORTH BOUND LANE.

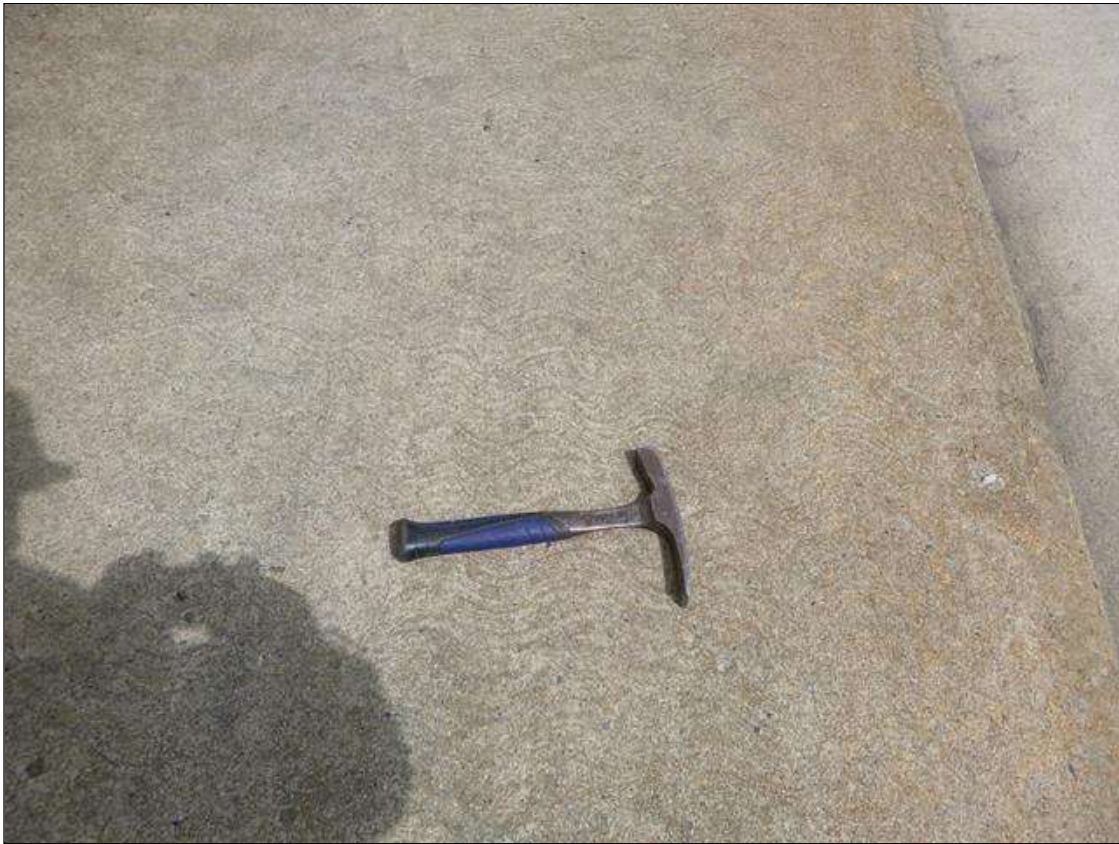
5' DIAGONAL HAIRLINE CRACK, DECK SURFACE, SOUTH END OF SOUTH BOUND LANE, 5' FROM LEFT CURB, AT END BENT 1.

Span 1 Deck: 5' DIAGONAL HAIRLINE CRACK, DECK SURFACE, SOUTH END OF SOUTH BOUND LANE, 5' FROM LEFT CURB, AT END BENT 1.

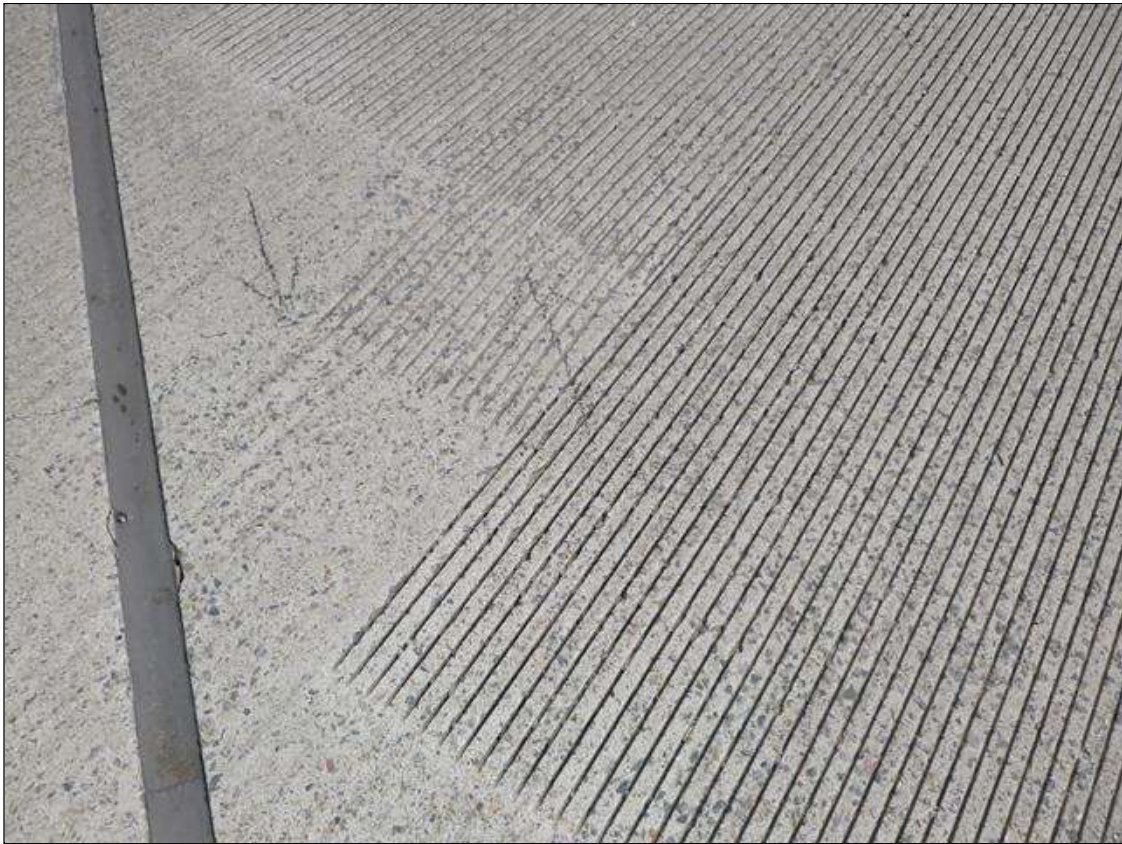
Drainage : 18' X 1' AREA OF WATER PONDING, AT LEFT CURB, BEGINNING AT BENT 1, DECK IS SLOPED TOWARD LEFT SIDE OF BRIDGE WITH NO DRAINS ON LEFT SIDE.

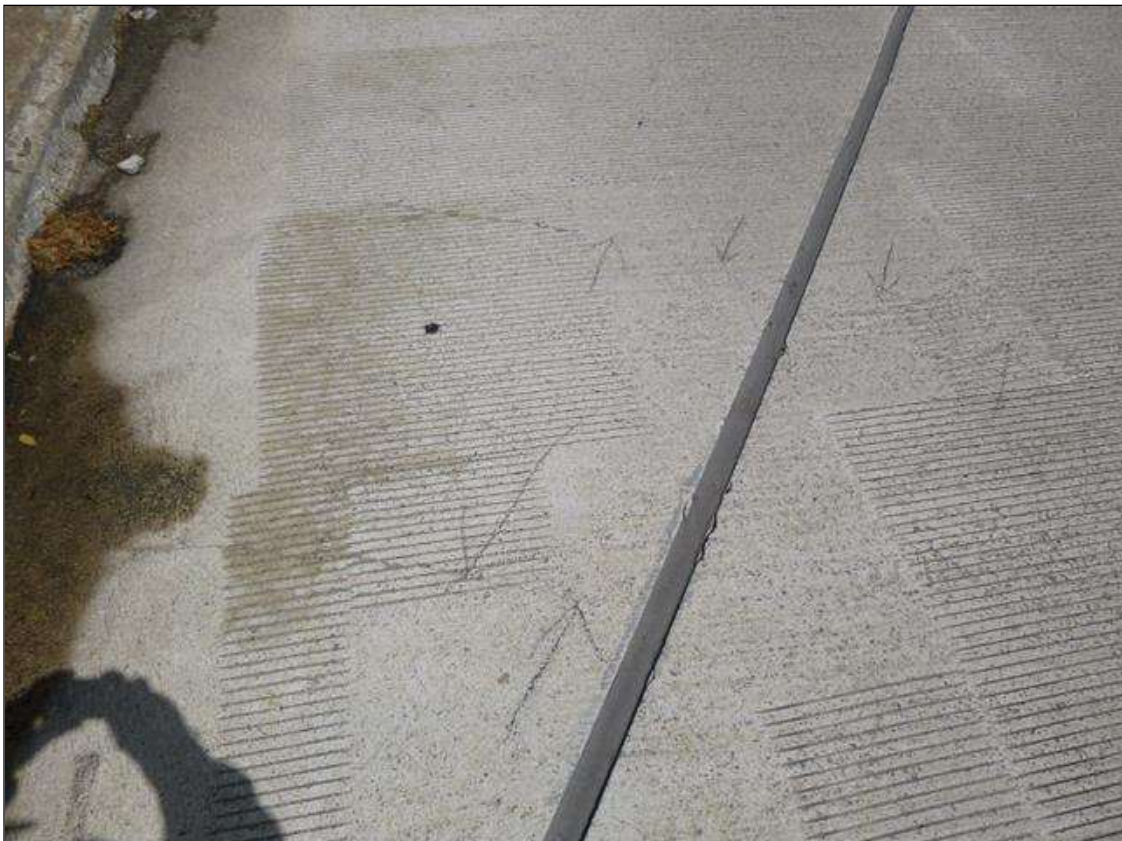
2' DIAGONAL HAIRLINE CRACK, DECK SURFACE, AT BENT 1, 5' FROM LEFT CURB.

Span 1 Deck: 2' DIAGONAL HAIRLINE CRACK, DECK SURFACE, AT BENT 1, 5' FROM LEFT CURB.

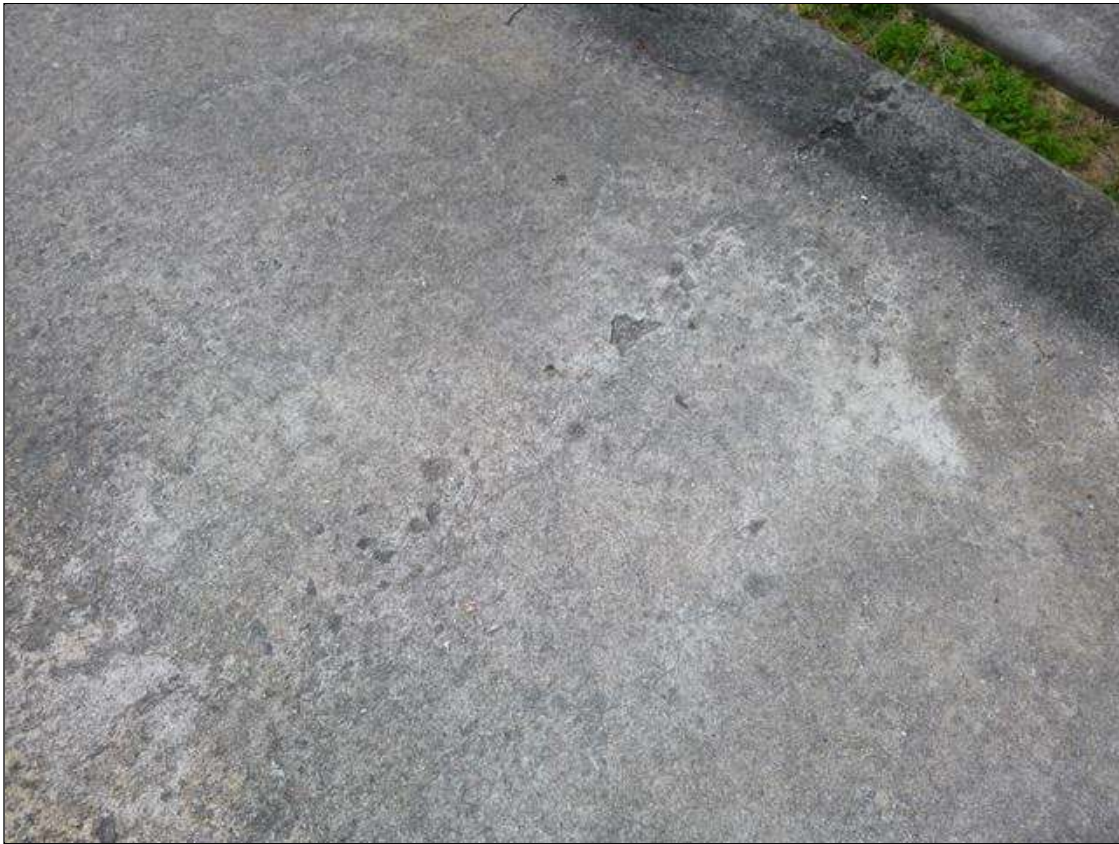
19" X 12" X 1" SPALL, TOP OF LEFT SIDE WALK, 5' FROM BENT 2.

Span 2 Left Bridge Rail: 19" X 12" X 1" SPALL, TOP OF LEFT SIDE WALK, 5' FROM BENT 2.

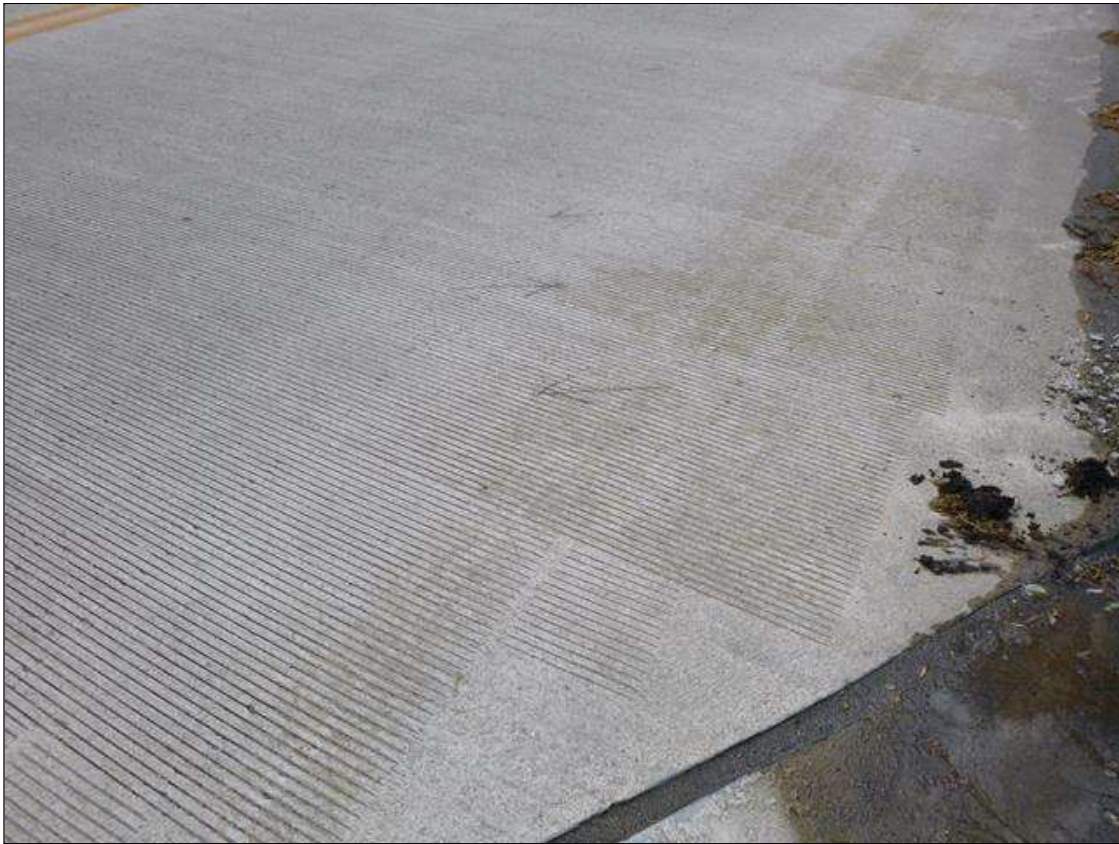
1' X 1' X 1/2" AREA OF SPALL, TOP EDGE OF LEFT SIDE WALK, AT BENT 2.

Span 2 Left Bridge Rail: 1' X 1' X 1/2" AREA OF SPALL, TOP EDGE OF LEFT SIDE WALK, AT BENT 2.

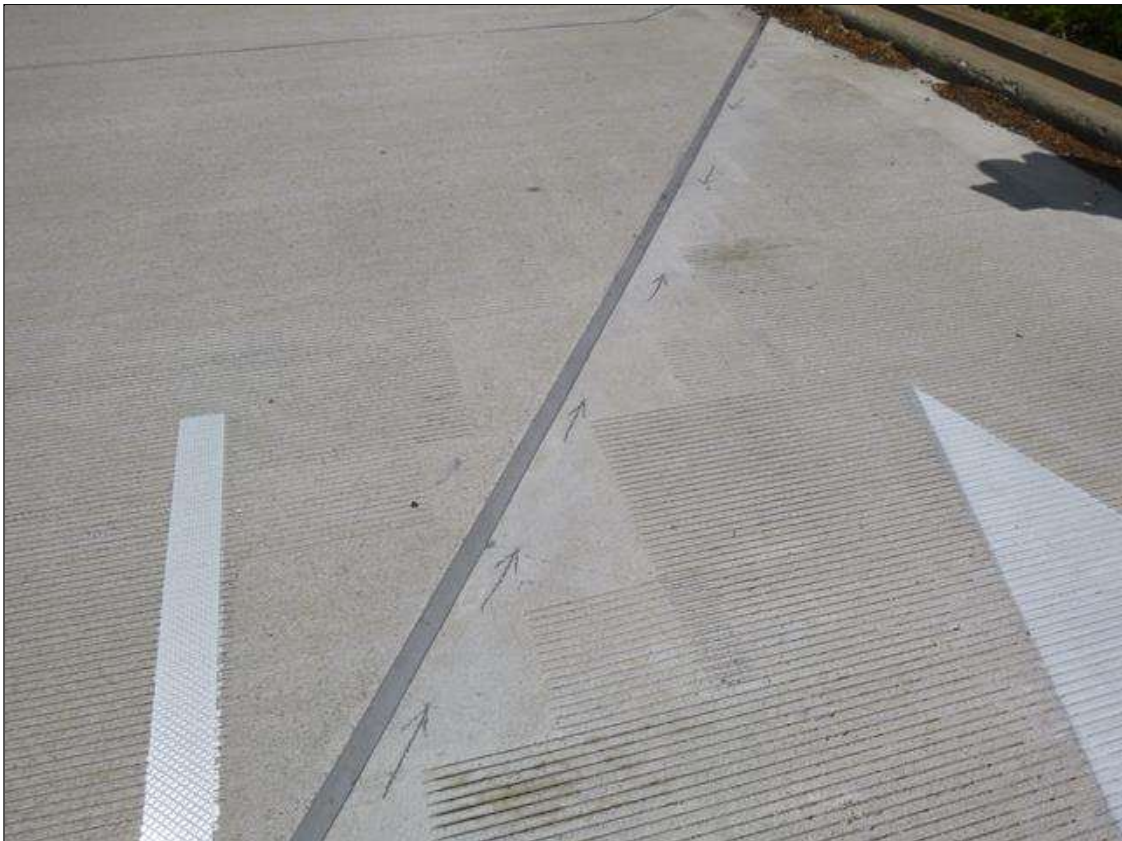
(10) 3' DIAGONAL HAIRLINE CRACKS AT 3' CENTERS, DECK SURFACE, AT BENT 1, BEGINNING AT RIGHT CURB.

Span 1 Deck: (10) 3' DIAGONAL HAIRLINE CRACKS AT 3' CENTERS, DECK SURFACE, AT BENT 1, BEGINNING AT RIGHT CURB.

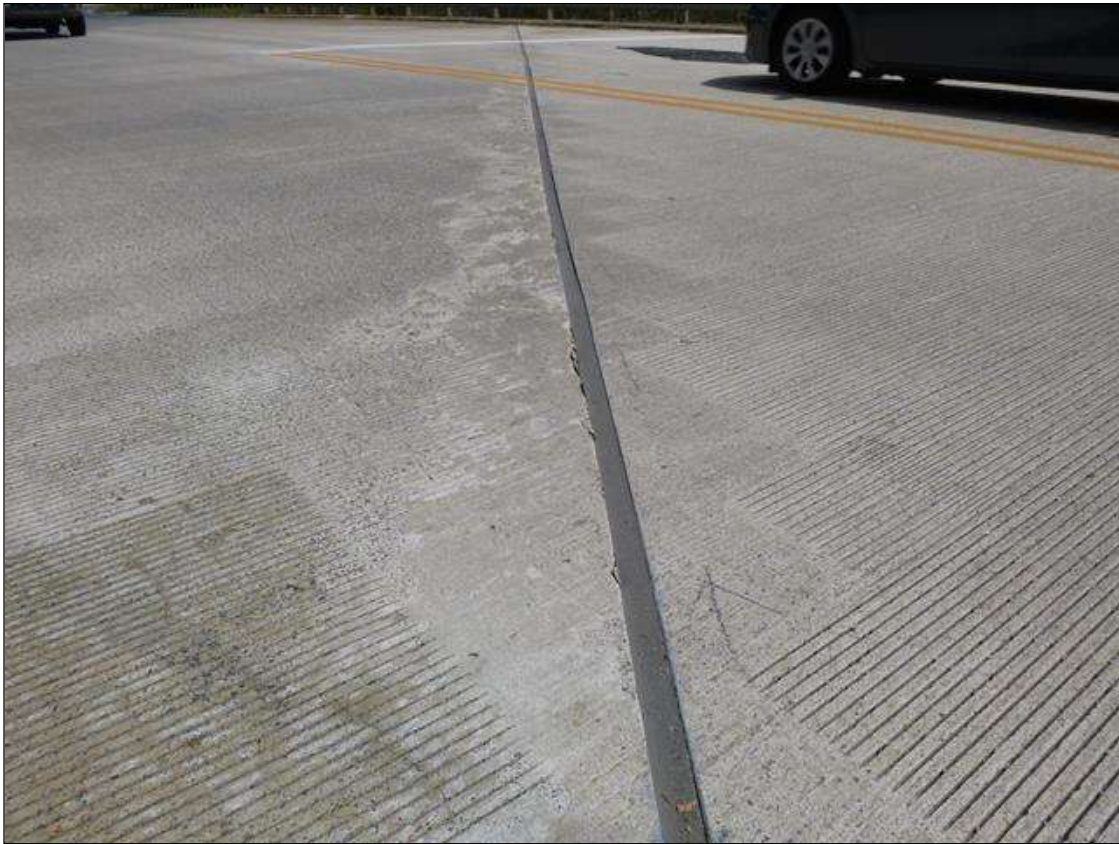
Span 3 Deck: (5) 2' DIAGONAL HAIRLINE CRACK AT 3' CENTERS, AT BENT 3, BEGINNING 5' FROM LEFT CURB.

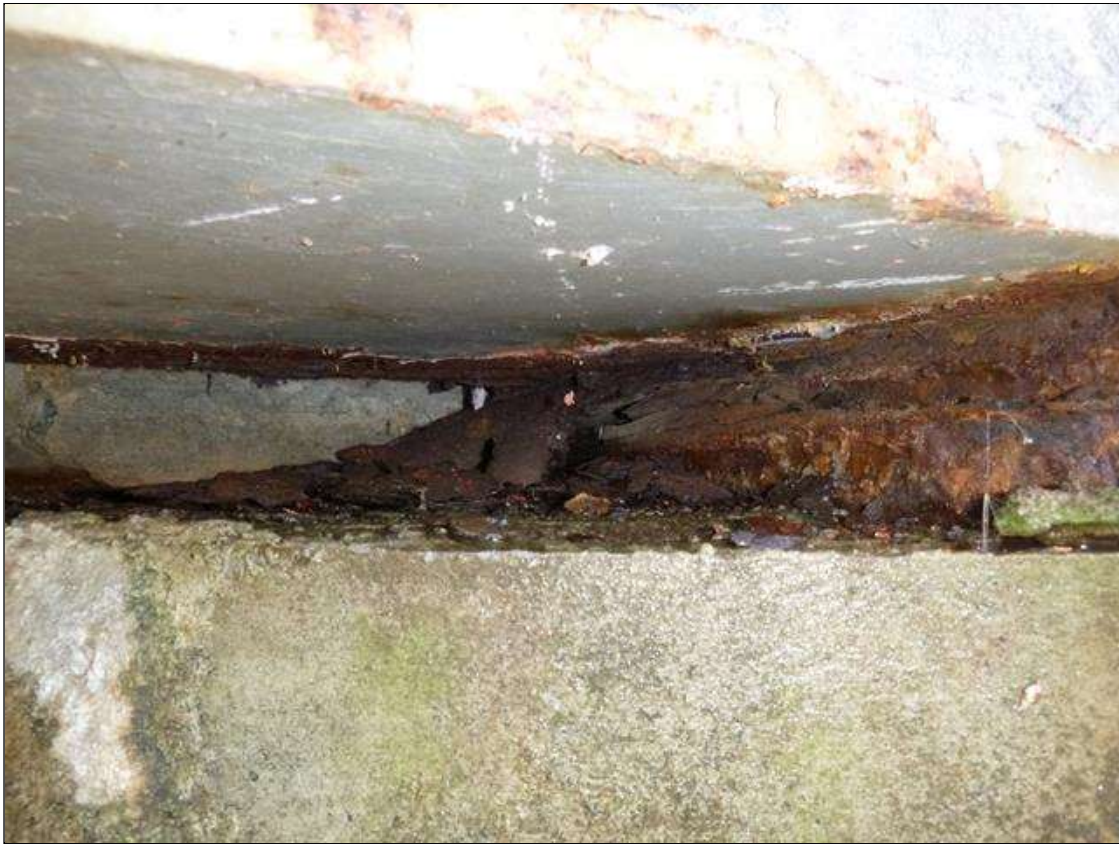
Drainage System : DECK DRAINS ARE PRESENT UNDERSIDE OF DECK, ALONG LEFT CURB BUT HAVE BEEN COVERED BY DECK PRESERVATION EFFORTS ON TOPSIDE.

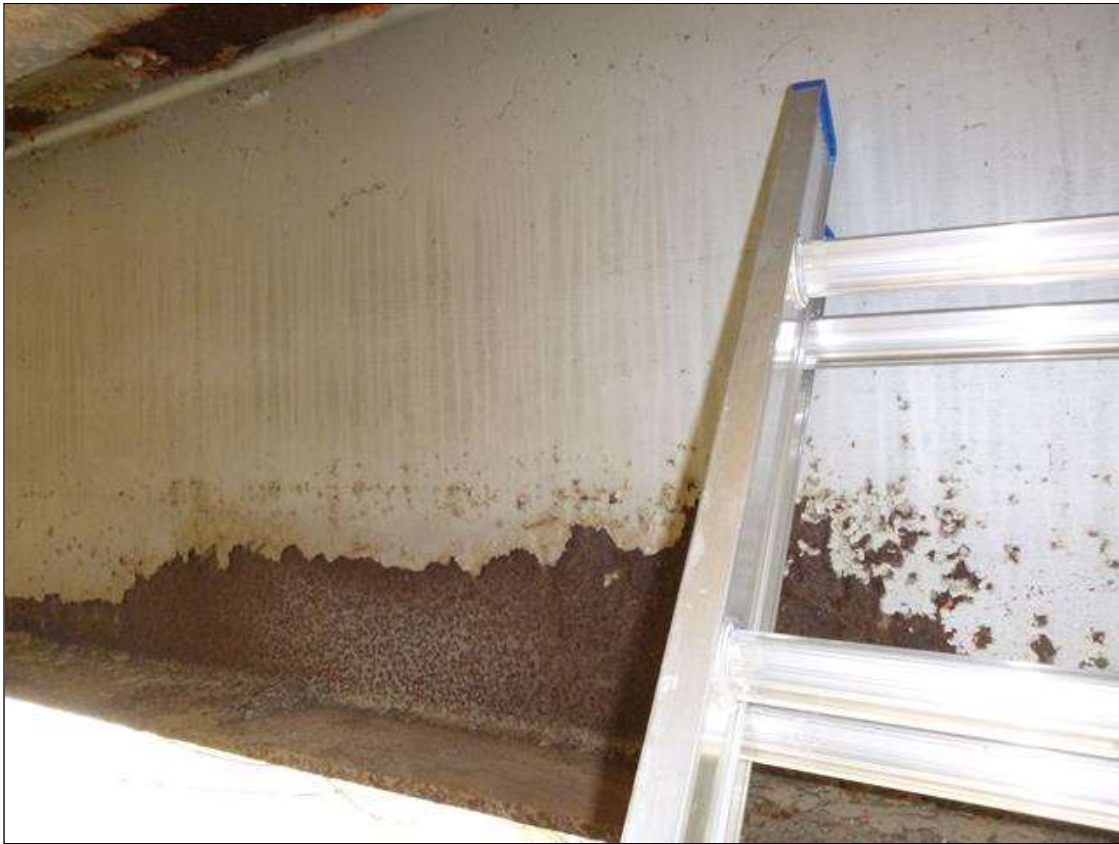
Span 1 Beam 1: 10' OF SURFACE PROTECTION HAS BEEN SCRAPED OFF UNDERSIDE OF BOTTOM FLANGE DIRECTLY ABOVE TRAIL.

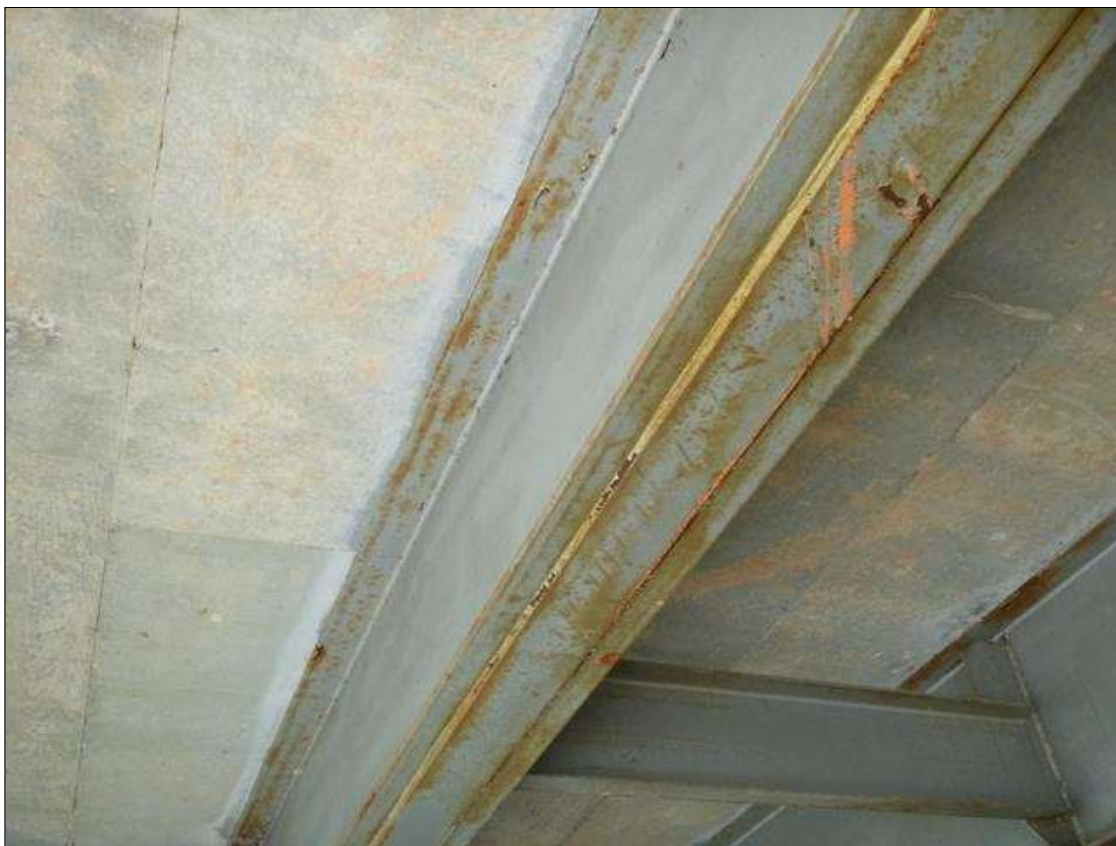
Span 1 Beam 2: 10' OF SURFACE PROTECTION HAS BEEN SCRAPED OFF UNDERSIDE OF BOTTOM FLANGE DIRECTLY ABOVE TRAIL.

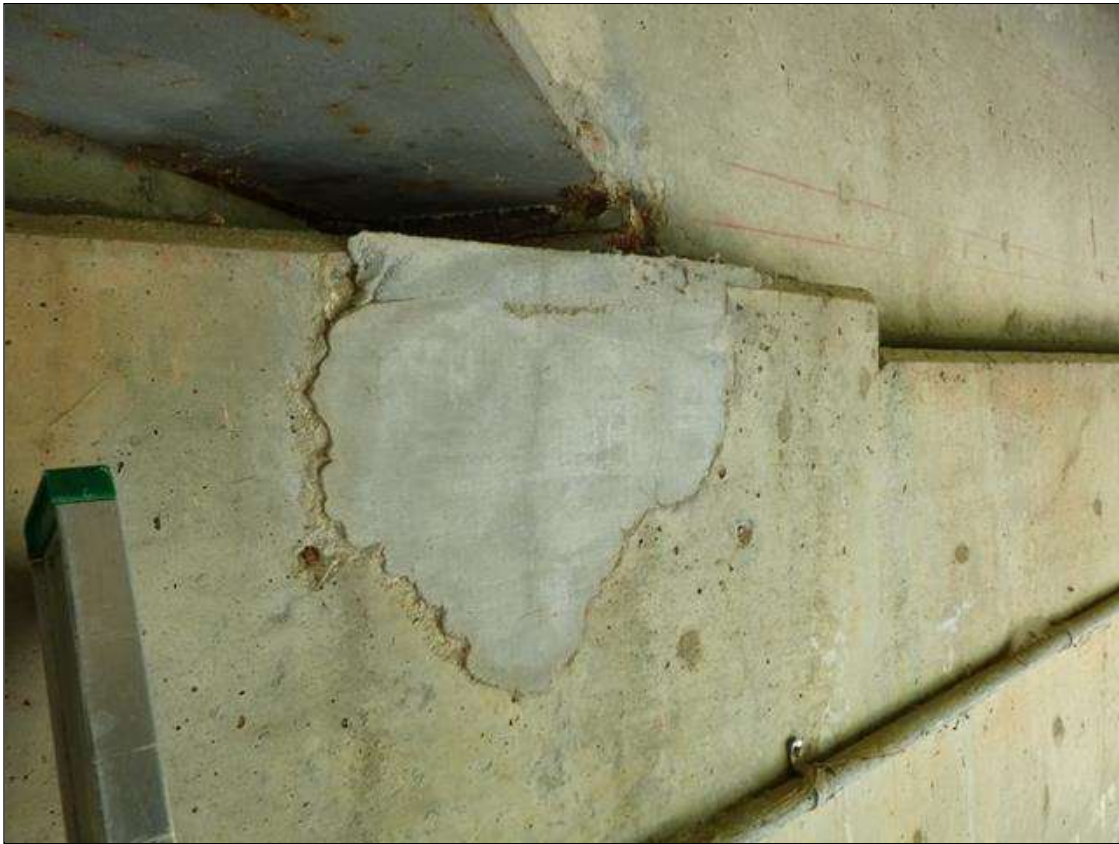
End Bent 1 Abutment/Backwall : (11) 9' VERTICAL CRACKS UP TO 1/32", AT AVERAGE 8' CENTERS, NORTH FACE OF ABUTMENT.

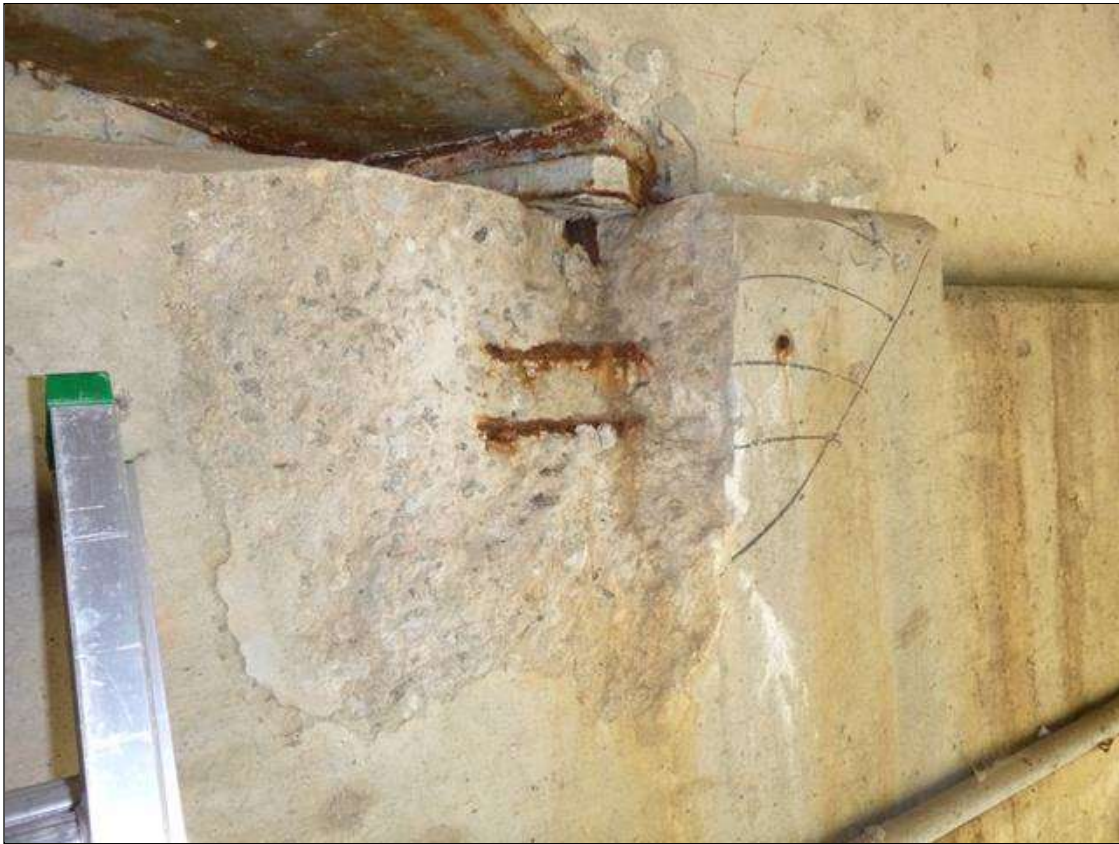
Span 1 Beam 3 Near Bearing : CORROSION WITH FRECKLED RUST THROUGHOUT.

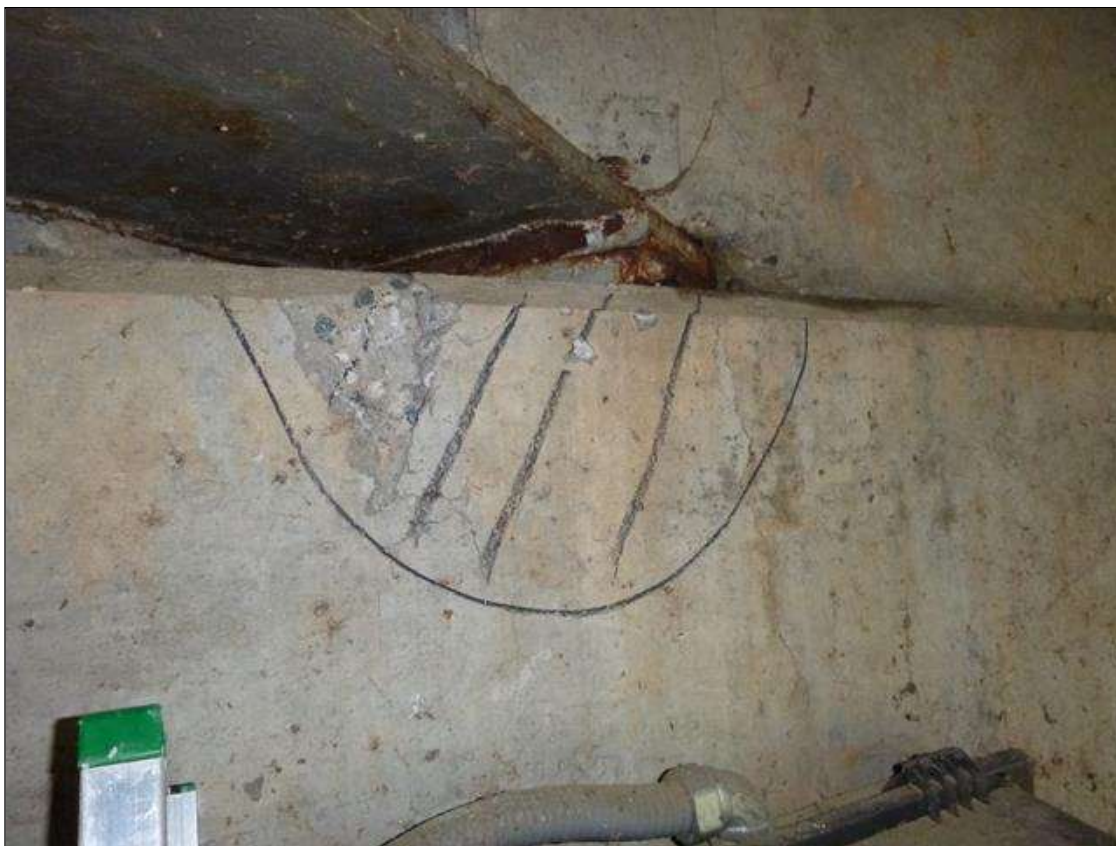
Span 1 Beam 4 Near Bearing : CORROSION WITH SURFACE RUST THROUGHOUT.

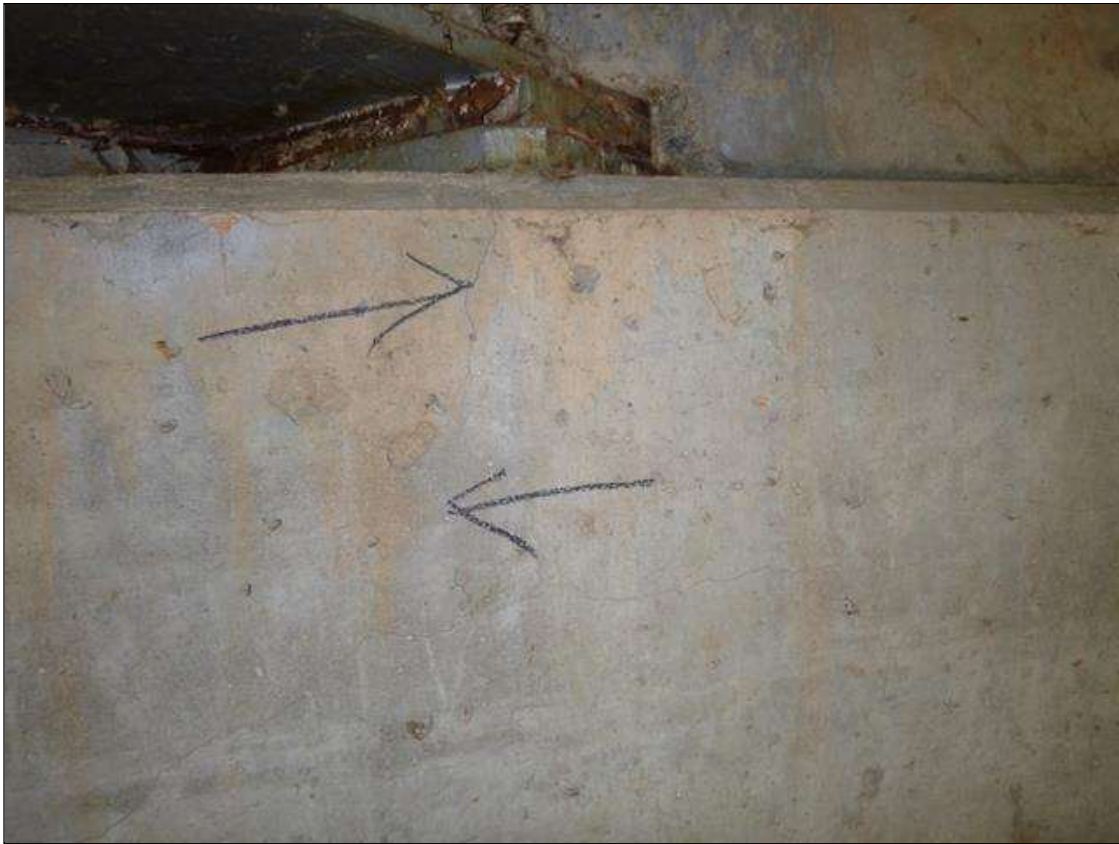
End Bent 1 Cap : 1' VERTICAL HAIRLINE CRACK BEGINNING AT TOP OF CAP, BELOW BEAM 6.

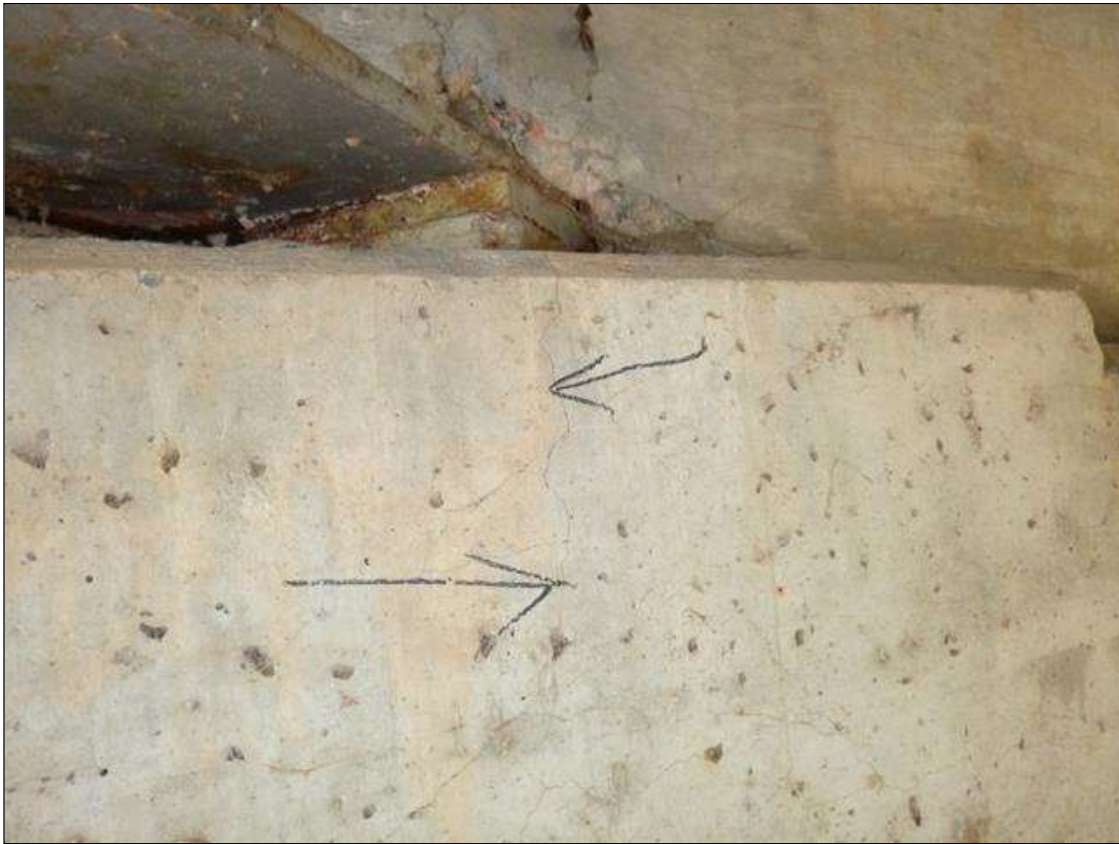
End Bent 1 Cap : 42' OF HAIRLINE MAP CRACKING, NORTH FACE OF CAP, BEGINNING AT BEAM 5.

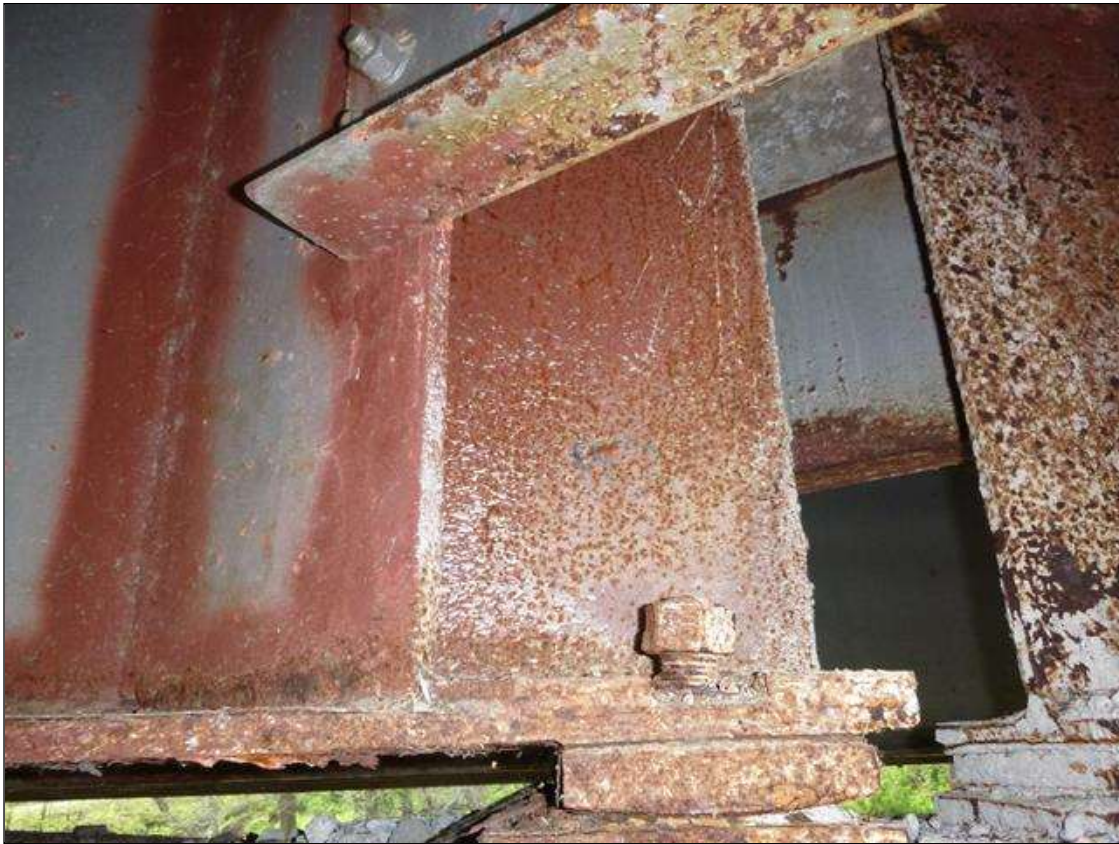
TEMPORARY REPAIR TO EAST BEARING STIFFENER.

Span 1 Beam 4: TEMPORARY REPAIR TO EAST BEARING STIFFENER.

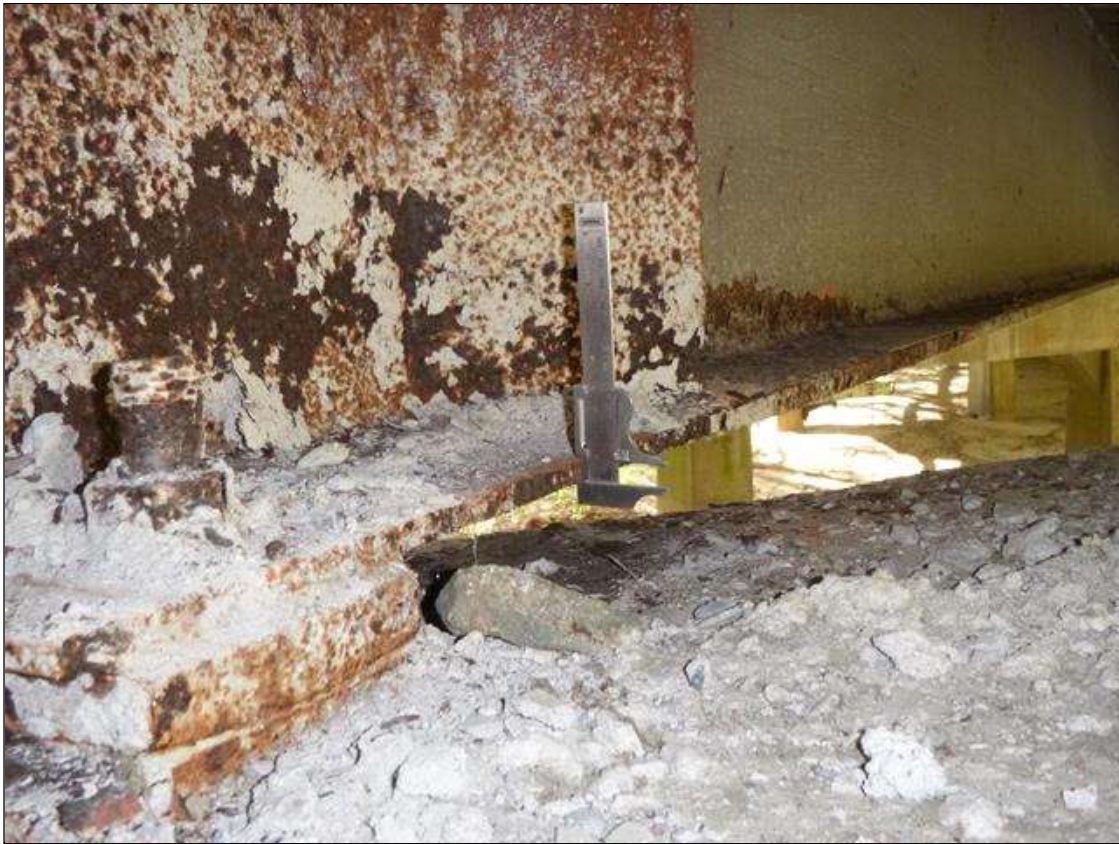
30" OF CORROSION WITH SECTION LOSS, 7/16" REMAINING ALONG BOTTOM FLANGE, AT BENT 1. (PM)

Span 2 Beam 5: 30" OF CORROSION WITH SECTION LOSS, 7/16" REMAINING ALONG BOTTOM FLANGE, AT BENT 1. (PM)

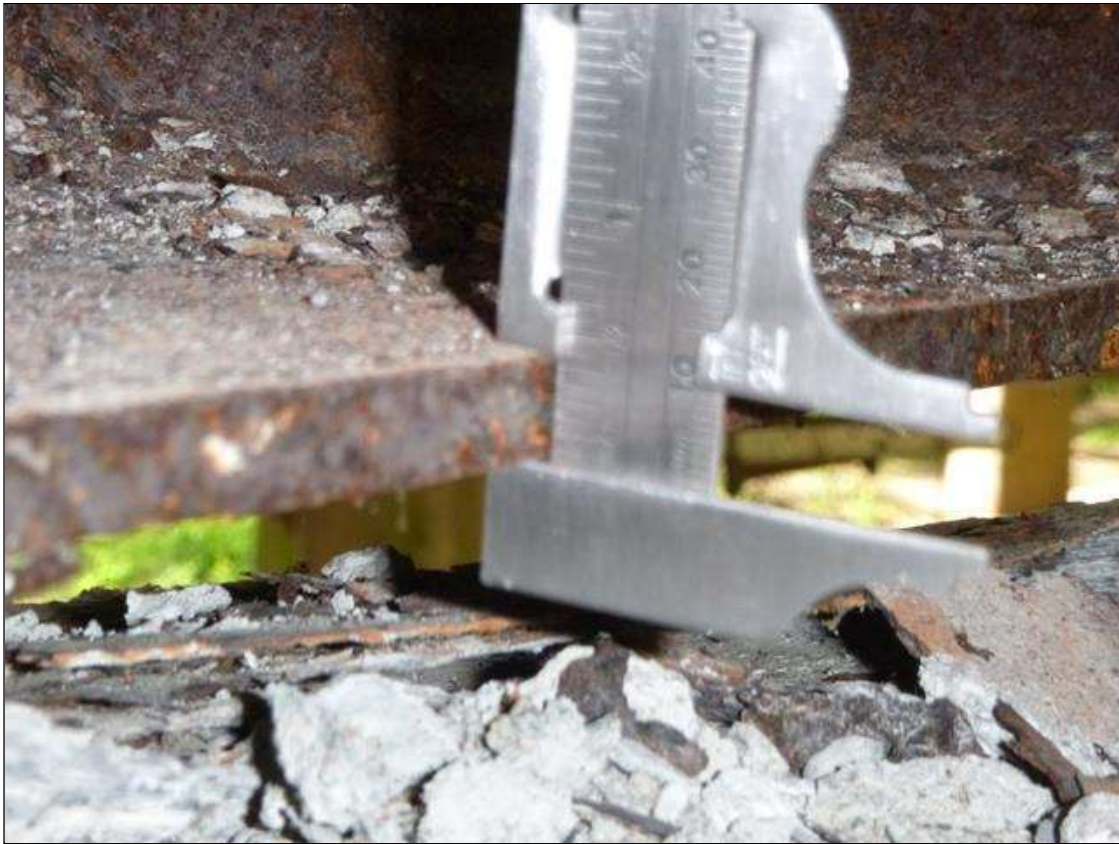
2' OF CORROSION WITH SECTION LOSS, 11/16" REMAINING ALONG BOTTOM FLANGE, AT BENT 1. (PM)

Span 1 Beam 6: 2' OF CORROSION WITH SECTION LOSS, 11/16" REMAINING ALONG BOTTOM FLANGE, AT BENT 1. (PM)

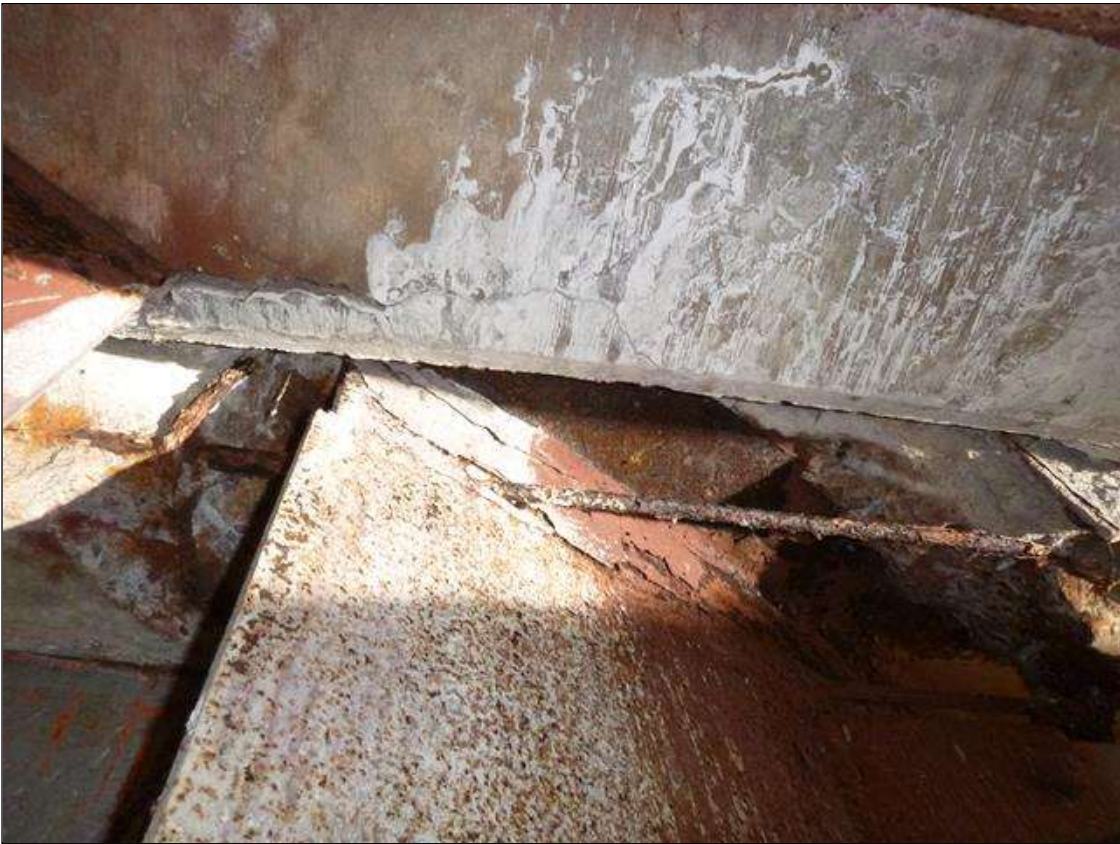
7.5' OF CORROSION WITH SECTION LOSS, 3/8" REMAINING ALONG BOTTOM FLANGE, EXTENDING UP TO 12" INTO WEB, AT BENT 1. (PM)

Span 2 Beam 6: 7.5' OF CORROSION WITH SECTION LOSS, 3/8" REMAINING ALONG BOTTOM FLANGE, EXTENDING UP TO 12" INTO WEB, AT BENT 1. (PM)

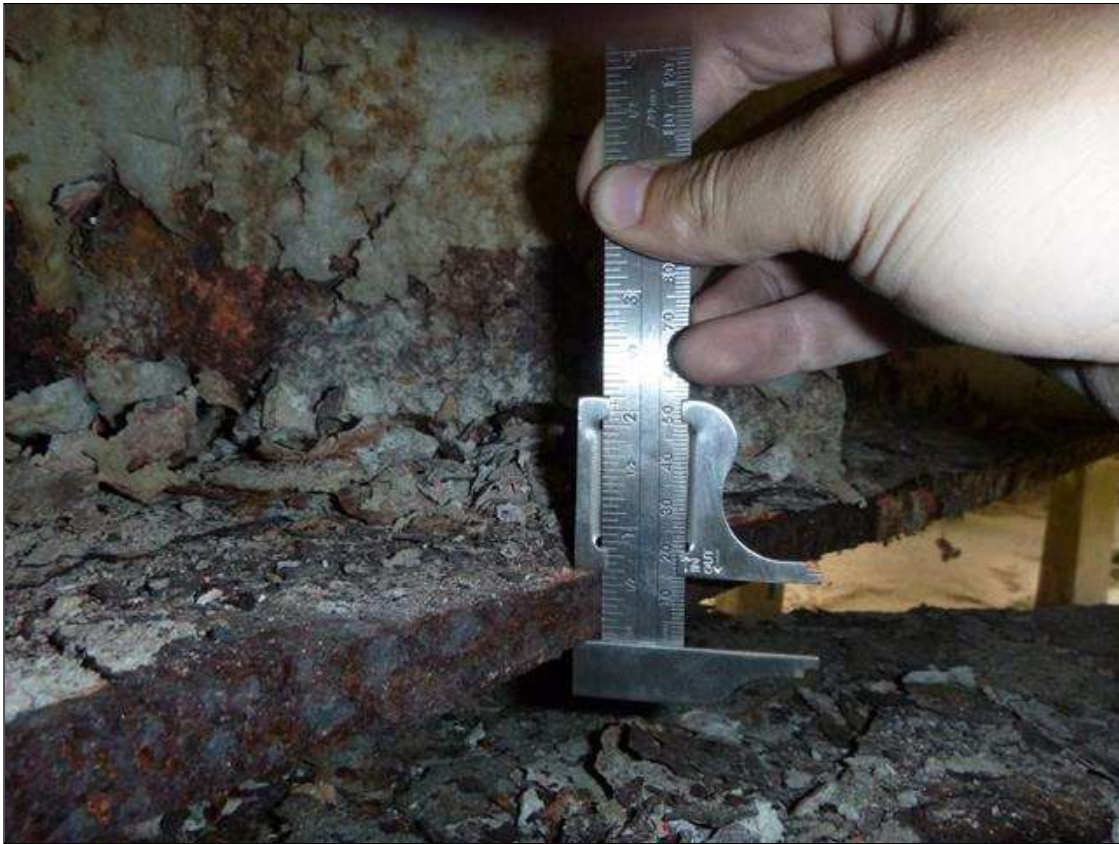
5' OF CORROSION WITH SECTION LOSS, 5/8" REMAINING, ALONG BOTTOM FLANGE EXTENDING INTO WEB, AT BENT 1. (PM)

Span 2 Beam 7: 5' OF CORROSION WITH SECTION LOSS, 5/8" REMAINING, ALONG BOTTOM FLANGE EXTENDING 6" INTO WEB, AT BENT 1. (PM)

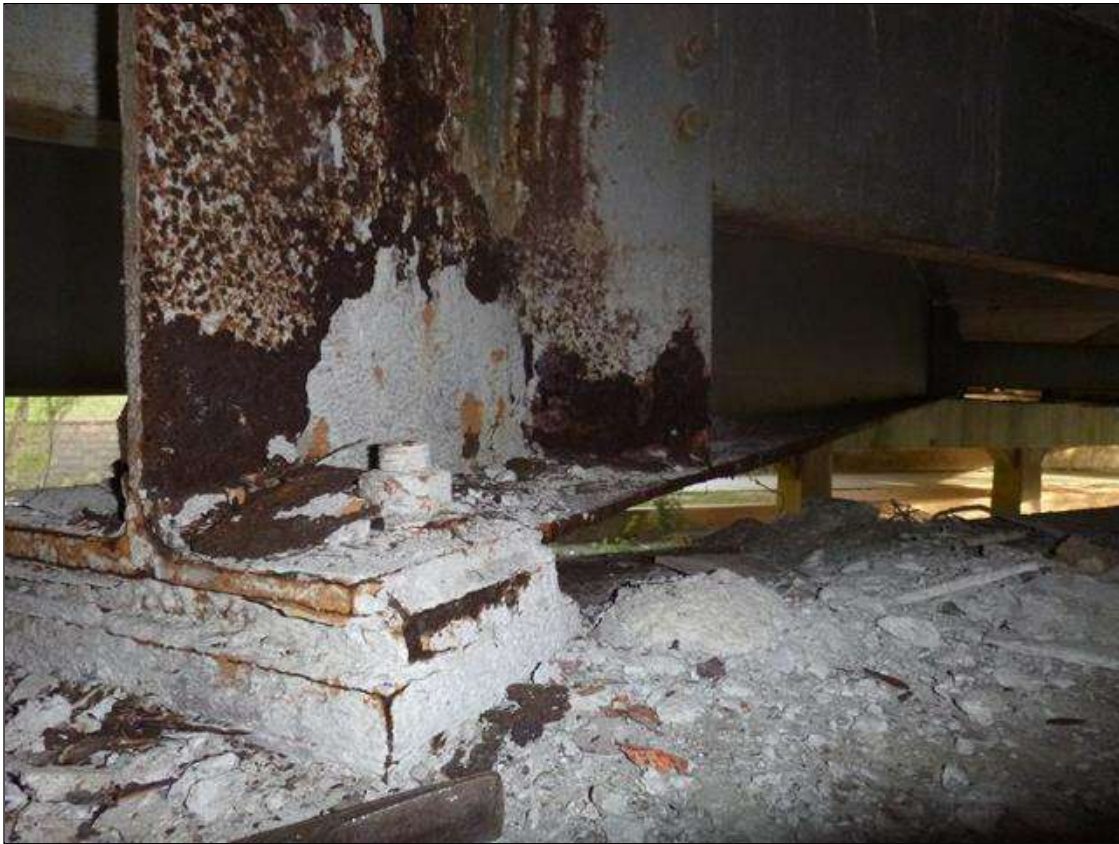
Span 3 Beam 1: 5' OF CORROSION WITH SECTION LOSS, 7/16" REMAINING ALONG BOTTOM FLANGE, 4.5' FROM BENT 2 BEARING. (PM)
