NC DEPARTMENT OF TRANSPORTATION  
DIVISION OF HIGHWAYS  
STRUCTURE MANAGEMENT UNIT

## Structure Safety Report

### Routine Element Inspection - Contract

COUNTY: WAKE STRUCTURE NUMBER: 910494 FREQUENCY: 24 MONTHS

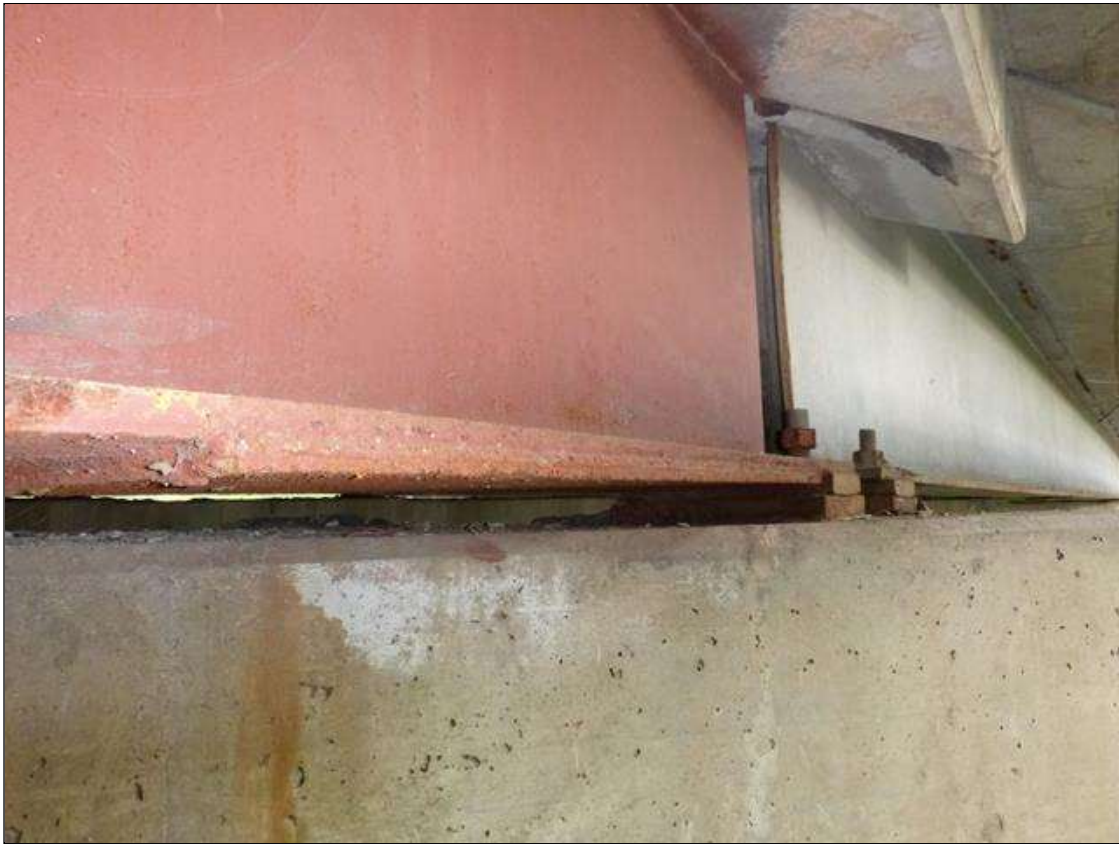
5' OF CORROSION WITH SECTION LOSS, 3/8" REMAINING ALONG BOTTOM FLANGE, 1' FROM BENT 2 BEARING.  
(PM)

Span 2 Beam 5: 5' OF CORROSION WITH SECTION LOSS, 3/8" REMAINING ALONG BOTTOM FLANGE, 1' FROM BENT 2 BEARING. (PM)

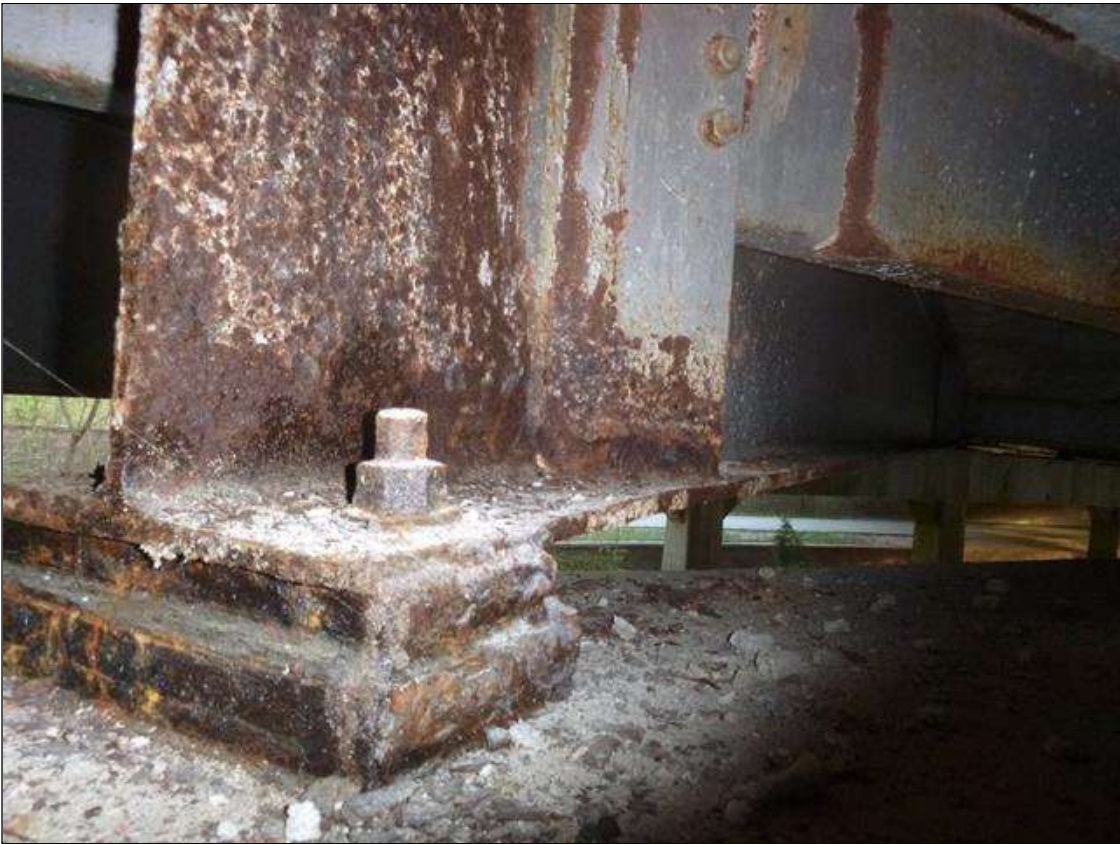
4' OF CORROSION WITH SECTION LOSS, 1/2" REMAINING ALONG BOTTOM FLANGE AT 8" FROM BEARING, WITH PITTING IN WEB, AT BENT 2. (PM)

Span 2 Beam 6: 4' OF CORROSION WITH SECTION LOSS, 1/2" REMAINING ALONG BOTTOM FLANGE WITH PITTING IN WEB 8" FROM BEARING, AT BENT 2. (PM)

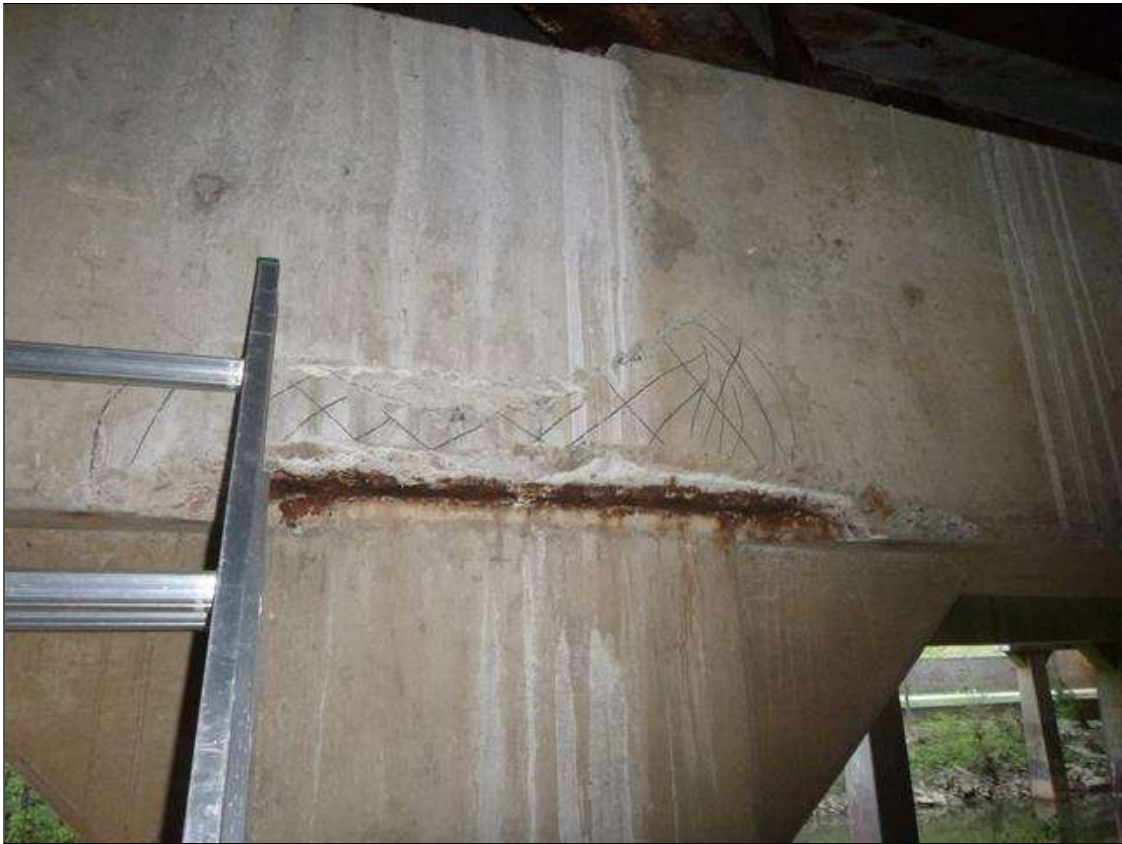
Bent 3 Cap : 48" X 15" X 4" DELAMINATION/SPALL WITH EXPOSED MAIN REINFORCING, BOTTOM CORNER OF NORTH FACE, ABOVE COLUMN 4. (PM)

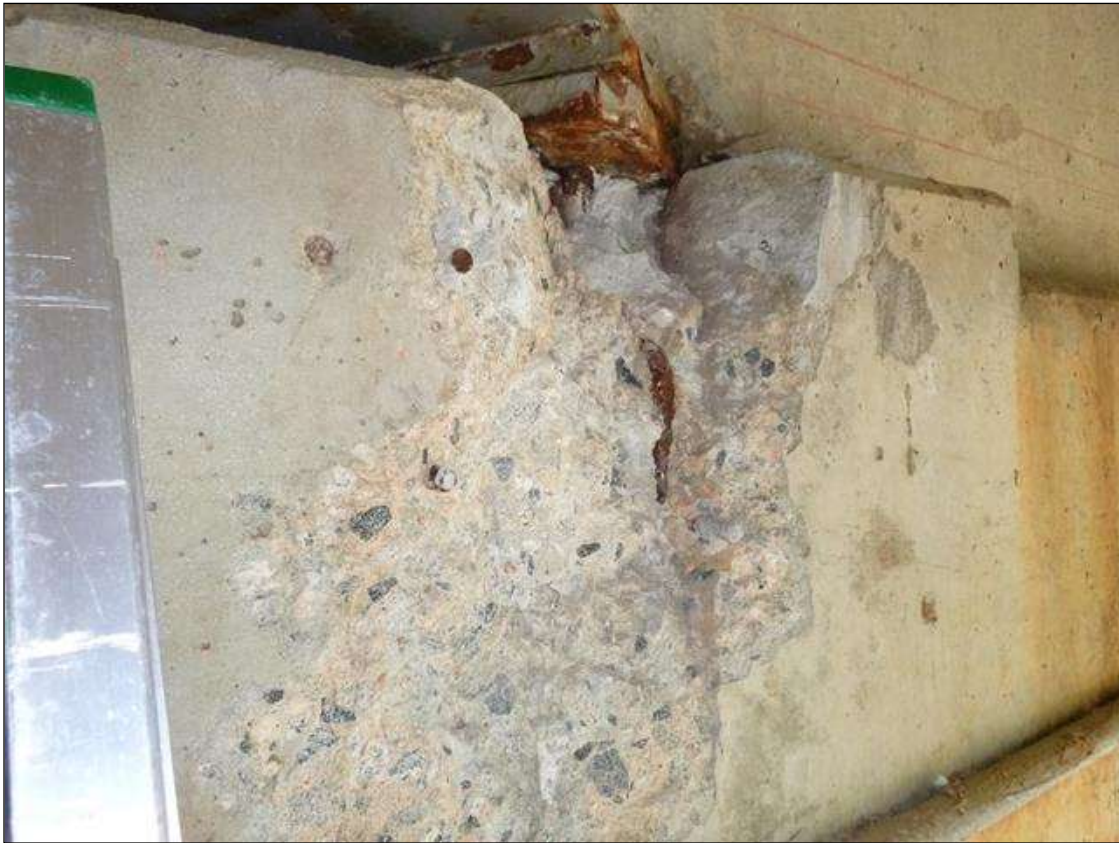
END BENT 1 CAP : 16" X 19" X 5.25" DEEP SPALL WITH EXPOSED REINFORCING, NORTH FACE, EXTENDING 3.75" UNDER BEAM 2 BEARING PLATE.

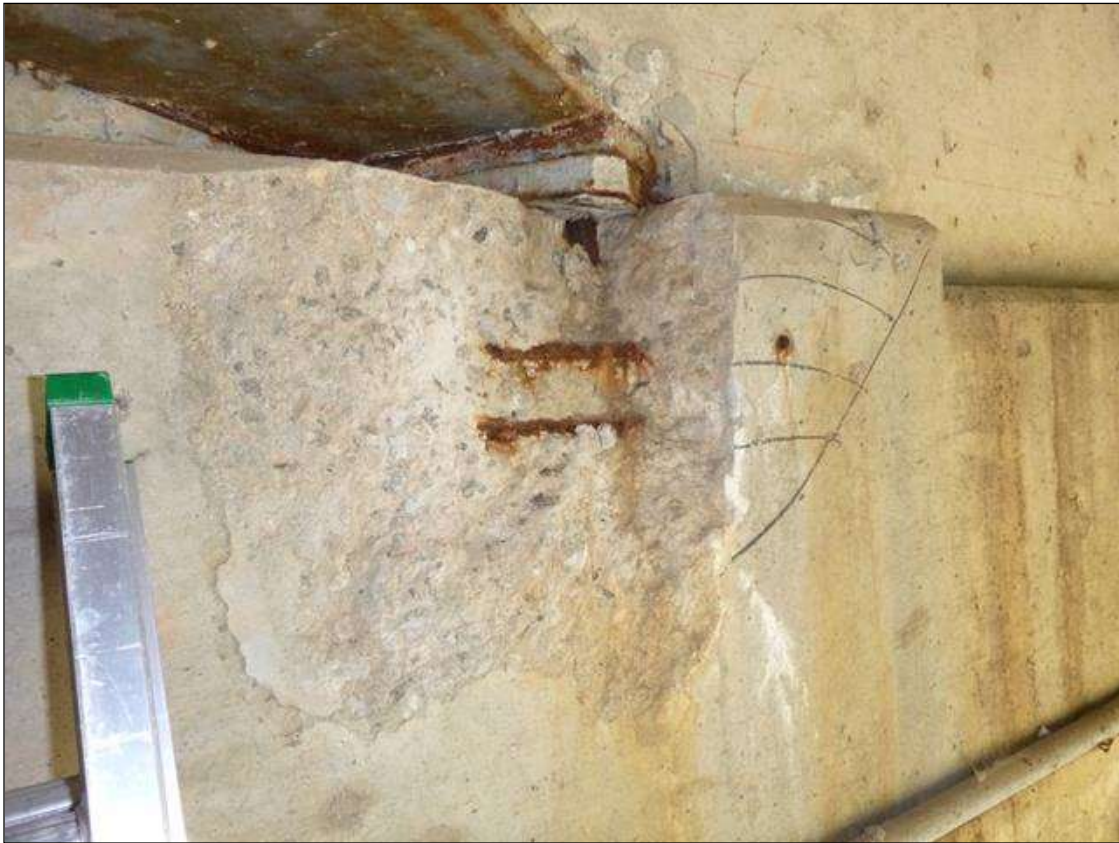
END BENT 1 CAP : 29" X 19" X 5.5" DEEP DELAMINATION/SPALL WITH EXPOSED REINFORCING, NORTH FACE, EXTENDING 3.5" UNDER BEM 4 BEARING PLATE.

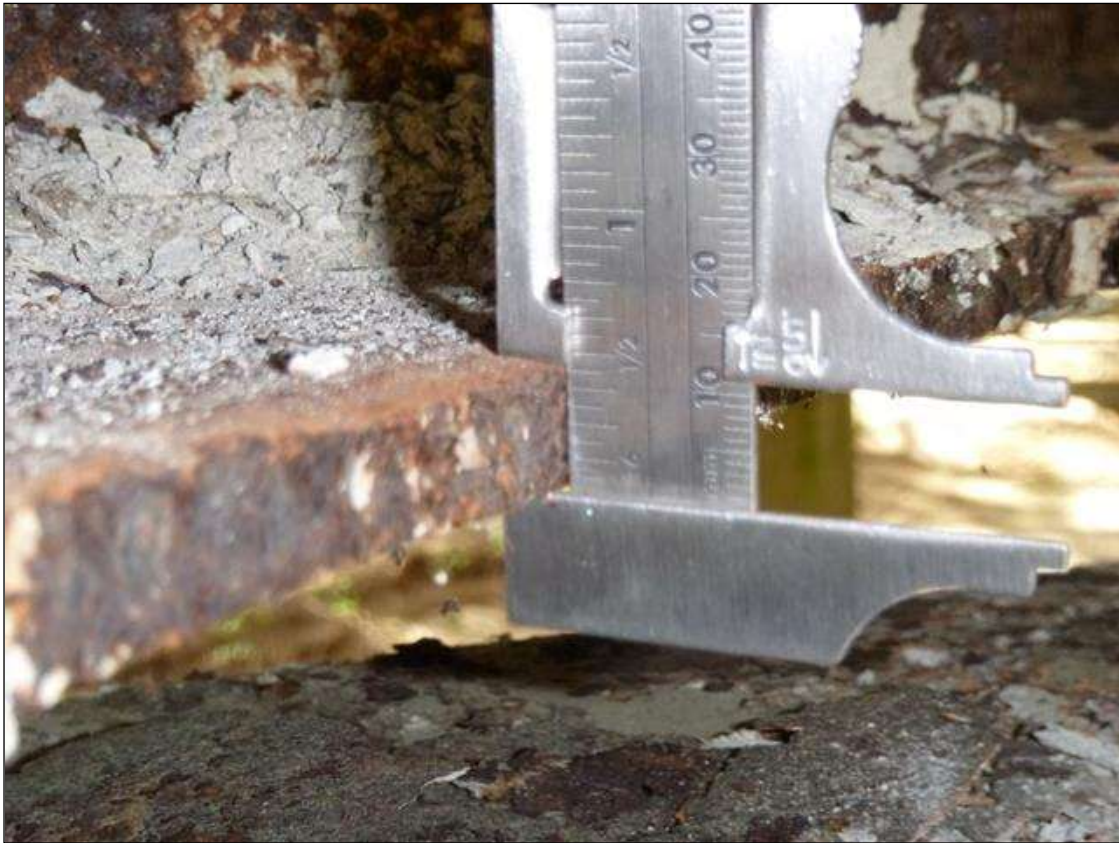
SPAN 2 BEAM 5: 30" OF CORROSION WITH SECTION LOSS, 7/16" REMAINING ALONG BOTTOM FLANGE, AT BENT 1.

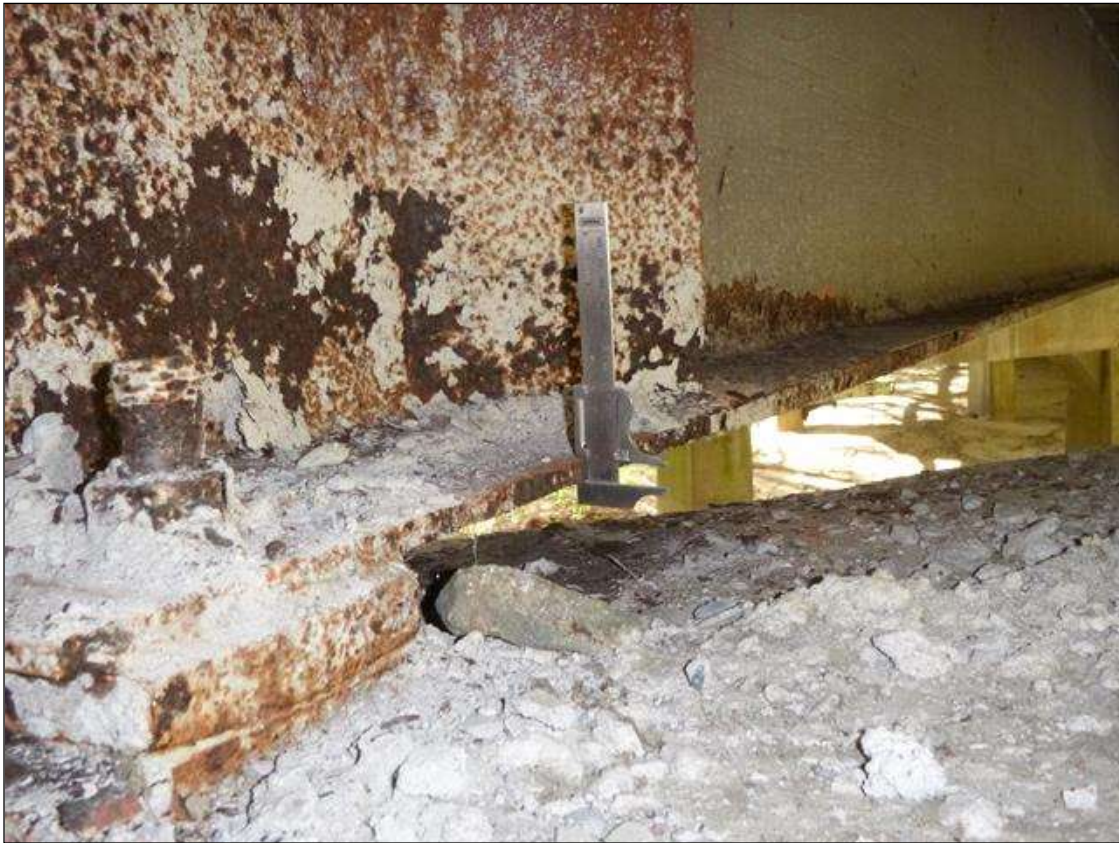
SPAN 2 BEAM 5: 30" OF CORROSION WITH SECTION LOSS, 7/16" REMAINING ALONG BOTTOM FLANGE, AT BENT 1.

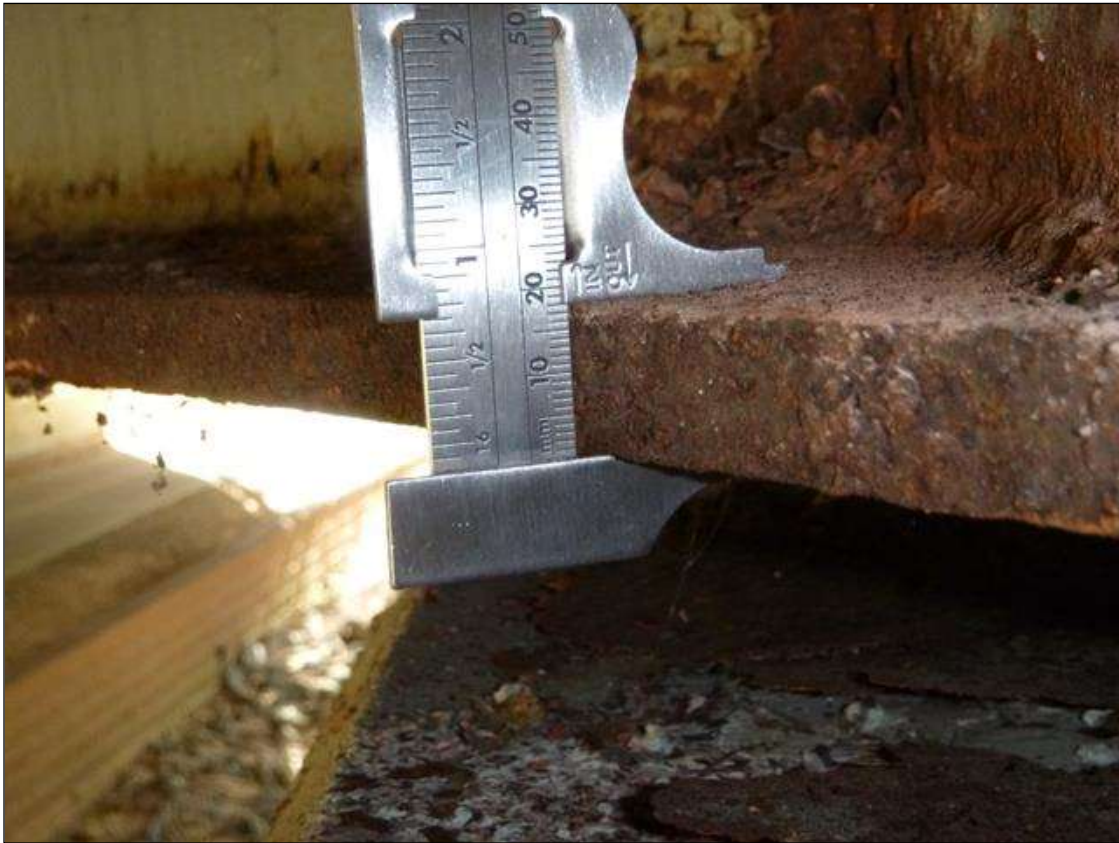
SPAN 1 BEAM 6: 2' OF CORROSION WITH SECTION LOSS, 11/16" REMAINING ALONG BOTTOM FLANGE, AT BENT 1.

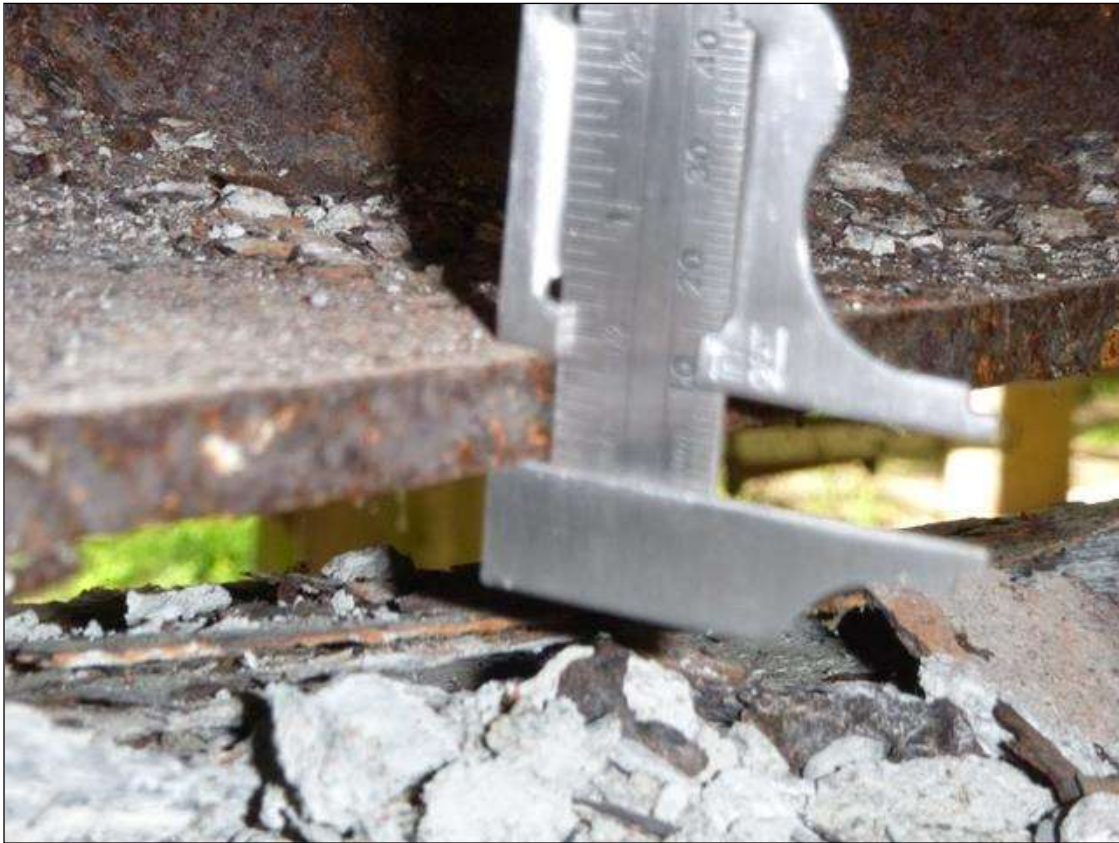
SPAN 2 BEAM 6: 7.5' OF CORROSION WITH SECTION LOSS, 3/8" REMAINING ALONG BOTTOM FLANGE, EXTENDING UP TO 12" INTO WEB, AT BENT 1.

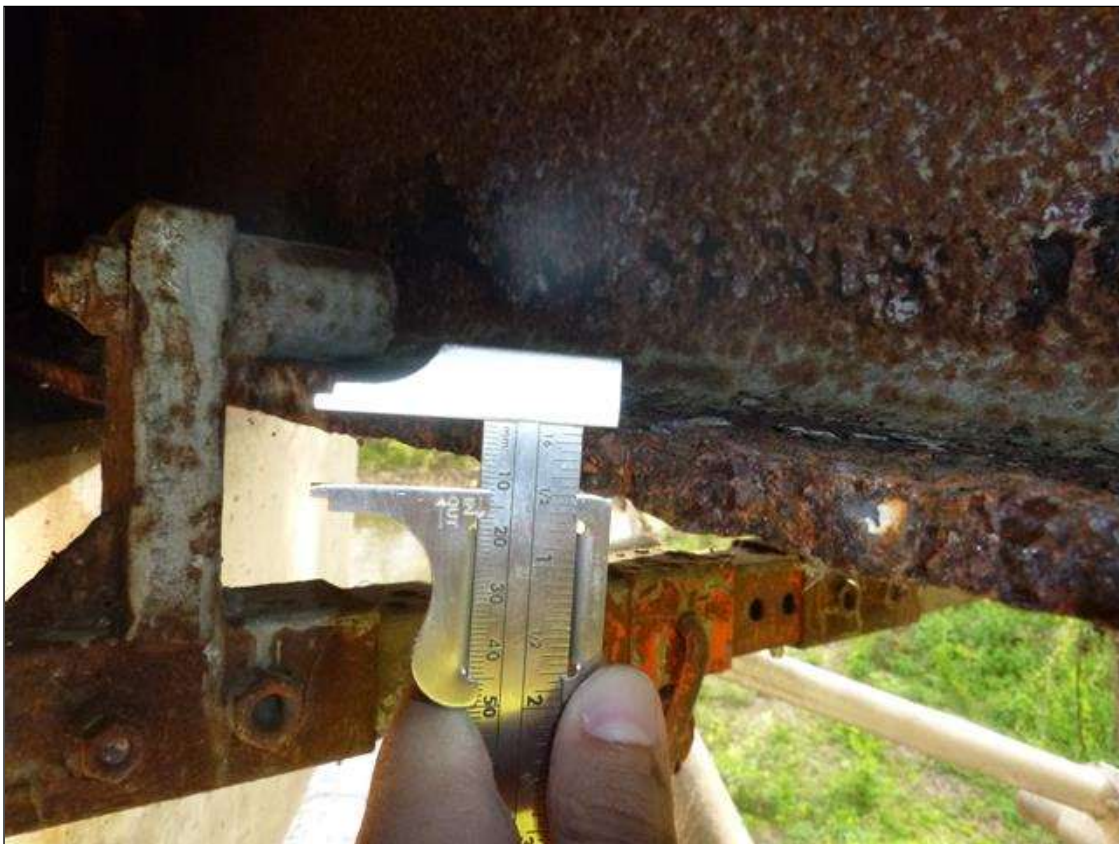
SPAN 3 BEAM 1: 5' OF CORROSION WITH SECTION LOSS, 7/16" REMAINING ALONG BOTTOM FLANGE, 4.5' FROM BENT 2 BEARING.
