APPENDIX D.2B: PHOTOGRAPHS - HIGH BENT SPANS

High Bent Span Photographs - Set D.2B

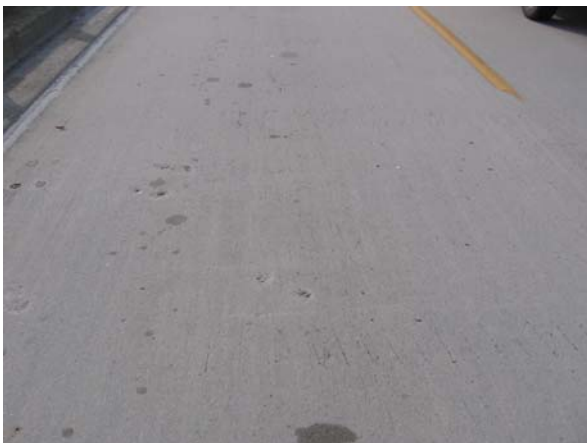
Span 129-130, mapped cracking at North end

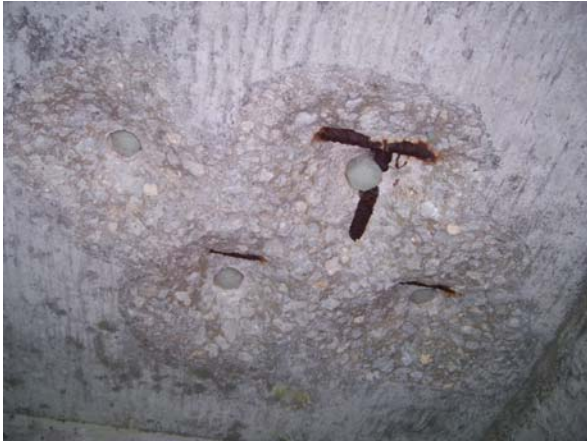
Span 129-130, spall & ER at North end

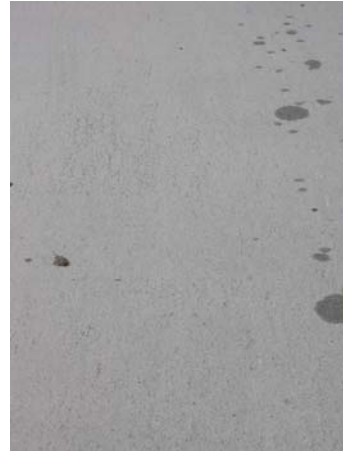
Span 129-130: mapped cracking south end

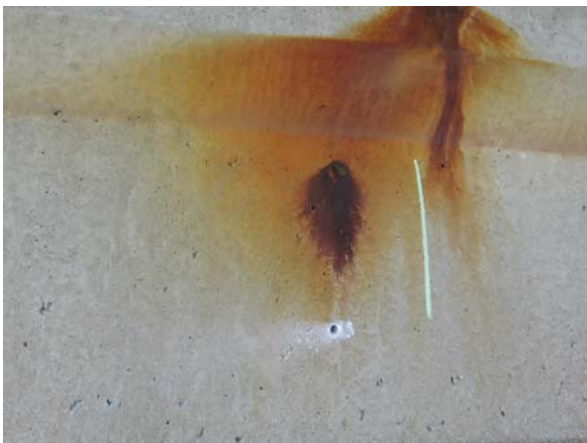
Span 131-132, Corroded Aggregate in girder

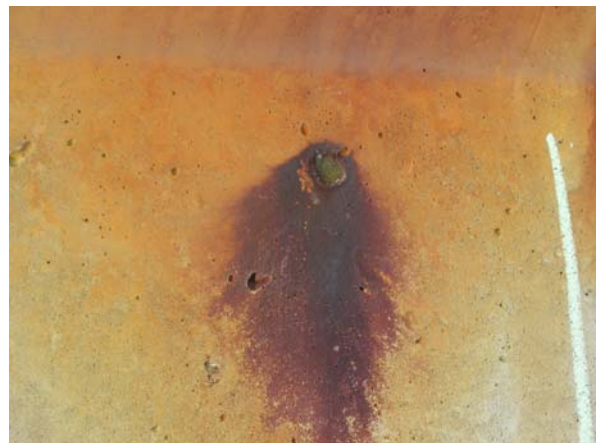
Span 131-132, Corroded Aggregate in girder

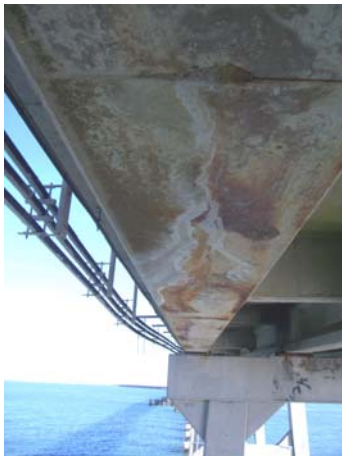
Span 131-132; CSagg along Girder bottom, typ.

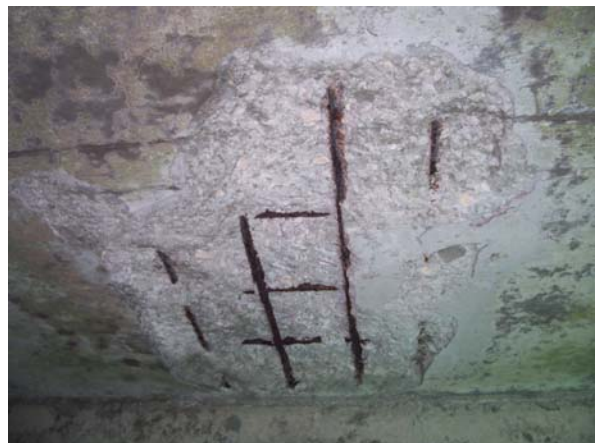
Span 134-135; SP & ER at soffit South end

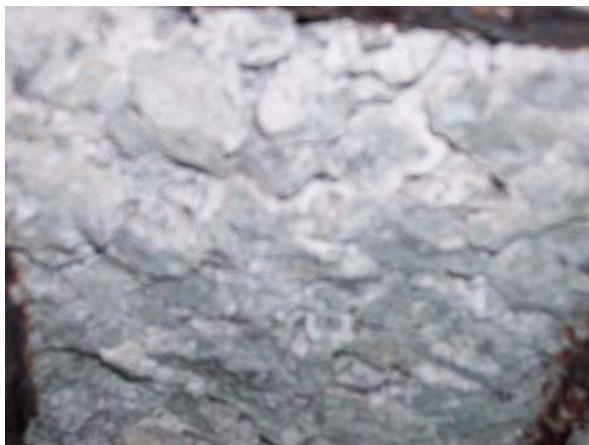
Span 134-135; SP & ER at soffit South end

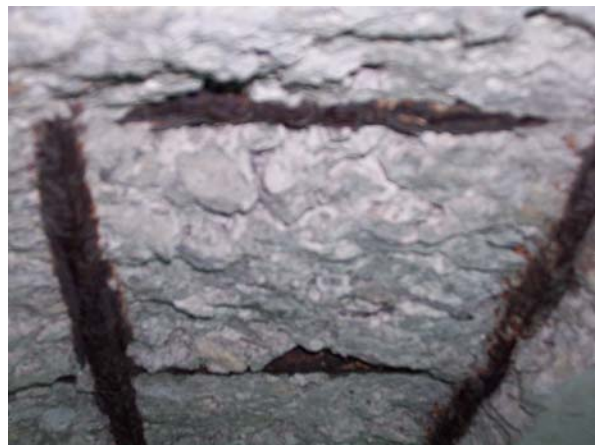
Span 134-135; SP & ER at soffit South end

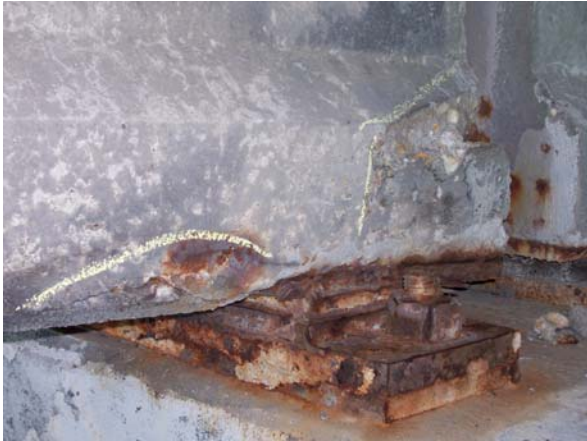
Span 134-135; SP & ES at Grder #2, East side,

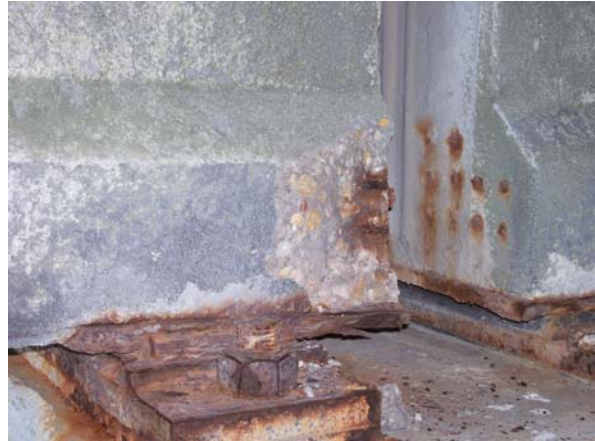
Span 134-135; SP at girder #2, East side, North

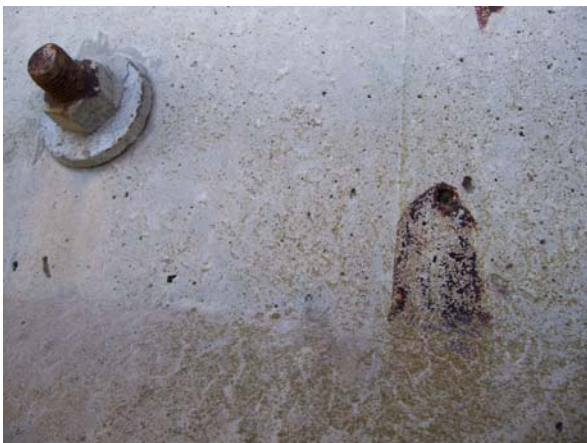
Span 139-140; CSagg on Girder #1, East side,

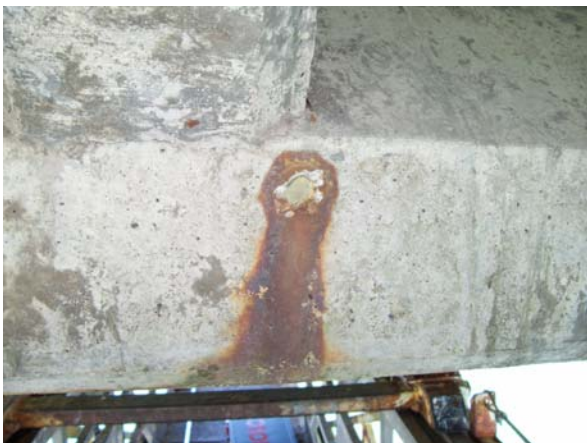
Span 149-150; CS agg on Girder #2, East side,

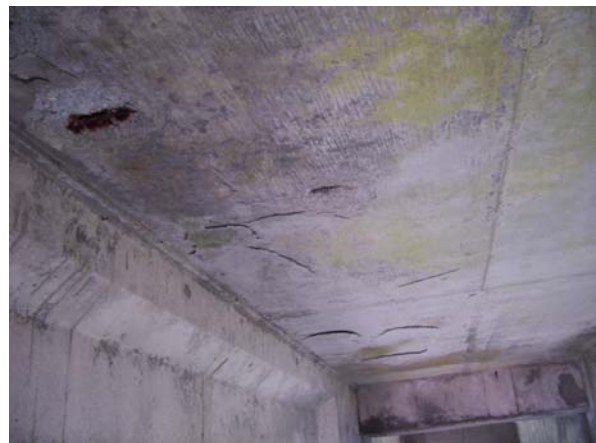
Span 149-150; ER on soffit, West bay, North

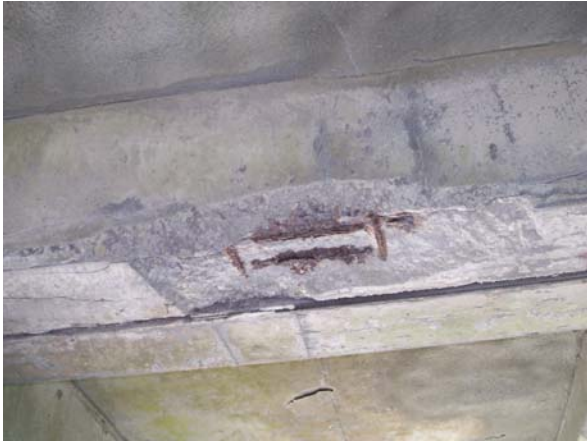
Span 149-150; SP & ER on soffit EJ Beam,

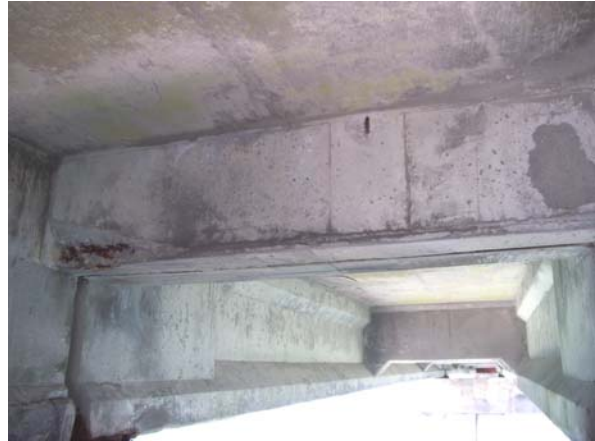
Span 149-150; SP & ER on soffit EJ Beam, West

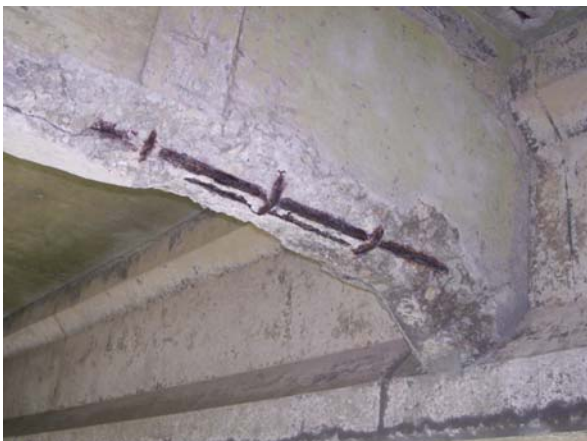
Span 160-161; SP & ER on South diaphragm,

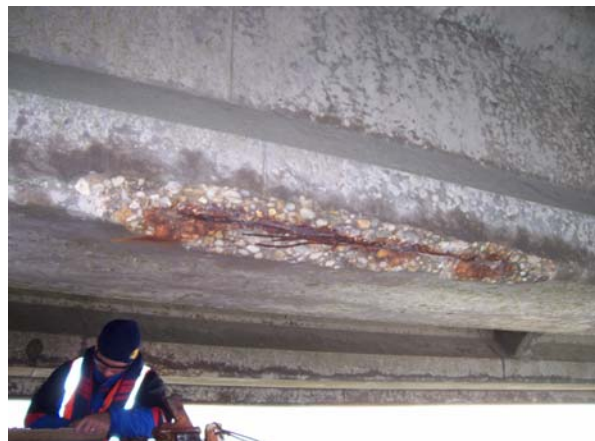
Span 160-161; SP & ES on Girder #2, East side,

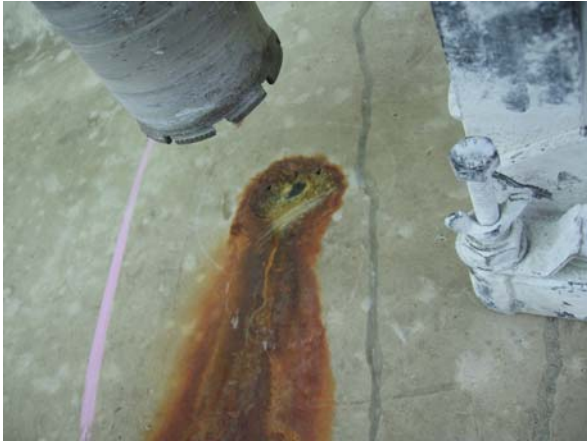
Span 161-162, Girder #3 corroded aggregate

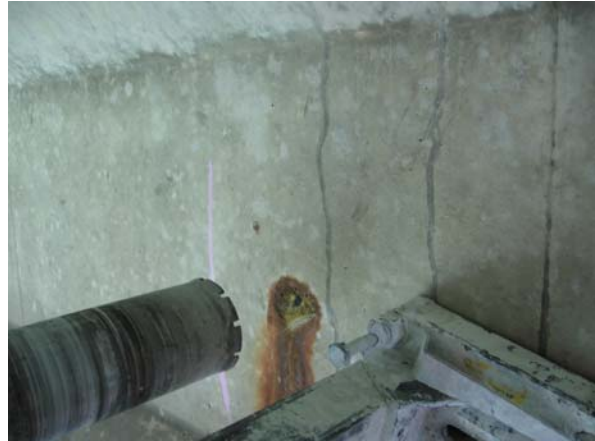
Span 161-162, Girder #3 corroded aggregate

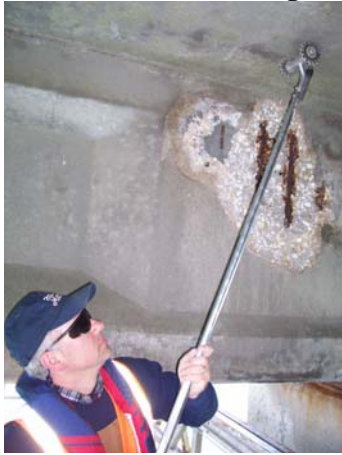
Span 161-162; SP & ER on Girder #1, West side,

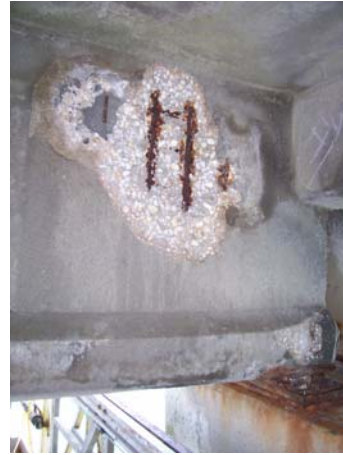
Span 161-162; SP & ER on Girder #1, West side,

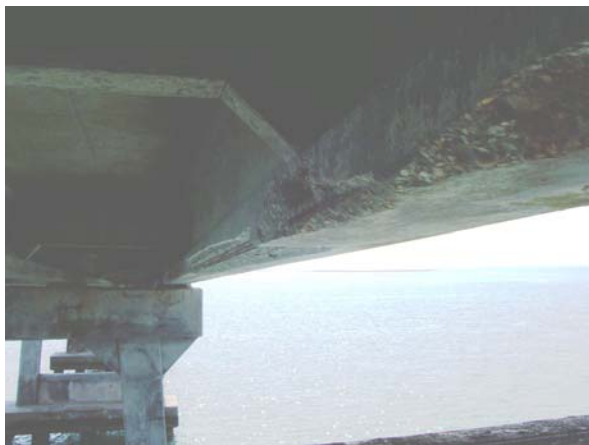
Span 161-162; SP & ESx5 on Girder #4, East

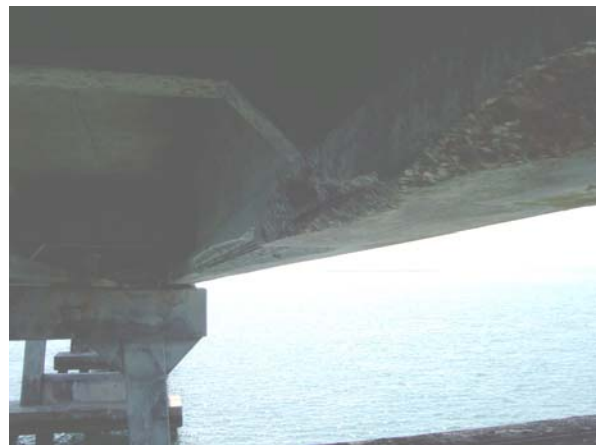
Span 161-162; SP & ESx5 on Girder #4, East

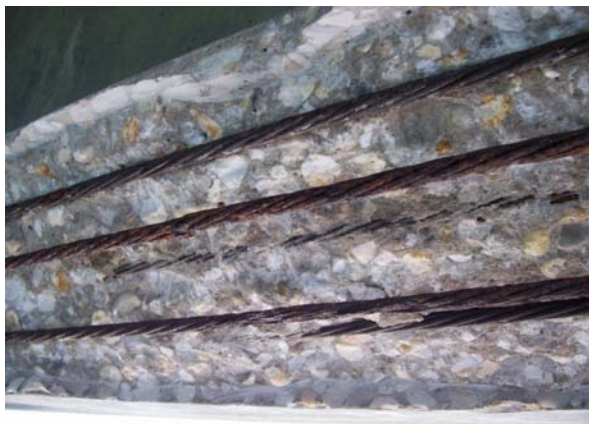
Span 161-162; SP & ESx5 on Girder #4, East

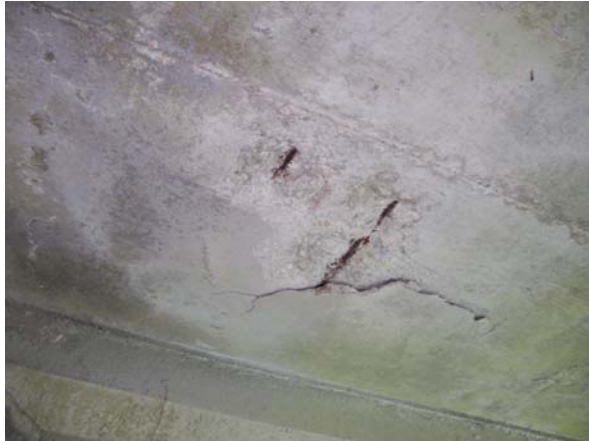
Span 162-163; SP & ER on soffit, East bay,

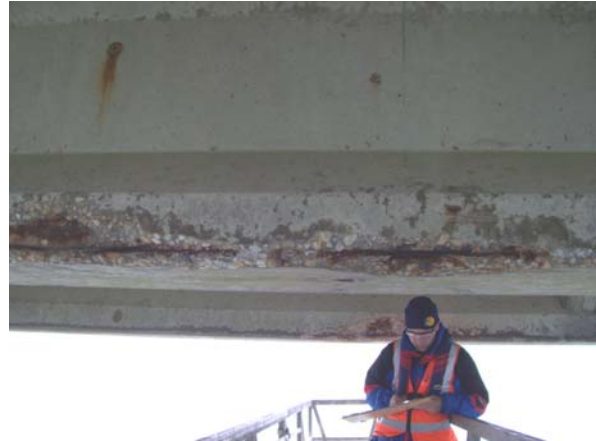
Span 162-163; SP & ES on Girder #3, East side,
