APPENDIX D.2D: PHOTOGRAPHS - APPROACH BENT SPANS

Approach Bent Span Photographs - Set D.2D

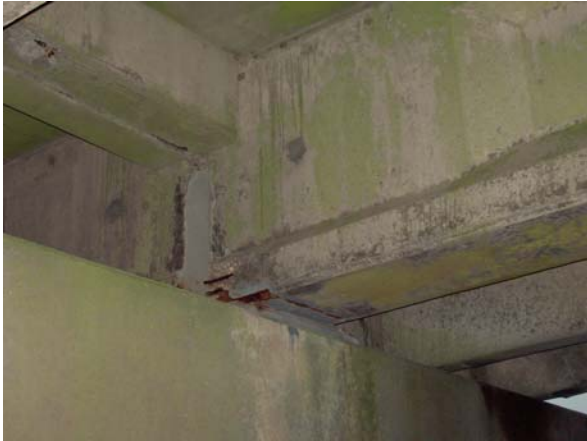
Bent 5, Girder #1: SP & ES south face

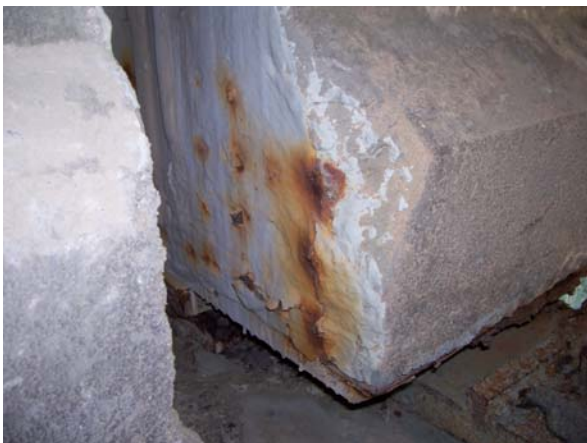
Span 48; Showing cracking at end of girder

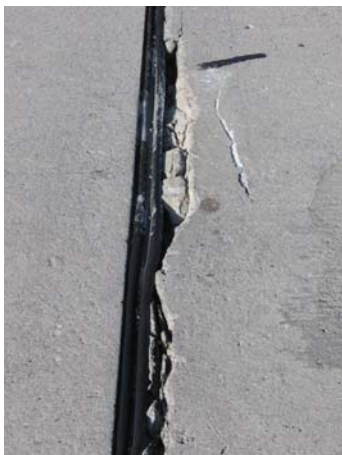
Span 116; deck surface; bad raveled edge
