**REPORT OF
UNDERWATER INVESTIGATION
OF
THE HERBERT C. BONNER BRIDGE
OVER
OREGON INLET**

**Final Report Date: SEPTEMBER 19, 2006
Prepared for: ALPHA & OMEGA GROUP
By: H.W. LOCHNER, INC.**

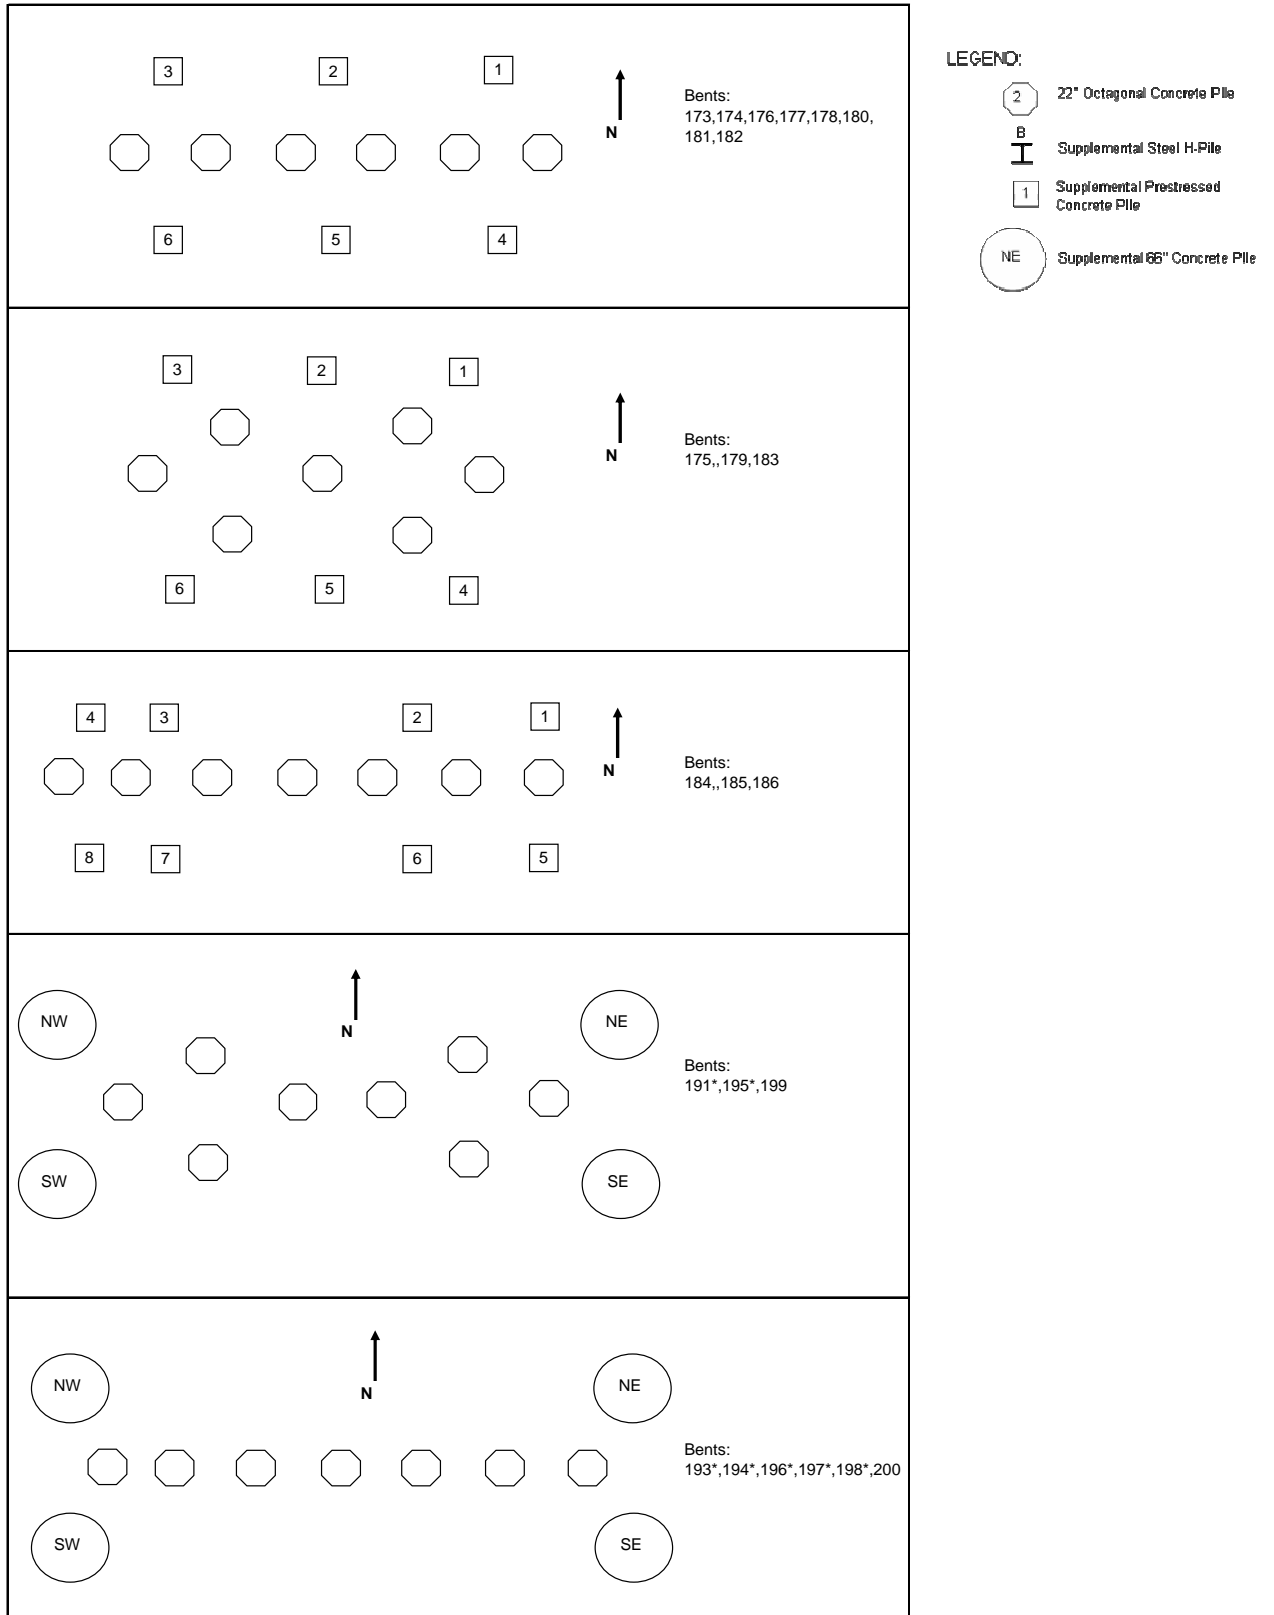
* - These bents also have deteriorated/ineffective steel H-pile and cap crutch bents in place (not shown)

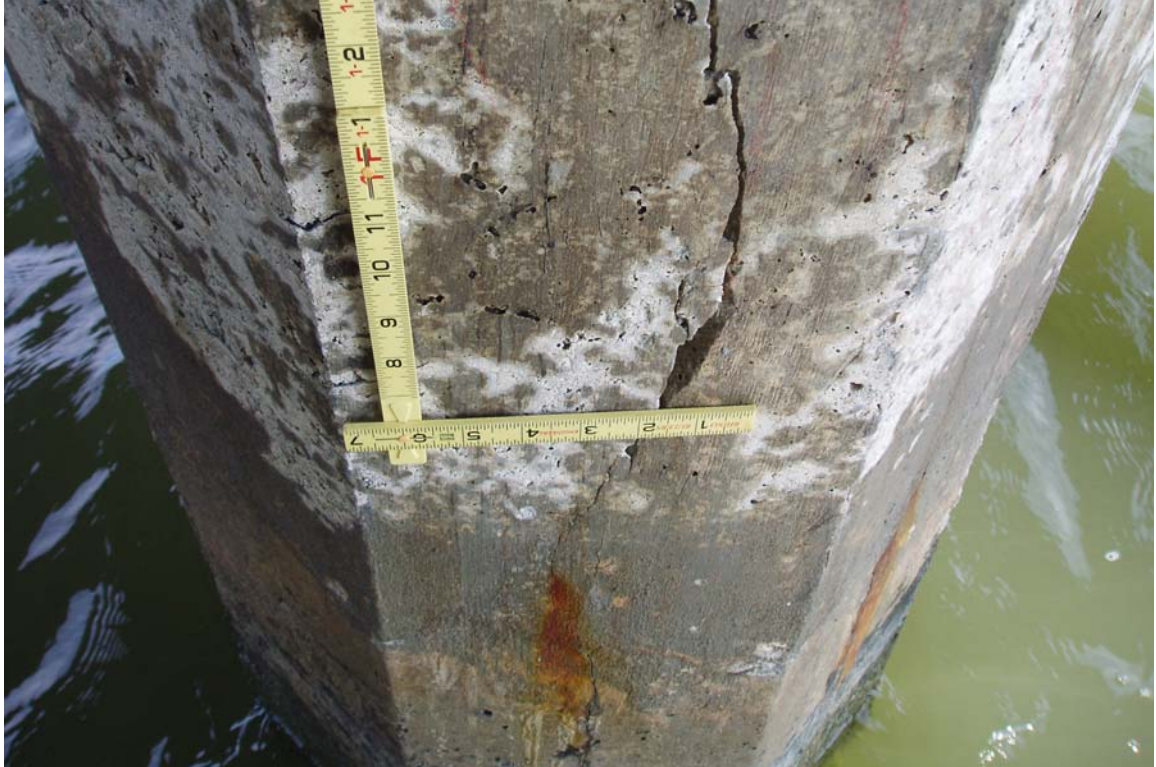
**PHOTO 1: CRACKING TO 1/8 IN. WIDE WITH CORROSION STAINS AT PILE 3 OF
BENT 95**

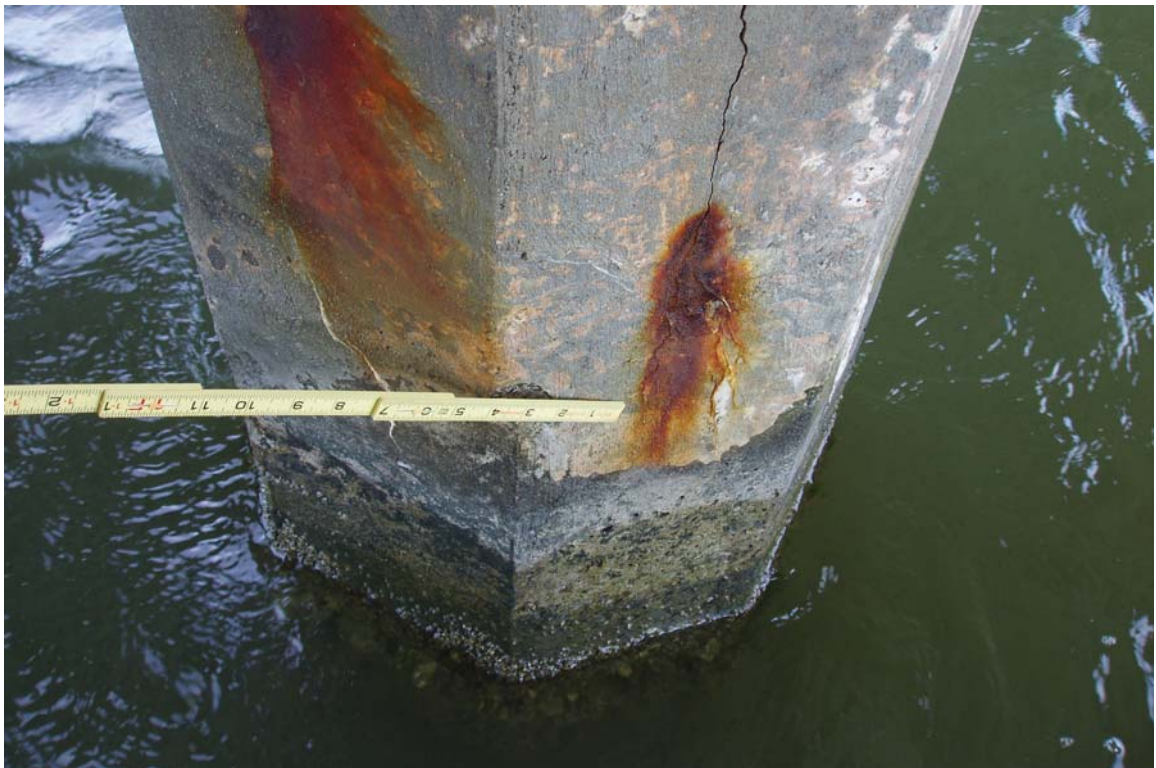
**PHOTO 2: CRACKING TO 1/8 IN. WIDE WITH CORROSION STAINS AT PILE 4 OF
BENT 95**

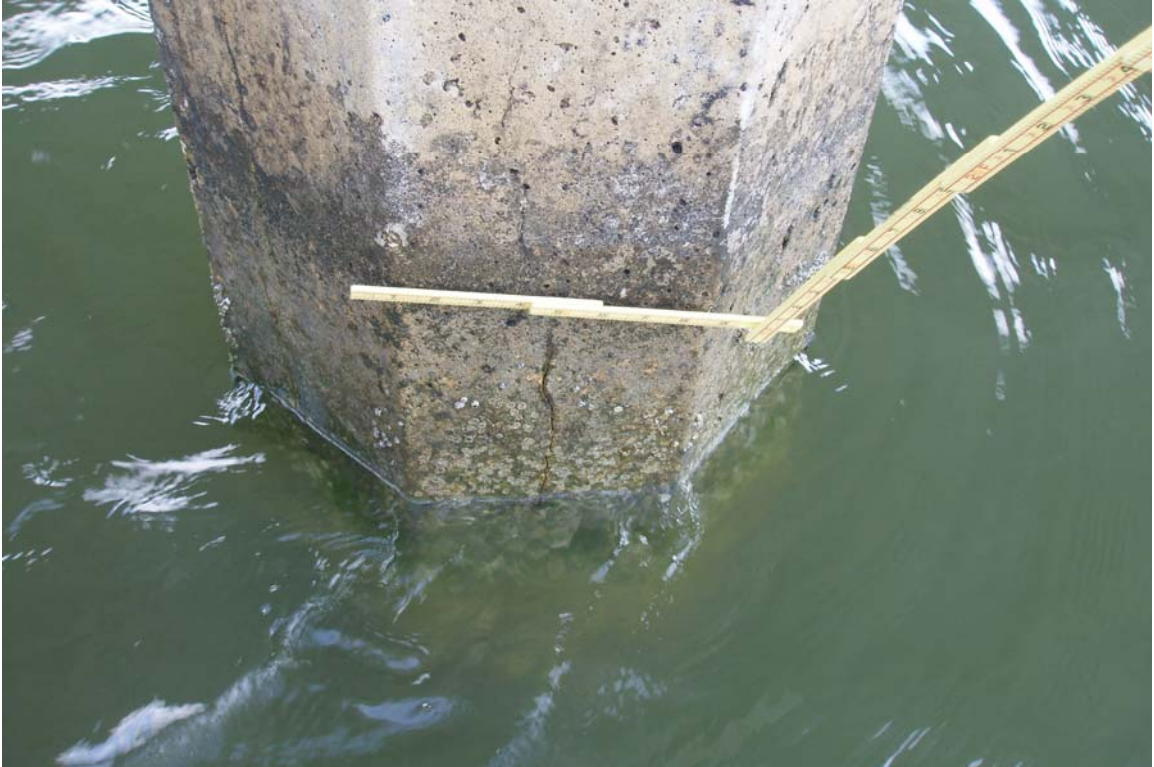
PHOTO 3: TYPICAL VERTICAL CRACKING AT PILE 1 OF BENT 106

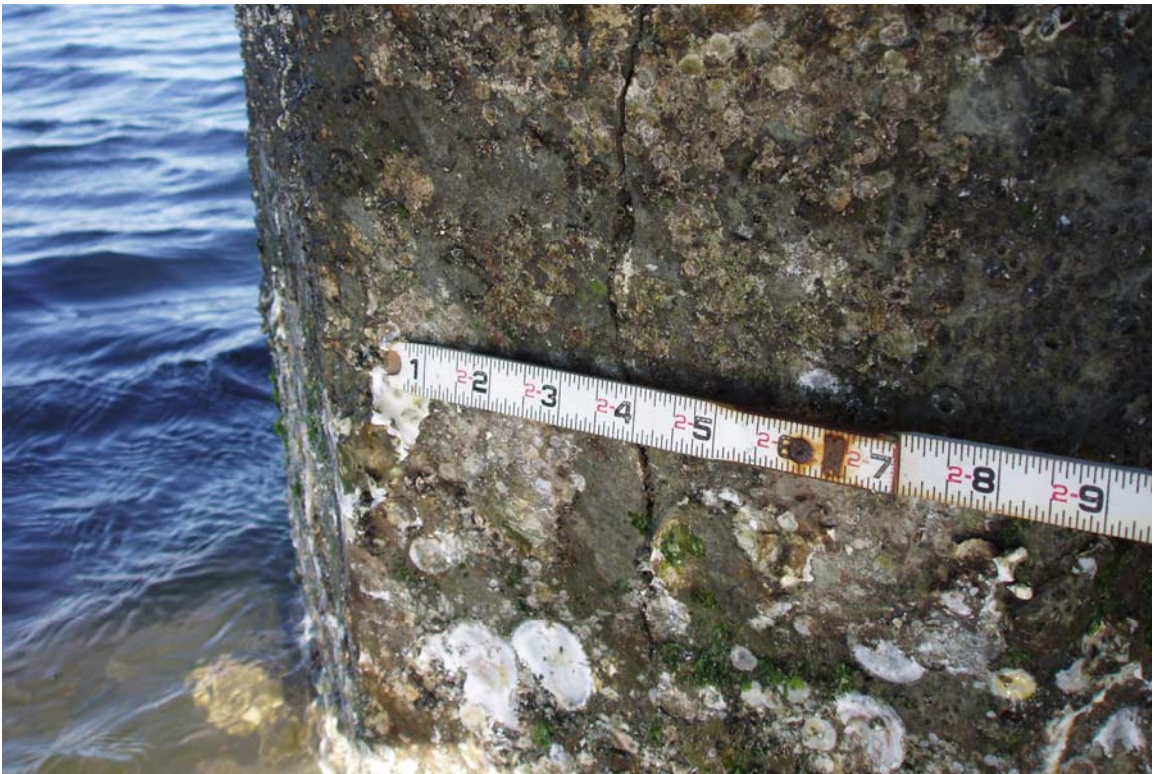
PHOTO 4: TYPICAL VERTICAL CRACKING AT PILE 6 OF BENT 55

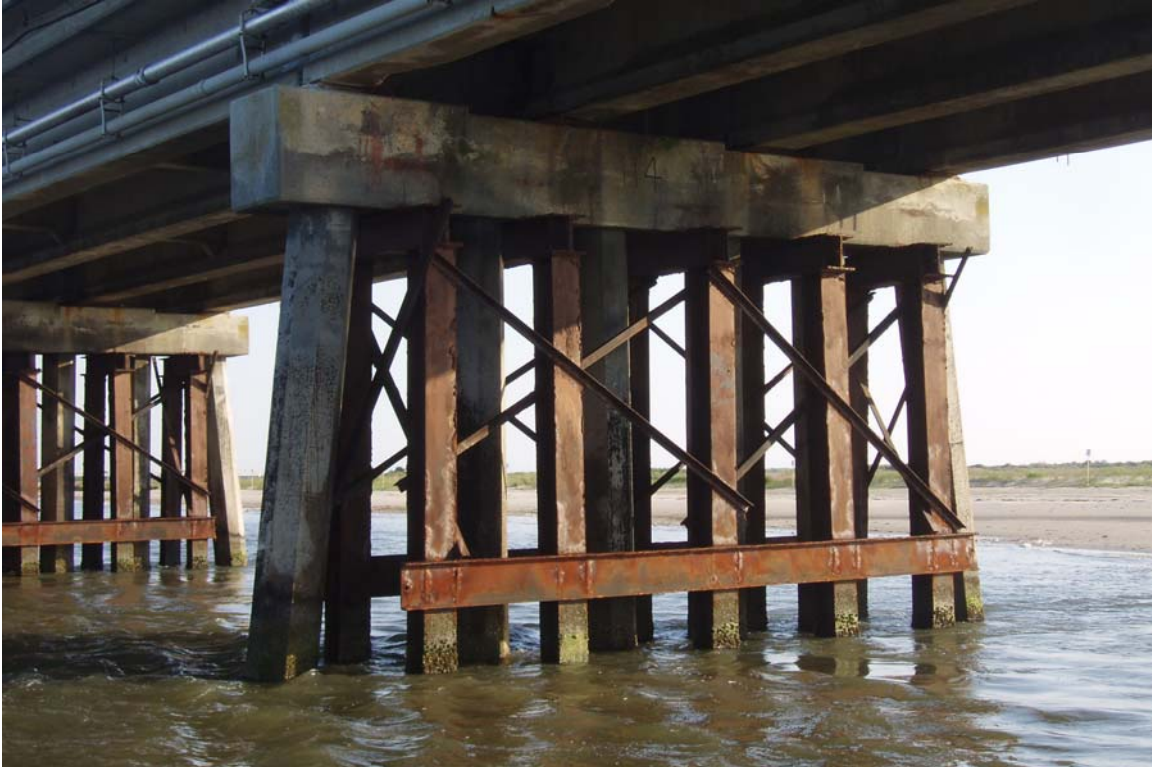
**PHOTO 5: TYPICAL CONFIGURATION OF APPROACH BENT SUPPLEMENTED
WITH H-PILES (BENT 115 SHOWN)**

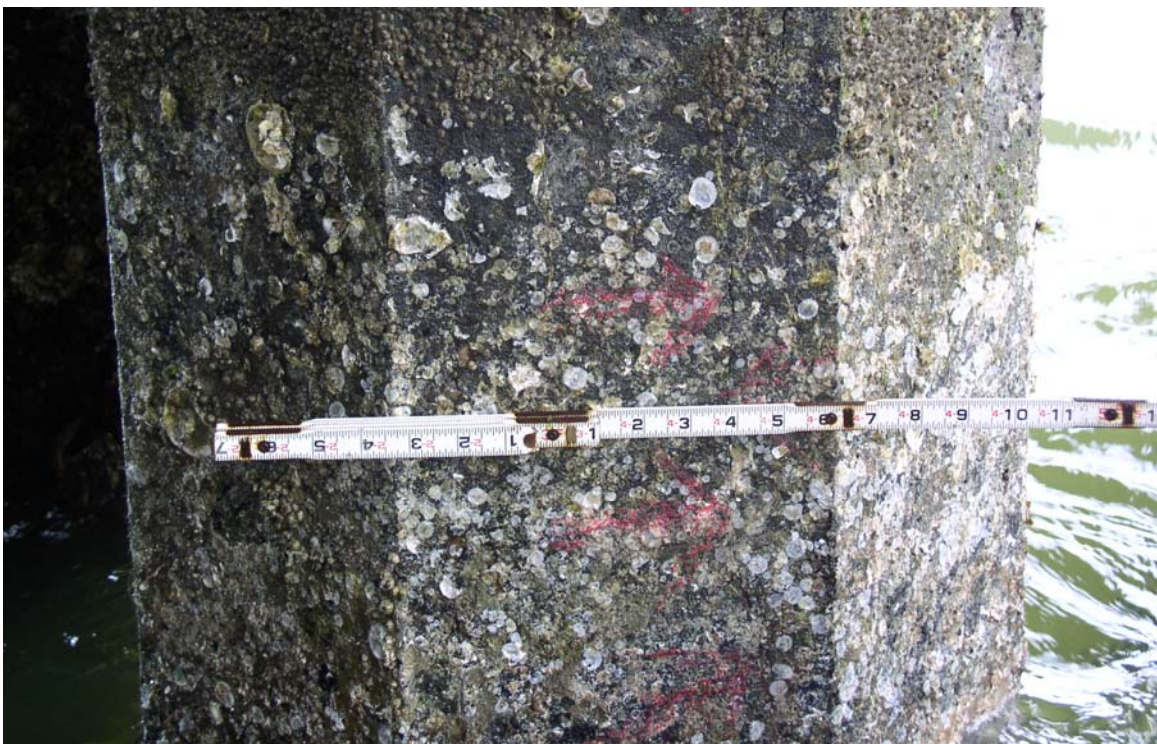
PHOTO 6: TYPICAL CRACKING IN CONCRETE PILE AT PILE 2 OF BENT 115

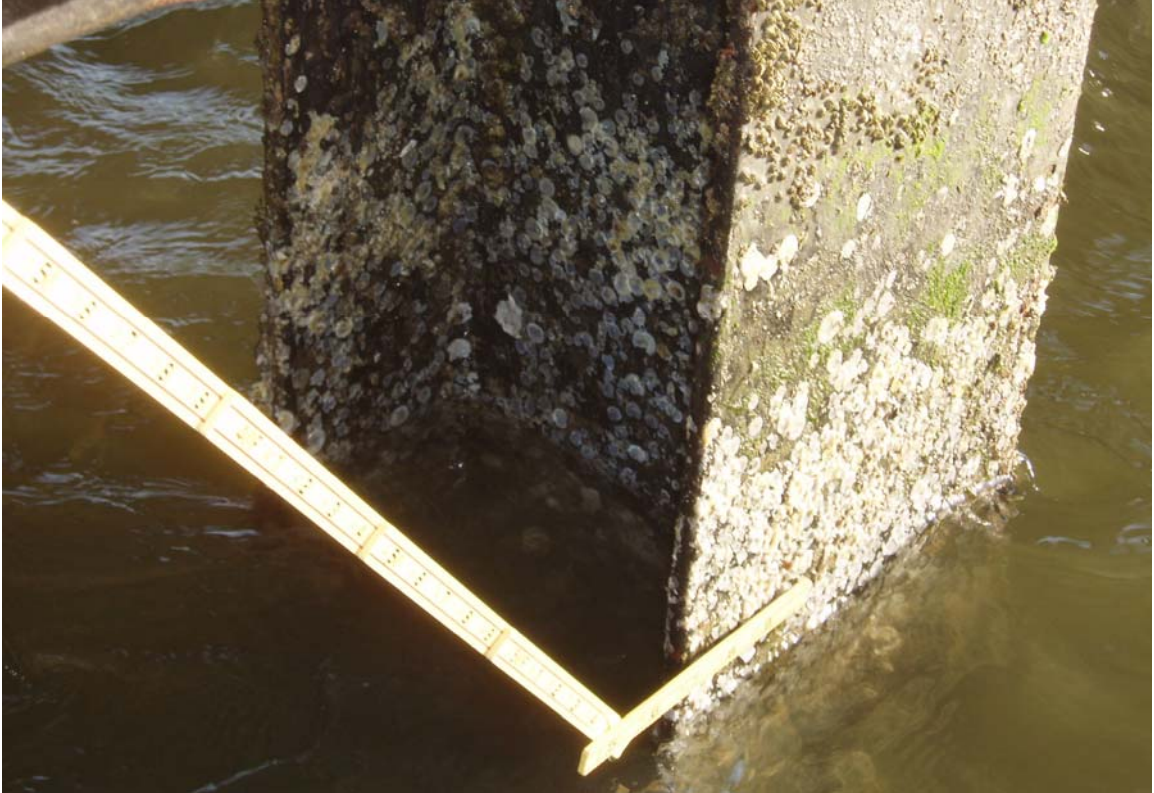
PHOTO 7: TYPICAL CONDITION OF STEEL H-PILE IN TIDAL ZONE (PILE I OF BENT 115 SHOWN)

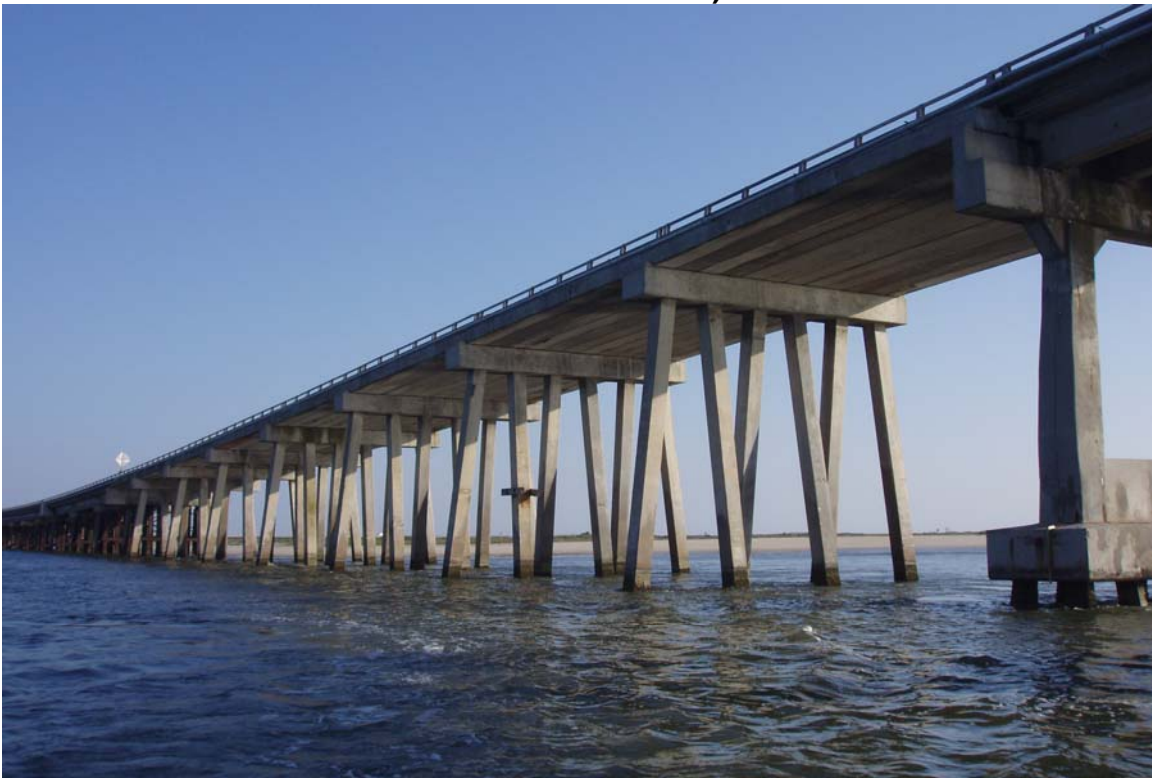
PHOTO 8: BENTS 124 THROUGH 128B, LOOKING NORTH

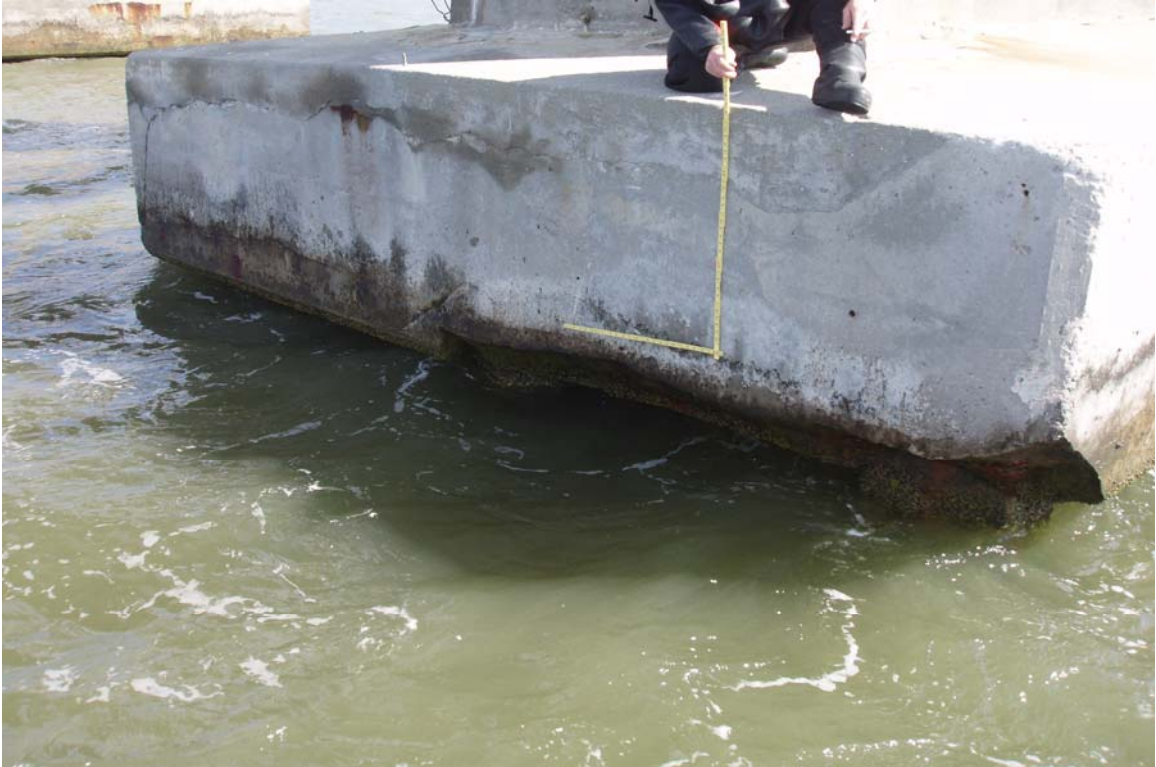
PHOTO 9: SPALL IN LOWER WEST EDGE OF BENT 143

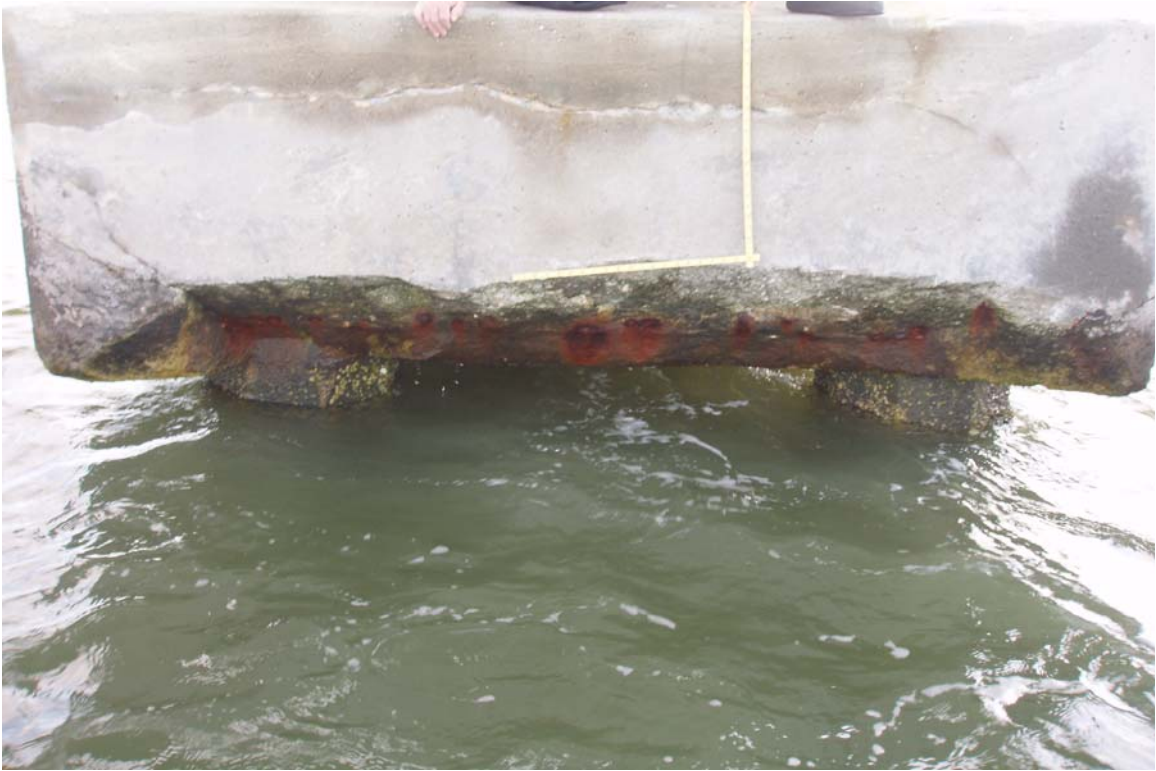
PHOTO 10: SPALL IN LOWER WEST EDGE OF BENT 159

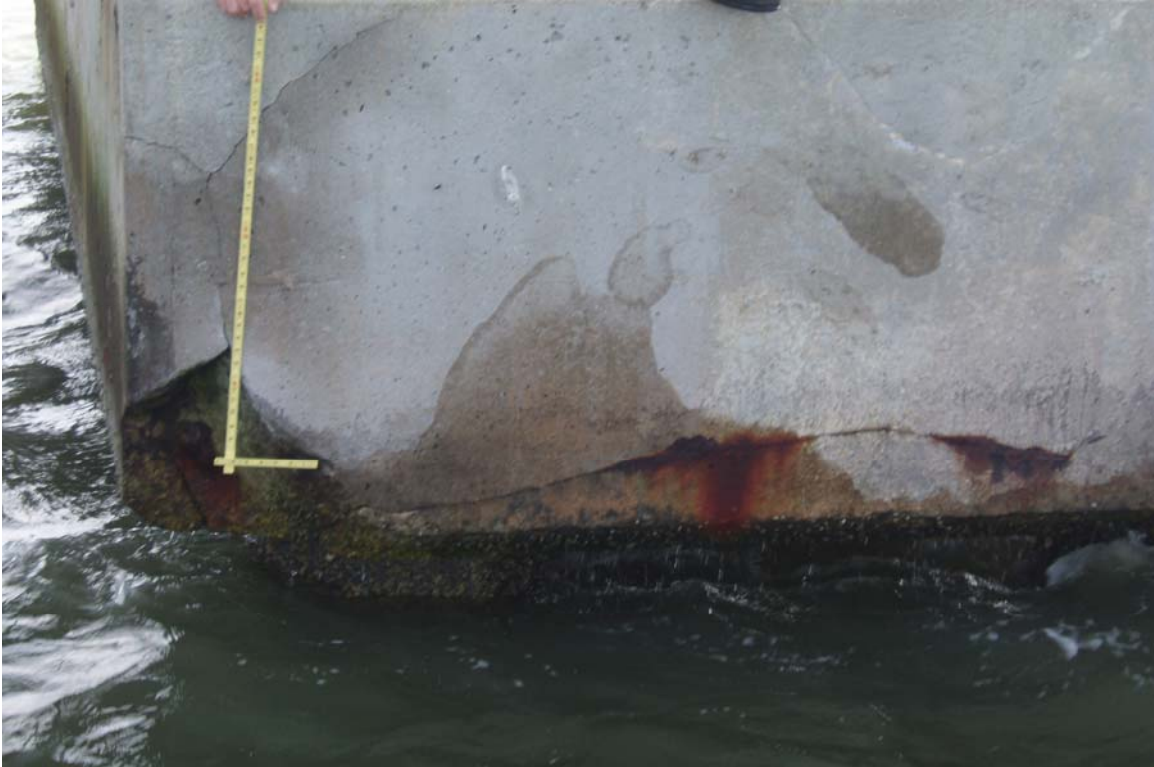
PHOTO 11: SPALL IN LOWER NORTHWEST CORNER OF BENT 164

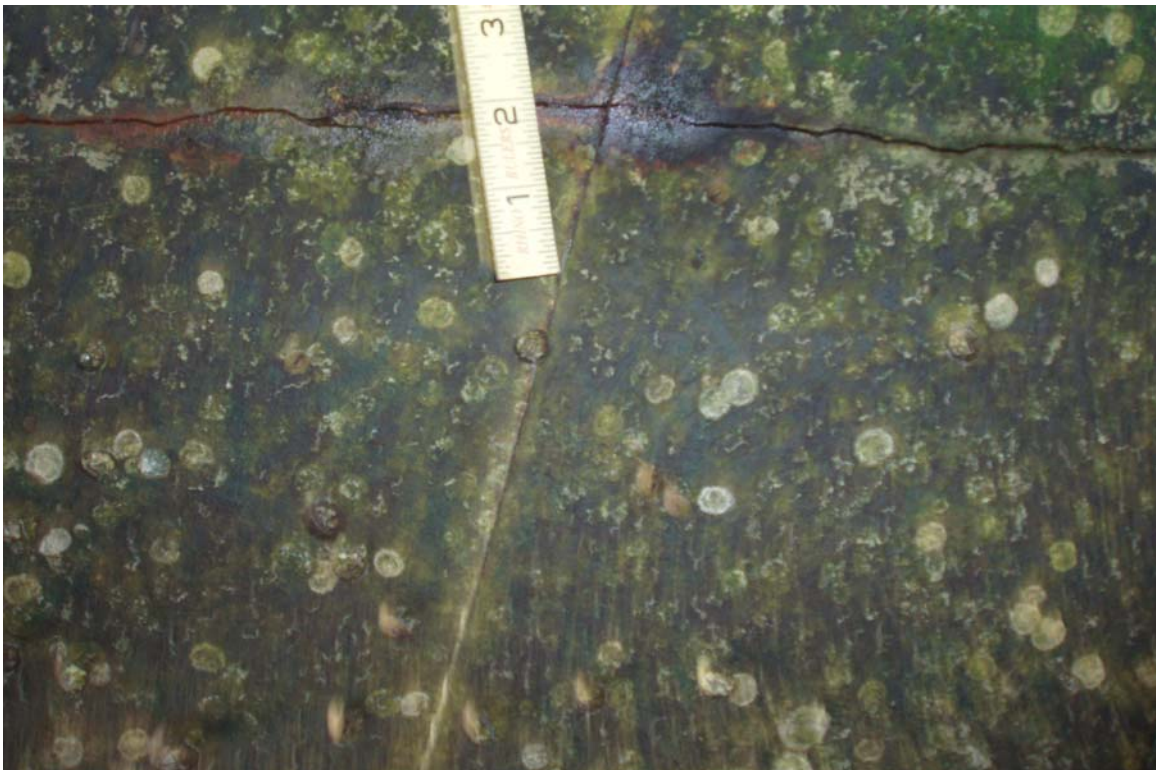
PHOTO 12: CRACKING IN UNDERSIDE OF BENT 144 PILE CAP

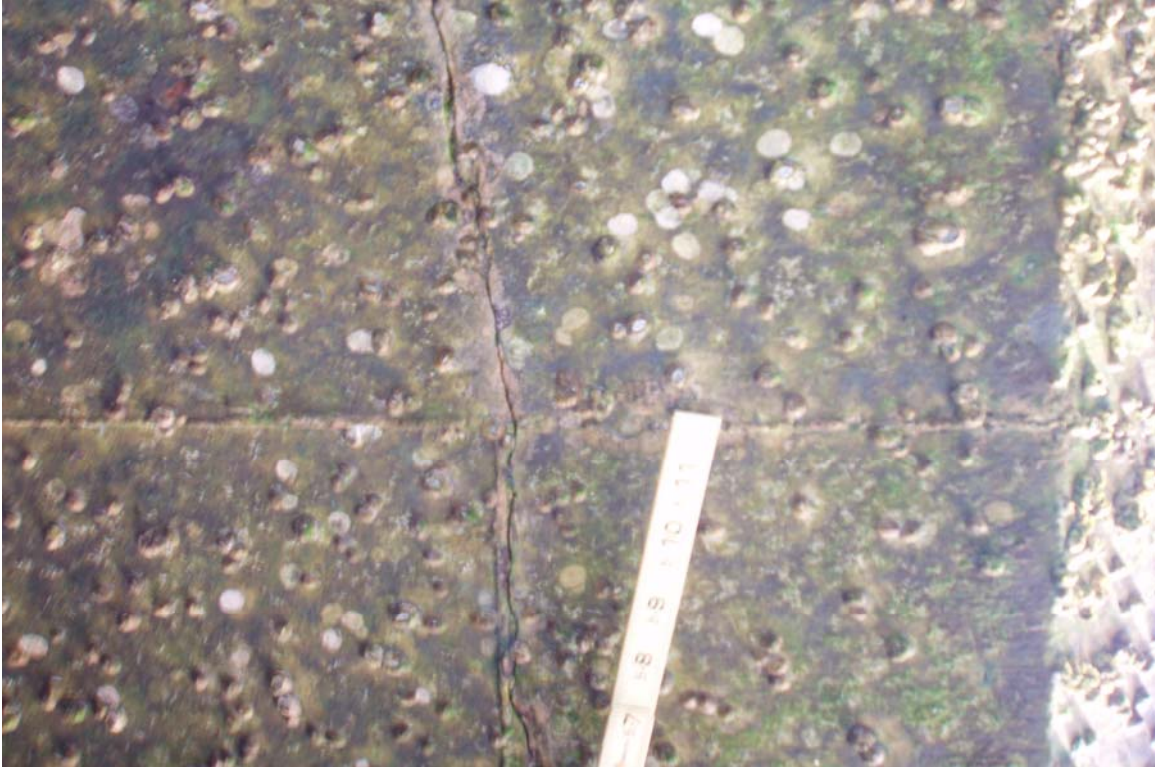
PHOTO 13: CRACKING IN UNDERSIDE OF BENT 147 PILE CAP

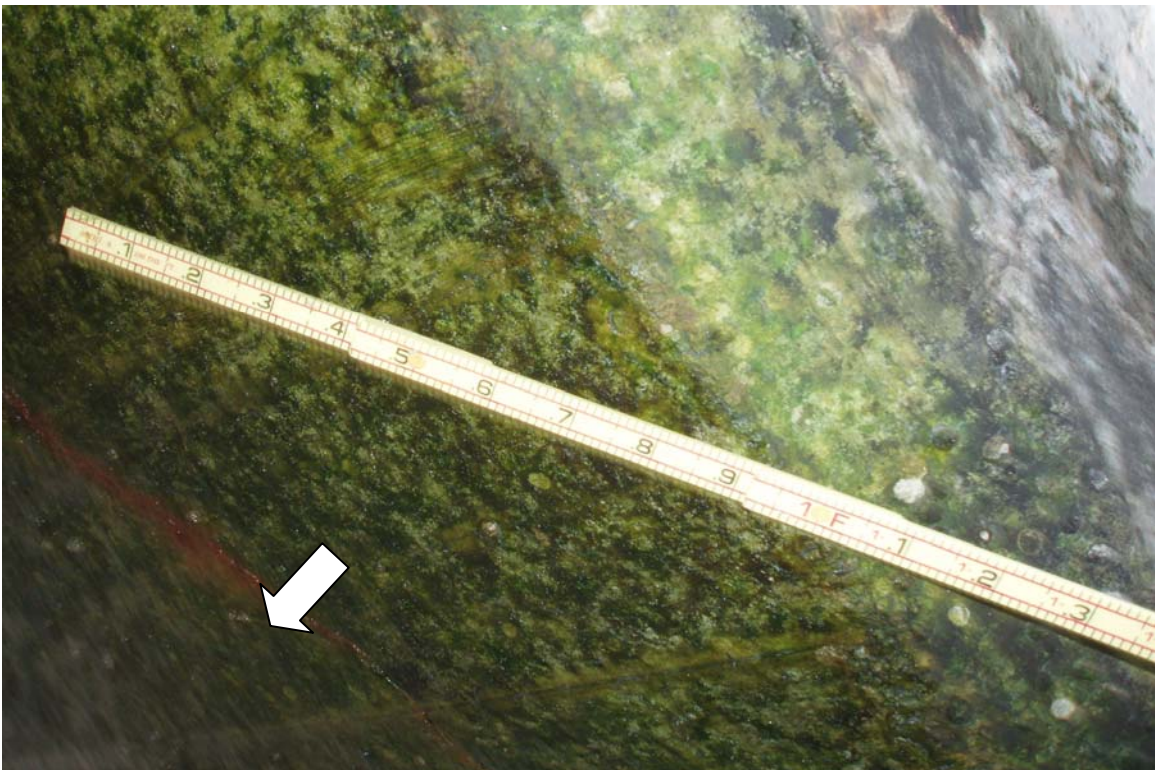
PHOTO 14: CRACKING IN UNDERSIDE OF BENT 160 PILE CAP

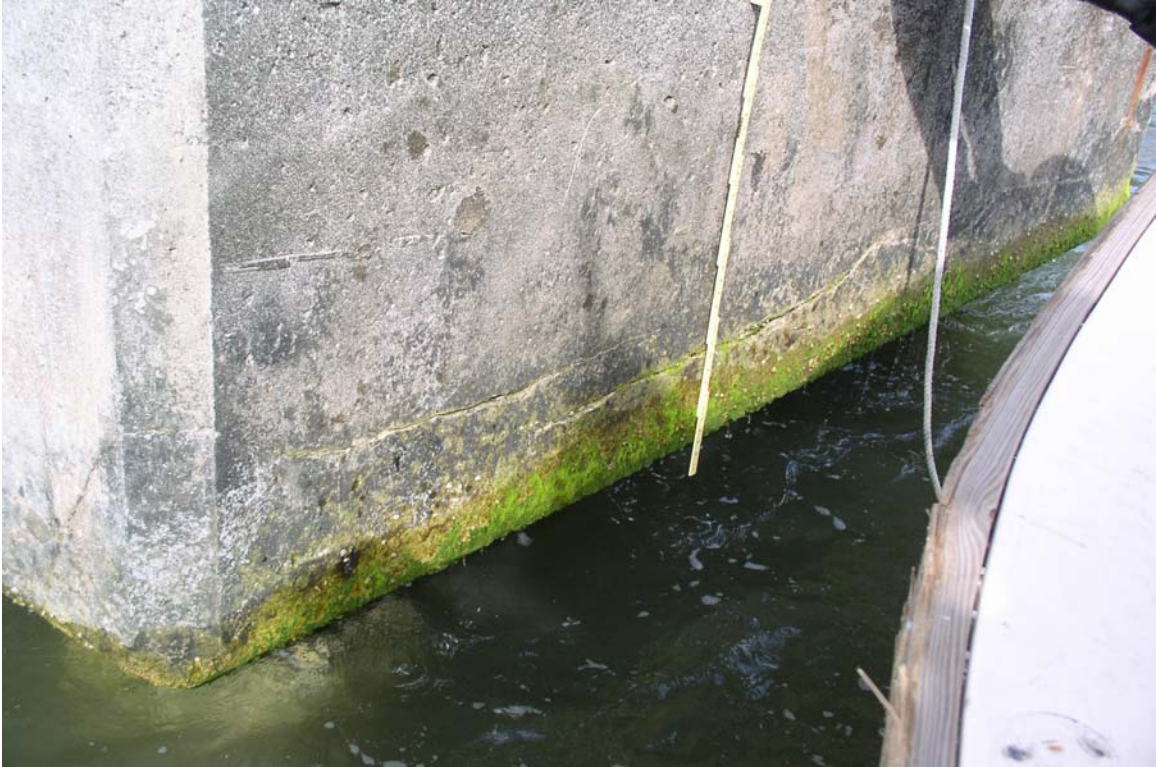
**PHOTO 15: HORIZONTAL CRACKING IN LOWER PORTION OF EAST FACE OF BENT 159
PILE CAP, TYPICAL**

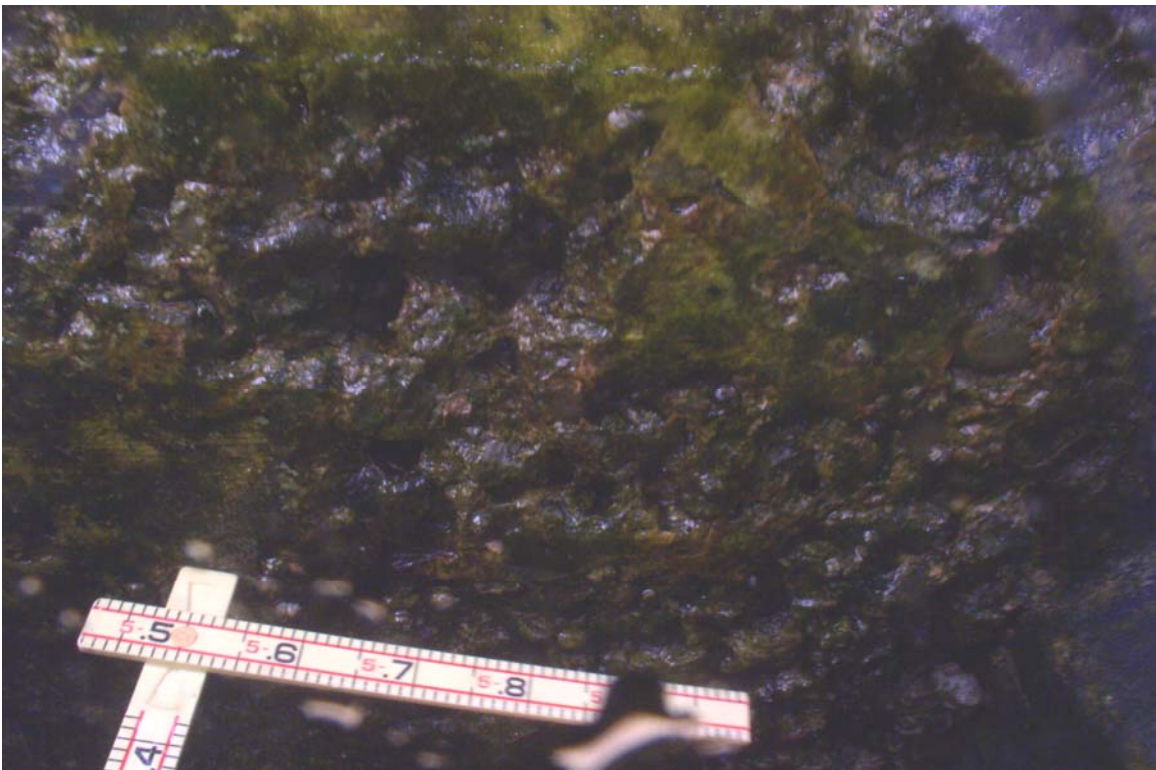
PHOTO 16: HONEYCOMBING IN UNDERSIDE OF BENT 144 PILE CAP

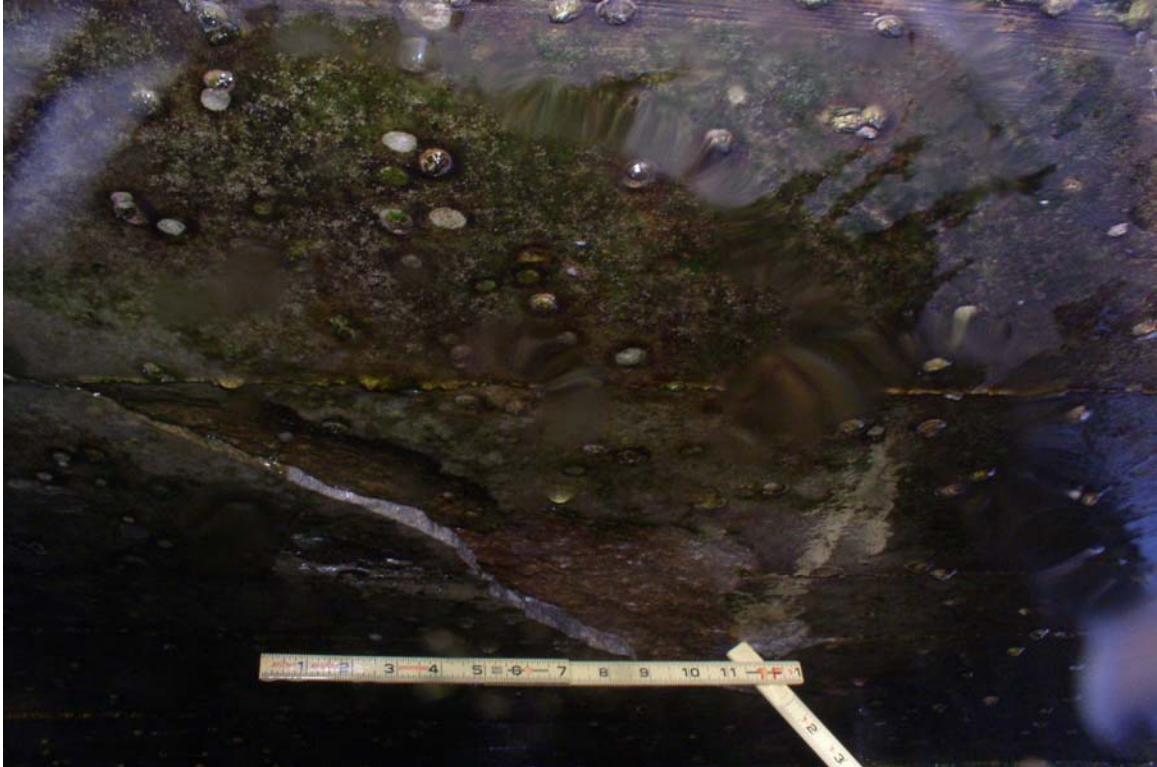
PHOTO 17: INCIPIENT SPALL IN UNDERSIDE OF BENT 145 PILE CAP IN NORTHEAST CORNER

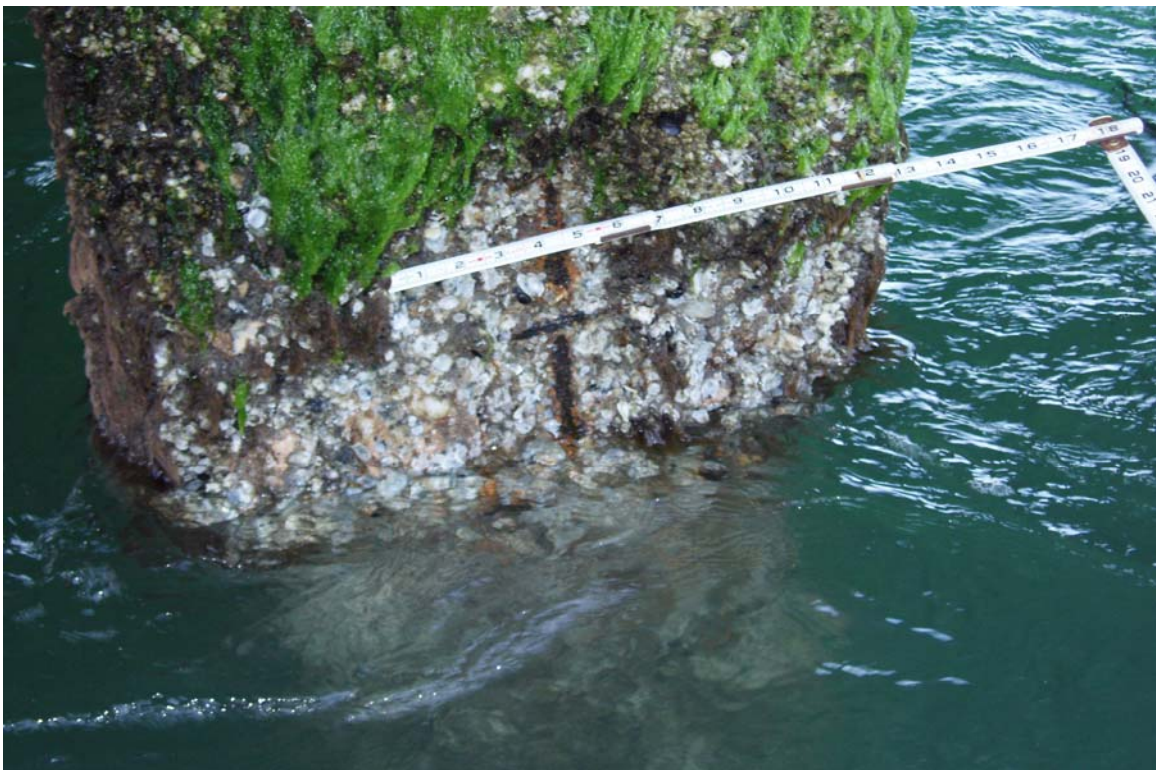
PHOTO 18: SPALLING IN TIDAL ZONE AT PILE 16 OF BENT 146

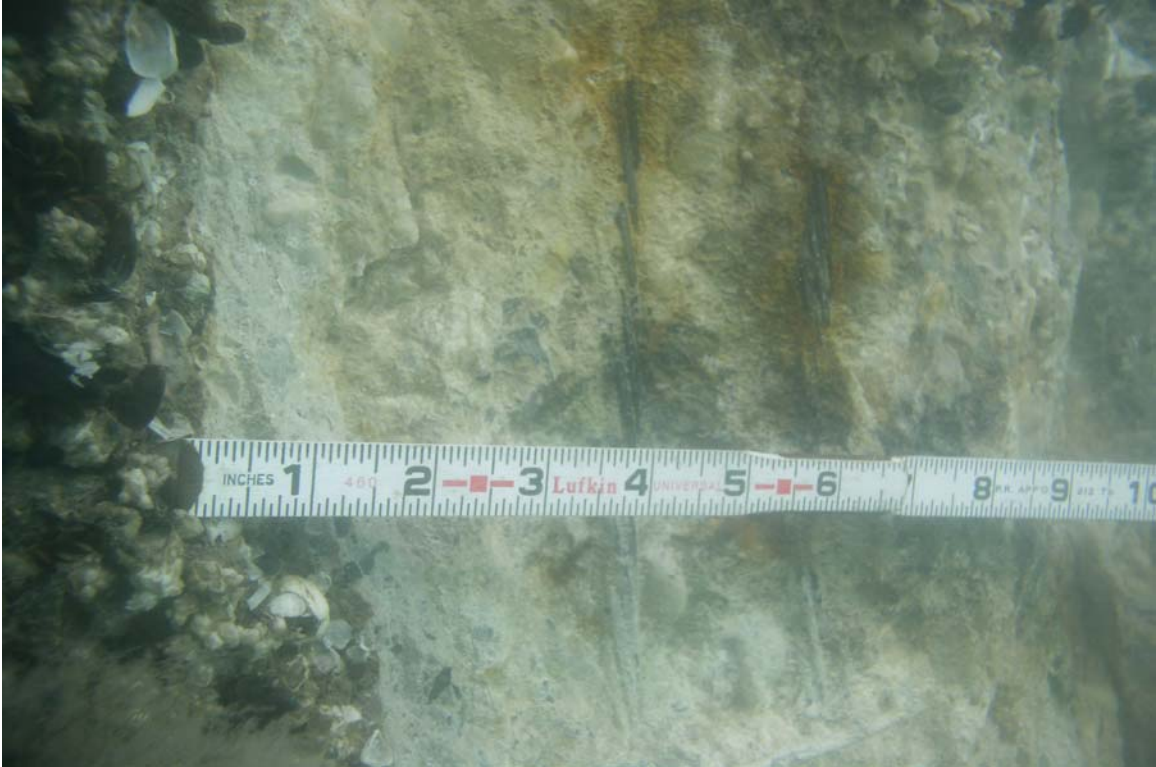
**PHOTO 19: SPALLING WITH EXPOSED PRESTRESSING STRANDS BELOW
WATER AT PILE 16 OF BENT 146**

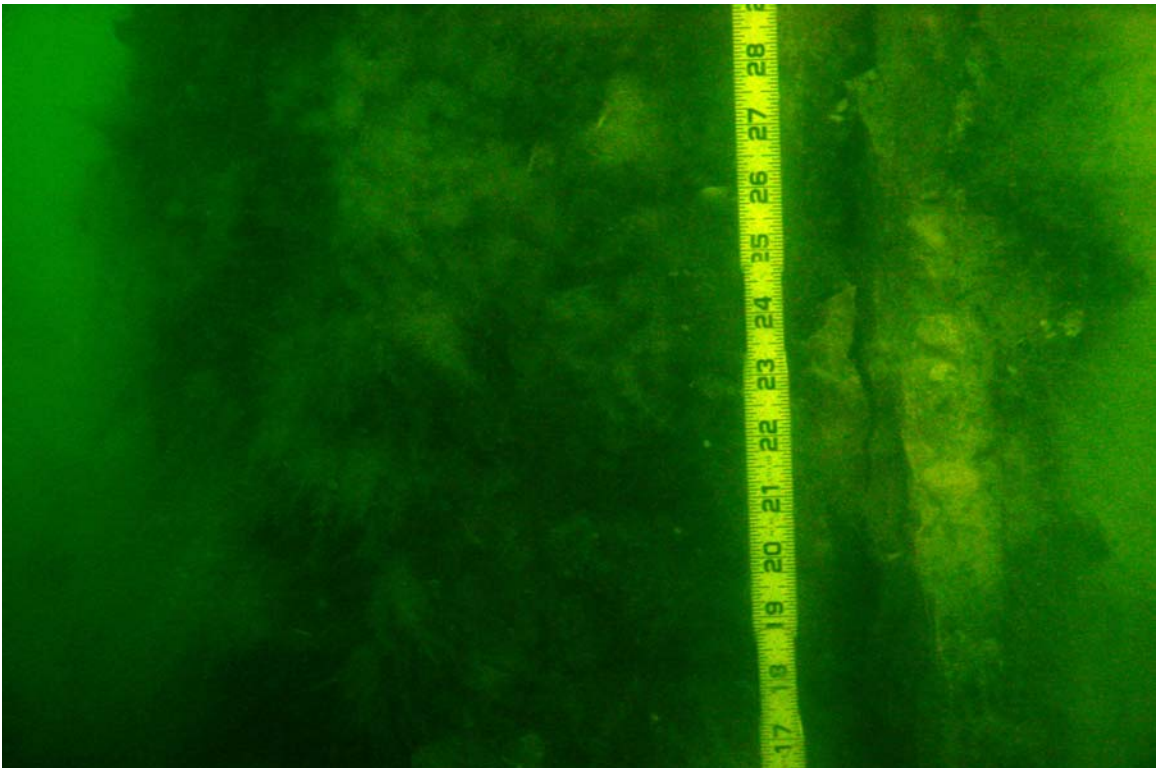
PHOTO 20: SPALLING (NOTE DELAMINATED CONCRETE) AT PILE 12 OF BENT 146

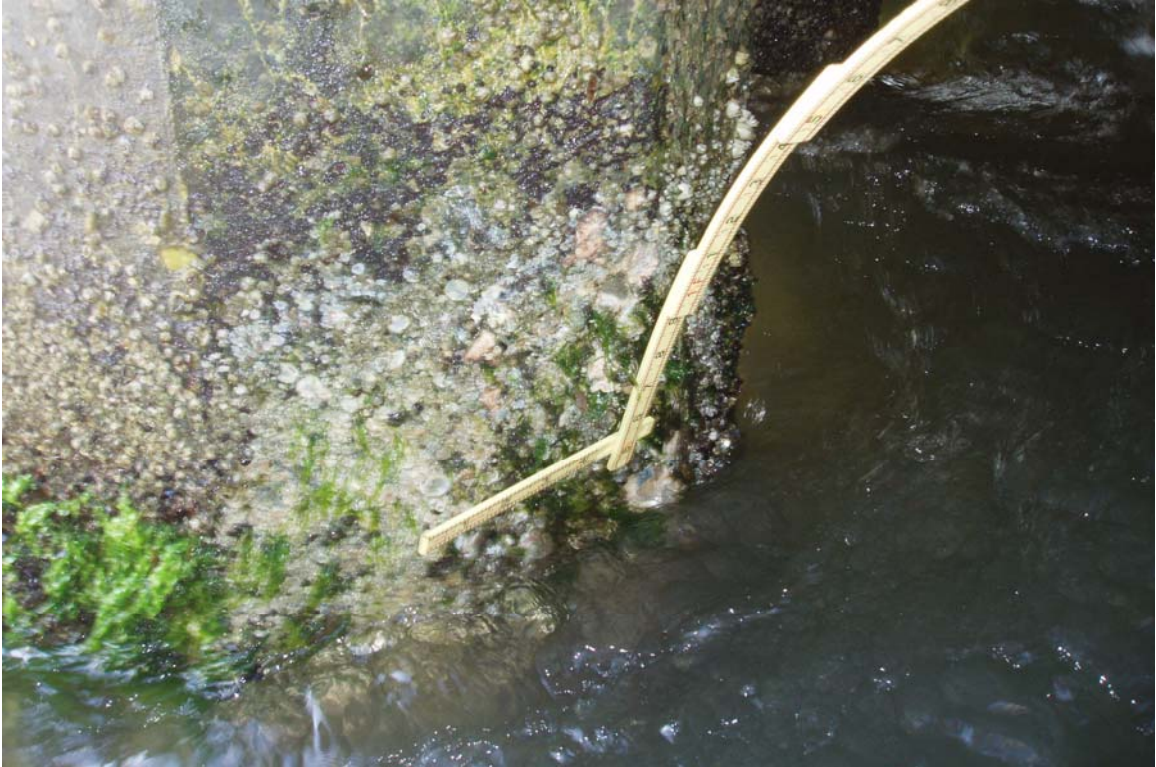
PHOTO 21: SPALL IN TIDAL ZONE AT PILE 9 OF BENT 144

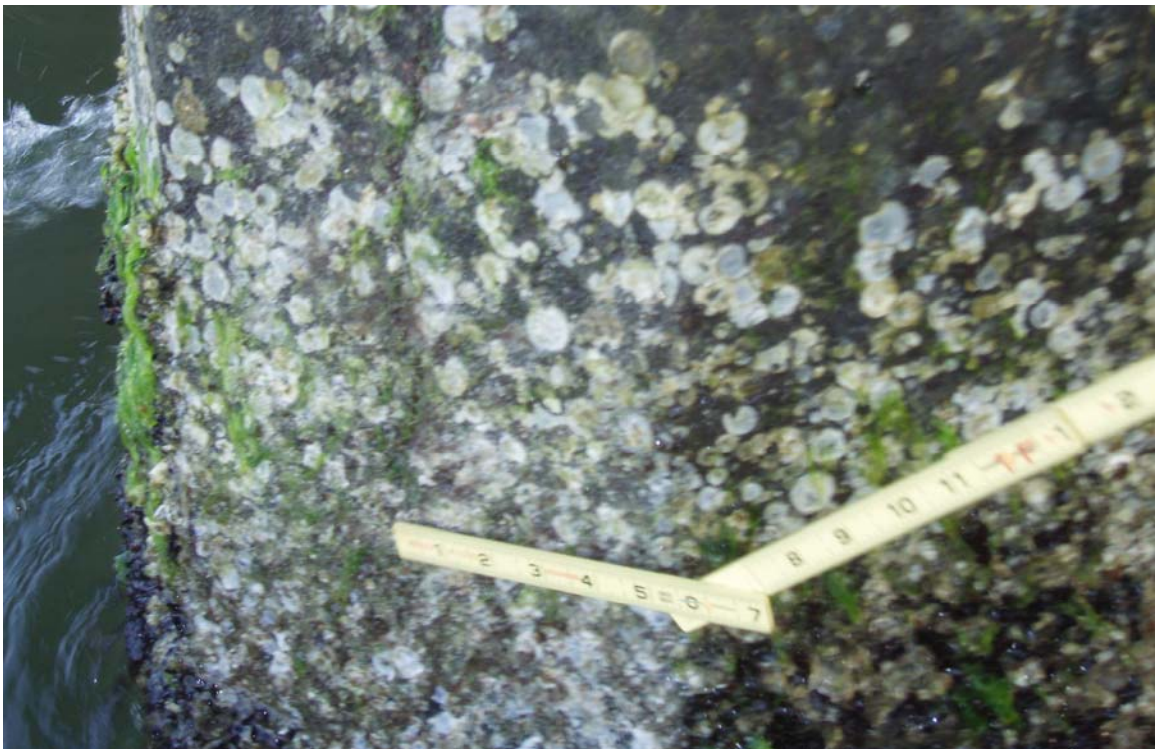
**PHOTO 22: VERTICAL CRACKING IN THE TIDAL ZONE AT PILE 10 OF BENT
160**

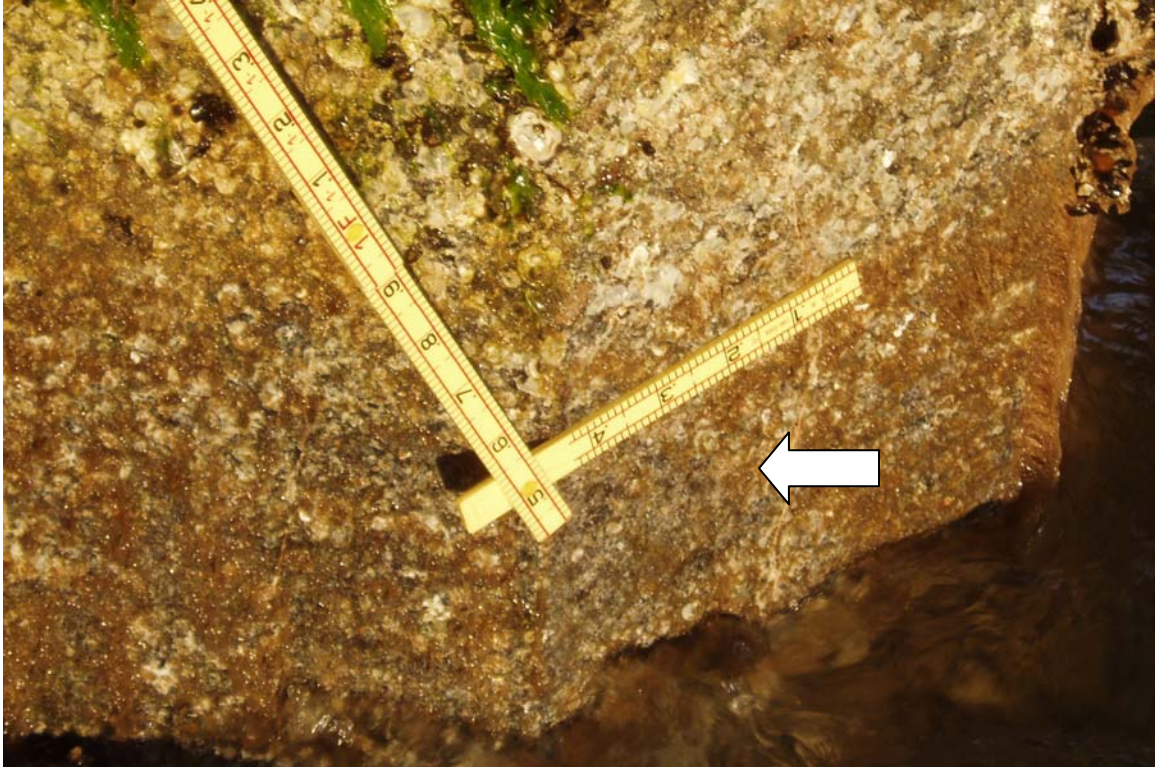
PHOTO 23: VERTICAL CRACKING IN THE TIDAL ZONE AT PILE 9 OF BENT 163
