**REPORT OF
UNDERWATER INVESTIGATION
OF
THE HERBERT C. BONNER BRIDGE
OVER
OREGON INLET**

**Final Report Date: SEPTEMBER 19, 2006
Prepared for: ALPHA & OMEGA GROUP
By: H.W. LOCHNER, INC.**

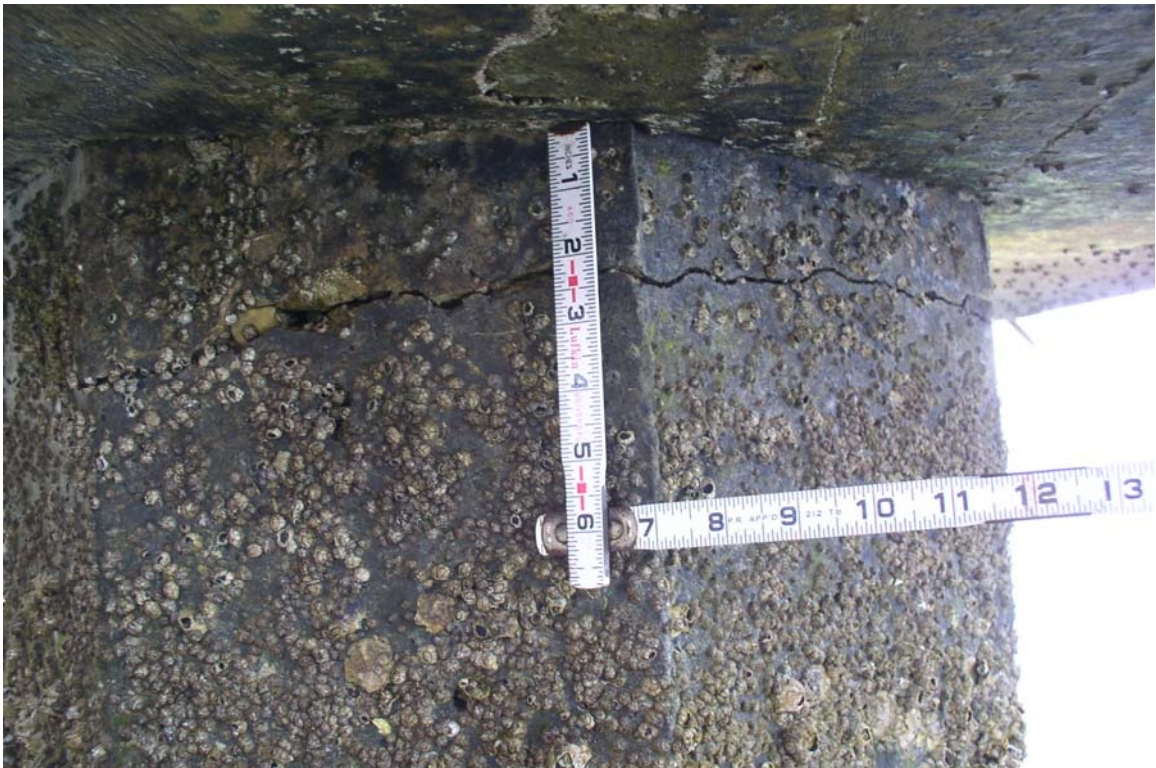
PHOTO 24: HORIZONTAL CRACKING AT TOP AT PILE 5 OF BENT 129

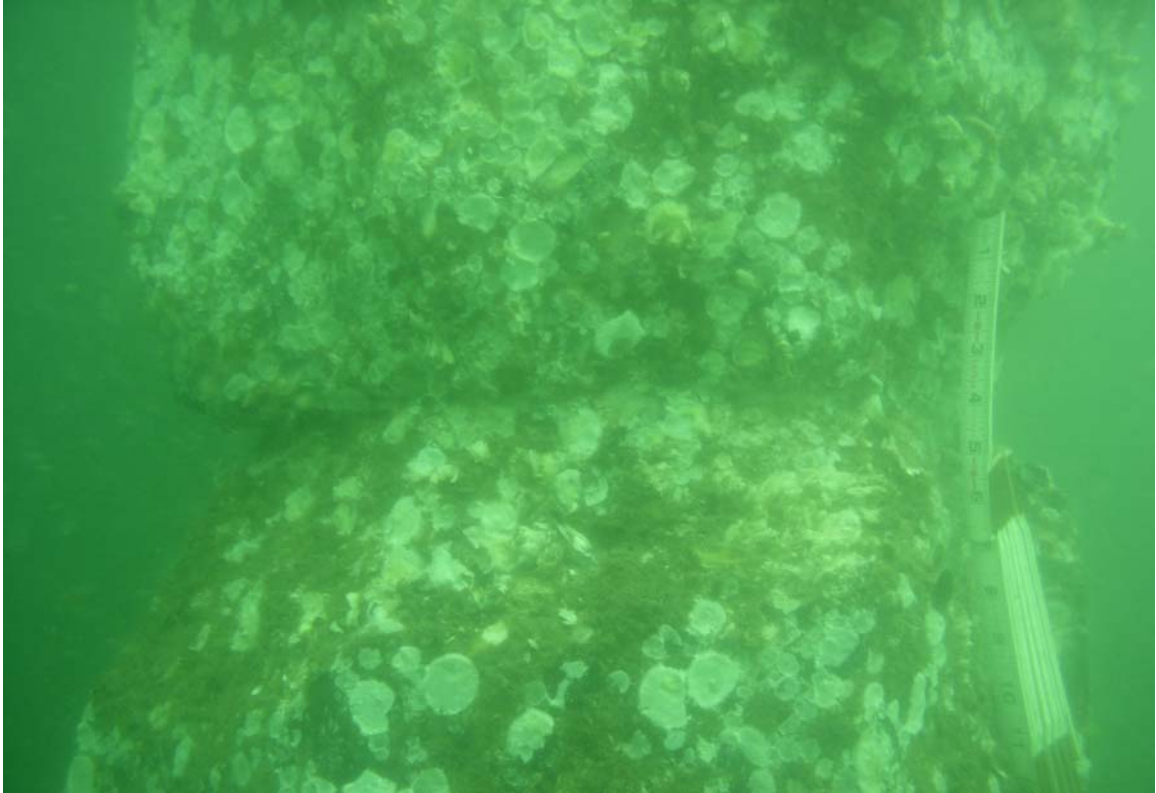
PHOTO 25: DETERIORATED SPLICE IN MID WATER COLUMN AT PILE 7 OF BENT 159

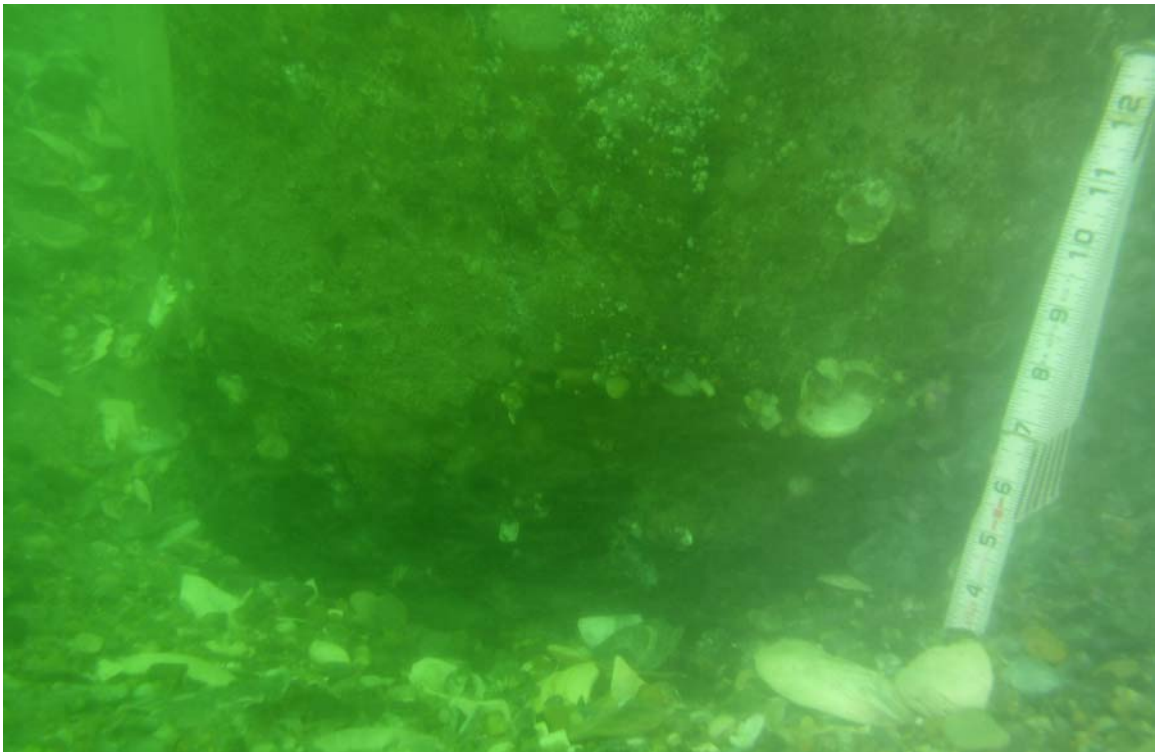
PHOTO 26: DETERIORATED SPLICE AT MUDLINE AT PILE 7 OF BENT 159

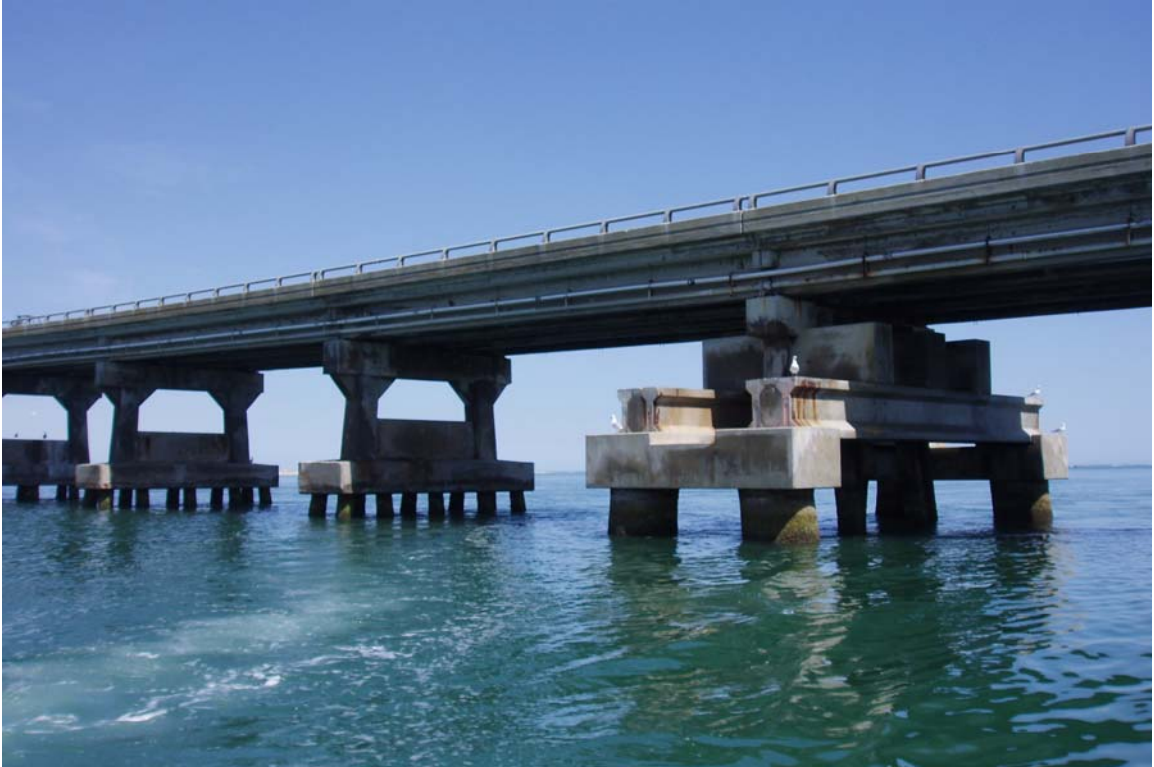
**PHOTO 27: TYPICAL CONFIGURATION OF NEW SUBSTRUCTURE ELEMENTS
(BENT 167 SHOWN)**

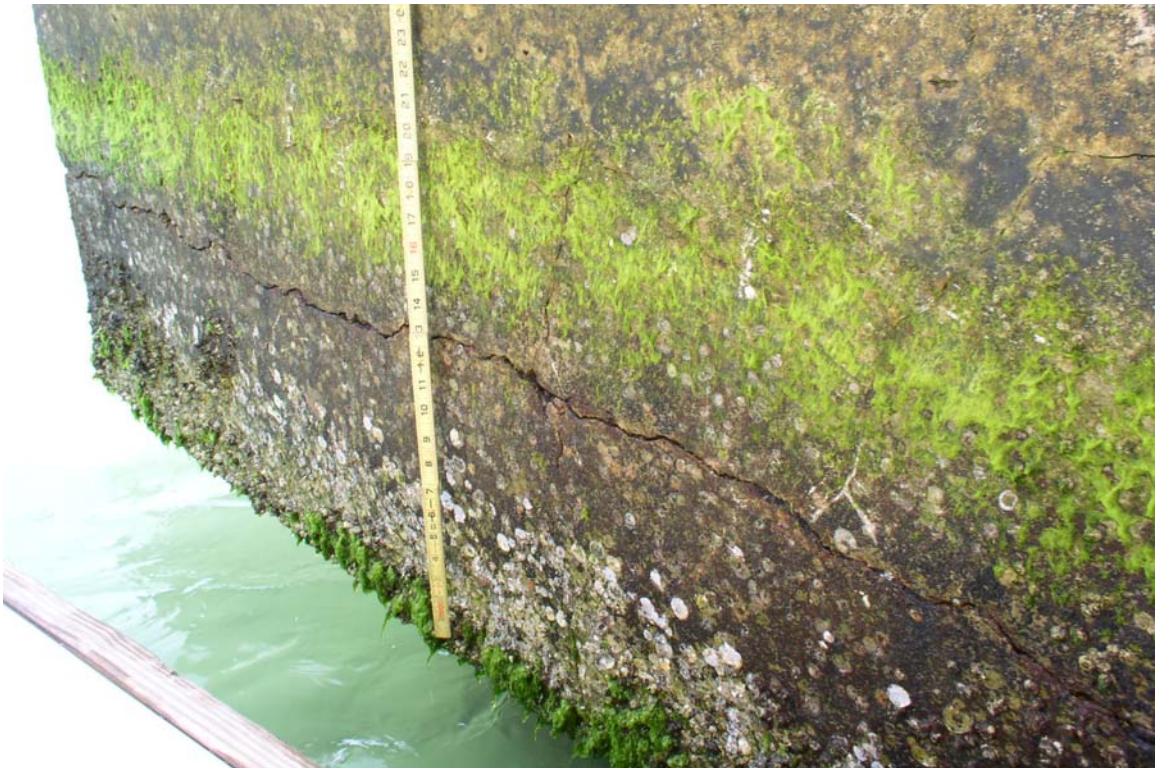
PHOTO 28: CRACKING IN NORTH END OF EAST "NEW" CAP AT BENT 171

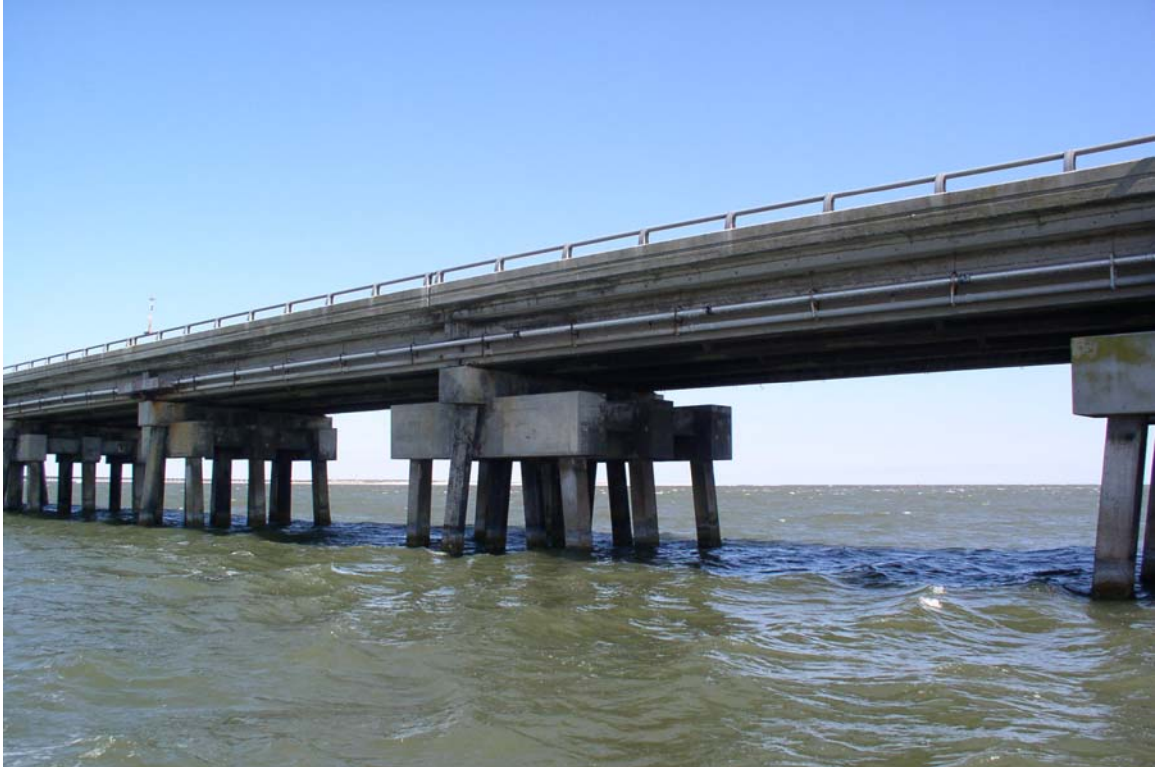
PHOTO 29: SUPPLEMENTAL PILES AND CAPS AT BENTS 173 THROUGH 186

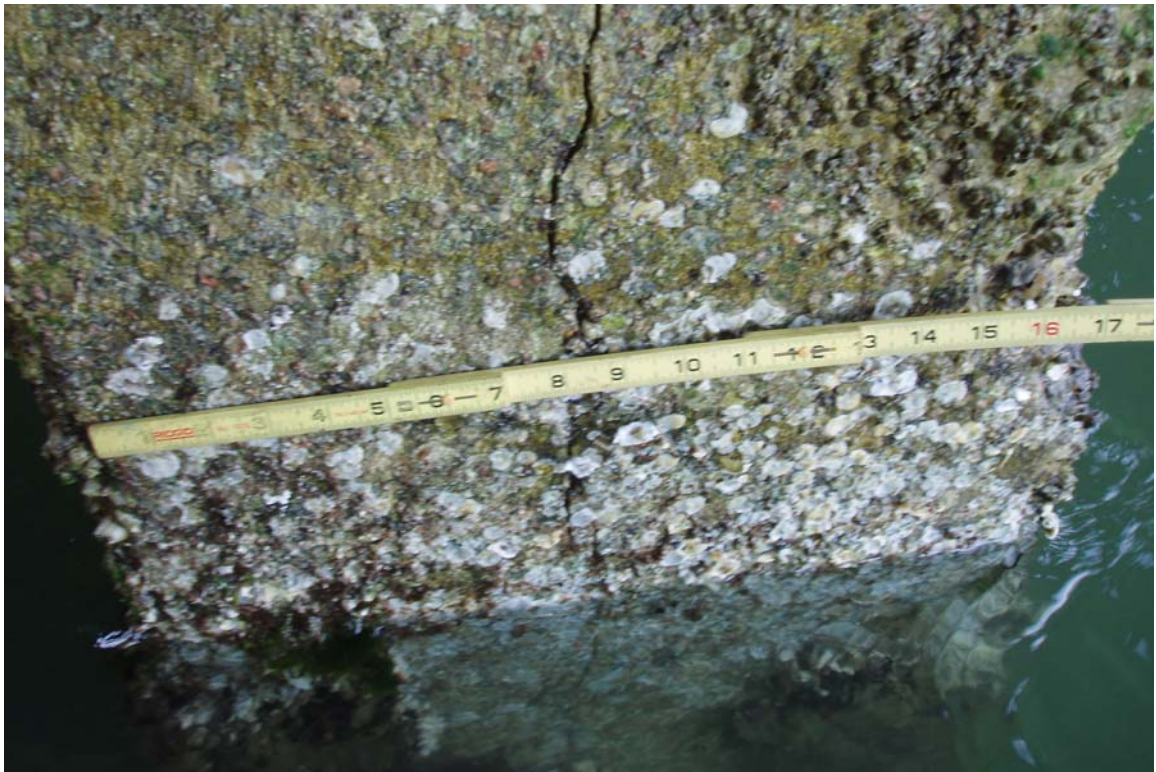
PHOTO 30: CRACK IN FACE 4 (WEST FACE) AT PILE 6 OF BENT 186

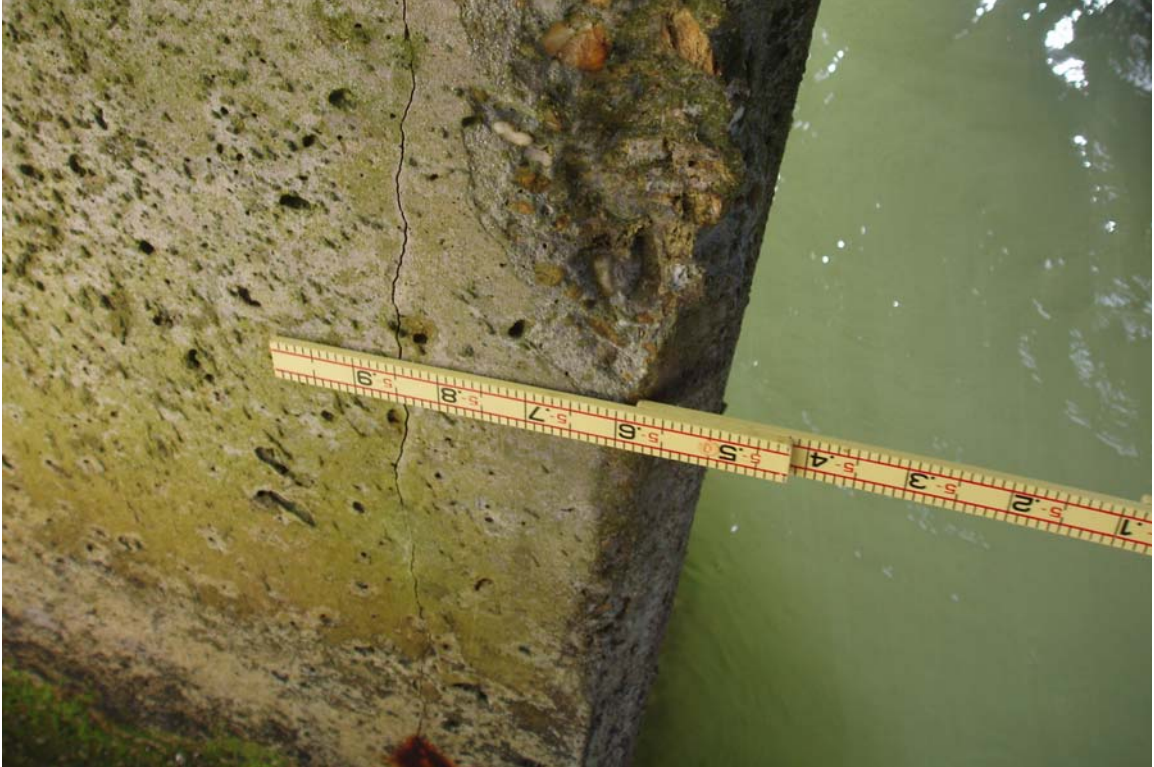
PHOTO 31: DELAMINATED SOUTHWEST EDGE AT PILE 1 OF BENT 174

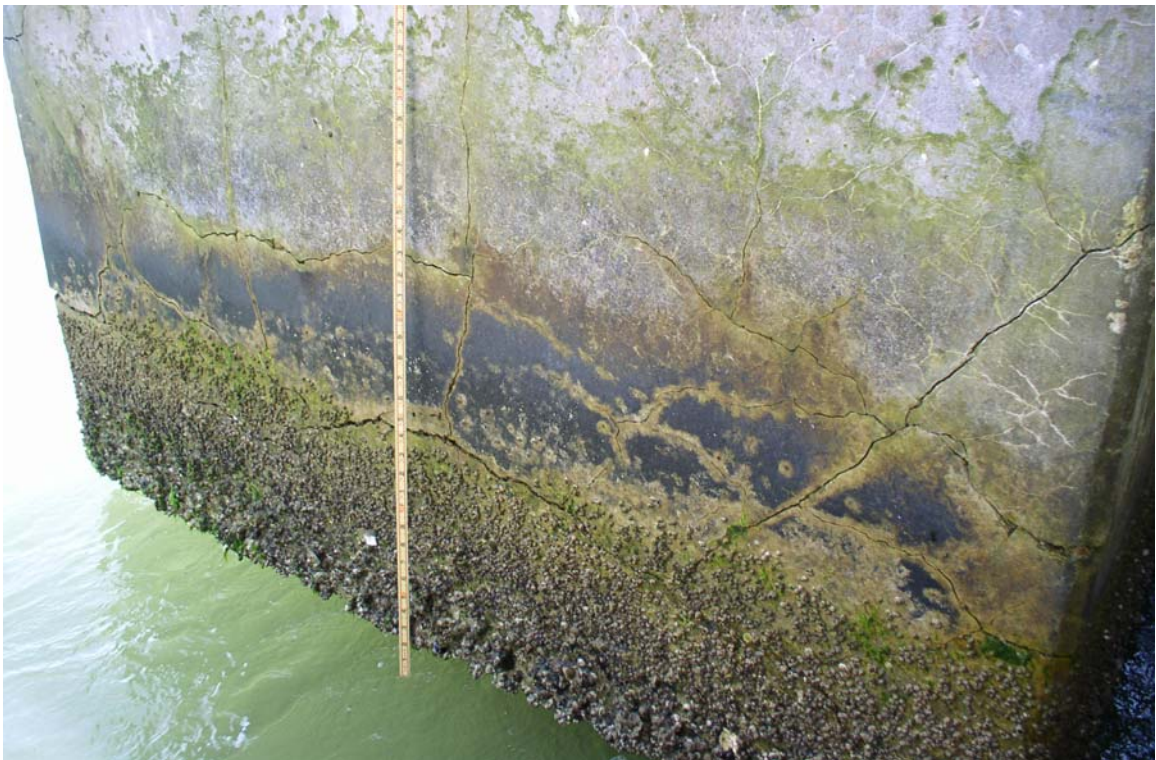
**PHOTO 32: CRACKING IN NORTH END OF EAST "NEW" CAP AT BENT 189
EXTENDING ABOVE THE TIDAL ZONE**

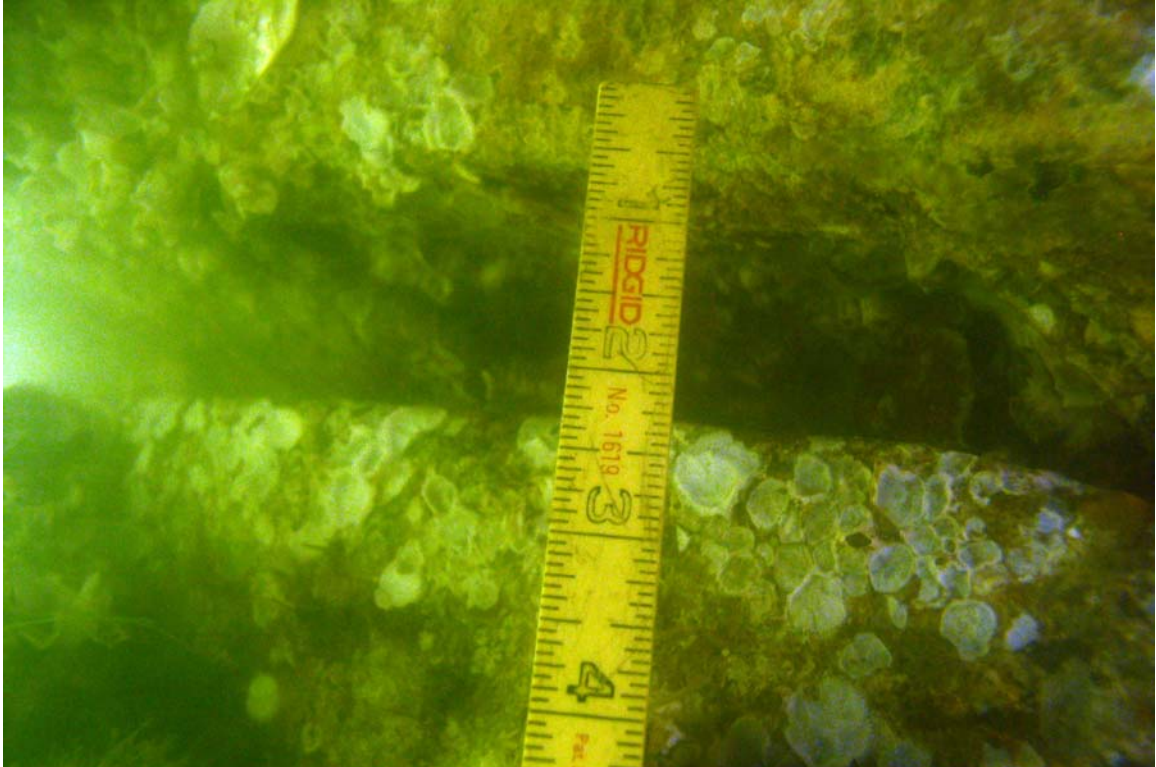
**PHOTO 33: VOID IN THE NORTHWEST 66 IN. DIAMETER PILE AT BENT 197
UNDER THE WEST "NEW" CAP**

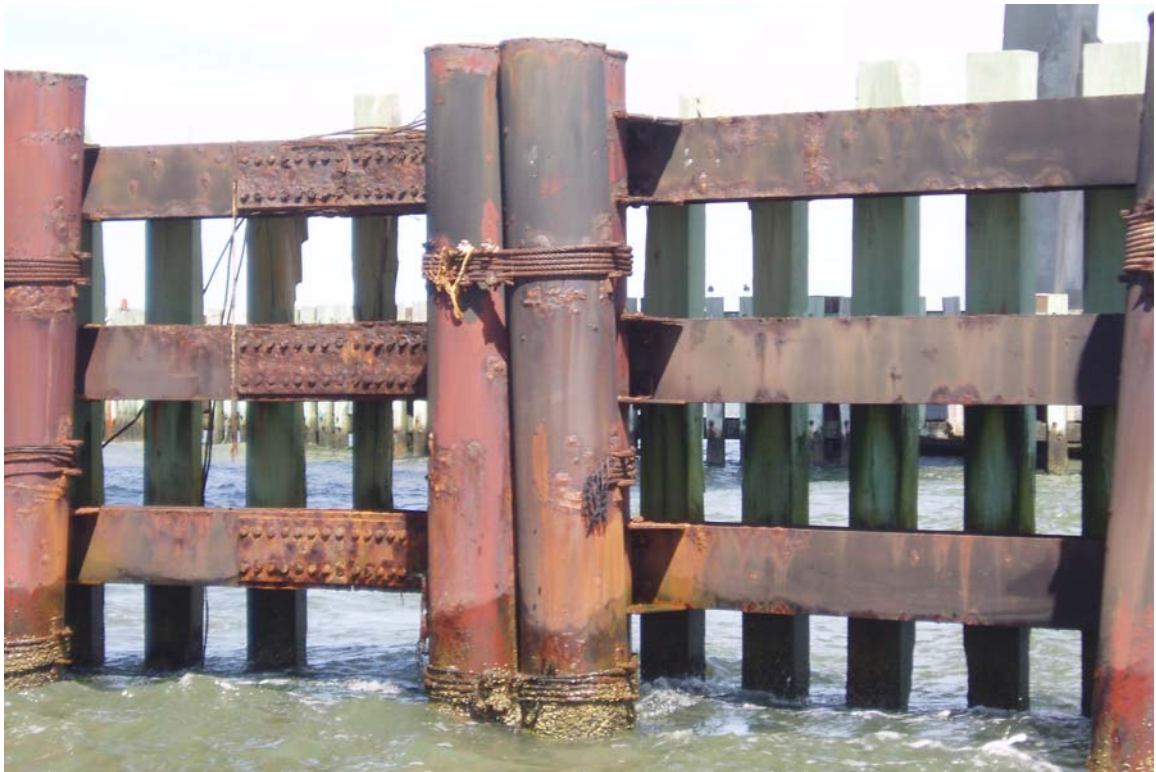
**PHOTO 34: TYPICAL CORROSION ON STEEL ELEMENTS OF FENDER SYSTEM
ABOVE THE HIGH WATER MARK, SOUTH FENDER SHOWN**

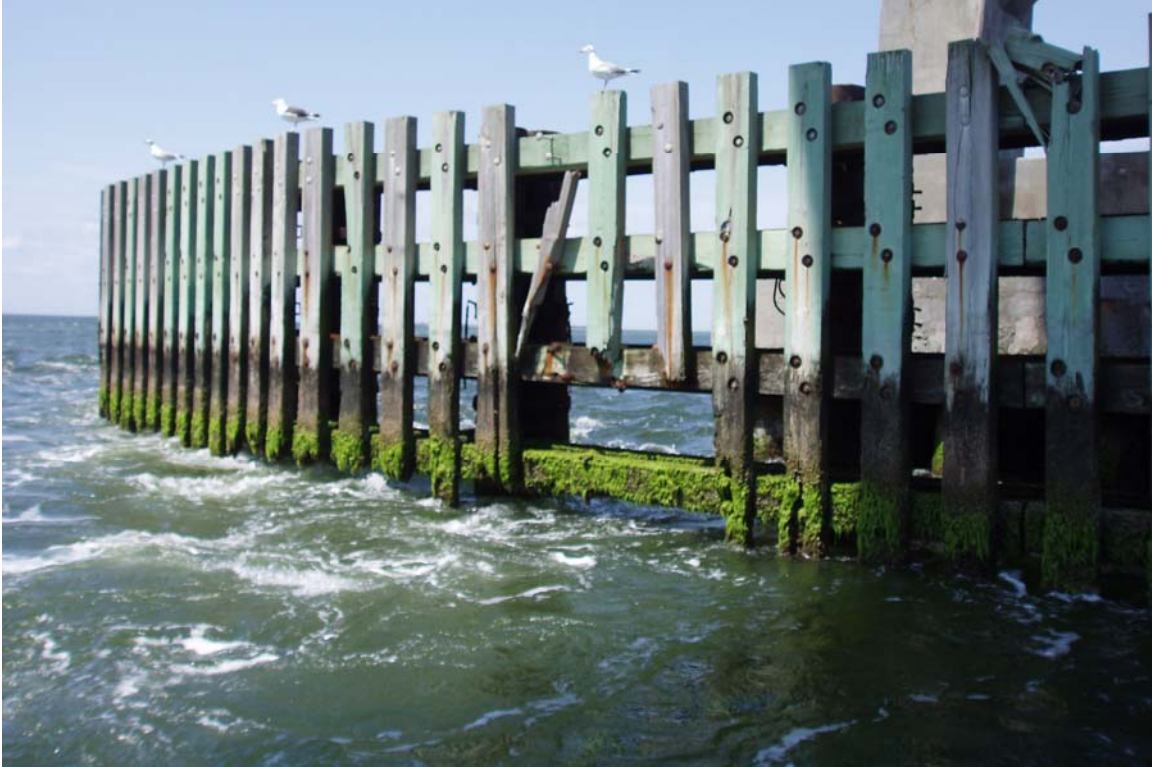
**PHOTO 35: DAMAGED TIMBER RUB STRIPS NEAR THE WEST END OF THE
NORTH FENDER.**

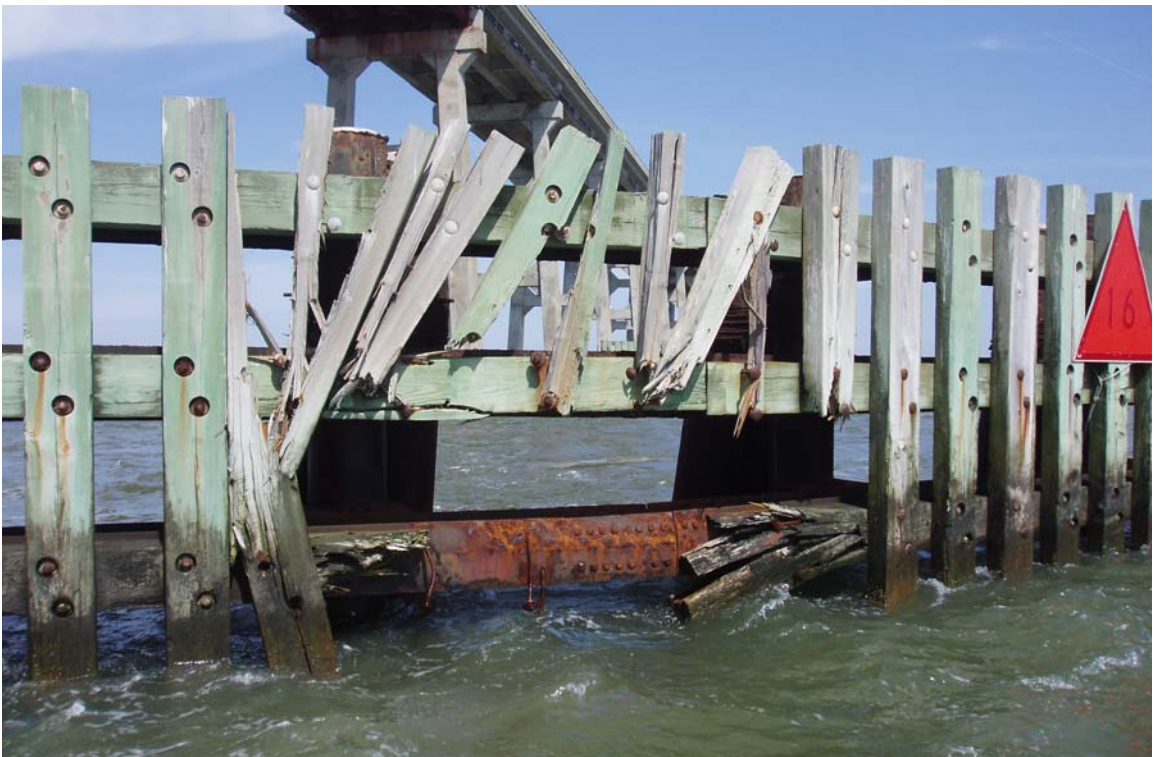
**PHOTO 36: DAMAGED TIMBER RUB STRIPS AND BACKING TIMBER, NORTH
FENDER SHOWN BETWEEN CLUSTERS 2 & 3**

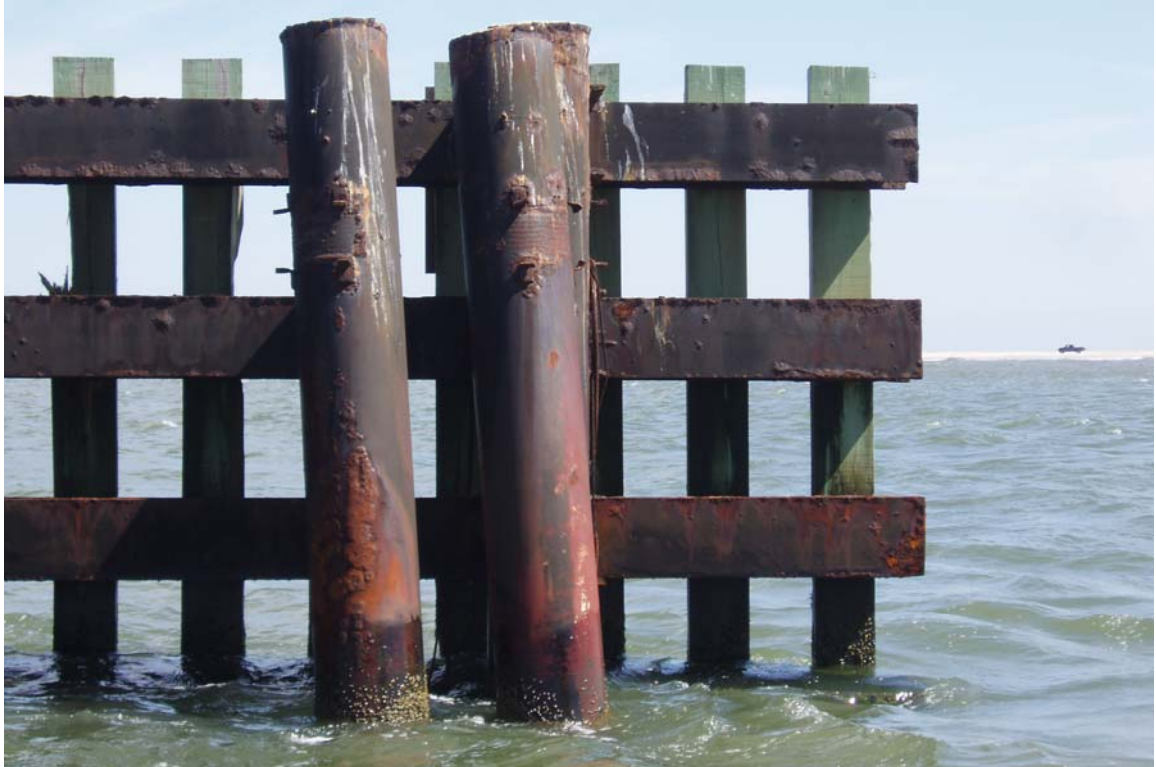
PHOTO 37: LOOSE PILES AT CLUSTER 1 OF THE SOUTH FENDER

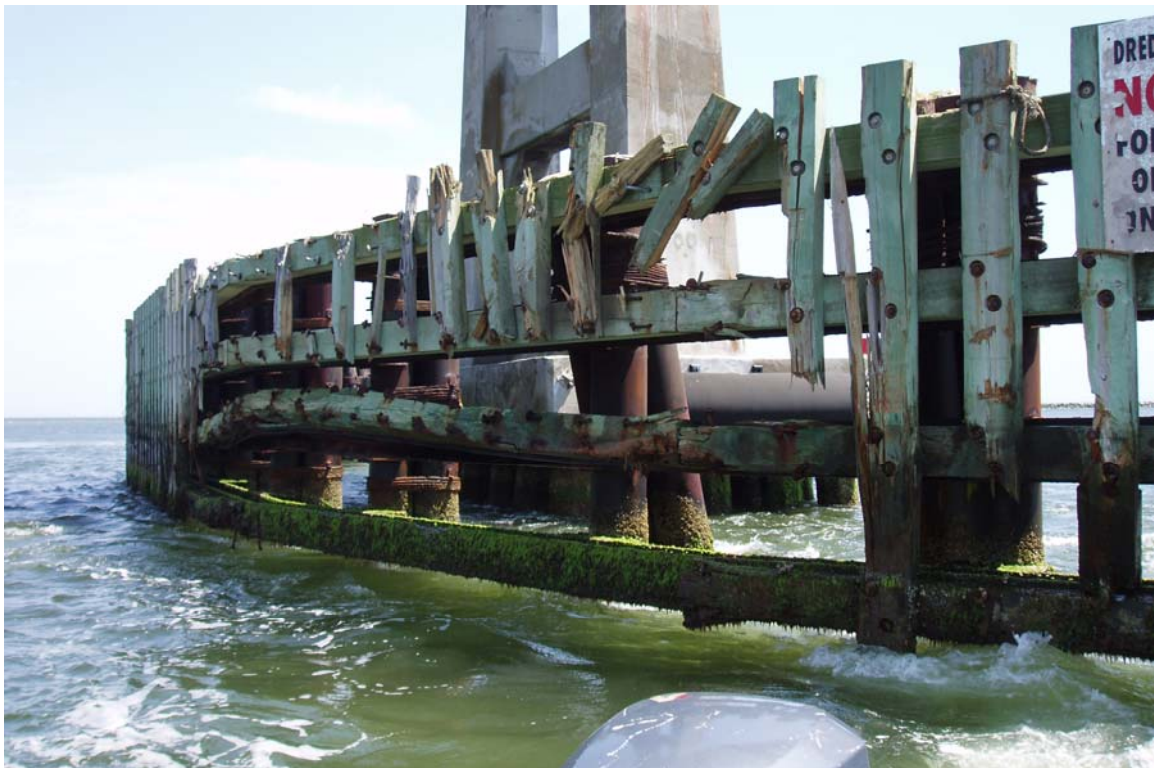
**PHOTO 38: IMPACT DAMAGE BETWEEN PILE CLUSTERS 10 AND 13 OF THE
SOUTH FENDER**

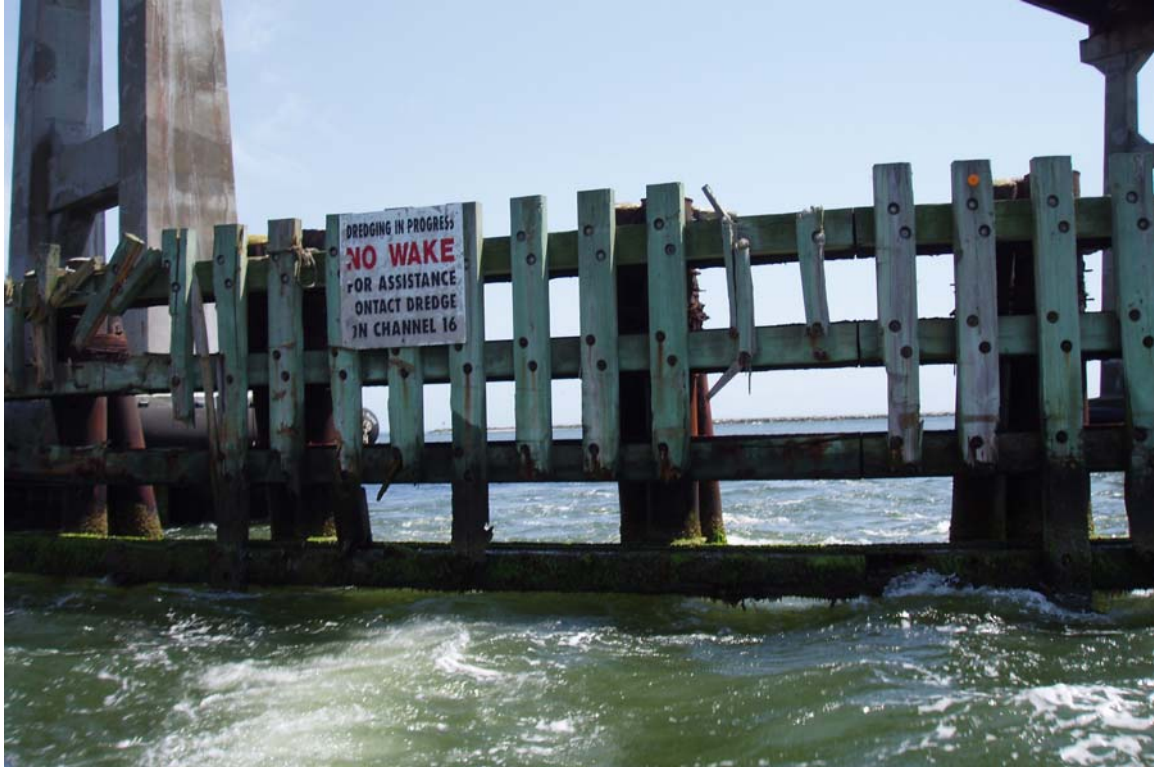
**PHOTO 39: DAMAGED/MISSING TIMBER RUB STRIPS IN THE WEST END OF
THE SOUTH FENDER**
