Testing Program

Field Testing Methodology

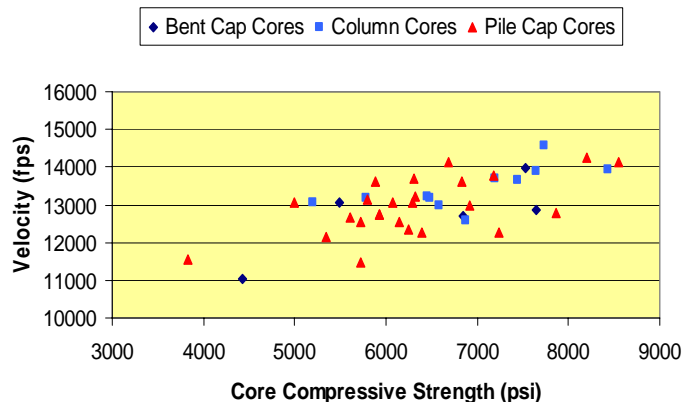
The relationship between UPV measurements and concrete compressive strength data for these cores is shown in the graph in Figure 11. Because the overall concrete compressive strengths are generally between 5,000 and 8,000 psi and the

Figure 11. Comparison of Compressive Strength to UPV

concrete appears to be of high quality (good consolidation and well blended), the resulting ultrasonic pulse velocities are in a fairly narrow range extending from 12,000 to 14,500 fps which are velocities generally associated with good quality concrete. More significant is the narrow band of velocities which indicates uniformity in the concrete from one location to another.

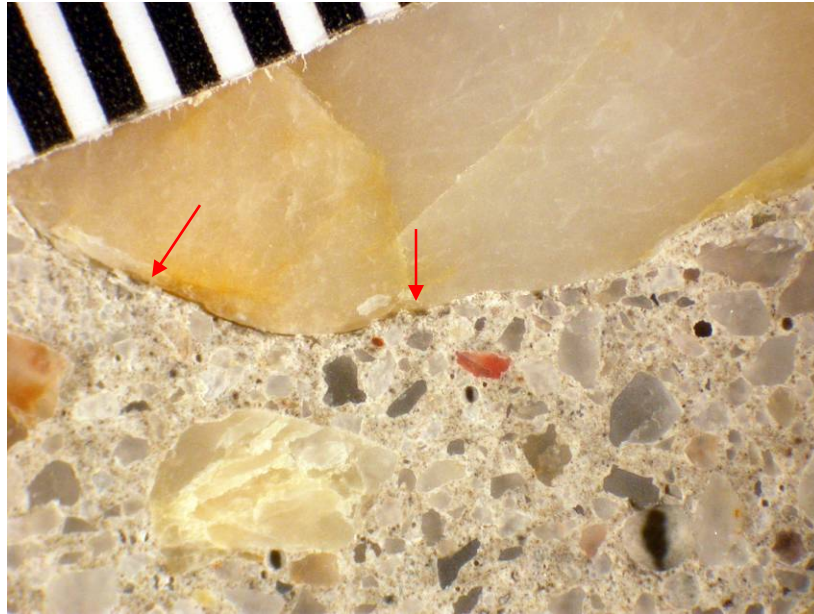
No joints, cracks or significant microcracks were observed in the examined portion of the core, except for the adhesion cracks that partially surround many of the coarse aggregate particles.

Figure 12. Adhesion crack partially surrounding coarse aggregate particle. Millimeter scale.

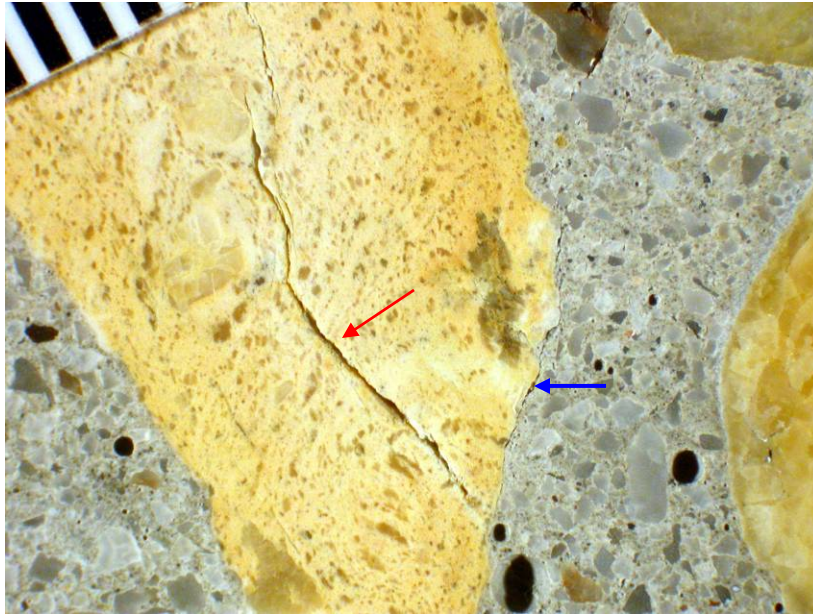
Core 138 - Span 162, Girder 3

The coarse aggregate, which was predominantly quartzite gravel, contained a few particles of friable orthoquartzite and soft weathered rock. No specific distress was associated with the friable rock. The soft, weathered rock was reactive, but had not caused significant distress. A small amount of alkali-silica gel filled cracks in the peripheral region of the soft particle. These cracks did not extend into the paste.

Figure 13. Weathered coarse aggregate particle. Internal cracking (red arrow) unrelated to aggregate reactivity (ASR). Blue arrow shows adhesion crack. Millimeter scale.

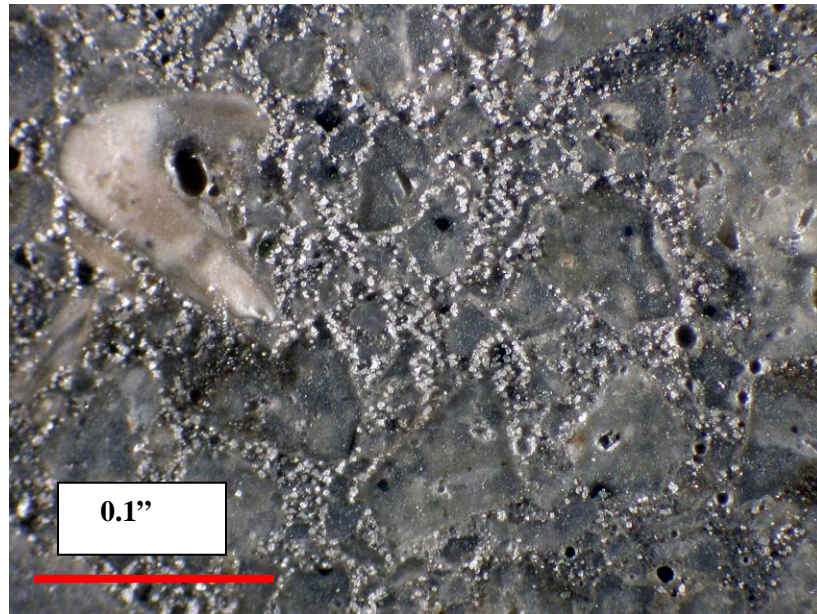
Figure 14. On drying, salt crystals appeared on the lapped concrete surface near the outside end of the core.

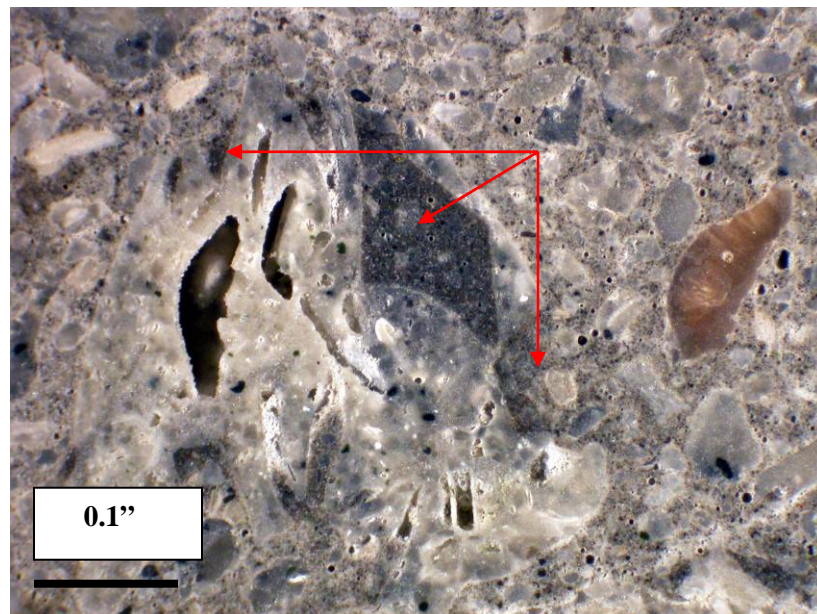
The paste properties were generally good. The paste was mottled light, medium, and dark gray. The paste luster and hardness were variable. The luster of the paste was dull to subvitreous locally. The paste hardness was moderately hard to locally soft. Partly hydrated and unhydrated Portland cement grains were moderately abundant. The hydration characteristics of the cement appeared to be normal. The extent of cement hydration was moderately high. No supplementary cementitious materials were observed. Calcium hydroxide crystals (portlandite) were fairly abundant, and were small to moderate in size. Overall, the paste characteristics indicated a variable w/c, estimated to be 0.42 to 0.47 in the dark dense areas of paste and 0.50 to 0.55 in the light gray, softer areas of paste.

Figure 15. Mottled paste color in the vicinity of a porous limestone aggregate particle. Dark gray paste (red arrows) was hard and dense.

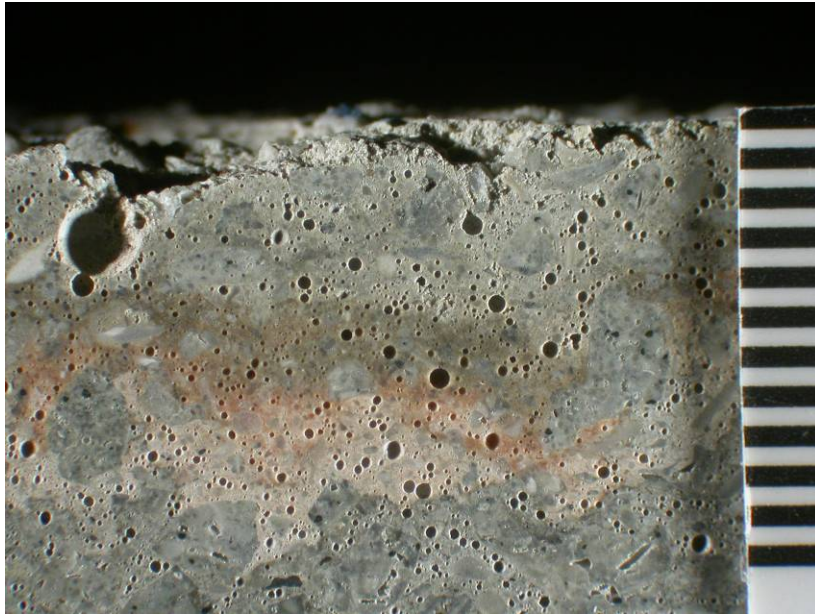
Core 103 - Bent 145 Pile Cap

Figure 16. Paste alteration at the outside end of Core 103. Millimeter scale.

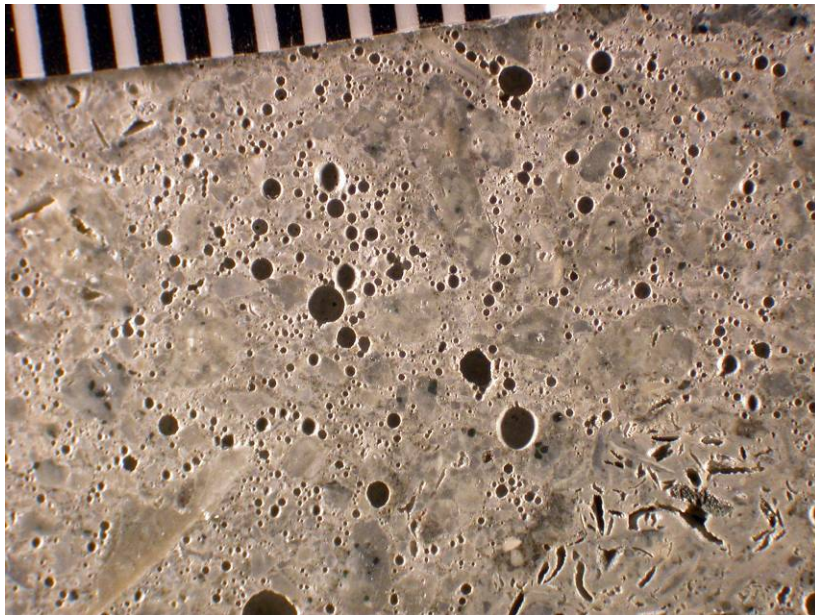
The concrete was air entrained. The estimated air content was 5 to 7 percent. The air voids were small, spherical, and were uniformly distributed throughout the concrete. Clusters of small voids were observed locally. The concrete also contained a small number of irregularly shaped entrapped air voids, typically 0.1" to 0.3" across.

Figure 17. Air entrainment in Core 103.

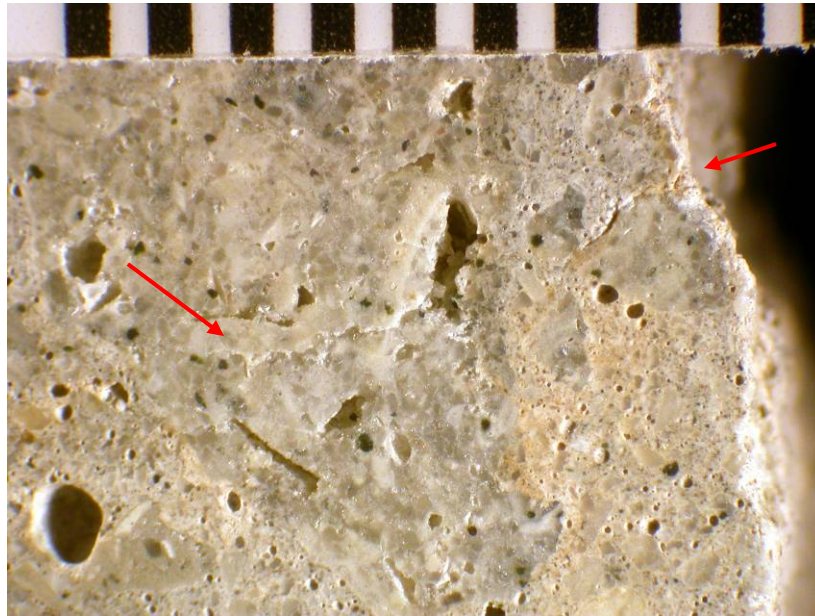
No joints or major cracks were observed. One microcrack extends from the outside surface to a depth of 0.4". This crack transected a limestone aggregate particle. The body of the concrete did not contain significant microcracks.

Figure 18. Microcrack extending from the outside surface through a limestone aggregate particle (between red arrows). Millimeter scale.

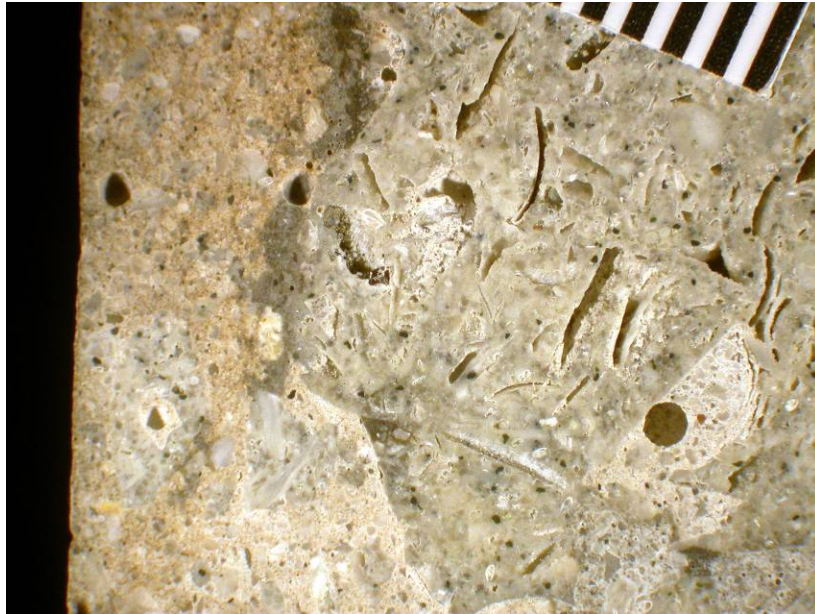
Core 93 - Span 132, Mid-span Deck

Figure 19. Discolored, carbonated paste at the top of Core 93. Millimeter scale.

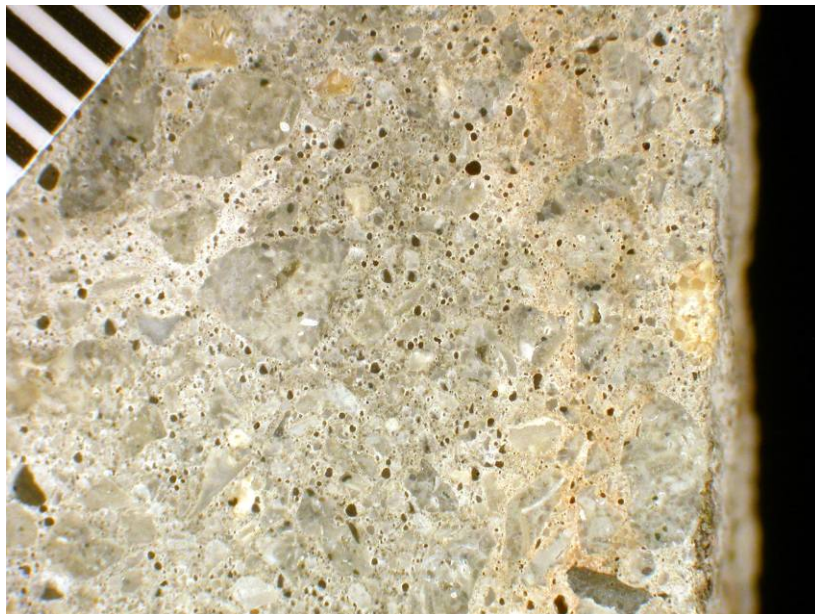
Figure 20. Discolored, carbonated paste at the bottom of Core 93. Millimeter scale.

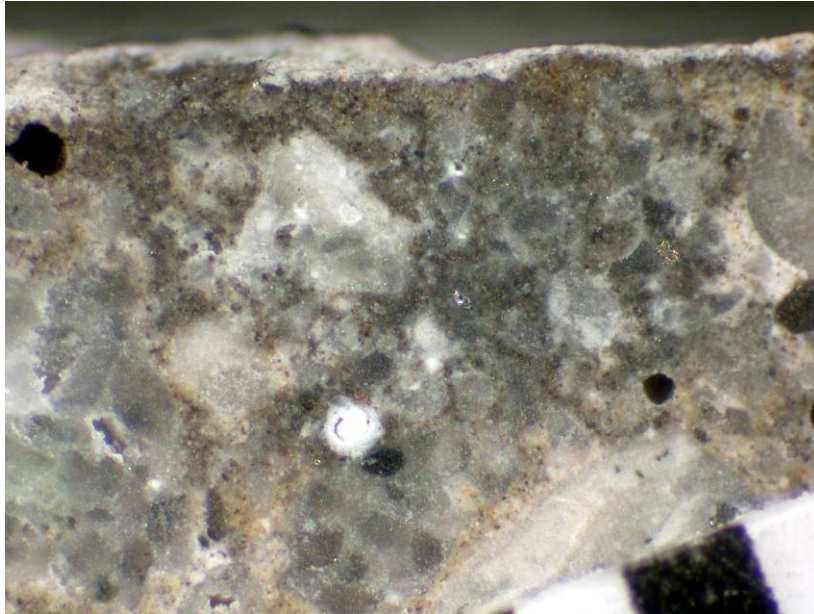
Core 90 - Span 130, Mid-span Deck

Secondary carbonate deposits occasionally filled or lined small air voids near the bottom surface of the concrete.

Figure 21. Small voids near the bottom surface of the concrete were lined or filled with secondary carbonate deposits. Millimeter scale.

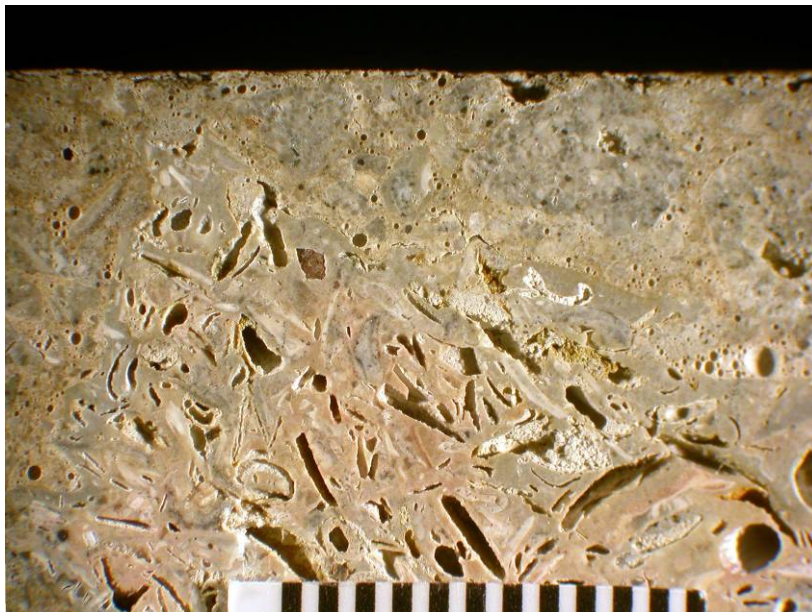
Core 137 - Span 162, Mid-span Deck

Figure 22. Pores in a coarse aggregate particle near the top surface of Core 137 contain soft, clay-like deposits. Millimeter scale.

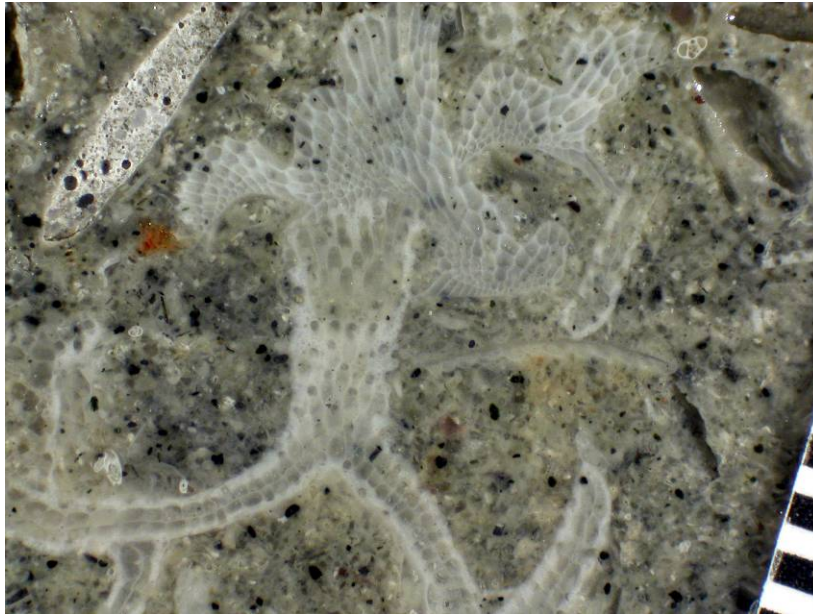
Figure 23. Coralline limestone coarse aggregate particle in Core 137 containing well preserved coral fragments. Millimeter scale.

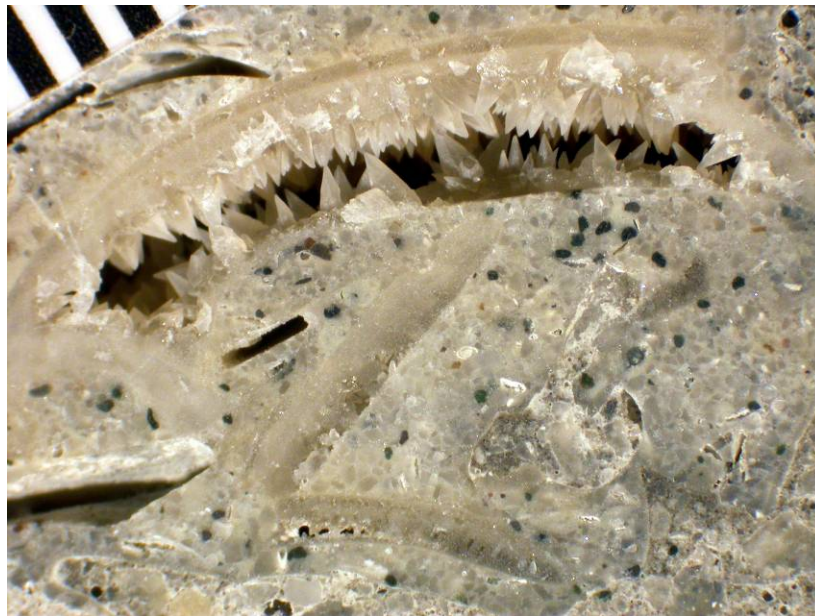
Figure 24. Carbonate crystals line a shell cavity within a limestone coarse aggregate particle.

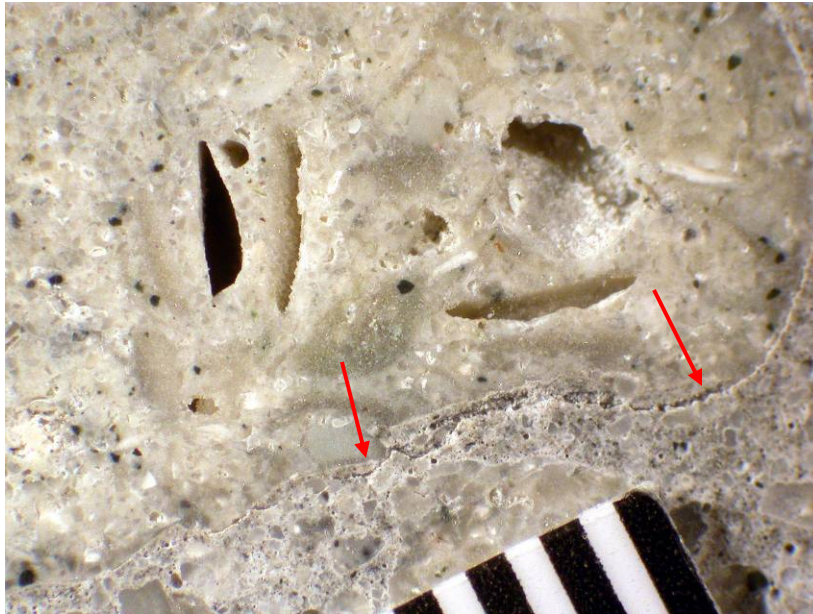
The characteristics of the coarse aggregate were similar to aggregates in the cores from the deck. Adhesion cracks were observed around portions of several coarse aggregates particles. The characteristics of the fine aggregate were similar to aggregates in the cores from the deck.

Figure 25. An adherence crack (arrows) partially encircles a coarse aggregate particle in Core 104. Millimeter scale.

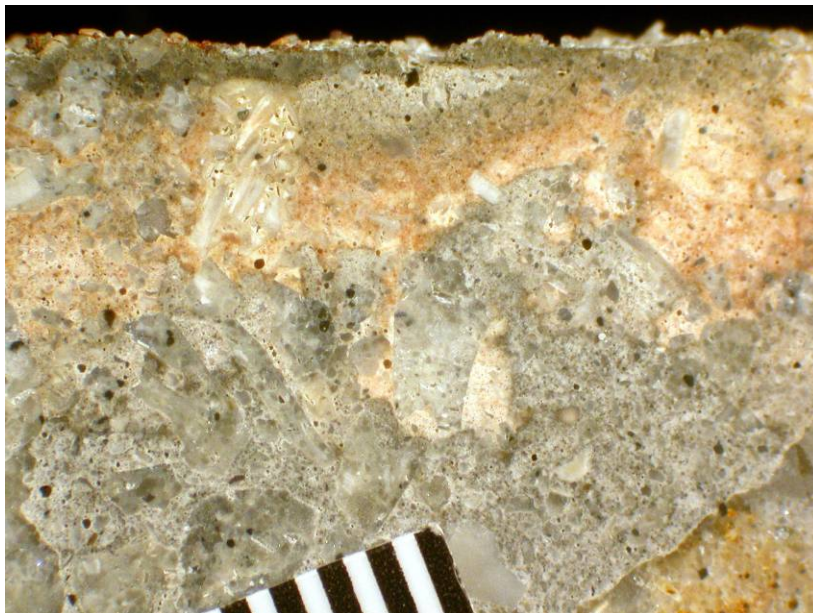
Core 117 - Bent 150 Middle Column

Figure 26. Paste discoloration at the outside end of Core 117. The dark gray layer at the surface was slightly eroded exposing sand grains.

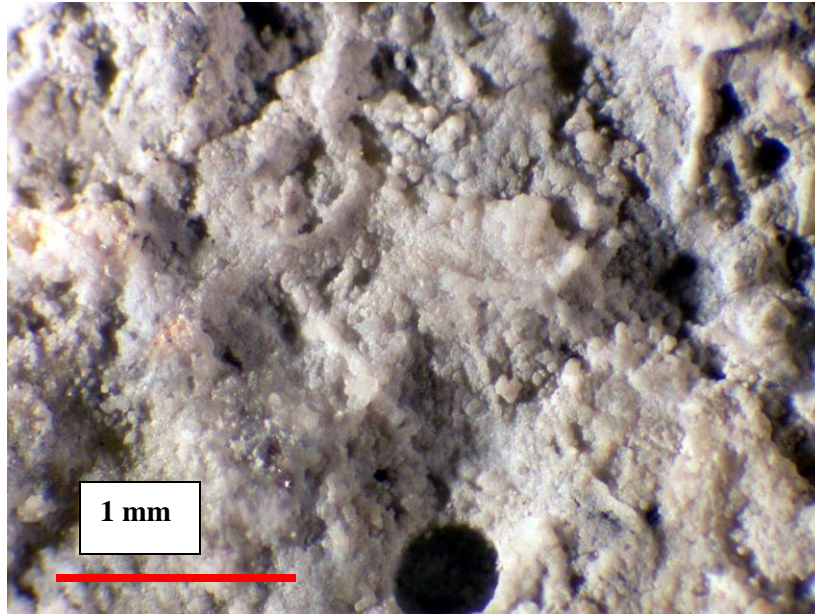
No joints were apparent. The principal fracture in the core was 1.2” to 2.6” from the outside end of the core. This fracture transected coarse aggregate particles, but did not appear related to any deficiencies in the aggregate particles. Other fracture surfaces appeared to be more recent. The paste exposed by the fractures was unaltered and no secondary deposits were observed. On each side of the fractures, one or two narrow microcracks were observed adjacent to the major fracture. Cracks and microcracks were not observed, except for these features.

Carbonate deposits were observed on the principal diagonal fracture surface. Minor amounts of ettringite were observed in a few air voids in the body of the concrete.

Figure 27. Secondary carbonate deposits coat the outside fracture surface 1.2 to 2.6" from the outside surface. This morphology characterizes open-space filling, and was not considered to be a "cause" of fracturing.

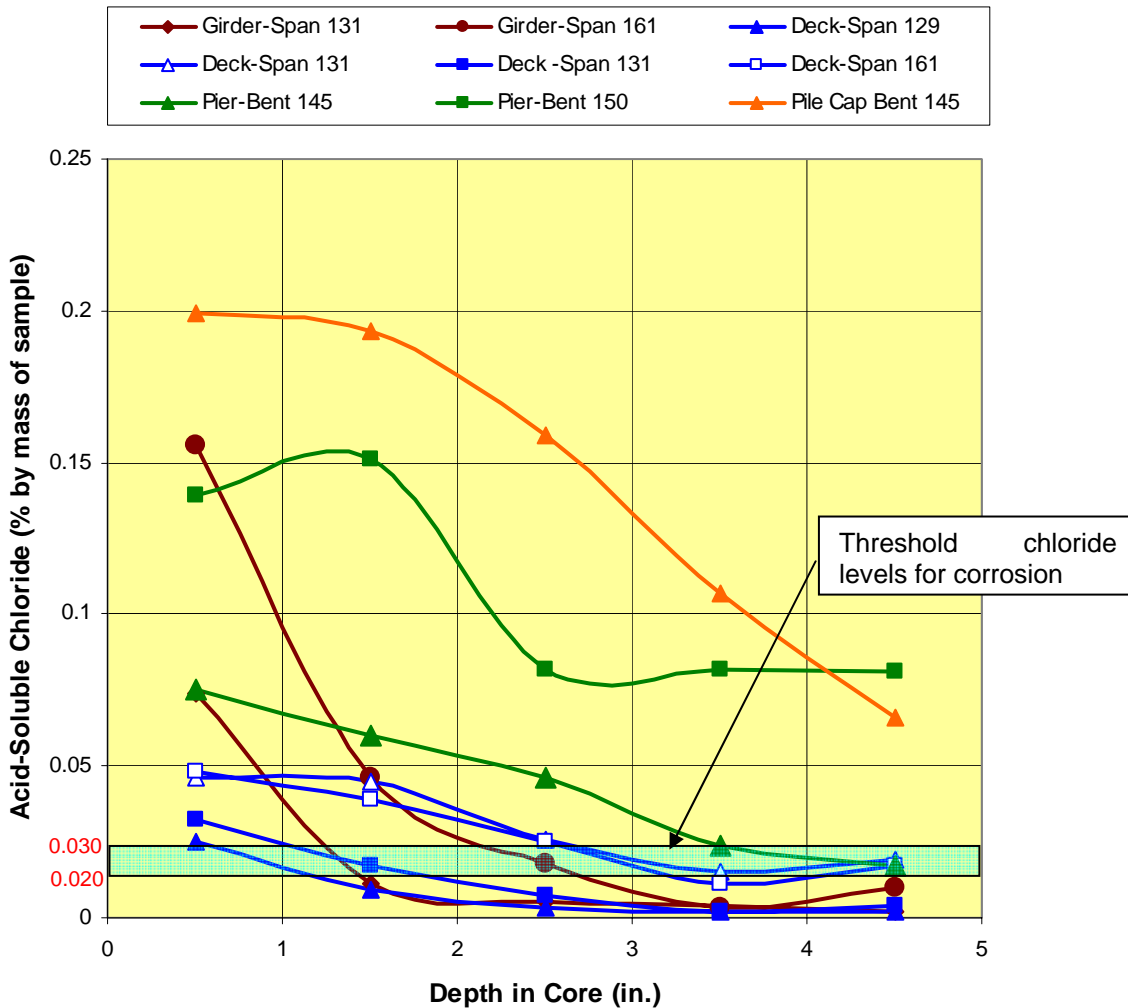
With the exception of Samples 17, 90, and 114, all the samples tested were found to have chloride levels above the threshold values normally required to promote corrosion actively in embedded steel reinforcement.

Samples 103, 117, and 120 were observed to have chloride contents significantly above those levels found in other samples. Samples 103 and 120 were removed from pile caps and Sample 117 was removed from the west column of Bent 150.

Samples 90, 93, 114, and 137 were removed from the bridge deck. Two of the samples from the bridge deck (93 and 137) were observed to have chloride levels above the threshold values at the depth of the top layer of reinforcement (1 1/2"). The other two samples (90 and 114) were observed to have chloride levels slightly below the threshold levels at this depth.

Figure 29. Chloride levels by depth in core. Note data from Core 120 not included in graph due to scale incompatibility.
