Repair Recommendations

The Herbert C. Bonner Bridge is in advanced stages of deterioration and is nearing the end of its lifespan. The bridge is anticipated to be replaced within the next ten years. The findings of the NBIS inspection and in-depth assessment are summarized as follows:

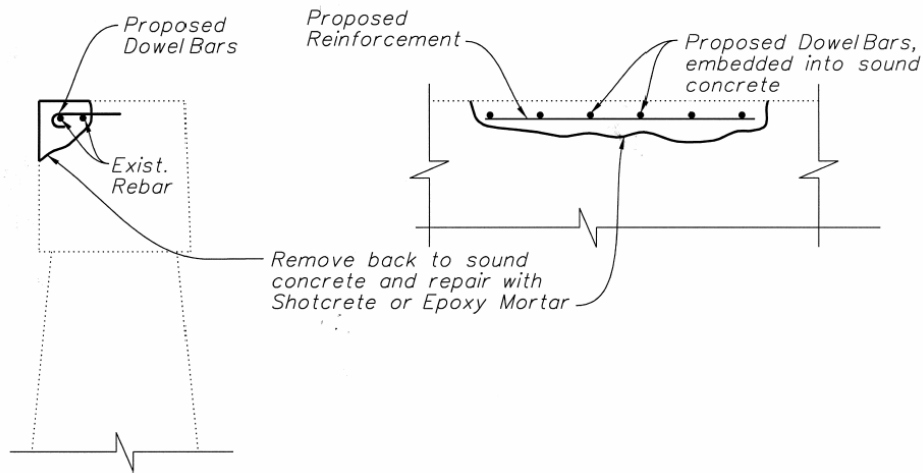
Figure 35. Typical spall/delamination repair.

The damaged areas can be broken down into three categories: spall/delamination (dry), spall/delamination (near/below the water surface), and cracking. The difference between the two types of spall/delamination

is critical since a wet concrete surface requires a different repair method. Regardless of the repair method used, the section should be repaired to the section's original dimensions. Figure 35 below describes a typical spall/delamination repair.

The bent caps, columns, and struts exhibit two primary types of damage: spall/delamination and cracking. The repair procedures will be the same for each component. The spall/delamination repair will be performed by shotcrete patching or a trowel applied patch. However, it is essential that all delamination be removed and the surface be properly prepared before the repair installation proceeds. If the delamination is not completely removed, further deterioration and spalling is likely to occur soon after the repair is complete.

1. Remove all spalled/delaminated material (with limitation described above).
2. Clean and roughen surface via high pressure wash.
3. Install anchor bars, wire mesh, etc.
4. Place concrete patch (shotcrete, trowel applied cementitious material, or epoxy mortar)
5. Roller apply silane sealer (once patch is cured)

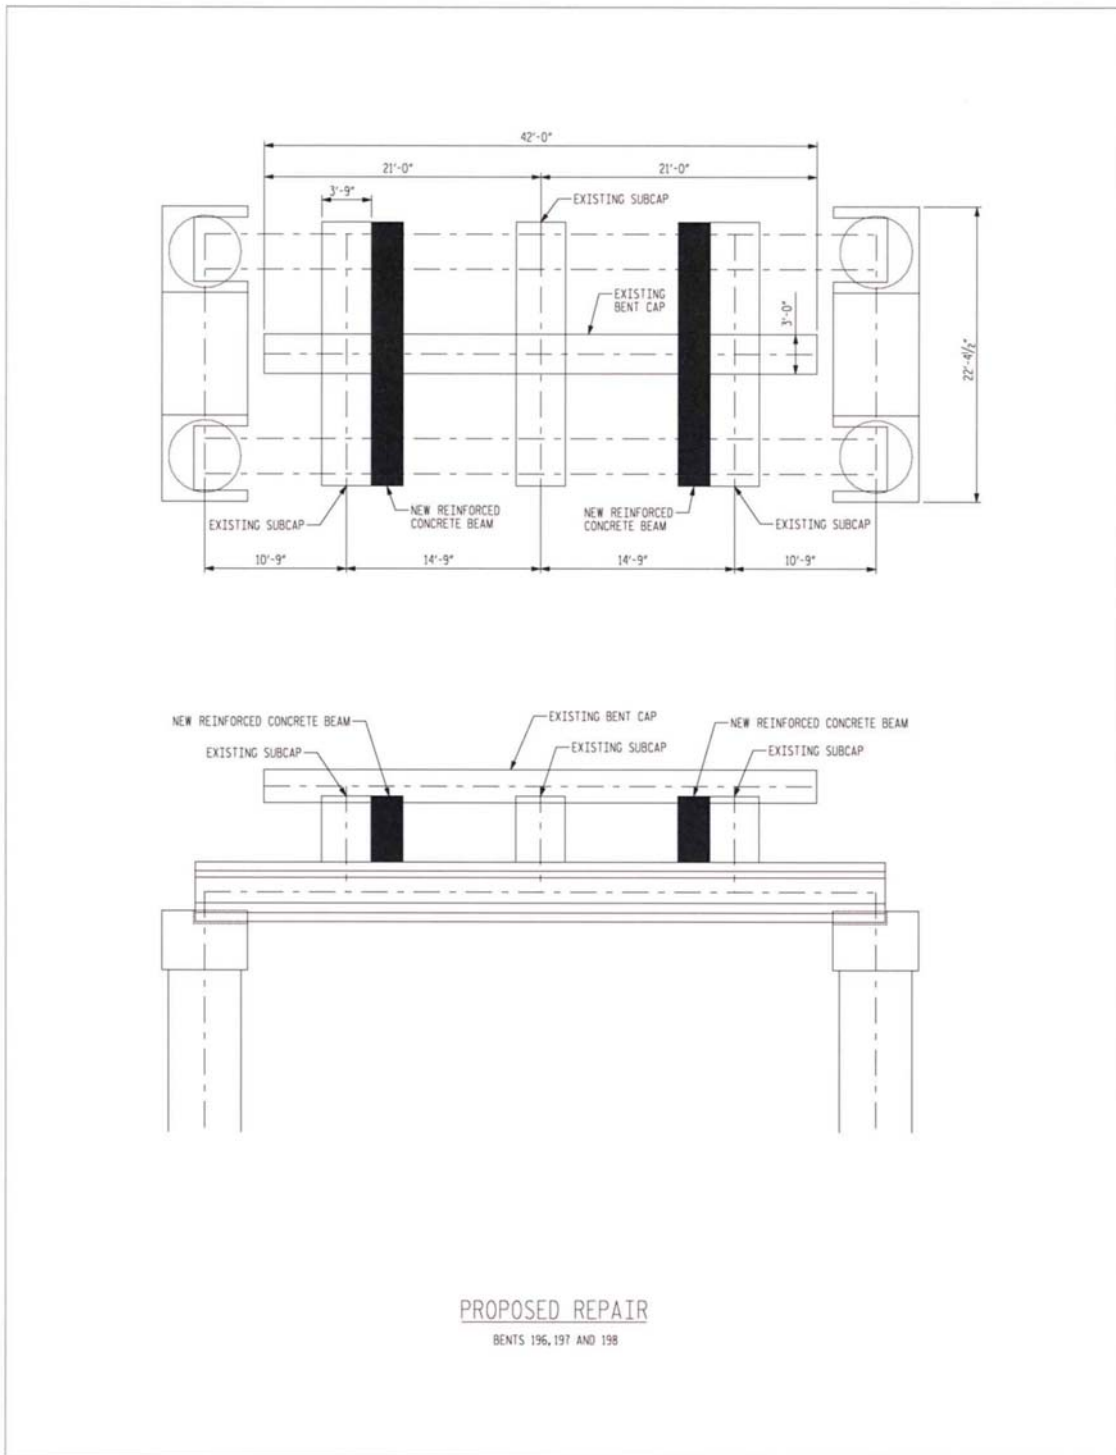
Figure 39. Approach bent cap supplemental support.

4. Structural capacities of the bridge components are adequate except for Bent Caps 196, 197, and 198. These caps are overstressed in shear, and it is recommended that additional concrete subcaps be placed to help in carrying the shear load to the crutch bents.

For Bents 196 to 198, it is recommend that an additional concrete subcap be placed beside the existing exterior subcaps at the location of the exterior girder. While this repair is not needed immediately, it is recommended that it be done with the NBIS repairs at these three bents. Refer to Figure 39 for the proposed supplemental cap repair.
