NC DEPARTMENT OF TRANSPORTATION DIVISION OF HIGHWAYS BRIDGE MAINTENANCE UNIT **ATTENTION**

BRIDGE INSPECTION REPORT

INSPECTION TYPE BRIDGE NO. 770169

STRUCTURE TYPE REINFORCED CONCRETE FLOOR ON PRESTRESSED CONCRETE GIRDERS ROUTE ORIENTATION W - E

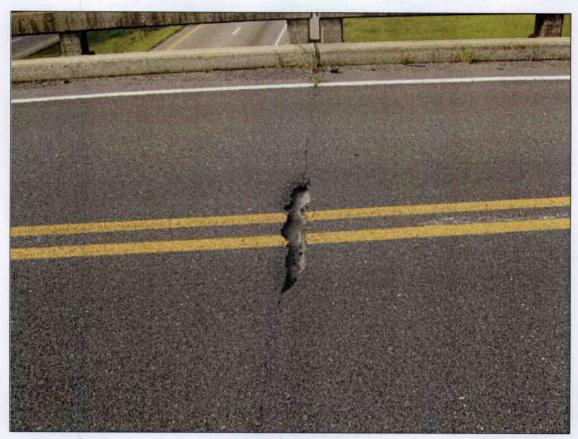
Assisted By	TLF	
Item No.	Grade	
1	7	THE DECK HAS FAIRLY NEW BST SURFACE. IT IS CRACKING LONGITUDINALLY AT THE JOINTS AND A 6 INCH WIDE X 36 INCH LONG POTHOLE HAS RAVELED LOOSE NEAR THE CENTERLINE OF BENT 3.
2a	5	AT SPAN 1 THERE IS A MINOR DIAGONAL CRACK IN BAY 3 AT THE SOUTHWEST CORNER OF THE BRIDGE. ONE TRANSVERSE CRACK IS LEAKING EFFLORESCENCE AT APPROXIMATELY THE 2/3 POINT OF BAY 3. AT SPAN 2, THE CONCRETE CORED SLABS SHOW NO SIGNS OF DISTRESS. THERE IS SPOT EFFLORESCENCE AT RANDOM THROUGHOUT THE SLAB JOINTS. AT SPAN 3, THERE IS HEAVY LEAKAGE AT THE CENTERLINE OF BAY 3, 1/4 OF WAY INTO THE SPAN. SEVERAL LIGHT TRANSVERSE CRACKS IN BAY 1 AND BAY 2 WERE NOTED. AT SPAN 4 THERE ARE 5 TO 6 TRANSVERSE CRACKS LEAKING EFFLORESCENCE AT EACH BAY. OVERALL THE DECK APPEARS TO BE SOUND.
3a	7	THERE IS MINOR SCALING AND COARSE AGGREGATE EXPOSED ON THE RAILS AT SPANS 1, 3, AND 4. SEVERAL CHIPS AND SPALLS HAVE BEEN PATCHED. AT SPAN 2, THE RAILS ARE MUCH NEWER AND ARE GOOD.

POTHOLE IN JOINT MEASURING 4 INCHES WIDE X 2 INCHES DEEP X 4 FOOT LONG AT INTERIOR BENT 3

Function Code	Description of Function	Unit	Quantity	Remarks	Est. Cost
556	Bridge approaches, surfacing or pavement replacement or repair	Man-Hours	40	EAST APPROACH IS UNEVEN AND SETTLED.	
560	Maintenance and repairs to concrete bridge floors	Sq-ft	2900	CRACKS IN THE DECK.

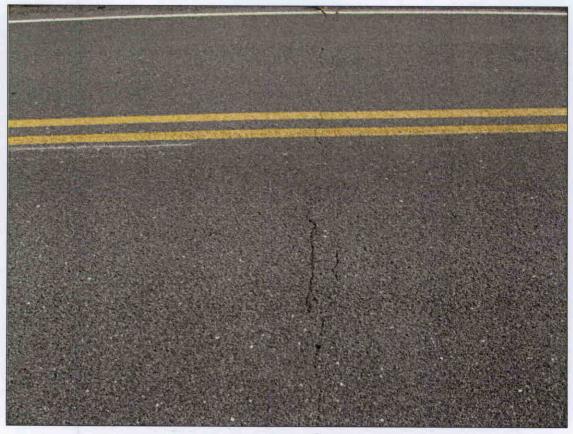
TYPICAL HAIRLINE CRACK OVER INTERIOR BENT 2 JOINT

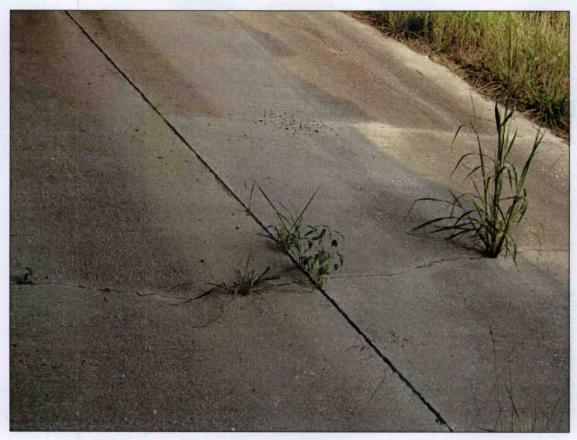
VEGETATION GROWING OUT OF CRACK IN SLOPE BANK

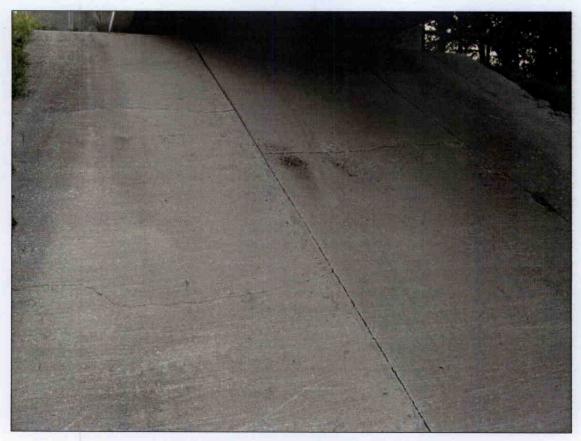
CRACKING IN SLOPE PROTECTION - SPAN 1

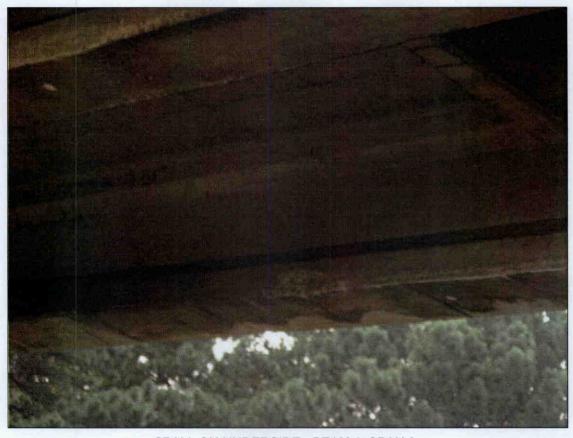
SPALL ON UNDERSIDE - BEAM 1, SPAN 3

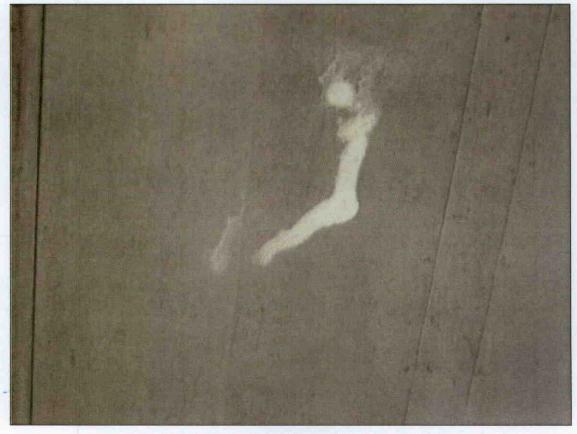
EFFLORESCENCE LEAKAGE IN SPAN 3 - 1/4 POINT

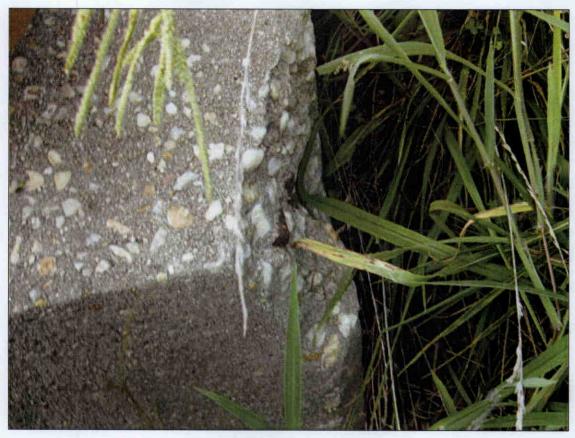
CHIP ON SOUTHEAST WINGWALL
