**AIR EXCAVATION ACTIVITIES
ON PARCEL 132**

**State Project U-4020, WBS Element 35015.1.1
US 421 (King Street) from US 321 (Hardin Street)
to East of NC 194 (Jefferson Road) in Boone
Watauga County, North Carolina**

March 18, 2009
Project Number 08210020.07

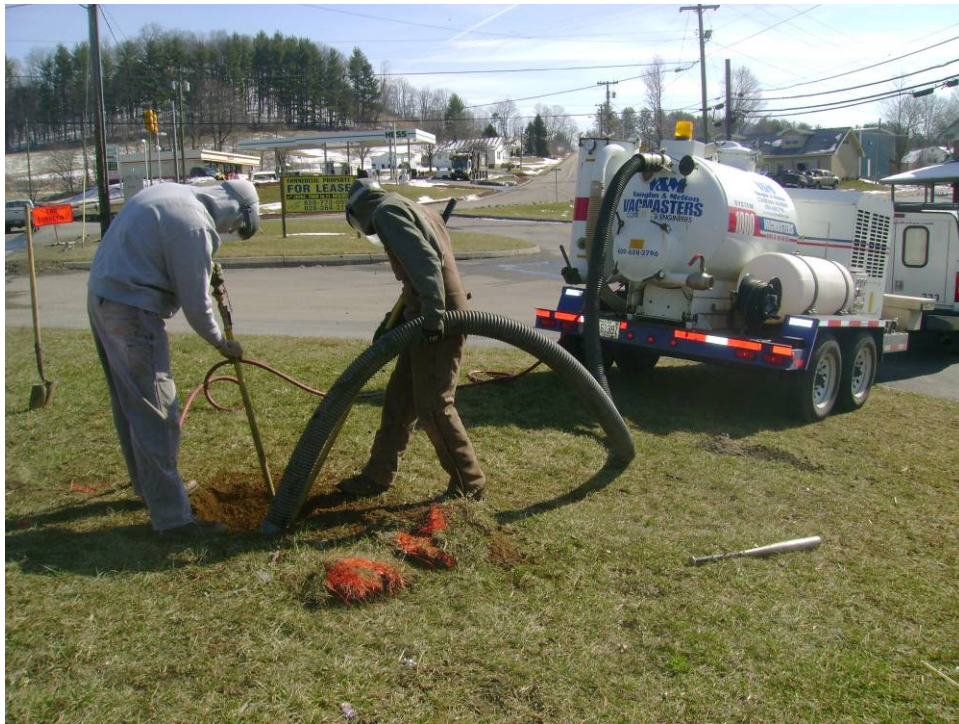
FIGURE 1

On March 4, 2009, Schnabel personnel relocated the center of the possible UST with DGPS and GPR. We observed Vaughn & Melton Consulting Engineers as they utilized their Vacmasters 1000 air excavation unit to remove soil from the possible UST location. The Vacmasters 1000 is a trailer-mounted unit that includes an air jetting wand to loosen the soil and a suction hose to pull the soil into a holding tank (Figure 1, top photo).

Start of air excavation with Vacmasters 1000 unit

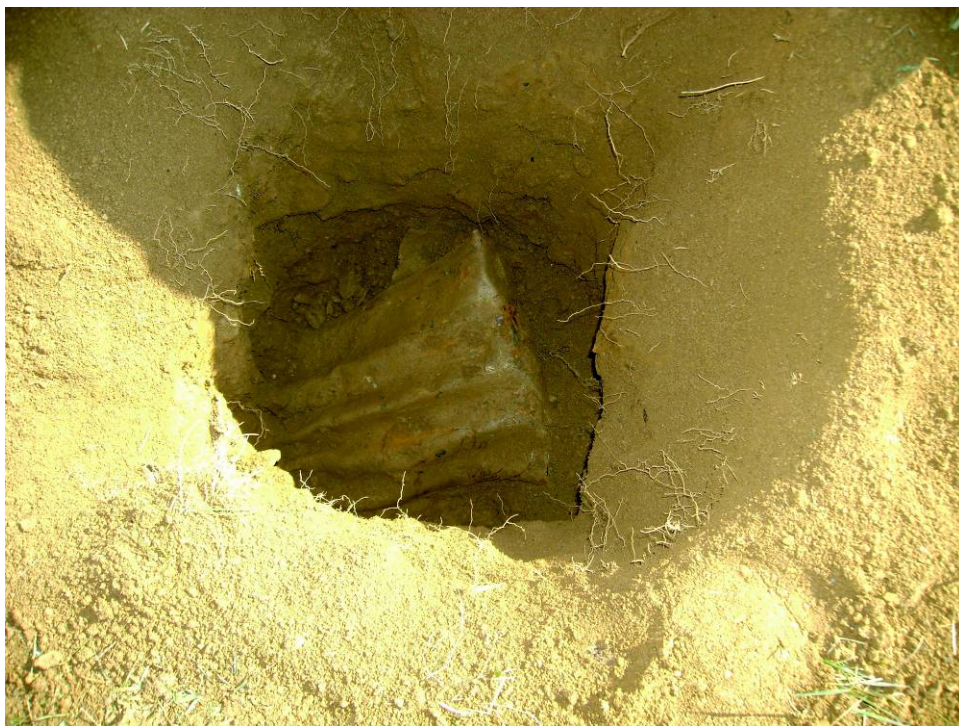
Vaughn & Melton removed the sod and began excavating the soil in an approximately 2-foot by 2-foot hole centered on the location of the center of the possible UST. At a depth of approximately 2 feet, we encountered a bent piece of metal that appeared to be an old section of guard rail (Figure 1, bottom photo). We removed the surrounding soil, but the piece of metal extended laterally into the undisturbed soil and was not able to be removed (Figure 2, top photo). We increased the size of the hole to approximately 4-foot by 2-foot and continued excavating downwards to determine if a UST was present beneath the scrap metal.

- The geophysical anomalies that had been recorded previously were likely caused by a piece of scrap metal and one or more boulders. The EM61 response was probably due to the piece of buried metal guard rail. The hyperbolic response seen on the GPR record was probably due to one or more of the boulders adjacent to the buried metal guard rail.
- Evidence of a UST was not found within the excavation limits at this location on Parcel 132.

Initial scrap metal encounter

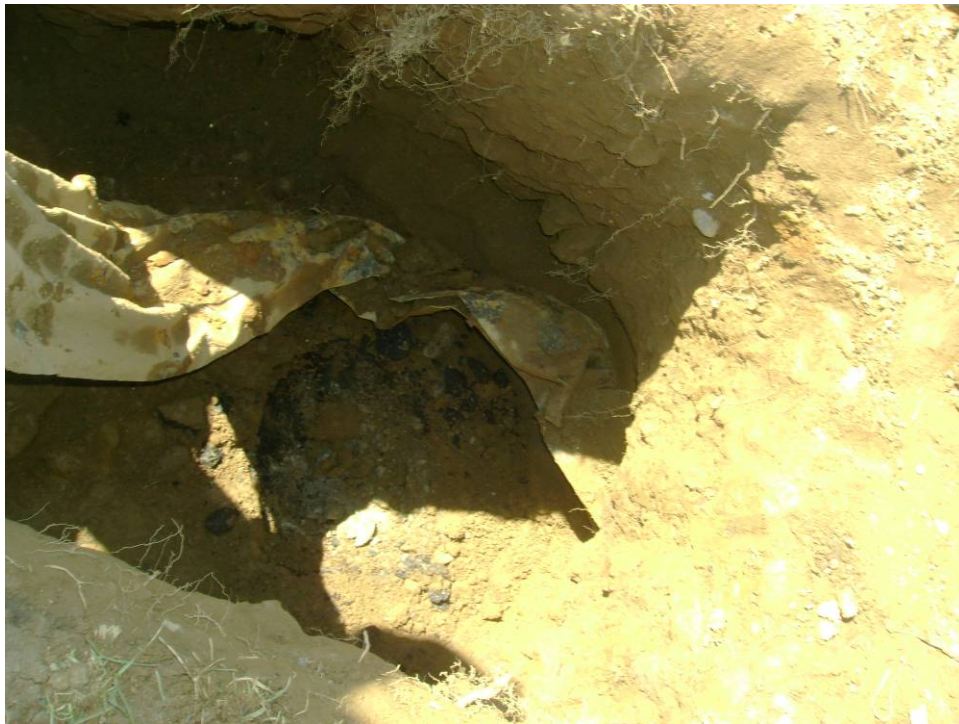
FIGURE 2

More of the scrap metal uncovered

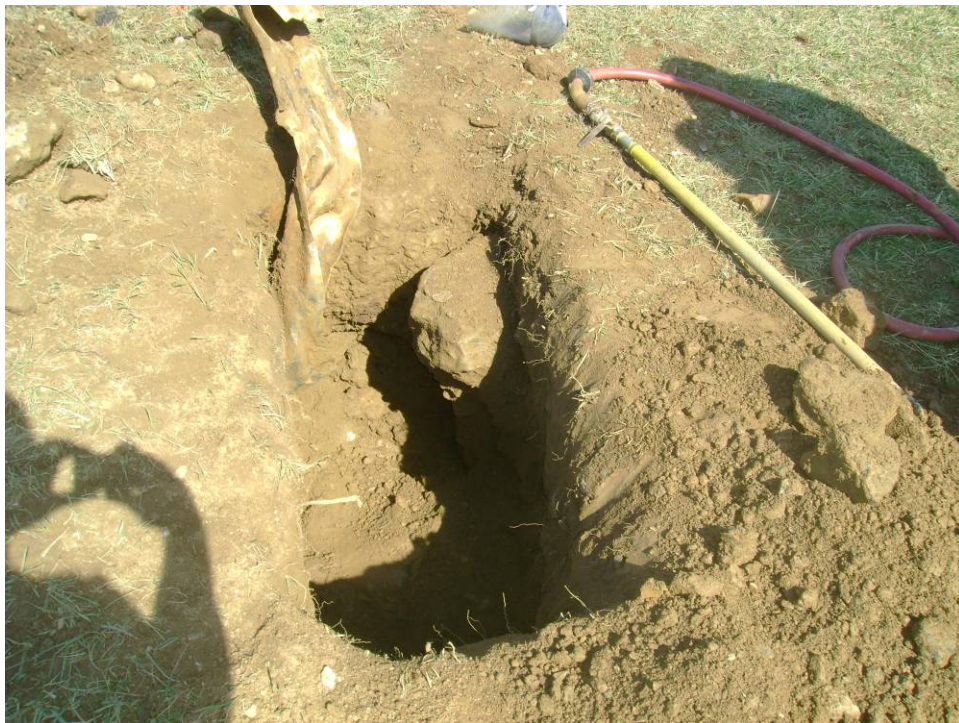
In addition to the scrap metal, a large boulder and several smaller boulders and cobbles were found in the hole and in the sides of the hole (Figure 2, bottom photo). At a depth of approximately 3.5 feet we encountered an asphalt layer. We attempted to chip through the asphalt and continue excavating downwards but the asphalt was underlain by hard weathered rock. At this point we contacted Cyrus Parker, from the NCDOT, with our findings. Mr. Parker agreed with our recommendation to backfill the hole and demobilize (Figure 3).

Exposed boulder next to scrap metal

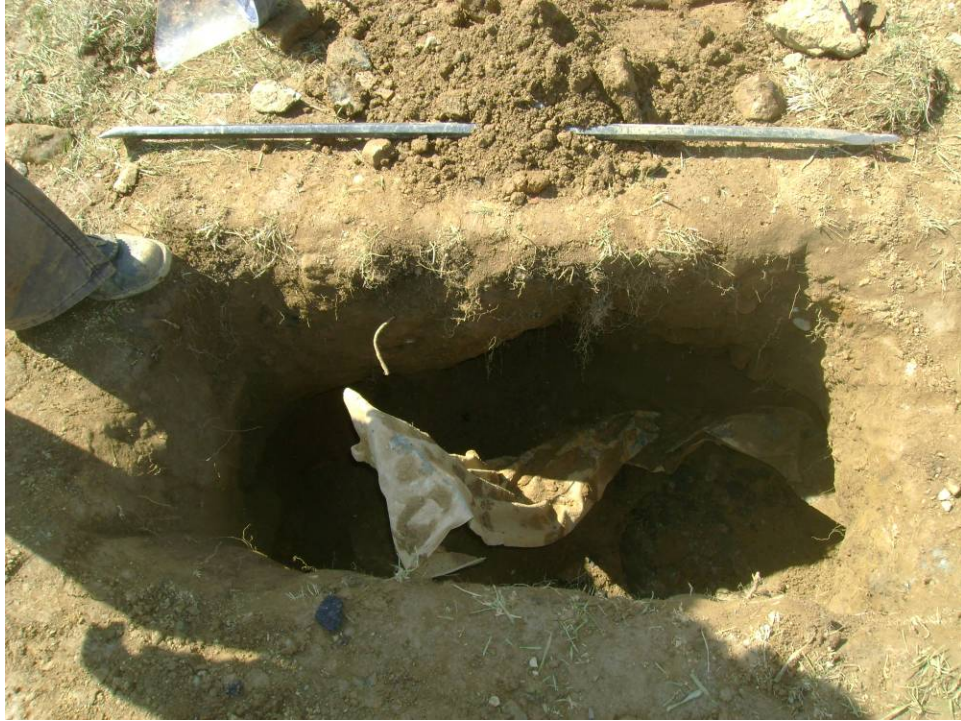
FIGURE 3

End of air excavation

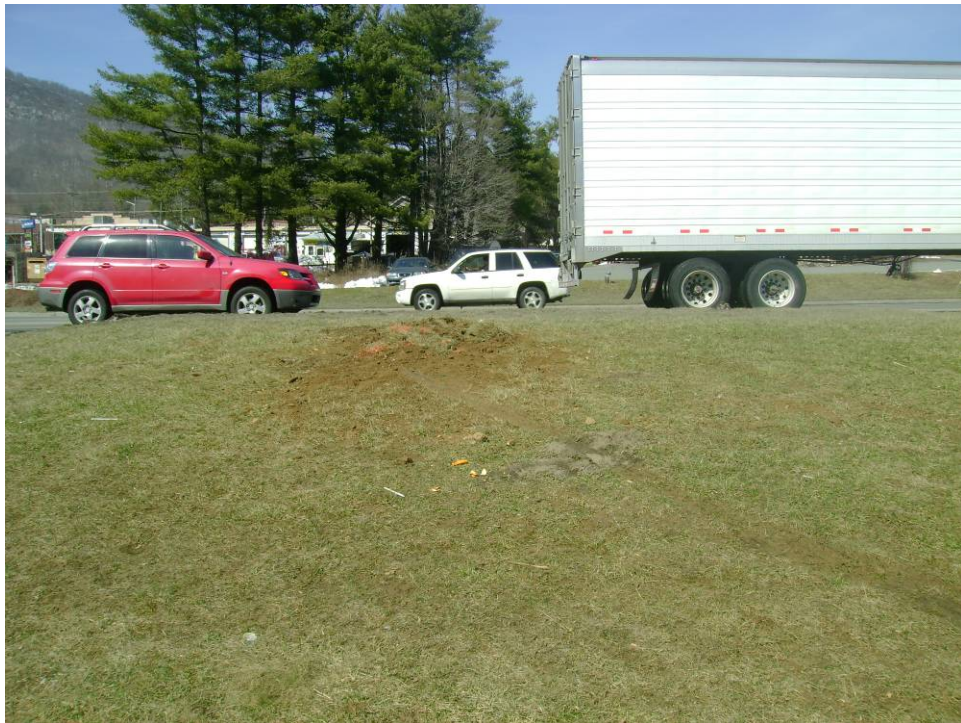
Backfilled hole
