SUBJECT: Transmittal of Bridge Scour Assessments

BRIDGE SCOUR REPORT

COUNTY: New Hanover BRIDGE: 640012 ROUTE: US74&76 STREAM CROSSED: Intracoastal Waterway

FINAL REPORT OF CODE T BRIDGE FOUNDATION INVESTIGATION
BRIDGE # 640012
NEW HANOVER COUNTY
ROUTE US 74 & 76
INTRACOASTAL WATERWAY

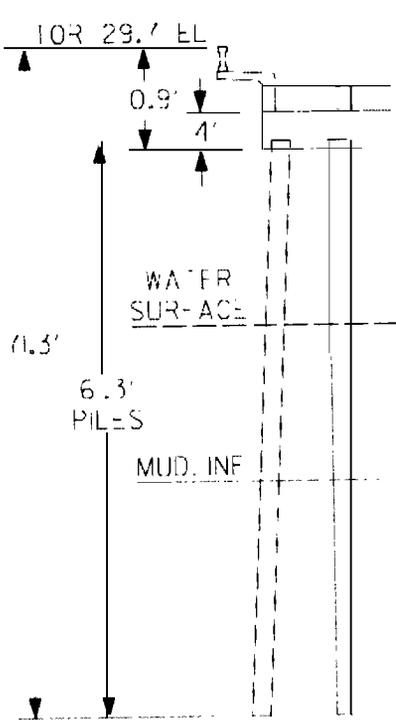
BENT
7

Bents 6 and 7 have shown scouring to 3 feet in past inspection. Recent inspection reports indicate that the previous scour at bents 6 and 7 appear stable at the time of inspection.

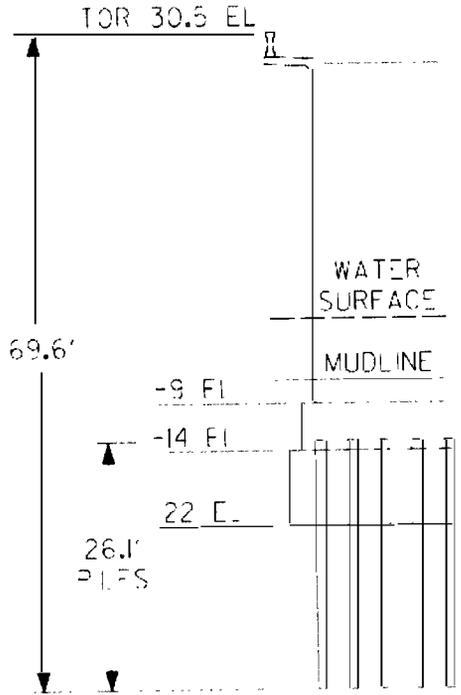
BENT
8

1991 prompt action repair on footing No. 1 of bent 8. Current scouring is occurring at footing No. 2 of bent 8 and extends downstream along the eastern face of the pier. A 2004 prompt action was issued for the scouring occurring on footing No two and was re-issued in 2007.

A 1990 inspection found that scour had exposed the timber piles beneath footing No. 1 of bent 8, and that 30 of the 91 piles had been exposed with 12 of the piles “100% eaten away by borers”. A prompt action report states that a coffer dam was driven around the pier, pilings were legged up, and 300 cu yd of concrete was poured beneath the pier in 1991. Details of this repair are provided in the 1990 prompt action report and the 1991 underwater report.

A 1998 underwater inspection report notes an irregular surface and the presence of scour holes caused by sand bags that remain from the 1991 repair. The same report mentioned that the repair appeared stable at that time.

A 2002 inspection found scouring conditions beneath the eastern side of bent 8 starting at footing No. 2 and extending downstream along the face. A 2002 prompt action report was issued with no remedial work performed. Prompt action was re-issued in 2004 due to increased scour and severed foundation piles. A new prompt action was issued in 2007. The latest underwater inspection report stated that the scour mentioned in the 2004 inspection was still active at that time.

Monitor Bent 8 and 9 for exposed piles or timber piles damaged by marine borers.

Increase U/W inspection frequency to every 2 years. If no problems are found after two cycles, return to 4yr frequency
