January 6, 2012

Re: Site Inspection Report
Parcel 122A, 1211 Piney Green Road
Onslow County, North Carolina
TIP: U-3810, WBS No. 35801.1.1

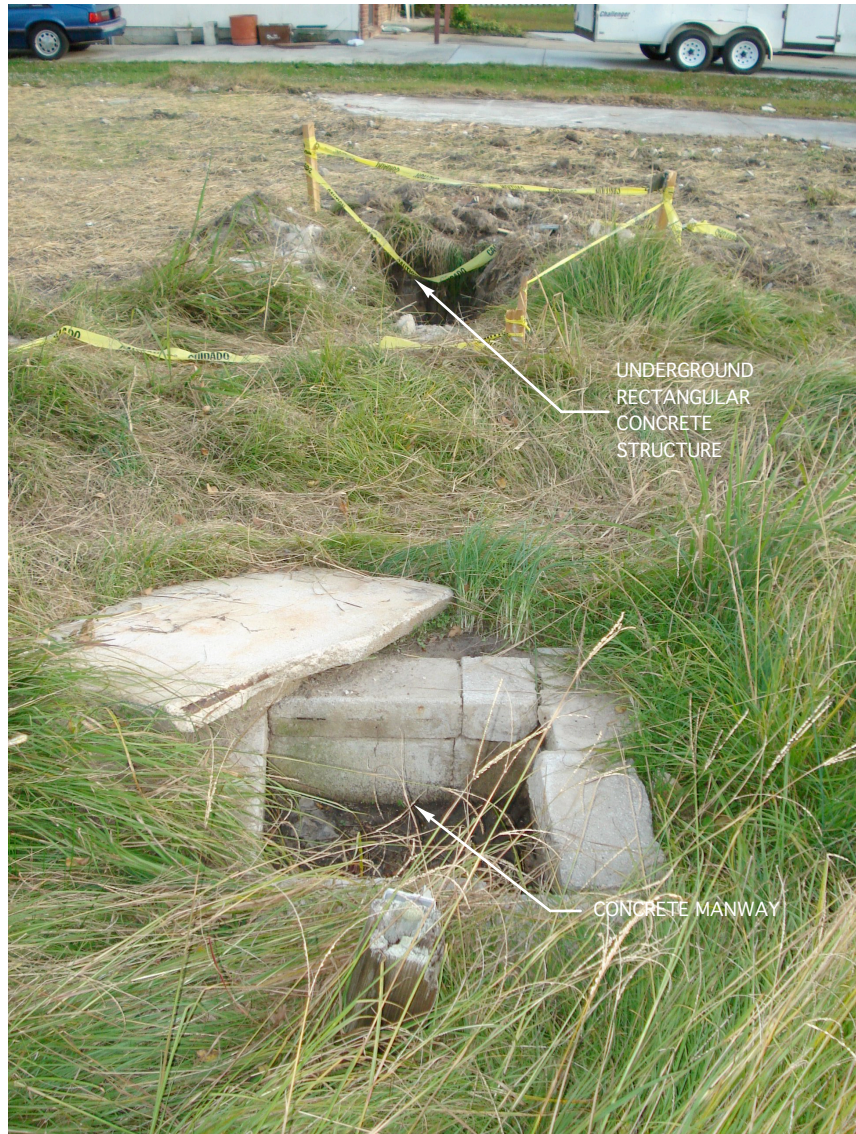
The underground structure encountered by the demolition contractor is shown in Photographs 1, 2, and 3 in Attachment A, and its approximate location is shown in Figure 2. It appears to be a concrete rectangular storm water drainage or former irrigation structure that is oriented in a northwest-southeast direction. Two pipes (construction material not determined) and extend off site in a northwesterly direction from the structure off site to the northwest, and two pipes appear to extend into the interior of the site in a southeast direction. An at-grade concrete access manway (or valve box) located

Photograph 2: View looking southeast at underground concrete structure encountered by NCDOT demolition contractor.

Based on our observations during the site inspection, the structure is not an underground storage tank or a septic tank, and there is no evidence that the structure contains or previously contained liquids or materials that would potentially impact the surrounding soil as a result of a release. Therefore, GEL recommends no further action regarding the structure.

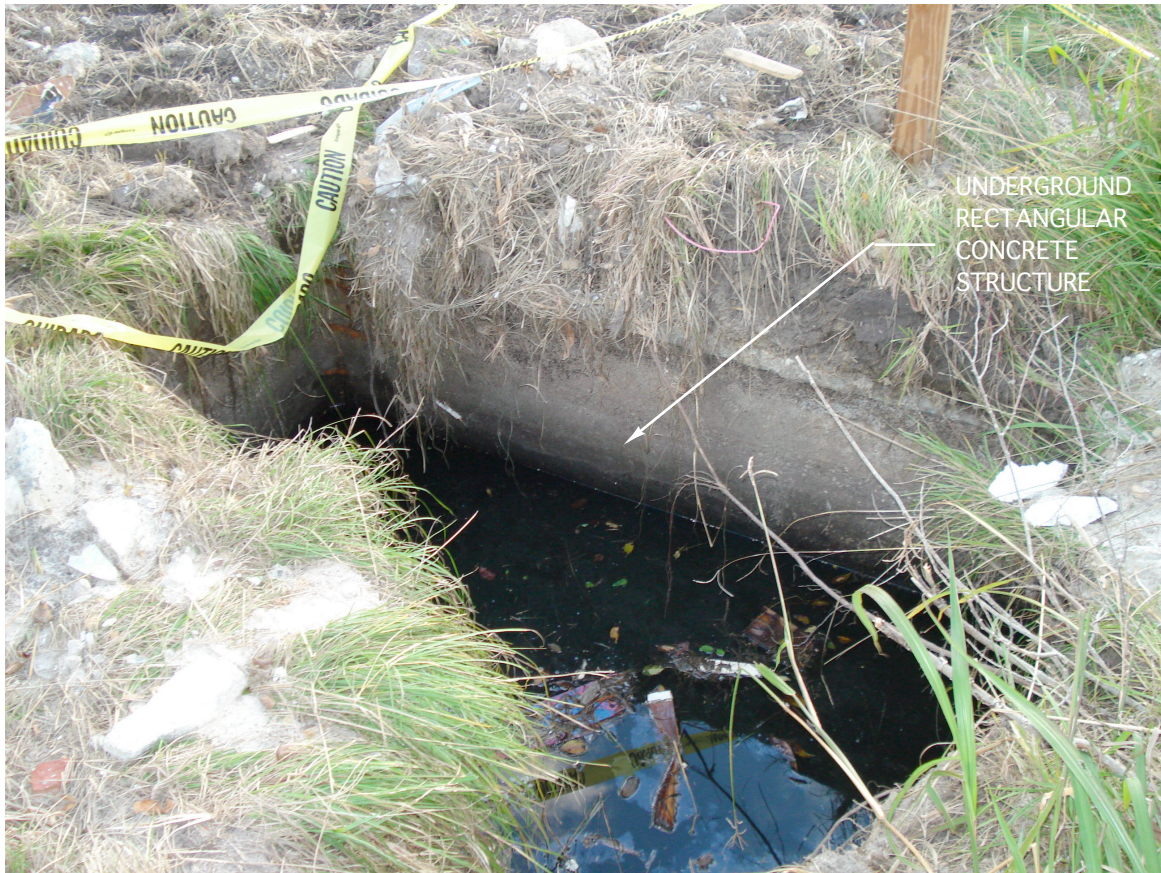
As shown in Photograph 3, standing water was observed in the structure, but there was no evidence of any other liquids, such as free petroleum product, or noticeable odors. The soil surrounding the structure did not appear to be stained or otherwise impacted from a release from the structure.

Photograph 3: View looking south at underground rectangular concrete structure encountered by NCDOT demolition contractor. Two pipes, oriented northwest-southeast, extend from each end of structure. Apparent sheen shown on water surface is believed to be due to naturally occurring bacteria, not petroleum.
