PROJECT NO. I-5788  
CUMBERLAND COUNTY  
 BRIDGE NO. 157

STATE OF NORTH CAROLINA  
 DEPARTMENT OF TRANSPORTATION  
 RALEIGH  
 SUPERSTRUCTURE  
 REPAIR  
 SPAN A  
 NBL

REVISIONS						SHEET NO. S-25
NO.	BY:	DATE:	NO.	BY:	DATE:	
1			3			TOTAL SHEETS 72
2			4

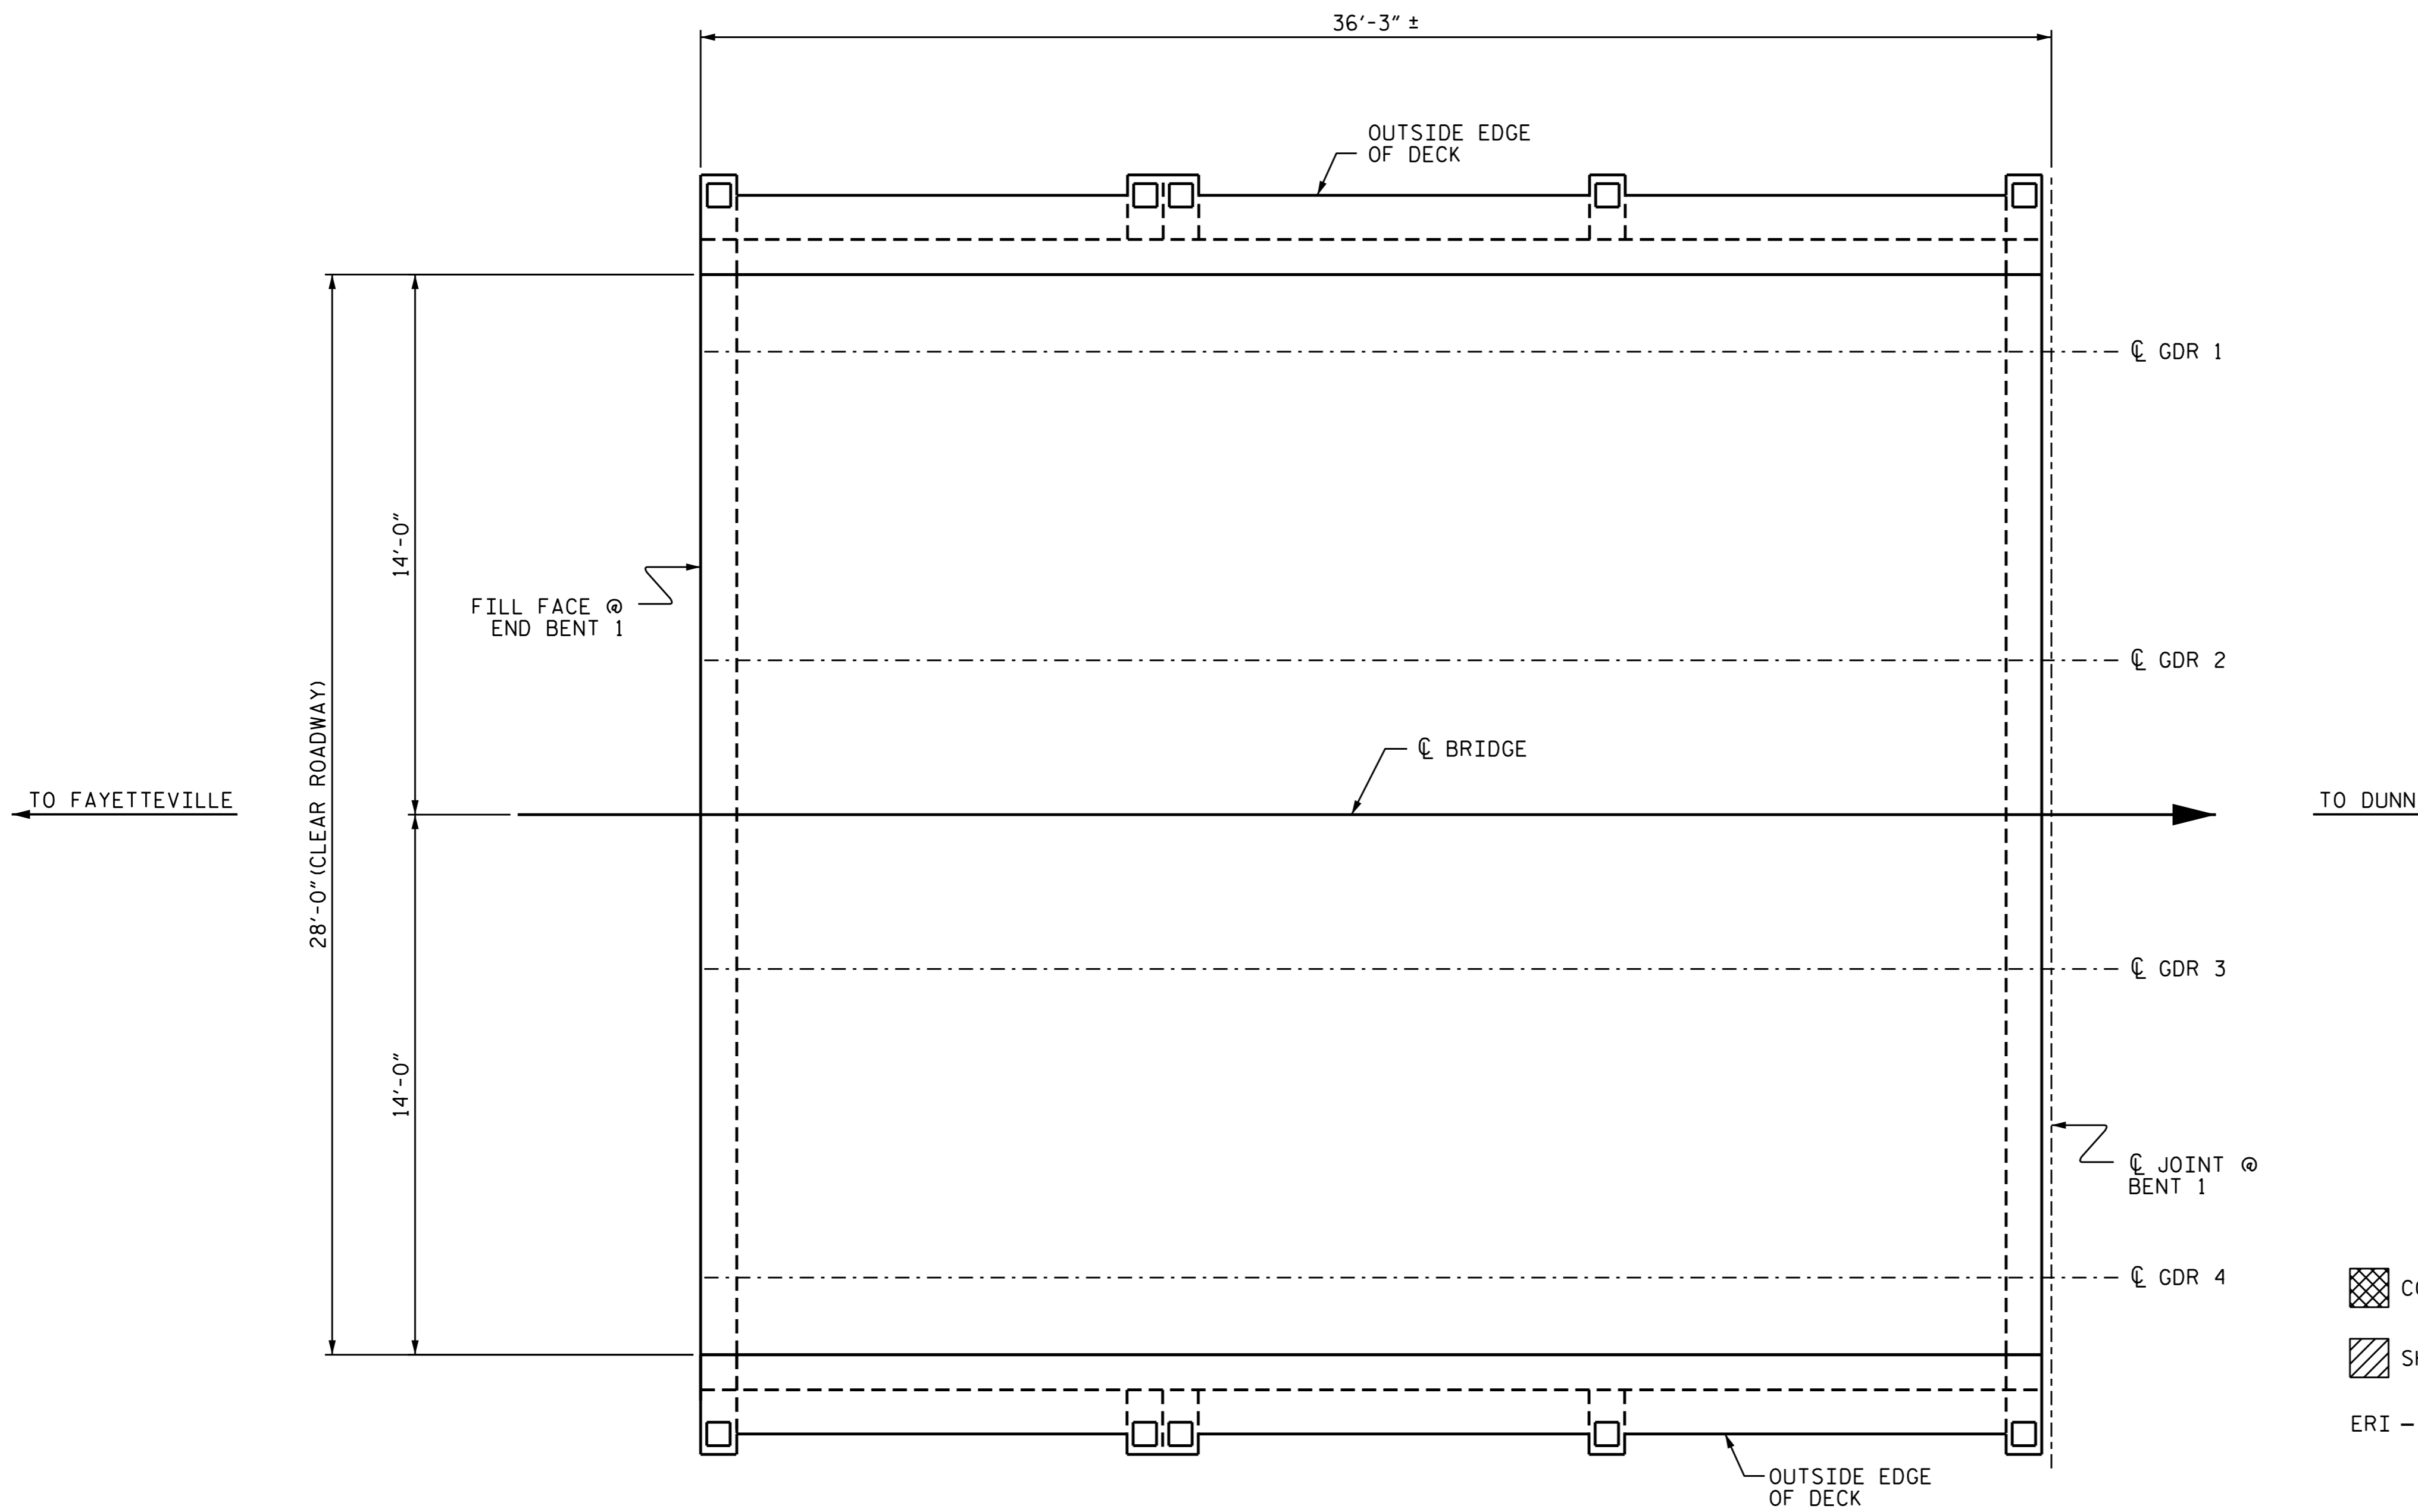
PLAN OF SPAN A

VALUES IN CHARTS REPRESENT ESTIMATED UNDERSIDE OF DECK REPAIR TOTALS AFTER REMOVAL OF UNSOUND CONCRETE, MIN. OF 1" BEHIND REBAR AND MIN. 1" CLEAR TO SAWCUT. SEE REPAIR DETAILS.

REPAIR CONCRETE BENT DIAPHRAGMS AS DIRECTED BY THE ENGINEER.
