PROJECT NO. I-5788
CUMBERLAND COUNTY
 BRIDGE NO. 157

SUPERSTRUCTURE
 REPAIR
 SPAN C
 NBL

REVISIONS						SHEET NO. S-27
NO.	BY:	DATE:	NO.	BY:	DATE:	
1			3			TOTAL SHEETS 72
2			4

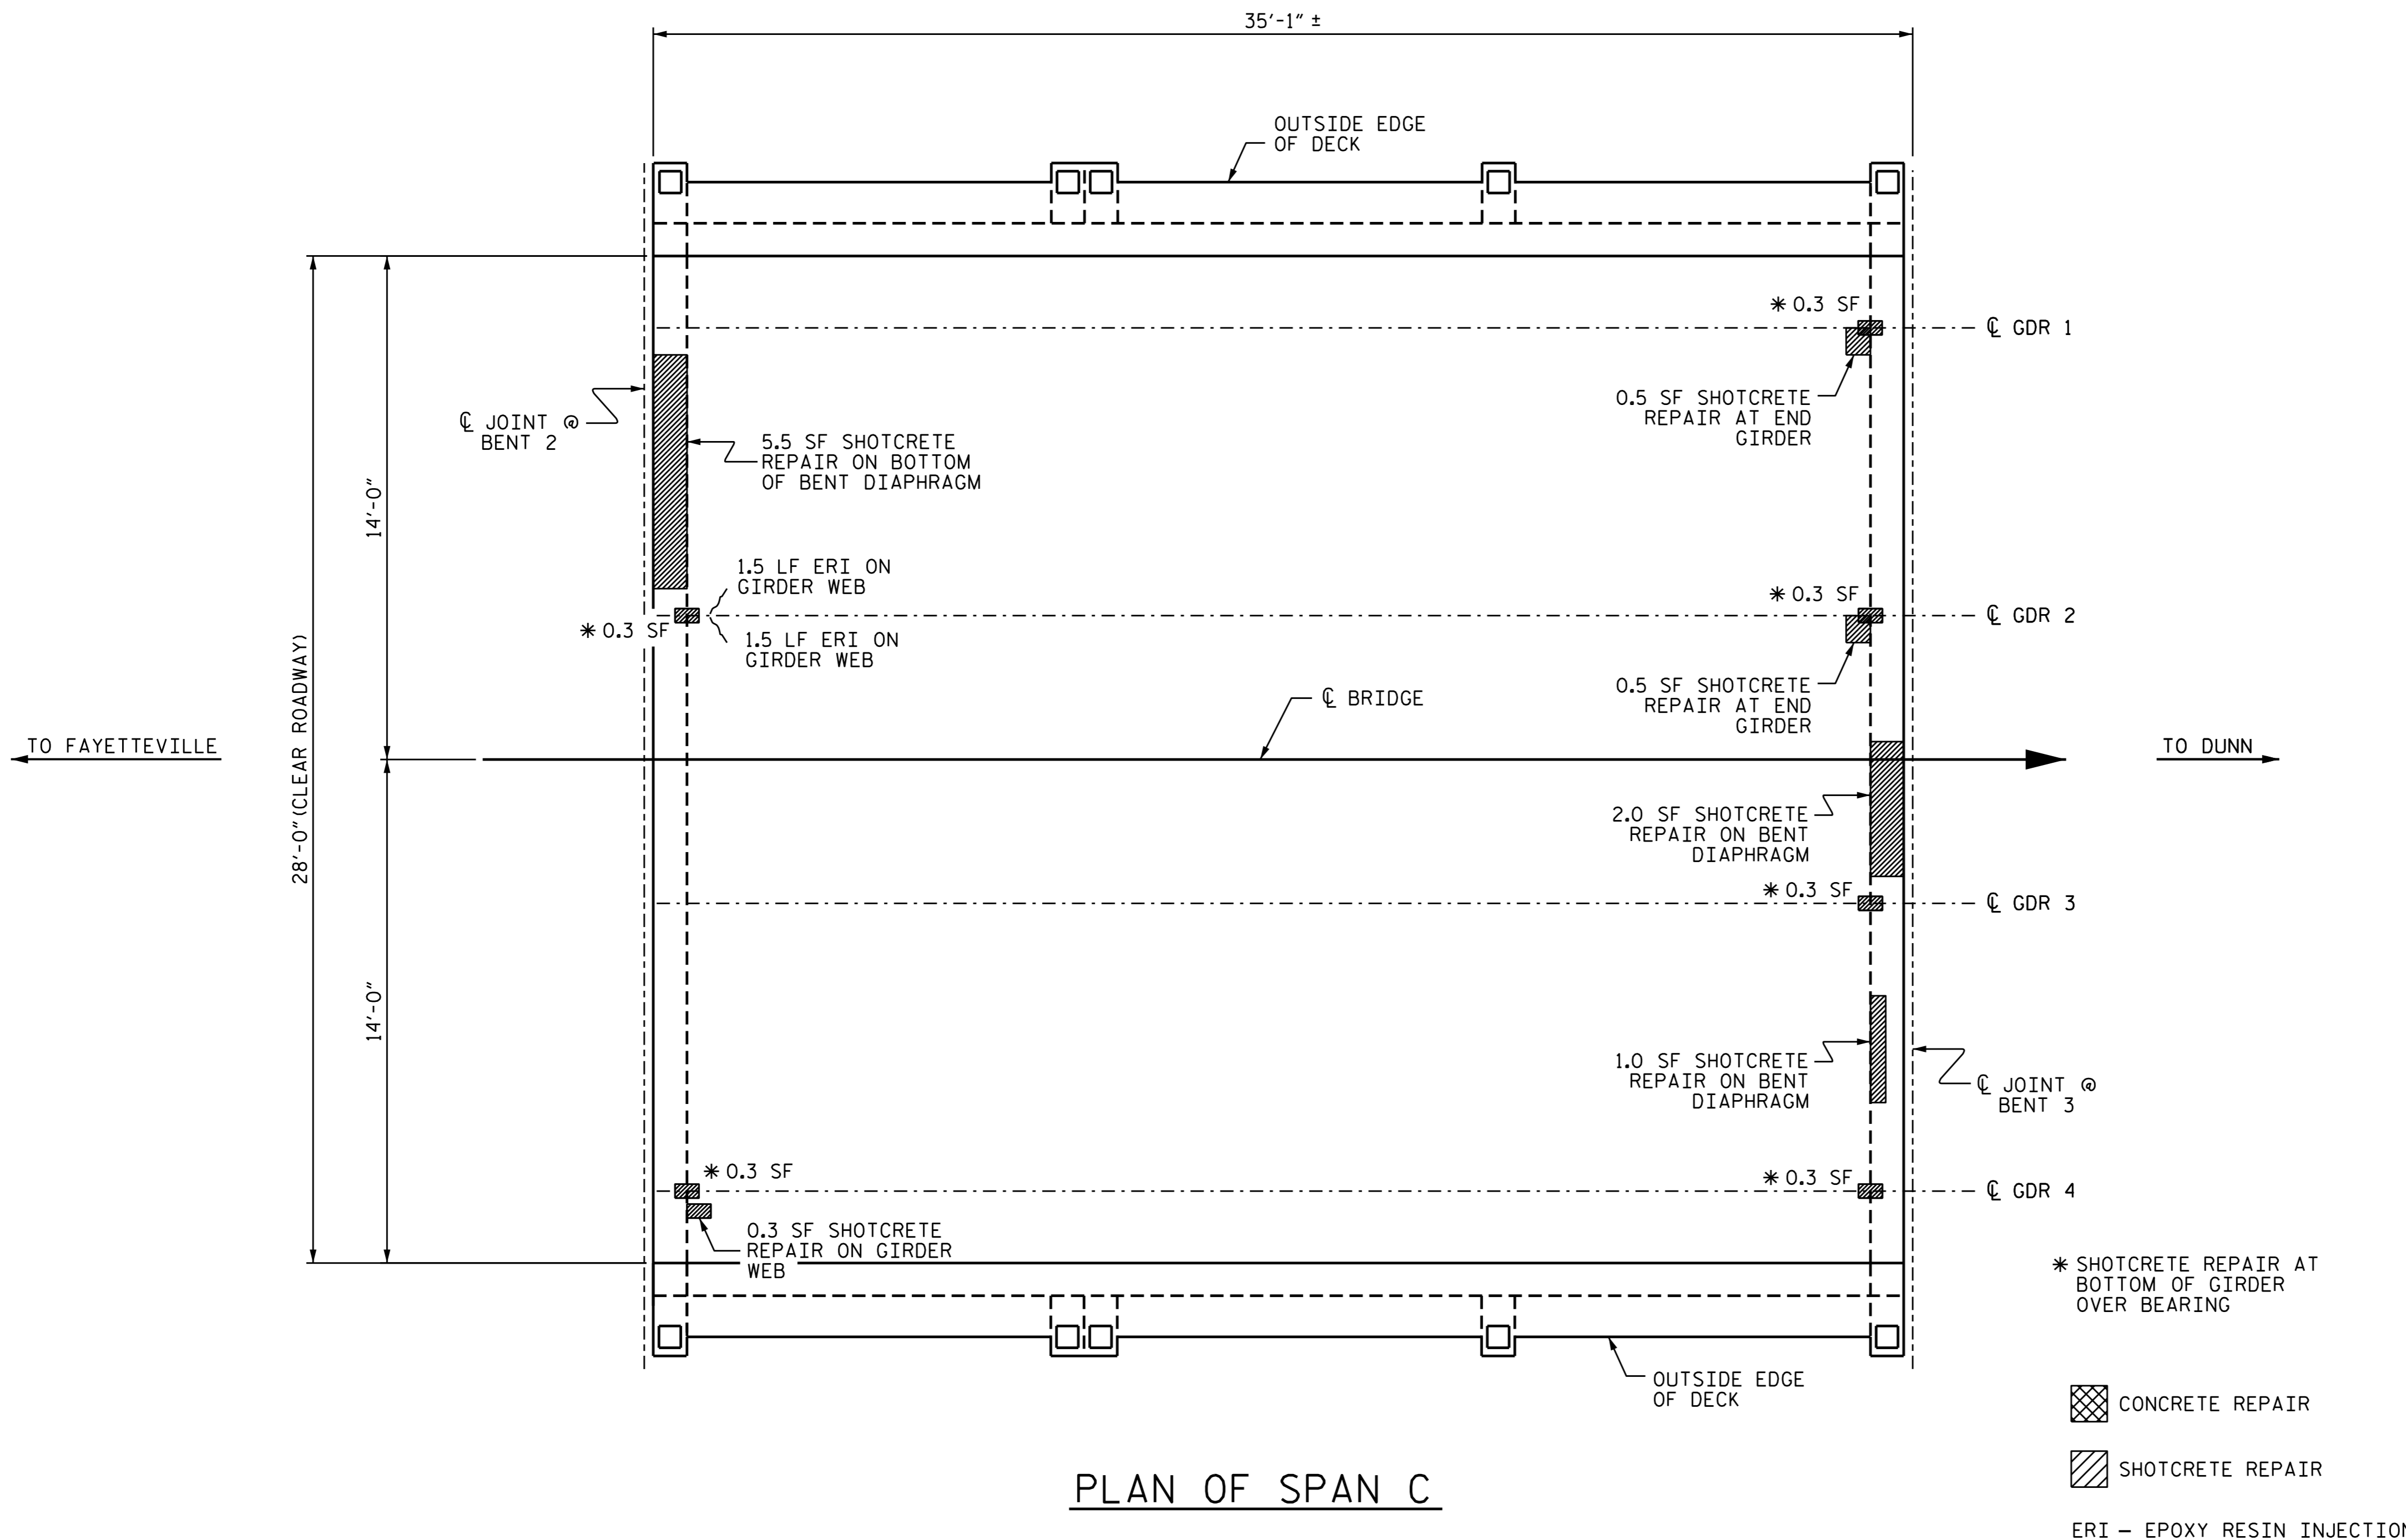
UNDERSIDE OF DECK REPAIRS

SHOTCRETE REPAIRS	ESTIMATE		ACTUAL	
	AREA SF	VOLUME CF	AREA SF	VOLUME CF
UNDERSIDE OF DECK & OVERHANGS				
BENT DIAPHRAGMS	8.5	2.1		
RC DECK GIRDERS	3.1	0.8		
	ESTIMATE		ACTUAL	
EPOXY RESIN INJECTION	3.0 LF

VALUES IN CHARTS REPRESENT ESTIMATED UNDERSIDE OF DECK REPAIR TOTALS AFTER REMOVAL OF UNSOUND CONCRETE, MIN. OF 1" BEHIND REBAR AND MIN. 1" CLEAR TO SAWCUT. SEE REPAIR DETAILS.

FOR BENT DIAPHRAGM AND RC DECK GIRDER REPAIR DETAILS SEE SHEET S-24.

REPAIR CONCRETE BENT DIAPHRAGMS AS DIRECTED BY THE ENGINEER.
