PROJECT	NOI	-5788			
CUMBERLAND COUNTY					
BRIDGE NO. 157					
SHEET 4 OF 5					
STATE OF NORTH CAROLINA DEPARTMENT OF TRANSPORTATION RALEIGH					
SUPERSTRUCTURE REPAIR SPAN D					
NBL					
	REVISIONS	SHEET NO. S-28			
NO. BY: DA 1 2	ГЕ: NO. ВҮ: 33 44	DATE: 5-28 TOTAL SHEETS 72

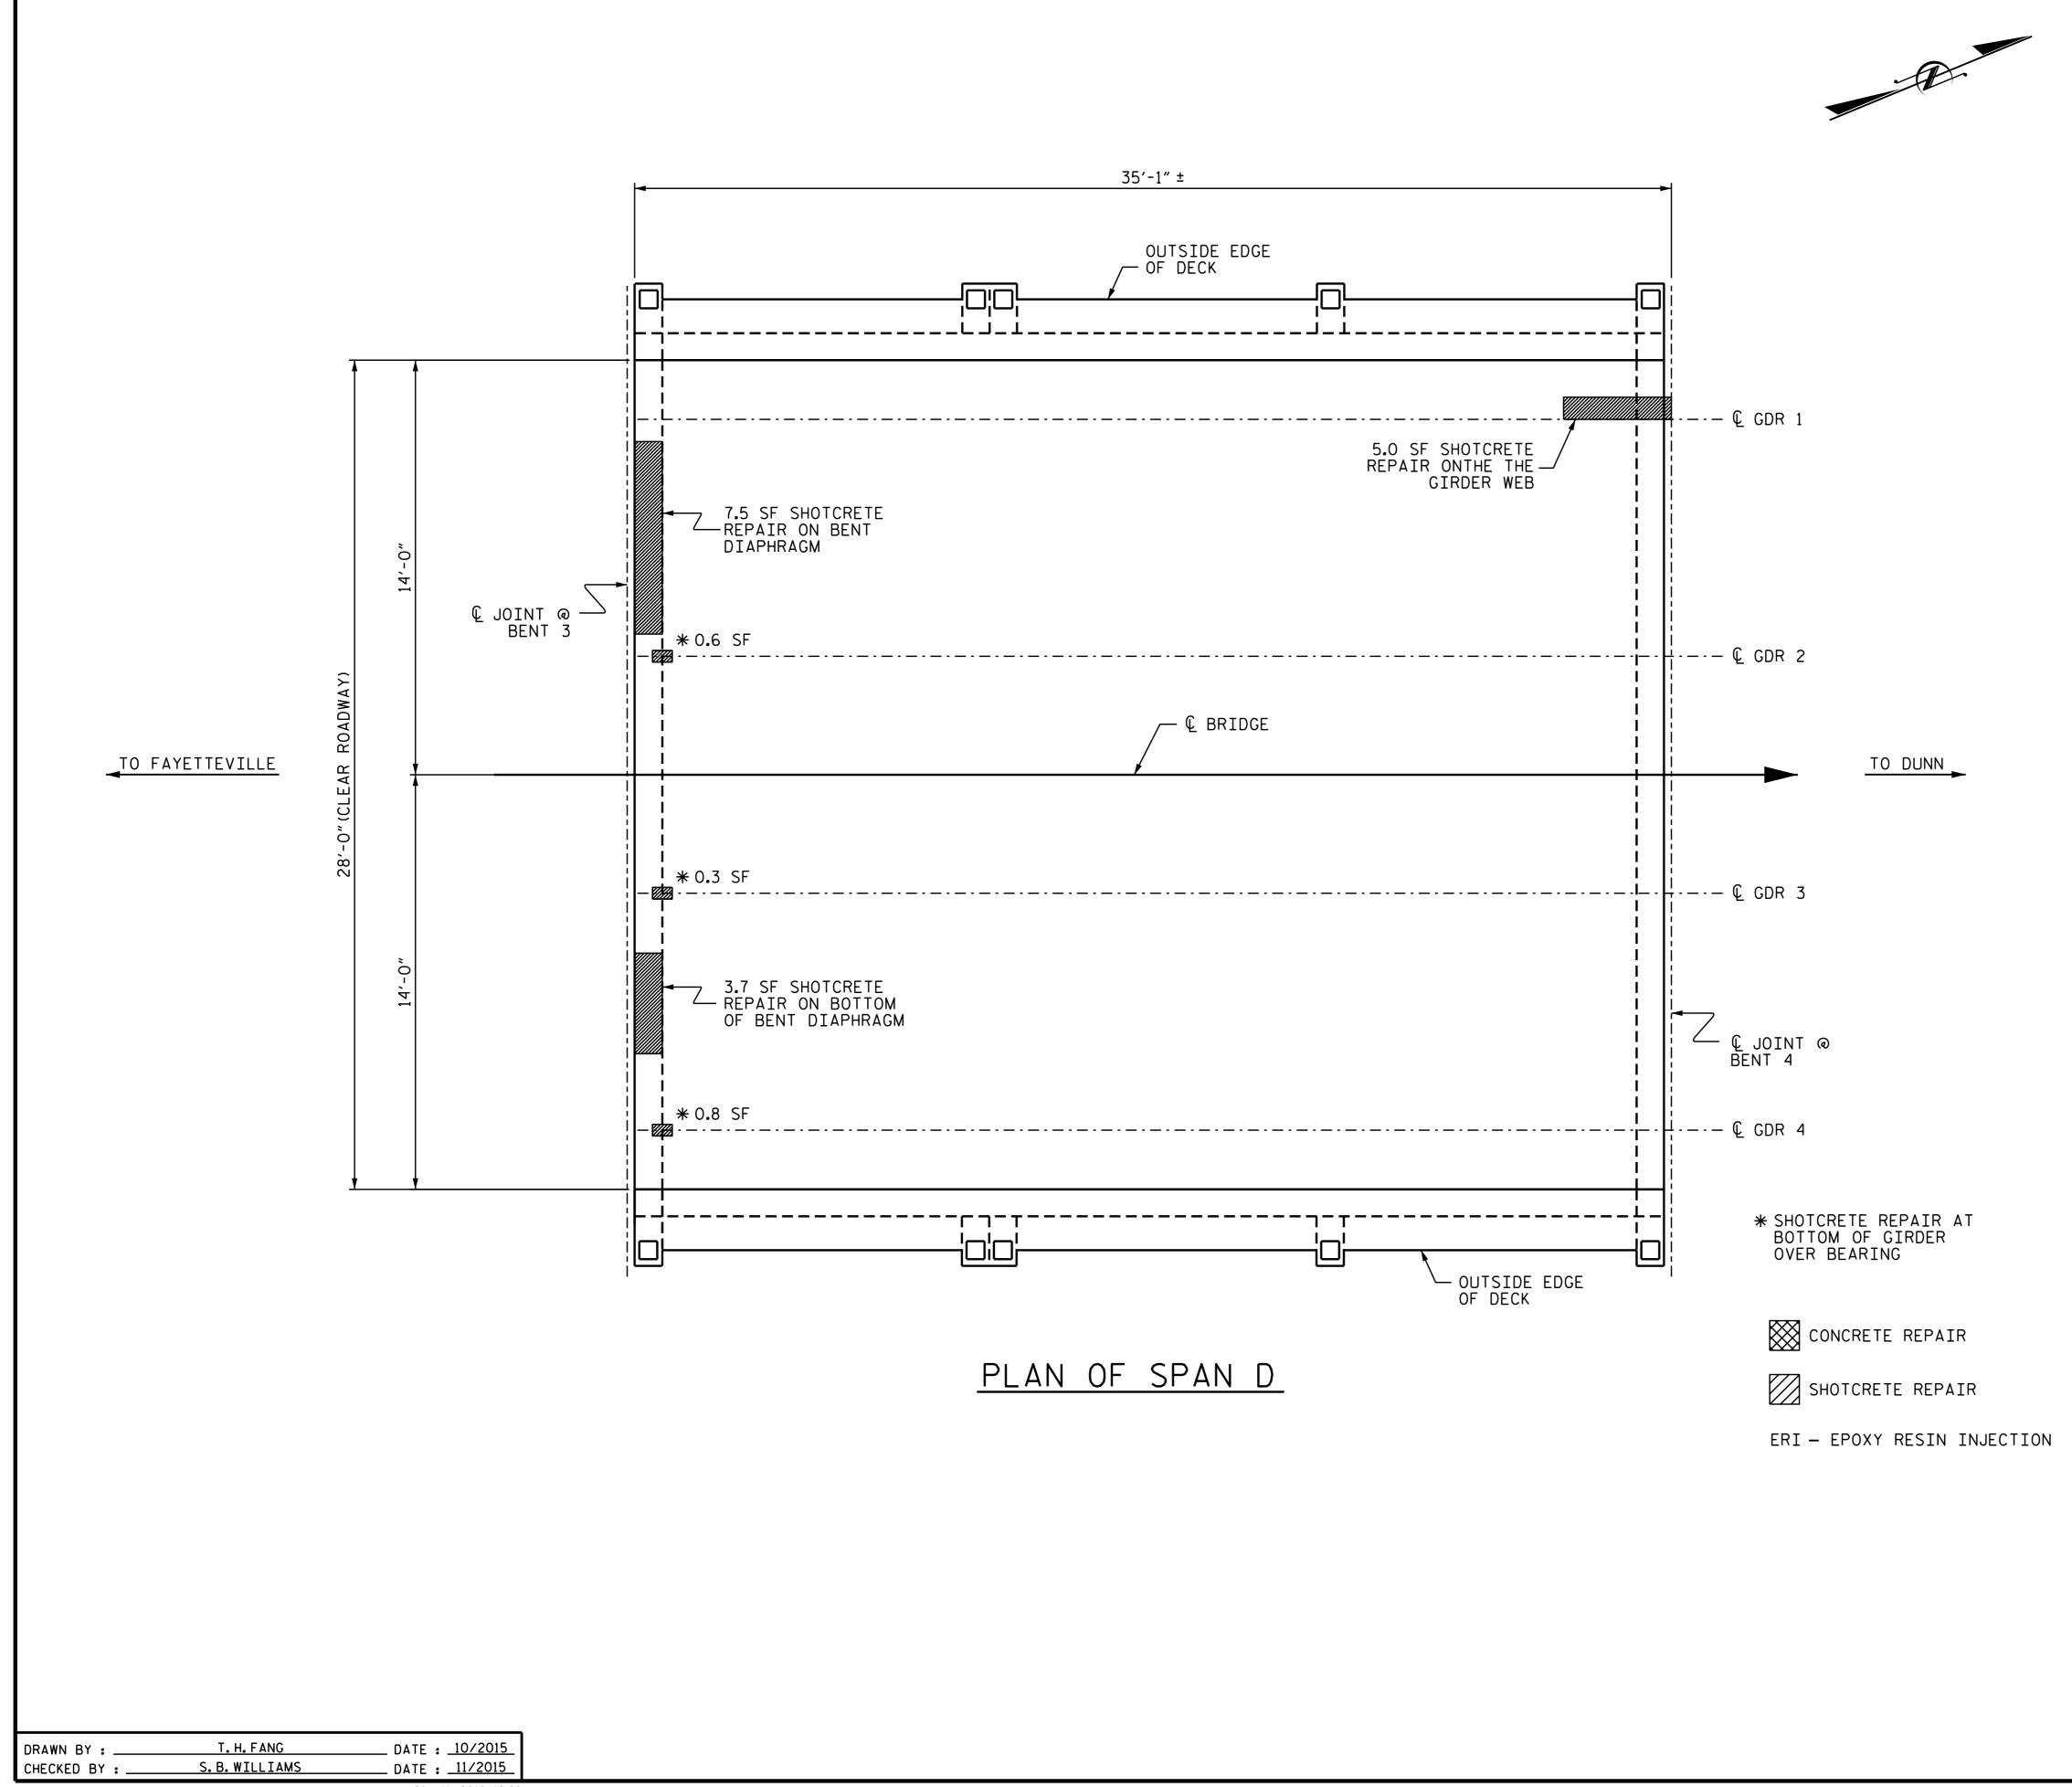
REPAIR QUANTITY TABLE					
UNDERSIDE OF DECK REPAIRS					
SHOTCRETE REPAIRS	ESTIMATE		ACTUAL		
	AREA SF	VOLUME CF	AREA SF	VOLUME CF	
UNDERSIDE OF DECK & OVERHANGS					
BENT DIAPHRAGMS	11.2	2.8			
RC DECK GIRDERS	6.7	1.7			
	ESTIMATE		ACTUAL		
EPOXY RESIN INJECTION	0.0 LF

VALUES IN CHARTS REPRESENT ESTIMATED UNDERSIDE OF DECK REPAIR TOTALS AFTER REMOVAL OF UNSOUND CONCRETE, MIN.OF 1" BEHIND REBAR AND MIN.1" CLEAR TO SAWCUT. SEE REPAIR DETAILS.

REPAIR LOCATIONS AND ESTIMATE OF QUANTITIES ARE GIVEN WITH THE BEST INFORMATION AVAILABLE. IF ADDITIONAL REPAIRS NOT SHOWN ON THE DRAWINGS ARE DEEMED NECESSARY BY THE ENGINEER, THE ENGINEER SHALL NOTE ON THE DRAWINGS THE APPROXIMATE LOCATION AND DESCRIPTION OF THE REPAIRS AND ADJUST THE ACTUAL QUANTITIES ENTERED INTO THE REPAIR QUANTITY TABLE. FOR BENT DIAPHRAGM AND RC DECK GIRDER REPAIR DETAILS SEE SHEET S-24. REPAIR CONCRETE BENT DIAPHRAGMS AS DIRECTED BY THE ENGINEER.
