PROJECT NO. I-5788
CUMBERLAND COUNTY
STATION: 157

STATE OF NORTH CAROLINA
DEPARTMENT OF TRANSPORTATION
RALEIGH
SUBSTRUCTURE REPAIR
BENT 1
NBL

REVISIONS						SHEET NO. S-31
NO.	BY:	DATE:	NO.	BY:	DATE:	
1			3			TOTAL SHEETS 72
2			4

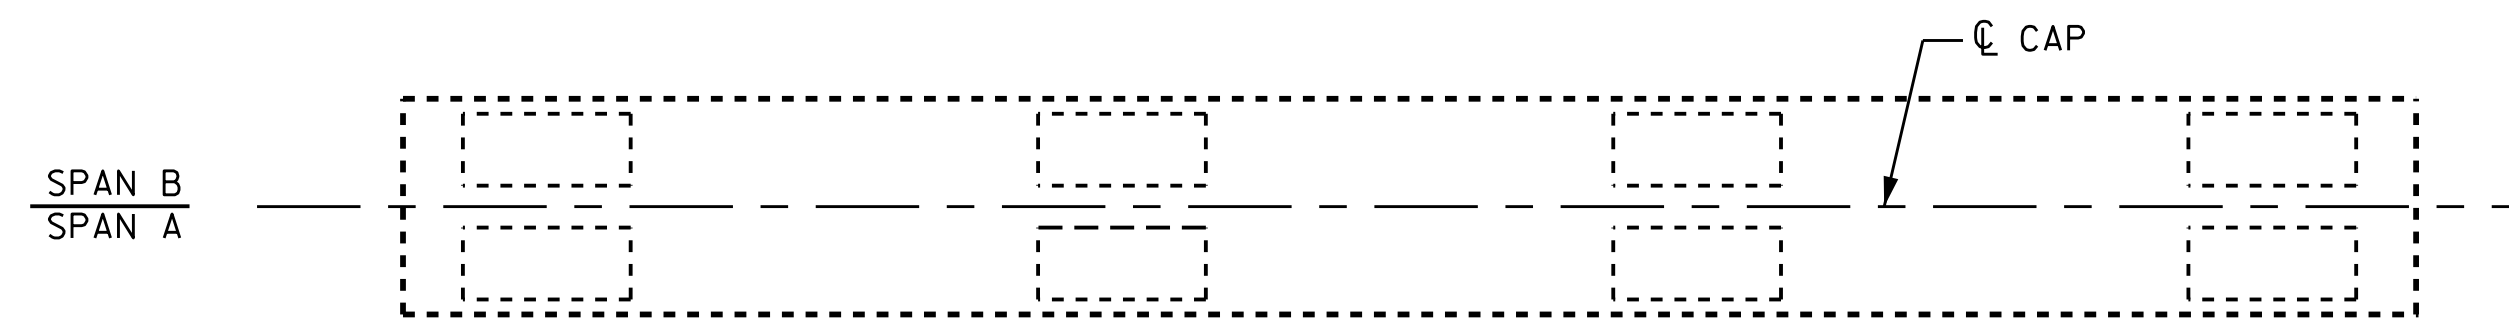
TOP OF CAP

EPOXY COATING SHALL BE APPLIED TO THE TOP FACE OF THE BENT CAP.
