PROJECT NO. I-5788

CUMBERLAND COUNTY

BRIDGE NO. 158

SUPERSTRUCTURE REPAIR SPAN A

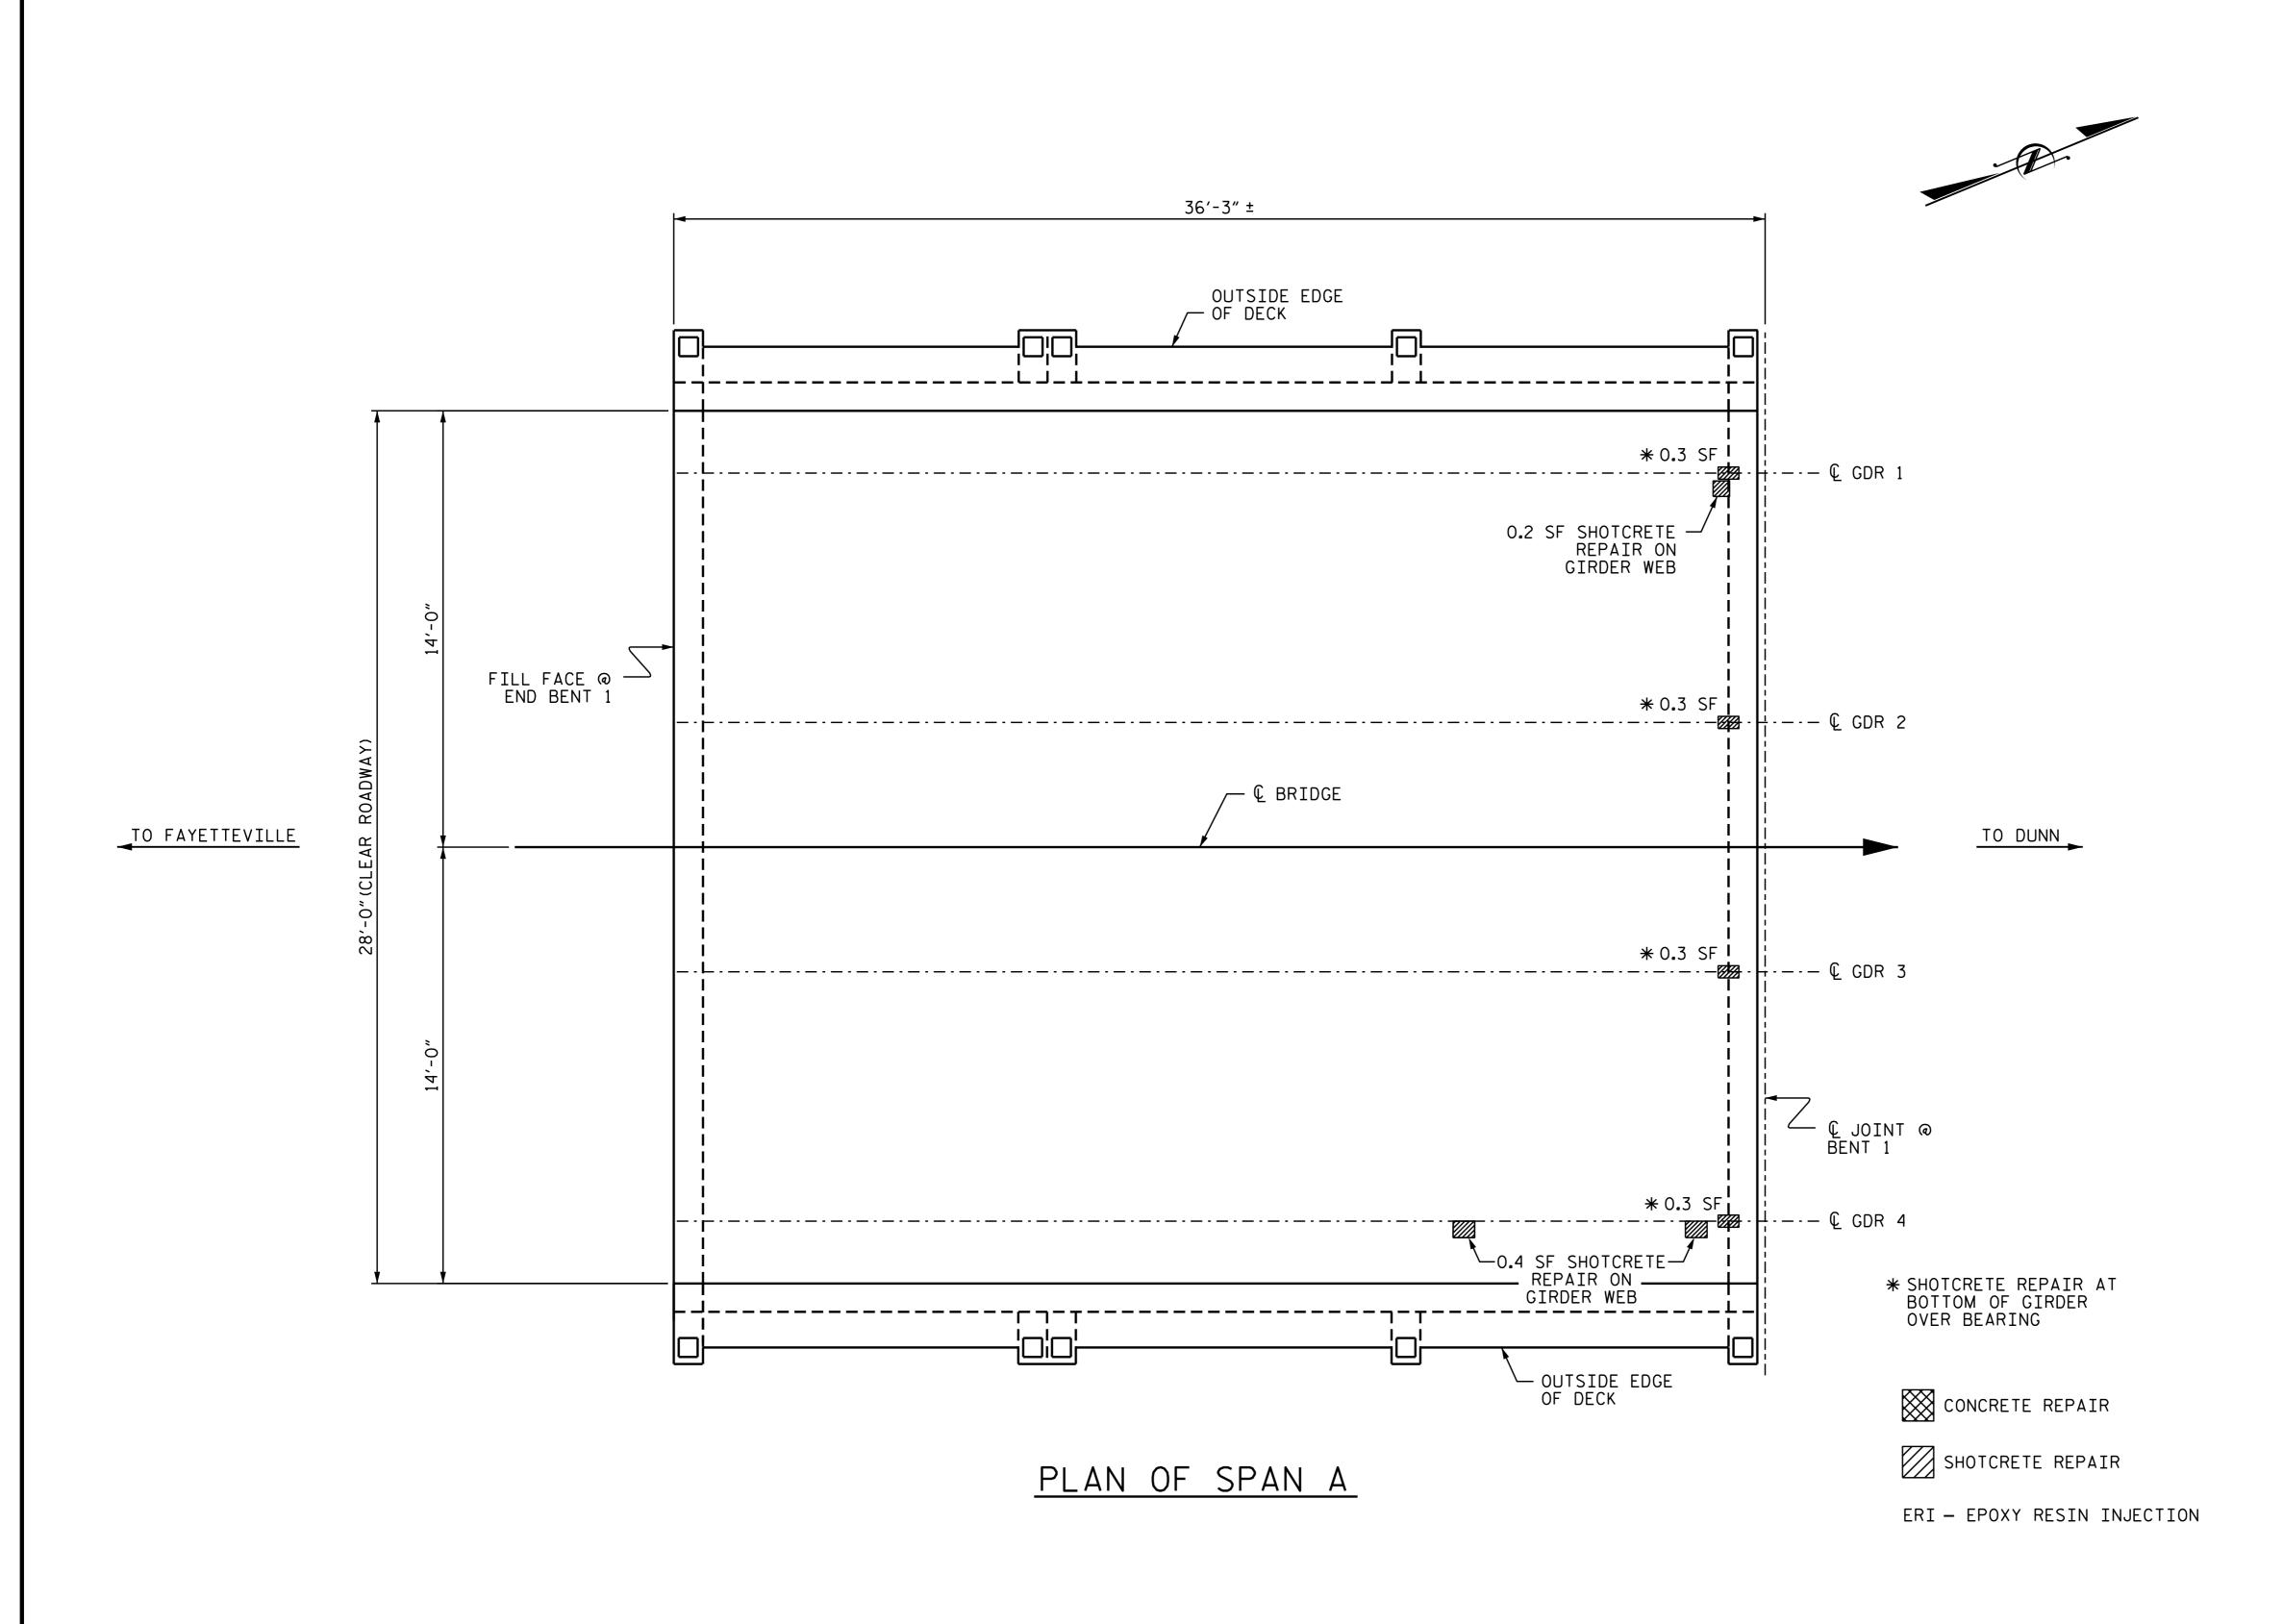
UNDERSIDE OF DECK REPAIRS

SHOTCRETE REPAIRS	ESTI	ESTIMATE		ACTUAL	
	AREA SF	VOLUME CF	AREA SF	VOLUM CF	
UNDERSIDE OF DECK & OVERHANGS					
BENT DIAPHRAGMS					
RC DECK GIRDERS	2.2	0.6			
	ESTIMATE		ACTUAL		
EPOXY RESIN INJECTION	0.0	0.0 LF

VALUES IN CHARTS REPRESENT ESTIMATED UNDERSIDE OF DECK REPAIR TOTALS AFTER REMOVAL OF UNSOUND CONCRETE, MIN. OF 1" BEHIND REBAR AND MIN. 1" CLEAR TO SAWCUT. SEE REPAIR DETAILS.

FOR BENT DIAPHRAGM AND RC DECK GIRDER REPAIR DETAILS SEE SHEET S-24.

REPAIR CONCRETE BENT DIAPHRAGMS AS DIRECTED BY THE ENGINEER.
