PROJECT NO. I-5788

BRIDGE NO. 158

SHEET 3 OF 5

SUPERSTRUCTURE REPAIR SPAN C SBL

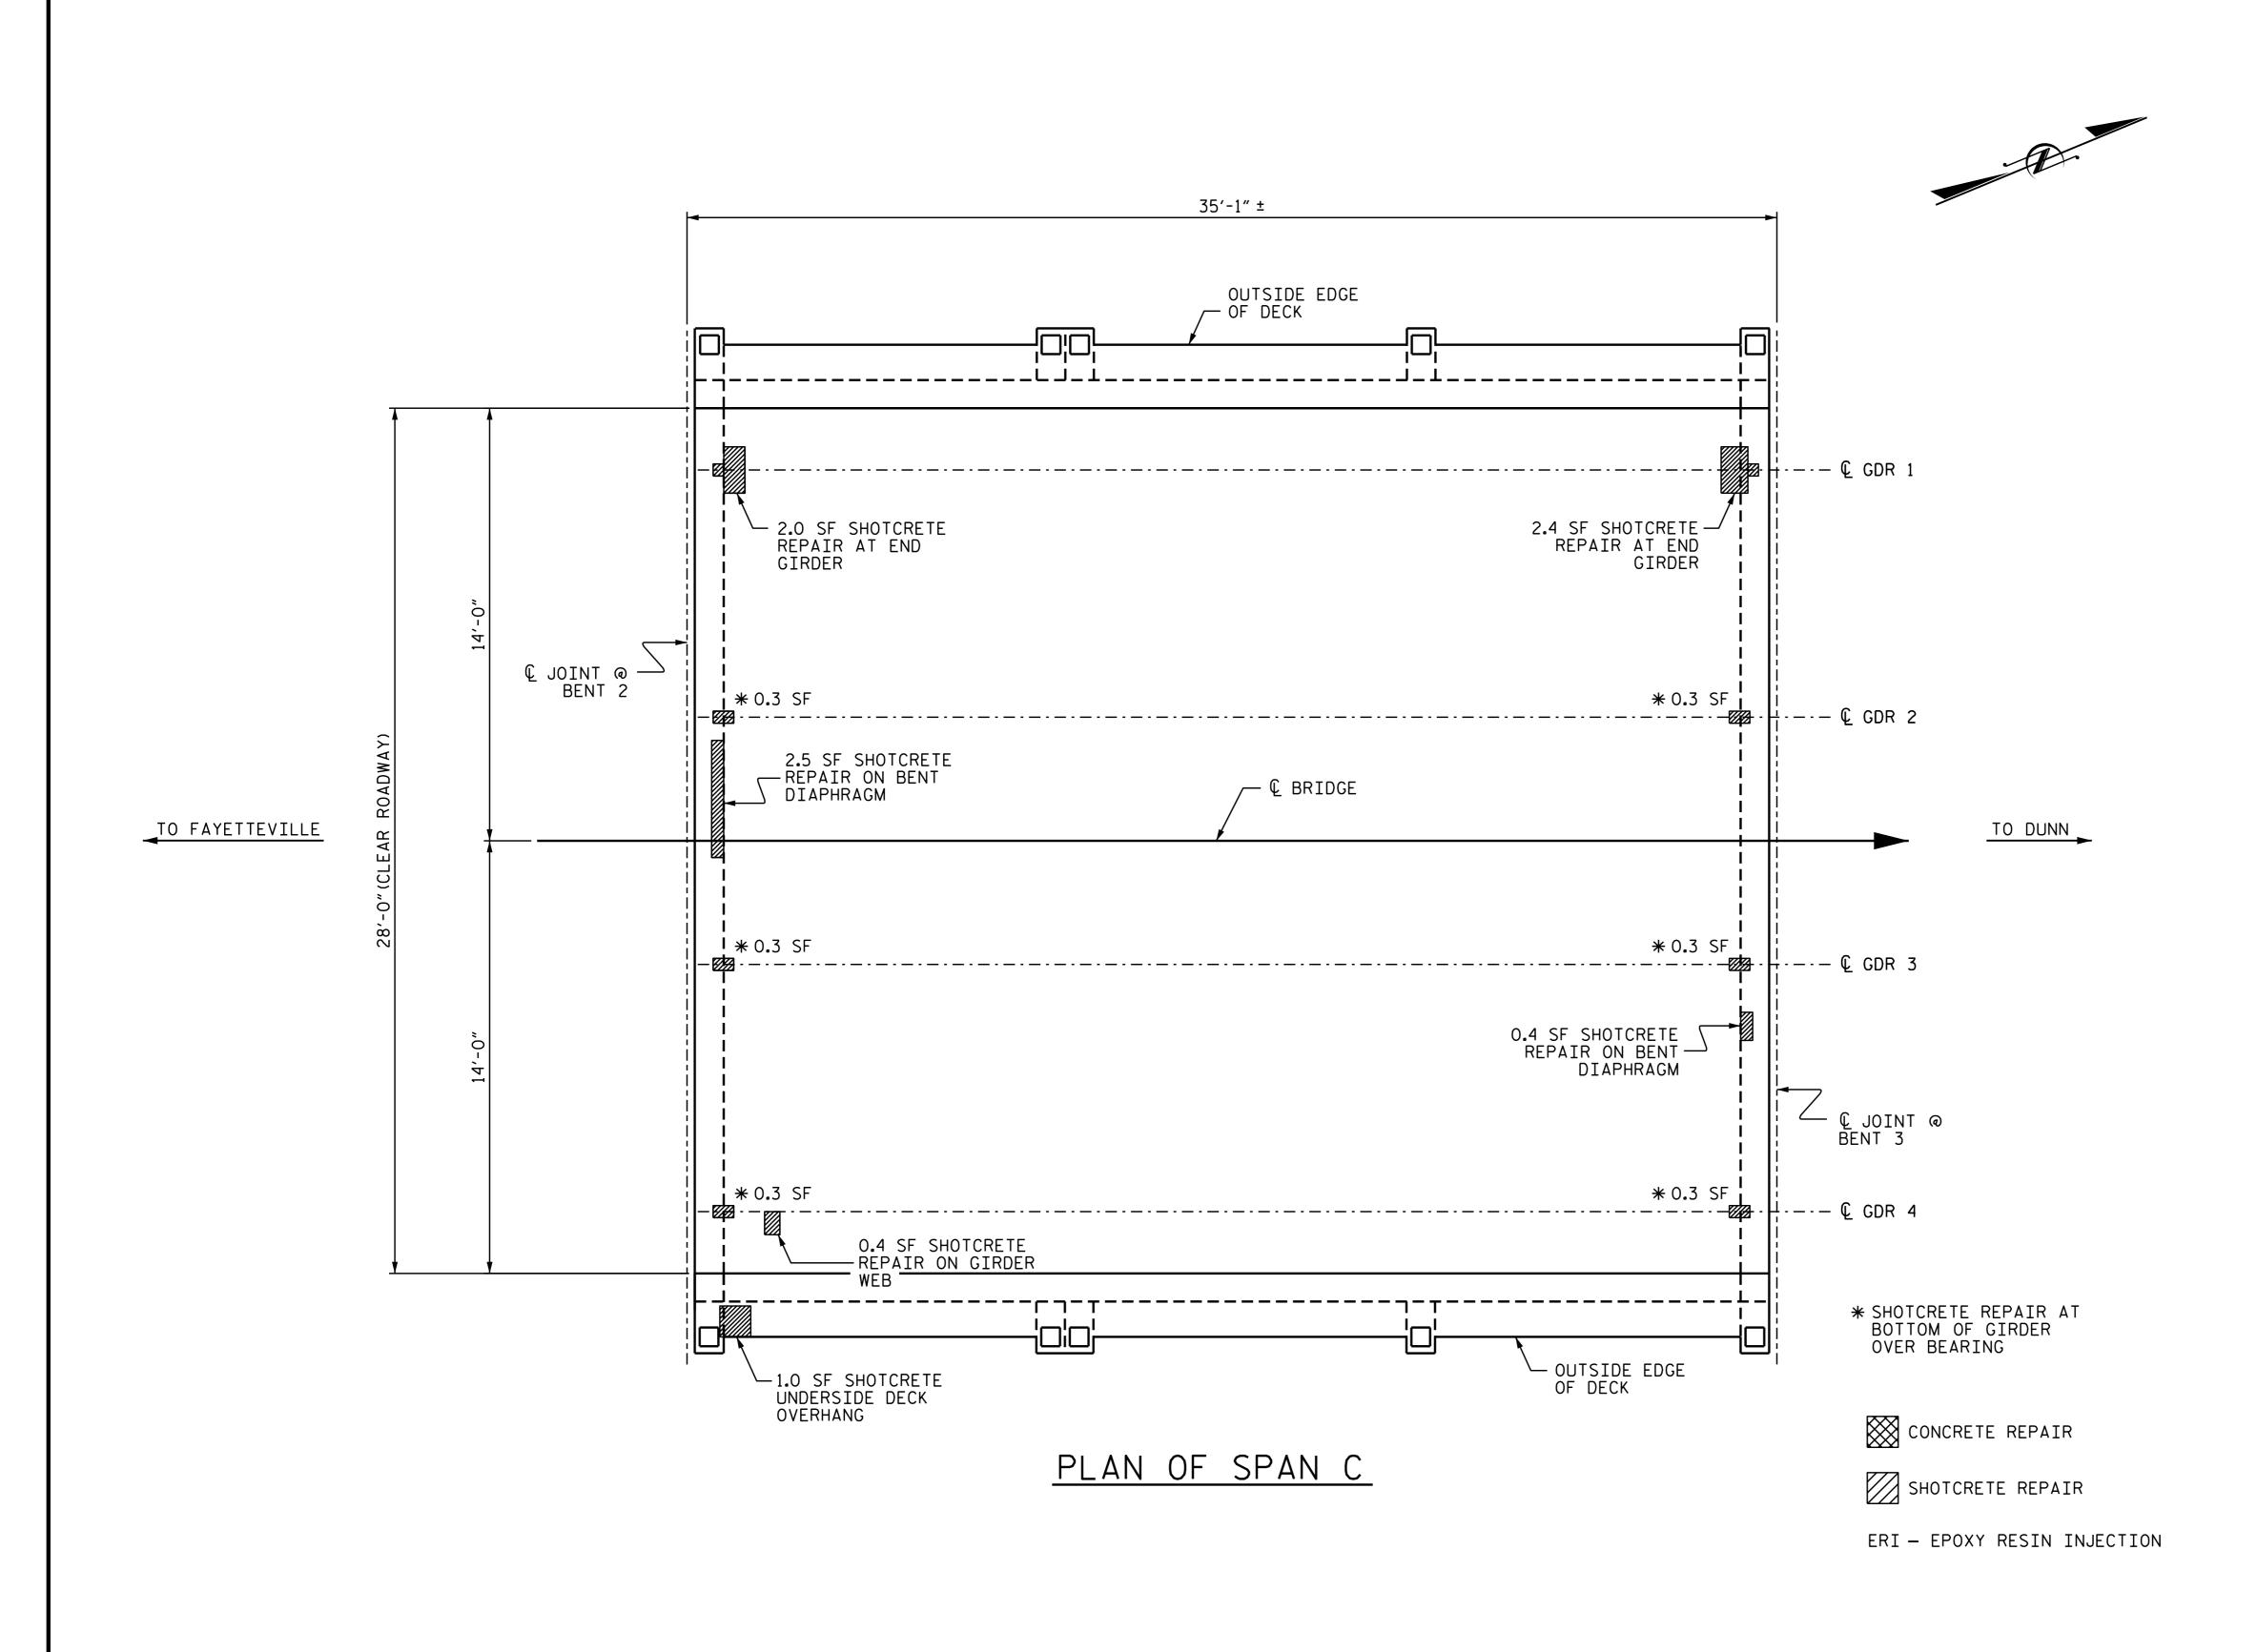
UNDERSIDE OF DECK REPAIRS

REPAIR CONCRETE BENT DIAPHRAGMS AS DIRECTED BY THE ENGINEER.

VALUES IN CHARTS REPRESENT ESTIMATED UNDERSIDE OF DECK REPAIR TOTALS AFTER REMOVAL OF UNSOUND CONCRETE, MIN. OF 1" BEHIND REBAR AND MIN. 1" CLEAR TO SAWCUT. SEE REPAIR DETAILS.
