PROJECT NO. I-5788
HARNETT COUNTY
BRIDGE NO.: 73

STATE OF NORTH CAROLINA
DEPARTMENT OF TRANSPORTATION
RALEIGH
SUBSTRUCTURE REPAIR
BENT 2
NBL

REVISIONS						SHEET NO. S-60 TOTAL SHEETS 72
NO.	BY:	DATE:	NO.	BY:	DATE:	
1			3			
2			4

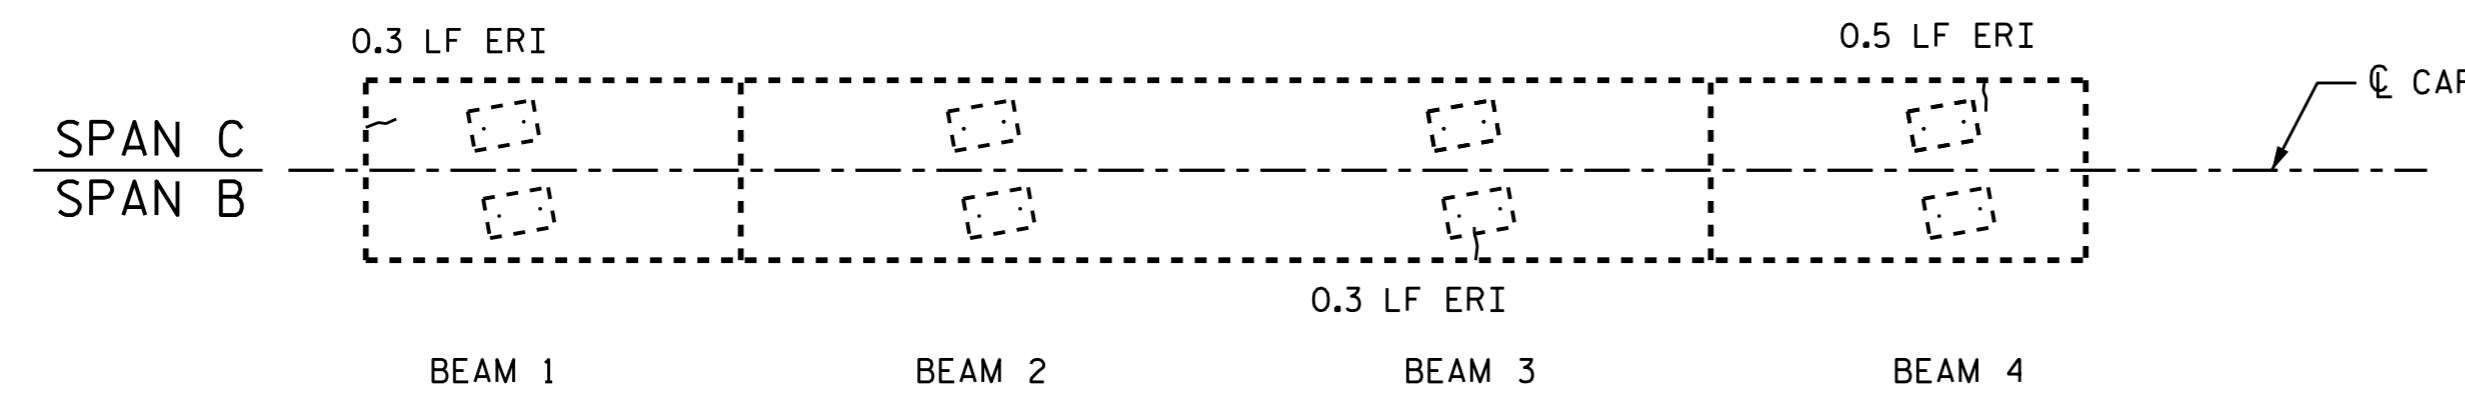
TOP OF CAP

EPOXY COATING SHALL BE APPLIED TO THE TOP FACE OF THE BENT CAP.
