PROJECT NO. I-5788
HARNETT COUNTY
BRIDGE NO.: 77

STATE OF NORTH CAROLINA
DEPARTMENT OF TRANSPORTATION
RALEIGH
SUBSTRUCTURE REPAIR
BENT 2
SBL

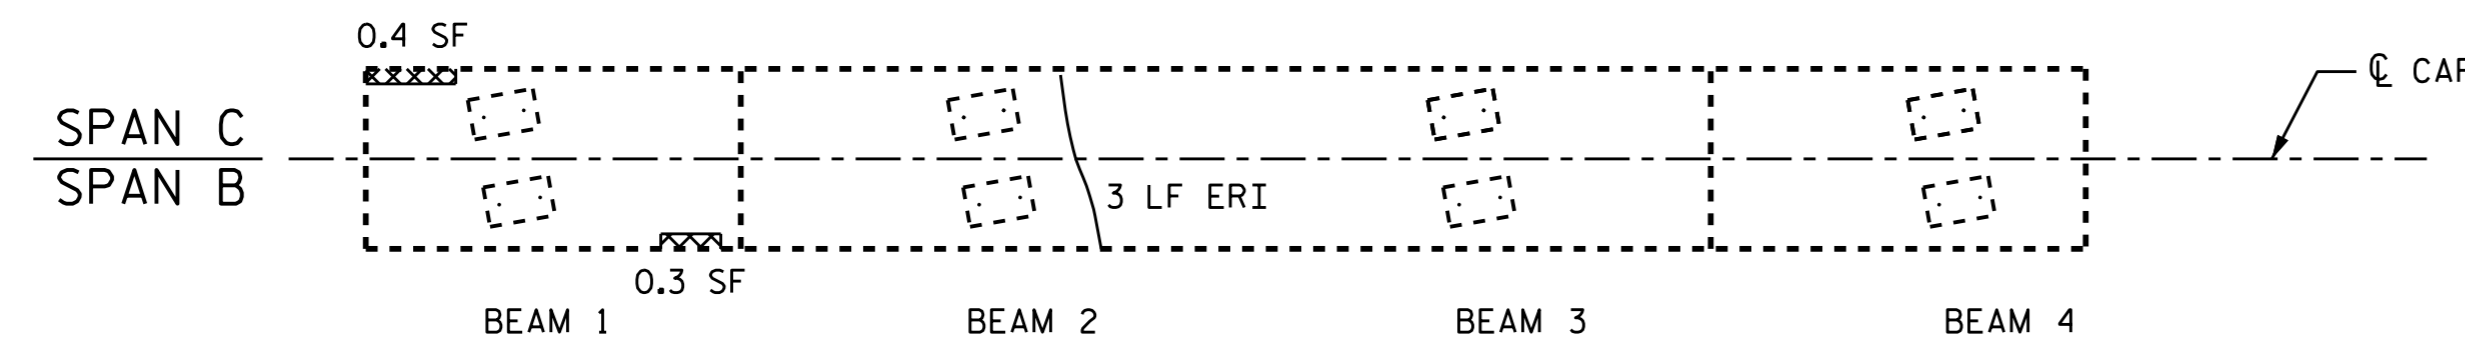
TOP OF CAP

EPOXY COATING SHALL BE APPLIED TO THE TOP FACE OF THE BENT CAP.
