PROJECT NO. I-5788
HARNETT COUNTY
 BRIDGE NO.: 77

SHEET 4 OF 4

STATE OF NORTH CAROLINA
 DEPARTMENT OF TRANSPORTATION
 RALEIGH
SUBSTRUCTURE REPAIR
BENT 3
SBL

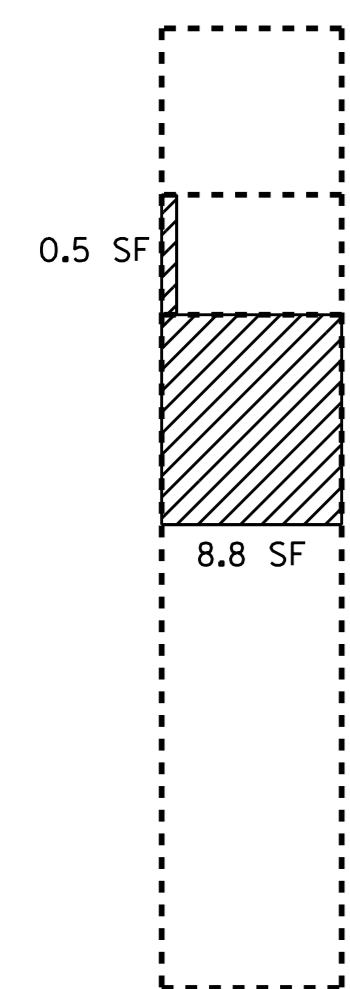
END VIEW
WEST FACE

COL 1

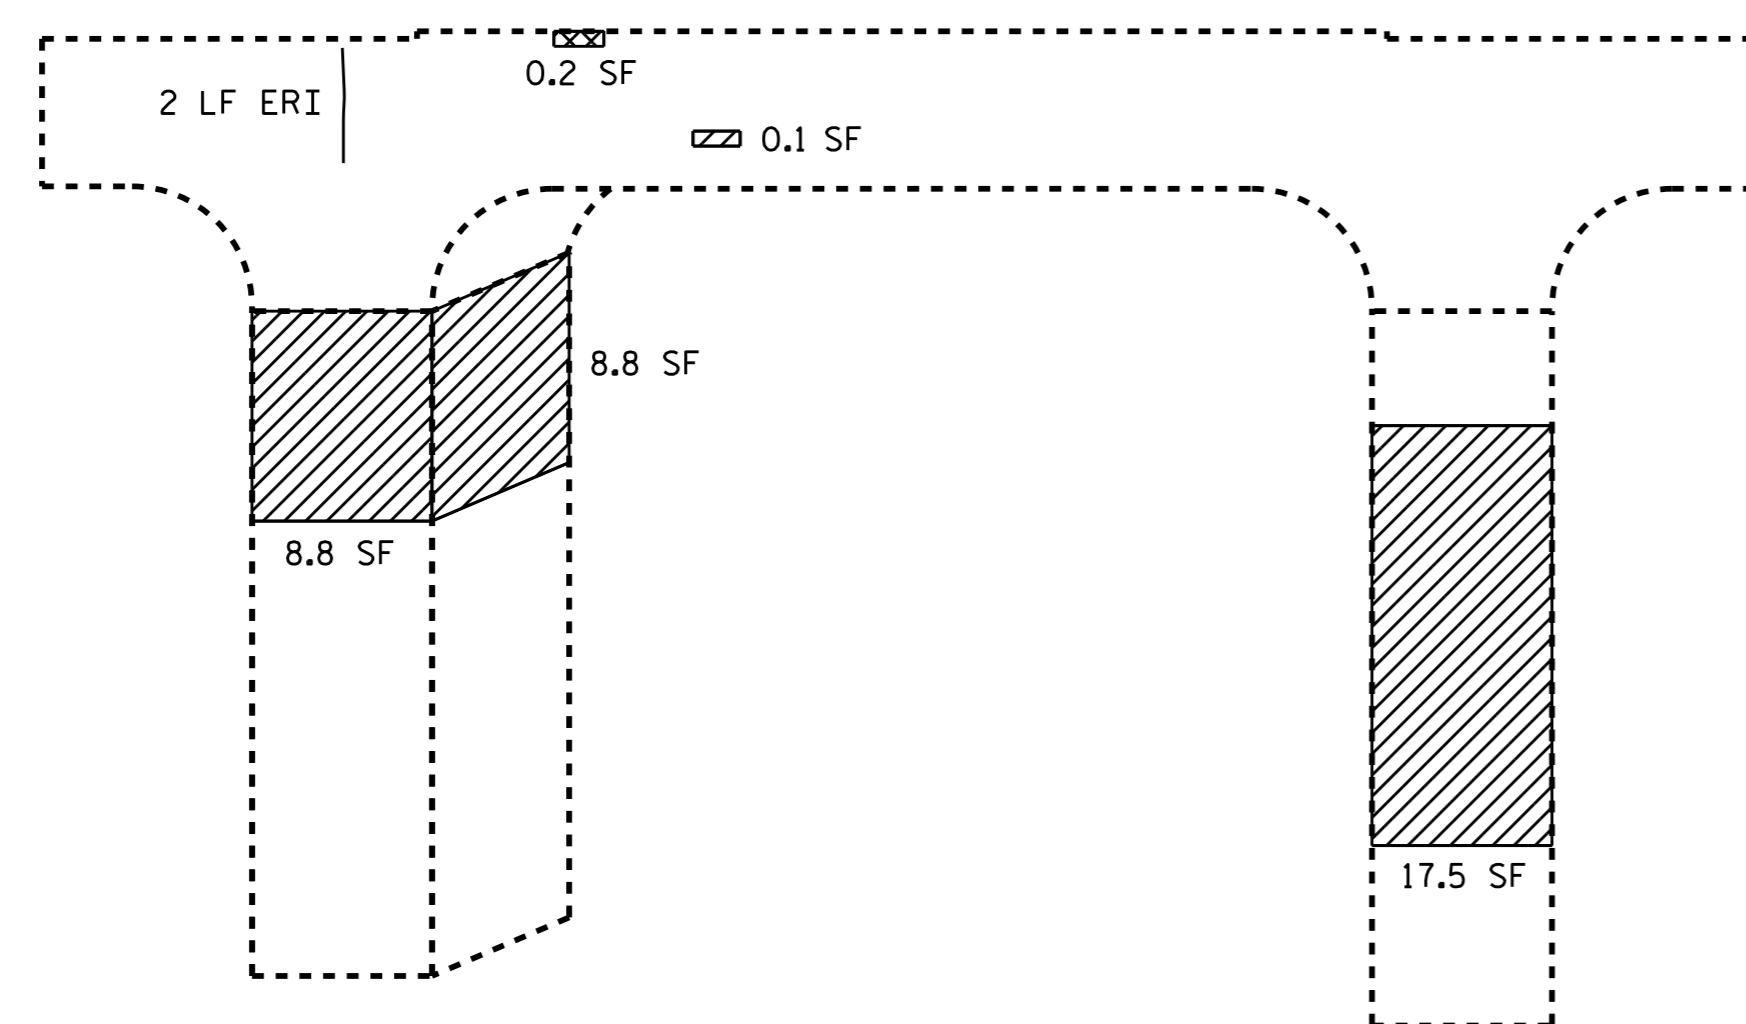
ELEVATION
SOUTH FACE

COL 1

COL 2

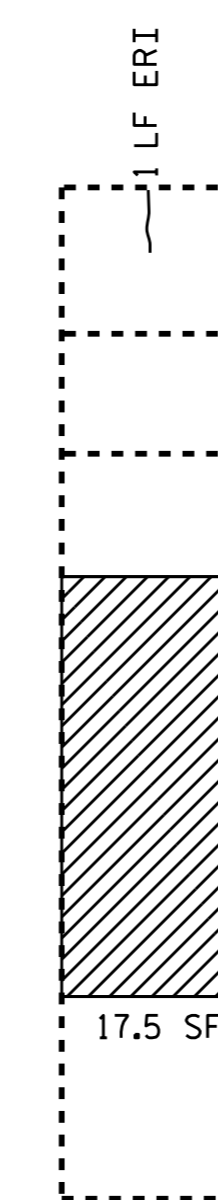
END VIEW
EAST FACE

COL 2

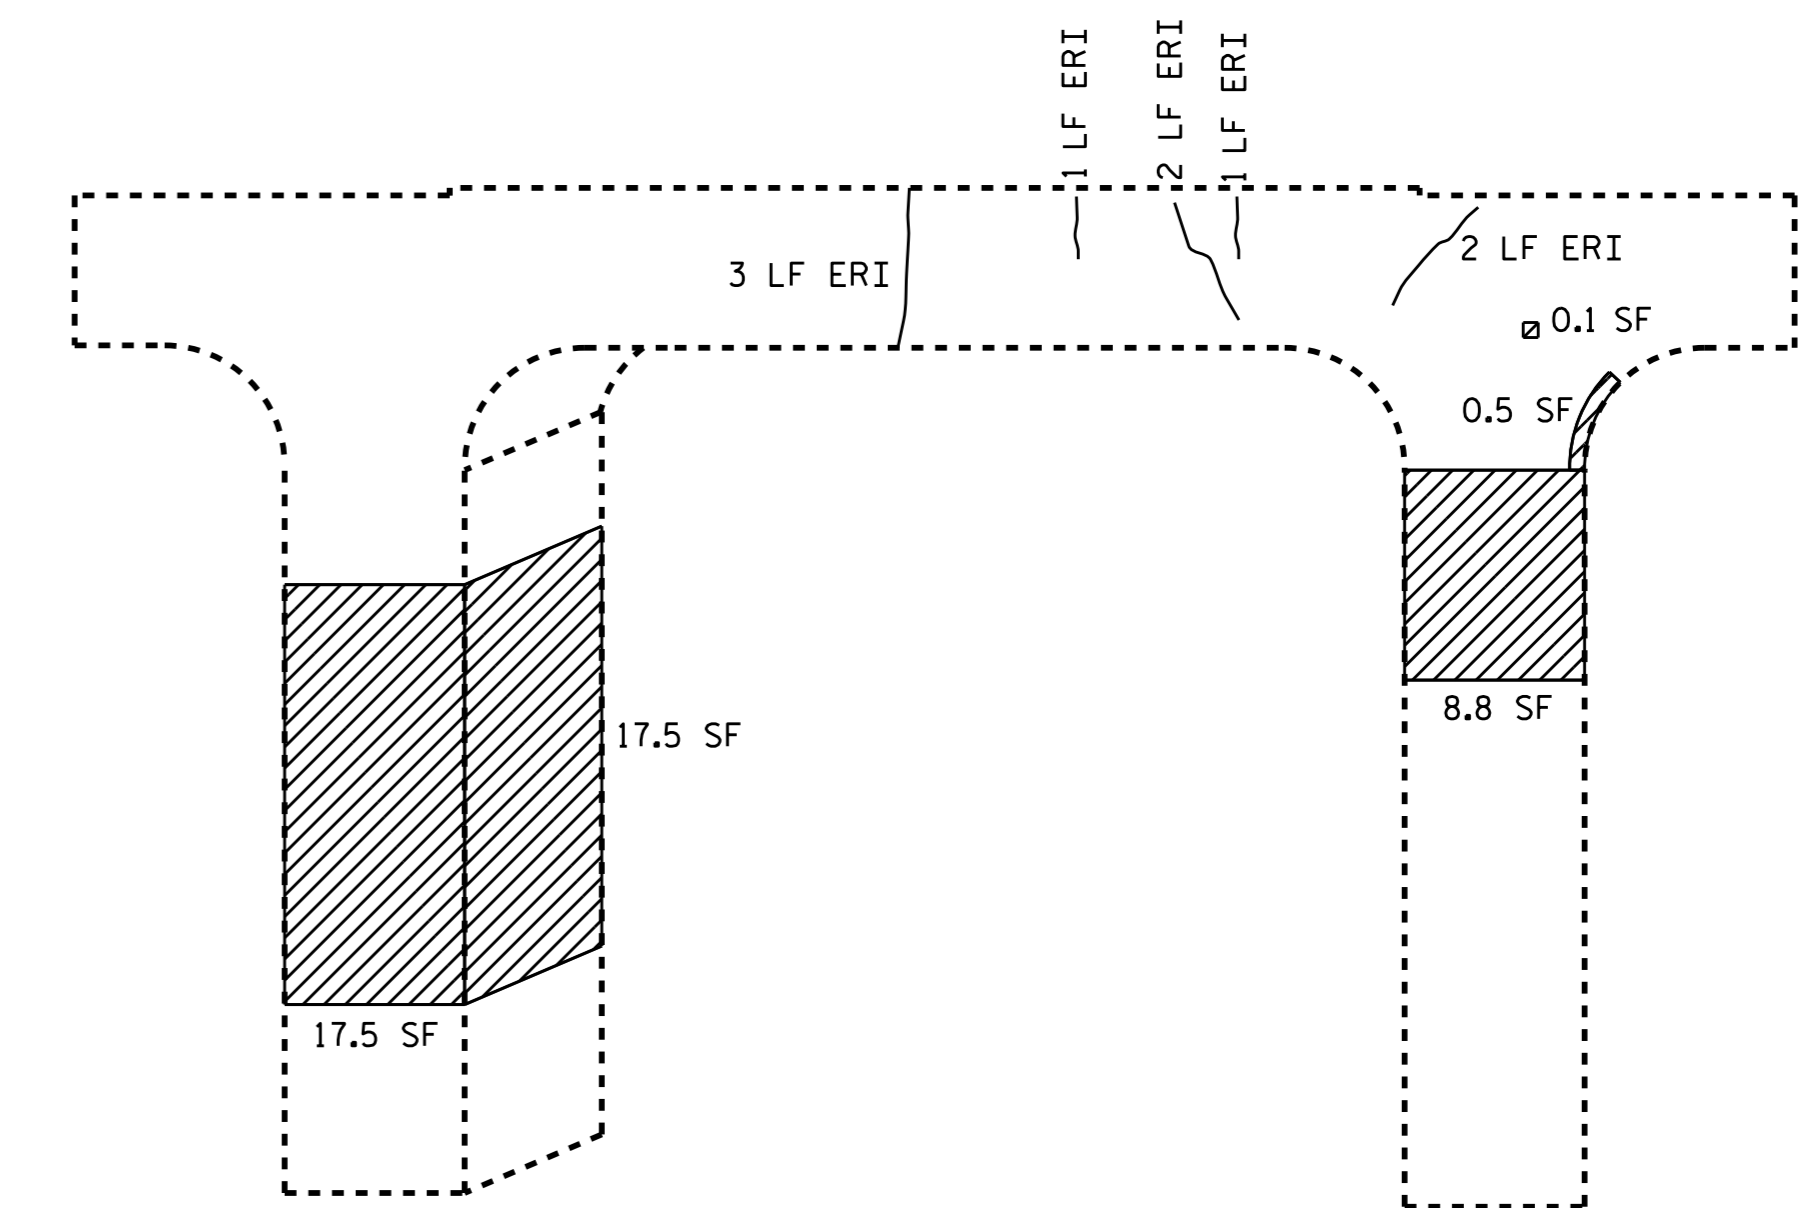
ELEVATION
NORTH FACE

COL 1
