PROJEC	DAV	-	<u>I-576</u> 0 	:5 :OUNTY			
	STATE OF NORTH CAROLINA DEPARTMENT OF TRANSPORTATION RALEICH							
AD50B1D977456C6L 18565 MGNEE	SUBSTRUCTURE BENT 2 (EBL)							
12/9/2016	REVISIONS SHEET NO.							
	NO. BY:	S-10						
DOCUMENT NOT CONSIDERED FINAL UNLESS ALL SIGNATURES COMPLETED	1	DATE:	№. вт: З 4	DATE:	TOTAL SHEETS 35

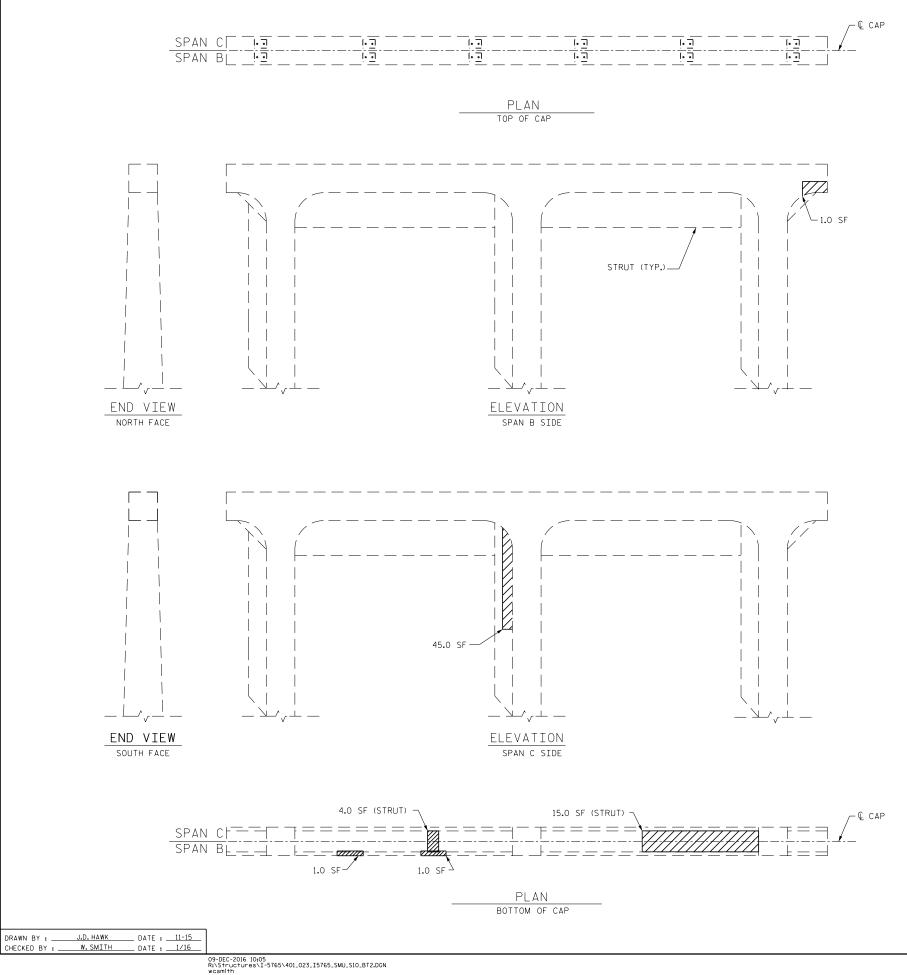
REPAIR QUANTITY TABLE								
REPAIRS BENT 2	QUANTITIES							
REPAIRS BENI Z	ESTIMATE		ACTUAL					
SHOTCRETE REPAIRS	AREA SF	VOLUME CF	AREA SF	VOLUME CF				
CAP (VERTICAL FACE)	1.0	0.5						
CAP (HORIZONTAL, CORNER)	21.0	5.5						
COLUMN (HORIZONTAL FACE)	45.0	12.0						
EPOXY RESIN INJECTION		LN. FT	LN. FT					
CAP	0							
COLUMN	0							
EPOXY COATING	SQ. FT	SQ. FT						
TOP OF CAP	92.0

VALUES IN CHART REPRESENT ESTIMATED REPAIR TOTALS AFTER REMOVAL OF UNSOUND CONCRETE, MIN. OF 1"BEHIND REBAR AND MIN. 2"CL TO SAWCUT. SEE REPAIR DETAILS.
