I-5765 PROJECT NO. DAVIE COUNTY 74 BRIDGE NO .:

STATE OF NORTH CAROLINA DEPARTMENT OF TRANSPORTATION

SUBSTRUCTURE

BENT 1 (EBL)

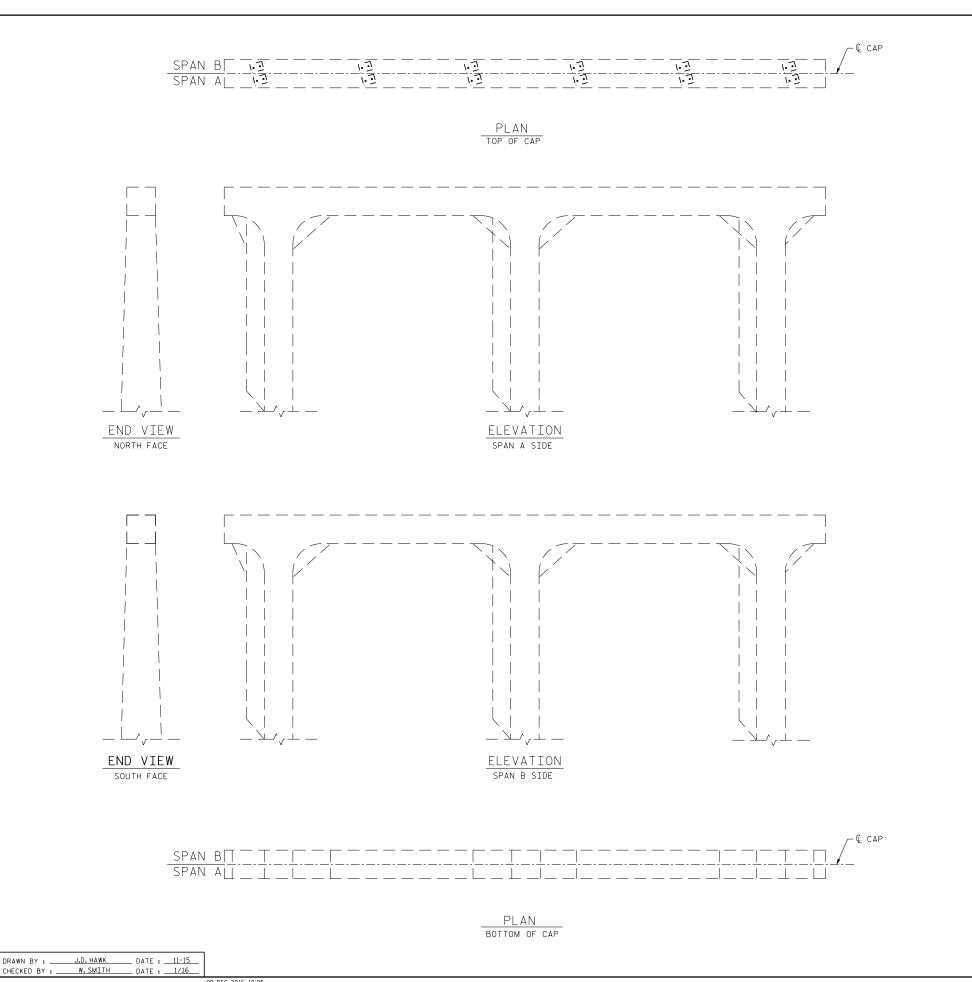
NO REPAIRS NOTED DURING INSPECTION BY STRUCTURES MANAGEMENT UNIT. THE CONTRACTOR AND ENGINEER SHALL INSPECT THE BENT PRIOR TO BEGINNING WORK.
