PROJECT NO. I-5765

DAVIE COUNTY

BRIDGE NO.: 74

BENT 2 (EBL)

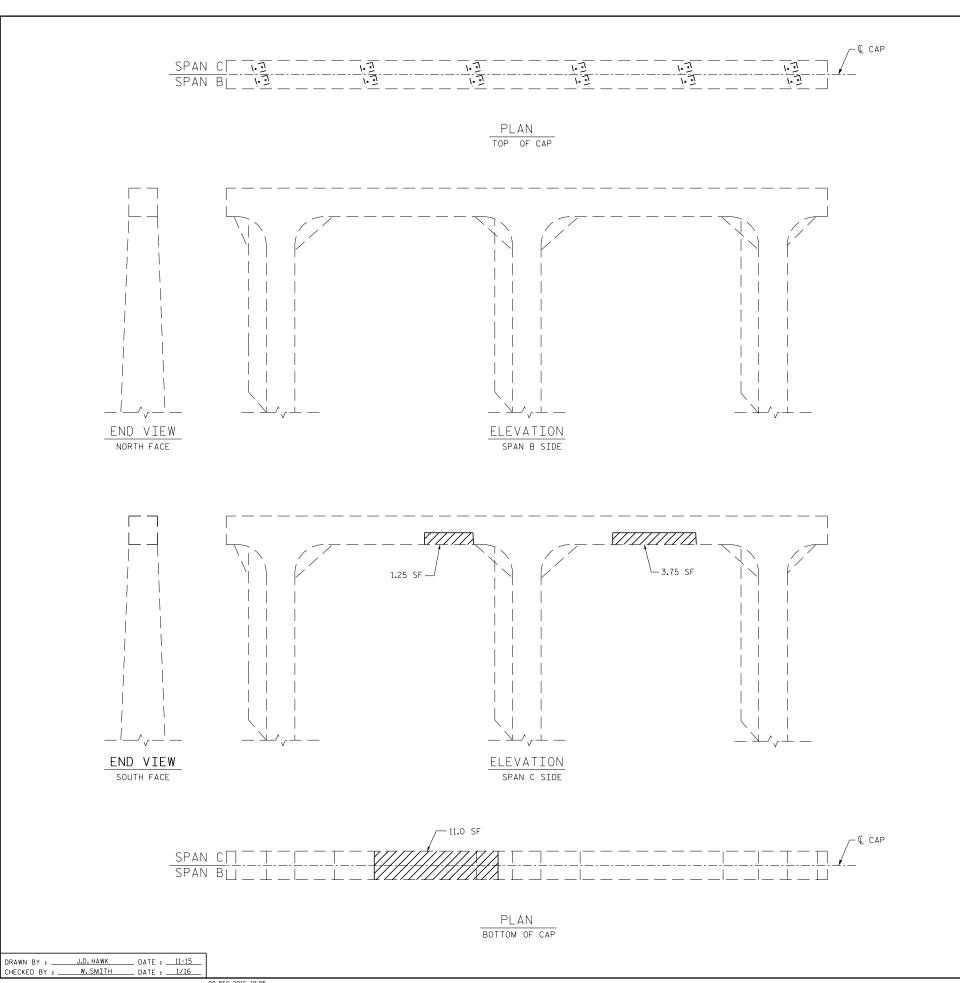
REPAIR QUANTITY TABLE QUANTITIES REPAIRS BENT 2 ESTIMATE ACTUAL AREA VOLUME AREA VOLUME SF CF SF CF SHOTCRETE REPAIRS 1.25 CAP (VERTICAL FACE) 5.0 CAP (HORIZONTAL, CORNER) 11.0 2.75 COLUMN (HORIZONTAL FACE) 0 0 LN. FT EPOXY RESIN INJECTION CAP 0 COLUMN 0 EPOXY COATING TOP OF CAP 106.0

VALUES IN CHART REPRESENT ESTIMATED REPAIR TOTALS AFTER REMOVAL OF UNSOUND CONCRETE, MIN. OF 1"BEHIND REBAR AND MIN. 2"CL TO SAWCUT. SEE REPAIR DETAILS.

CONTRACTOR SHALL SAW CUT TO A MINIMUM DEPTH OF $^{1\!/}_{2}{}''$ BUT REINFORCING STEEL SHALL NOT BE DAMAGED.

FOR REPAIR DETAILS, SEE "TYPICAL CAP AND COLUMN REPAIR DETAILS" SHEET.
