I-5765 PROJECT NO. DAVIE COUNTY 75 BRIDGE NO .:

STATE OF NORTH CAROLINA DEPARTMENT OF TRANSPORTATION

SUBSTRUCTURE

BENT 1 (WBL)

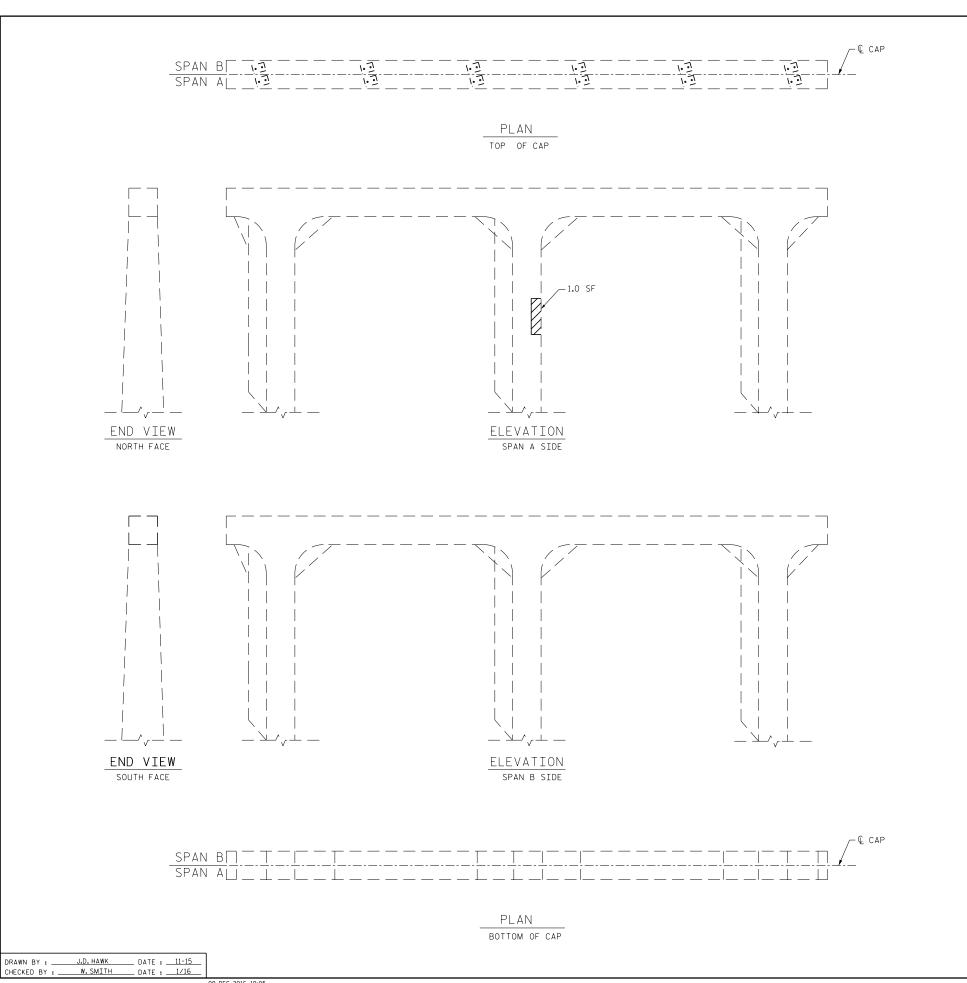
REPAIR QUANTITY TABLE QUANTITIES REPAIRS BENT 1 ESTIMATE ACTUAL AREA VOLUME AREA VOLUME SF CF SF CF SHOTCRETE REPAIRS CAP (VERTICAL FACE) 0 0 CAP (HORIZONTAL, CORNER) 0 COLUMN (HORIZONTAL FACE) 1.0 0.5 LN. FT EPOXY RESIN INJECTION CAP 0 COLUMN 0 EPOXY COATING TOP OF CAP 106.0

VALUES IN CHART REPRESENT ESTIMATED REPAIR TOTALS AFTER REMOVAL OF UNSOUND CONCRETE, MIN. OF 1"BEHIND REBAR AND MIN. 2"CL TO SAWCUT. SEE REPAIR DETAILS.

REPAIR LOCATIONS AND ESTIMATE OF QUANTITIES ARE GIVEN WITH THE BEST INFORMATION AVAILABLE. IF ADDITIONAL REPAIRS NOT SHOWN ON THE DRAWINGS ARE DEEMED NECESSARY BY THE INSPECTOR OR ENGINEER THE CONTRACTOR SHALL NOTE ON THE DRAWINGS THE APPROXIMATE LOCATION AND DESCRIPTION OF THE REPAIRS AND ADJUST THE ACTUAL QUANTITIES ENTERED INTO THE REPAIR QUANTITY TABLE.

CONTRACTOR SHALL SAW CUT TO A MINIMUM DEPTH OF $^{1\!/}_{2}{}''$ BUT REINFORCING STEEL SHALL NOT BE DAMAGED.

FOR REPAIR DETAILS, SEE "TYPICAL CAP AND COLUMN REPAIR DETAILS" SHEET.
