PROJECT NO. I-5809
McDOWELL COUNTY
 BRIDGE NO. 146

SHEET 3 OF 4

BENT 3

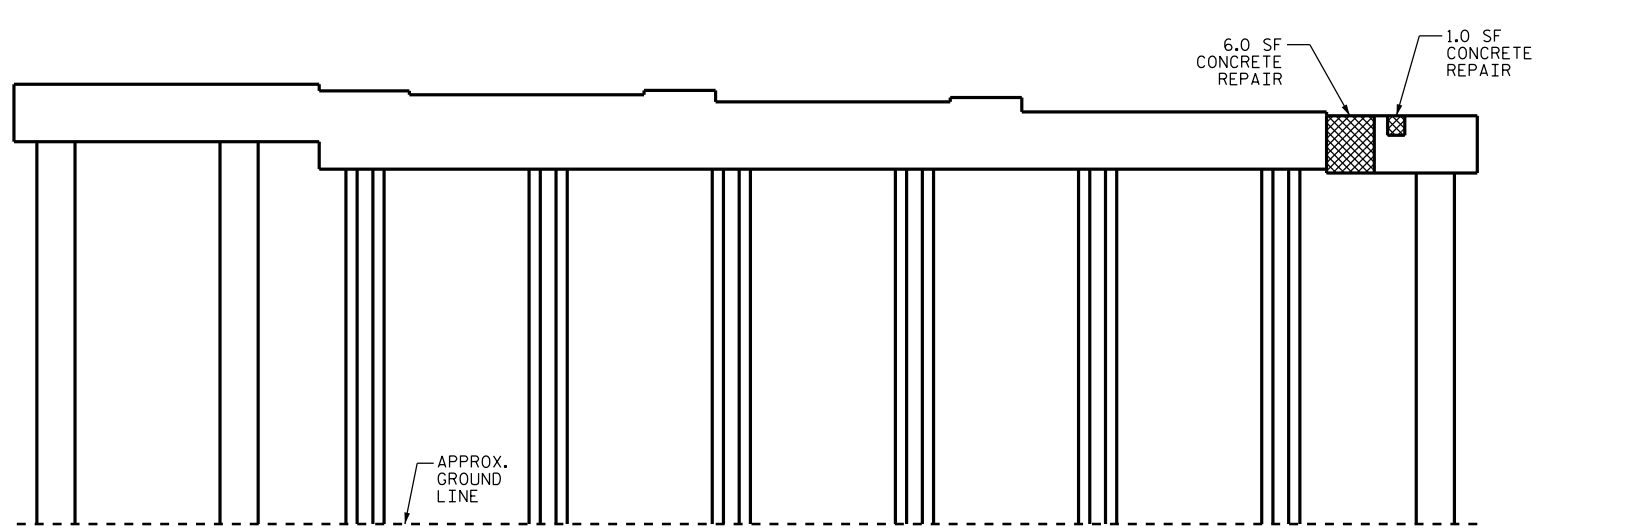
PLAN - BOTTOM OF CAP

* QUANTITY HAS BEEN INCREASED DUE TO THE POTENTIAL FOR FURTHER DETERIORATION SINCE THE FIELD INSPECTION BY STRUCTURES MANAGEMENT UNIT.

FOR REPAIR DETAILS, SEE "TYPICAL CAP AND COLUMN REPAIR DETAILS" SHEET.
