PROJECT NO. I-5809

McDOWELL county
BRIDGE NO. 152

STATE OF NORTH CAROLINA
DEPARTMENT OF TRANSPORTATION

BENT 2

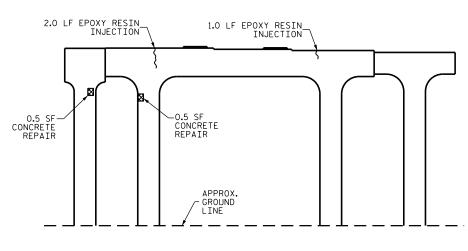
SPAN B VIEW - ELEVATION

DAMAGED AREA

EPOXY RESIN INJECTION

FOR REPAIR DETAILS, SEE "TYPICAL CAP AND COLUMN REPAIR DETAILS" SHEET.
