AS-BUILT REPAIR QUANTITY TABLE

PROJECT NO. I-5892
BUNCOMBE COUNTY
 BRIDGE NO. 421

**BENT 1
 SPAN A FACE**

BENT 1

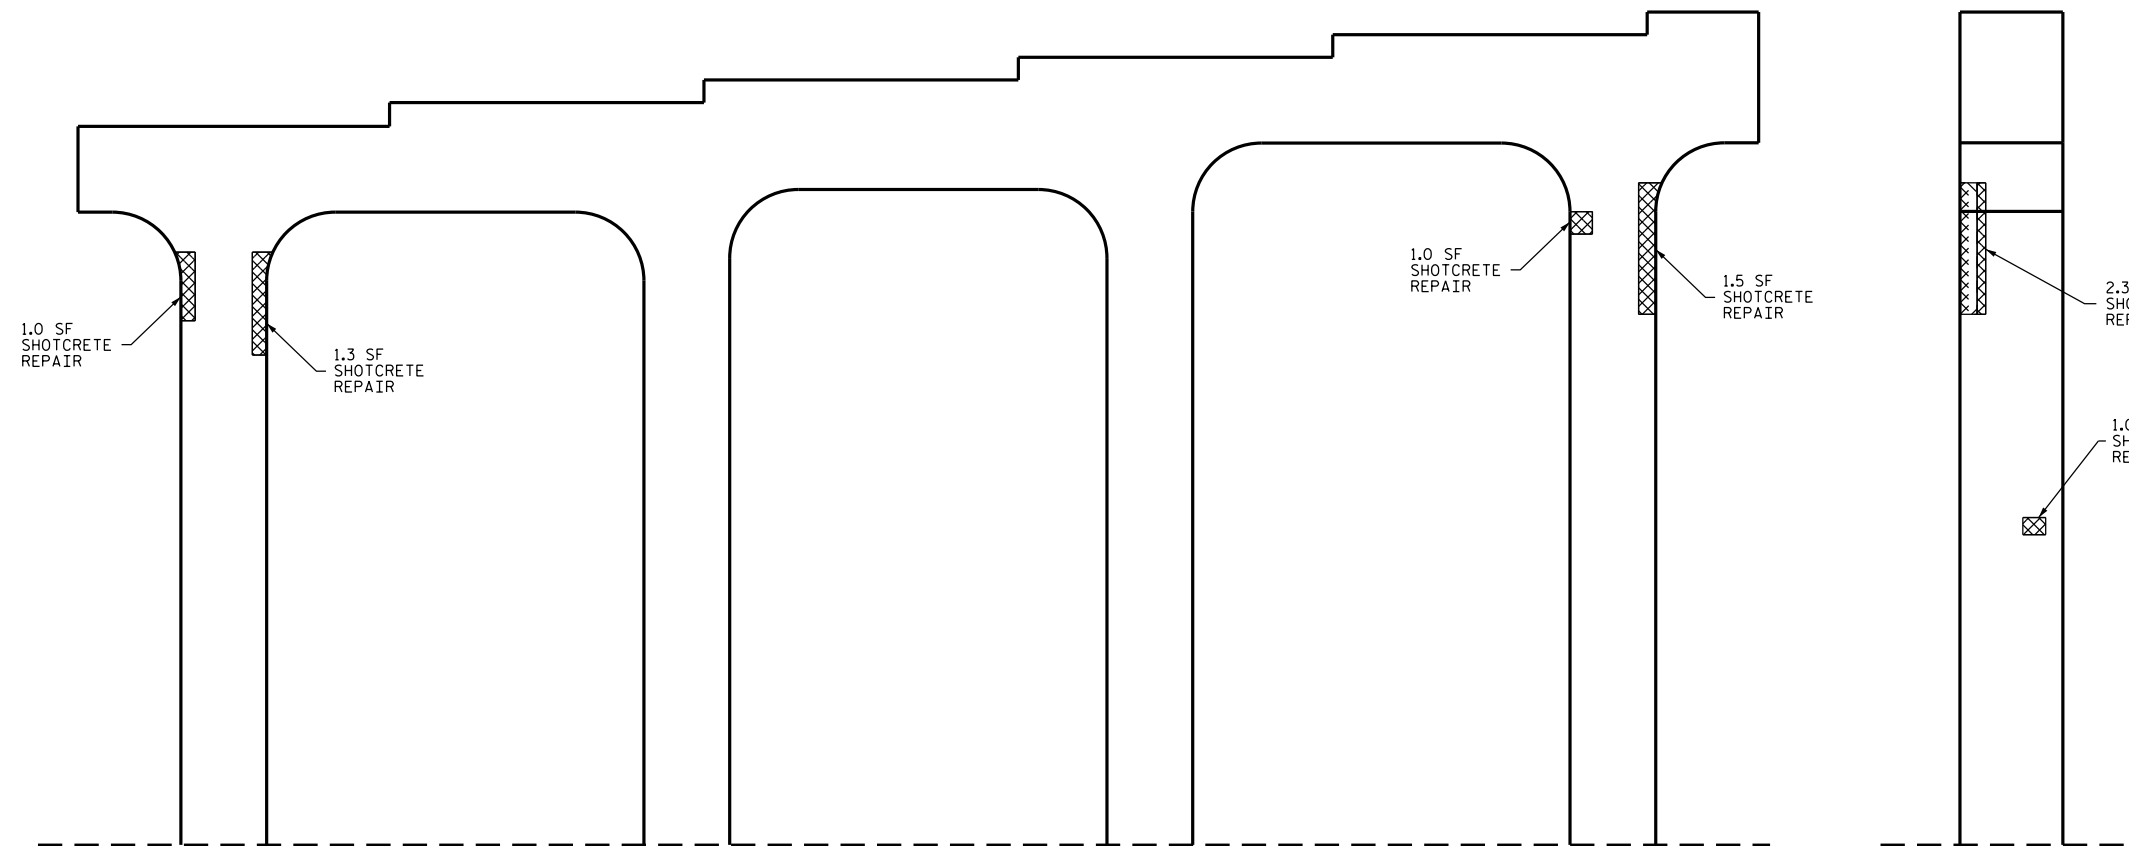
ELEVATION
 (SPAN A FACE)

BENT 1 REPAIRS	QUANTITIES			
	ESTIMATE		ACTUAL	
SHOTCRETE REPAIRS	AREA SF	VOLUME CF	AREA SF	VOLUME CF
CAP	0.0	0.0		
COLUMN	11.1	6.9 *		
CONCRETE REPAIRS	AREA SF	VOLUME CF	AREA SF	VOLUME CF
CAP	1.0	0.5 *		
COLUMN	0.0	0.0		
EPOXY RESIN INJECTION		LN. FT		LN. FT
CAP		1.0		
COLUMN		1.7		
EPOXY COATING		SO. FT		SO. FT
TOP OF BENT CAP		147

DAMAGED AREA

EPOXY RESIN INJECTION

FOR REPAIRS, SEE "TYPICAL CAP AND COLUMN REPAIR DETAILS" SHEET.

CLEAN AND REMOVE DEBRIS FROM THE TOP OF THE CAP AND APPLY EPOXY PROTECTIVE COATING. EPOXY COATING SHALL BE APPLIED TO THE TOP FACE OF THE CAP. THE CONTRACTOR SHALL NOT COAT THE AREA OF THE CAP BENEATH THE MASONRY PLATES. FOR EPOXY COATING, SEE SPECIAL PROVISION.
