-	PROJECT NO. <u>I-5892</u> <u>BUNCOMBE</u> COUNTY BRIDGE NO. <u>421</u>					
John Annacon -780000 Herecking SEAL 32492 HANNAC	DEPARTMENT OF NORTH CAROLINA DEPARTMENT OF TRANSPORTATION RALEIGH BENT 1 SPAN B FACE					
		SHEET NO.				
DOCUMENT NOT CONSIDERED	NO. BY:	DATE:	NO.	BY:	DATE:	S-24
FINAL UNLESS ALL SIGNATURES COMPLETED	1 2		3 4			TOTAL SHEETS 68

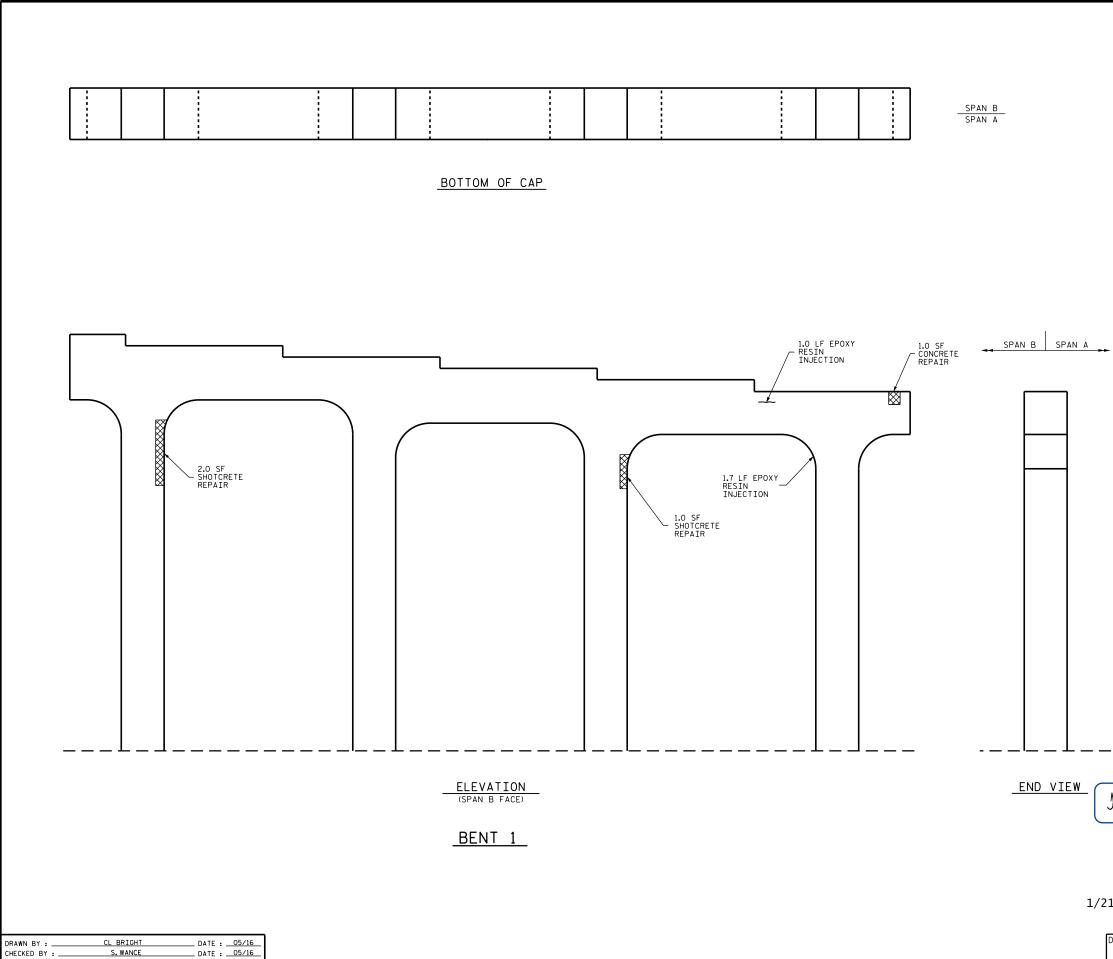
DAMAGED AREA

FOR REPAIRS, SEE "TYPICAL CAP AND COLUMN REPAIR DETAILS" SHEET.

CLEAN AND REMOVE DEBRIS FROM THE TOP OF THE CAP AND APPLY EPOXY PROTECTIVE COATING. EPOXY COATING SHALL BE APPLIED TO THE TOP FACE OF THE CAP. THE CONTRACTOR SHALL NOT COAT THE AREA OF THE CAP BENEATH THE MASONRY PLATES. FOR EPOXY COATING, SEE SPECIAL PROVISION.
