TION SINCE THE FIELD INSPECTION DI STRUCTURES MANAGEMENT UNIT.					
PROJECT NO.		<u>I-58</u>	<u>39</u> 2		
BUNCO					
		429			
BRIDGE NO		J			
DocuSigned by: SHEET 1 OF 2					
DEPARTMENT		RANSPO	RTAT	ION	
ABC SOLUCIES BURGES					
SEAL 32492 μ ΡΙΔΝ	PLAN OF SPANS				
	SPANS A & B

74.7 YANNA		2.	-		
-,					
	IONS NO. BY:	DA1		SHEET NO. S-42	
FINAL UNLESS ALL 1	3		<u> </u>	TOTAL SHEETS	
SIGNATURES COMPLETED 🙎	4			68

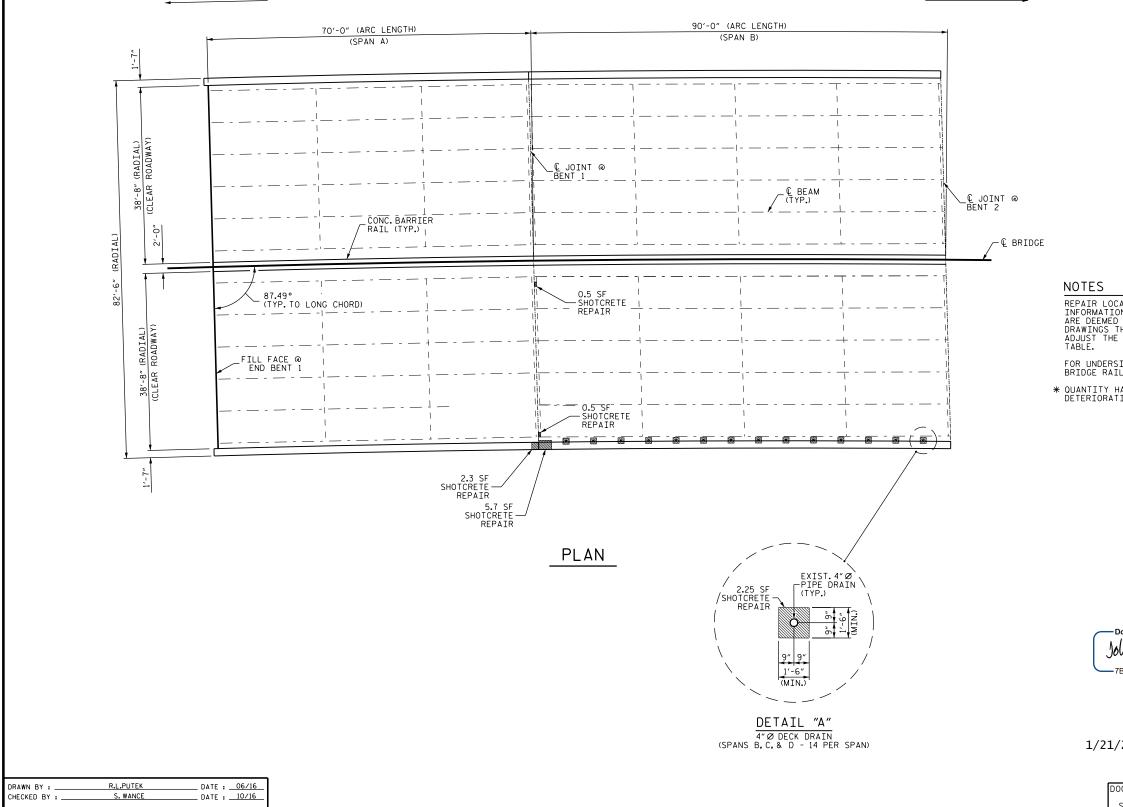
AS-BUILT REPAIR QU	IANT	ITY	ΤA	BLE	
UNDERSIDE OF DECK REPAIRS					
SHOTCRETE REPAIRS		MATE VOLUME		TUAL VOLUME	
UNDERSIDE OF DECK	SF 0.0	CF 0.0	SF	CF	
OVERHANG DIAPHRAGMS	0.0	0.0			
UNDERSIDE OF OVERHANG INTERIOR DIAPHRAGMS	133.3 4.3	83.9 * 2.6 *

• • •		
UNDERSIDE EPOXY RESIN INJECTION	ESTIMATE ACTUAL				
VALUES IN CHARTS REPRESENT ESTIMATED UNDERSIDE OF DECK					
VALUES IN CHARTS REPRESENT ESTIMATED UNDERSIDE OF DECK REPAIR TOTALS AFTER REMOVAL OF UNSOUND CONCRETE,MINIMUM OF 1" BEHIND REBAR AND MINIMUM 2" CLEARANCE TO SAWCUT. SEE REPAIR DETAILS.					
SEE REPAIR DETAILS.					
UNDERSIDE REPAIR					
DIAPHRAGM REPA	DIAPHRAGM REPAIR				
ERI EPOXY RESIN INJECTION					
CATIONS AND ESTIMATED OUANTITIES ARE GIVEN WITH THE BEST ION AVAILABLE.IF ADDITIONAL REPAIRS NOT SHOWN ON THE DRAWINGS D. NECESSARY BY THE ENGINEER, THE ENGINEER WILL NOTE ON THE					
D NECESSARY BY THE ENGINEER, THE ENGINEER WILL NOTE ON THE THE APPROXIMATE LOCATIONS AND DESCRIPTION OF THE REPAIRS AND THE ACTUAL QUANTITIES ENTERED INTO THE AS-BUILT REPAIR QUANTITY					
SIDE OF DECK AND DIAPHRAGM REPAIRS, SEE ``OVERHANG, DIAPHRAGM AND IL REPAIR DETAILS'' SHEET.					
HAS BEEN INCREASED DUE TO THE POTENTIAL FOR FURTHER ITION SINCE THE FIELD INSPECTION BY STRUCTURES MANAGEMENT UNIT.
