PROJECT NO. I-5892
BUNCOMBE COUNTY
 BRIDGE NO. 429
 SHEET 1 OF 3

STATE OF NORTH CAROLINA
 DEPARTMENT OF TRANSPORTATION
 RALEIGH
BENT 1
SPAN A FACE

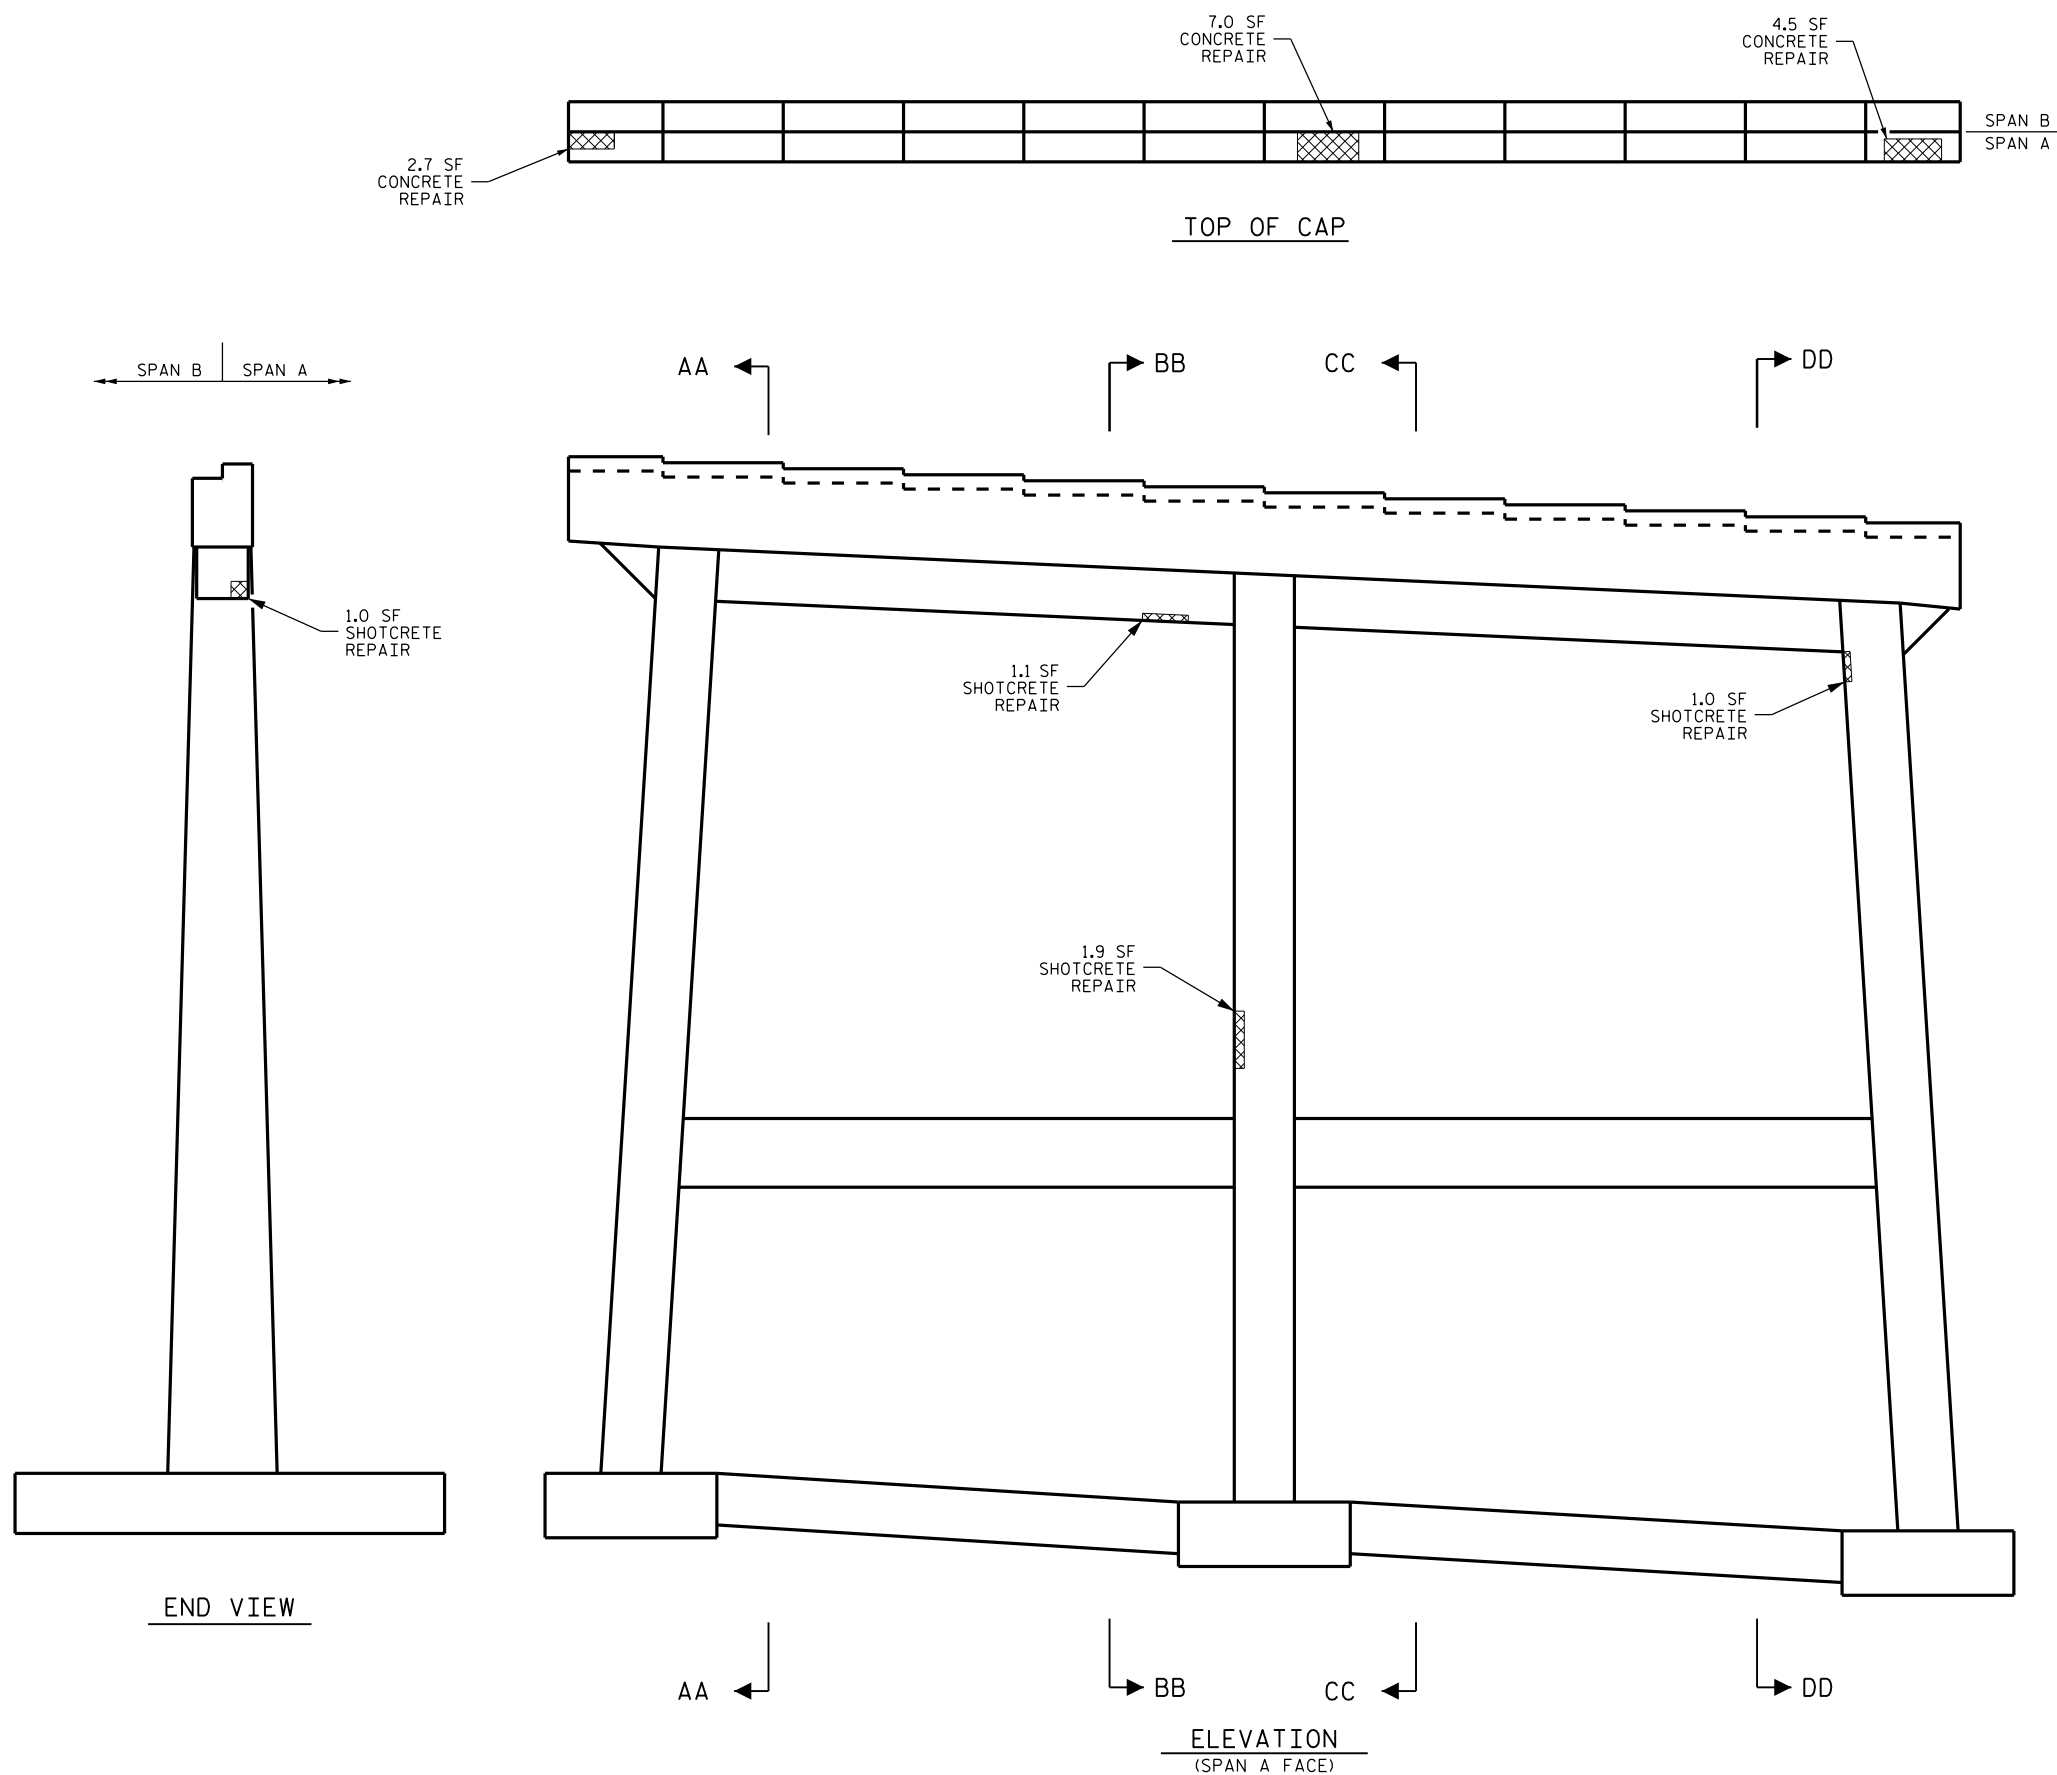
AS-BUILT REPAIR QUANTITY TABLE				
REPAIRS BENT 1	QUANTITIES			
	ESTIMATE		ACTUAL	
SHOTCRETE REPAIRS	AREA SF	VOLUME CF	AREA SF	VOLUME CF
CAP	95.6	59.8 *		
COLUMNS AND STRUTS	220.0	137.5 *		
CONCRETE REPAIRS	AREA SF	VOLUME CF	AREA SF	VOLUME CF
CAP	14.2	8.9 *		
COLUMNS AND STRUTS	0.0	0.0		
EPOXY RESIN INJECTION		LN. FT		LN. FT
CAP		3.0		
COLUMNS AND STRUTS		15.0		
EPOXY COATING		SO. FT		SO. FT
TOP OF BENT CAP		28

VALUES IN CHART REPRESENT ESTIMATED REPAIR TOTALS AFTER REMOVAL OF UNSOUND CONCRETE, MINIMUM OF 1" BEHIND REBAR AND MINIMUM 2" CLEARANCE TO SAWCUT. SEE REPAIR DETAILS.

DAMAGED AREA
 EPOXY RESIN INJECTION
